***Engineering Archaeological  
Services Ltd***

***Tai Bach, Maenan***

***February 2014***

***EAS Client Report 2014/02***

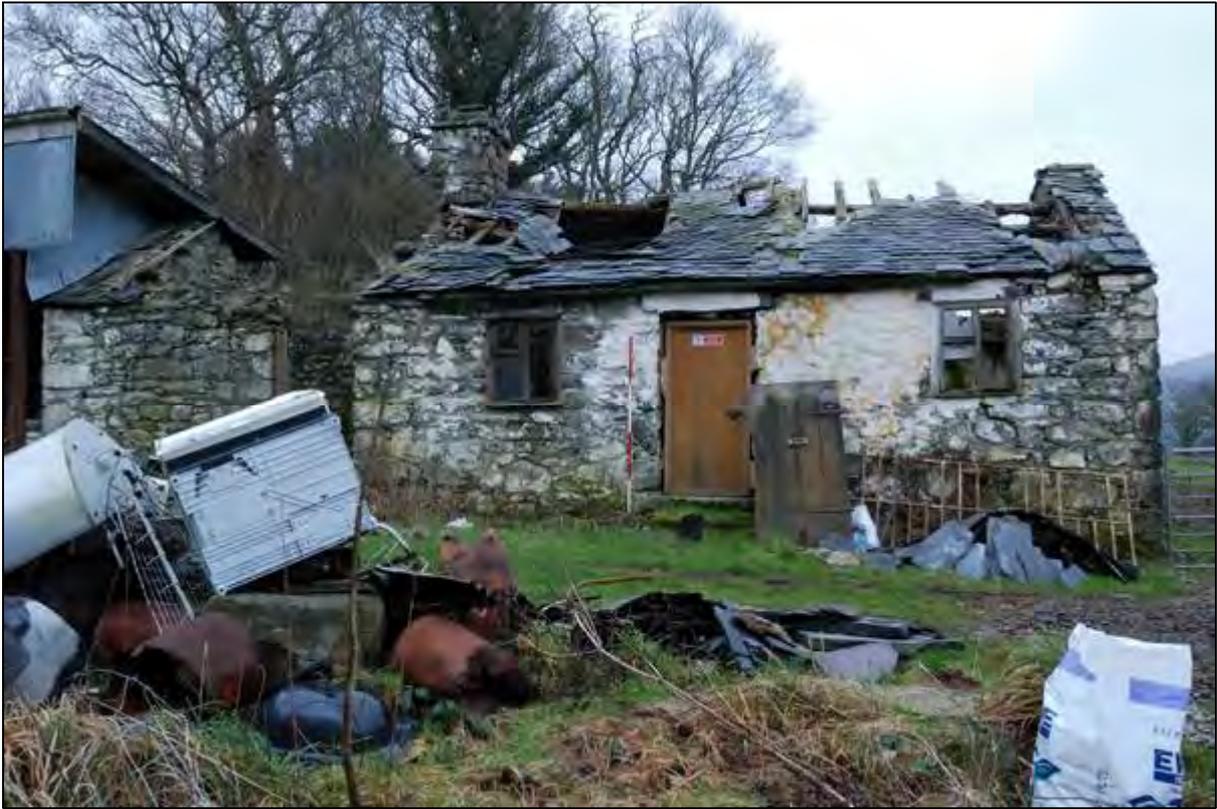
Tai Bach is a single storey cottage with an attached cow-house on its south-eastern gable. (Plate 1, Figure 8). It is constructed of poorly coursed stone boulder with limited use of squared quoins, particularly at the cow house end. The stonework has a lime mortar bonding and in places the wall appear to have been lime-washed. The cottage was under a slate roof, which has largely collapsed at the time of the survey, and has a single chimney (Plate 2) on the south eastern gable of the cottage.

Plate 1: The northern elevation.

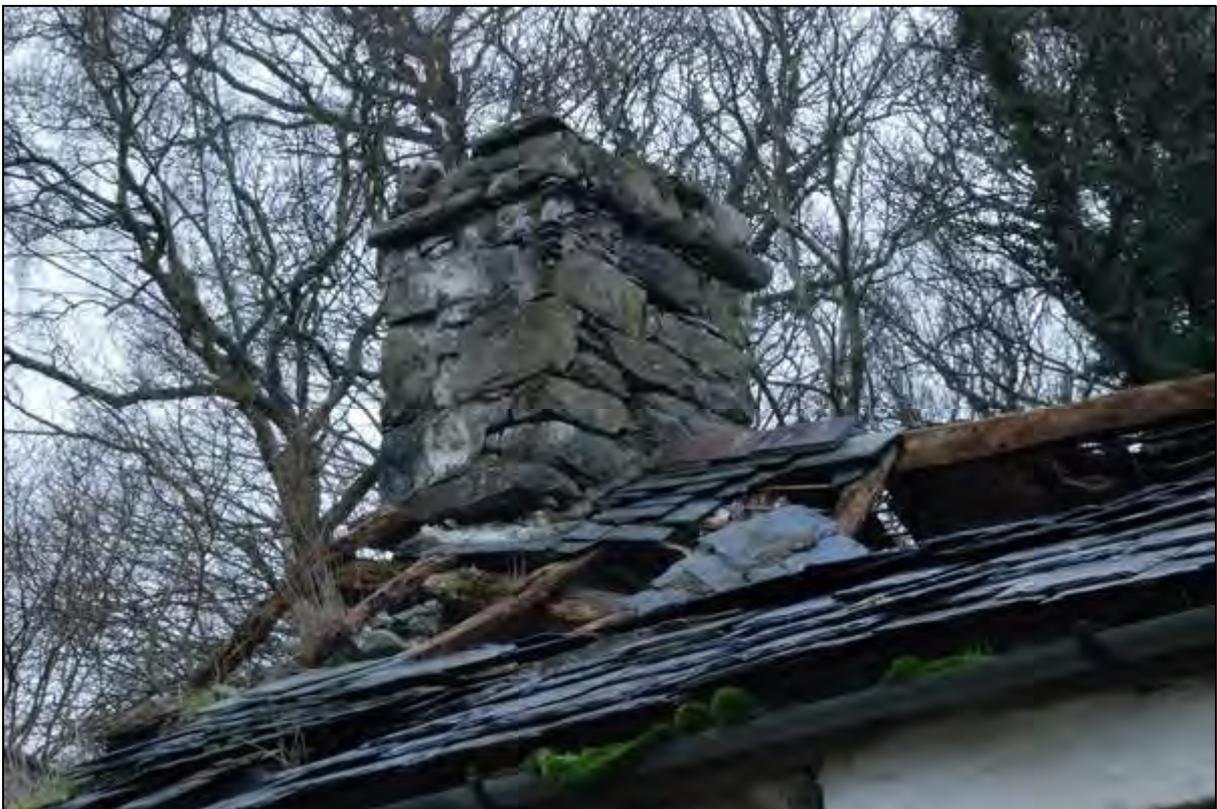
Plate 2: The chimney, looking SW

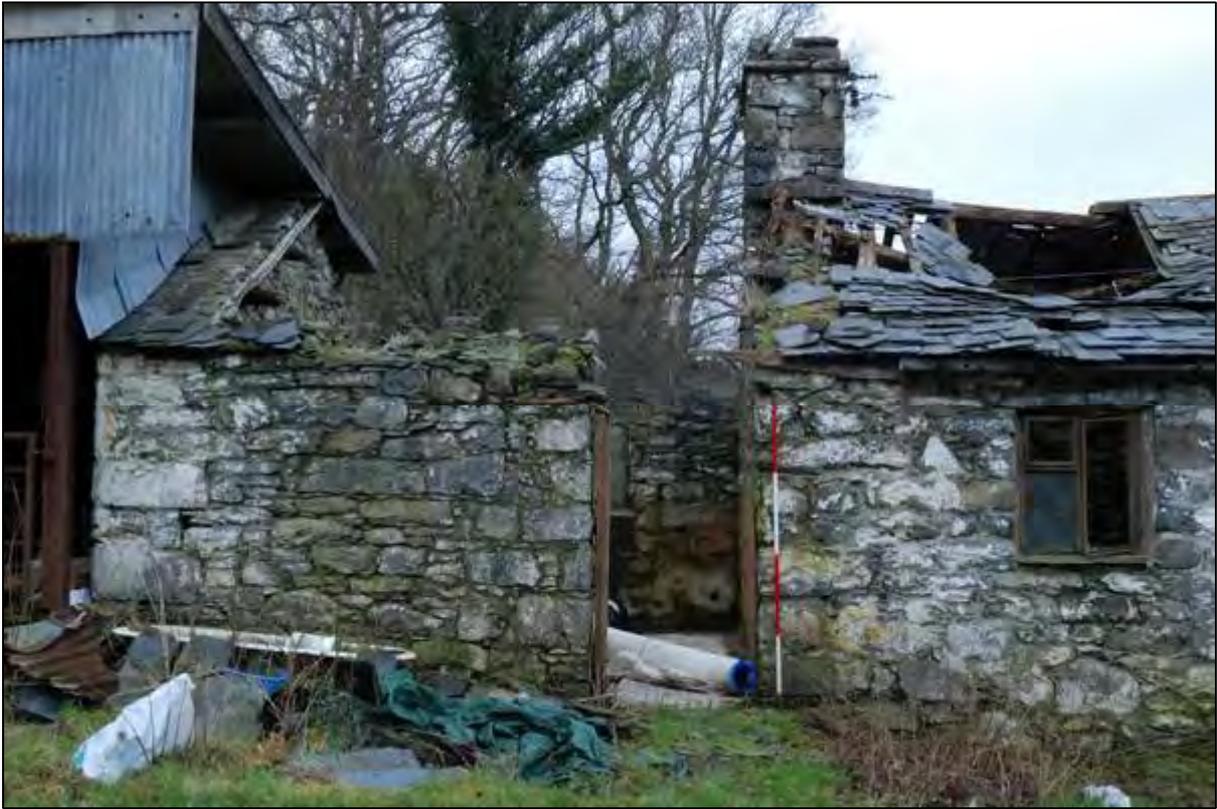
The front elevation of the cow house (Plate 3) has a single doorway adjacent to the gable wall to the cottage and the gable end of the cow house, itself, is marked by a series of squared stone quoins. No evidence of the probable pig sty on the south eastern gable of the cow house survives, however this area is now occupied by a modern space frame agricultural building.

Plate 3: The northern elevation of the cow house

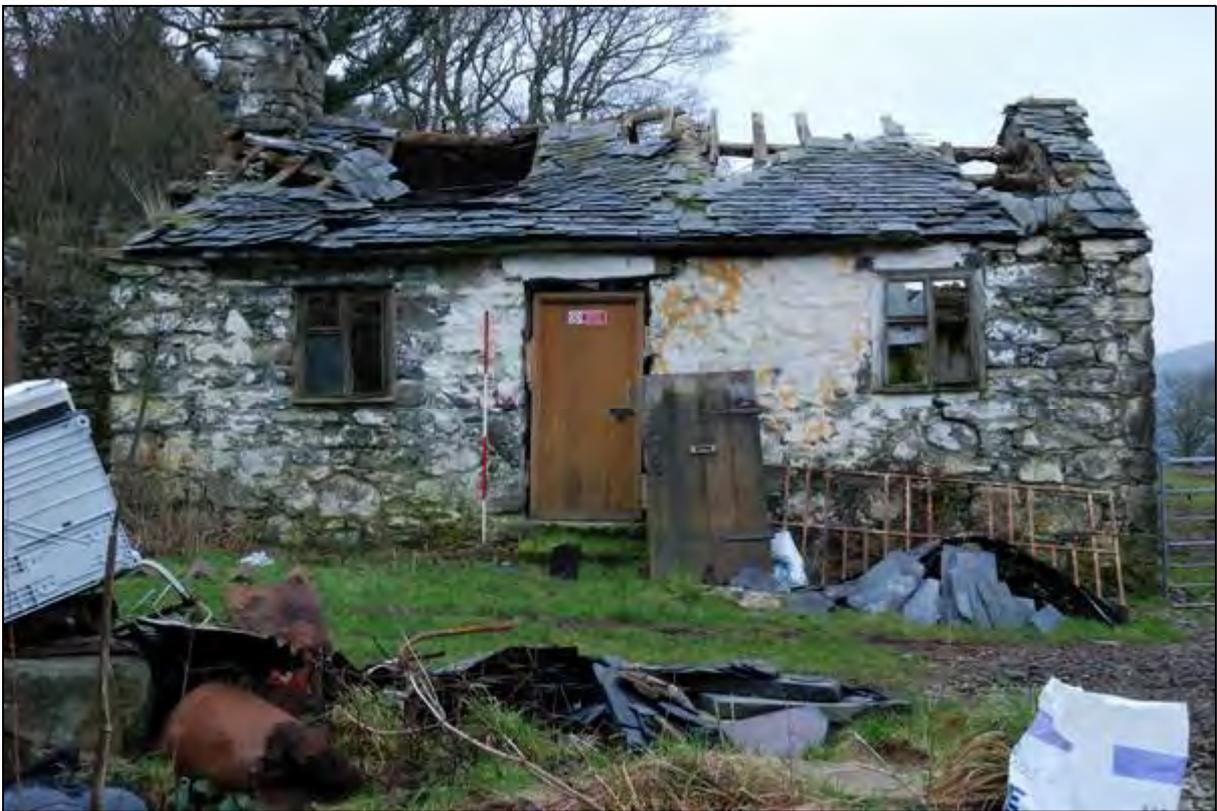
The house faces north-east with a central doorway flanked by two windows (Plate 4). These two windows (Plates 5 and 6) are wooden casement windows with stone lintels and cut slate cills. It is not certain whether the door (Plate 7) propped up outside the property is the original door to the property, however it is a four plank ledged door with strap hinges and a simple latch lifter. Whilst the strap hinges appear to be blacksmith made, the latch lifter would appear to be a later commercially made item. The door also retains two bands of decoration with cross decoration.

Plate 4: The northern elevation of the house

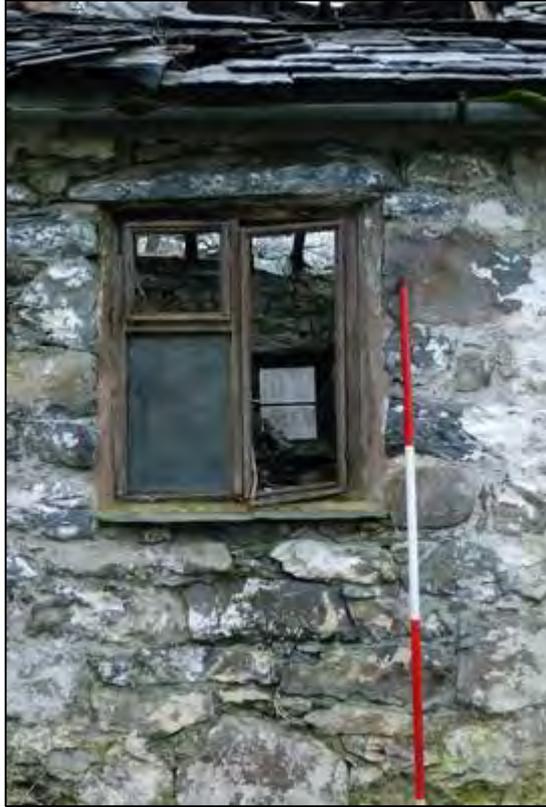
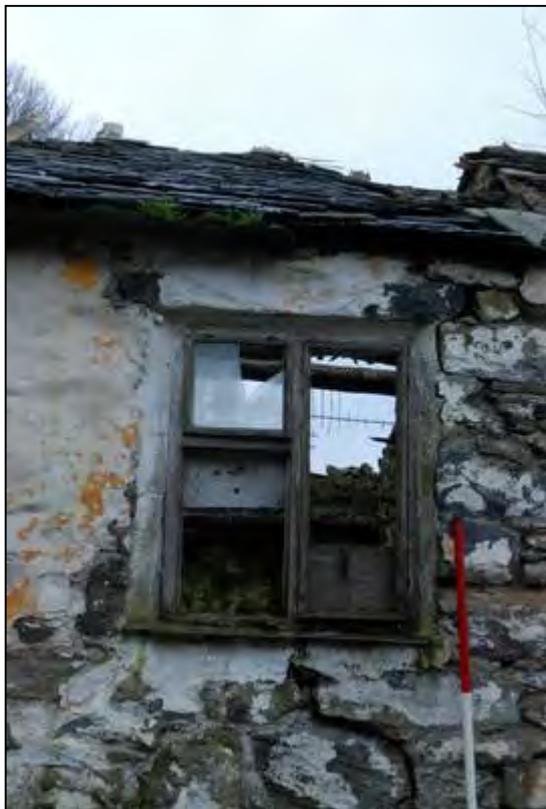
Plate 5: The eastern window in the front elevation

Plate 6: The western window in the front elevation

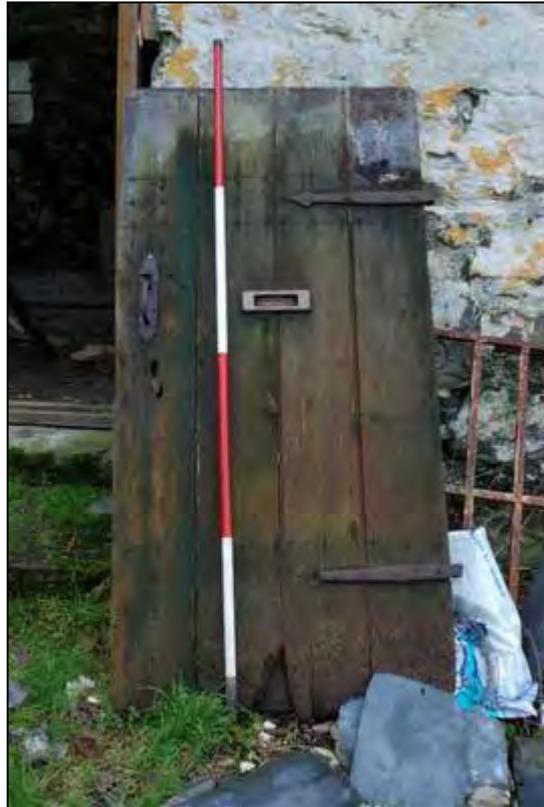
Plate 7: The possible original front door

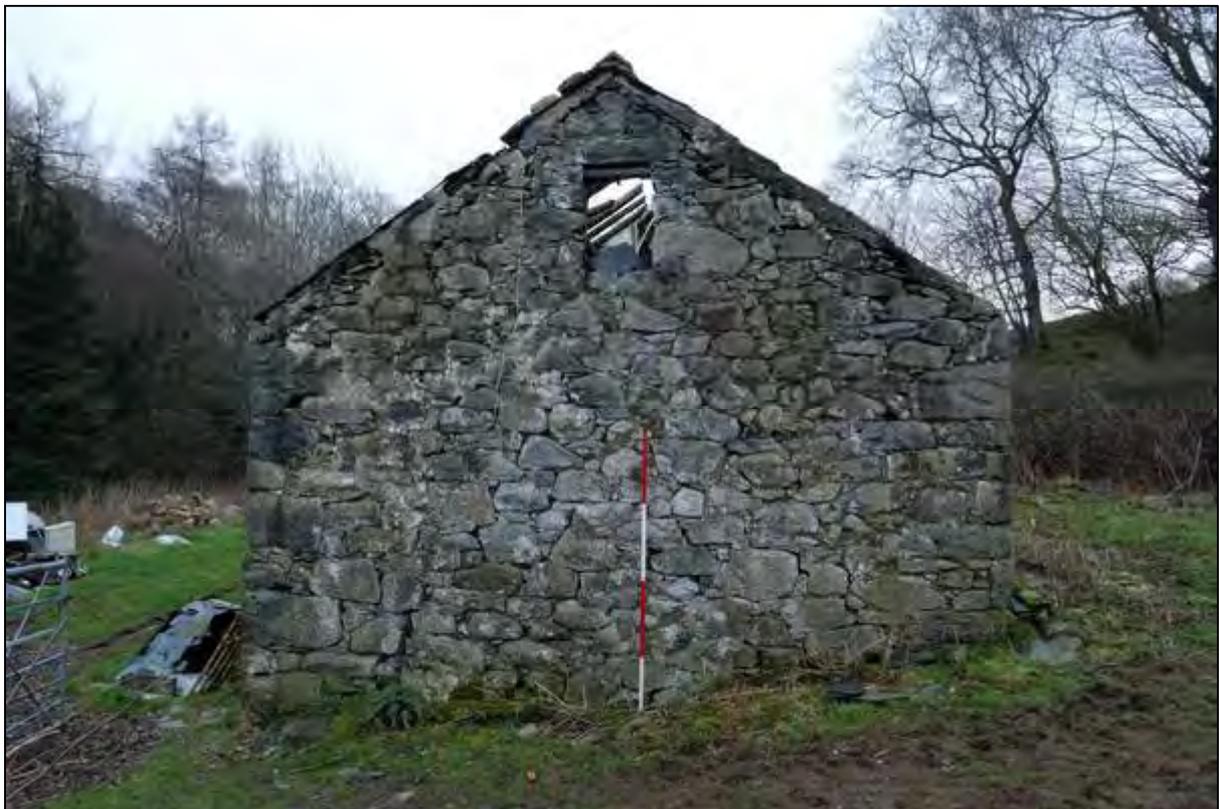
The north western gable end (Plate 8) has a single window opening at a high level which gave light to the *crogloft*. Most of the window frame is now missing, however the top rail survives suggesting that there was a wooden mullion dividing the opening. The window has a stone lintel, however the cill is missing.

Plate 8: The north western gable end

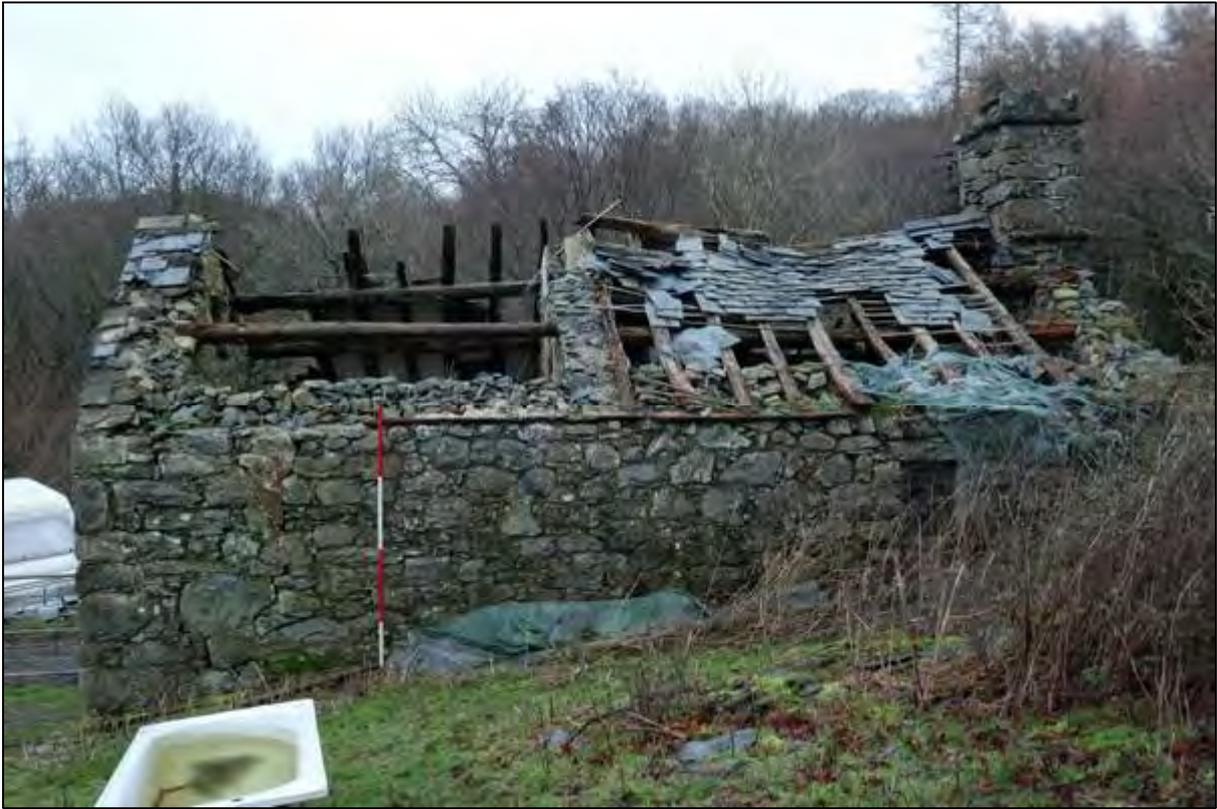
The rear elevation of the property is slightly terraced into the hill-slope (Plate 9) with the terracing becoming deeper towards the south-eastern end of the building such that the ground level is close to the level of the window of the cow house. There is a single window (Plate 10) in the rear wall which gave light to the main room of the cottage. This has a metal frame, divided into two panes

Plate 9: The rear elevation

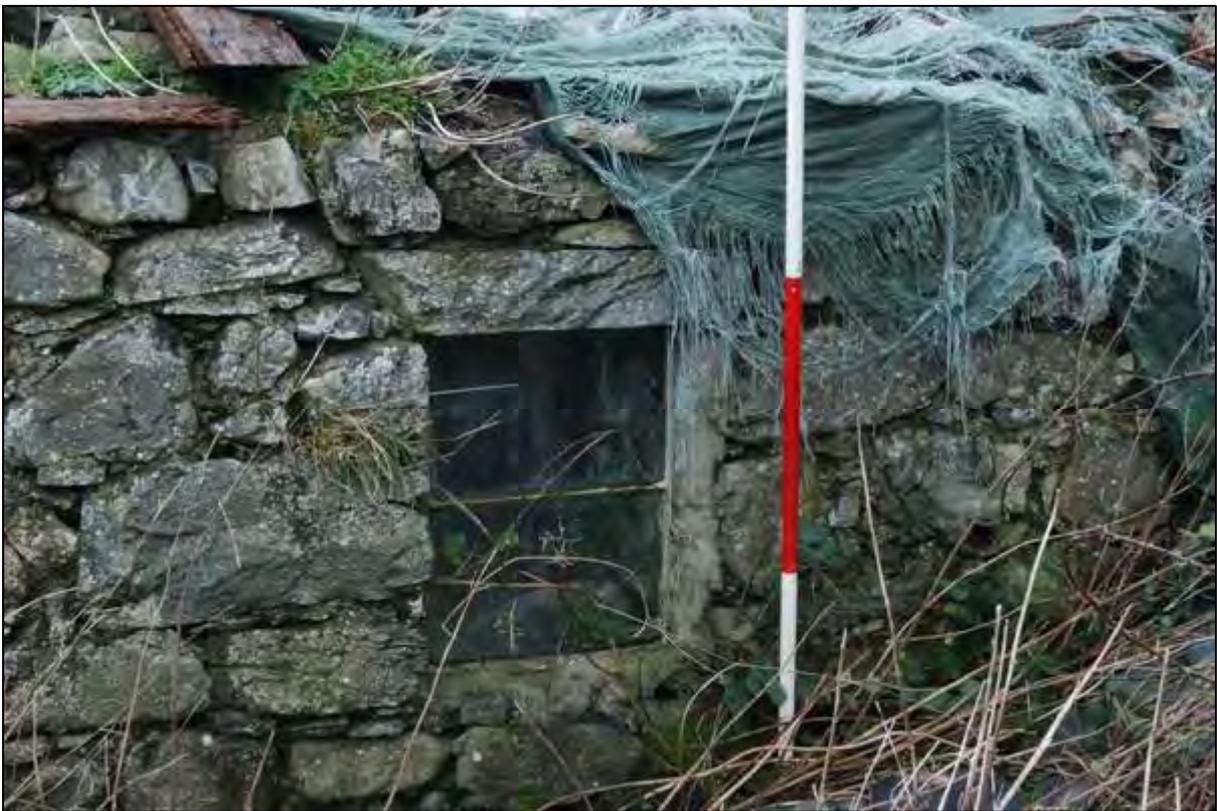
horizontally, and a stone lintel. There is also a window in the rear wall of the cow house.

Plate 10: The window in the rear elevation

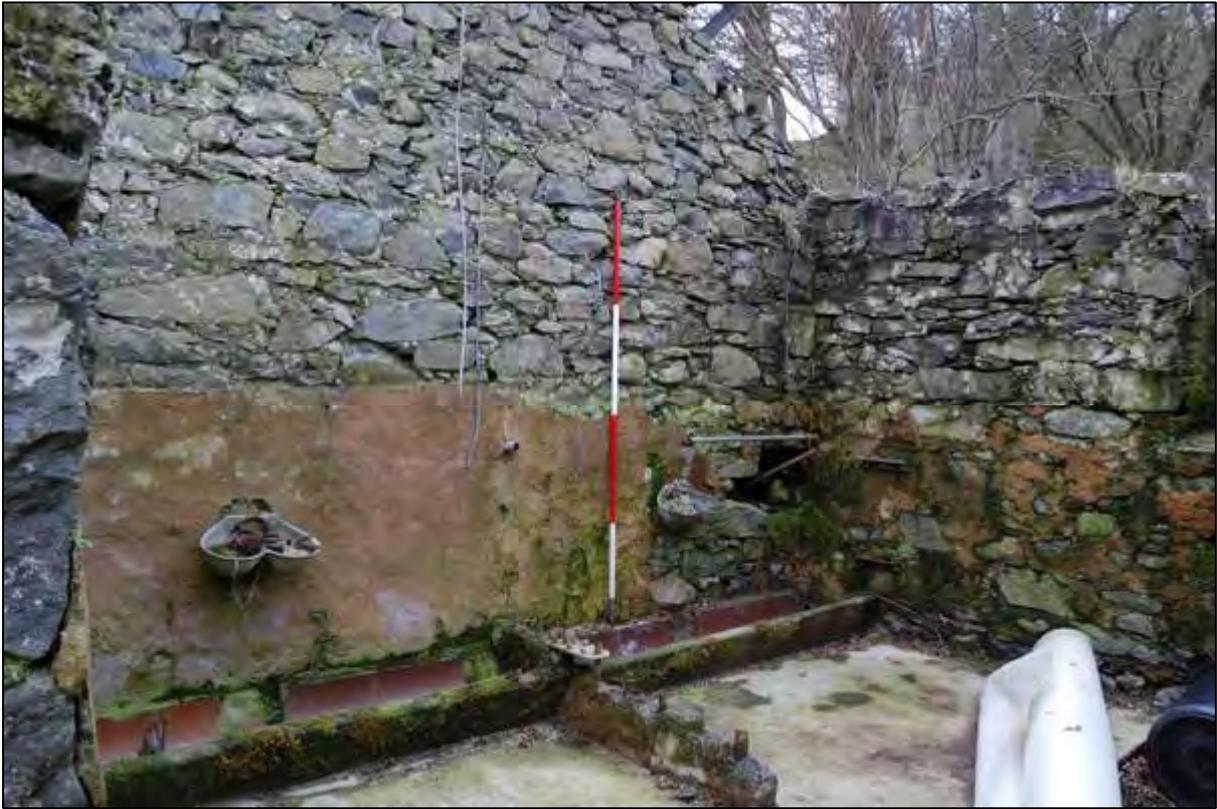
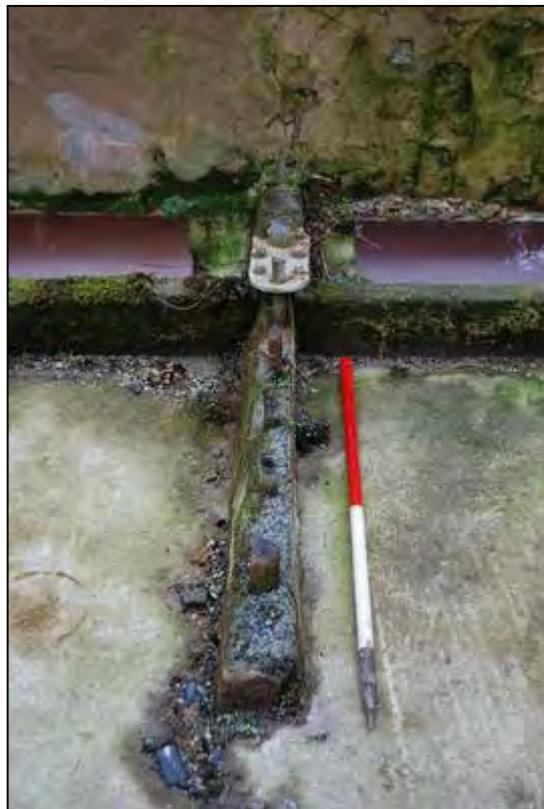
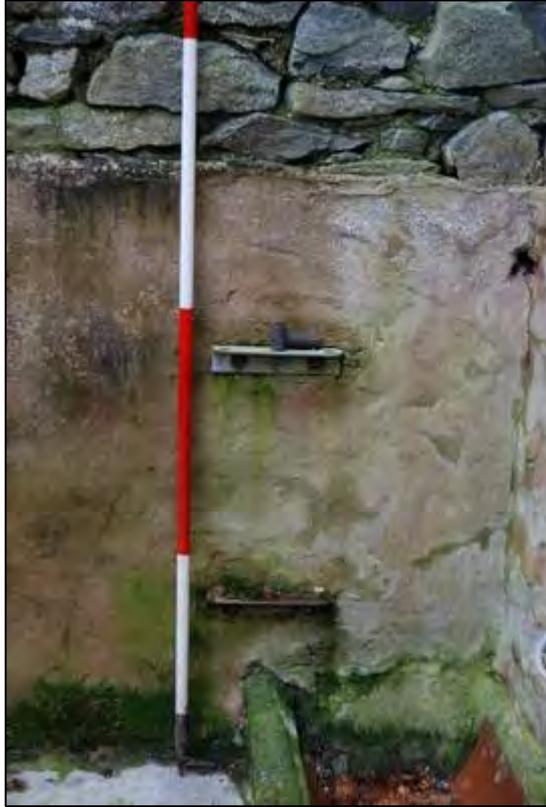
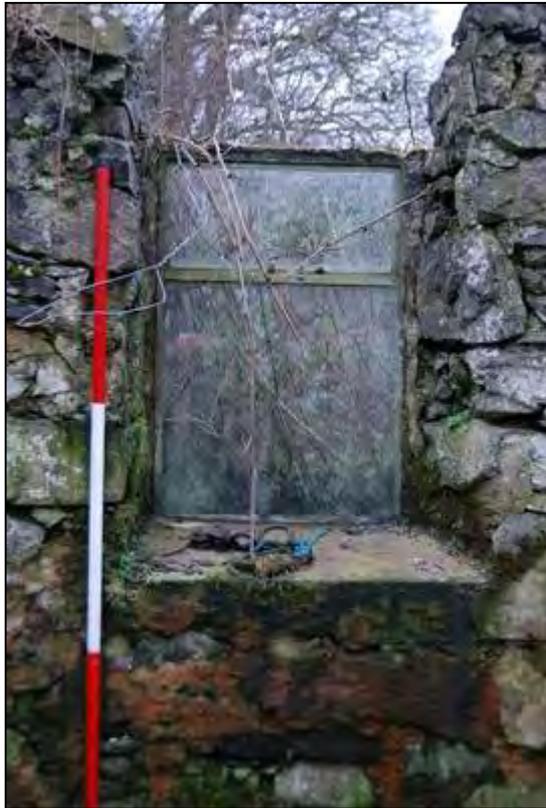
Inside the cow house is divided into two bays (Plate 11), each with a galvanised water feeder with two drinking positions suggesting the provision for four cows. Below the water basins is a trough running the width of the building consisting of a ceramic glazed trough set in concrete. The two bays were divided by metal bars set in a concrete dwarf wall (Plate 12). There were also bars in front of the trough, the mounts for which are bolted to the walls of the building (Plate 13). There is also a trough in the floor to help with the cleaning of building, which gave access to a drain below the front wall. The window in the rear wall (Plate 14) has a metal frame and cemented cill. Unfortunately the lintel is missing.

Plate 11: The cow house looking south

Plate 12: The divider between the bays in the cow house

Plate 13: Fittings for the bars in front of the trough in the cow house

Plate 14: The window in the cow house

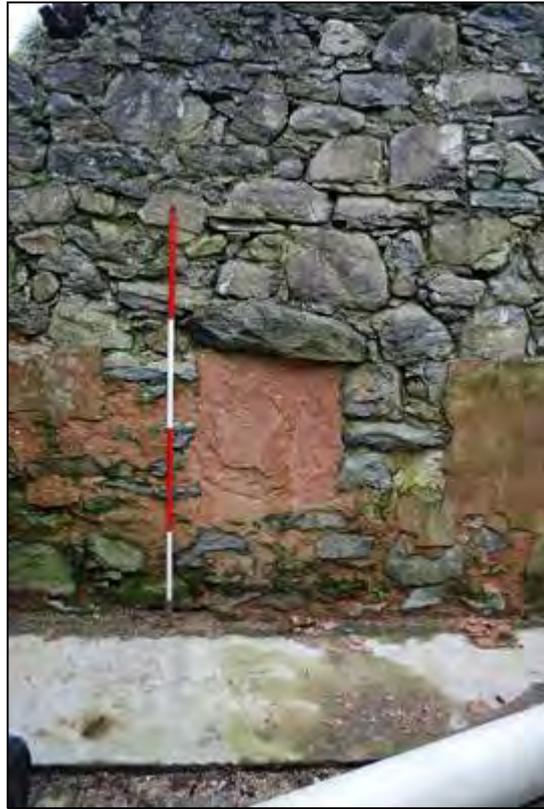
There is a blocked opening in the south eastern gable wall of the cottage (Plate 15) whose function is uncertain. Given its position the opening may have been related to the installation of the kitchen range on the other side of this wall.

Plate 15: Blocked opening in the south eastern gable wall of the cottage

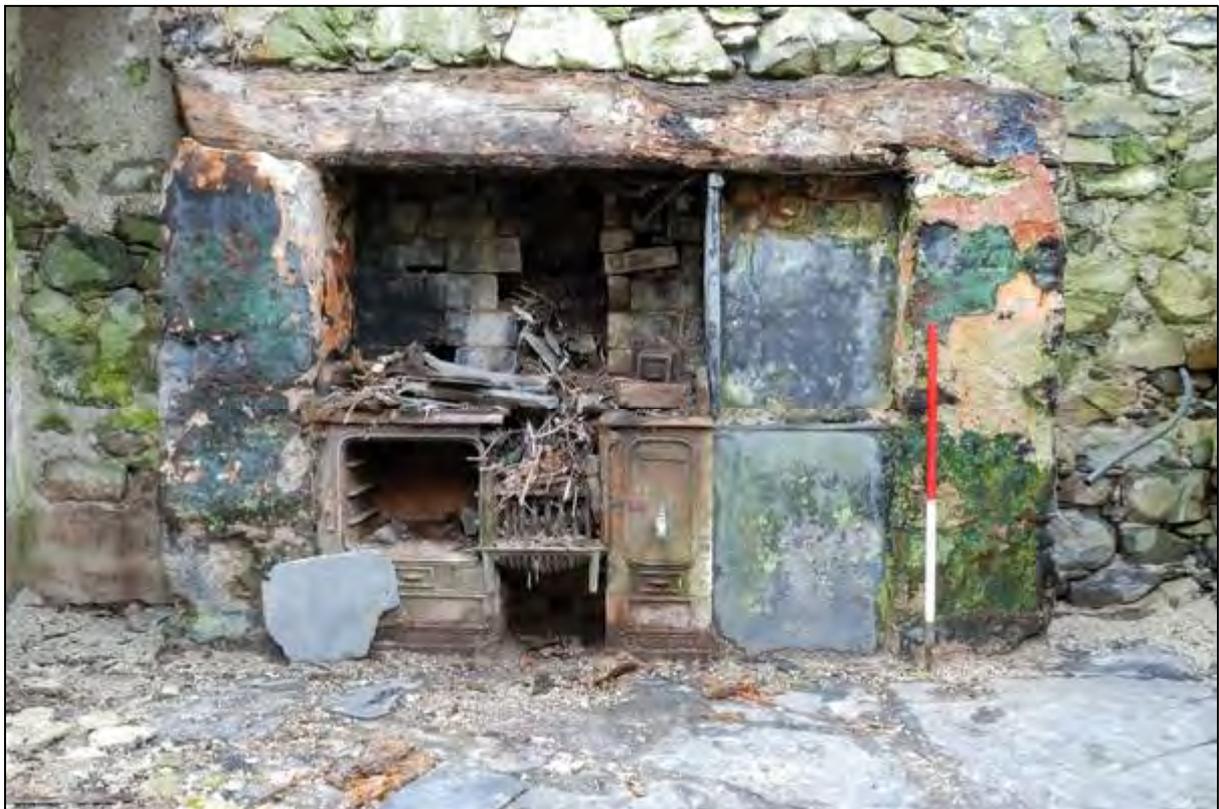
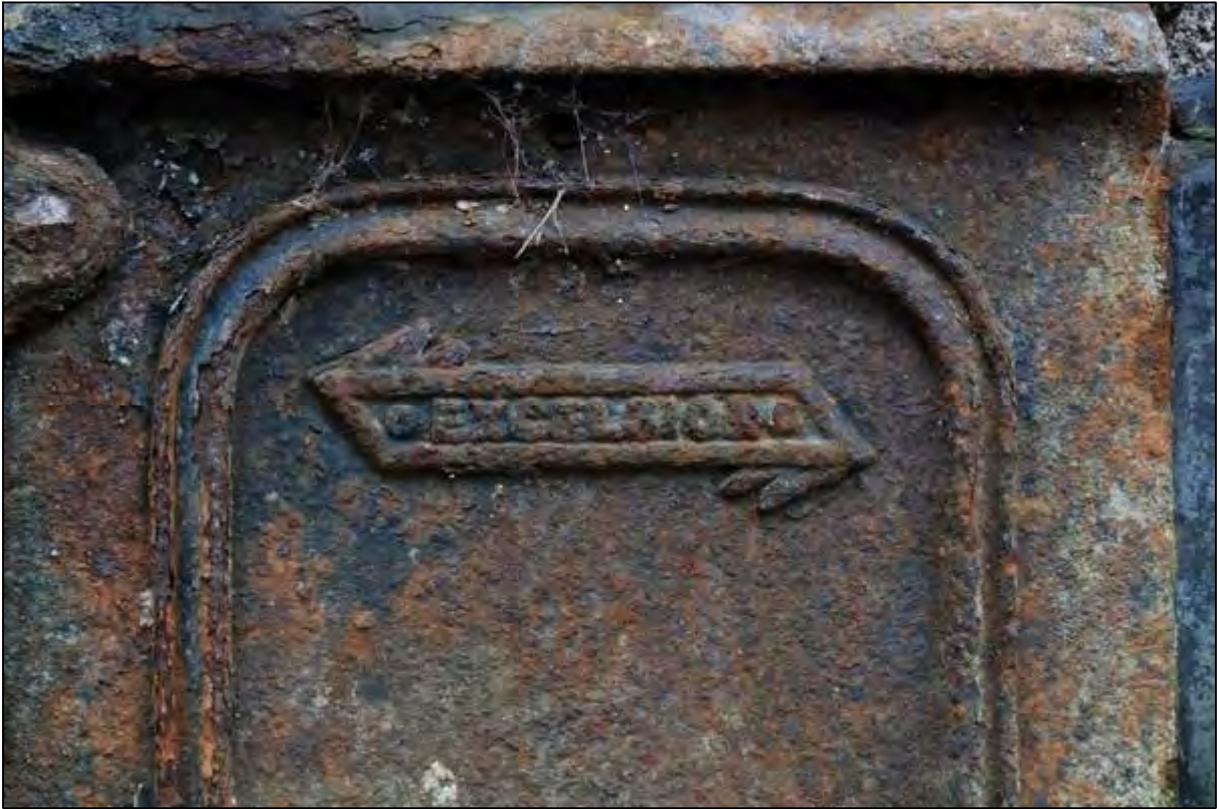
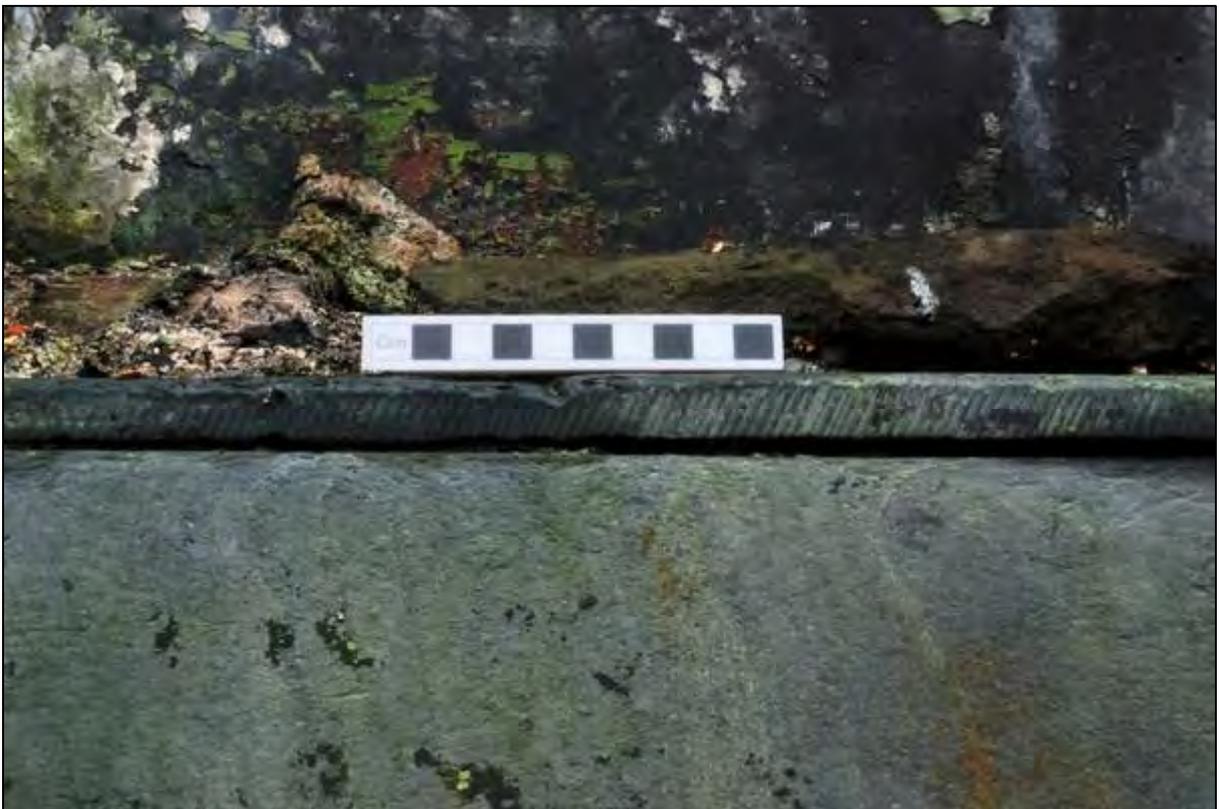
The cottage is divided into two room on the ground floor, with only the south eastern room being heated. There is also a *crogloft* over the north western room. The main room is dominated by the range set in the south eastern gable wall (Plate 16). This is a closed range with an oven to one side and a water tank with a tap to the other. Above the tap is the inscription "Excelsior" representing the model type (Plate 17). Such ranges are of 19<sup>th</sup> century design representing an improvement to the cottage. The range occupies the original fireplace, which had a large wooden bressumer supporting the chimney breast. The southern side of the range has a slate surround consisting of sawn and planed slate slabs. The marking on the edge of these slabs (Plate 18) suggest that they were cut with a "Greaves" saw demonstrating that they were cut after the 1850's (W. Jones *pers. comm.*).

Plate 16: The range

Plate 17: Detail of the water tank of the range

Plate 18: Detail of the slate surround showing the saw marks

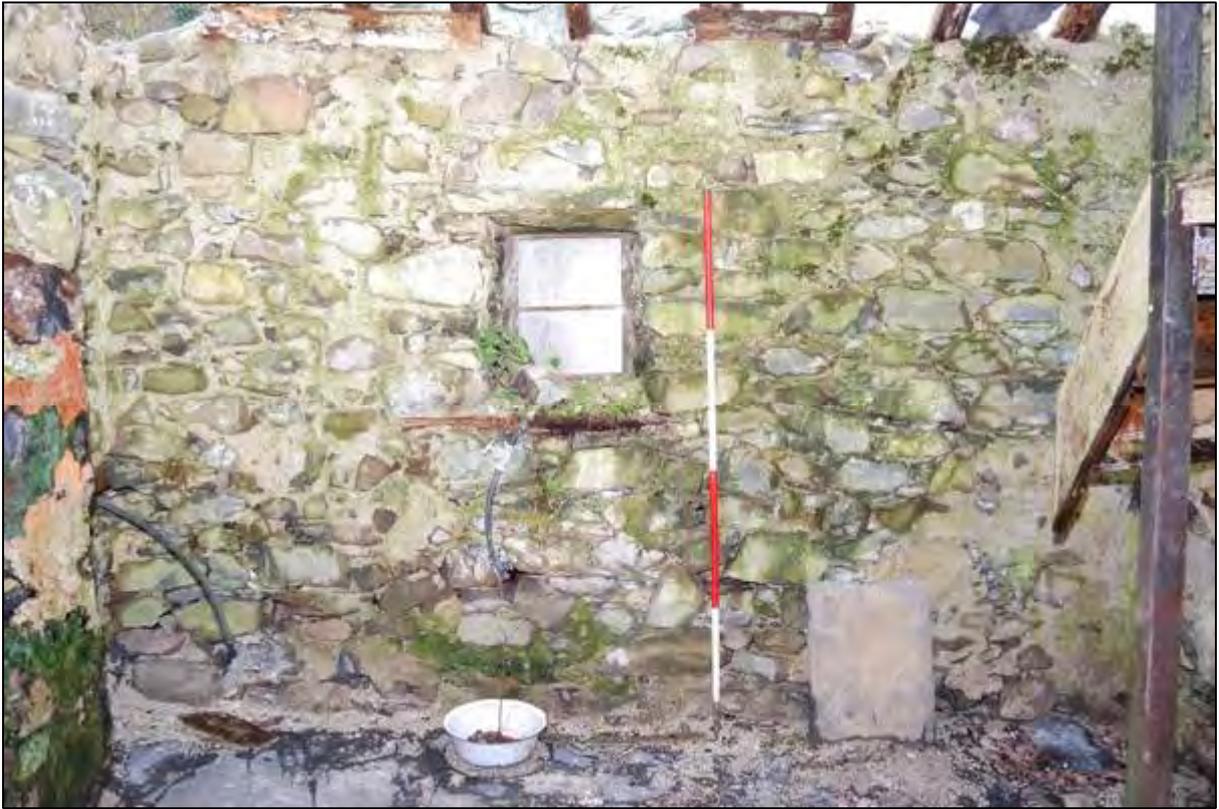
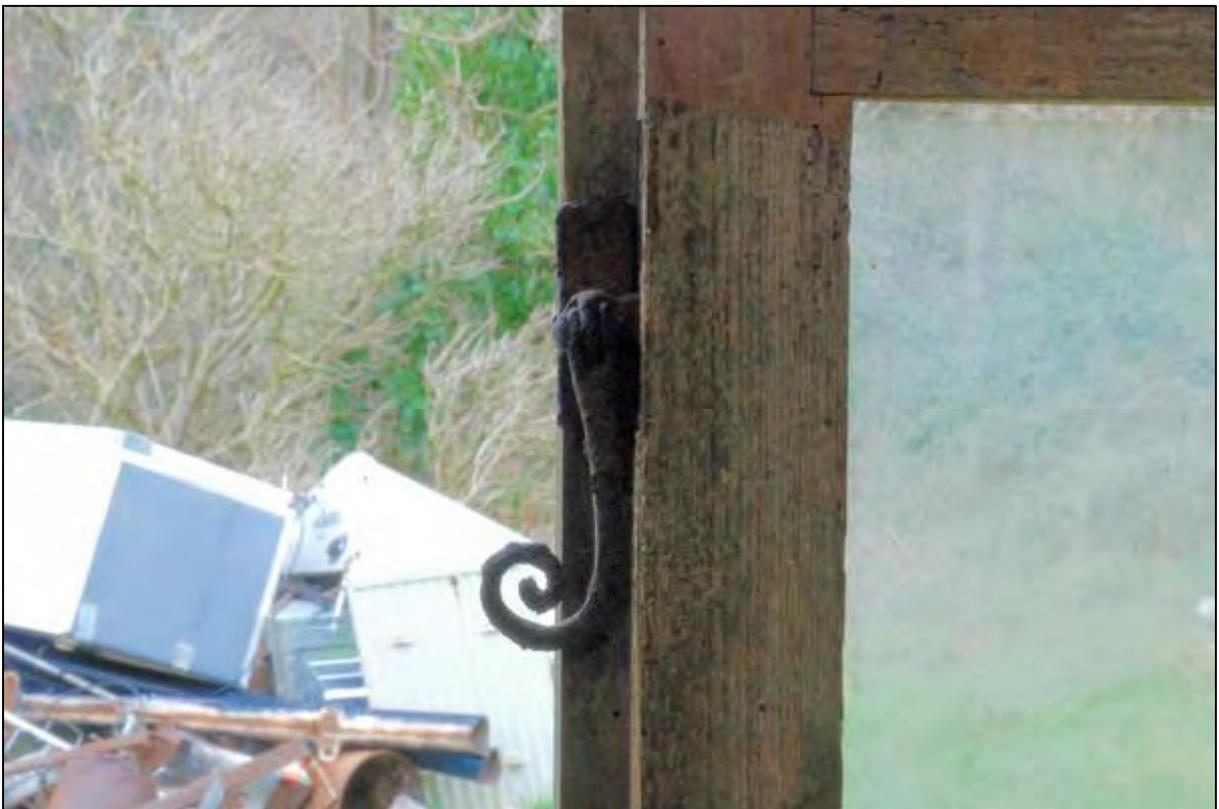
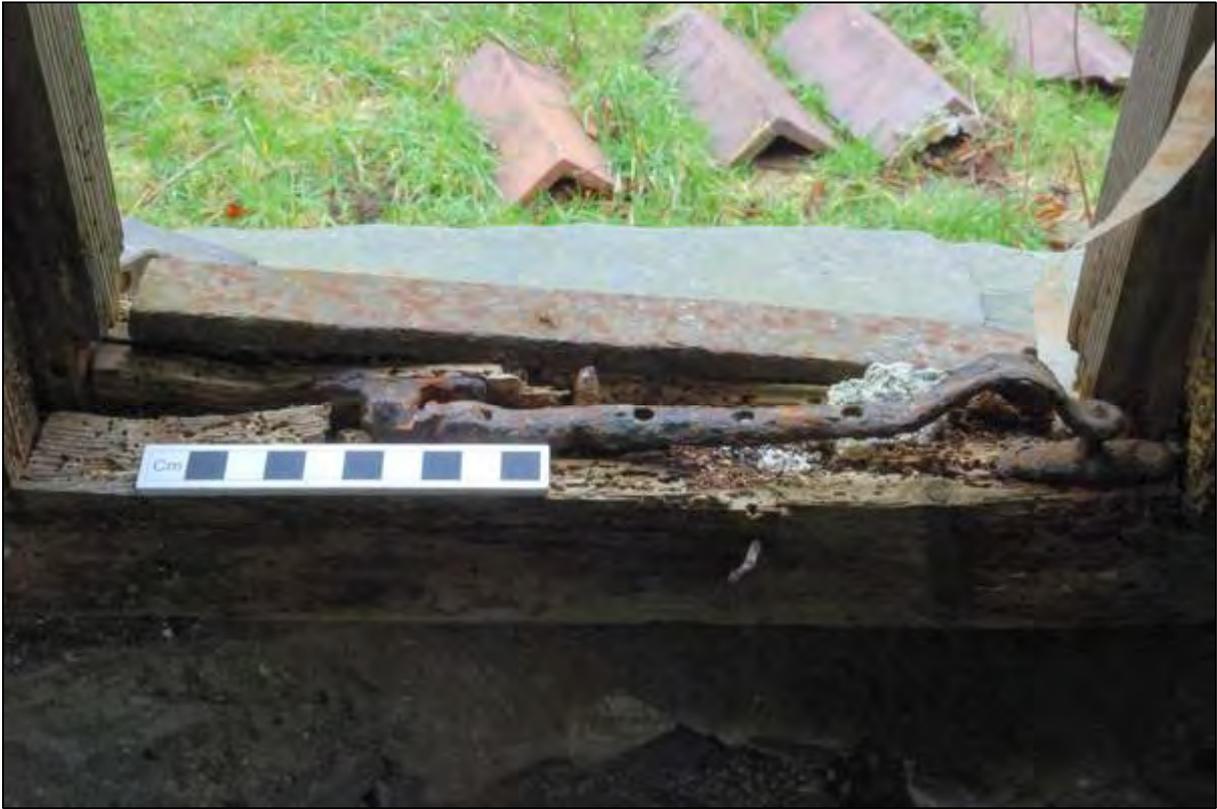
Two windows gave light to this room. That in the rear wall (Plate 19) had a fixed, metal frame with wooden lintel and cill. That in the front wall, however, had one opening leaf with a hand crafted latch (Plate 20) and latch lifter (Plate 21).

Plate 19: The window in the rear wall of the main room

Plate 20: The latch on the front window of the main room

Plate 21: The latch lifter for the front window in the main room

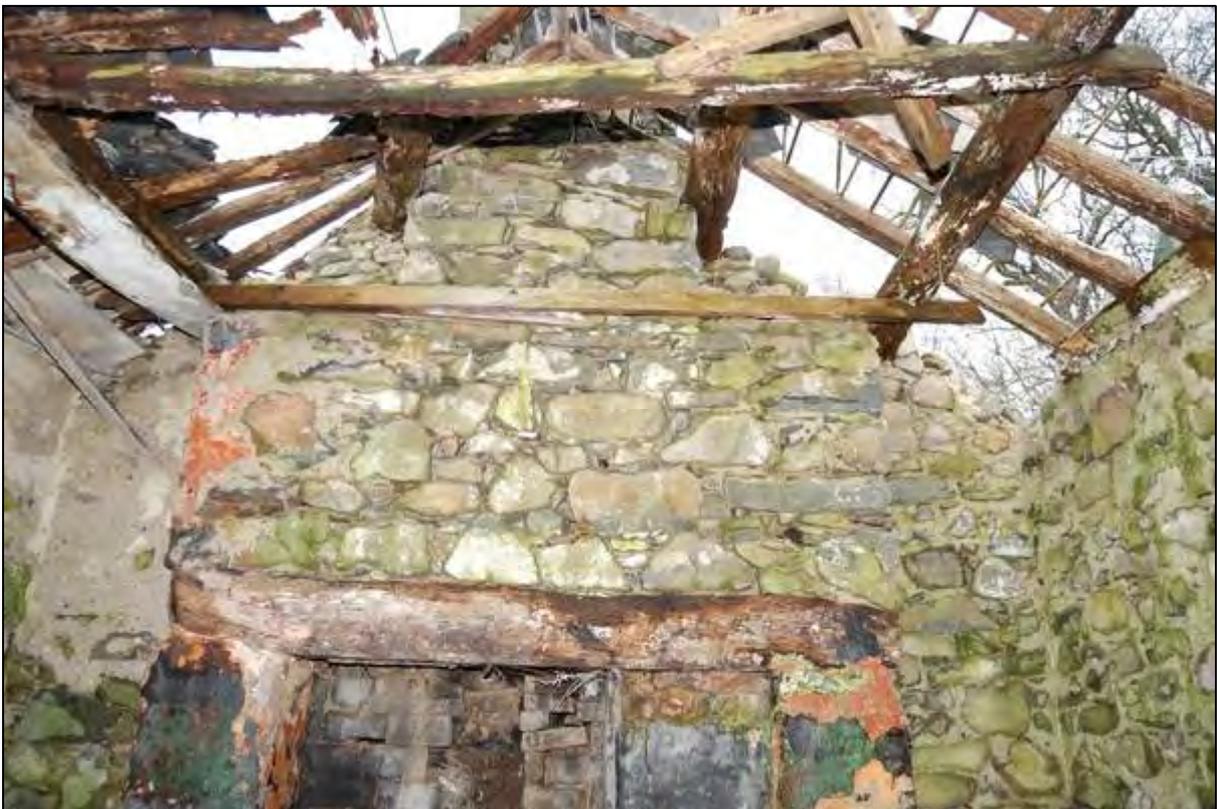
The main room was open to the roof (Plate 22) which was supported by four soft wood purlins and a ridge piece (Plate 22). There was no need for a central truss as the dividing wall between the main room and the bedroom was constructed in stone giving the necessary support to the purlins and ridge piece. This dividing wall also has an opening above head height which gave access to the *croglofft* (Plate 23). It is assumed that this opening was originally accessed by means of a ladder (Wiliam 2010, 71), however at a later date a steep staircase was added consisting of an “L” shaped flight in the western corner of the main room (Plate 24). The style of the balusters would suggest that the staircase was a twentieth century modification, possibly in the 1920’s or 30’s (Callow 2005, 438). This could be a modification made by John Frederick Kerry after he bought the property in 1936, or by Lemuel Pritchard after he had paid off his mortgage in 1927.

Plate 22: The roof structure in the main room

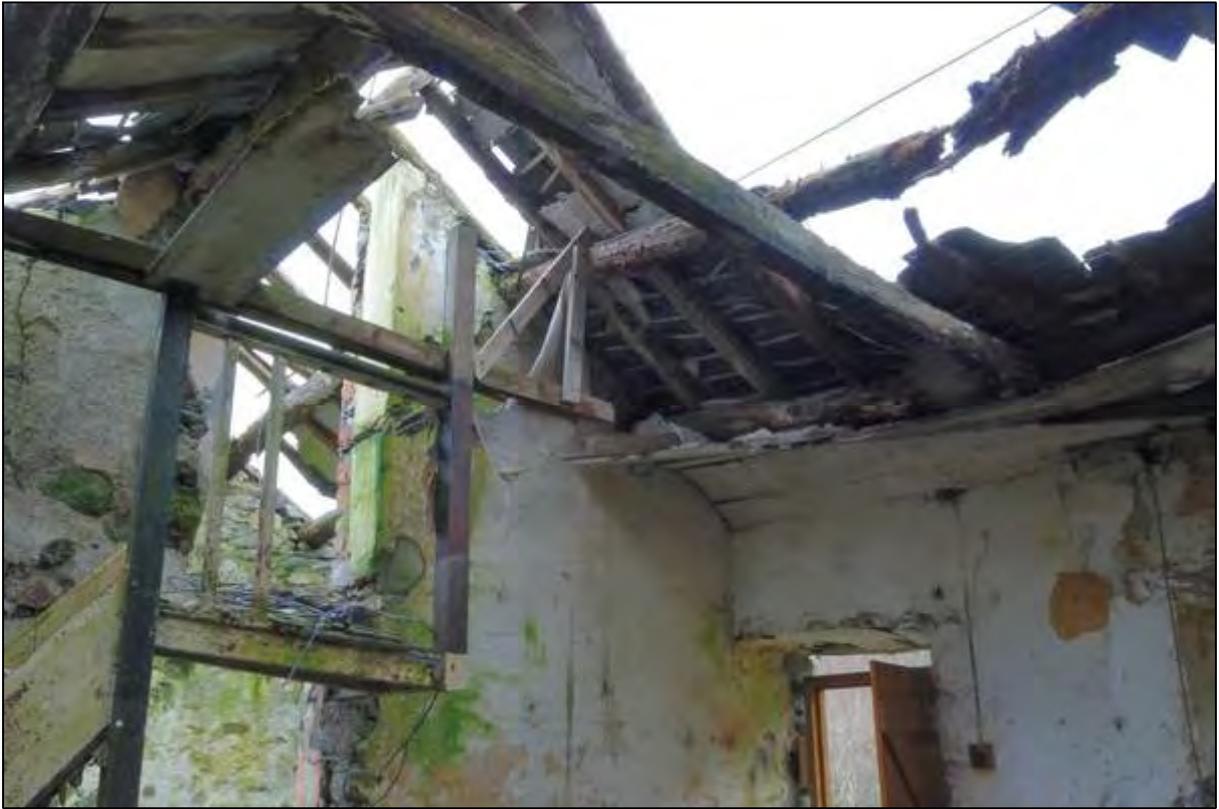
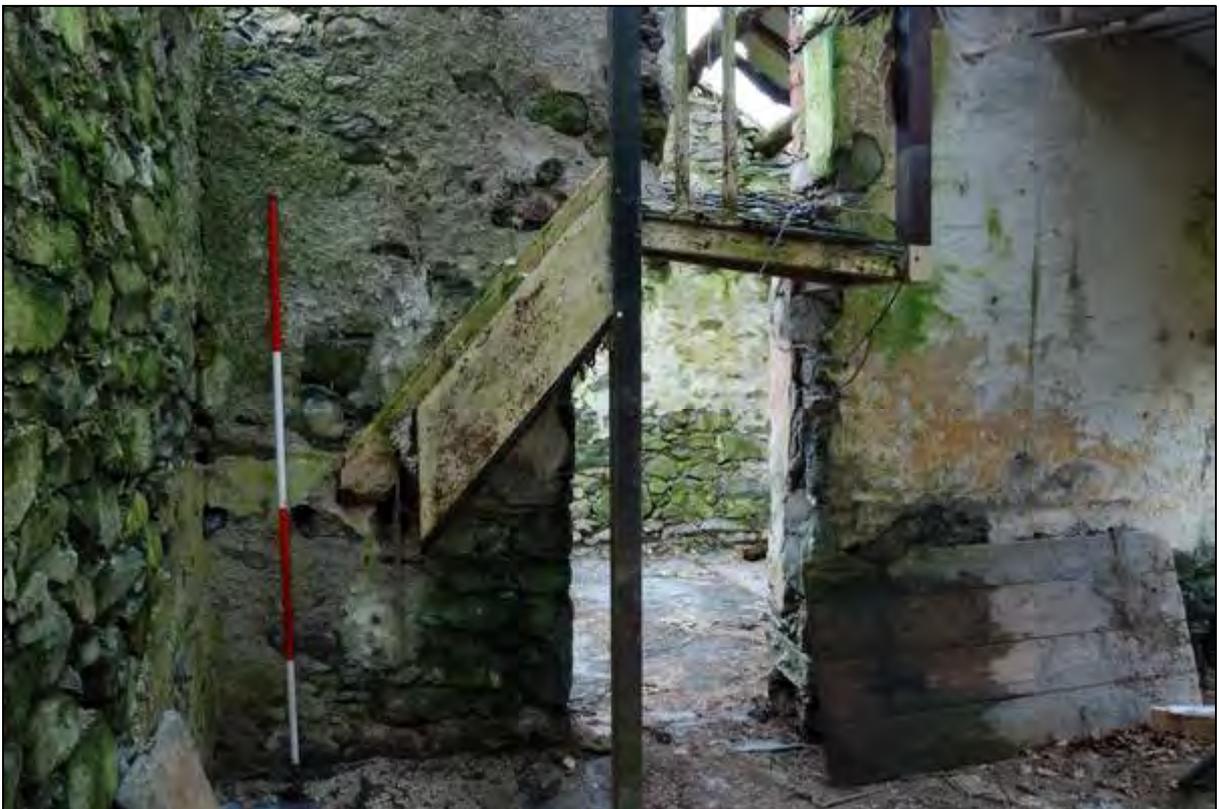
Plate 23: Access to the *croglofft*

Plate 24: The stairs to the *croglofft*
