***Engineering Archaeological  
Services Ltd***

***Tai Bach, Maenan***

***February 2014***

***EAS Client Report 2014/02***

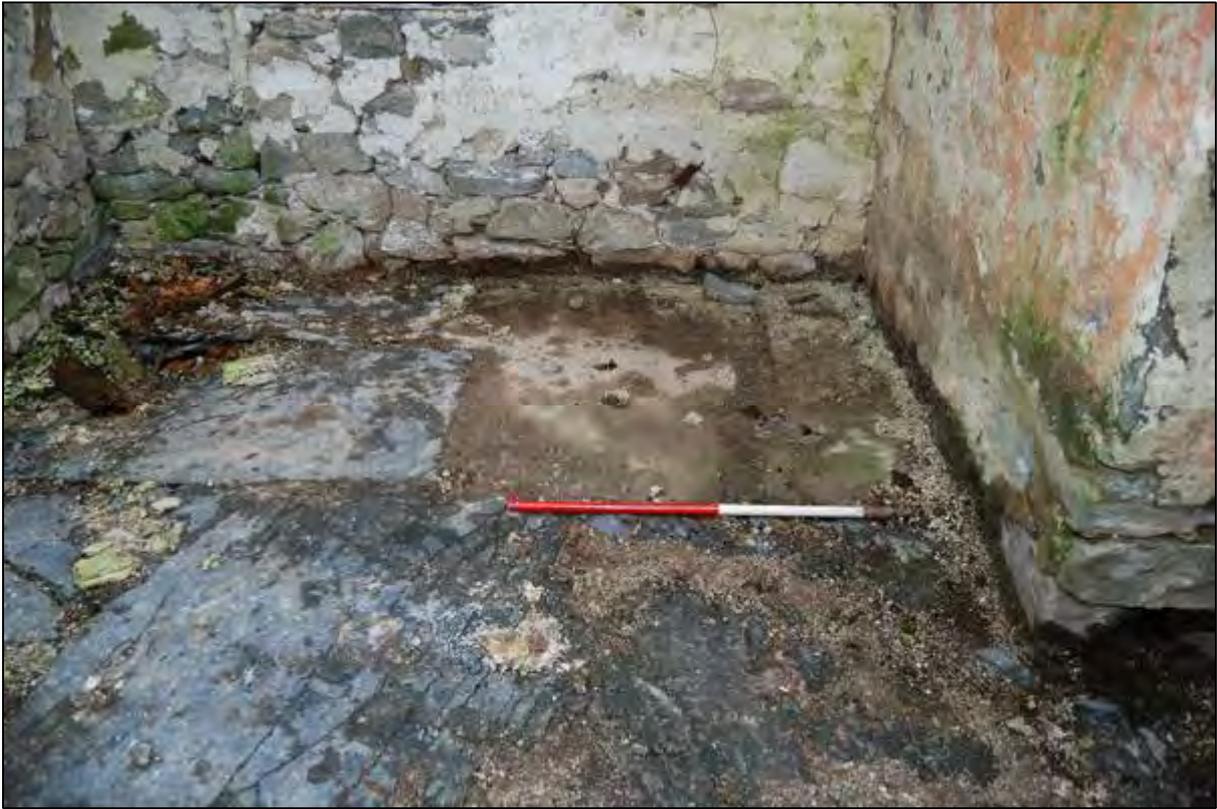
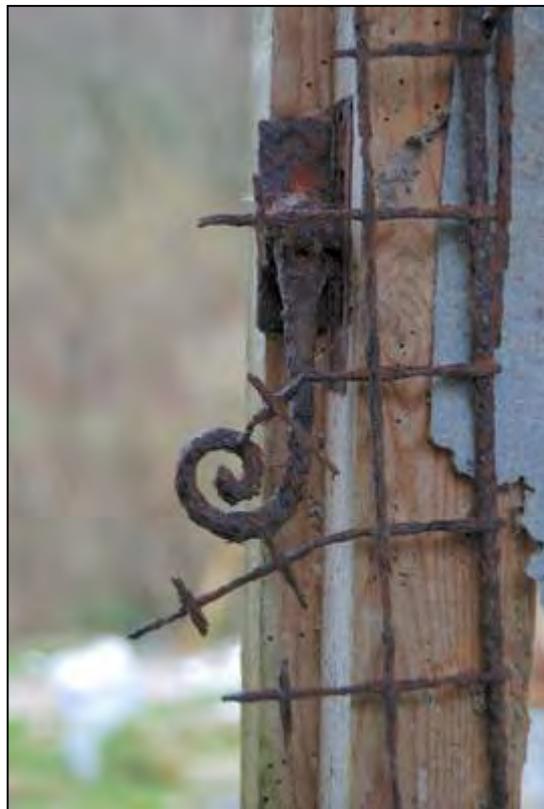
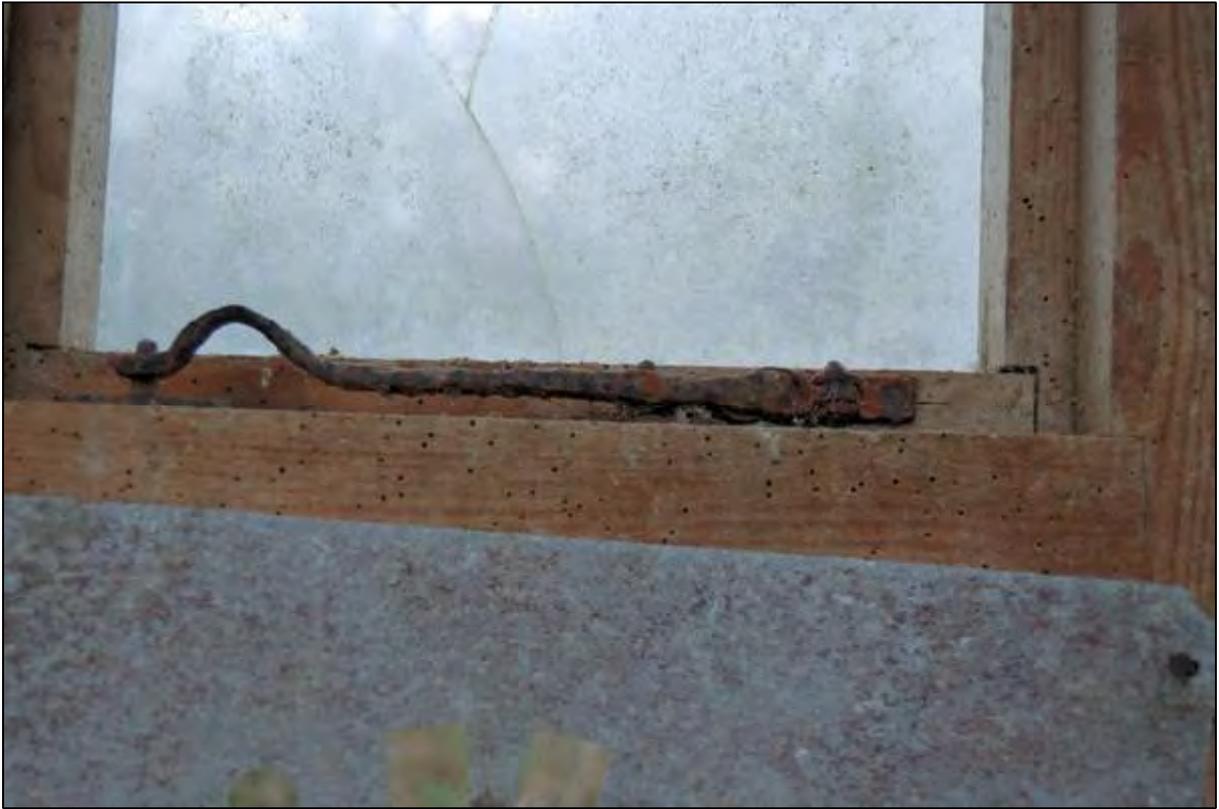
The ground floor bedroom was unheated, although the concrete pad in the eastern corner may have been for a freestanding stove (Plate 25). This is the only part of the ground floor which is not covered in slate slabs. The one window in this room is similar to that in the main room with similar blacksmith made fittings (Plate 26 and 27)

Plate 25: The concrete pad in the eastern corner of the bedroom

Plate 26: The latch on the window in the bedroom

Plate 27: The latch lifter for the window in the bedroom

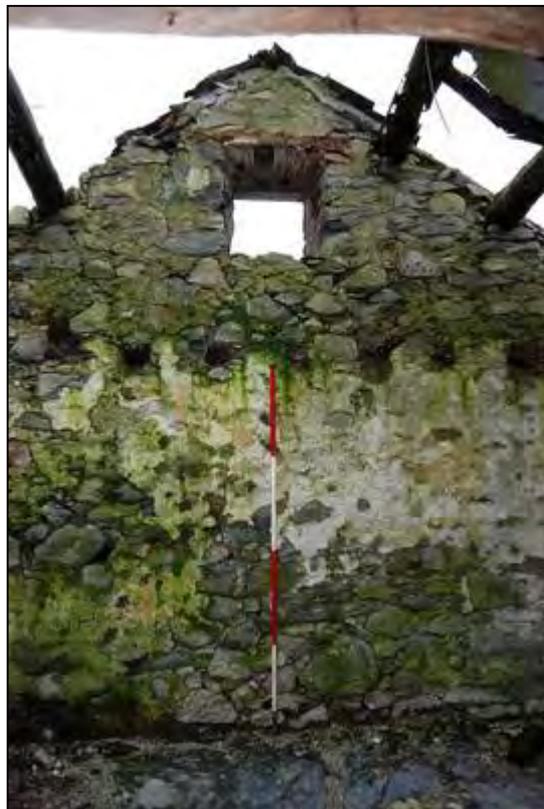
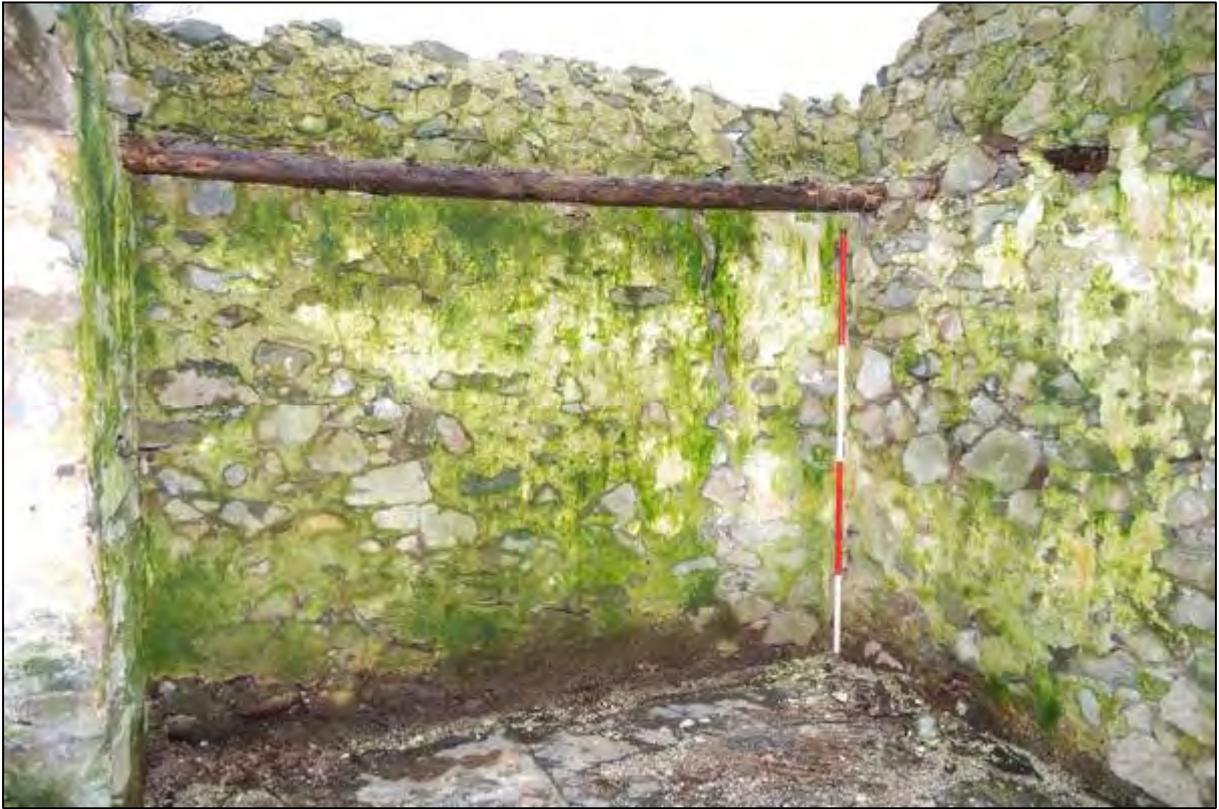
The supports for the *croglofft* were a mixture of squared and round softwood timbers (Plate 28, Figure 9) at a height of 2.04 m above the floor of the bedroom. Unfortunately only one of these joists survives (Plate 29), however the stub ends of most of the other joists survive in the walls. Above this level, the window which gave light to the *croglofft* had a wooden lintel

Plate 28: The supports for the *crogloft* and the upper window.

Plate 29: The surviving joist for the *croglofft*.

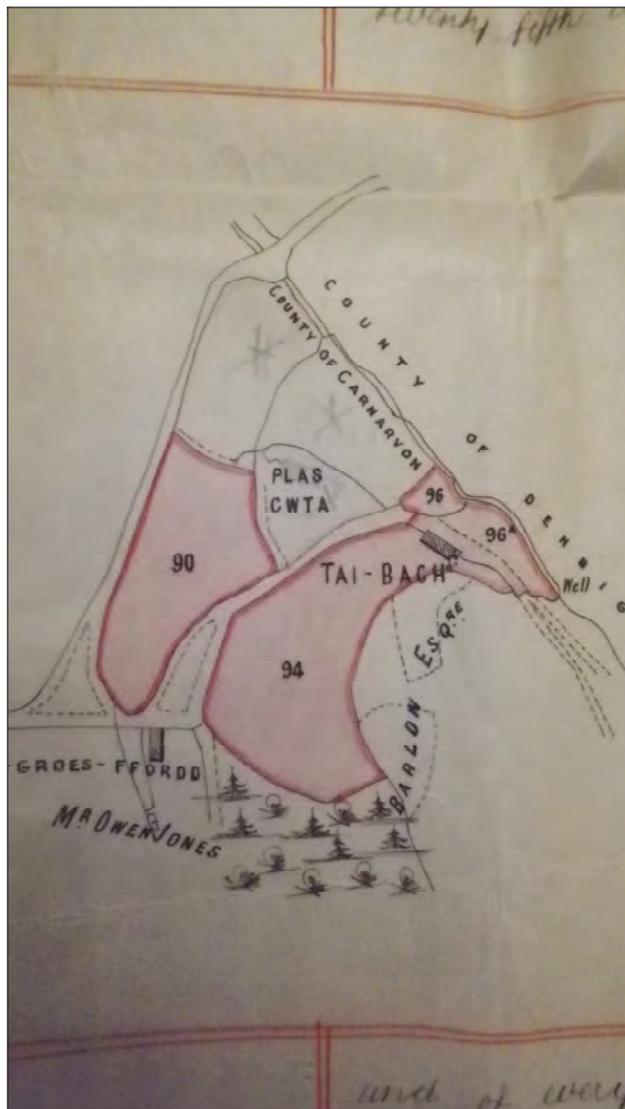
Figure 4: Extract from the Ordnance Survey, First Edition Map  
Carnarvonshire XIV.1 (1889)  
Scale 1:2,500

The first detailed mapping is the First Edition Ordnance Survey Map, Caernarvonshire XIV.1 published in 1889 (Figure 4). This shows Tai Bach with its cow house attached to the south eastern gable and a probable pig sty attached to the cow house, a common feature in the slate quarrying areas on north-west Wales (Wiliam 2010, 71). A similar pattern is shown on the map attached to the 1889 Conveyance (Figure 5), however there would also appear to be a small, divorced, building to the south which is probably a toilet or "Ty Bach".

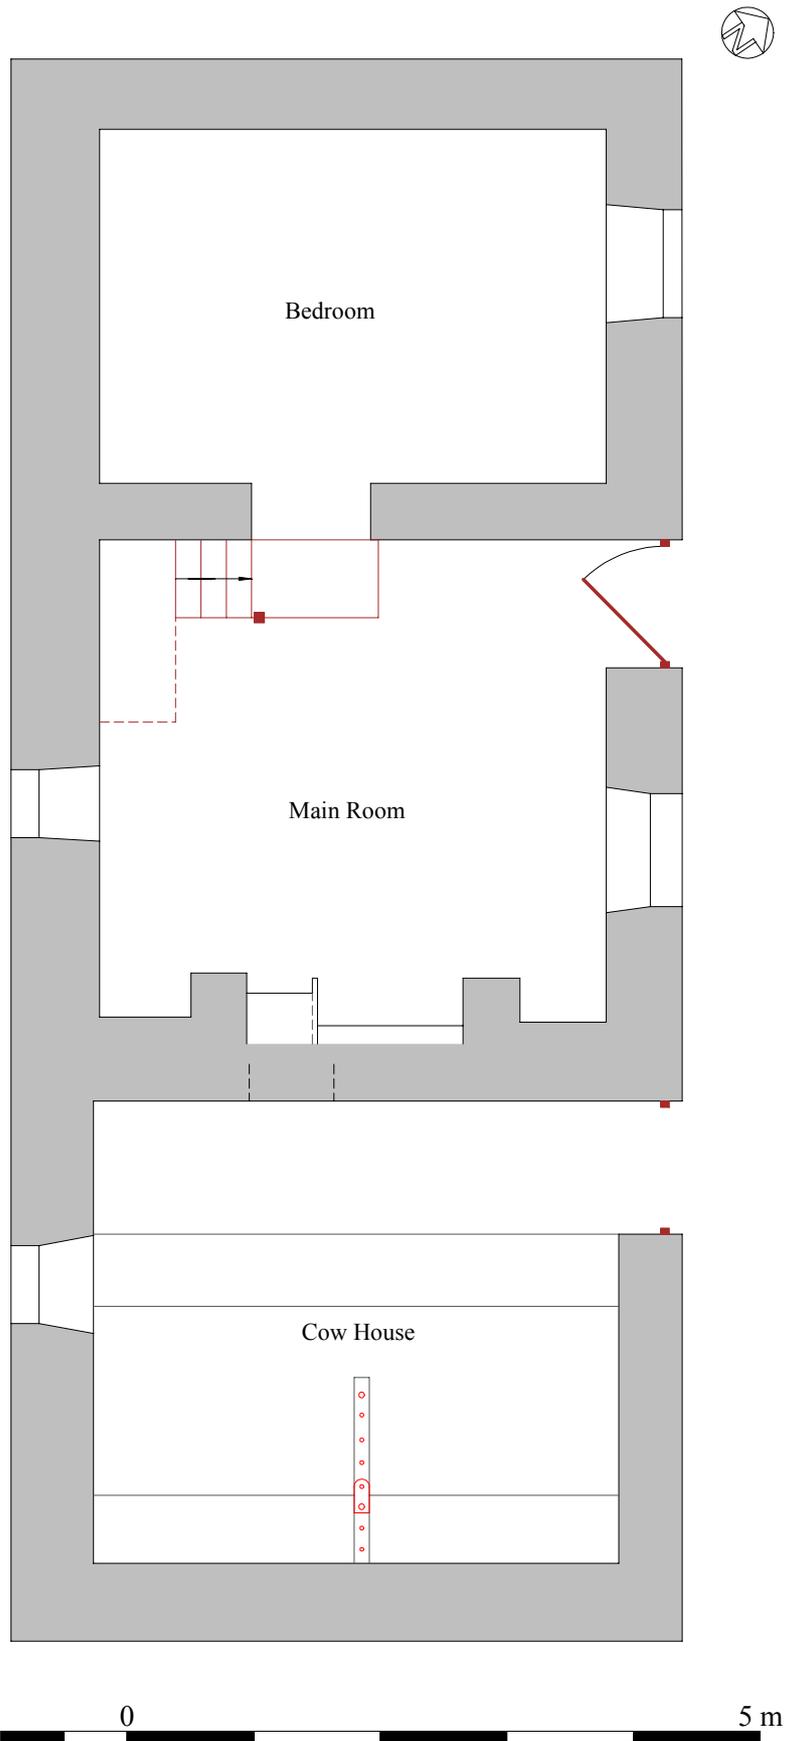
Figure 8: Plan  
Scale 1:16

Tai Bach is a single storey cottage with an attached cow-house on its south-eastern gable. (Plate 1, Figure 8). It is constructed of poorly coursed stone boulder with limited use of squared quoins, particularly at the cow house end. The stonework has a lime mortar bonding and in places the wall appear to have been lime-washed. The cottage was under a slate roof, which has largely collapsed at the time of the survey, and has a single chimney (Plate 2) on the south eastern gable of the cottage.

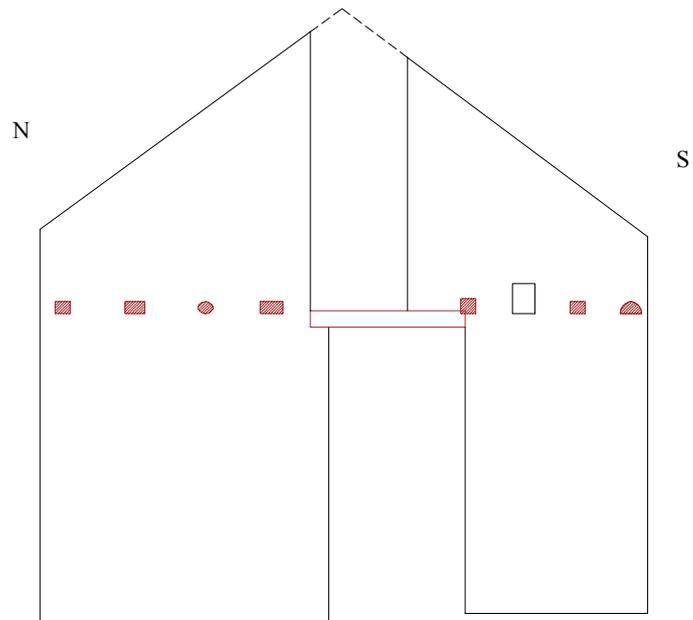
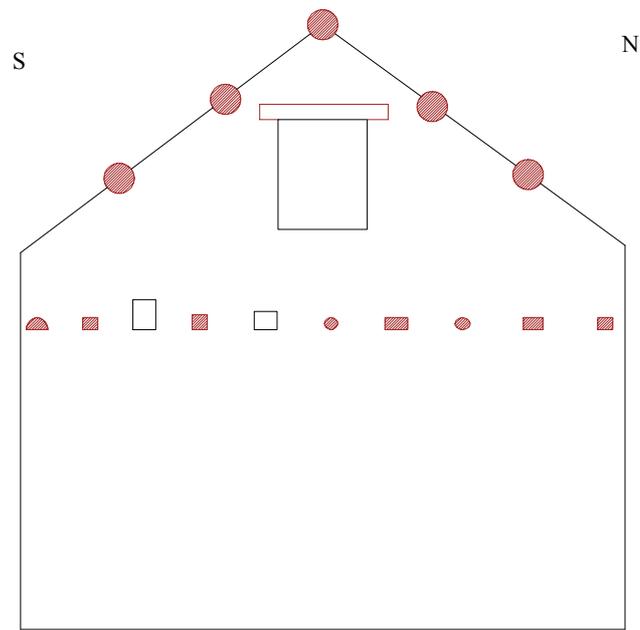
Figure 9: Sketch Sections  
Scale 1:50

Dividing Walls

Gable end
