Surveyed
by
I.P. Brooks
Engineering Archaeological
Services Ltd

Cwm Bychan Hydro Scheme

March 2015
EAS Client Report 2015/06

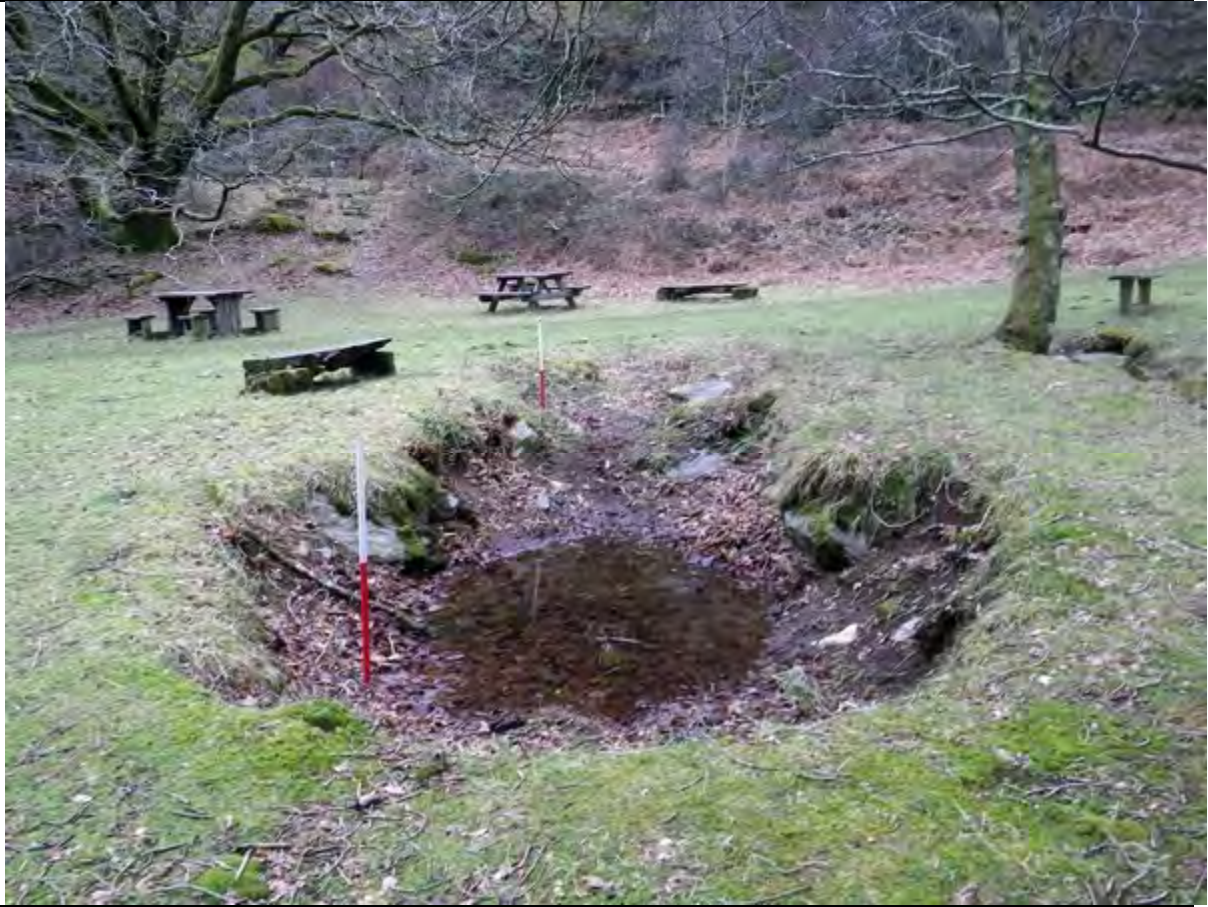
National Trust ID 41588	Site Name Cwm Bychan Settling Tank 1	Grid Reference SH 59775 46269
NPRN	PRN 3792 (part of)	Period Modern
Description Rectangular pond 4.8 x 2.6 m in size and up to 0.5 m deep, with a second pond 2.3 x 2.6 m in size to the west. There is some sign of stone walling in the northern face. Probable settling pond associated with the extraction of copper. Related to a very similar pond immediately to the north. No obvious sign of an outfall, but a slight linear hollow to the SE may make the outfall to the stream

Significance Local	Condition Fair	Survival Moderate
Stability Slow Deterioration	Vulnerability Medium	Threat Adjacent to the works
Management Recommendations Watching brief on any works near to this site		
Photograph Cwm Bychan 13	Surveyed by I. Brooks	Date 21/2/15

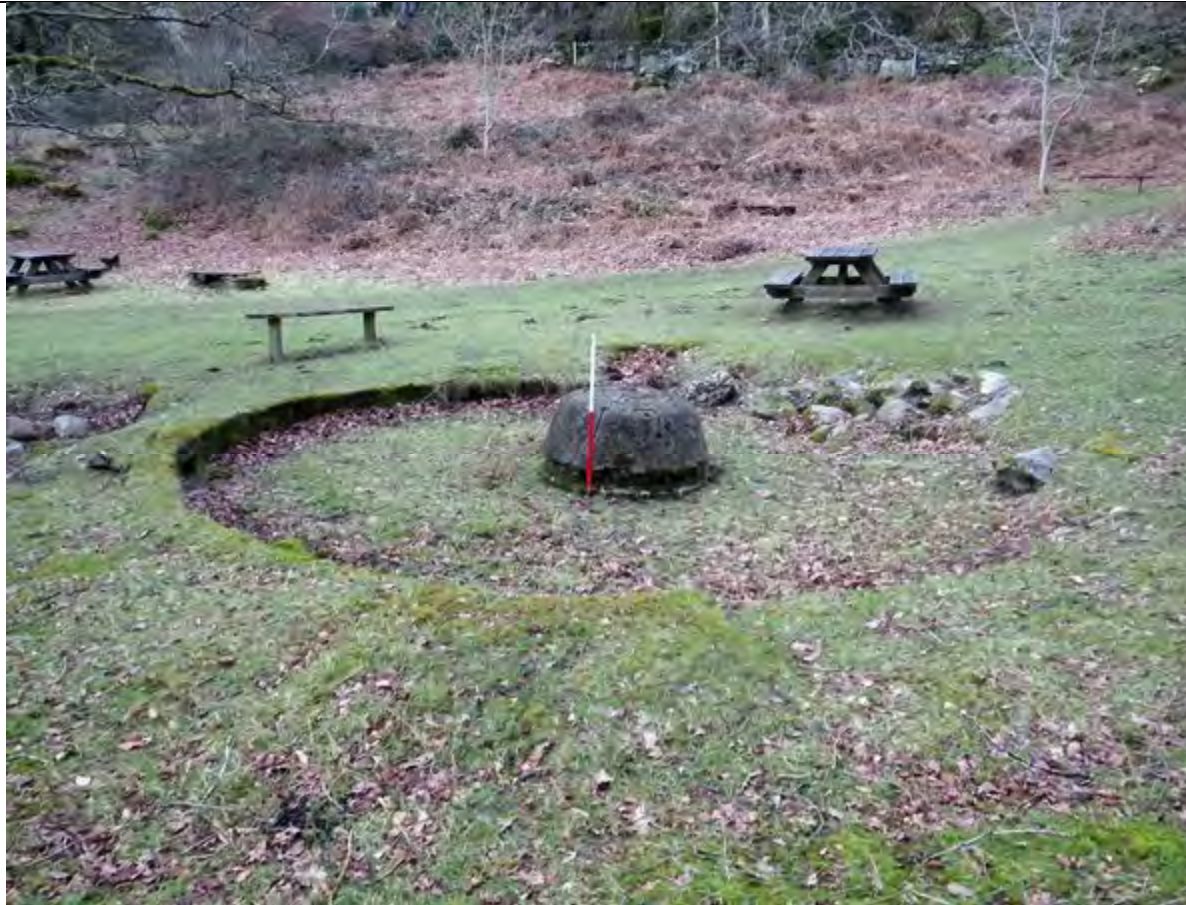
National Trust ID 41589	Site Name Cwm Bychan Buddle 1	Grid Reference SH 59782 46281
NPRN	PRN 3792 (part of)	Period
Description Circular buddle defined by a low concrete wall 5.9 m in diameter with a central boss or pivot point of concrete in the form of a "beehive" shaped concrete block 1 m in diameter with a metal pivot point in the top of the block. Possible cut outs either side of the pan may have gave access or may have been the support positions for the superstructure. Drainage point to the south leading to settling tank 2. Probably fed from Buddle 2 (415455) above.

Significance Local	Condition Good	Survival Good
Stability Slow Deterioration	Vulnerability Low	Threat None
Management Recommendations Avoid		
Photograph Cwm Bychan_15 Cwm Bychan_16	Surveyed by I. Brooks	Date 21/2/15

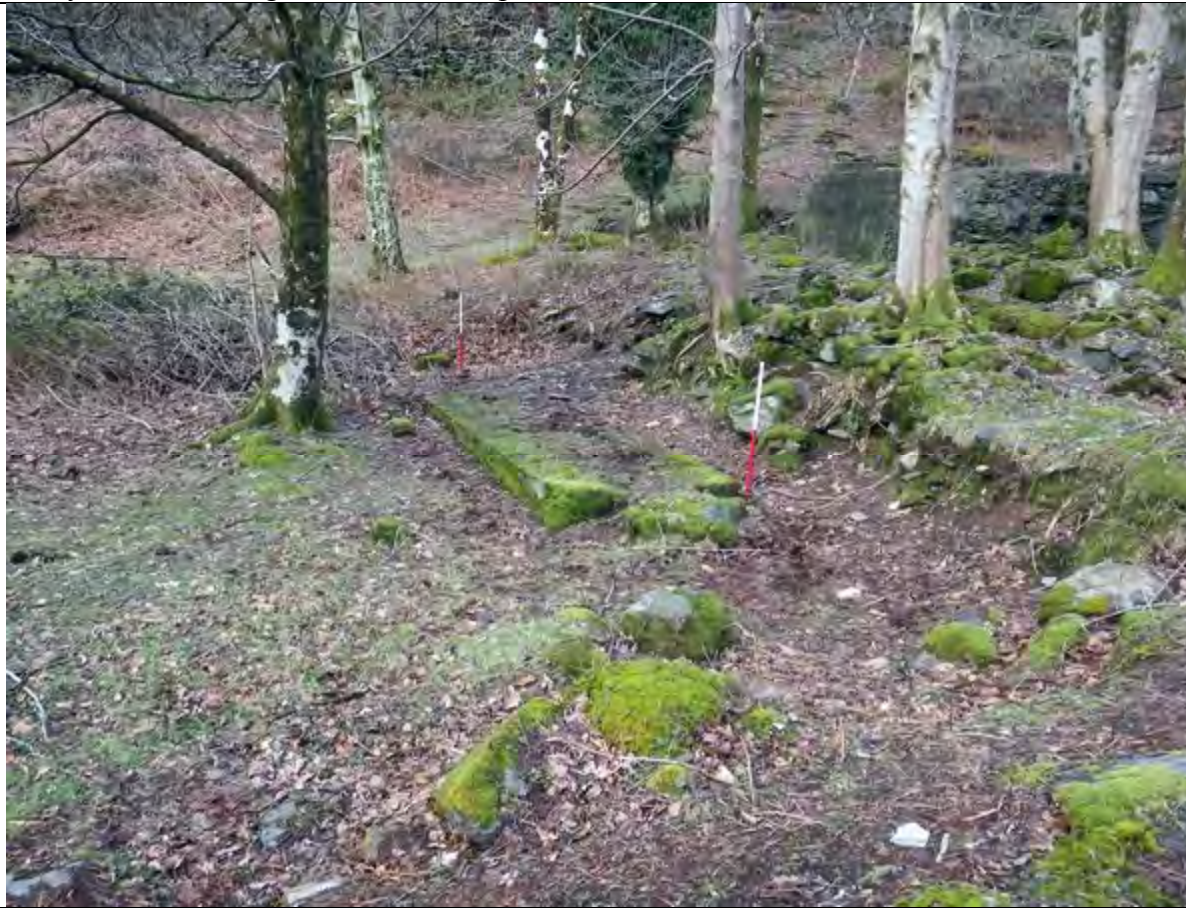
National Trust ID 41590	Site Name Cwm Bychan Possible industrial building	Grid Reference SH 59780 46304
NPRN	PRN 3792 (part of)	Period Modern
Description Large concrete slab 5.8 x 1.4 m in size siting within a larger (10 x 6.4 m) flat platform which is revetted into the hillside on three sides by a maximum of 0.8 m. Some remnants of dry stone revetting wall survives in places

Significance Local	Condition Poor	Survival Moderate
Stability Slow Deterioration	Vulnerability Low	Threat Trees growing within the structure
Management Recommendations Remove trees and prevent regrowth		
Photograph Cwm Bychan_19	Surveyed by I. Brooks	Date 21/2/15

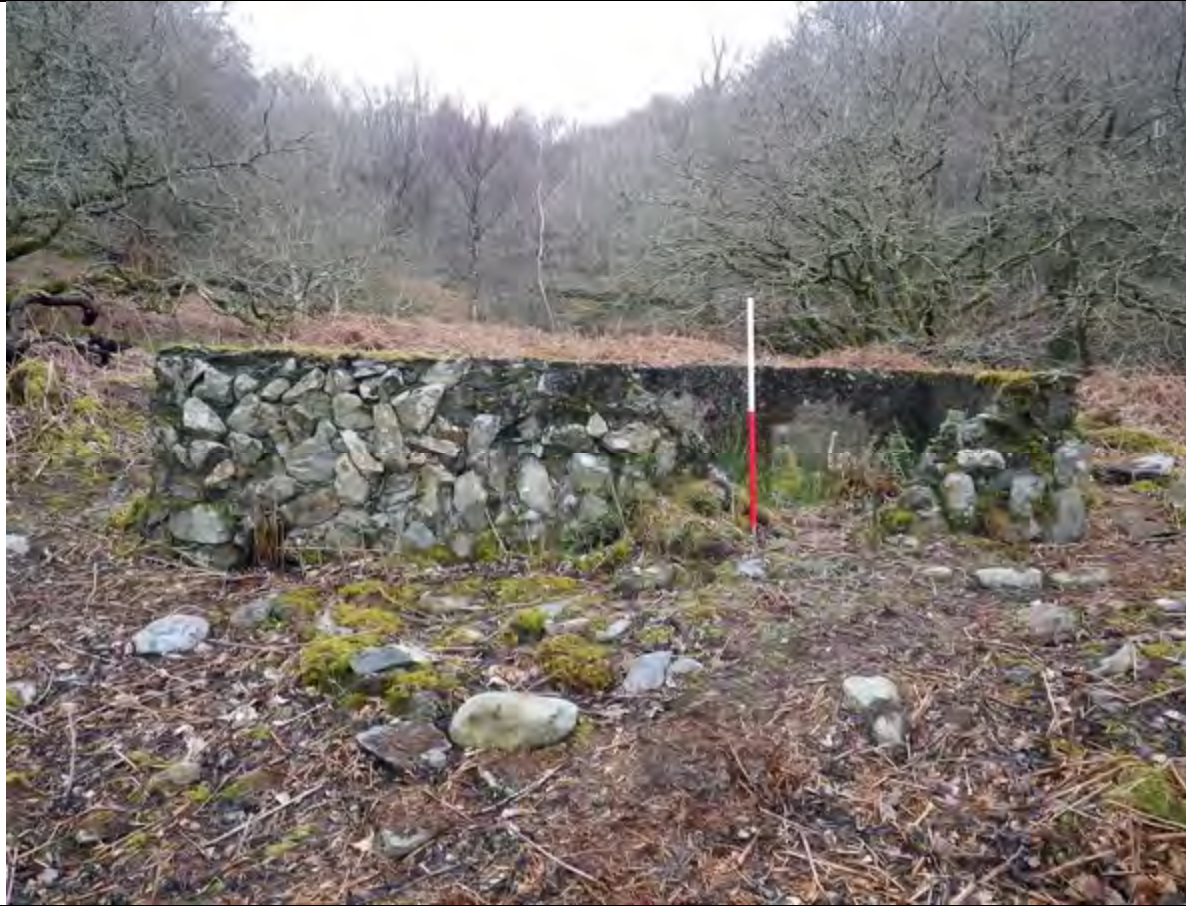
National Trust ID 41591	Site Name Cwm Bychan Rectangular Tank 1	Grid Reference SH 59798 46317
NPRN	PRN 3792 (part of)	Period Modern
Description Rectangular water tank 4.1 x 2.2 m in size and at least 0.8 m deep. Partly dug into the natural slope and partly built up. There was a stone outer wall which has been largely lost. This is one of a pair of tanks with Tank 2

Significance Local	Condition Poor	Survival Moderate
Stability Slow Deterioration	Vulnerability Low	Threat None
Management Recommendations Maintain in an open area, prevent regrowth		
Photograph Cwm Bychan_24 Cwm Bychan_26 Cwm Bychan_27	Surveyed by I. Brooks	Date 21/2/15

On the next terrace are two concrete tanks (41591 and 415457) which are assumed to be the header tanks for the buddles further down the complex. 41591 is 4.1 x 2.2 m in size and at least 0.8 m deep, whilst 415457 is 4.95 x 2.1 m in size and at least 0.95 m deep. Both tanks were originally partly dug into the natural slope and partly faced with stone walling, although much of this walling is now missing.

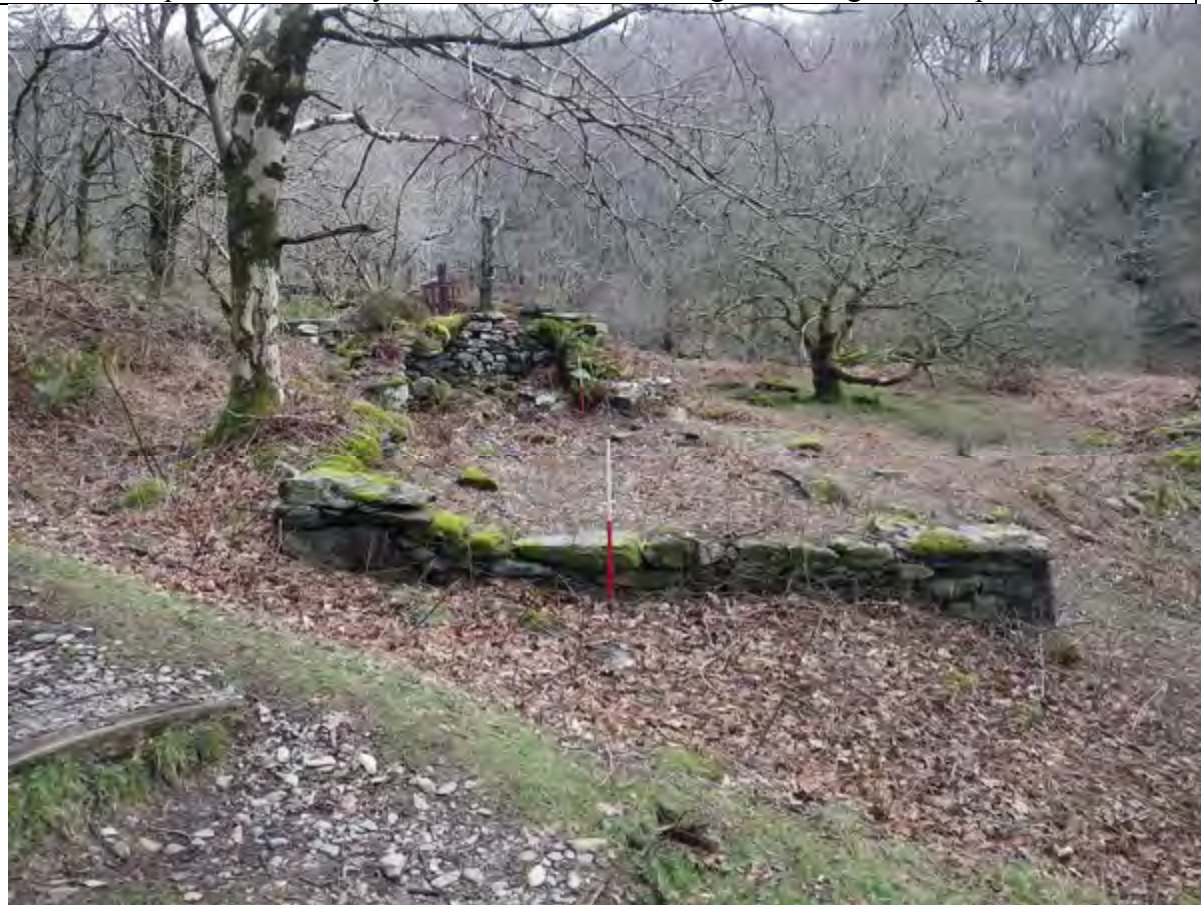
National Trust ID 41592	Site Name Cwm Bychan Cottage	Grid Reference SH 59779 46319
NPRN	PRN	Period Post Medieval

Rectangular stone built cottage 5 x 12 m in size with a protruding gable end chimney which appears to have been a later addition. Sitting on a platform partly cut into the hillside this building is on a completely different alignment to the industrial remains around it. Very poorly preserved with the exception of the chimney gable which stands to a height of 1.5 m. Two possible doorways to the east. This building was being lived in prior to 1920.

Significance Regional	Condition Poor	Survival Bad
Stability Slow Deterioration	Vulnerability Low	Threat Tree regrowth
Management Recommendations Maintain as an open area, prevent regrowth. Remove adjacent tree if possible		
Photograph Cwm Bychan_28	Surveyed by I. Brooks	Date 21/2/15

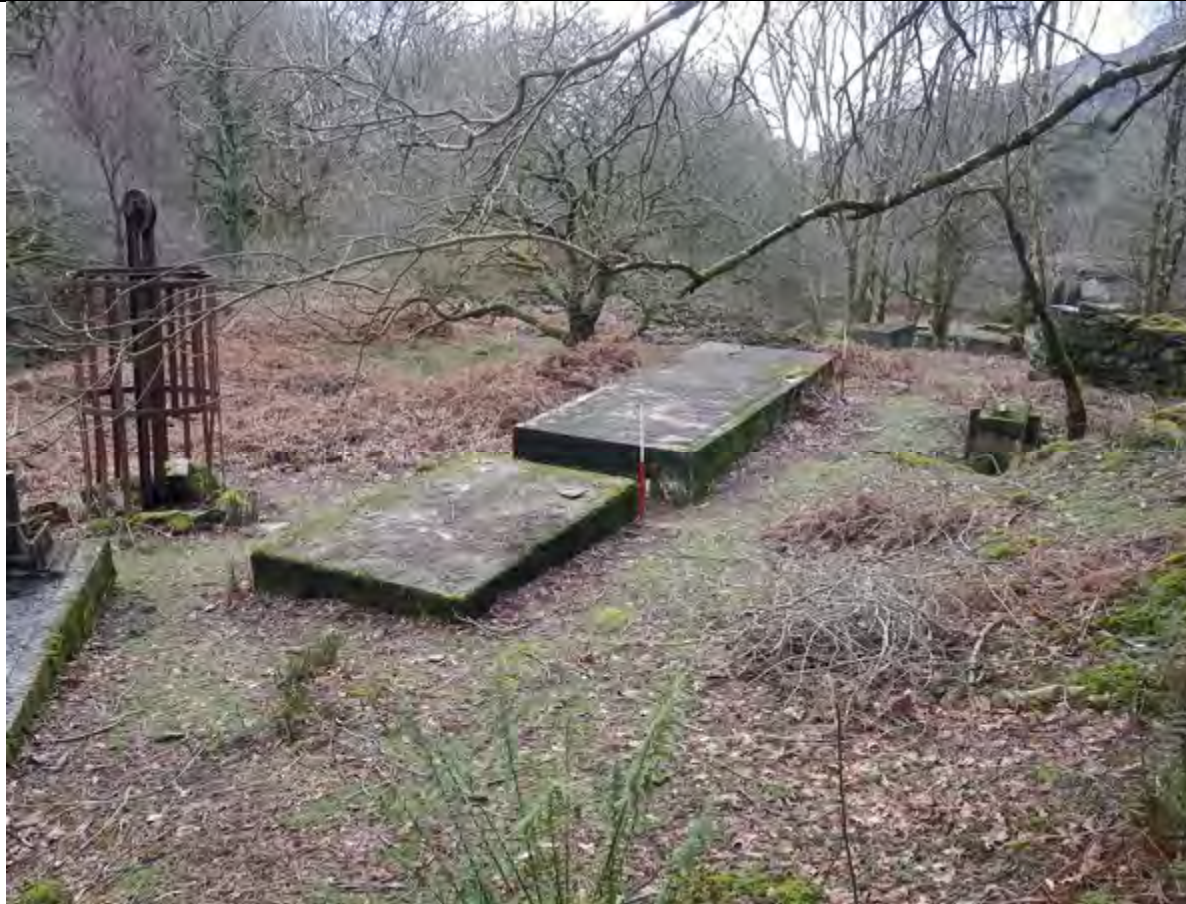
National Trust ID 41594	Site Name Two concrete blocks	Grid Reference SH 59794 46327
NPRN	PRN 3792 (part of)	Period Modern
Description Two large concrete blocks, one 2.0 x 5.9 m in size and the other 2.8 x 1.75 m both standing proud of the ground by up to 0.75 m. Various metal fitting in the top of both blocks

Significance Local	Condition Good	Survival Good
Stability Slow Deterioration	Vulnerability Low	Threat None
Management Recommendations Maintain in open are		
Photograph Cwm Bychan_30	Surveyed by I. Brooks	Date 21/2/15

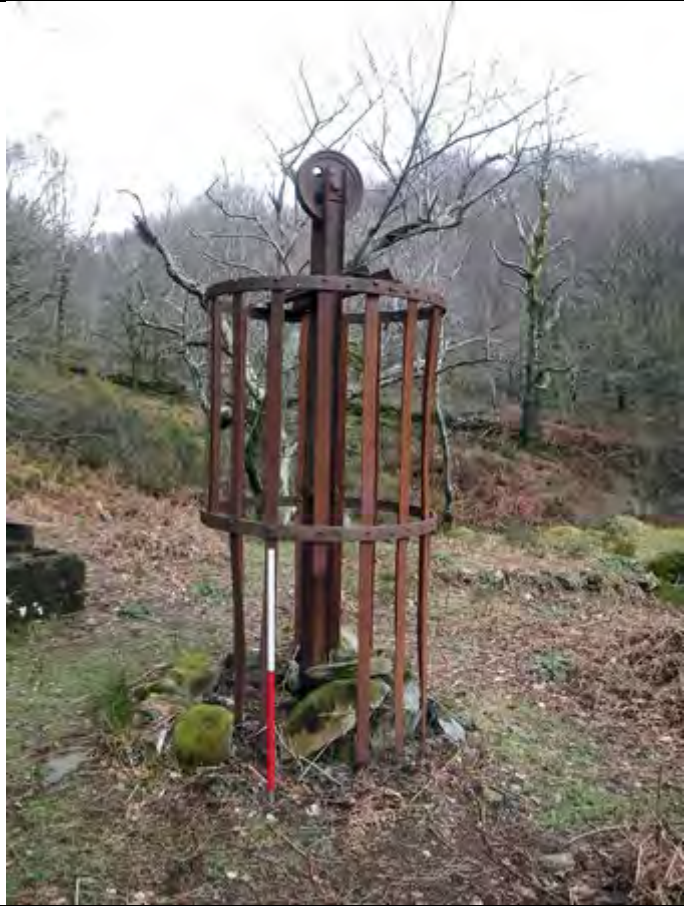
National Trust ID 41595	Site Name Cwm Bychan Tensioner Cage	Grid Reference SH 59801 46329
NPRN	PRN 3792 (part of)	Period
Description Circular metal cage 1.15 m in diameter and at least 2.15 m high. The central metal frame extends higher and has two pulley wheel. Thought to be the counter balanced for the aerial ropeway. Not <i>in situ</i> .

Significance Local	Condition Fair	Survival Moderate
Stability Slow Deterioration	Vulnerability Low	Threat None
Management Recommendations Maintain in cleared		
Photograph Cwm Bychan_32	Surveyed by I. Brooks	Date 21/2/15

together with the metal cage (41595) which was originally found in the stream Latham and Plunkett-Dillon 1987, 10). It is thought that the cage was filled with rocks and was used to provide the tension to a trolley sitting on the “jetty”. This seems to be an overly complex arrangement when the same effect could have been achieved by the simple use of a windlass. Further up the valley a series of pylon bases were recorded.

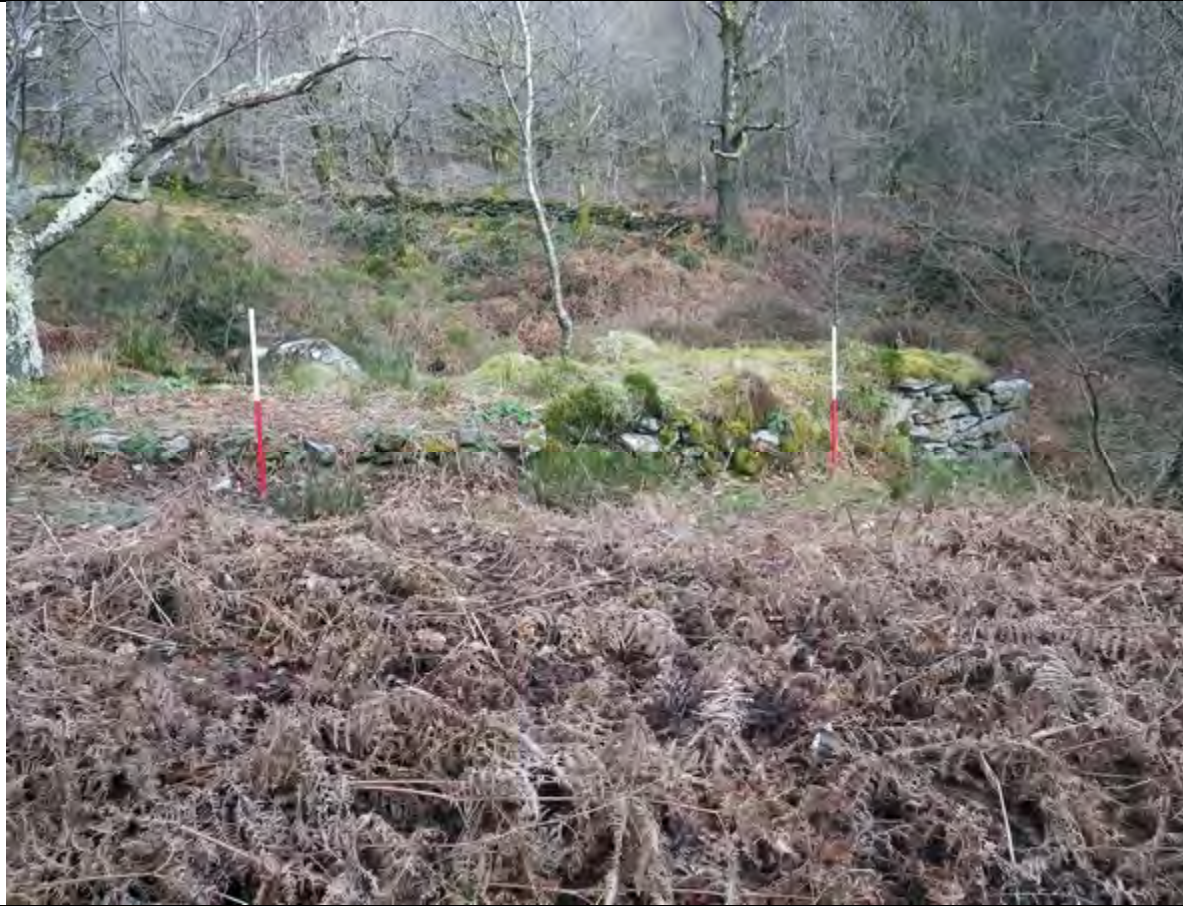
National Trust ID 41596	Site Name Cwm Bychan Jetty or Trackway	Grid Reference SH 59808 46329
NPRN	PRN 3792 (part of)	Period Uncertain probably Post Medieval
Description Stone revetted platform 2.6 m wide and 9 m long extending from the area of the bottom of the aerial ropeway towards the stream where it reaches a height of 2.2 m above the ground. Dry stone revetting with sub- angular stones up to 0.4 m in size. Probably part of the tensioning mechanism for the aerial ropeway

Significance Local	Condition Good	Survival Good
Stability Slow Deterioration	Vulnerability Low	Threat Stream at the base
Management Recommendations Monitor the stability of the structure		
Photograph Cwm Bychan_33 Cwm Bychan_34	Surveyed by I. Brooks	Date 21/2/15

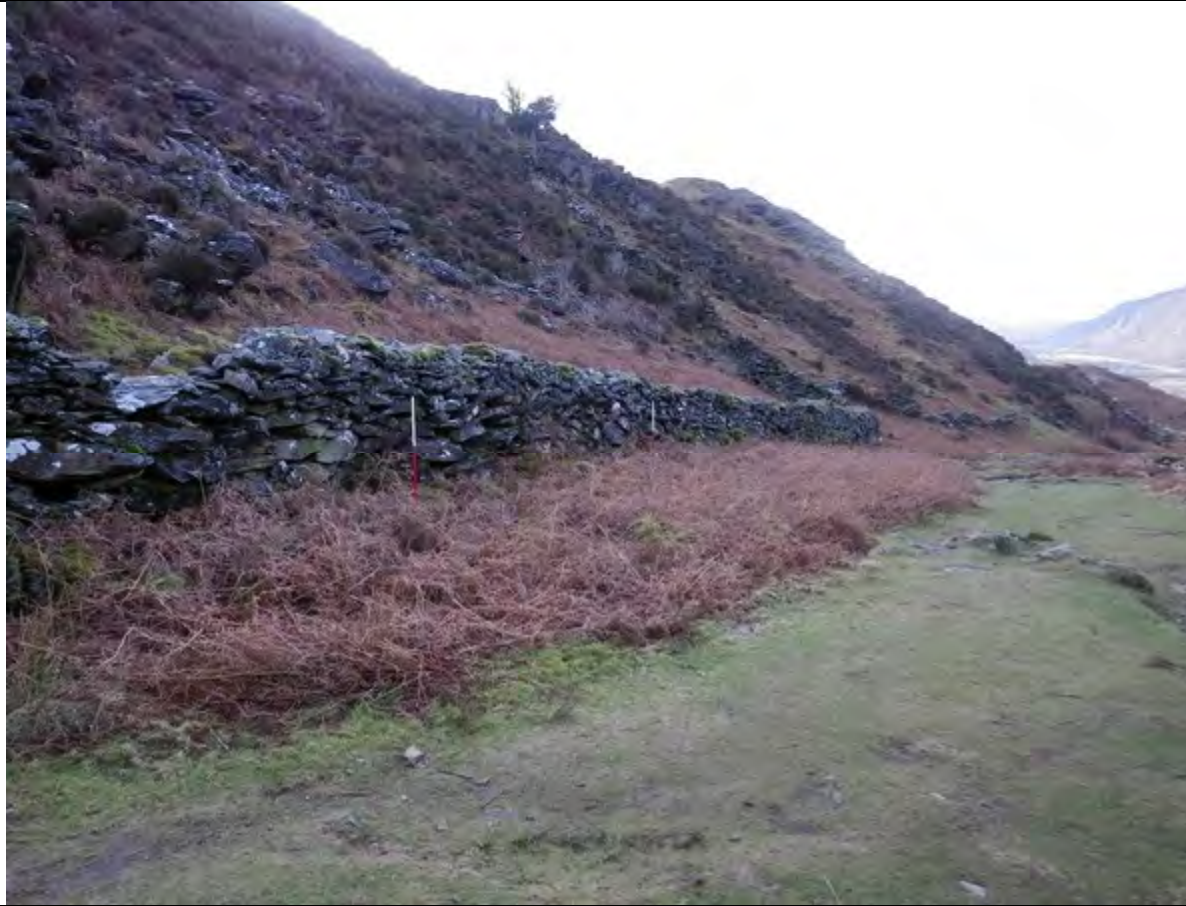
National Trust ID 415445	Site Name Cwm Bychan wall 1	Grid Reference SH 60256 47192 - SH 260248 47137
NPRN	PRN	Period Post medieval
Description A dry stone wall, up to 1.5 m high and 0.6 m thick running parallel to the stream from the possible sheep washing station NPRN 413472 before turning to the south west and running up hill. Constructed of local angular blocks with some larger boulders towards it base.

Significance Local	Condition Good	Survival Good
Stability Slow Deterioration	Vulnerability Medium	Threat On edge of working area
Management Recommendations Avoid during construction		
Photograph Cwm Bychan_01	Surveyed by I. Brooks	Date 21/2/15

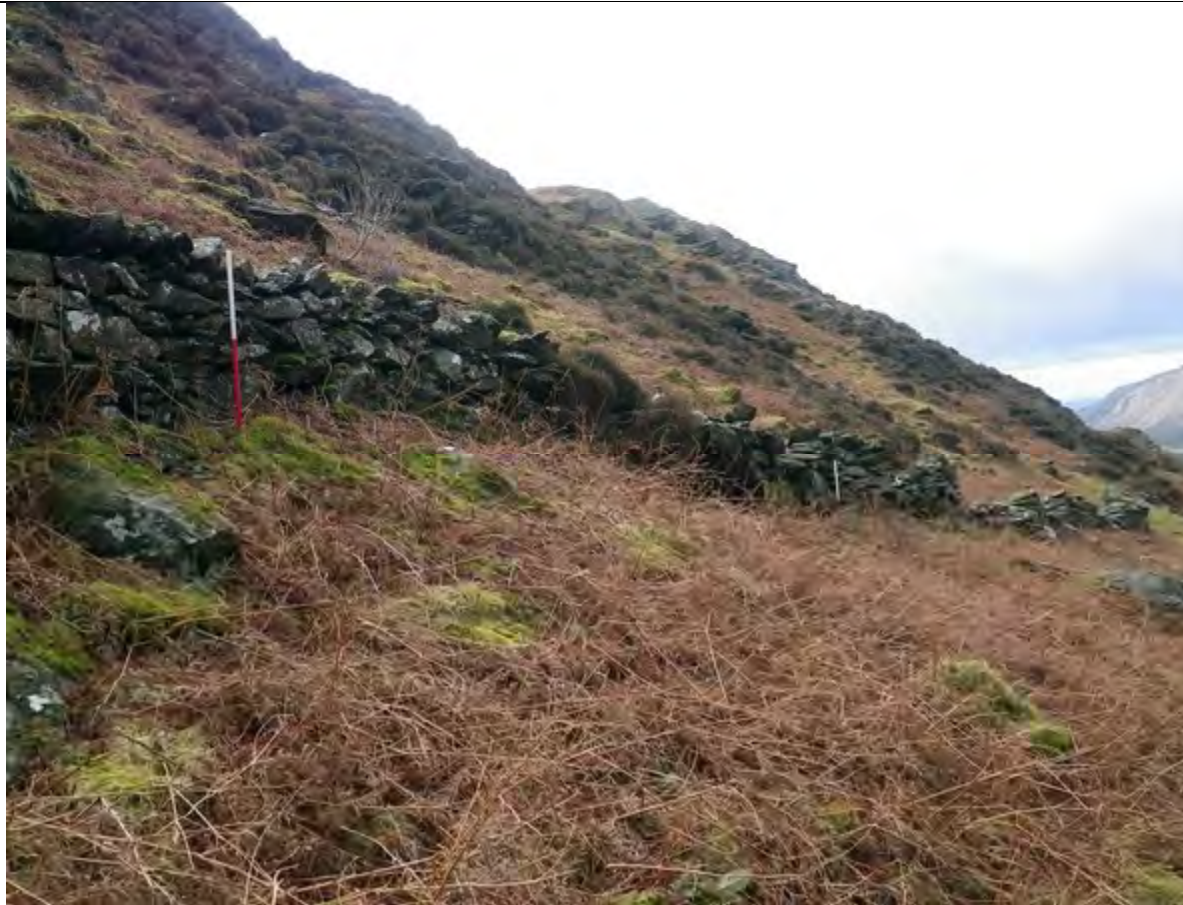
National Trust ID 415446	Site Name Cwm Bychan Wall 2	Grid Reference SH 60247 47139 - SH 60023 46668
NPRN	PRN	Period Post medieval
Description Dry stone wall snaking along the eastern side of the valley, linking in to the better preserved wall 1. Local angular stone blocks generally less than 400 mm in size although incorporating natural boulders up to 1.5 m in size. This feature appears to be cut by Wall 3 (415449)

Significance Local	Condition Poor	Survival Moderate
Stability Slow Deterioration	Vulnerability Moderate	Threat Crossed by route
Management Recommendations Use existing gaps if possible, if not record in detail and re-instate		
Photograph Cwm Bychan_02	Surveyed by I. Brooks	Date 21/2/15

Where the pipeline crosses any of the dry stone walls, particularly on the eastern side of the stream, there will also be a direct impact. If possible the pipeline should be modified to take account of any areas where the walls are already collapsed in order to minimise the damage. It is also recommended that any damage is made good. This will require the detailed recording of the crossing points before any damage takes place so that the reconstruction of the wall can, at least, imitate the original appearance.

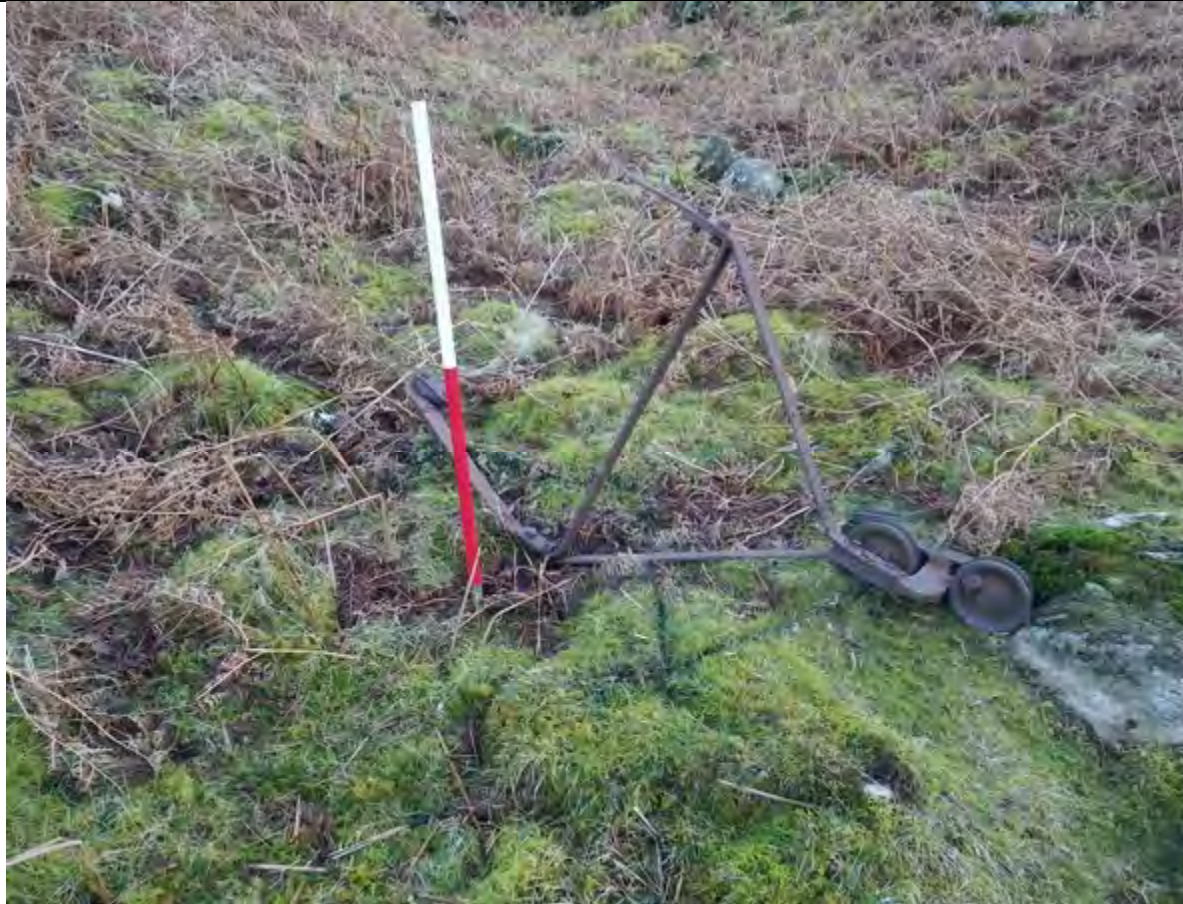
National Trust ID 415447	Site Name Aerial Ropeway fragment 2	Grid Reference SH 60193 47094
NPRN	PRN 3792 (part of)	Period Modern
Description Two small pulley wheels on an iron frame originally used to suspend a container from the aerial ropeway. Not <i>in situ</i>

Significance Local	Condition Good	Survival Good
Stability Stable	Vulnerability High	Threat On Route
Management Recommendations Avoid		
Photograph Cwm Bychan_04	Surveyed by I. Brooks	Date 21/2/15

At the northern end of the pipeline the proposed route conflicts with two fragments of aerial ropeway (41601 and 415447). These should not be disturbed and the pipe routed around these features. Care should also be taken that any other metal objects buried in the undergrowth be avoided, or at least not damaged. One possible way of minimising this risk would be to carry out a metal detector survey in the area between the inlet and the point where the route crosses the stream. It is also intended to bury the pipe at this end of the route. The First Edition Ordnance Survey Maps (Figure 4) shows a footpath on the eastern bank of the stream; whilst no structure was recorded in the walkover survey it is possible that remains of the footpath may survive and thus at least an intermittent watching brief is recommended.

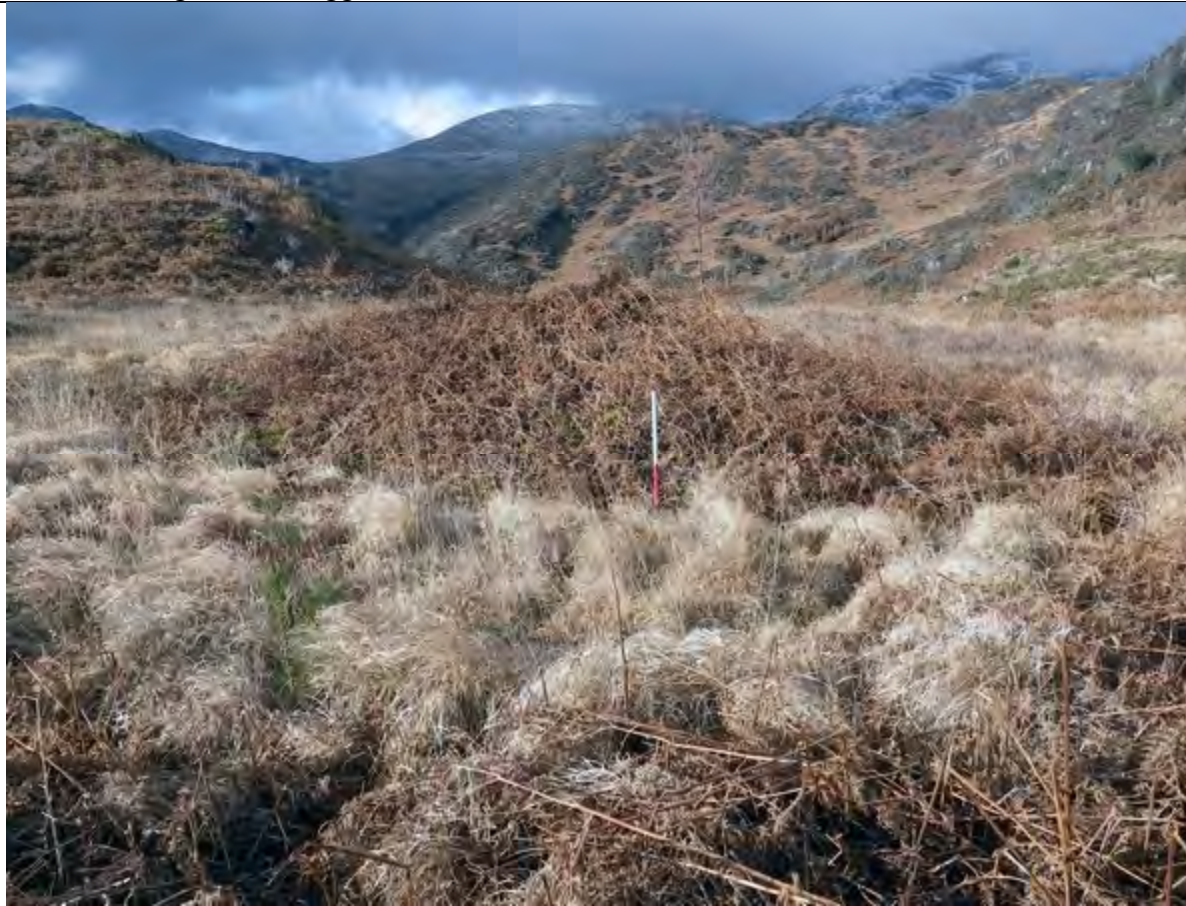
National Trust ID 415448	Site Name Cwm Bychan Mound	Grid Reference SH 60190 46886
NPRN	PRN	Period Uncertain
Description Oval mound 12 x 5 m in plan and up to 1 m high within an area of wet, peaty ground. Steep sides and a relatively flat top would suggest this is man-made. Possible peat drying stack. Probing did not suggest a stone core

Significance Good	Condition Good	Survival Good
Stability Slow Deterioration	Vulnerability Low	Threat None
Management Recommendations Maintain in current condition		
Photograph Cwm Bychan_06	Surveyed by I. Brooks	Date 21/2/15

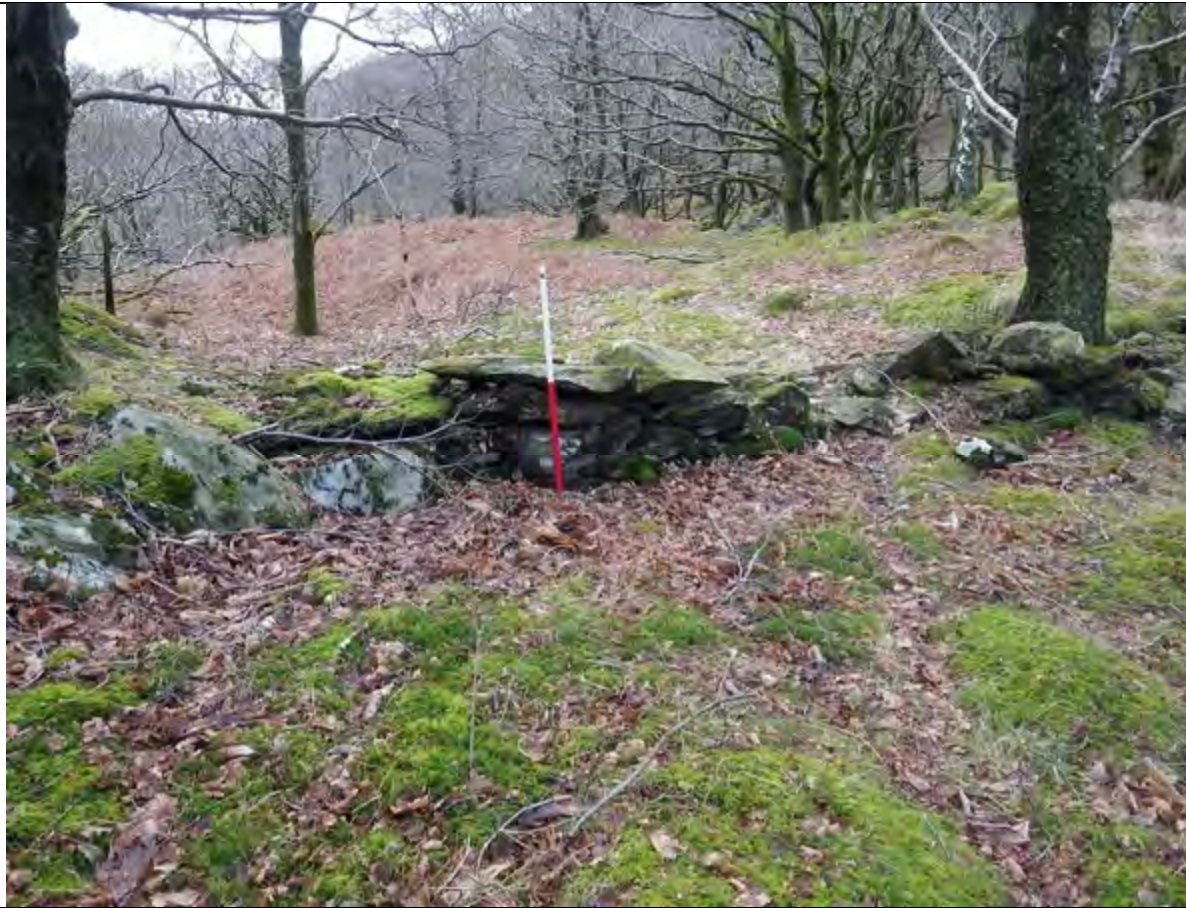
National Trust ID 415452	Site Name Cwm Bychan Wall 4	Grid Reference SH 59826 46472 - SH 59834 46473
NPRN	PRN	Period Post medieval
Description A short length of dry stone wall between the stream and a natural rock. Only surviving to 0.5 m high this wall is 0.5 m thick and constructed of rock slabs up to 1 m long, but only 0.25 m thick

Significance Local	Condition Poor	Survival Bad
Stability Slow Deterioration	Vulnerability Low	Threat Edge of survey area
Management Recommendations Avoid		
Photograph Cwm Bychan_10	Surveyed by I. Brooks	Date 21/2/15

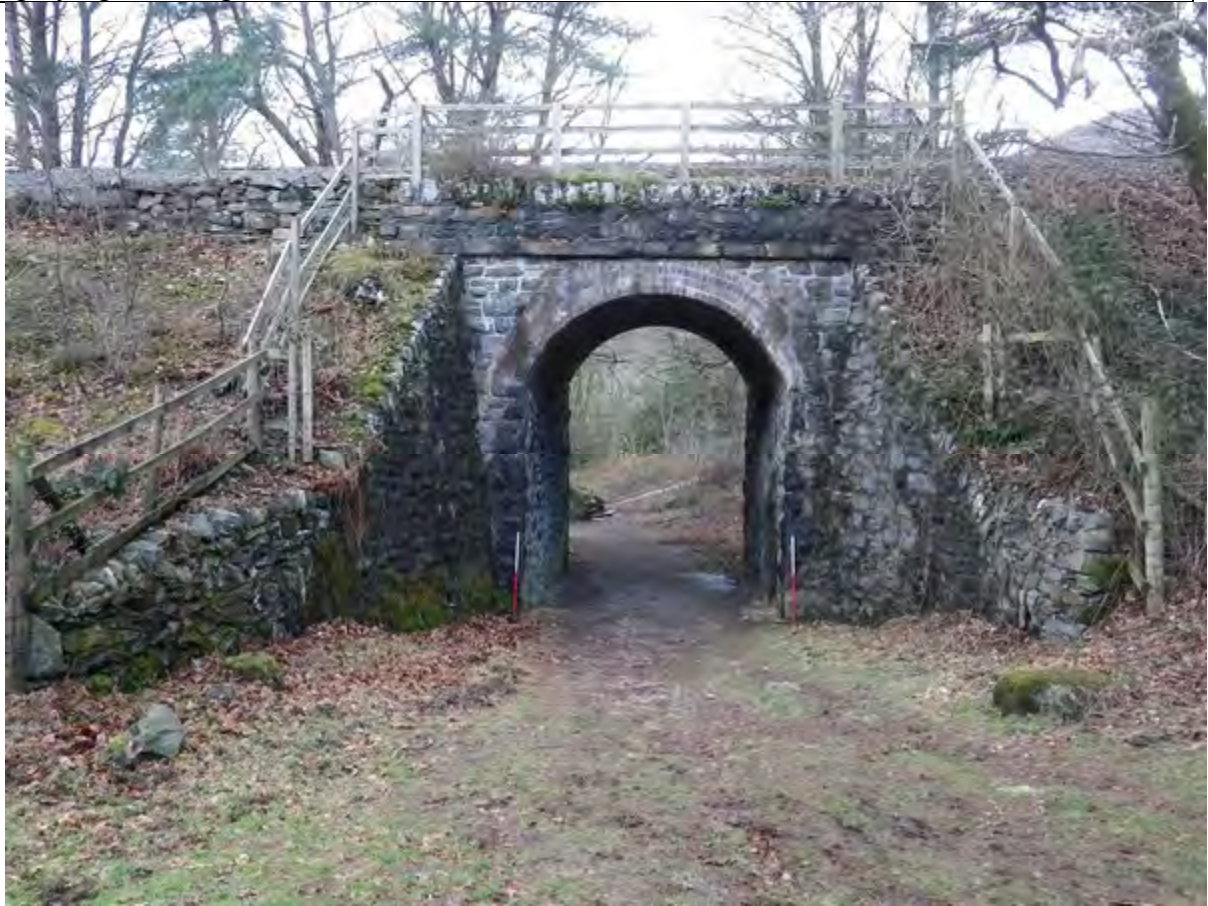
National Trust ID 415453	Site Name Cwm Bychan Embankment	Grid Reference SH 59750 46248
NPRN	PRN 57254	Period Modern
Description Railway embankment approximately 6 m high with an access tunnel/bridge below. Notated stone structure with a brick vault. The access tunnel is 3.4 m wide and 6.9 m long with splaying retaining walls either side to retain the earthen bank of the embankment.

Significance Regional	Condition Good	Survival Good
Stability Stable	Vulnerability Low	Threat Route passes below tunnel
Management Recommendations Record any trench		
Photograph Cwm Bychan_12	Surveyed by I. Brooks	Date 21/2/15

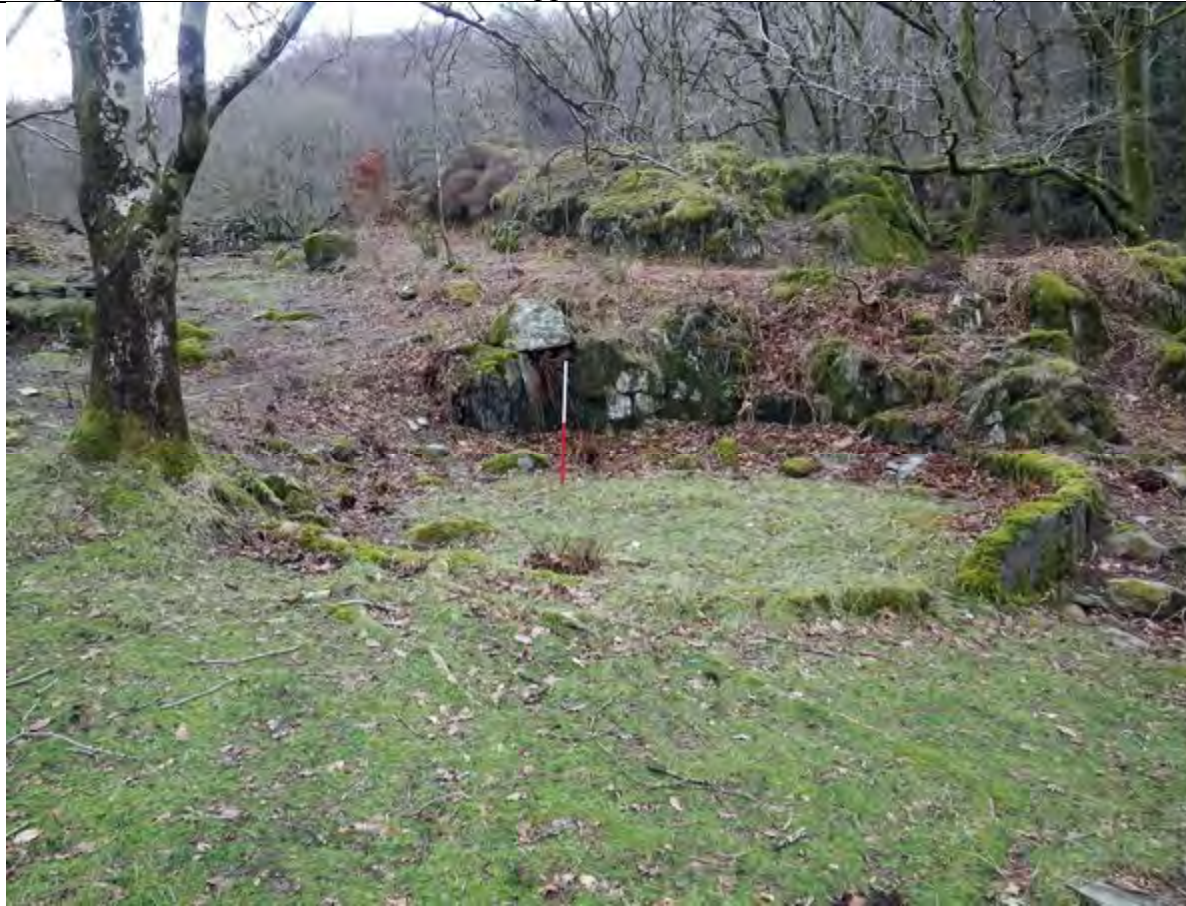
National Trust ID 415455	Site Name Cwm Bychan Buddle 2	Grid Reference SH 59784 46291
NPRN	PRN 3792 (part of)	Period
Description Flat circular area 5.5 m in diameter defined partly by a low concrete wall and partly by natural rock quarried to shape. No sign of a central pivot block. Possibly driven from rock cut platform above. Outfall to the south appears to lead into Buddle 1 (41589)

Significance Local	Condition Fair	Survival Moderate
Stability Slow Deterioration	Vulnerability Low	Threat None
Management Recommendations Keep clear of vegetation		
Photograph Cwm Bychan 17	Surveyed by I. Brooks	Date 21/2/15

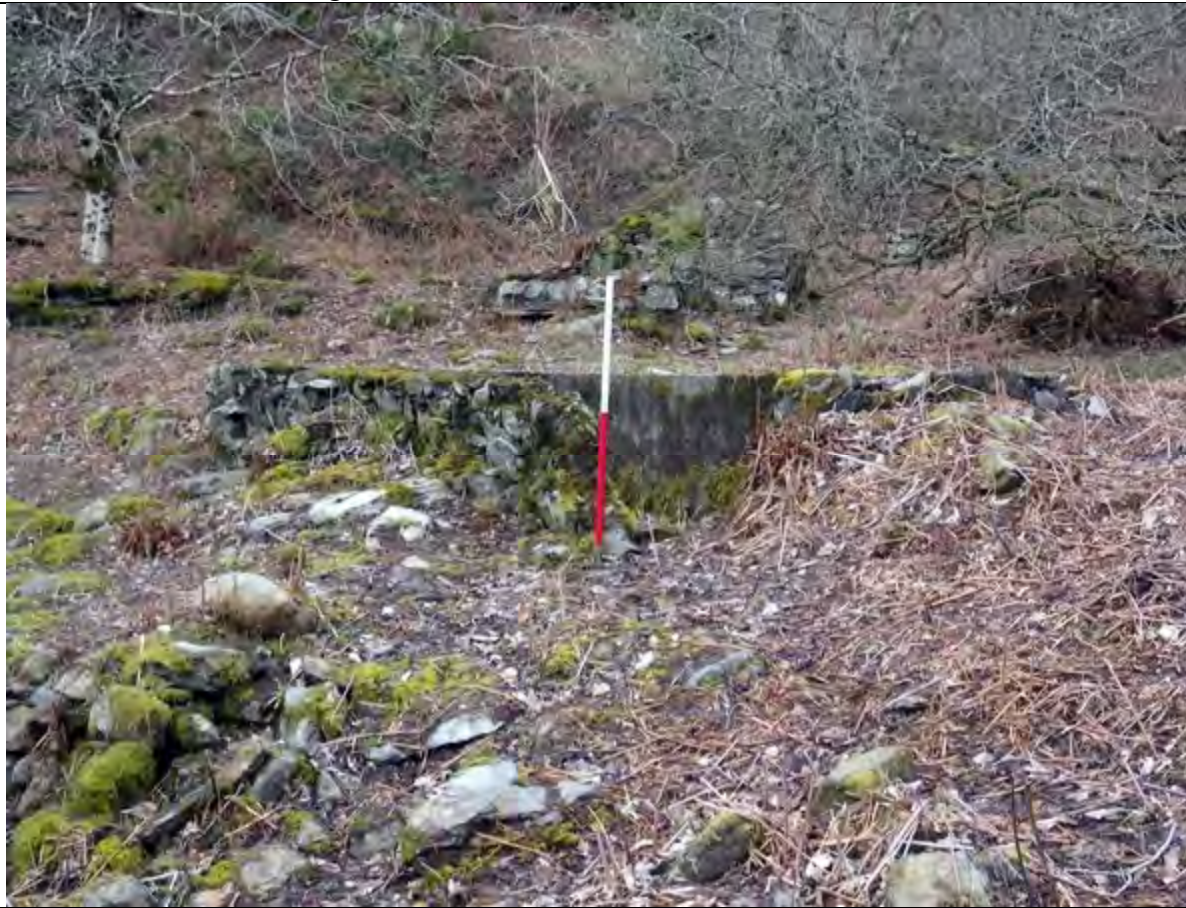
National Trust ID 415457	Site Name Cwm Bychan Rectangular Tank 2	Grid Reference SH 59791 46318
NPRN	PRN 3792 (part of)	Period
Description Rectangular concrete lined tank 4.95 x 2.1 m and at least 0.95 m deep. The outer surface of the tank had stone walling which is now lost. Partly buried into the natural slope. The front wall is broken and leaning

Significance Local	Condition Poor	Survival Moderate
Stability Rapid Deterioration	Vulnerability Medium	Threat Regrowth of trees within the tank
Management Recommendations Prevent regrowth		
Photograph Cwm Bychan_25 Cwm Bychan_26 Cwm Bychan_27	Surveyed by I. Brooks	Date 21/2/15

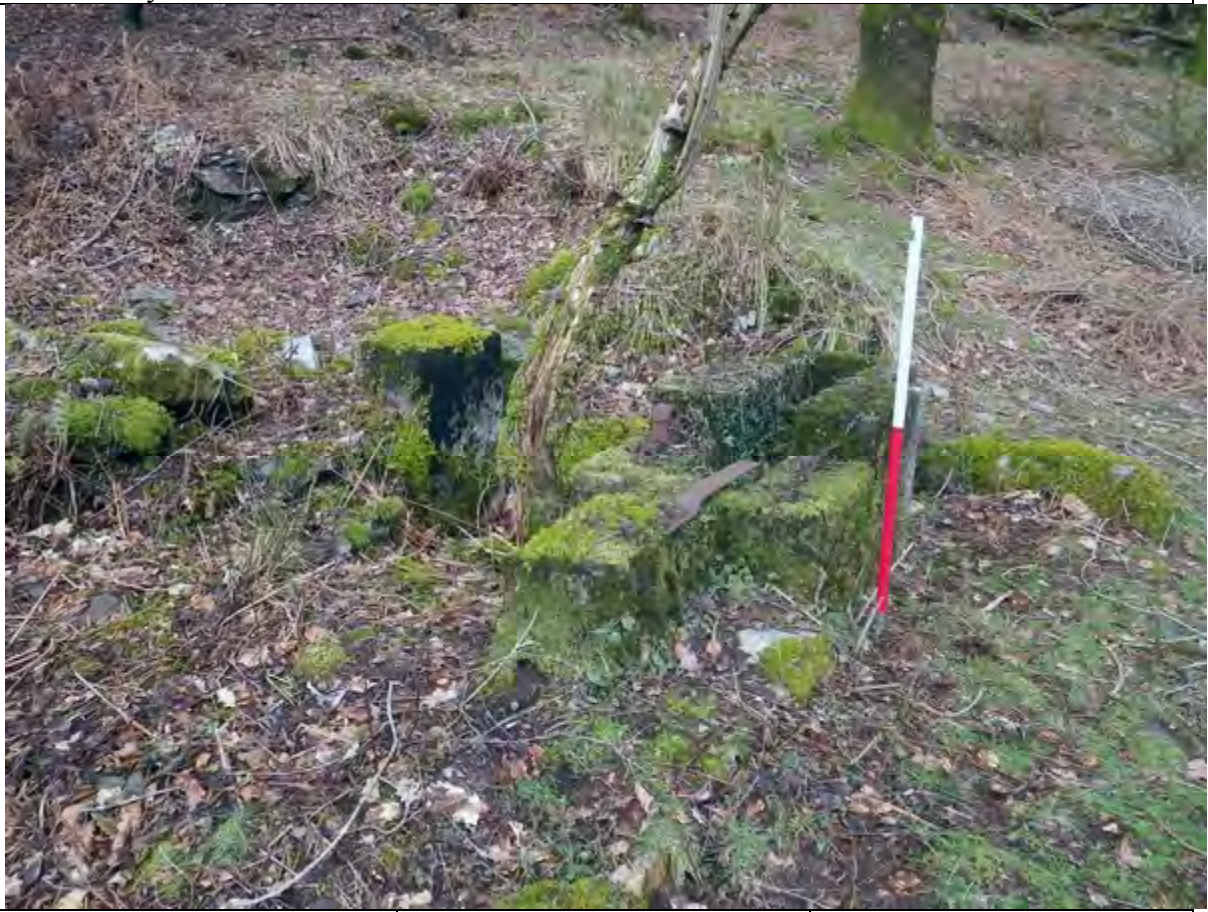
National Trust ID 415458	Site Name Cwm Bychan Possible flywheel pit	Grid Reference SH 59789 46329
NPRN	PRN 3792 (part of)	Period Modern
Description Two concrete block constructed structures with metal fittings on either side of a possible flywheel pit 0.95 m wide and at least 1.5 m long. The eastern block is approximately 2 m long and 0.65 m wide and forms a squat, hollow cross with a bearing block and other fittings on its top surface. The other block is 0.3 x 0.45 m in size and has iron bolts on its upper surface probably for another bearing block. Possibly related to the aerial ropeway. Possible dry stone wall attached the western block.

Significance Local	Condition Fair	Survival Moderate
Stability Slow Deterioration	Vulnerability Medium	Threat Tree growing out of pit
Management Recommendations Remove tree and prevent regrowth		
Photograph Cwm Bychan_29	Surveyed by I. Brooks	Date 21/2/15

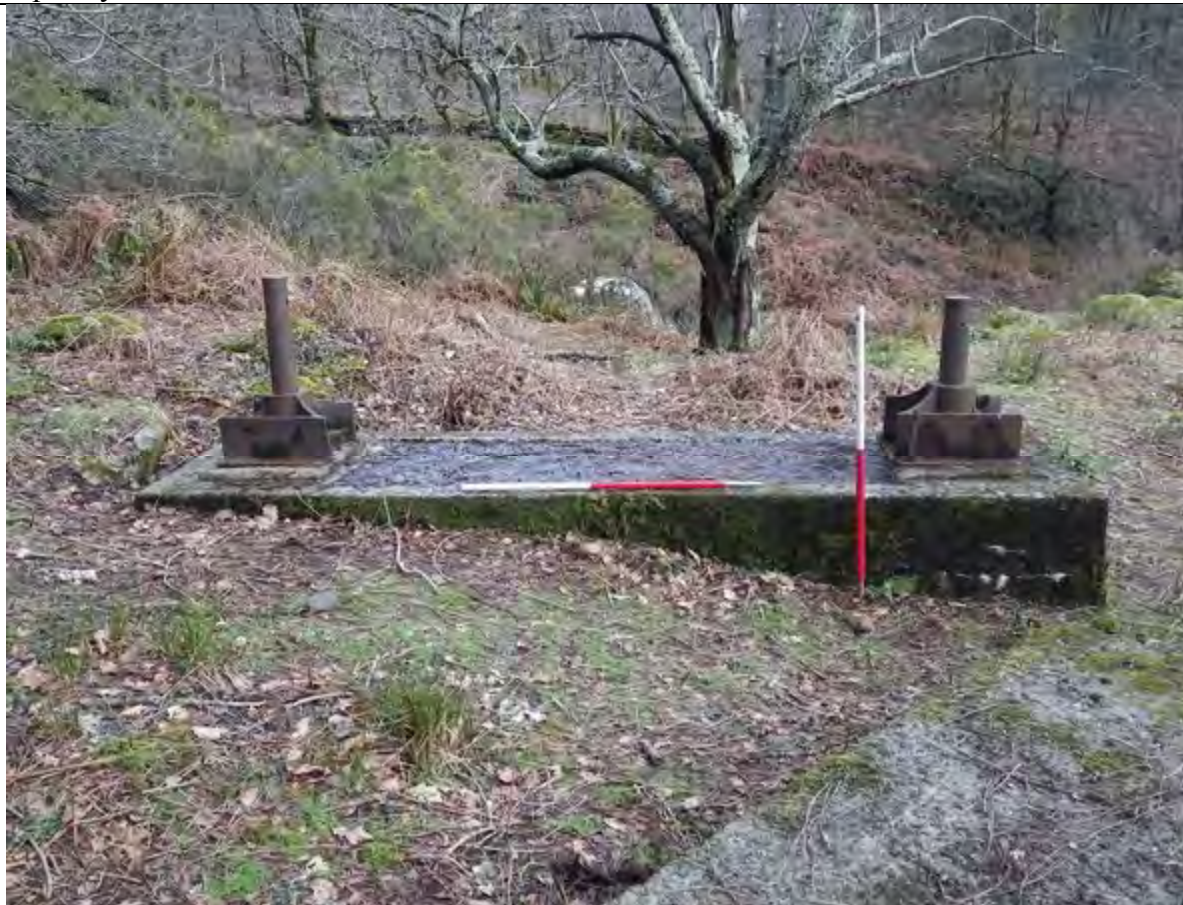
National Trust ID 415459	Site Name Cwm Bychan Stanchion Support	Grid Reference SH 59796 46332
NPRN	PRN 3792 (part of)	Period Modern
Description Concrete block 3.65 x 0.93 m in size and at least 0.4 m thick with the bases for two iron stanchion, one set at either end. The base of the metal fittings are 0.46 m square with a circular post 0.1 m in diameter set vertically. Possibly the last supports for the aerial ropeway.

Significance Local	Condition Good	Survival Good
Stability Slow Deterioration	Vulnerability Low	Threat None
Management Recommendations Maintain in an open area		
Photograph Cwm Bychan_31	Surveyed by I. Brooks	Date 21/2/15
