Surveyed
by
I.P. Brooks
Engineering Archaeological
Services Ltd

Cwm Bychan Hydro Scheme

March 2015
EAS Client Report 2015/06

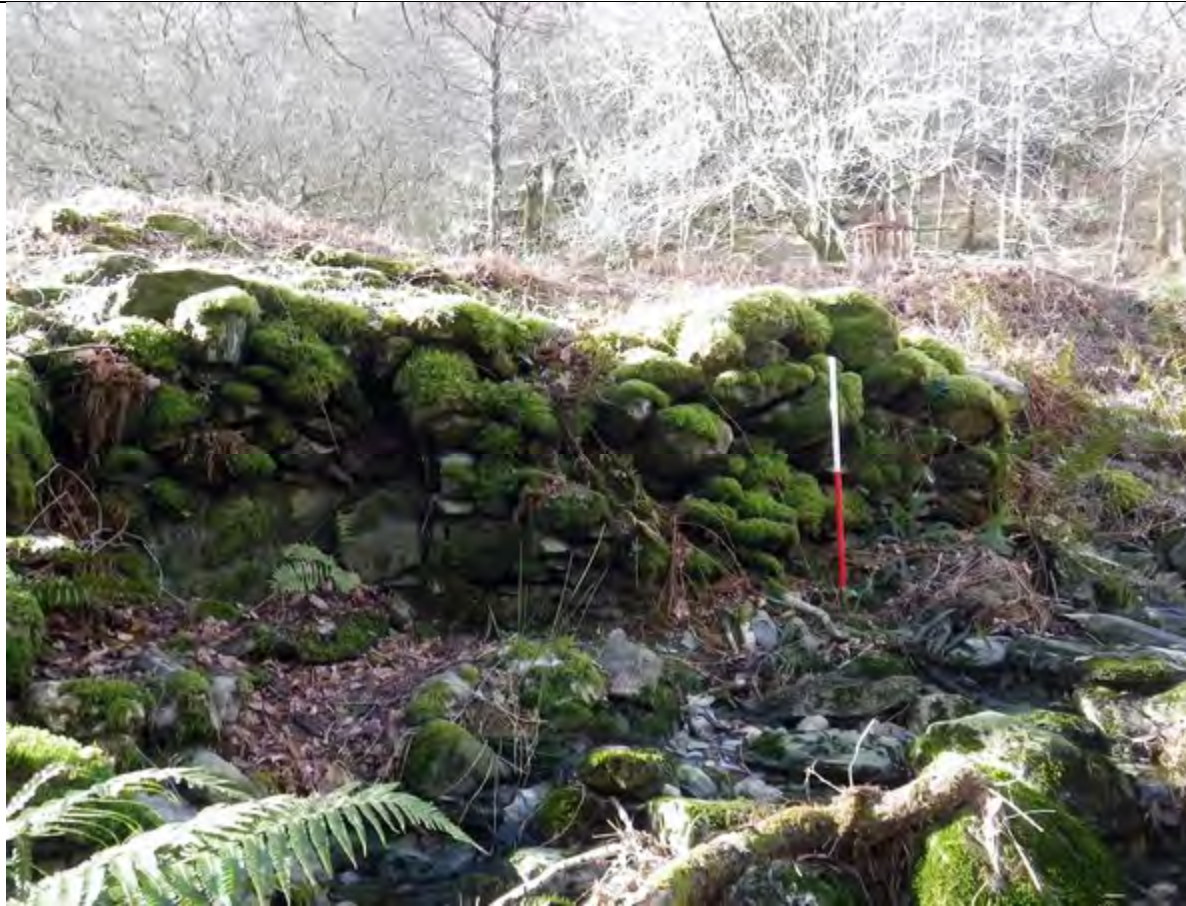
National Trust ID 415460	Site Name Cwm Bychan Revetting Wall	Grid Reference SH 59812 46317
NPRN	PRN	Period Post Medieval
Description A short length (4.6 m) of dry stone walling revetting the western side of the stream. Standing up to 1.5 m high this wall is made of poorly coursed rounded boulders up to 0.4 m in size.

Significance Local	Condition Fair	Survival Moderate
Stability Slow Deterioration	Vulnerability Medium	Threat On route
Management Recommendations Avoid damage		
Photograph Cwm Bychan_35	Surveyed by I. Brooks	Date 21/2/15

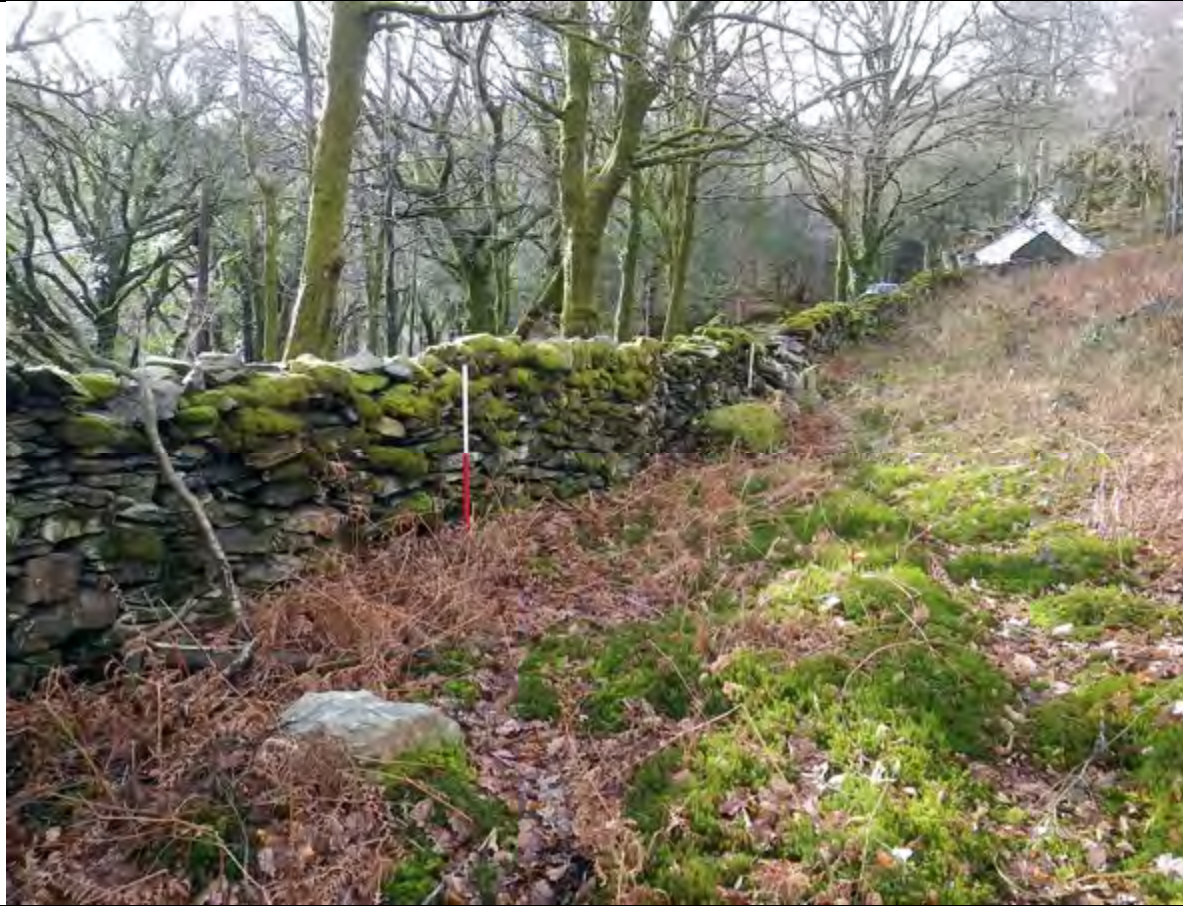
National Trust ID 415461	Site Name Pen y Groes Wall	Grid Reference SH 59693 46171 - SH 59624 46197
NPRN	PRN	Period Post Medieval
Description Well maintained dry stone wall alongside the drive to Pen y Groes cottage. Up to 1.5 m high and 0.6 m thick the wall is constructed of relatively small (up to 0.3 m) sub-angular stone blocks. Some areas of coping. Two areas of recent collapse

Significance Local	Condition Good	Survival Good
Stability Slow Deterioration	Vulnerability Low	Threat Trees growing close to wall
Management Recommendations Monitor the condition, consider removal of adjacent trees		
Photograph Cwm Bychan_36	Surveyed by I. Brooks	Date 21/2/15

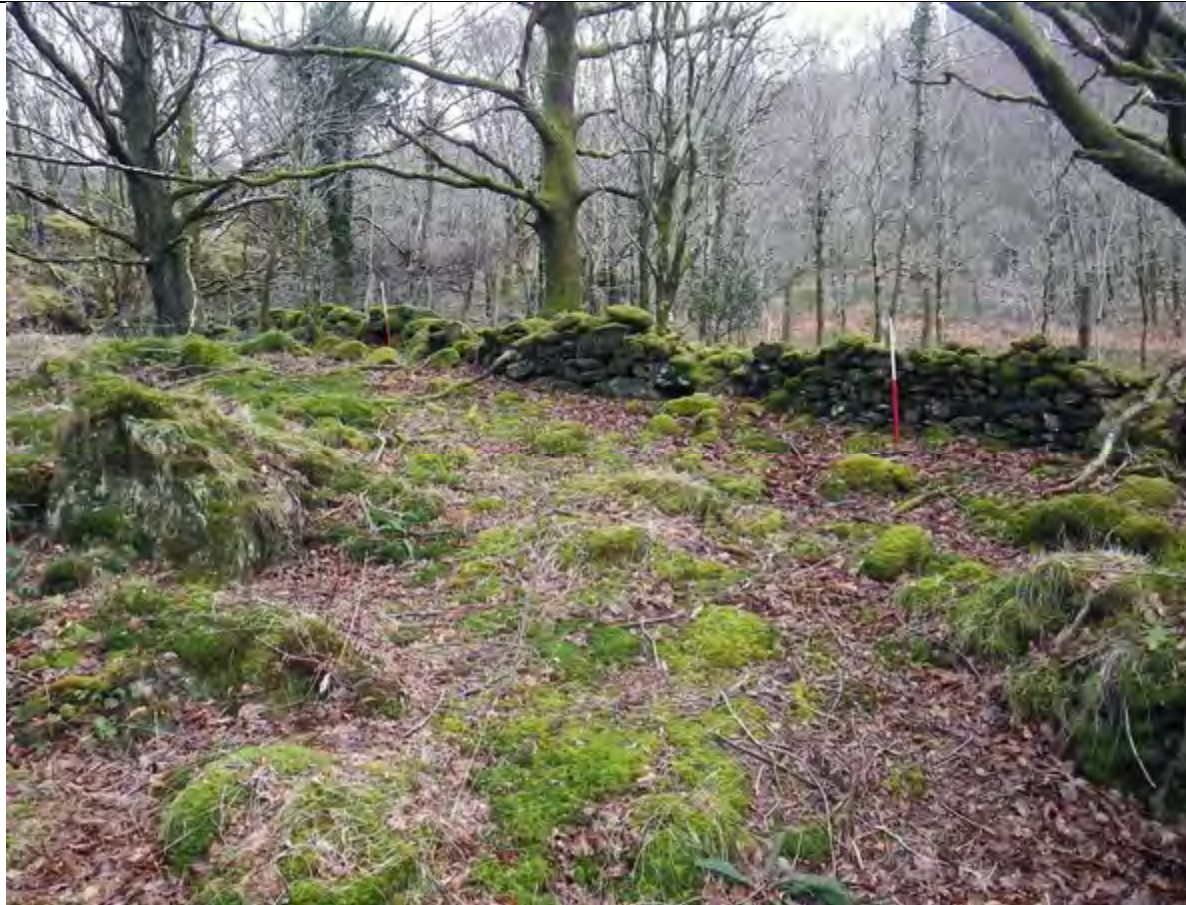
National Trust ID 415462	Site Name Cwm Bychan Wall 5	Grid Reference SH 59856 46406 - SH 59829 46292
NPRN	PRN	Period Post medieval
Description Dry stone wall running along the western side of the stream. Somewhat tumbled wall up to 0.75 m high and 0.5 m thick forming the western side of the valley floor. Constructed of local sub-angular rocks up to 0.4 m in size and incorporating local boulders and rock outcrops in places

Significance Local	Condition Fair	Survival Moderate
Stability Slow Deterioration	Vulnerability Medium	Threat Adjacent to route
Management Recommendations Avoid		
Photograph Cwm Bychan_10	Surveyed by I. Brooks	Date 21/2/15
