**St Aelrhiw's Church
Archaeological Survey**

EAS Client report 2015/15

St Aelrhiw's Church, Rhiw

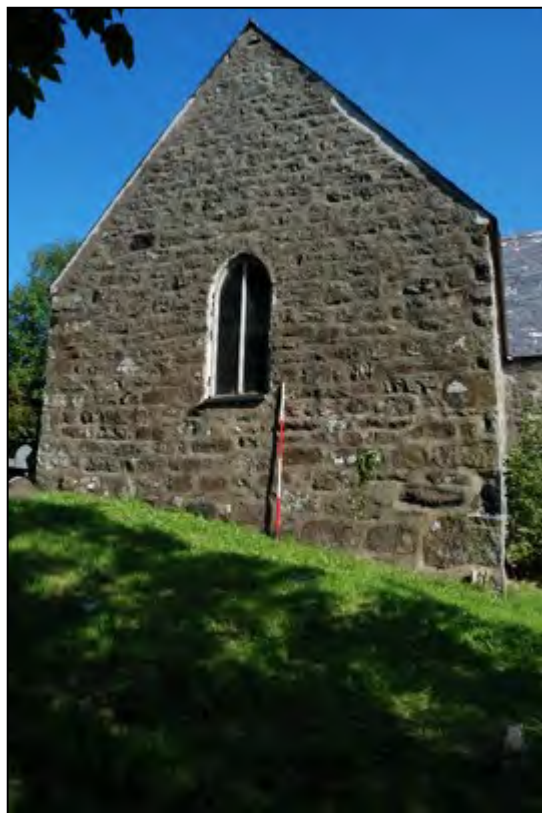
Plate 13: Southern elevation of the south transept

The southern gable end of the south transept contains a single window (Plate 13) which is similar to that in the northern gable of the northern transept. It has a two-centred arch defined by voussoirs and a wooden mullion defining two large panes. There are no opening in neither the western side of the south transept nor the south face of the nave (Plate 14).

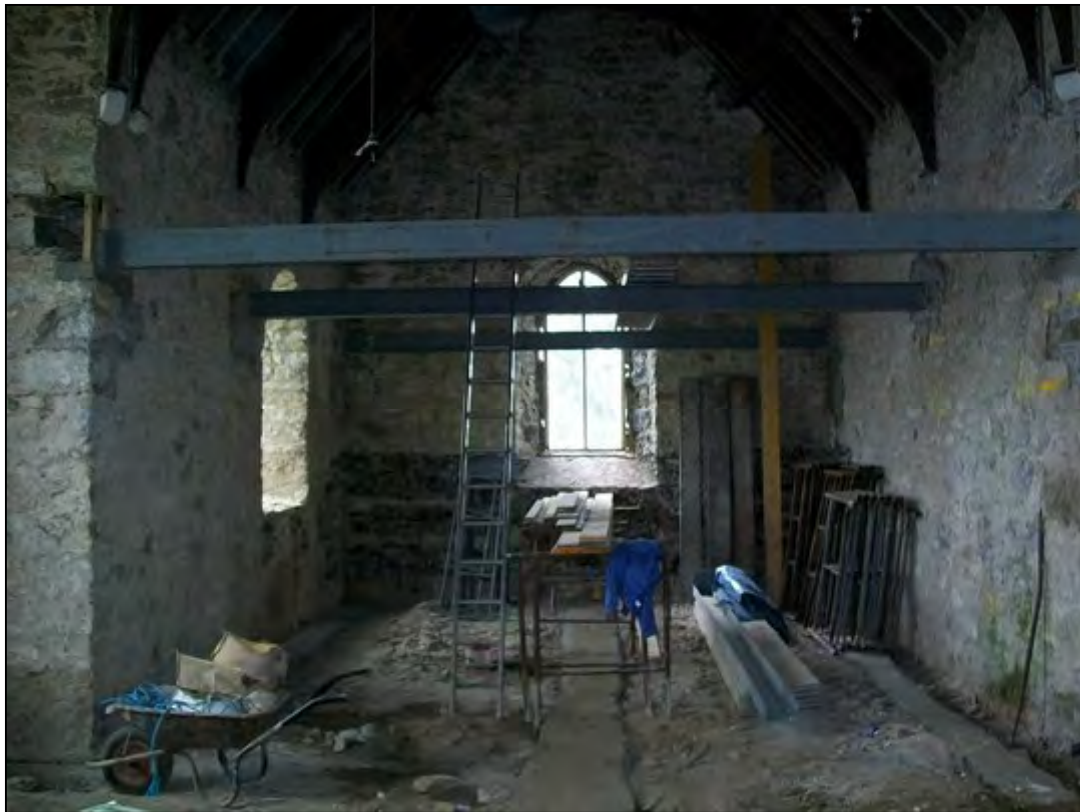
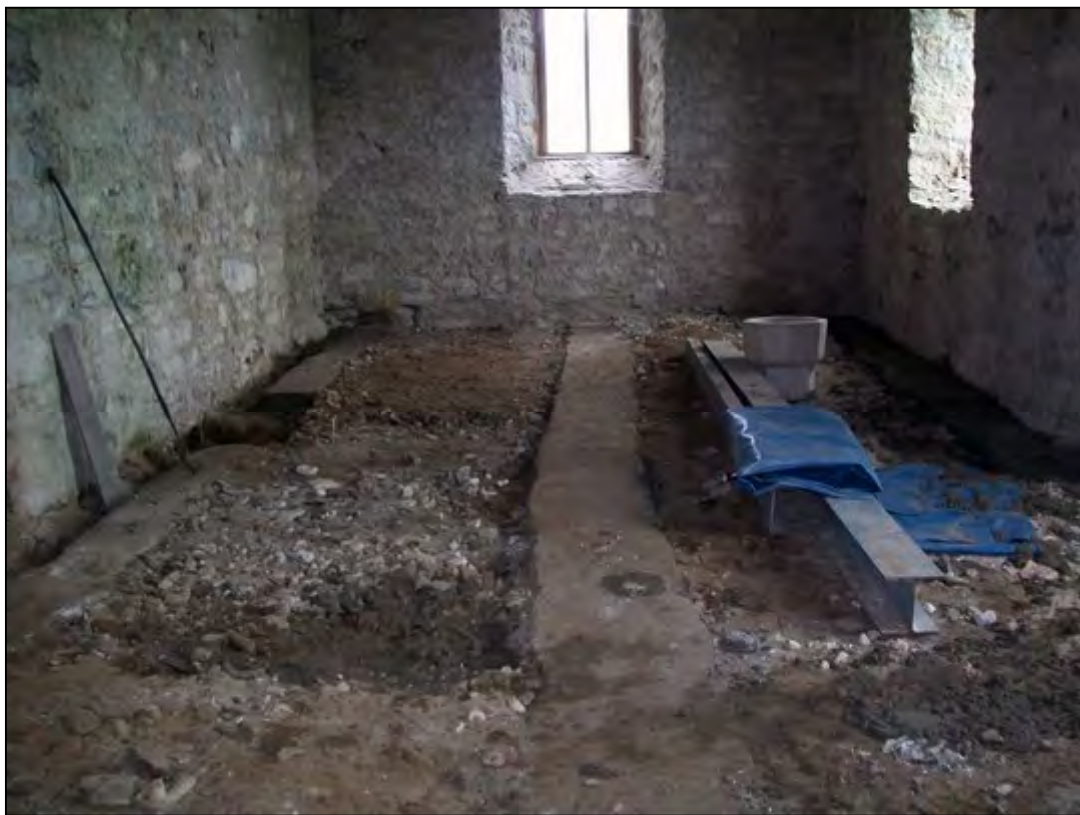
Photographs taken during the conversion works show the structure below the floors (Plate 29 - 31). Whilst the floor in the nave appears to have been laid on natural clay, that in the two transepts had three lines of stone slabs running along the transepts with the gap between filled with stone rubble. It is assumed that this rubble was derived from the destruction of the previous church. Some of this rubble was available for inspection, either in a pile just outside the church or in the yard of J and S Jones Building Contractors Ltd where the bulk of this deposit was stored. The majority of this rubble was unshaped stone blocks, however a single fragment of carved stone (Plate 33, Figure 12) was recovered. This appears to be part of a window or door surround, although there is insufficient fragments to be sure. The floor, before it was removed, appears to have been covered, at least in part, by plain clay tiles (Plate 32) some of which have been retained by the developers.

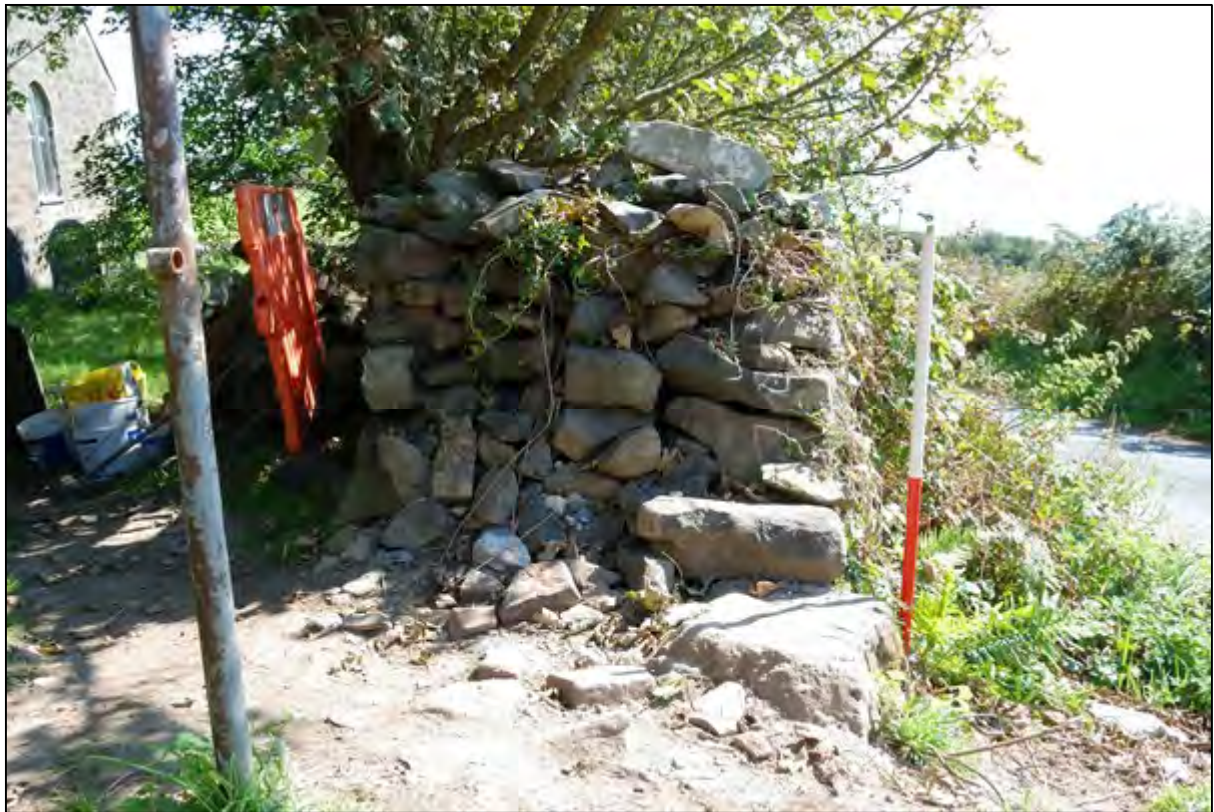
Plate 38: The structure of the boundary wall

already discussed. In the north western corner of the graveyard was another opening. This has been widened as part of the works to restore the church, however it does show the width of the boundary wall (Plate 38) which is approximately 1 m wide and consists of well-made faces with rubble infill.

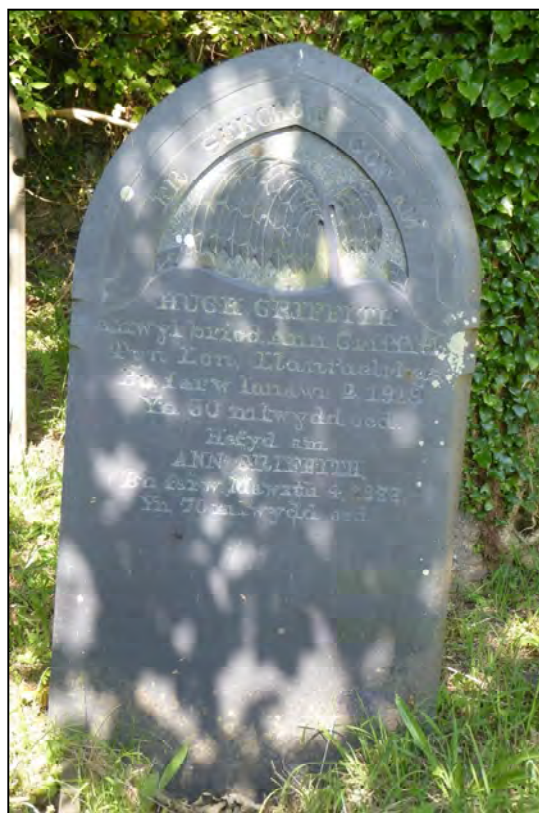
Plate 39: Typical 19th century grave stone with willow pattern

Majority of the graves are 19th century in date, however the marked graves range from 1778 to 2006. There are also many unmarked, or barely marked graves which are shown by a series of low mounds within the church yard. Within the 19th century graves it is noticeable that there is a preference for the depiction of a willow on the markers (Plate 39).

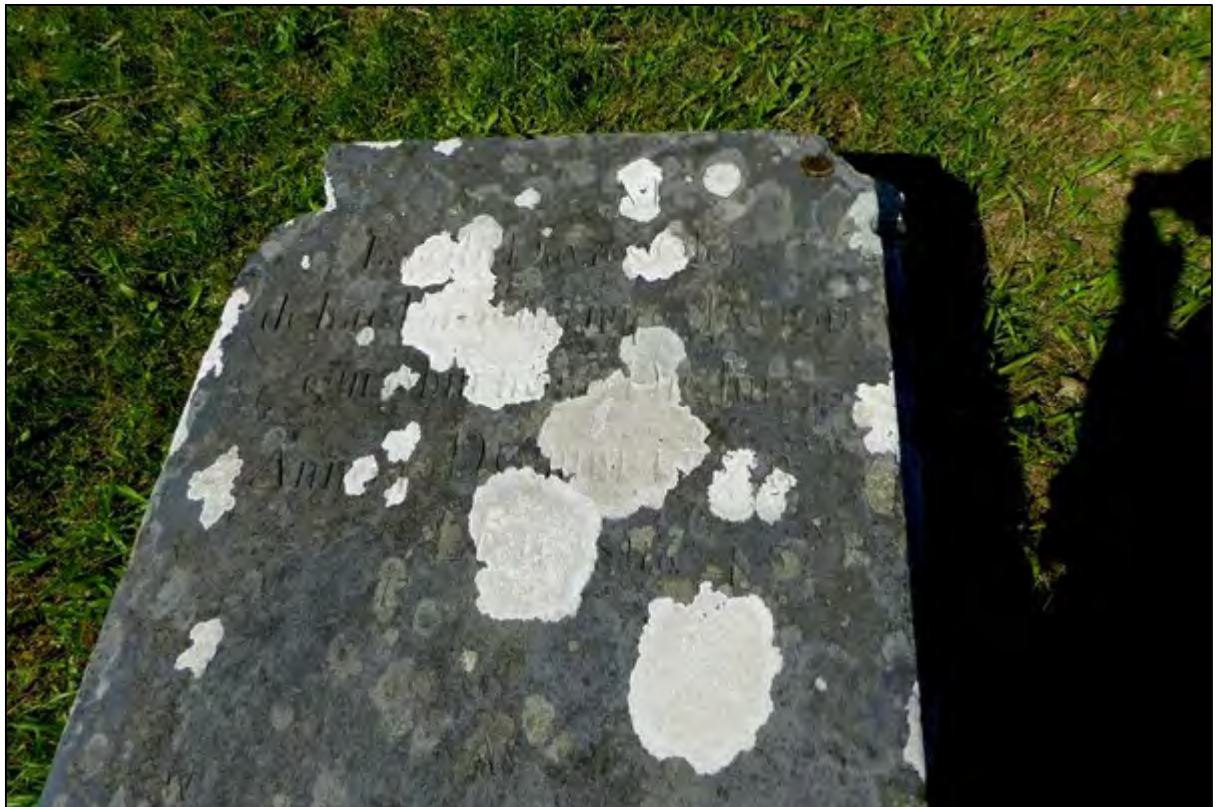
Plate 40: Grave of Jacob Davies

The two earliest graves are both of the clergy and their families. The earliest is of Jacob Davies, Vicar of Rhiw between 1772 and 1778 (Plate 40). The grave slab is very worn making the inscription difficult to determine, however, Jones (1903, 156) record the inscription as:

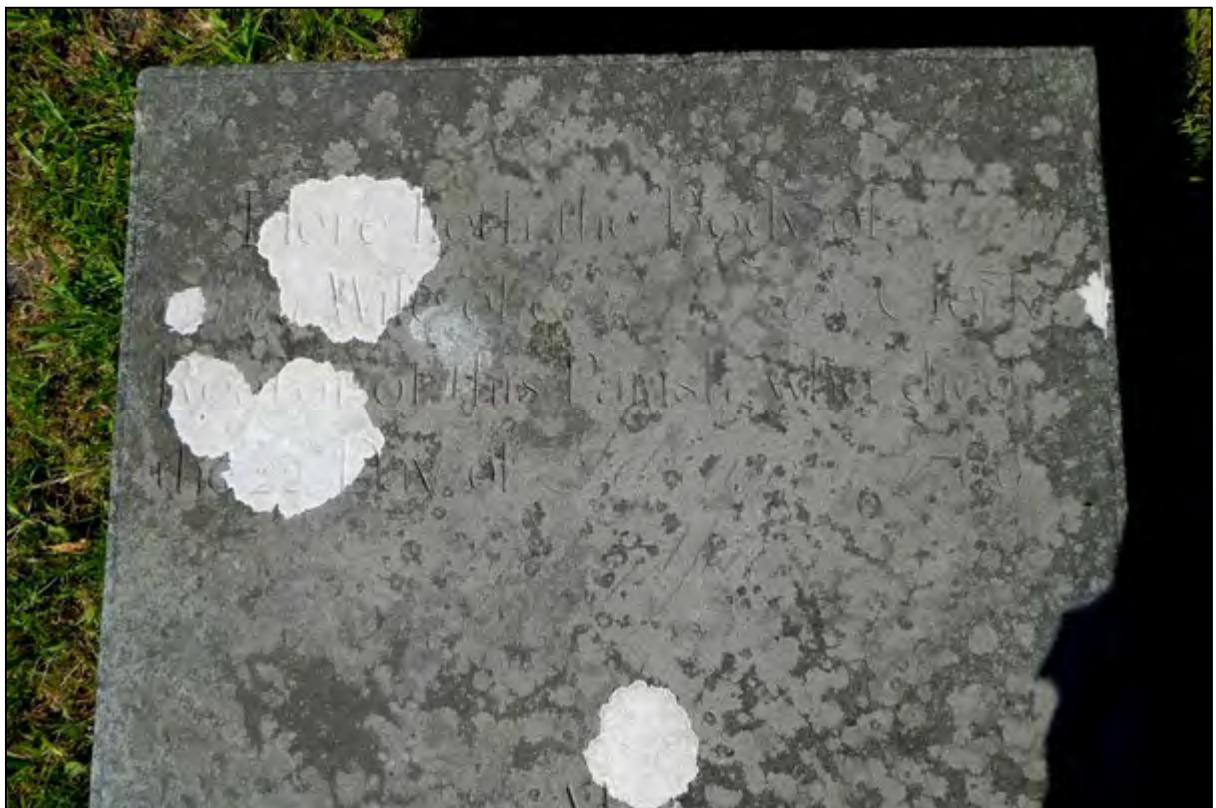
Plate 41: Grave of Mary and Evan Rees

The second is for the wife of Evan Rees (vicar 1779 – 1811) and later Rees himself (Plate 41). The slab is less worn, however the full inscription is recorded by Jones (1903, 156) as:

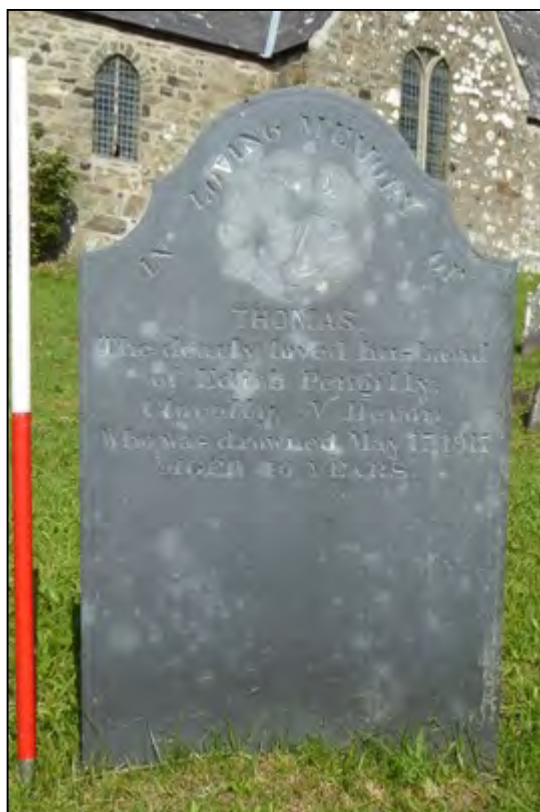
Plate 42: Grave of Thomas Pengilly

One of the graves is recorded by the War Graves Commission (BMSS/4012b). It is the grave of Thomas Pengilly from Clovelly, Devon, who drowned in 1917 and was one of a series of bodies washed at Porth Neigwl (Kendrick nd. 26) (Plate 42)

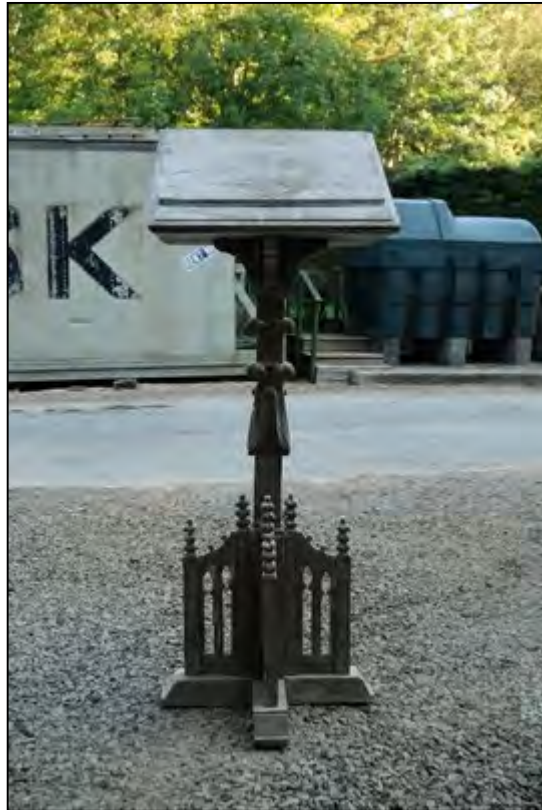
Plate 48: The lectern

The lectern (Plates 48-54) stands to a height of 1.53 m high and has an inscription somewhat crudely carved into its upper surface (Plate 49). This reads:

The lectern gives the impression of having been constructed from at least three other pieces of furniture with the decorative styles for each of the elements not matching. The reading slope (Plates 51 and 52) has pierced quatrefoil decoration on its sides (Plate 51) and pierced scrollwork on its back (Plate 52), which has half quatrefoils along the base and roses carved in triangular spaces above. The shaft (Plate 53), however, has inverted acanthus decoration, whilst the base (Plate 54) has pieced arabesque arches surmounted by pinnacles with multiple crockets.

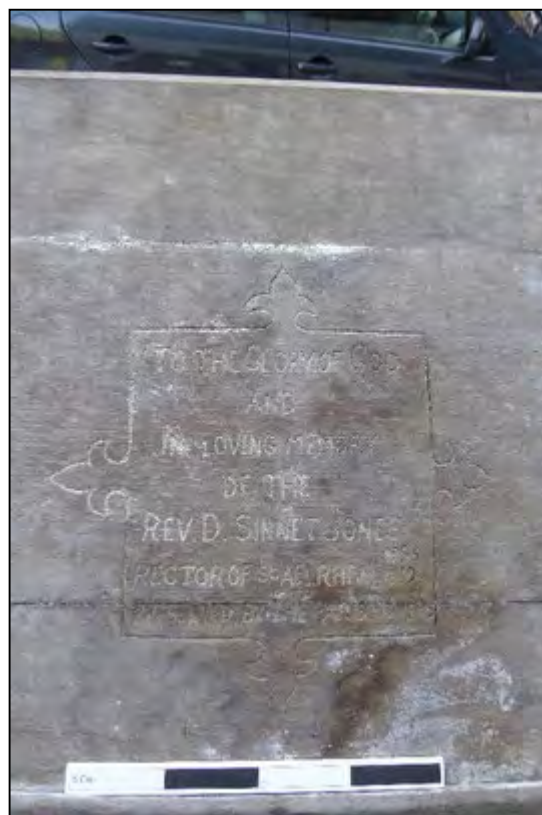
Plate 49: The inscription on the top of the lectern

The carving is cramped in places such that the dates had to be included in a smaller font and one above the other. Below the reading slope there is also a maker’s mark (Plate 50) which consists of:

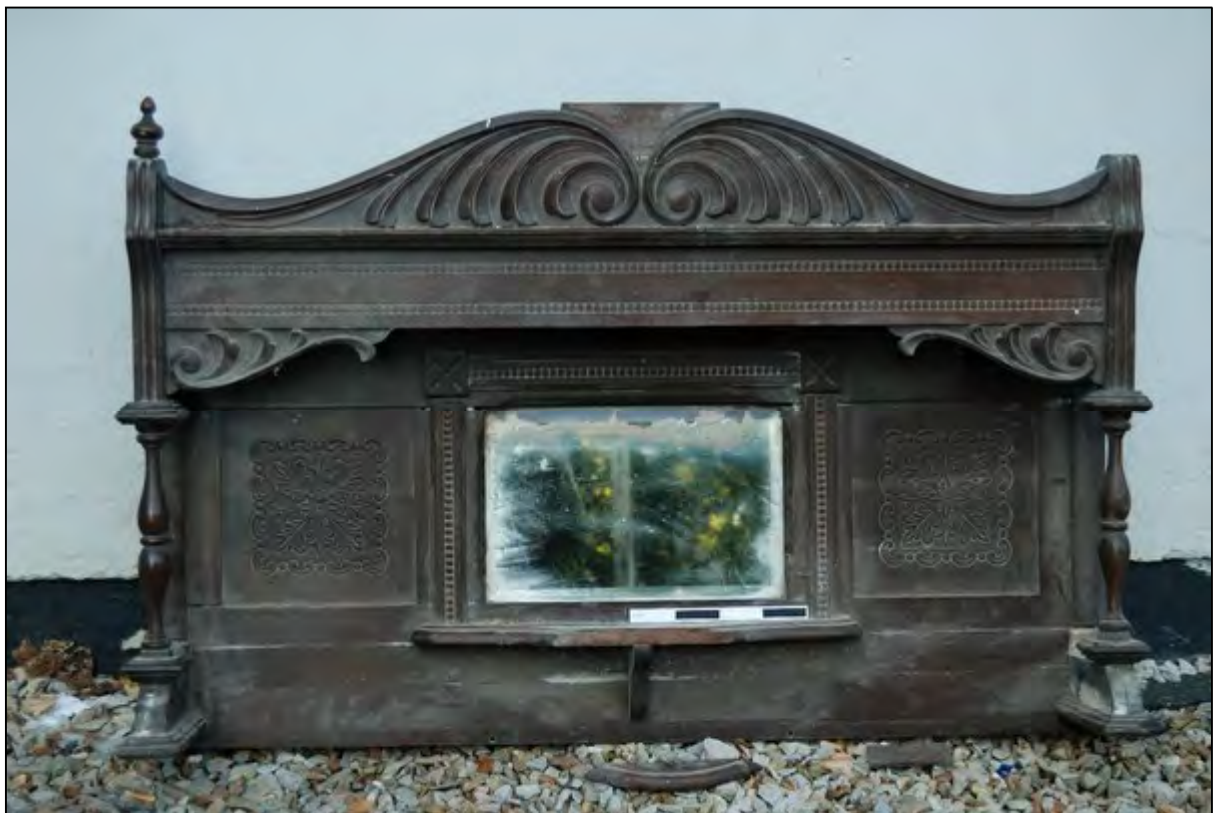
Plate 55: The probable top to a chest of draws

The other item stored off site appears to be the top of a domestic chest of draws or sideboard (Plate 55). Although broadly “Georgian” in style the use of machine cut veneer decorative elements would suggest that is part of a late 19th or early 20th century reproduction. This piece of furniture sat above and slightly behind another item, as is shown by the supports near to the base. Either side of the centrally placed mirror are panels of geometric floral decoration (Plate 56) which are shallowly carved. The mirror is defined by a band of dot decoration which is also repeated as two bands below the pediment. The pediment is supported by acanthus decoration and two turned balusters. It has a mirrored, scrolled floral design and turned finials.
