# Belfast Store, Gwaith Powdwr, Penrhyndeudraeth, Gwynedd Standing Building Record

**EAS Client Report 2016/04**

**Belfast Store, Gwaith Powdwr , Penrhyndeudraeth, Gwynedd  
Standing Building Recording**

**The National Trust  
On behalf of  
The North Wales Wildlife Trust**

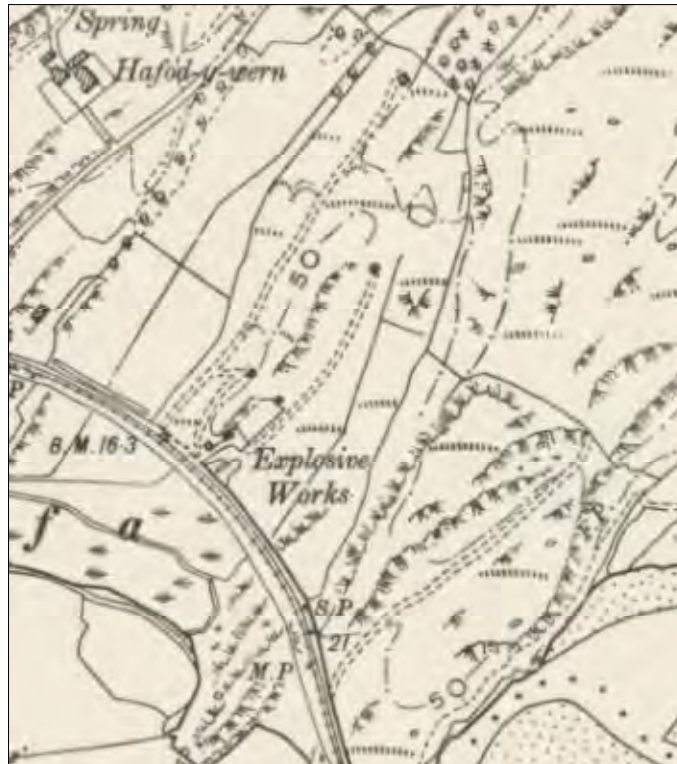
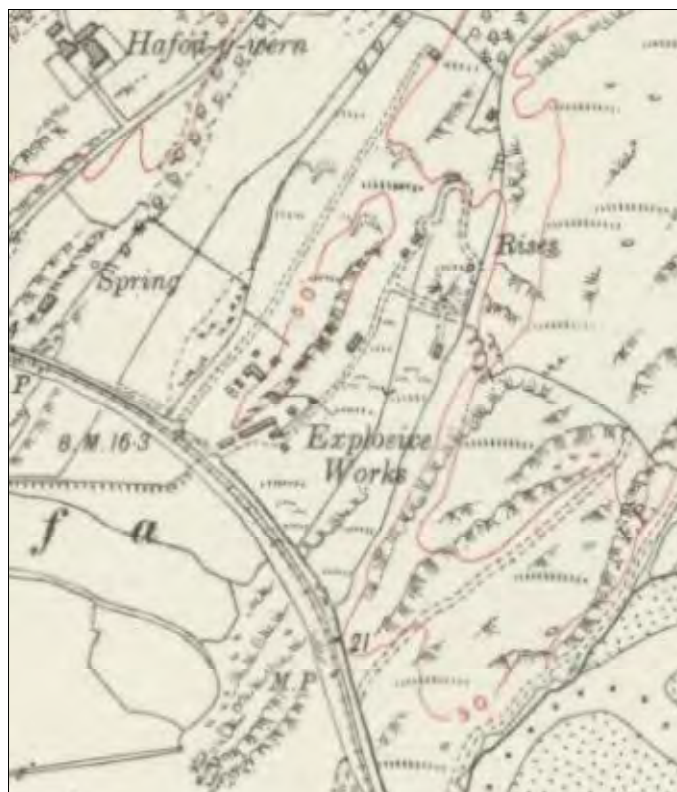
Figure 7: Extracts from the Ordnance Survey  
Caernarvonshire XXXV SW Maps  
Not to Scale

The Belfast Store has clearly had a complex history of use and modification like many industrial buildings. An initial inspection of the easily available historic mapping of the area (Figure 7) would suggest that the building was initially constructed before the First World War, but after 1899. The building first appears on the Ordnance Survey map published in 1920 (although surveyed in 1913), but not on the earlier map published in 1901 (surveyed in 1889). At this phase it was likely to have been a stone built structure, probably with a Belfast Truss roof. It is not certain if this was a single storey building at this time or was divided into two floors. The supports for the first floor, however are probably the result of later modifications.

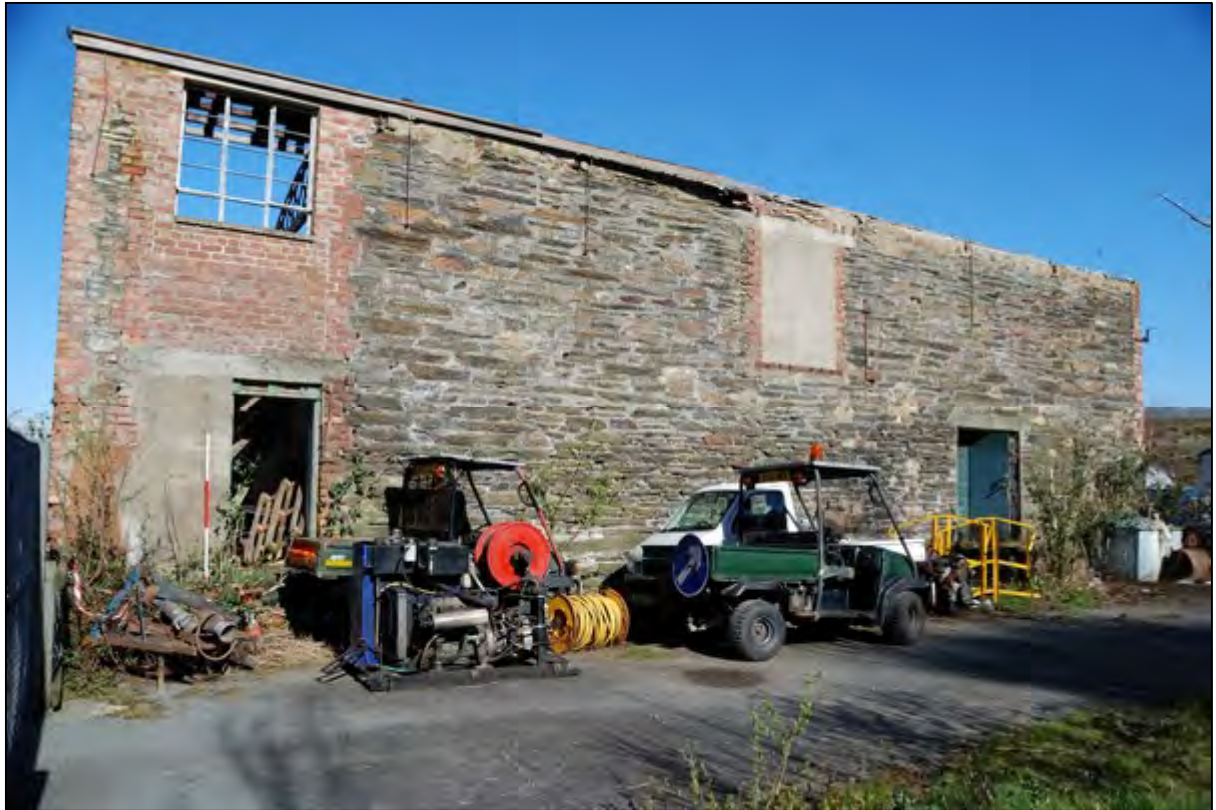
The eastern elevation (Plates 1 – 3, Figure 4) consist of two main construction styles, whilst the majority of the building is constructed of coursed stone slabs, the southern end is largely constructed of red industrially produced bricks (Plate 2). This end of the building has a doorway leading into what is assumed to have been an office space and a first floor window with an iron framed casement window frame. It would appear that this brickwork represents a secondary phase of construction with the door having been added at a later date. This window is divided by two mullions and four transoms (all of iron) giving fifteen panes, with three panes on each side of the window forming the opening sections of this window. This window would appear to have been a late insertion into the building as is demonstrated by the panel of later brickwork below it. This suggests at least three phases of construction at this end of the

Plate 1: The eastern elevation

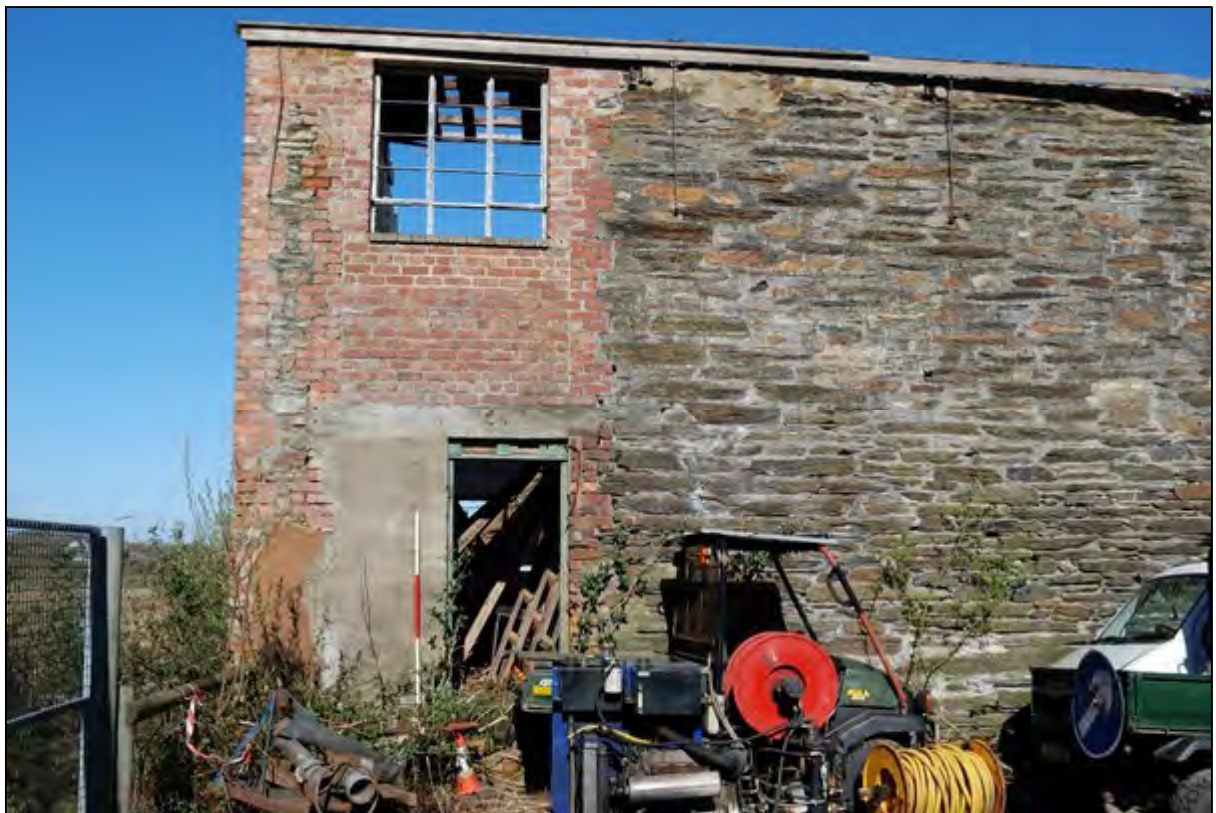
Plate 2: Southern end of the eastern elevation

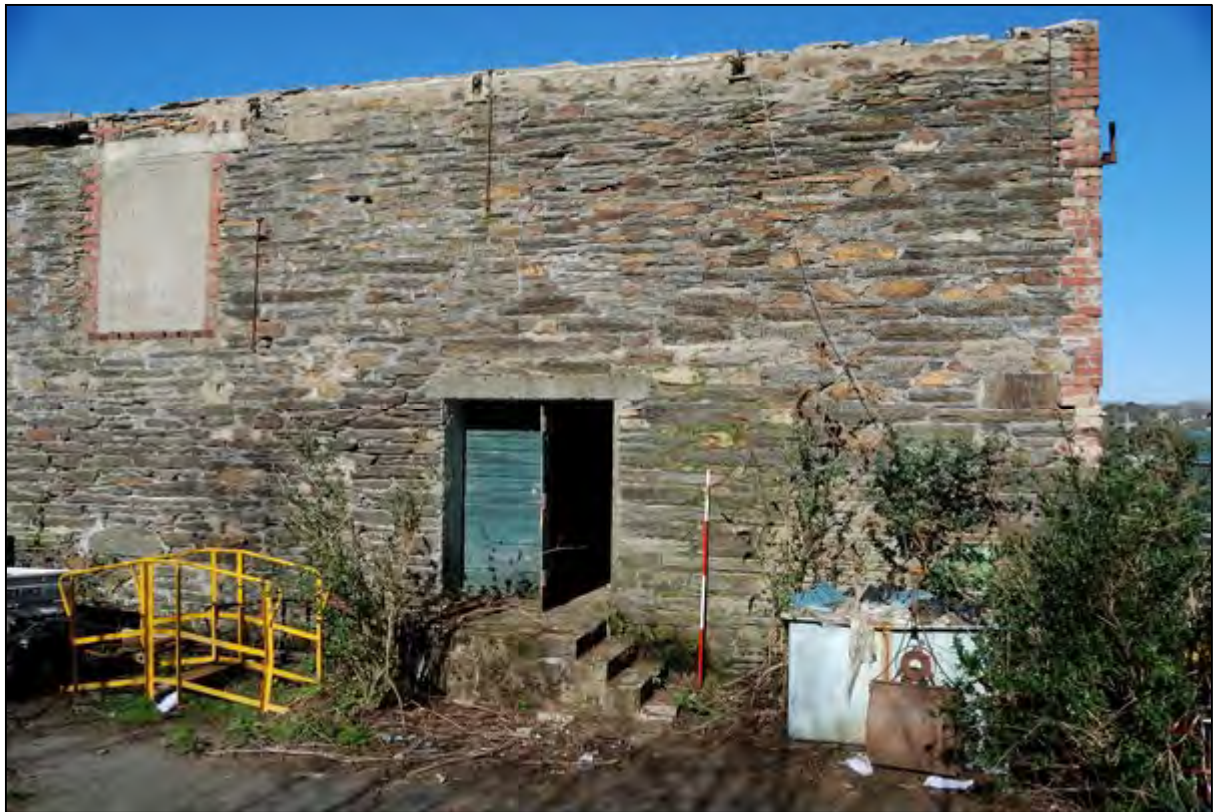
building. The bulk of the rest of the elevation is of stonework (Plate 3), however there are brick quoins around the centrally placed, blocked, first floor opening and on the north eastern corner of the building above the height of 2.23 m above the current ground level. It is not certain as to whether these features are part of the original design, however it would seem likely that they are part of one of the phases of modification of the building. The main doorway is placed, in the northern half of the elevation. Set back in the wall, the ledged door only occupies the northern half of the opening, possibly suggesting the presence of double door in the original structure. It is set approximately 0.60 m above the current ground level and is approached by a set of rendered stone steps. The rest of the opening is now filled by a wooden partition. Both the door and the central, first floor opening have concrete lintels.

Plate 3: Northern end of the eastern elevation

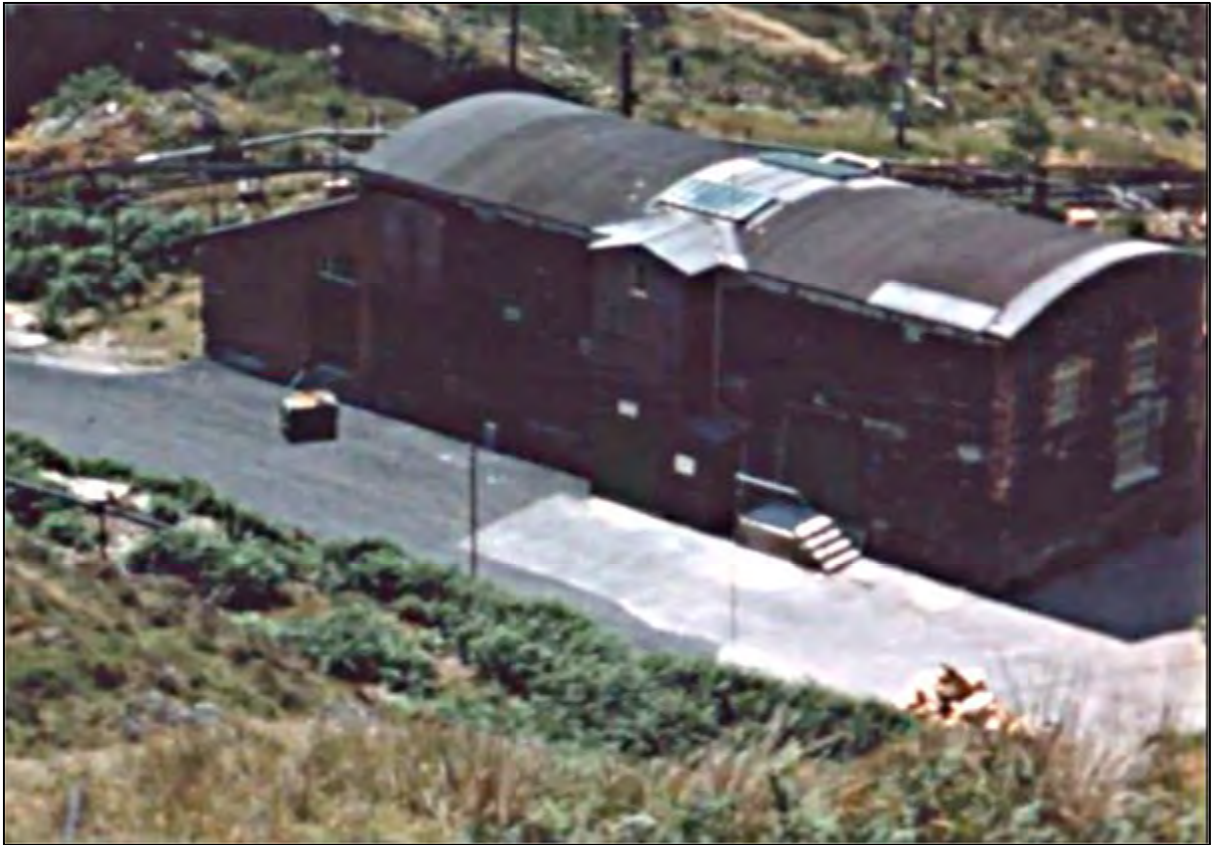
There are a series of iron fittings attached to this elevation. A series of six, iron bars, (Plate 4) each 1.40 m long with an iron ring at each end, were used to hold the roof structure in place. They are retained at their lower ends by iron studs into the stonework and at the upper ends were attached to the woodwork of the roof. There are also a series of metal fittings around the central blocked opening (Plates 5 and 6). There was clearly a major structure attached to the side of the building at this point and a film shot in 1960 shows a two storey bay attached to the building at this point (<http://player.bfi.org.uk/film/watch-cookes-explosives-limited-an-account-of-explosives-manufacture-in-penrhyn-deudraeth-1960/>) (Plate 7).

Plate 7: Screen grab from the 1960 film “Cooke’s Explosives Ltd – an account of explosive manufacture in Penrhyndeudraeth.”

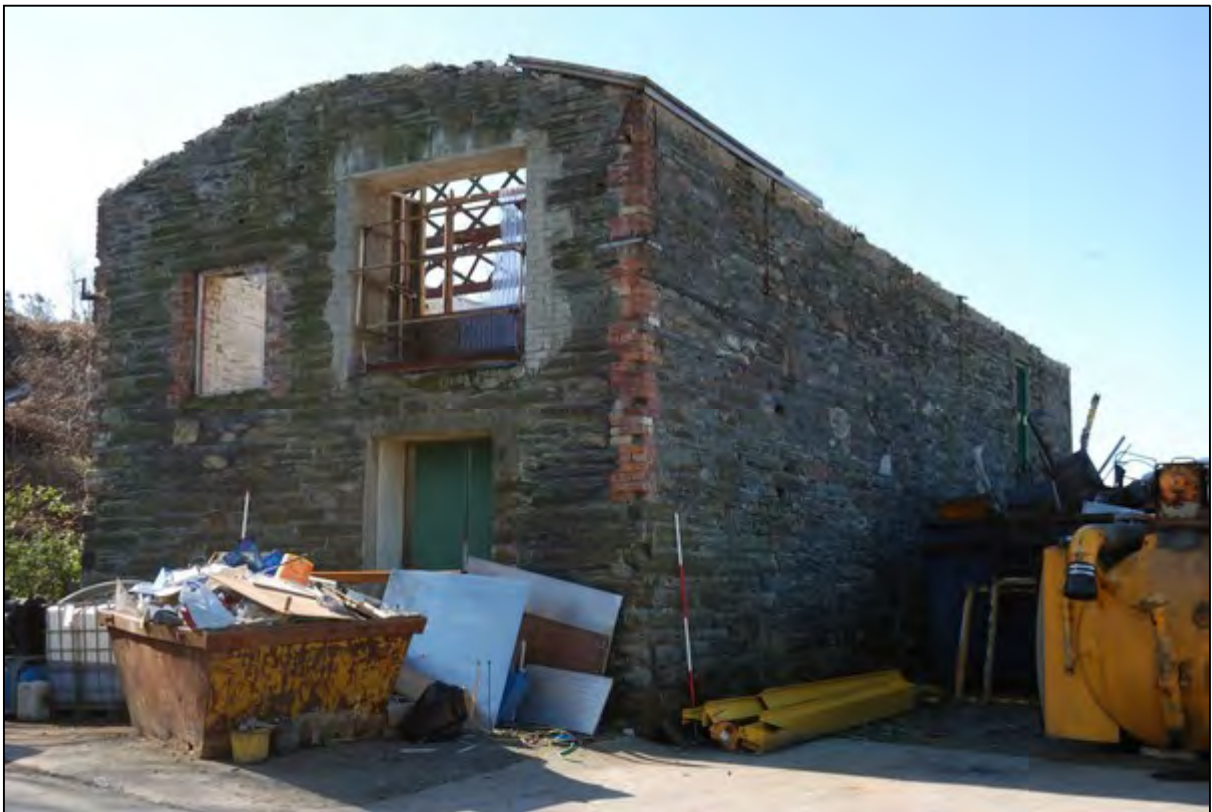
The northern elevation (Figure 5, Plate 8) has three openings, two on the first floor and one on the ground floor, all of which are shown as windows in the 1960 film of the works. Currently, however, the ground floor opening is occupied by double, ledged doors and the larger of the first floor openings has a complex structure of metal tubes and springs which appear to have swung out of the building to act as a luccum (a covered post extending from a building with a winch to allow the loading of materials to a higher floor). Whilst the smaller of the first floor openings and both corners of this elevation have red brick quoins, the larger opening is surrounded by grey, industrial brickwork showing that it has been modified at a late date. The ground floor opening now has a double, ledged, door set back near the inner surface of the wall and the return surfaces are covered in render. Scratched into this render, is the inscription "GR 99". This date is after production had stopped on the site and may be related to works to make this building secure after it had been abandoned. (Plate 9)

It was not possible to record the western elevation in detail, because of the quantity of old vehicles and general junk along this elevation obscured the view. However, only limited features were noted (Plate 8) over the majority of this wall. There are similar iron retaining bars for the roof at regular intervals as on the eastern elevation. At the southern end of the elevation there are two openings: on the ground floor there is a doorway, which is surrounded by grey industrial brick (Plate 10), suggesting that it is a late modification of the building, and a window surrounded with red brick on the first floor.

Plate 8: The northern and western elevations

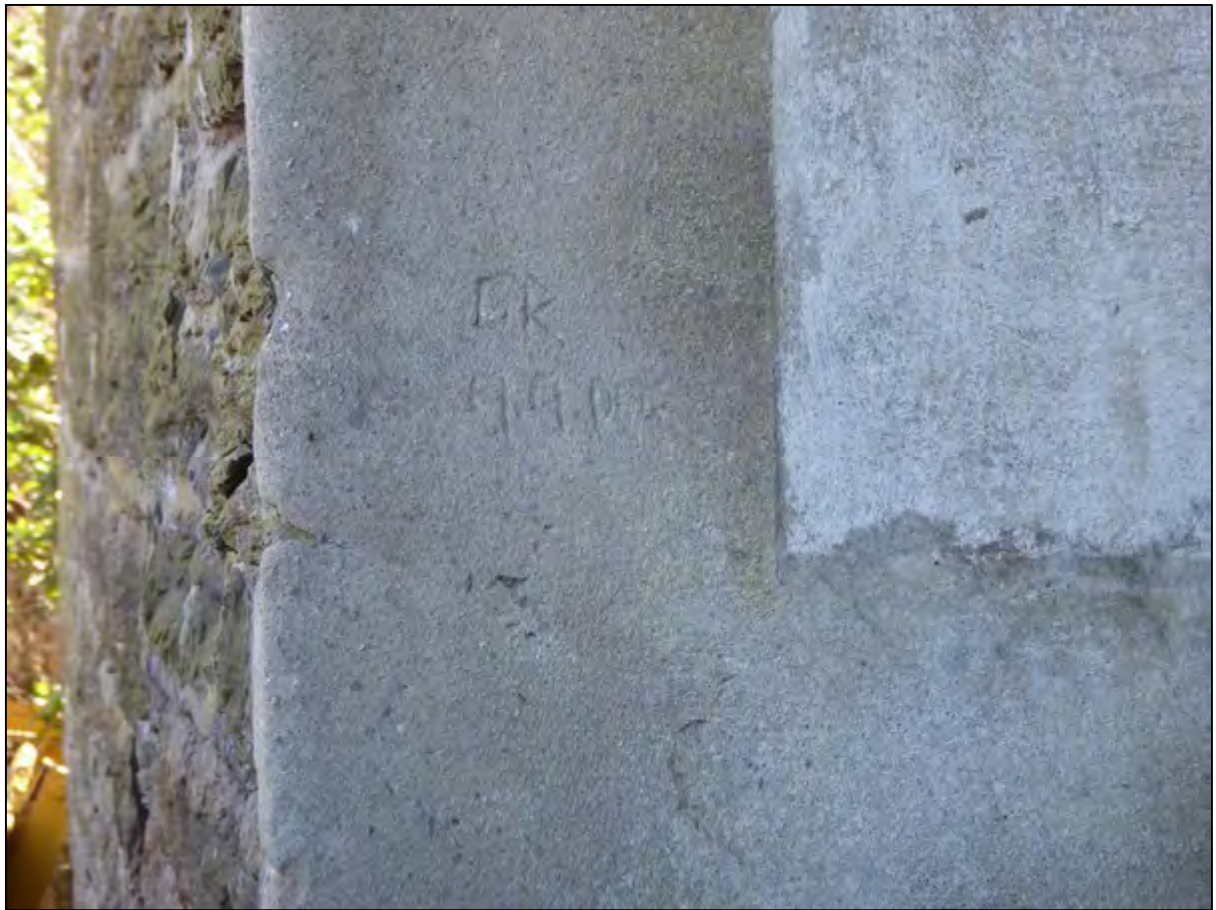
Plate 9: Graffiti scratched into the return of the northern door

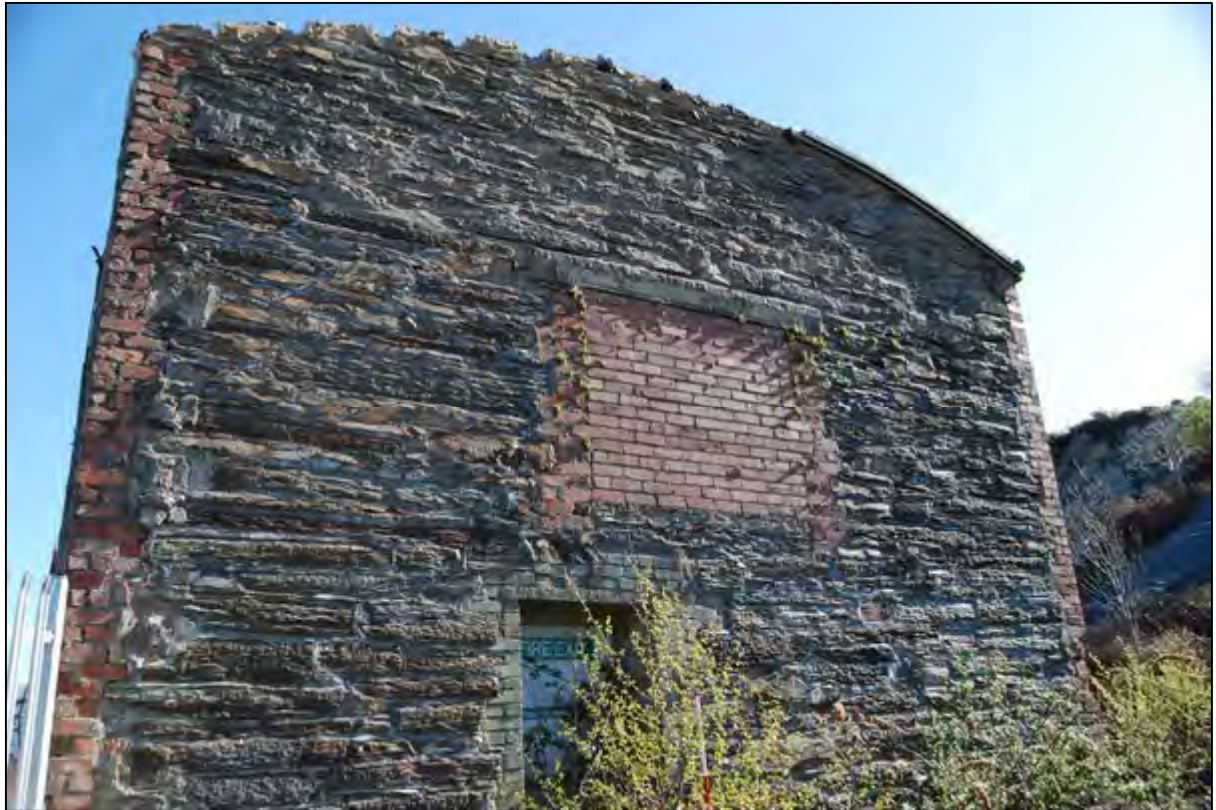
The southern gable (Plate 11) also has two openings, a doorway on the ground floor and a blocked window on the first floor. The doorway is surrounded by grey, industrial bricks suggesting it is a late feature. The blocked window, however is both surrounded by, and blocked with red, machine made bricks. This blocking is probably related to the construction of the lean-to building seen both on the image from the 1960 film and on an aerial photograph taken in 1995 by C. Musson for the Royal Commission on the Ancient and Historical Monument in Wales (<http://www.coflein.gov.uk/en/site/85184/images/COOKE%27S+EXPLOSIVE+WORKS%2C+PENRHYNDEUDRAETH/>)

Plate 11: The southern gable

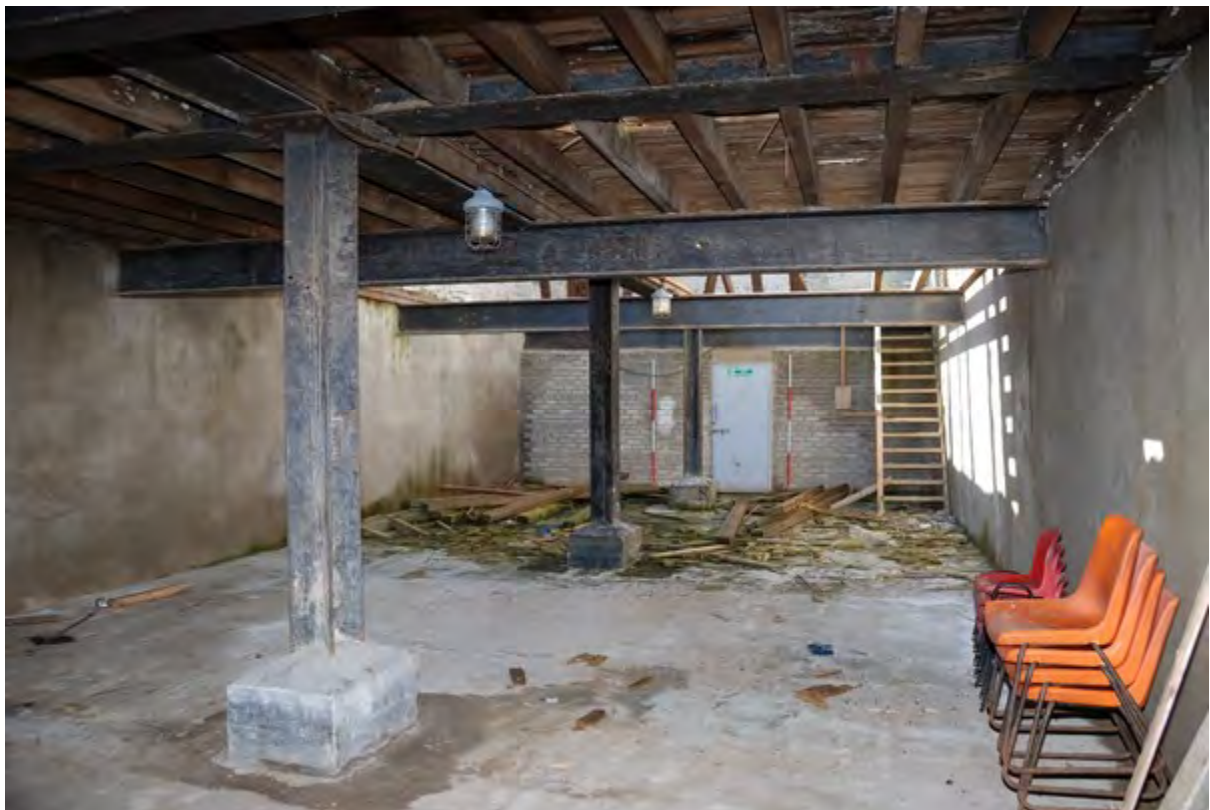
Inside, the ground floor (Figure 2) is divided into two rooms by a wall of grey industrial brick (Plate 12) similar to those around the doors in the western and southern elevations and to the surround of the larger opening in the northern elevation. It has a single centrally placed door. This is a ledged door with a wooden handle and a later iron bolt on its northern side. The southern room consists of a relatively small space, little more than a corridor running across the southern end of the building, which was presumably used as an office.

Plate 12: Ground floor, looking south

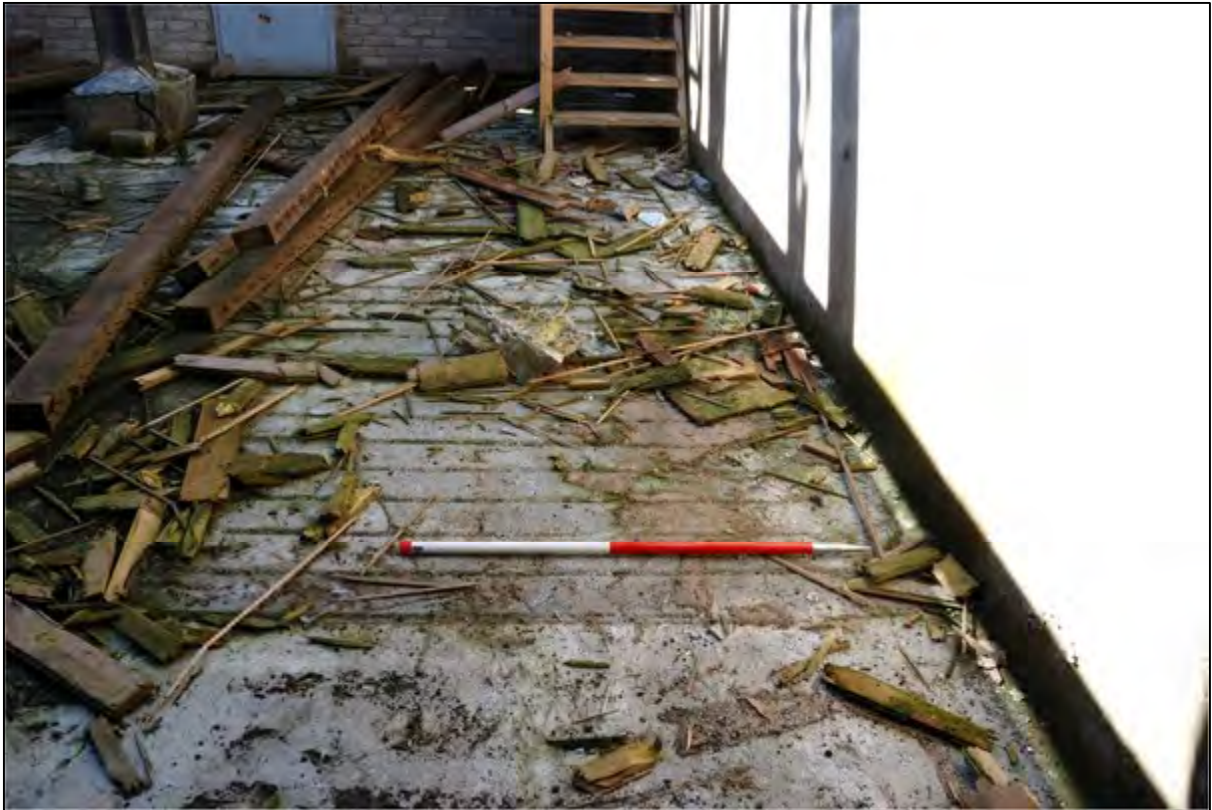
Within the main room there are two staircases to the first floor, one adjacent to the wall dividing the ground floor and the other in the north eastern corner. That in the south western corner of the main room is a simple, straight, flight of wooden steps leading over the southern ground floor room. That in the north eastern corner (Plate 13) is also of wood, but has a quarter turn supported by dwarf brick walls. Adjacent to the turn in the stairs a steel “L” profile post supports the first floor. The rest of the first floor is supported by three “X” profile steel posts set in concrete plinths (Plate 14) and two “T” profiled posts, each partly set in each of the gable walls of the building (Plate 15). These posts support both lateral and transverse beams, each consisting of two “L” profile beams bolted together to form an inverted “T” profile beam. Between the posts the ceiling is also supported by three “I” section rolled steel beams which cross the width of the building. One of these beams is marked “Shelton Steel” with a weld mark (Plate 16). The Shelton Works in Hanley (Stoke of Trent) stopped making steel in 1978 having been formed as the Shelton Bar Iron works in 1841 and installing its first rolling mill in 1850 (<http://www.thepotteries.org/shelton/dates.htm>). The beams in the Belfast store, however are likely to be from the latter part of the production at the Shelton Works. There is some evidence that some at least two of the rolled steel beams were second hand when they were installed as they have a series of holes for fittings which do not appear to relate to the current building (Plate 17). The wooden floor above the steelwork was supported by a series of wooden joist which rest on the steelwork. It is possible that the first floor structure replaced an earlier structure as there is a disturbed area in the floor around the central post (Plate 18). This central post also marks the division between two finishes to the concrete floor of the building with the southern end having a series of parallel ridges whilst the northern half of the floor is smooth (Plate 19).

Plate 19: Differential floor finish between the two ends of the main ground floor room

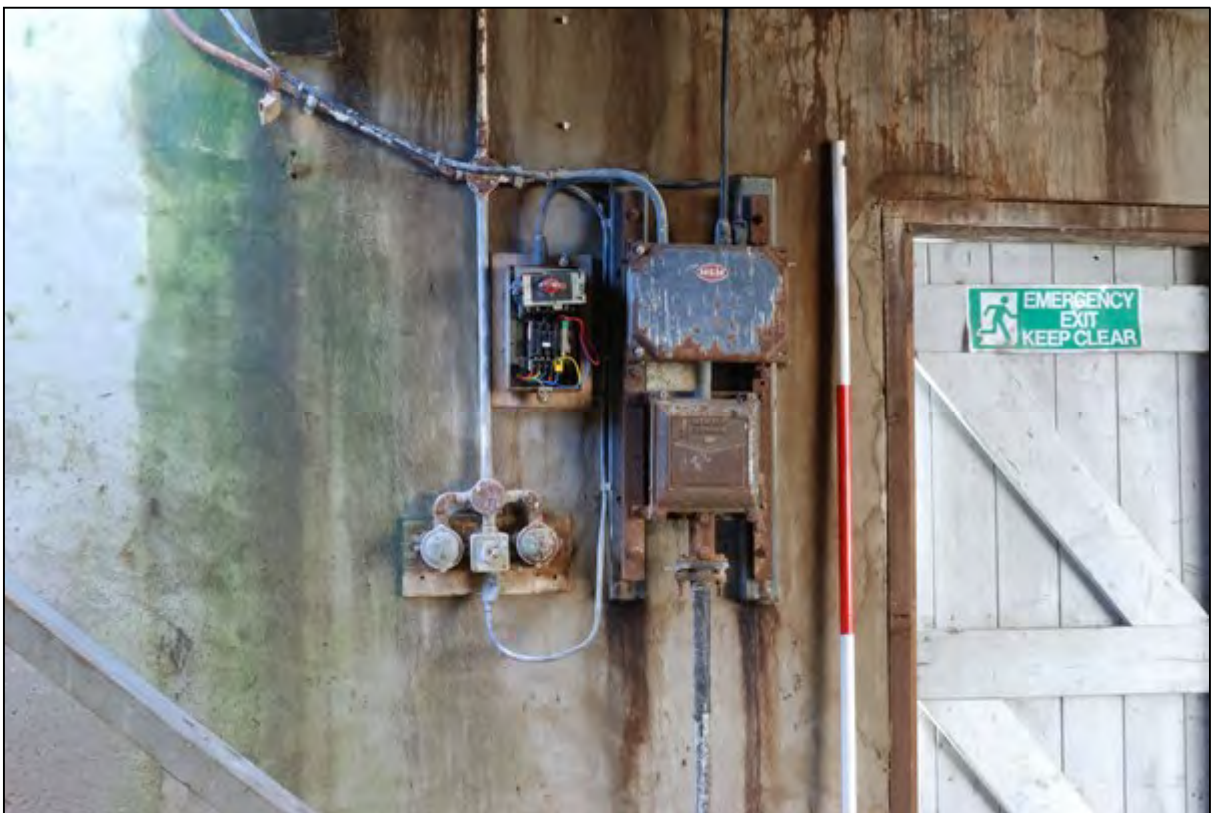
There appears to have been only limited electrical power to the building with the main switches located just inside the main doorway (Plate 20). This appears to have largely been used to power the two lights which hang from the ceiling (Plate 21).

Plate 20: The power supply to the building

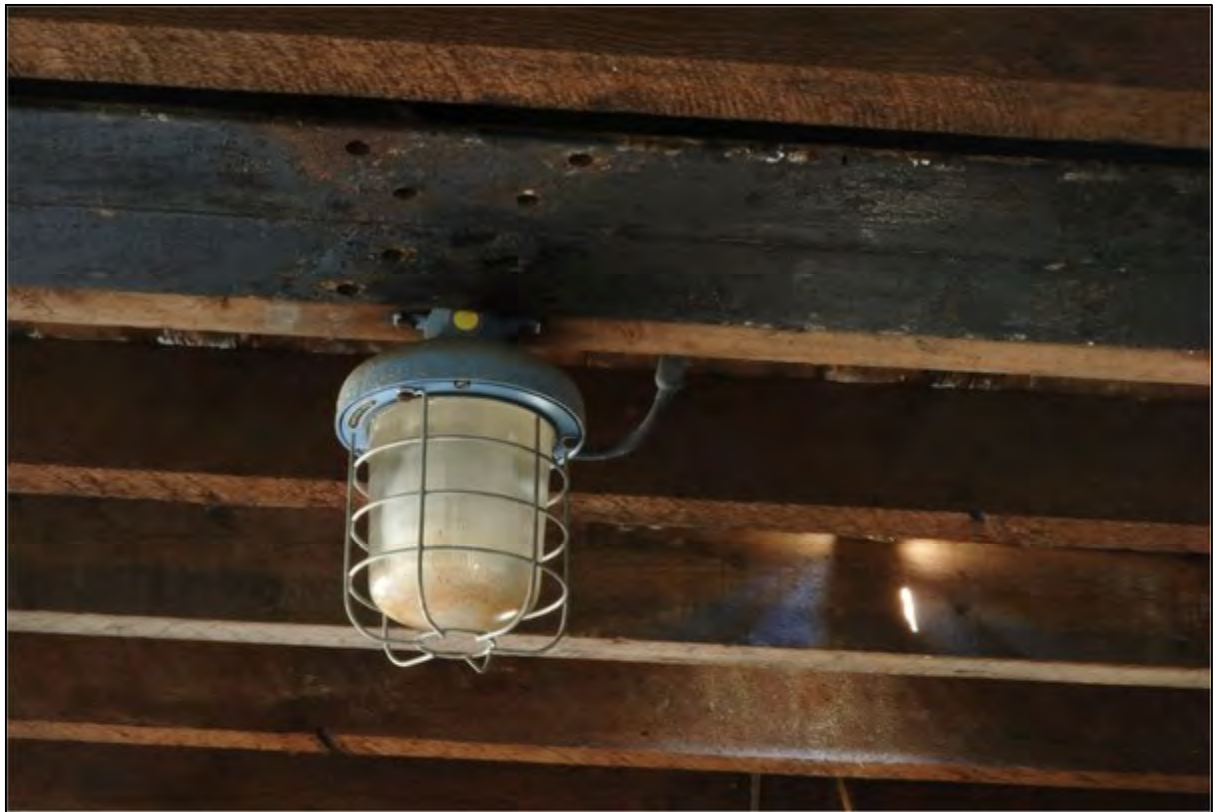
Plate 21: One of the ground floor lights

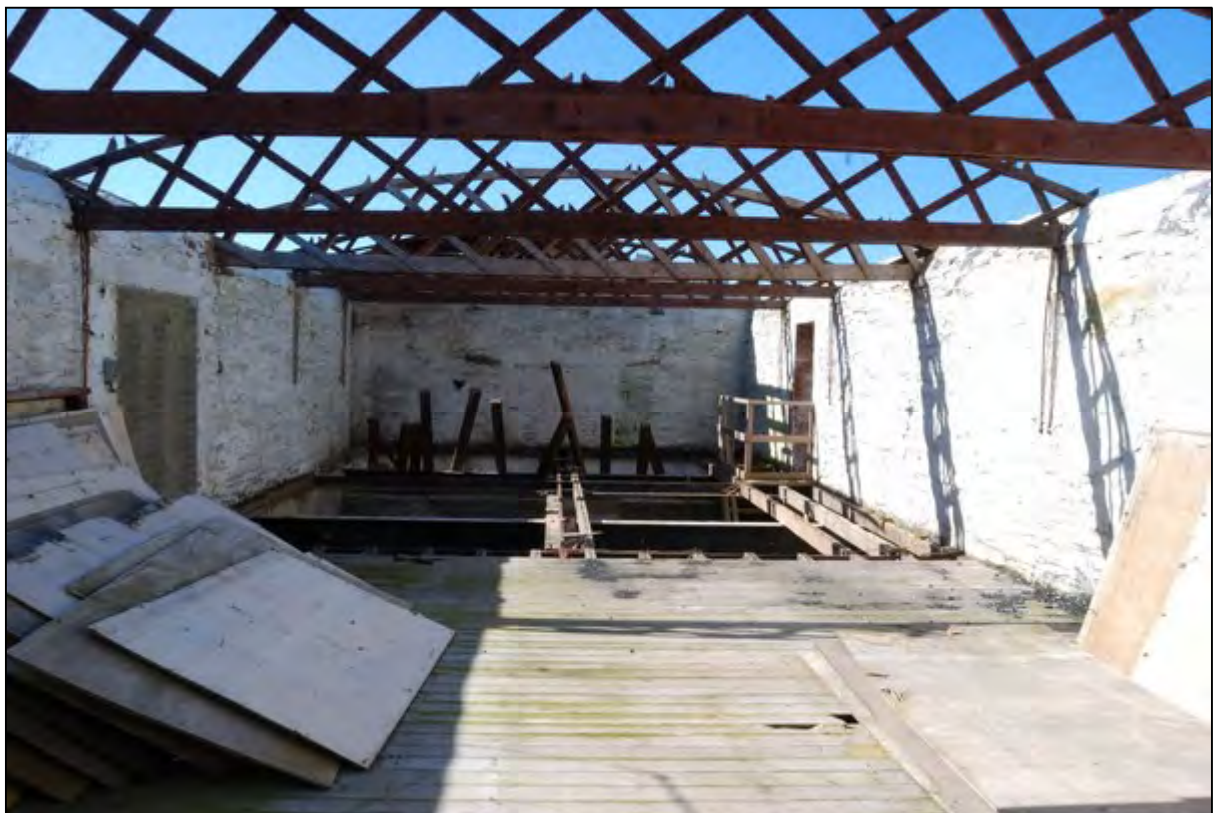
The first floor is a single space (Plate 22), although the wooden floor only survives over part of the structure. This, however, allows the upper side of the floor support structure to be inspected (Plate 23) with the two “L” shaped beams bolted together to form the longitudinal and lateral supports. The larger of the openings in the southern gable contains a structure of iron pipes and springs (Plate 24) which appears to have swung out of the building to provide a means of winching materials into the upper floor. This clearly relates to the last phase of use of the building and is attached to the grey industrial brickwork which surrounds this opening.

Plate 22: The first floor looking south

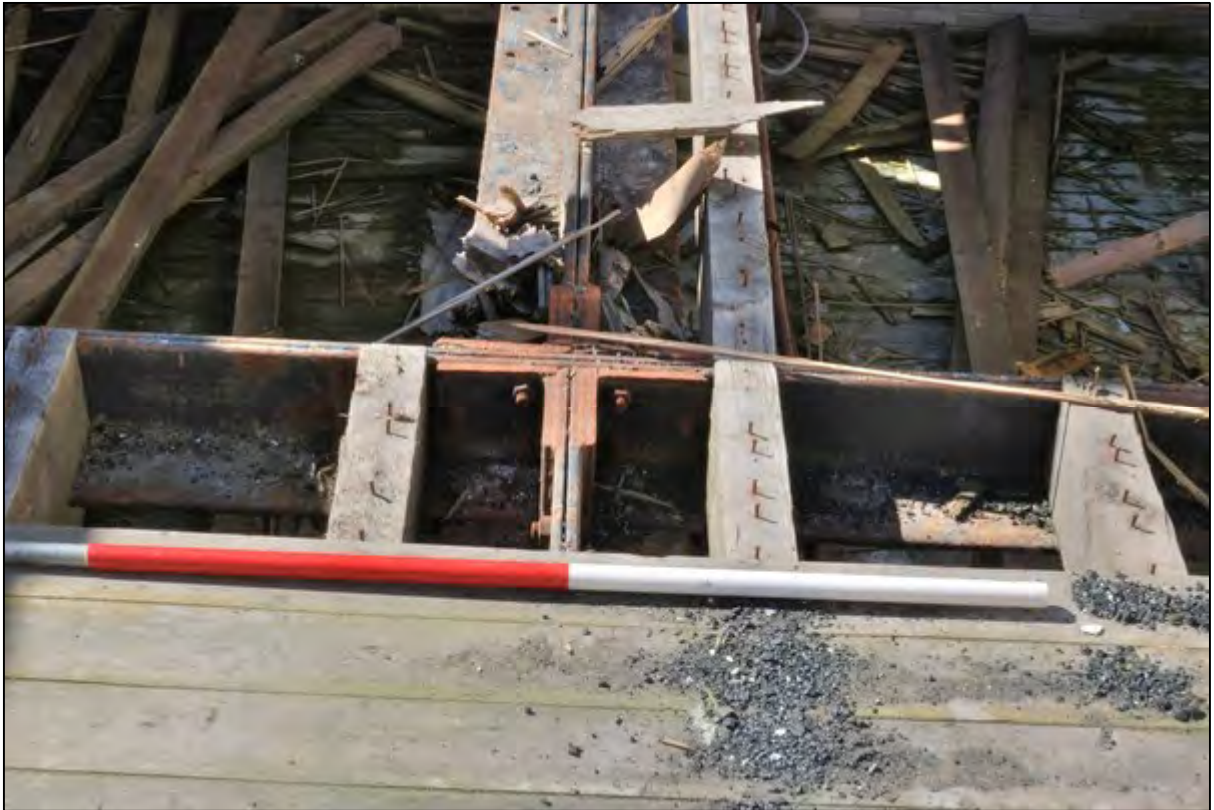
Plate 23: The upper side of the floor supports

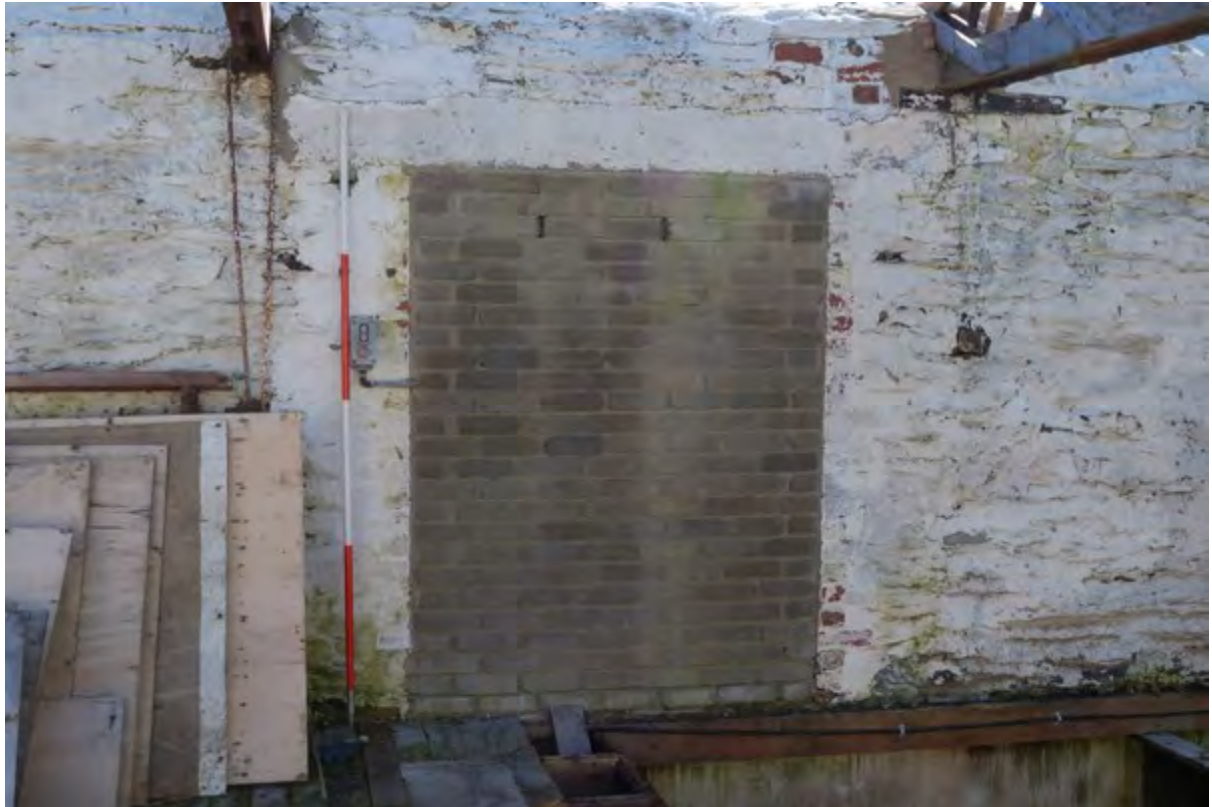
There are two blocked openings on the first floor level. That in the eastern elevation (Plate 25) is blocked with grey industrial brick and appears to be related to the last phase of use of the building, that in the southern gables (Plate 26), however, is clearly from an earlier phase of modification having been whitewashed over the red bricks used for this modification.

Plate 25: Blocked opening in the eastern face

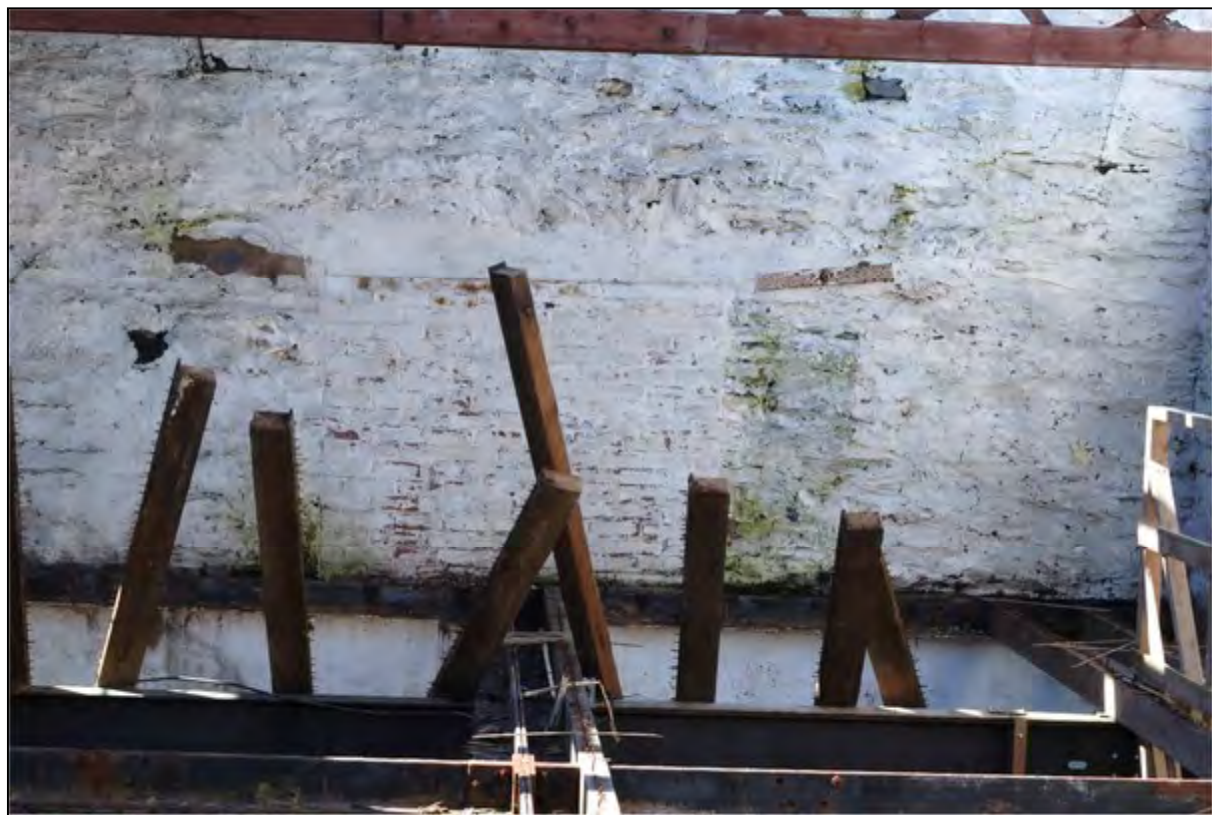
Plate 26: Blocked opening at the southern end of the first floor.

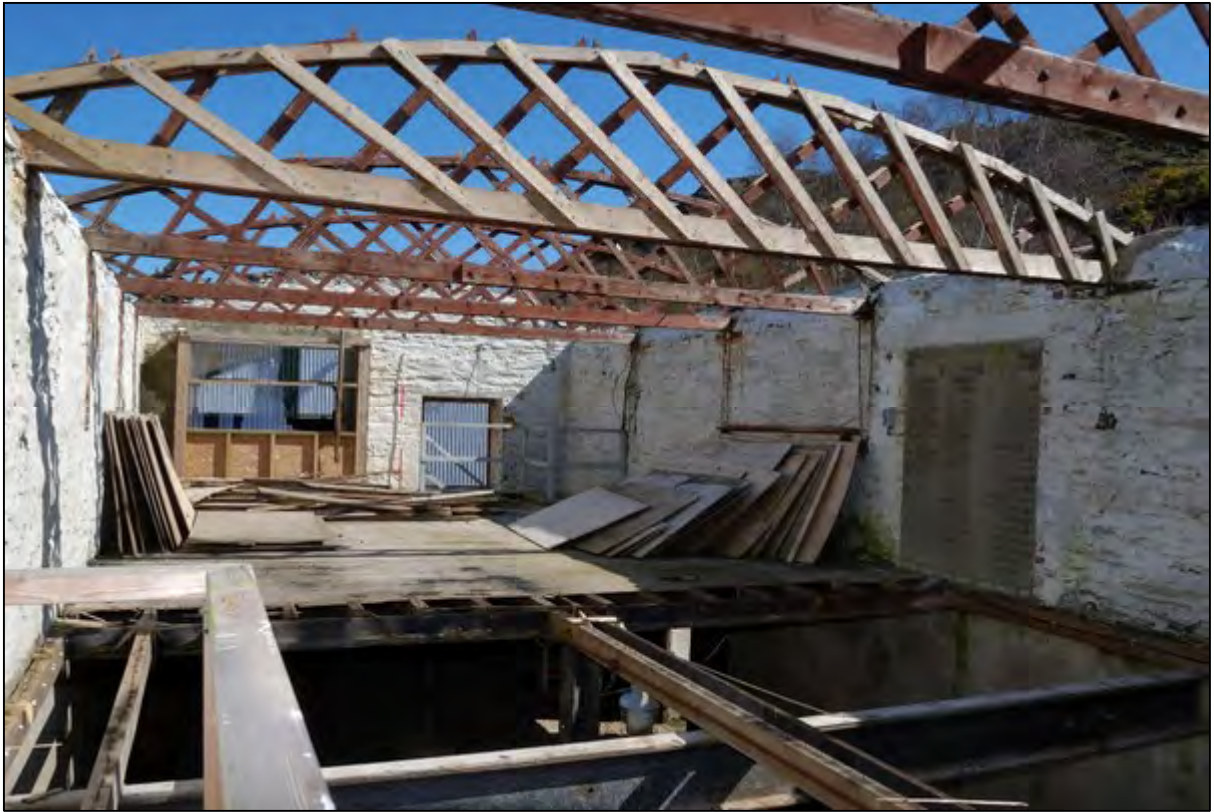
The roof consists of six “Belfast Trusses” (Plate 27) which supported a light structure of boards covered by tar paper. Each of the trusses consists of a pair of tie-beams and segmental

Plate 27: The “Belfast Trusses”

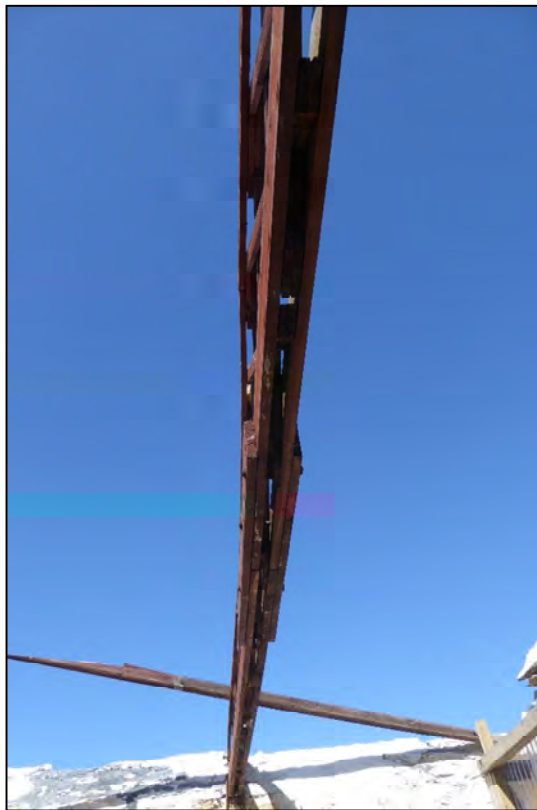
arches (Plate 28) held together by a series of lattice work struts (Figure 6). This structure allowed relatively large spaces to be spanned by trusses constructed by short lengths of timber. A small section of the roof, itself, survives at the southern end of the building (Plate 29) showing the planking with the planks aligned with the curve of the roof and a series of lightweight purlins linking the trusses. The rest of the roof (Plate 30) has blown off and now rests on the hillside to the east of the building. Each of the trusses and the gable ends of the roof structure were held onto the walls by a series of iron straps (Plate 31) similar to those on the outside of the building.

Plate 28: The underside of one of the trusses

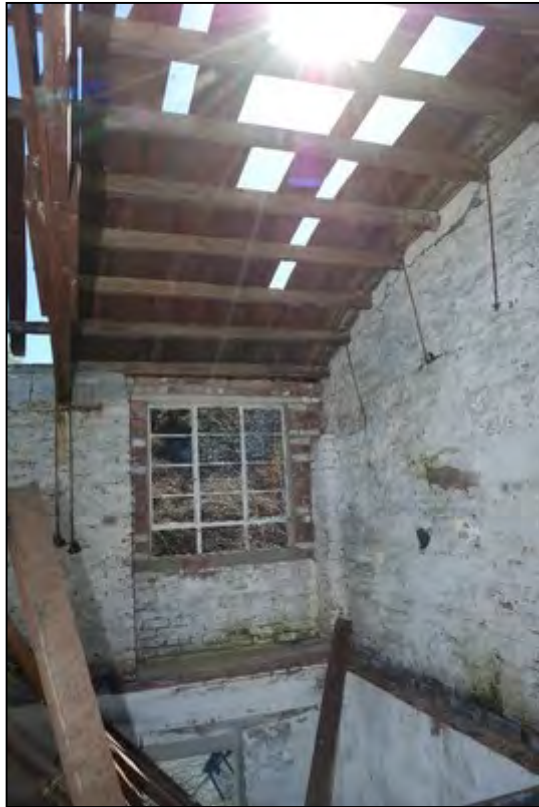
Plate 29: The surviving portion of the roof structure

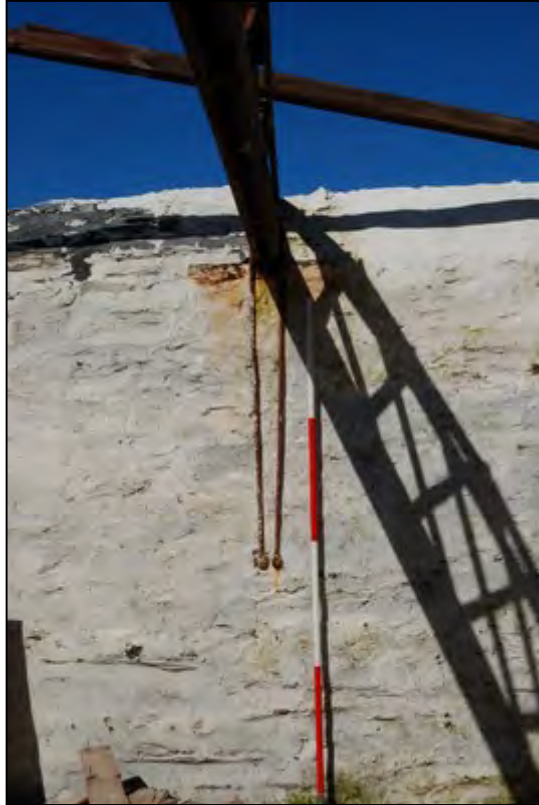
Plate 31: Iron straps holding the roof structure
