**Siop Newydd, Dolgellau  
Standing Building Report**

***EAS Client report 2017/10***

**Siop Newydd, Eldon Square, Dolgellau**  
**Standing Building Report**

**Survey Commissioned**  
**by**  
**Snowdonia National Park Authority**

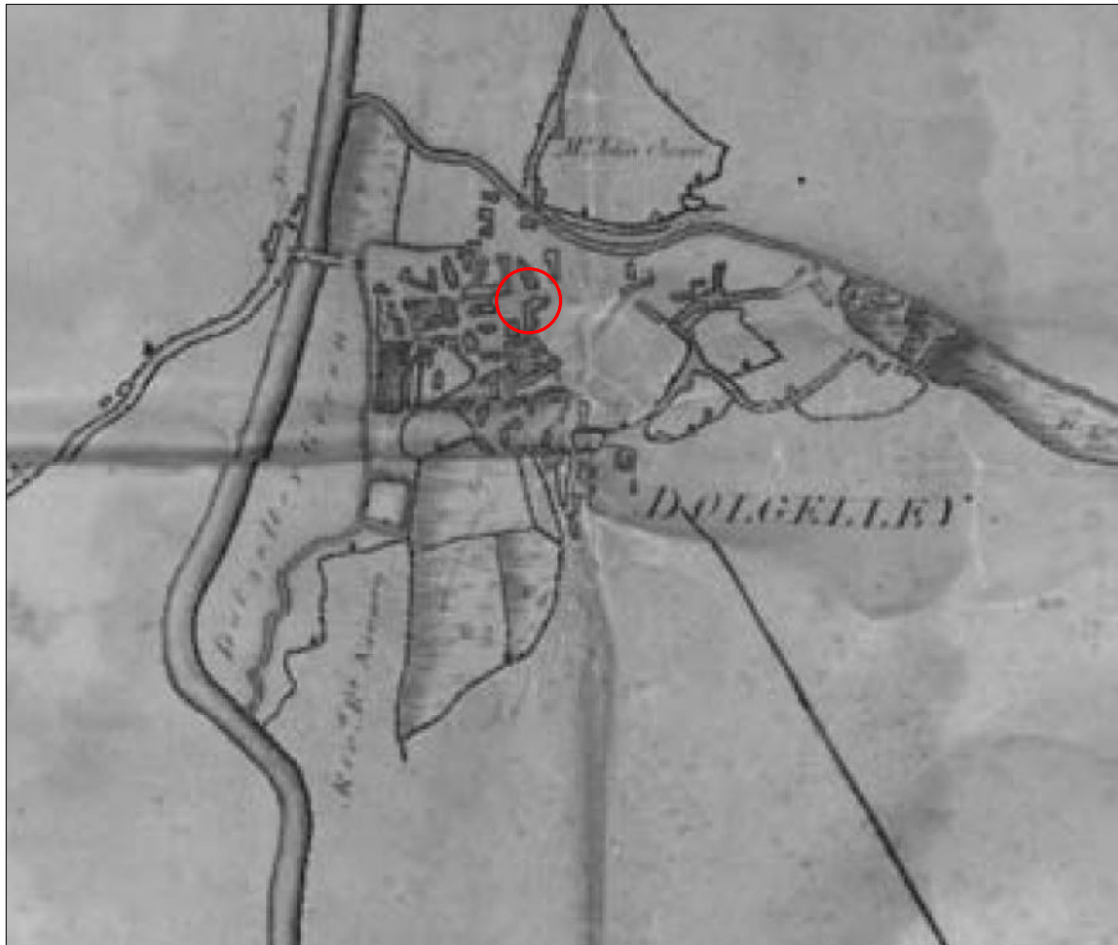
Figure 2: Extract from the 1760 Estate Map  
(National Library MS ESTATE MAPS Map 7425 )  
Not to Scale

The earliest maps located within this study are the 1760 and 1794 estate maps drawn for Griffith ap Howell Vaughan Esq and as part of a survey of the Nannau Estate (Figures 2 and 3). Both of these maps appear to show a remarkably similar layout to the current situation with the yard between what will become Siop Newydd and Plas Newydd already in existence. Although there are some comparisons between the current layout and these maps it would seem likely that the current shop fronting onto Eldon Square may be a replacement of an existing building.

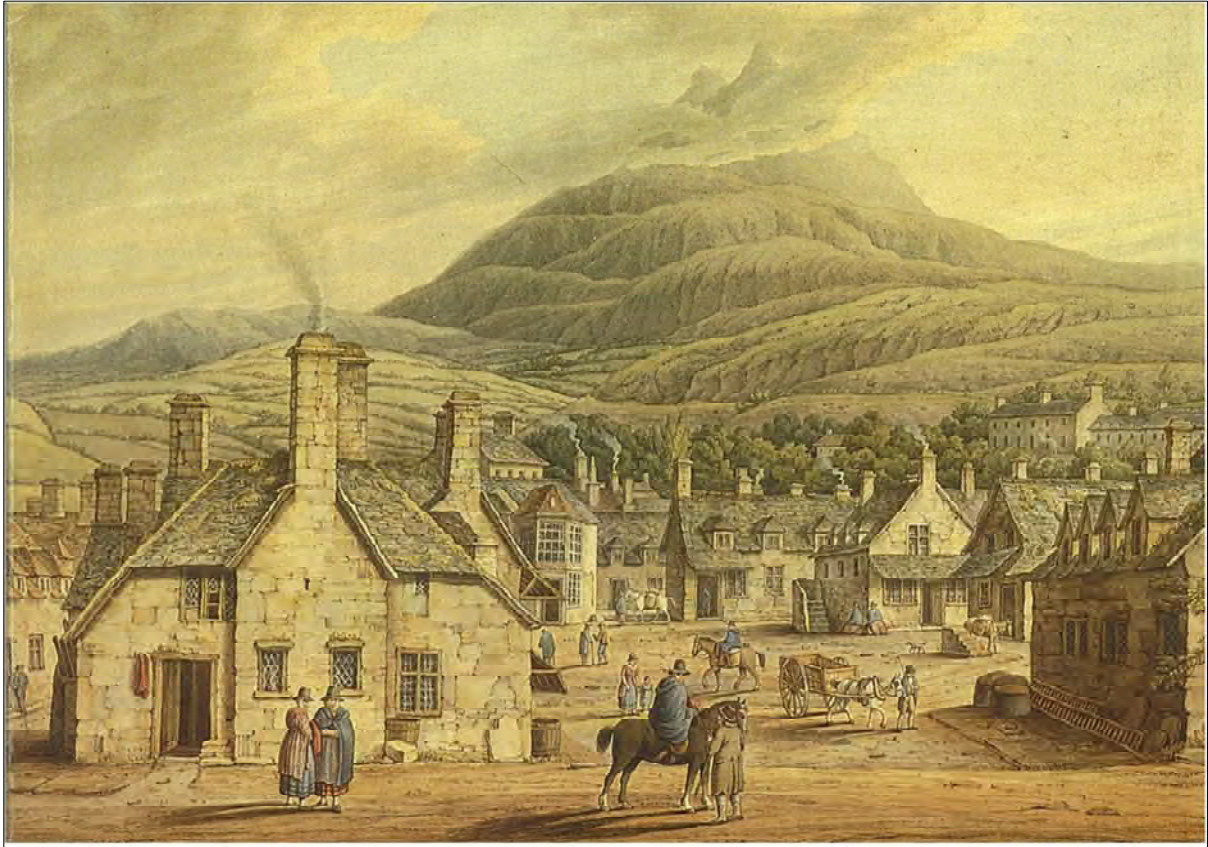
Figure 4: Watercolour by J.J. Dodd c. 1800  
(National Library)

The earliest image is a watercolour by J.J. Dodd, held by the National Library (Figure 4), which shows a one and a half storeyed building occupying the site of Siop Newydd. This presumably is the front range shown on the earlier estates maps and has another range behind it. Also, if taken on face value it would appear that there is a greater space between Plas

Newydd and the building occupying the space of Siop Newydd, however, this may just be artistic licence.

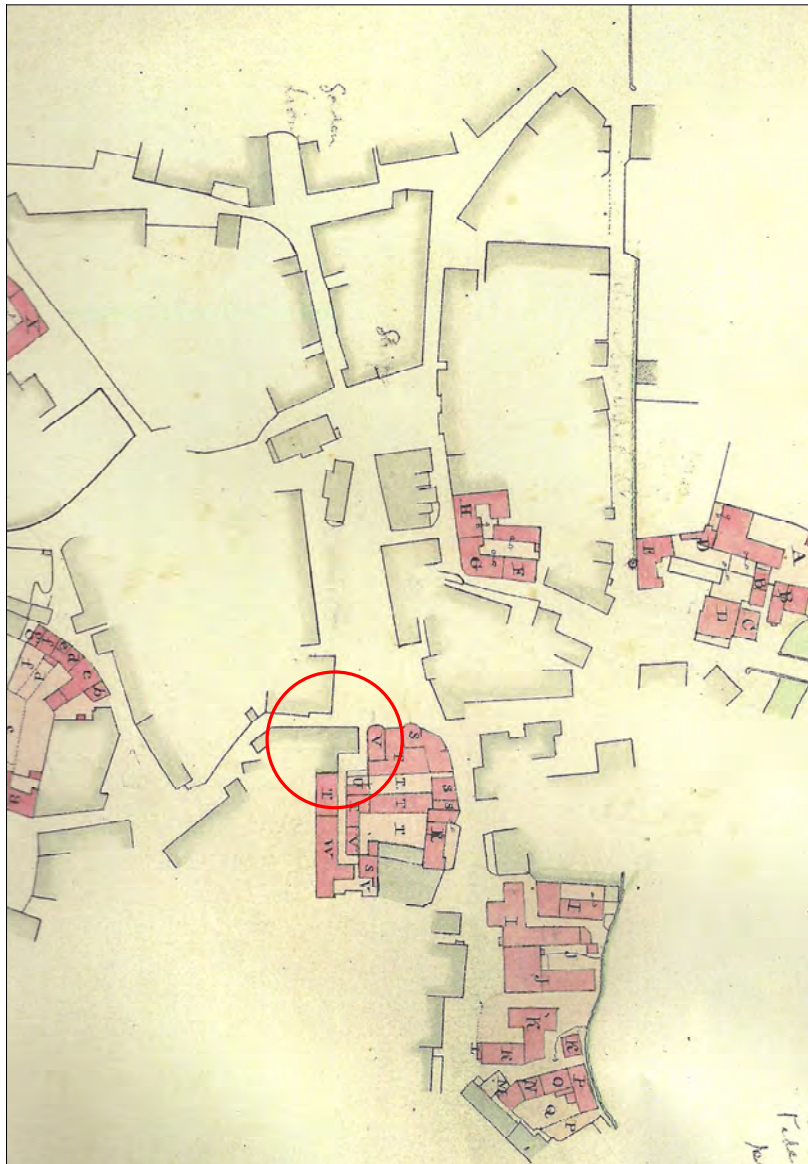
Figure 5: Extract from the 1820 Llwyn Estate Map  
(Merionethshire Archives ZM/86)  
Not to Scale

The 1820 plan from the Llwyn Estate (Figure 5) shows the “New Shop” is not part of the estate, but the property immediately to the south, and attached, is part of the estate. Once again it is not certain whether this represent the current building or an older building on a similar footprint. However, an engraving of Eldon Square from 1820 (Figure 6) possibly shows the construction of Siop Newydd underway.

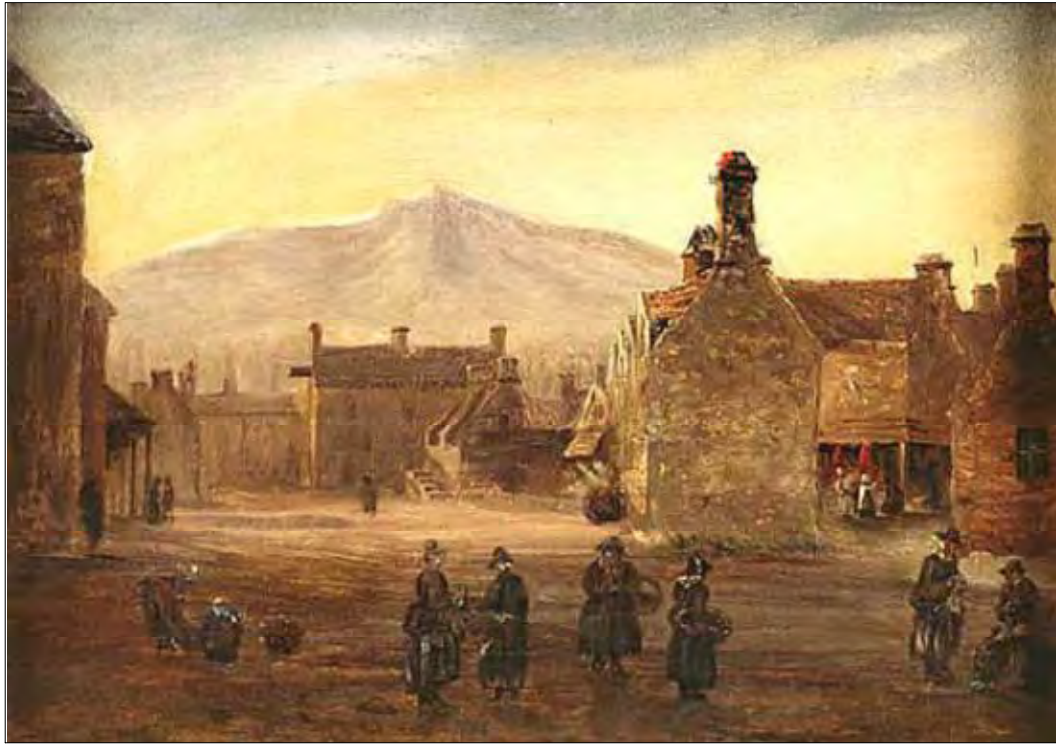
Figure 7: Painting by William Hughes c.1837

The painting by William Hughes from c. 1837 (Figure 7) shows a building of the right sort of size and shape to have been the current shop, however the accuracy of this painting can be questioned as it omits the adjacent Plas Newydd, which was certainly standing in 1837, suggesting there is some artistic licence with this painting.

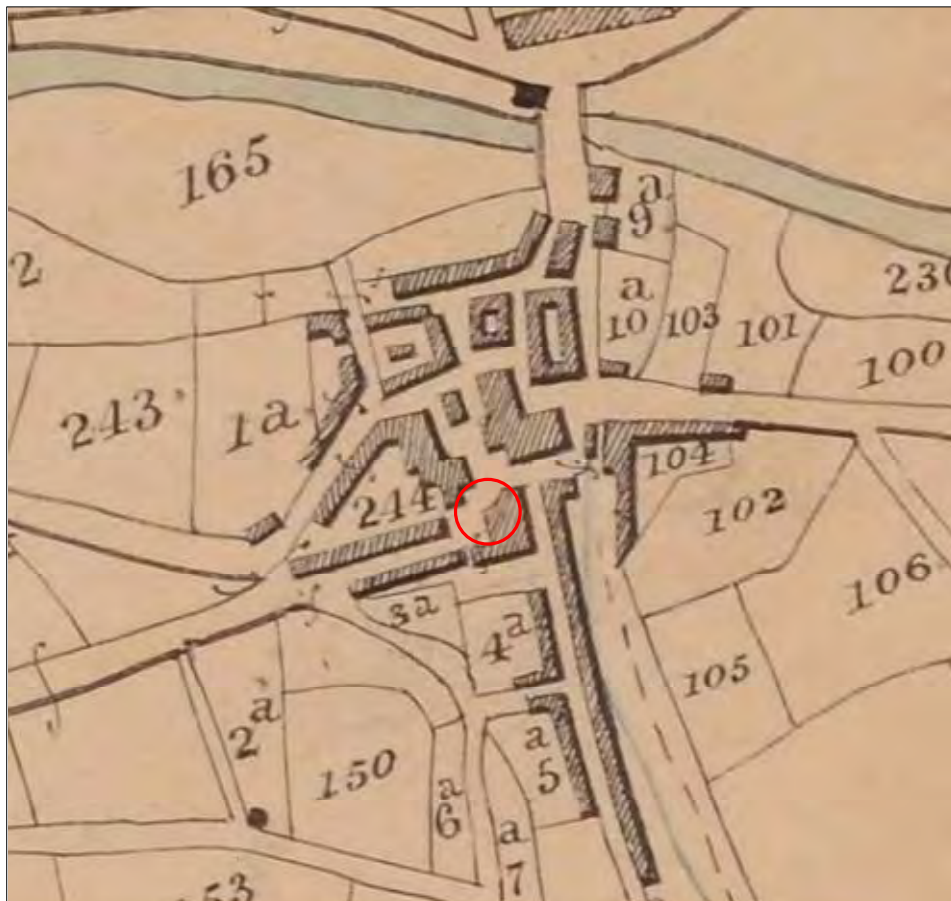
Figure 8: 1841 Tithe Map  
Source <http://cynefin.archiveswales.org.uk/en/tithe-maps/>  
Not to Scale

The Tithe map of 1841 (Figure 8), whilst giving an outline map, gives no detail of the ownership. It is also curious that the Tithe Map does not appear to show a layout similar to the earlier mapping, however, given that the town centre was outside the Tithe system and therefore was not important as a record of who was responsible for paying the tithe the lack of accuracy is understandable.

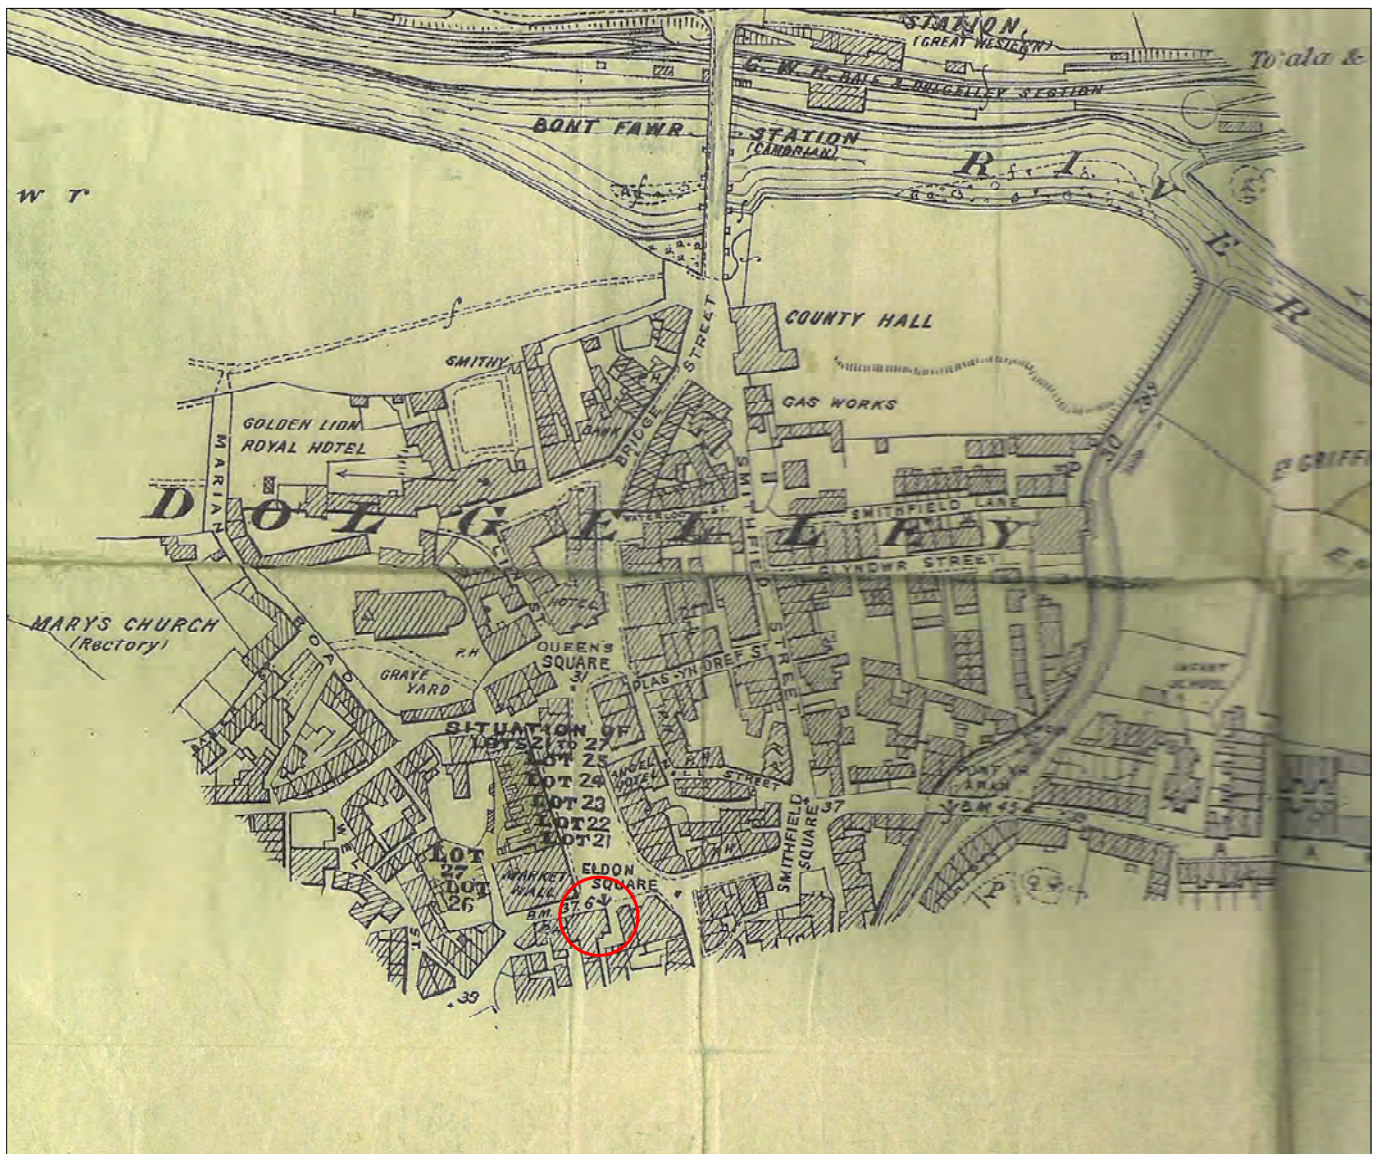
Figure 14: 1901 Sales Catalog  
 (Merioneth Archives ZDCE/9)  
 Not to scale

A plan drawn in 1890 (Figure 13) does not show any great detail of the form of Siop Newydd, but does show the lane/yard to the east. The sales catalogue map of 1901 (Figure 14) is clearly based on the Ordnance Survey 1:2500 map of the area (Merionethshire XXXVII.3, Figure 15) both of which show a layout essentially the same as that which exists today. Both maps show the presence of a bench mark on the north-eastern corner of Siop Newydd which no longer survives.

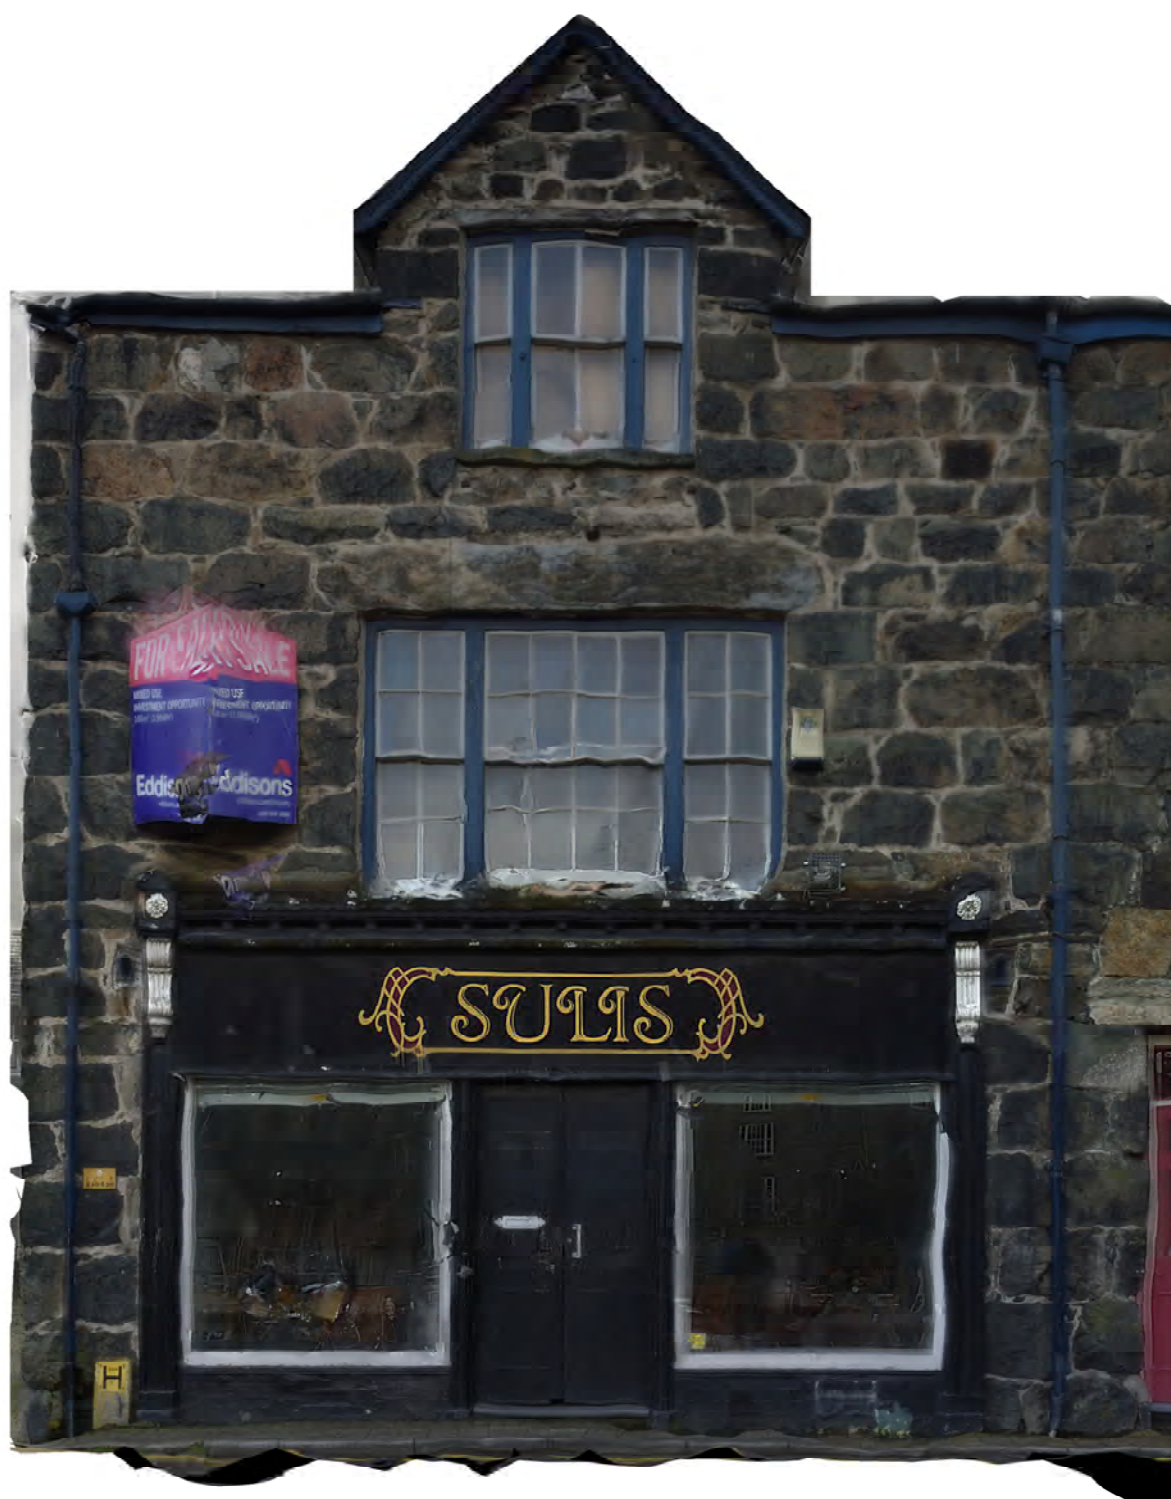
Figure 17: Front Elevation  
Scale 1:50

Constructed of coursed, roughly shaped stone block, the range fronting onto Eldon Square is a two and a half storeyed range with a gabled dormer containing the upper window (Plate 1, Figure 17). The ground floor is dominated by the large shop window which runs either side of the central door. Although now dominated by the “Sulis” shop sign it retains decorative elements which probably relate to its nineteenth century format. On either side of the shop window the opening is defined by sunk panelled pilasters surmounted by reeded consoles and pedimented caps decorated with Tudor rose decorations (Plates 2 and 3). The blind box between the two caps is further decorated with a scallop design. The centrally placed doorway now contains a modern double opening which hides a glass panelled door set at the rear to a short internal porch. Either side of the ground floor window there are the sockets for flag supports and metal pins mounted in the stones of the façade which presumably originally supported signs.

At first floor level there is a tripartite sash window with a central sixteen-paned sash flanked by two, eight-paned sashes. This is below a massive stone lintel formed of a single block 3.3 m long. Above this an eight-paned, tripartite sash window, with a four-paned central window flanked by two-paned side lights. located only partly above the eaves, but within a gabled dormer. The cill level of this window has been raised by about 0.5 m and it is possible that the window head was at just below the eaves level, possibly suggesting that the dormer was added to a pre-existing structure. The roof of this range is difficult to see from ground level; however, it appears to be covered in regular slates with a ceramic ridge tiling, a pattern which is also reflected on the dormer.

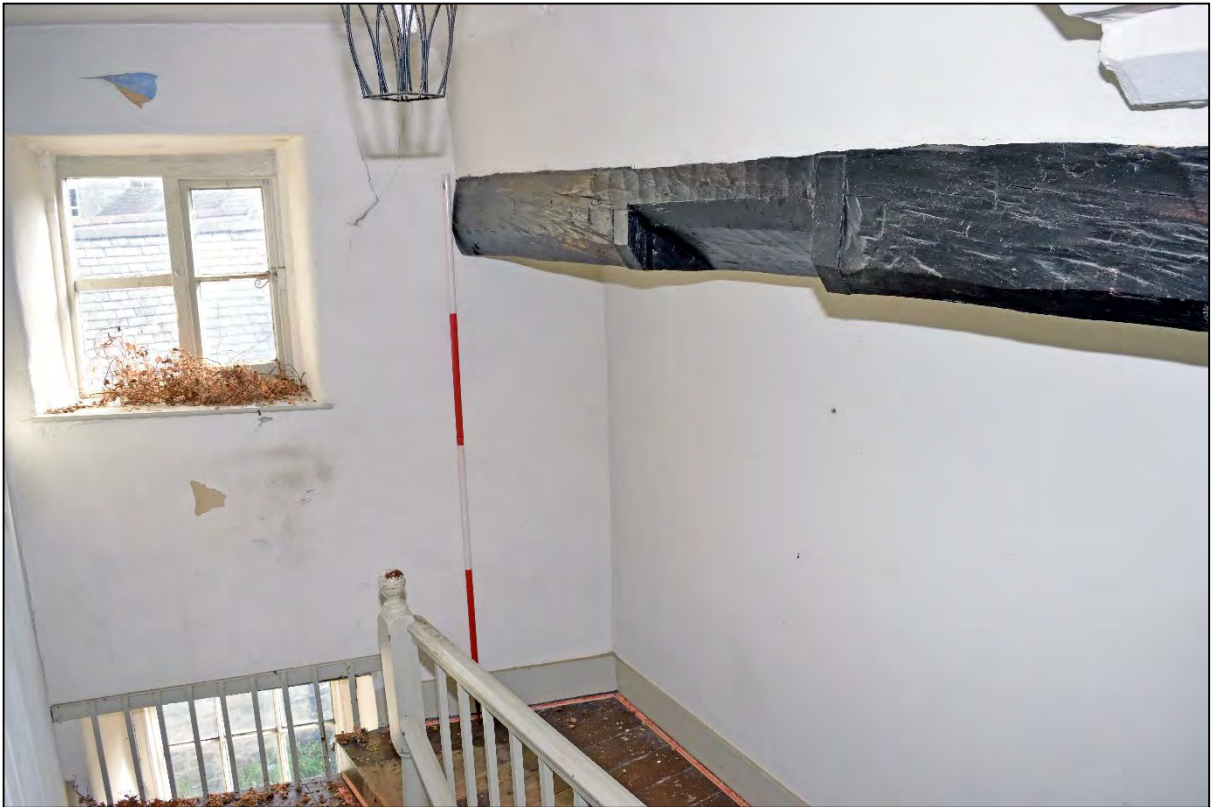
Plate 55: Beam over the stairwell

Over the stairwell there is a large wooden beam (Plate 55), probably of oak, which has is moderately chamfered and has a straight cut stop at its eastern end. There is also the socket for a joint on the lower surface of the beam which has two blocks infilling either end of the joint. The size of this timber is much larger than anything else recorded in the building and seems too large to be contemporary with the general style of building observed.

The date of construction of the rear range is uncertain. Although the windows and other surviving fittings are of nineteenth century type, the presence of the large timber over the stairwell and the alignment of the exposed timberwork in Rooms 2 and 9 hints at possible earlier phases of construction. Also, the timber beam in the cellar under the front range is chamfered and stopped suggesting it was re-used from a ceiling, possibly from the building which was replaced by the current building. Beams of this type are not uncommon in the sixteenth and seventeenth centuries and similar timberwork has been recorded from Plas Newydd, next door, which have been dated to late sixteen or early seventeenth century (Longley, 2012, 5).
