27 Castle Street, Criccieth, Archaeological Watching Brief Commissioned by Erik Kruzel, eka architects

27 Castle Street, Criccieth Archaeological Watching Brief

EAS Client report 2017/12

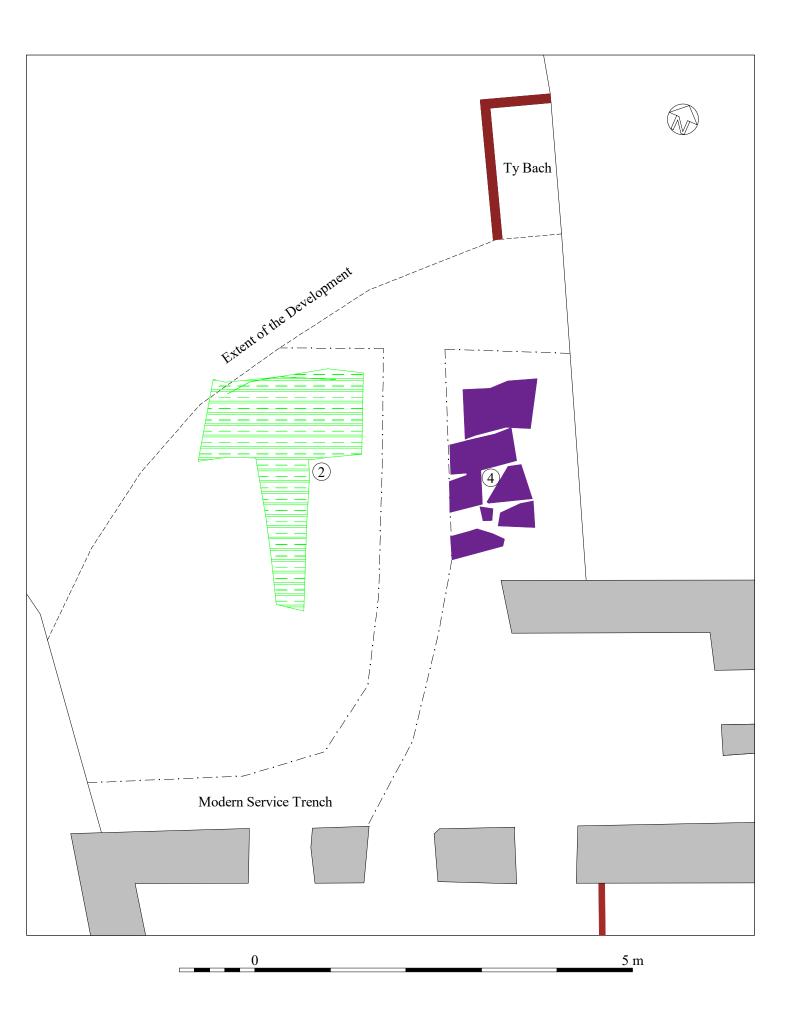
Figure 3: Location of the Archaeological Features Scale 1:50

The garden behind the revetting wall had clearly been built up. The excavation proved this assumption to have been true with the soil of the garden (Context 1) consisting of a mixed, mid grey brown sandy loam up to 600 mm thick with tips of coal ash and sea shells (largely cockles). This layer sealed a "T" shaped feature of rammed yellow clay (Plate 3, Figure 3) which was recorded as Context 2. This would appear to be the rammed clay footings to a building previously occupying the site. The clay used for these footings was locally derived, indeed the natural subsoil within the garden is identical to that used for the footings. The leg of the feature running along the line of the garden is much thinner (up to 0.7 m wide) and probably marks the line of an internal division, whilst the thicker, transverse leg is up to 1.1 m wide and probably represent the rear wall of the building. Neither of the legs of this feature was recorded as being more than 50 mm thick, possibly suggesting an early phase of levelling in the garden. Unfortunately, it was not possible to date this feature as no associated artefacts were found, however the layout would suggest that it pre-dates the current house which is assumed to be 18th century.

Context 2 was cut into a mixed, orange brown, sandy clay with patches of mid brown sandy silt (Context 3) which, in turn, lay over the natural yellow clay which underlies this part of Criccieth. No archaeological features were recorded cutting into this natural layer.

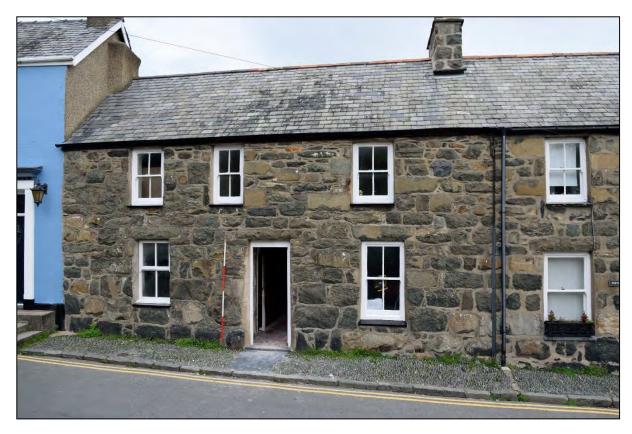
Plate 1: 27 Castle Street, Criccieth

The area of the new patio was part of the rear garden of 27 Castle Street, it was separated from the concrete surface immediately behind the house (Figure 2) by a low, boulder built wall which also partly revetted the side of the garden path running towards the "Ty Bach" and beyond (Plate 1). Attached the rear elevation of the house is a stone built, lean-too, extension, the south-western gable of which had already been demolished ready to be extended (Plate 2).

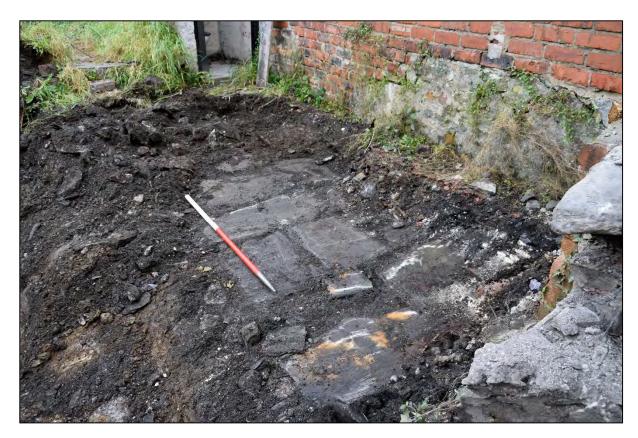
Plate 5: Slate path (Context 4)

Along the eastern side of the development area, a slate slab path was recorded (Context 4, Plate 5). This consisted of slate slabs up to 500 x 600 mm in size leading towards the "Ty Bach" in the garden. The level of this feature, however would suggest it was leading to an earlier structure as it was approximately 300 mm below the floor of the current structure. There was some evidence that the path had been replaced with a brick path at some point as there were a few hand-made bricks, each 220 x 120 x 60 mm in size, sitting on the slate slabs. It is highly unlikely that Contexts 2 and 4 are contemporary, although the stratigraphic relationship between these two features is uncertain.

The slate path (Context 4) is unlikely to have been contemporary with the rammed clay footings (Context 2). It probably represents a garden path to the assumed predecessor to the current "Ty Bach" or a longer path running along the eastern side of the plot.

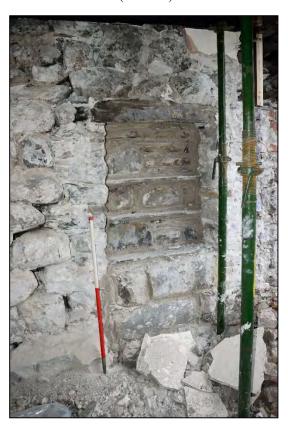
Plate 8: Blocked doorway in the rear elevation (external)

It is apparent that the house was originally a series of smaller units within the terrace, 27 itself starting life as two dwellings. What is now the western window in the front elevation (Figure 4, Plate 6) was originally a door and there is also a blocked window on the western edge of the front elevation. This has also been partly covered by the building of Hen Fecws y Castel (Old Castle Bakery) over the western gable of 27 Castle Street. A similar pattern can be seen in the rear elevation of the house. The current front door is matched by a blocked opening at the northern end of the passage (Plates 7 and 8). This has a slightly curved wooden lintel on the inside and has been used as an alcove with shelves in the extension (Plate 8). Above this blocked door, there is also a blocked window at first floor level (Plate 9).

The date of the construction of the stone-built extension on the rear of the building is uncertain, however it may be contemporary the major re-organisation of the building in that it used the blocked doorway as a shelving unit.

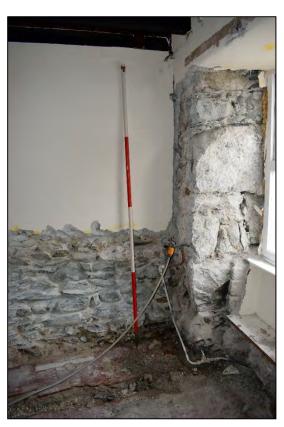
Plate 10: Junction between the front and dividing walls

The position of the original division between the two, original houses is not entirely clear. The current dividing stone, wall, defining the western side of the passage, now containing the stairs, appears to have a straight joint with the front wall (Plate 10) of the building. There also appears to be a possible socket in the rear wall between the dividing wall and the blocked doorway which might suggest that the original division was slightly to the east and was moved when the two houses were combined. This possible movement would have allowed for the stairs to be inserted into the passage.
