**Porth Mawr, Caernarfon
Archaeological Excavation**

EAS Client report 2017/12

Cadw

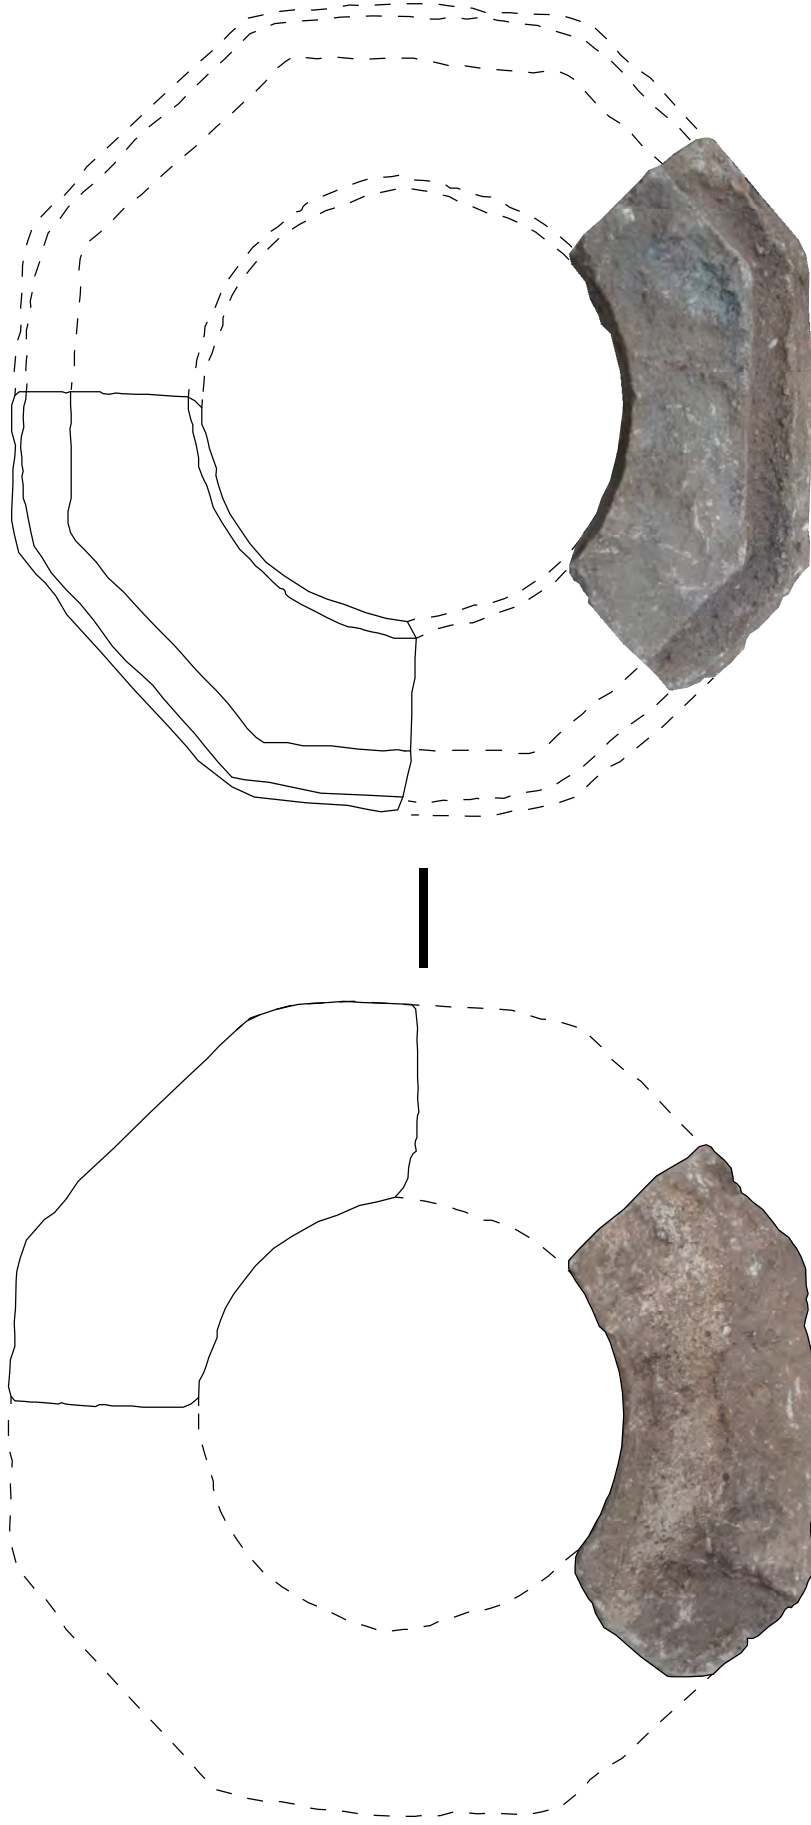
Figure 2: Chimney Cap

Brick
 Mortar
 Coal dust

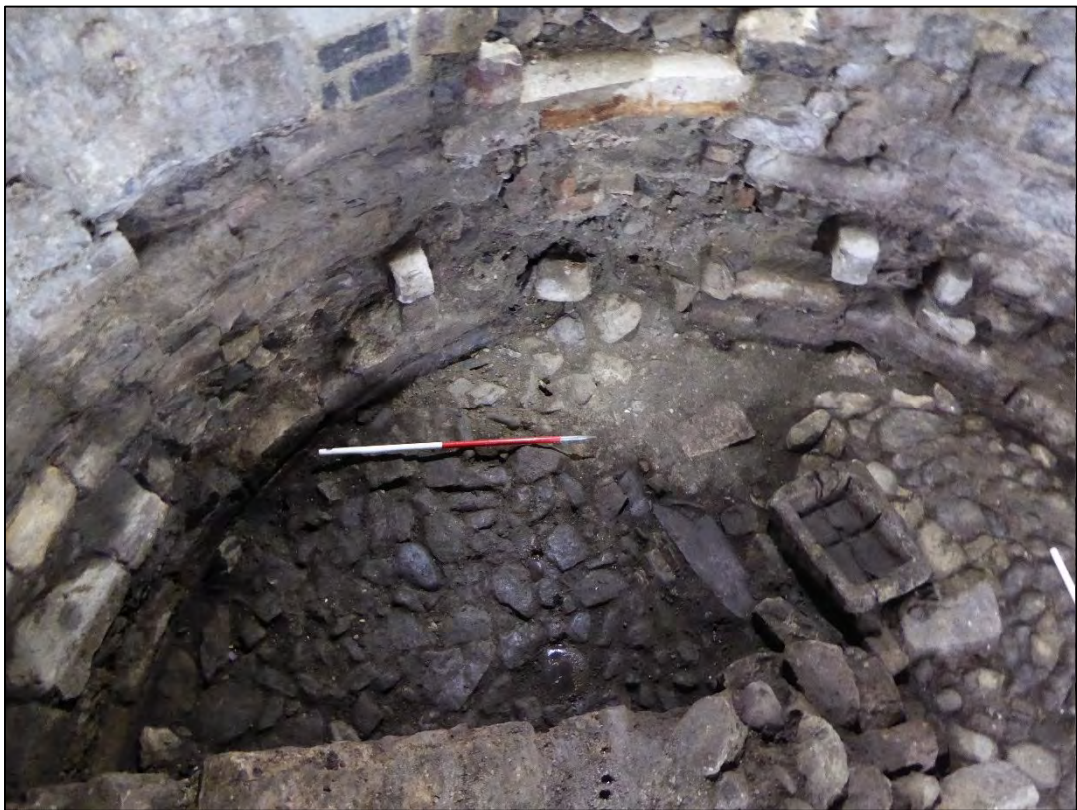
Plate 2: Modern disturbance below the window (Contexts 56 and 57)

Context 57 is a cut feature associated with the repair and conservation of the arrow slot in the eastern end of the Northern Gatehouse (Plate 2). This feature is at least 2 m deep and extends beneath the embrasure of the window and is presumably related to the repairs to the arrow slot and embrasure above. The fill (Context 56) is a very loosely packed dump of modern material including machine-made bricks, angular and sub-angular stone blocks (of a variety of lithologies) and crushed and fragmented mortar and concrete. The fill also included sweet wrappers and drinks cans appearing to date from the 1980's. This feature can be related to Context 29 within the previous assessment (Brooks and Gwyn 2017, 19).

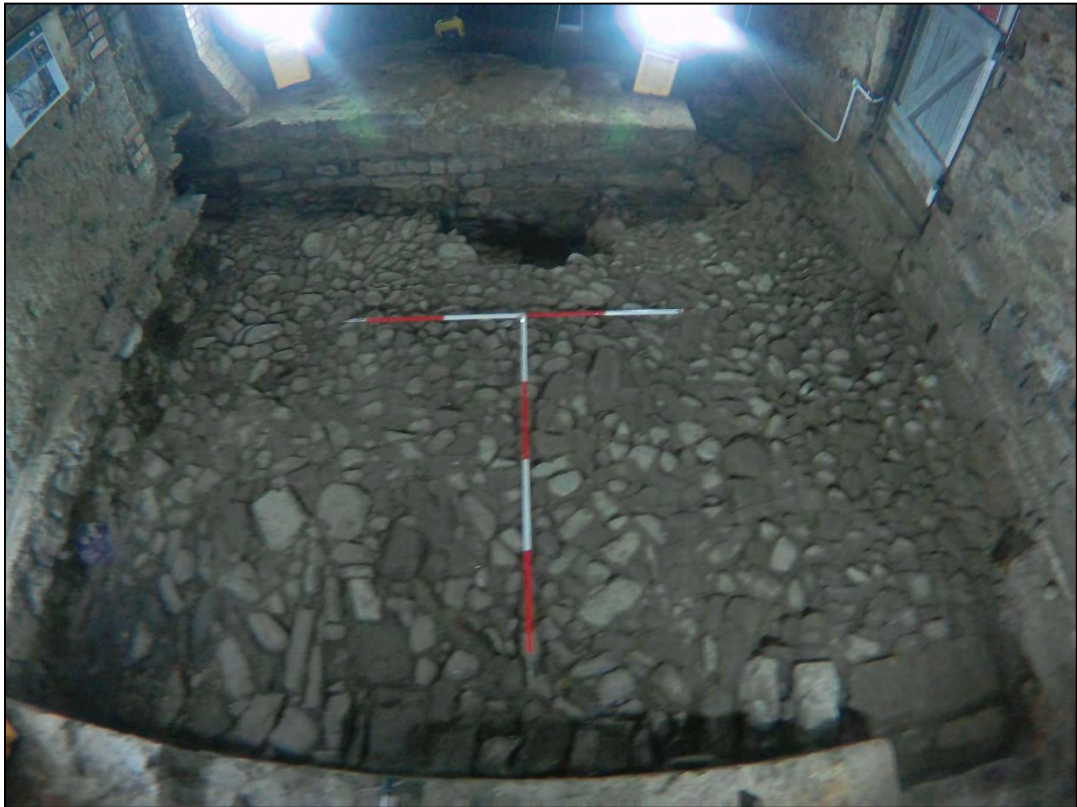
Plate 3: Pitched stone floor to the west of Context 20

To the west of the central wall, (Context 20) a consistent pitched stone floor was revealed over the whole of the area between the earlier wall (Contexts 6 and 20) (Figure 3, Plates 3 - 6). The assessment (Brooks and Gwyn 2017, 20) assumed that a pitched stone surface (Context 40), at the southern end of the trench, was at a higher level than the uppermost layer of pitched stones recorded in the rest of the trench. This, however, proved to be untrue as Contexts 40 and 36 proved to be part of the same pitched stone surface which not only occupied the space between Contexts 6 and 20, but extended around the southern end of Context 20. There is a degree of variability across this surface with an area of larger, elongated cobbles used in one area the northern end of Context 6 (Plate 4). The function of this variability is unknown; however, it is likely that it relates to repairs to the surface. There are also two areas where stone slabs have been incorporated into the surface. At the southern end of Context 6 and below the block (Context 8, Plate 5) thought to be a possible threshold are a group of four stone slabs which appear to relate to the possible threshold. The second area consists of two slabs below the fireplace on the northern wall of the gatehouse (Plate 6). It is likely that these slabs relate to an earlier manifestation of the fireplace. The floor as a whole abuts the two cross walls (Contexts 6 and 20), but runs under the southern, 19th century, wall of the gatehouse abutting the stone block of the underlying structure which extends and becomes part of the structure of the building with the "D" shape tower at its eastern end. The quality of this pitched stone surface does not appear to be good enough to serve as the floor to a prestigious civil building and would most likely have served as a yard surface, indeed a concentration of coal fragments in its north-western corner would suggest at least part of the space was being used to store coal.

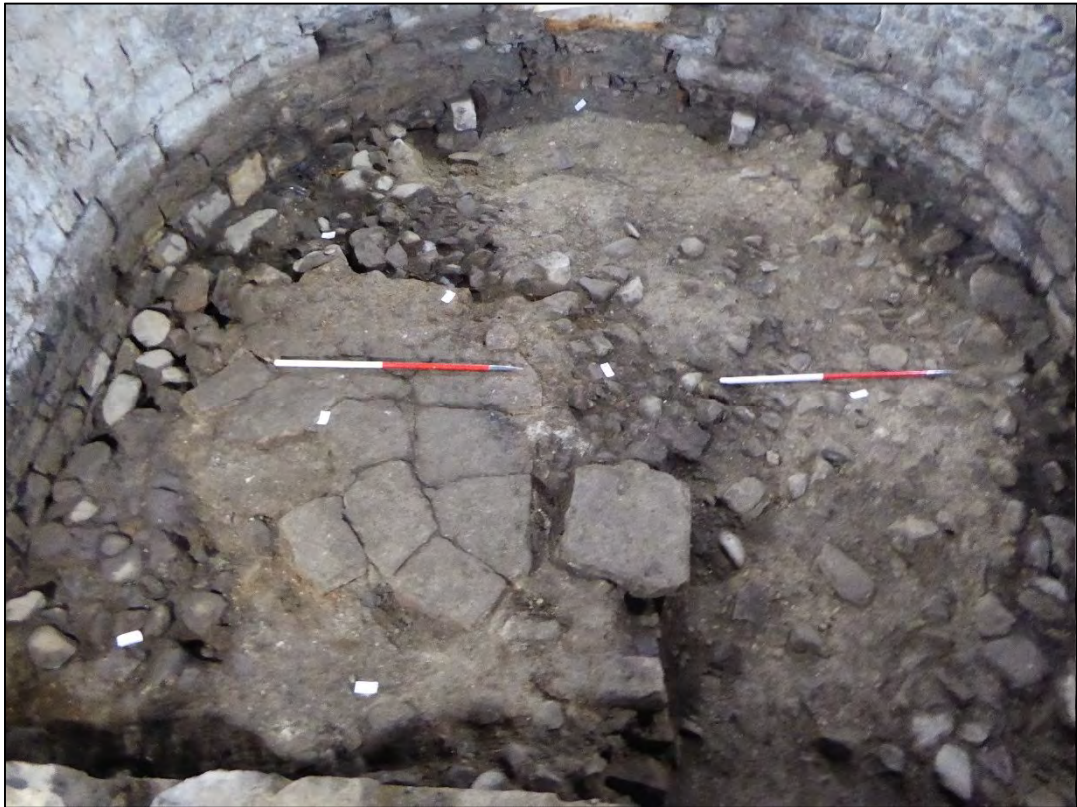
Plate 7: Eastern end of the gatehouse after the removal of Context 55

To the east of Context 20, the removal of the overburden revealed the top of a platform with a stone slab floor (Figure 3, Plate 7). This feature was 2.6 x 2.45 m in size and was position on the eastern side of Context 20 and against the northern wall of the gatehouse. The "floor" of this platform has the remains of a stone slab surface (Context 61) which is set in a yellowish/brown clay (Context 62) bed. The slabs were carefully placed with the impression of a deliberate arc pattern which appears to be at least partly decorative. The southern side of the platform is partly collapsed and one of the floor slabs has moved slightly to the south. The removal of Context 58 to the east and south of the platform demonstrated that it originally stood to a height of 0.8 m with revetting walls (Contexts 78 and 79, Figures 5.1 and 6.1, Plates 8 and 9) roughly constructed of stone blocks with a yellowish/brown clay matrix. The surviving section of the revetting wall on the southern side of the platform (Context 78) leans out by 130 mm showing the movement of this side of the structure, indeed the majority of this

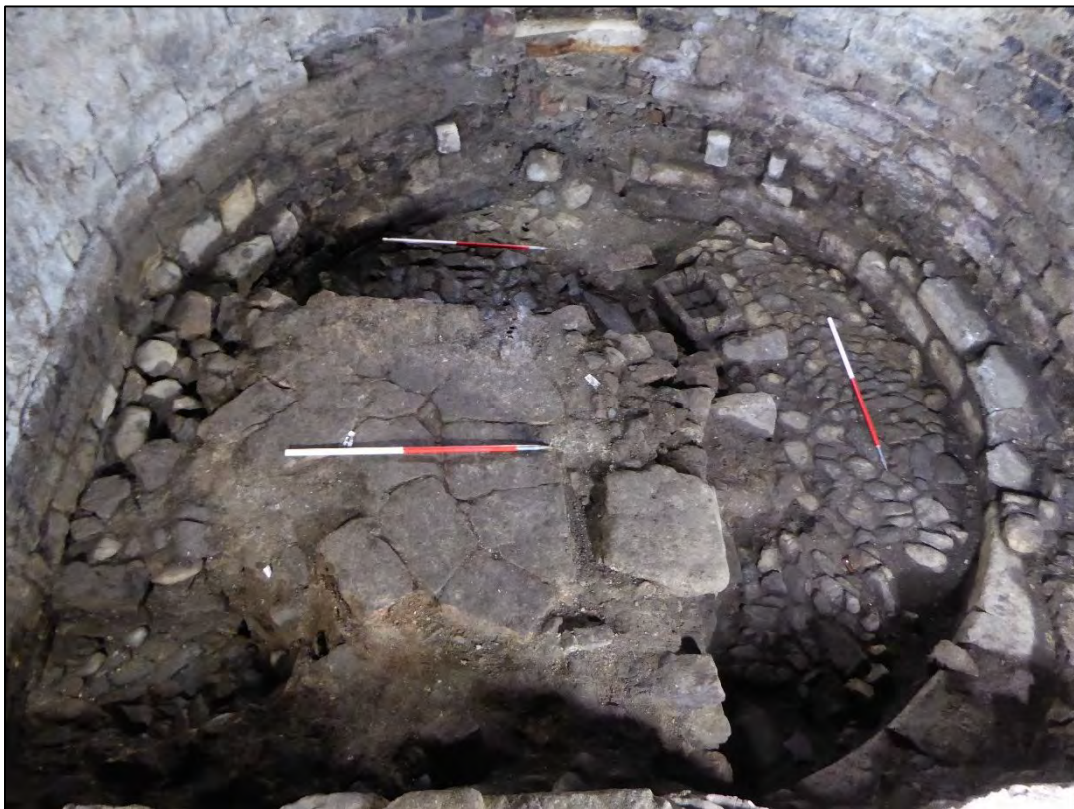
Plate 10: Eastern end of the gatehouse after the removal of Context 58

The platform sits on a pitched stone surface (Contexts 71 and 76) which now occupy a circular space defined by the wall (Context 79) (Plate 10). The uneven surface to this floor with up to 150 mm difference in the levels across this surface (Figure 7) with a particular noticeable difference between the two defined elements of this surface (Contexts 71 and 76). This unevenness is assumed to be the result of the same consolidation of the underlying deposits which gave rise to the movements in the platform. Also sitting on and incorporated with the pitched stone surface is a carved stone trough (Plate 11) which appears to be *in situ*, or at least close to its original position. As with Context 36/40, at the other end of the gatehouse, the cobbles of Contexts 71 and 76 do not look like the floor of a high-status building and appears to be more like a yard surface and once again deposits of coal were found resting on this surface included some fragments of coal including a single piece approximately 300 x 200 x 100 mm in size. The original level of this floor is uncertain, it seems unlikely that it was originally at the height of the pitched stone floor which occupies the western half of the gatehouse and extends around the southern end of Context 20 which is approximately 0.6 m higher than Context 71. There was also a small patch of pitch stone flooring (Context 83) discovered in the base of the modern disturbance, Context 64, (Plate 12) which is at a similar level to Context 36 on the other side of Context 20. The southern edge of this layer roughly follows the line of the underlying circular wall (Context 79), however this may be coincidental. The stone trough (Plate 11) is 0.47 x 0.29 m in size and has carved slots crossing the sides and base forming a cross dividing the basin into four areas. The function of this division is unknown; however, it is clear that the trough was designed to occupy its current position as there are larger stone slabs, as part of Context 71, defining the southern and western side of the trough.

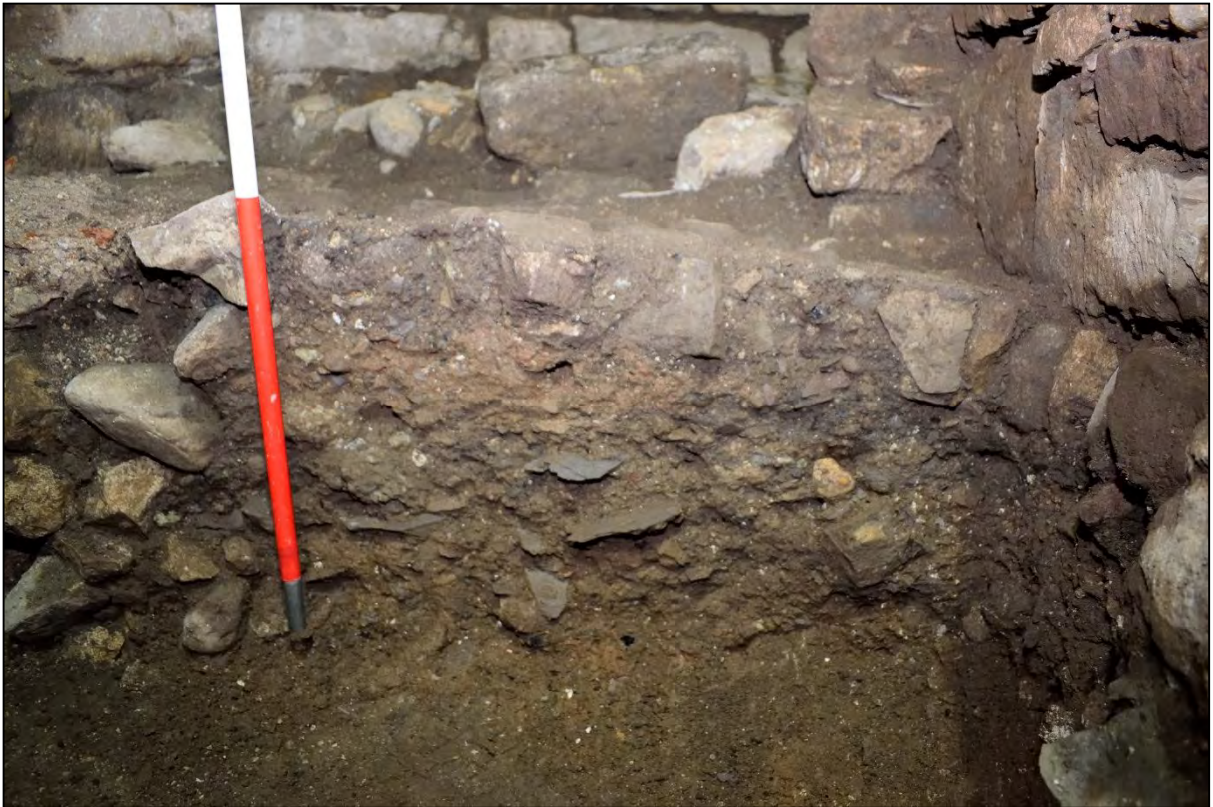
Plate 13: Context 75 in the sondage.

A sondage was dug to the east of the platform through the pitched stone surface (Context 76) reaching a depth of 0.60 m below Context 76 (Figure 6.2, Plate 13). Below Context 76 was a single deposit, at least 0.45 m thick of orange/brown sticky clay with a moderate density of lime mortar/plaster fragments and the occasional stone cobble up to 100 mm in size (Context 75). The layer also contained post-medieval pottery together with some animal bones and oyster shells. This would appear to be a deliberate dumped layer, presumably filling and consolidating the top of the space defined by the circular wall (Context 79) prior to the laying of the pitched stone surface (Contexts 71 and 76).

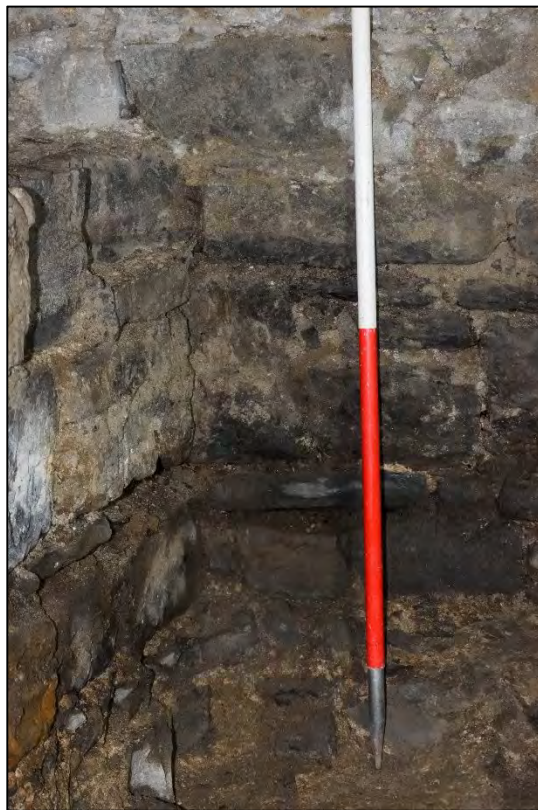
Plate 18: Relationship between Context 20 and the northern wall of the gatehouse

At the northern end of the east facing elevation of Context 20, the northern wall of the gatehouse butts up against Context 20 (Plate 18) with a straight joint suggesting that the standing structure is later than Context 20. It is assumed that both Contexts 6 and 20 are medieval in date and that their similarity in form and character suggesting that they are contemporary. They both have well formed, straight southern ends suggesting the possibility of a passage, or at least a route, along the southern side of the gatehouse.

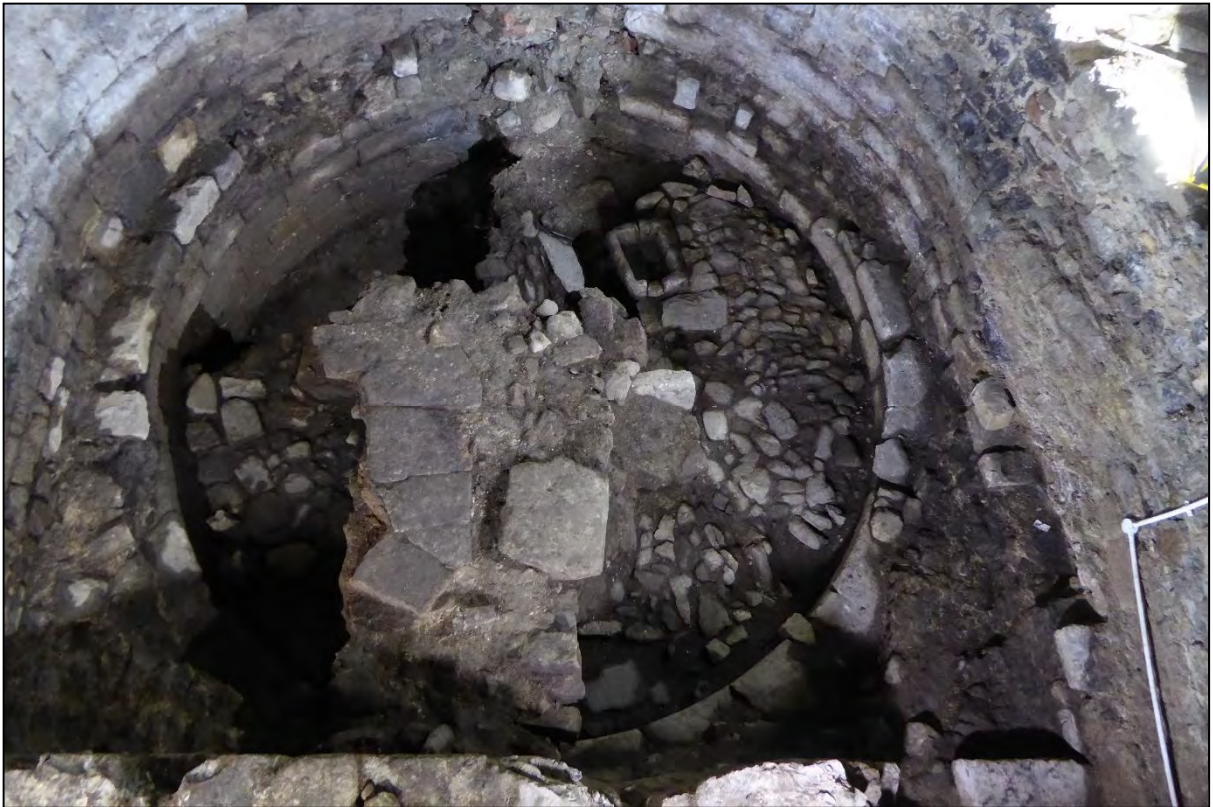
Plate 19: The circular tower base (Context 79)

The main feature of the eastern end of the gatehouse is a wall forming a circle 4.2 m in diameter (Figure 4, Plate 19). The western side of this wall can be demonstrated to be under Context 20 and therefore earlier. The sondage dug in the north-western sector of the gatehouse showed at least seven courses of well coursed stonework of carefully squared blocks giving an exposed height of 1.24 m. The bottom of the sondage was only 2.4 m above the pavement level of Greengage Street/Cei Banc giving a potential of at least 3.5 m of this wall surviving below the current level of excavation. The top layer of the stonework forms a flat level on the northern side of the building suggesting the top of this walling marks the position of a ledge to support a floor level, presumably of timber. It is probable that this circular wall is the remains of cellar below a circular tower. There was no signs of a staircase within the excavation and it is likely that any access to the cellar was through a trap door and a ladder rather than a fixed, stone, staircase.

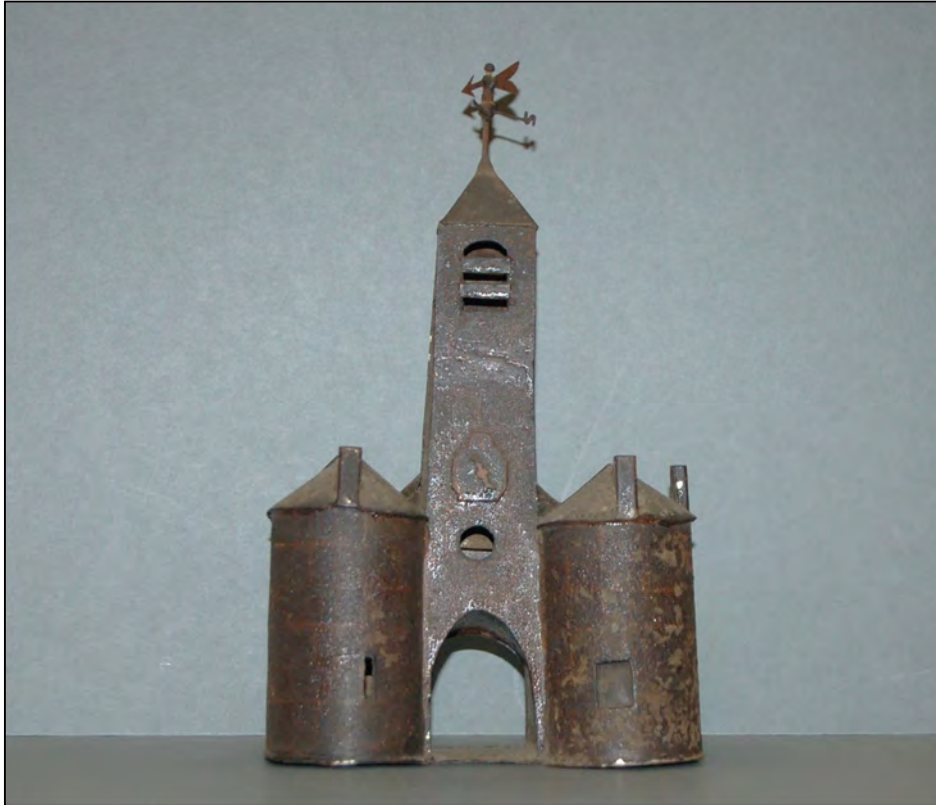
Plate 21: Late 18th century tinsplate model (Gwynedd Archives XD1/928)

Initially the relationship between the circular tower and the standing “D” shaped tower is not clear; however, the circular tower is clearly below the centrally placed wall (Context 20) against which the wall of the “D” shaped tower is built, thus although occupying a similar line these two elements are of different builds. Both the circular tower and the “D” tower structure have been cut by the modern disturbance (Context 56) which appears to be related to recent conservation works that have taken place to the window and associated embrasure in the eastern end of the gatehouse. Now an arrow slot, this opening would appear to have been a larger window in the late 18th or early 19th century as shown on a tinplate model (Plate 21) of the gatehouse held by the Gwynedd Archives (XD1/928).

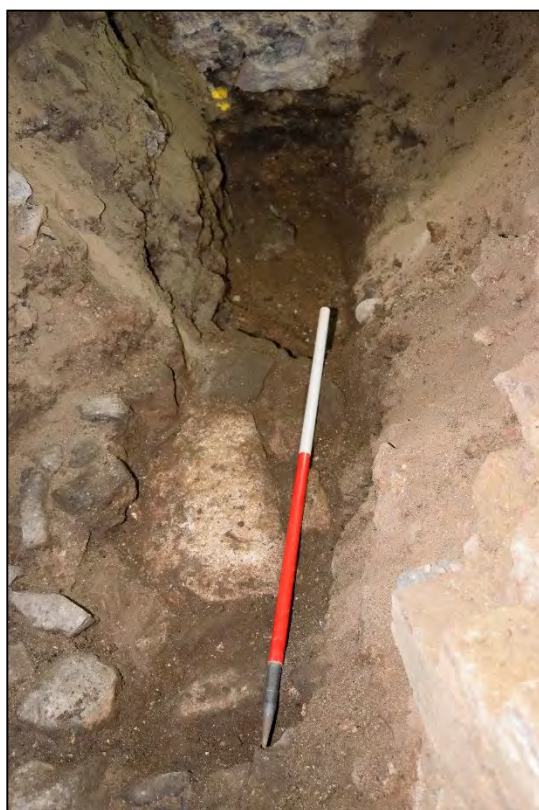
Plate 27: Context 72, looking west

(Context 72, Figure 13.2, Plate 27) which were less well packed than the overlying layer. At the western edge of Context 72 there was a patch of burnt clay (Context 73, Plate 28) with a dark, charcoal rich surface of unknown extent or function. To the west of Context 73, the deposit appears to be layer of orange brown clay with flecks of lime mortar (Context 74), probably a deliberate deposit.

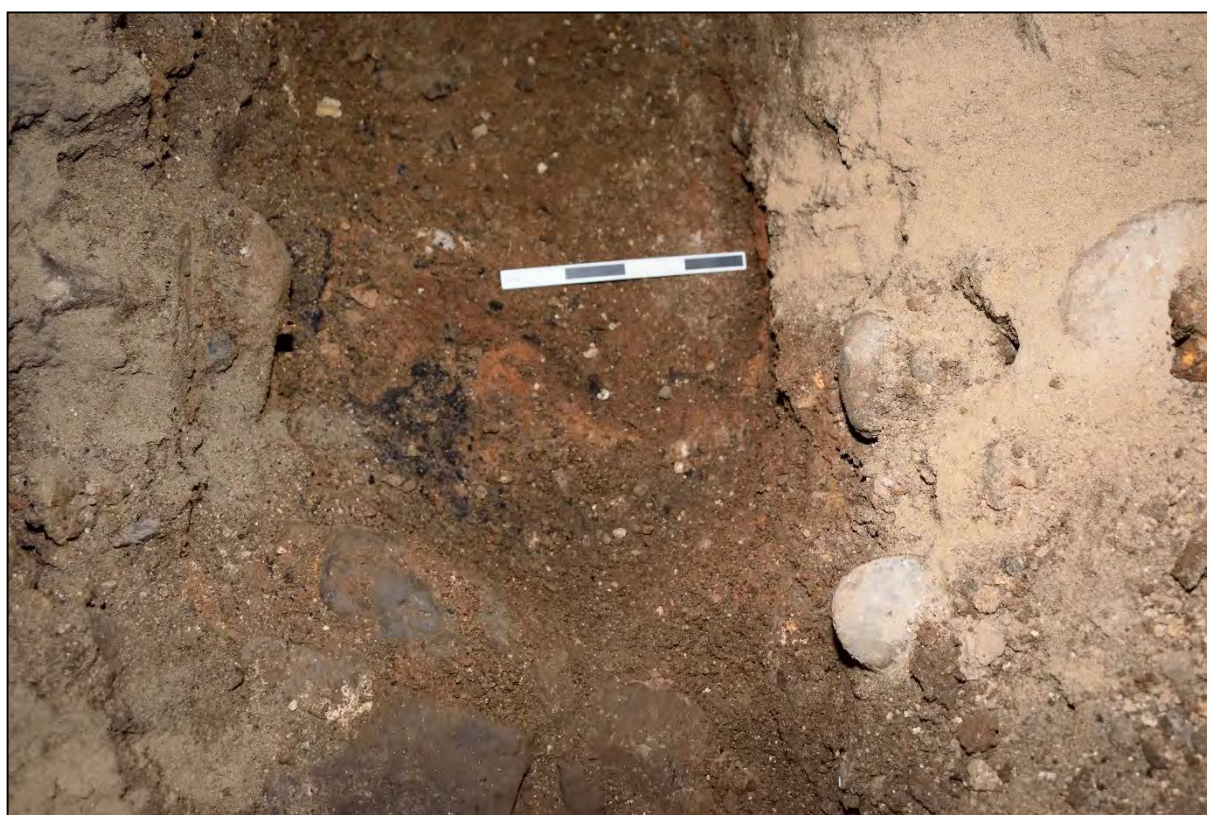
Plate 28: Burnt patch, Context 73
