**Plas Tirion Old House  
Interim Report**

***EAS Client report 2018/01***

**Plas Tirion Old House, Llanwrst**  
**Building Recording and Building Recording, Interim**  
**Report**

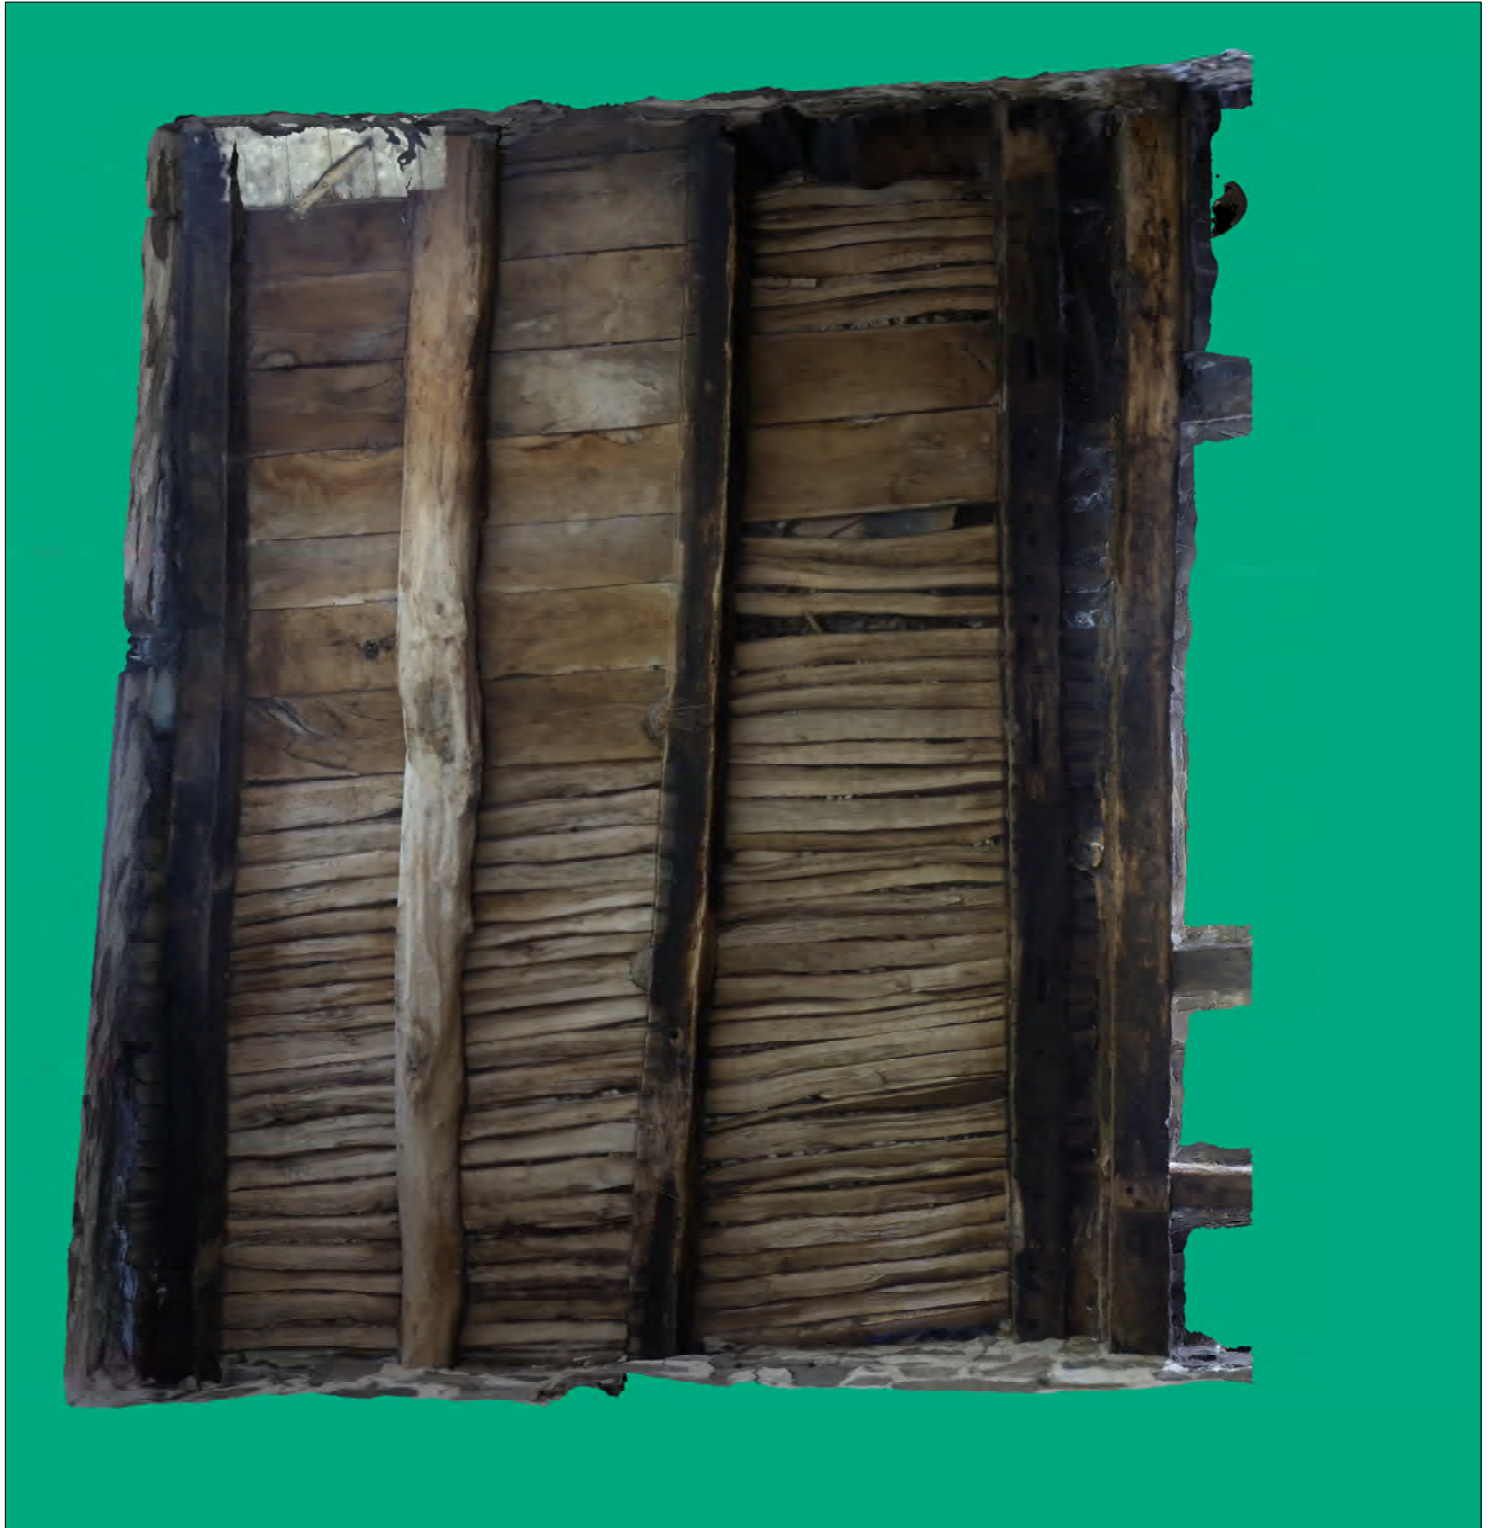
Figure 3: Photogrammetric plan of the underside of the loft  
Scale 1:25

Only limited further recording took place within the old house itself. This consisted of the recording of the underside of the half loft in the western end of the west room (Figure 3) and the photography of some graffiti on the southern wall of the same room. The loft platform consists of a mixture of split staves and planking which supports a lime mortar surface. The staves and planking rests on a series of beams, one of which (near the eastern end of the loft) has a series of slots and holes cut into its lower surface suggesting the presence of a partition. The position of the two slots may also suggest the position of the doorway through the partition. It is also clear that although the majority of the beams are prepared timbers one beam is of only roughly prepared round wood and is a later repair.

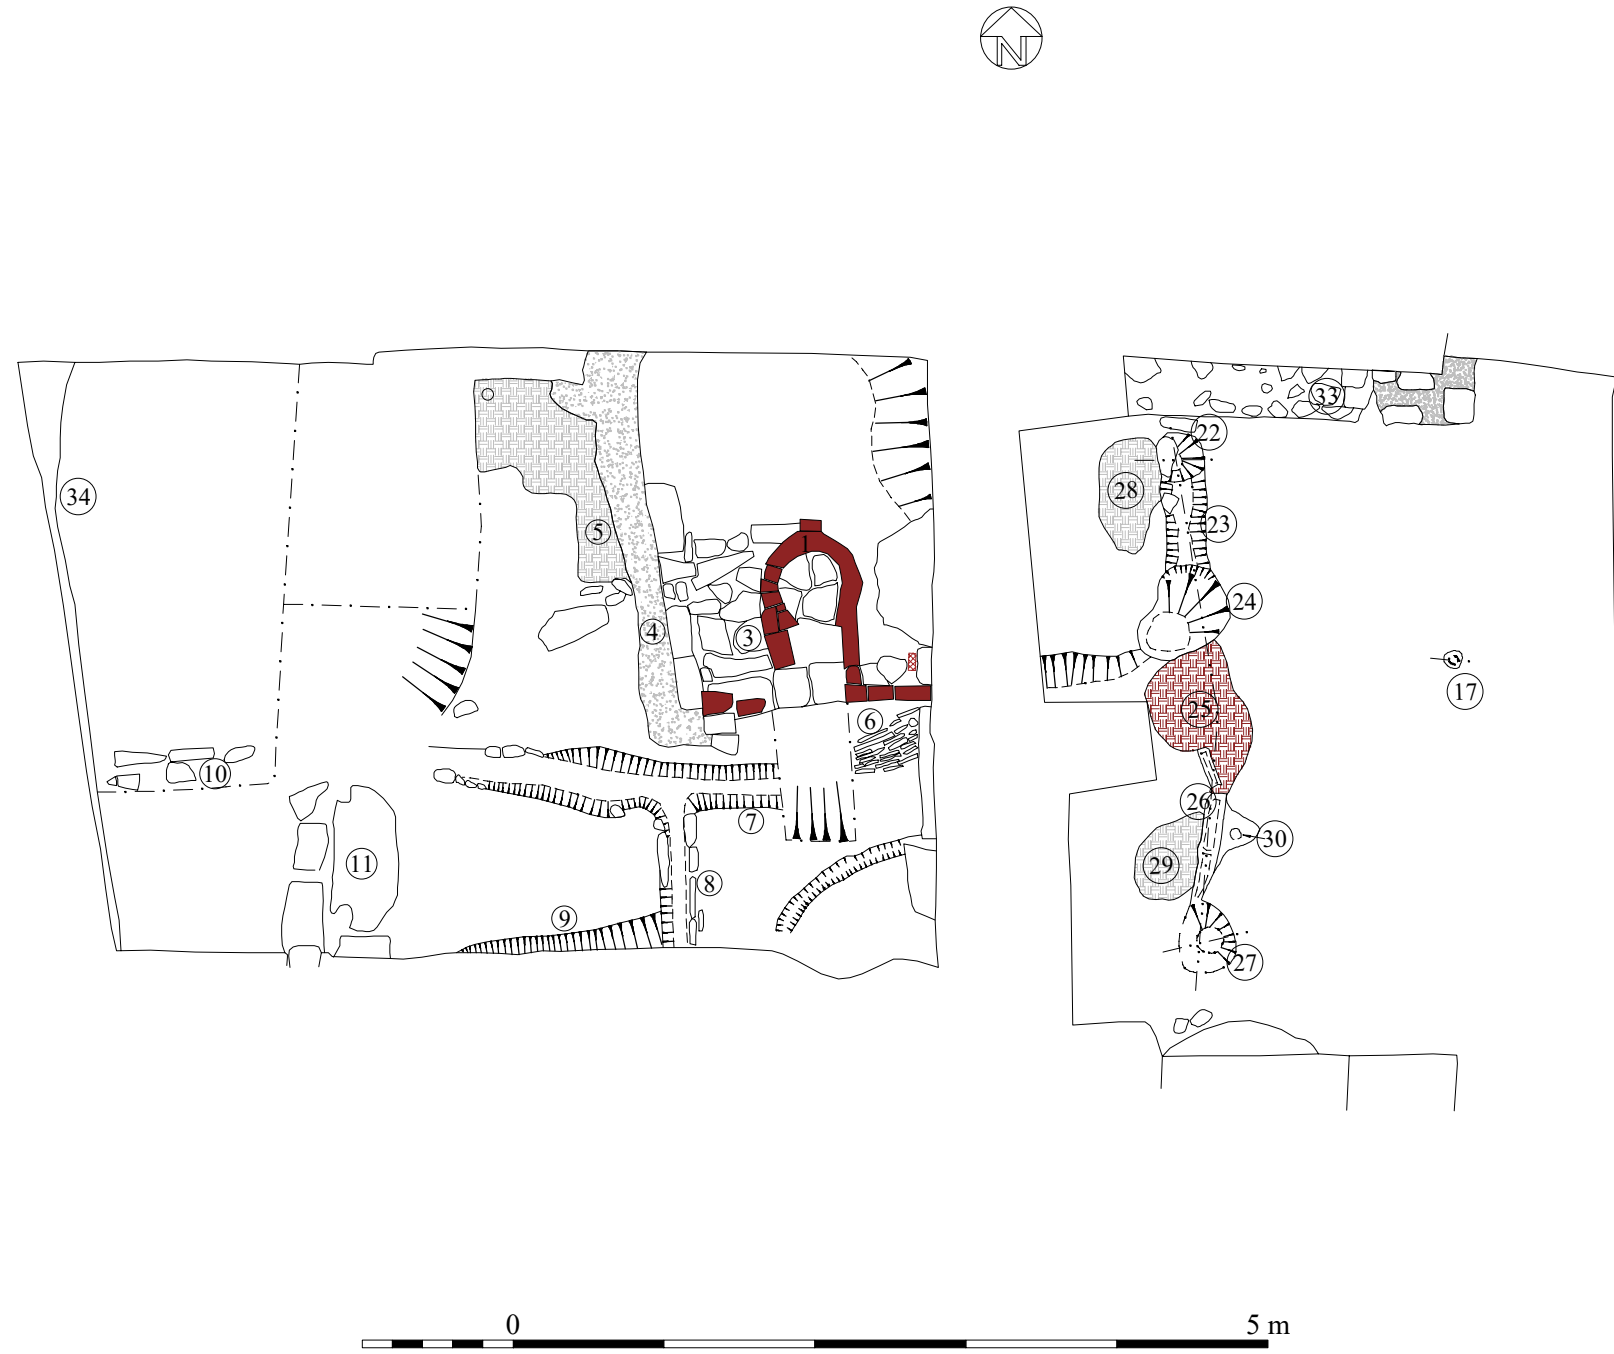
Figure 6: Excavation Plan  
Scale 1:50

The lifting of the slate floors revealed a number of features which appear to relate to earlier phases of activity in this end of the building (Figure 6). Crossing in front of the current hearth is a series of features which defines the line of a partition dividing the building (Plate 19). The northern side of this partition is defined by two post-holes (Contexts 22 and 23) linked by a shallow linear feature or gully (Context 23). Possibly Context 24 marks the position of a door post marking one side of a doorway through this partition. The southern side of the partition consists of a slot (Context 26) which leads to a possible post-hole (Context 27). The form of Context 26 is of particular interest as it appears to define a series of planks, between 280 and 380 mm wide set upright to form this side of the partition.

In the West Room, (Figures 6 and 8) the excavation by Cymdeithas Archaeoleg Bro Ffestiniog had removed much of the floor deposits which had survived in this end of the building. The most striking feature to survive is a brick built structure (Context 1, Plates 24 and 25) in the eastern end of the room. The structure consists of an apsidal ended brick structure 1.10 x 0.70 m in size defined by brick walls 112 mm thick made of soft, handmade bricks with a pale lime mortar. The complete bricks are 254 x 114 x 60 mm in size suggesting possible eighteenth-century affinities. There is a 0.50 m long passage leading to a roughly circular chamber 0.4 m in diameter. There are also two flanking walls on the southern side which extend from the passage. The function of this feature is not entirely clear, its form would suggest an oven or corn dryer; however, there is no evidence for extensive heating and little or no burnt material, such as charcoal, was recovered by either of the excavations. It is still possible that structure was part of a corn dryer, but if so any fire used in this structure was small and provided only a gentle heat. It was assumed that Context 1 was contemporary with the stone floored platform (Context 3) as it aligns with the southern edge of Context 3. However, there is a thin layer of very dark grey/brown soil (Context 2) below the brickwork suggesting that the possible corn dryer was constructed on a pre-existing platform.

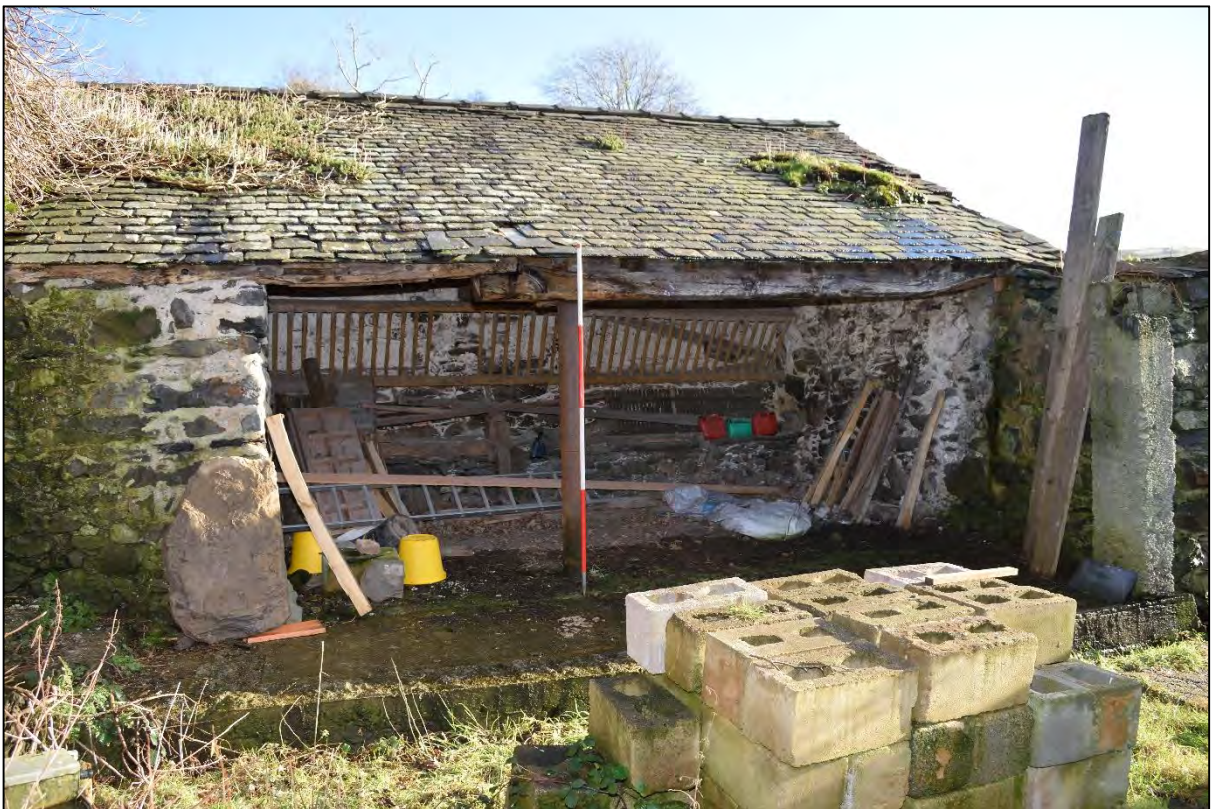
The byre to the south of the Old House (Plate 2) consists of an open sided building with a wooden hay rack along its northern wall. This is a relatively modern appearance as when the old house was originally recorded in 2012 there was a corrugated iron extension aligned with the concrete platform in front of the building (Plate 3). This extension may have been constructed as late as 1989 as suggested by the date inscribed in the mortar of the southern wall of the extension (Plates 4 and 5). The open face of the byre, itself, has a lintel made of two re-used timbers supported by a cast iron prop. The southern section of the lintel is a large timber with a series of mortise slots on its upper surface (Plate 6, Figure 4) which was clearly, previously, a ceiling beam with coggled joists. The original position of this beam is unknown; however, one possibility is the ceiling of the kitchen in the main house. The northern section of the lintel (Plate 7, Figure 4) consists of two timbers, both of which are also re-used. The inner timber has a mortice cut into its surface, whilst the outer timber has both a mortise slot and a drilled hole suggesting it may have been either the head or foot rail for a

Plate 2: The byre looking west

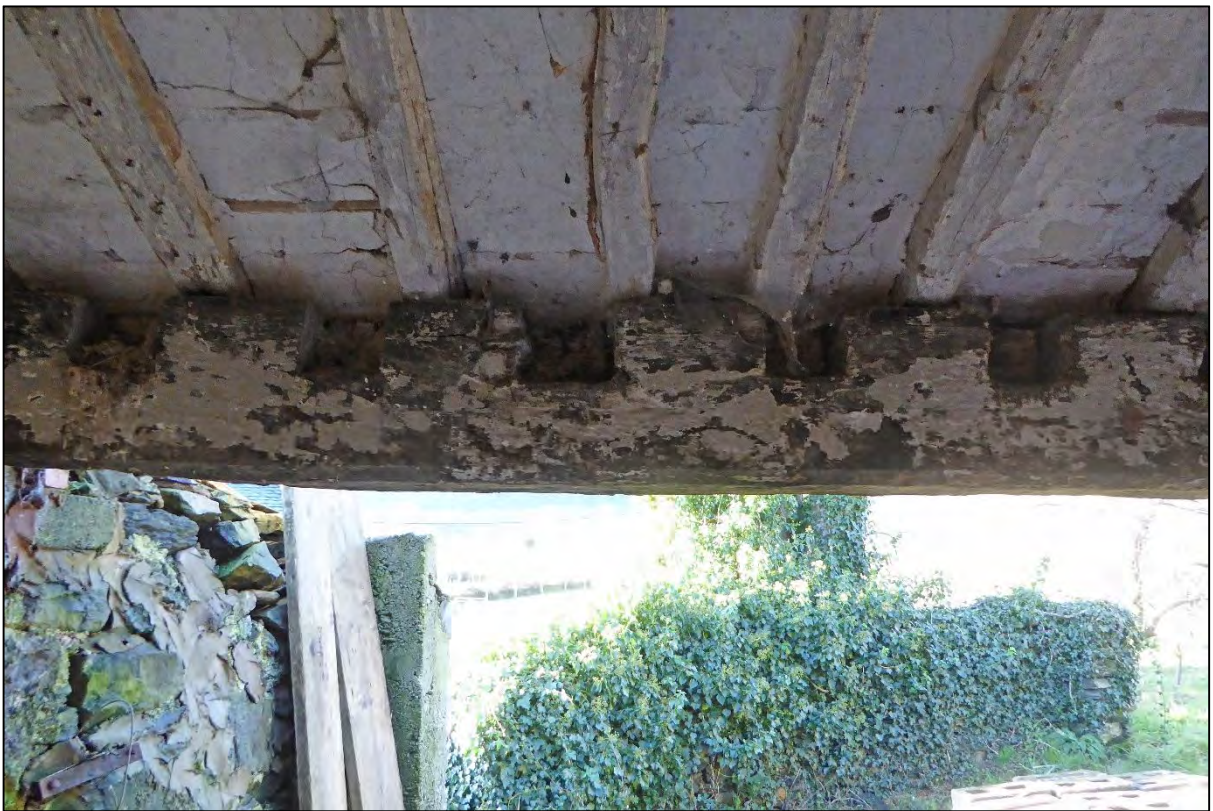
Plate 6: Southern lintel to the byre.

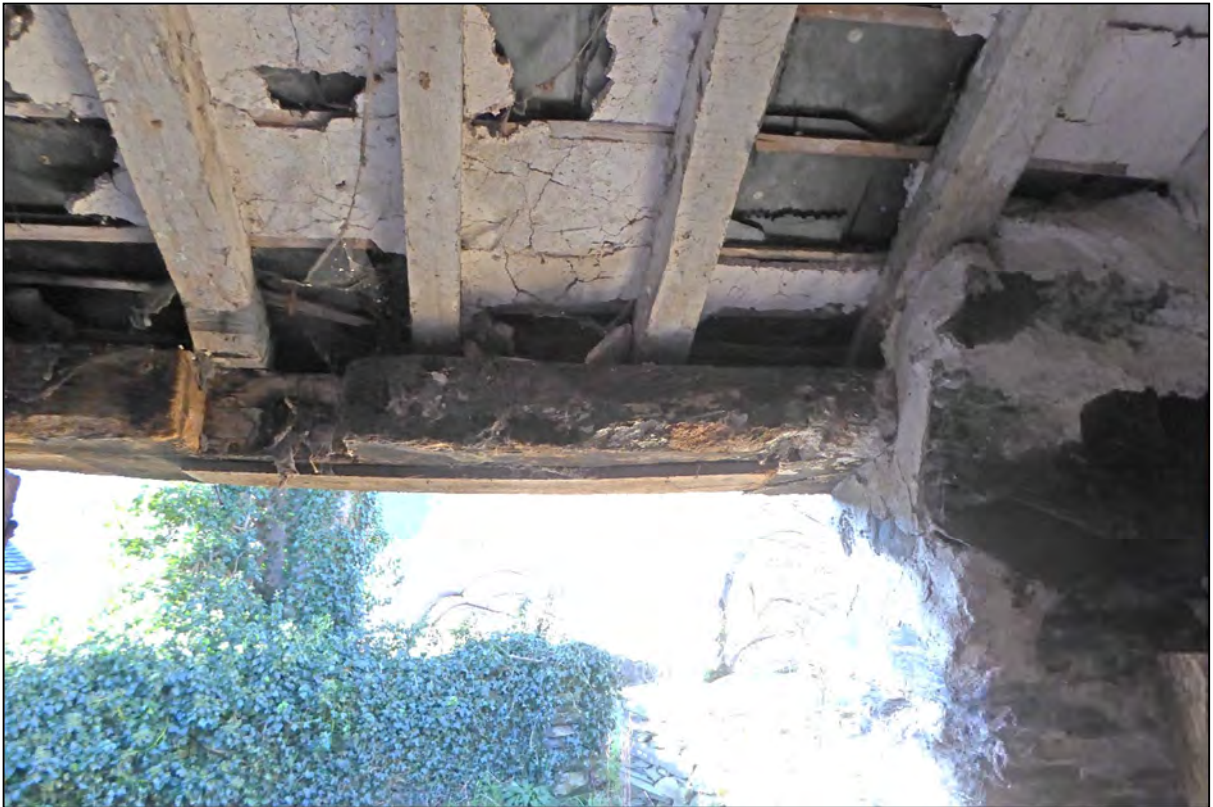
Plate 7: Northern lintel to the byre

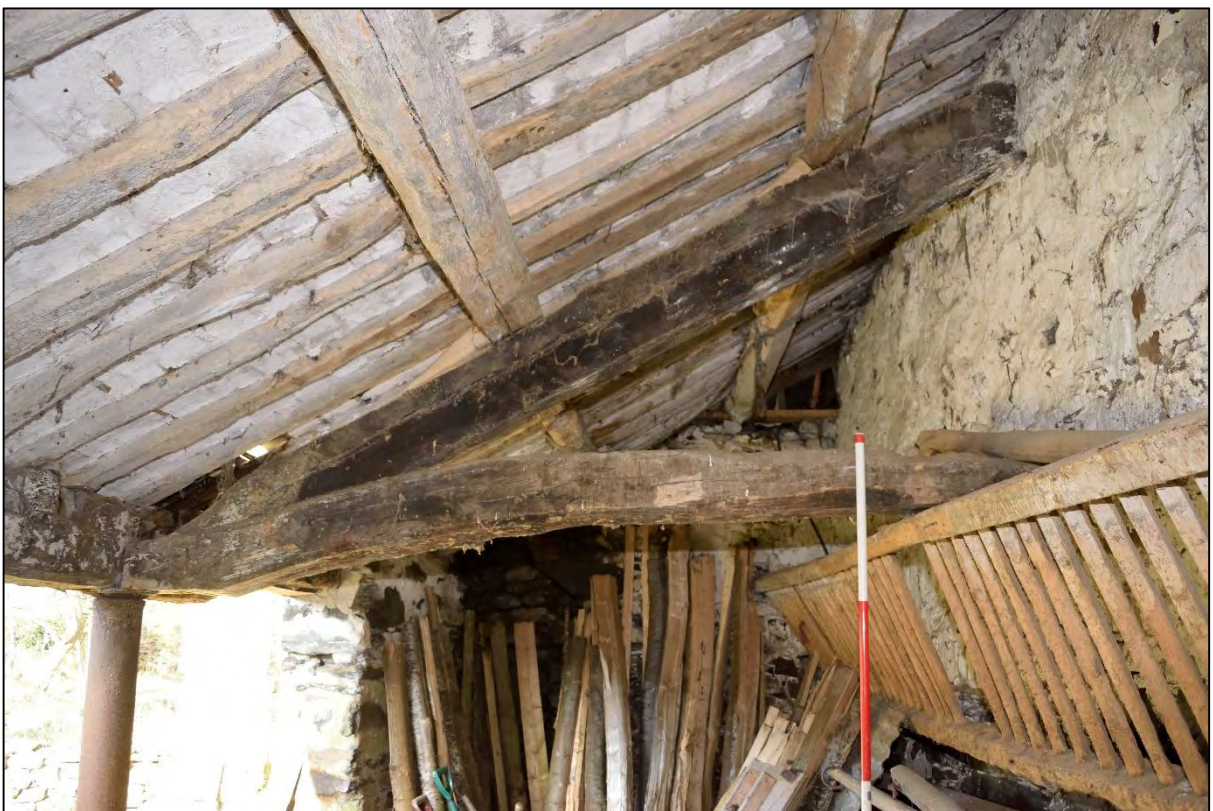
partition. The truss in this building (Plate 8, Figure 4) is also constructed of re-used timbers. The principle rafter is chamfered, whilst the brace is both chamfered and slightly curved. This brace would appear to be part of a cruck frame, adapted for its current use. The original position of this cruck frame is unknown, although it may have originally been part of the Old House.

Plate 8: Truss in the byre, looking north

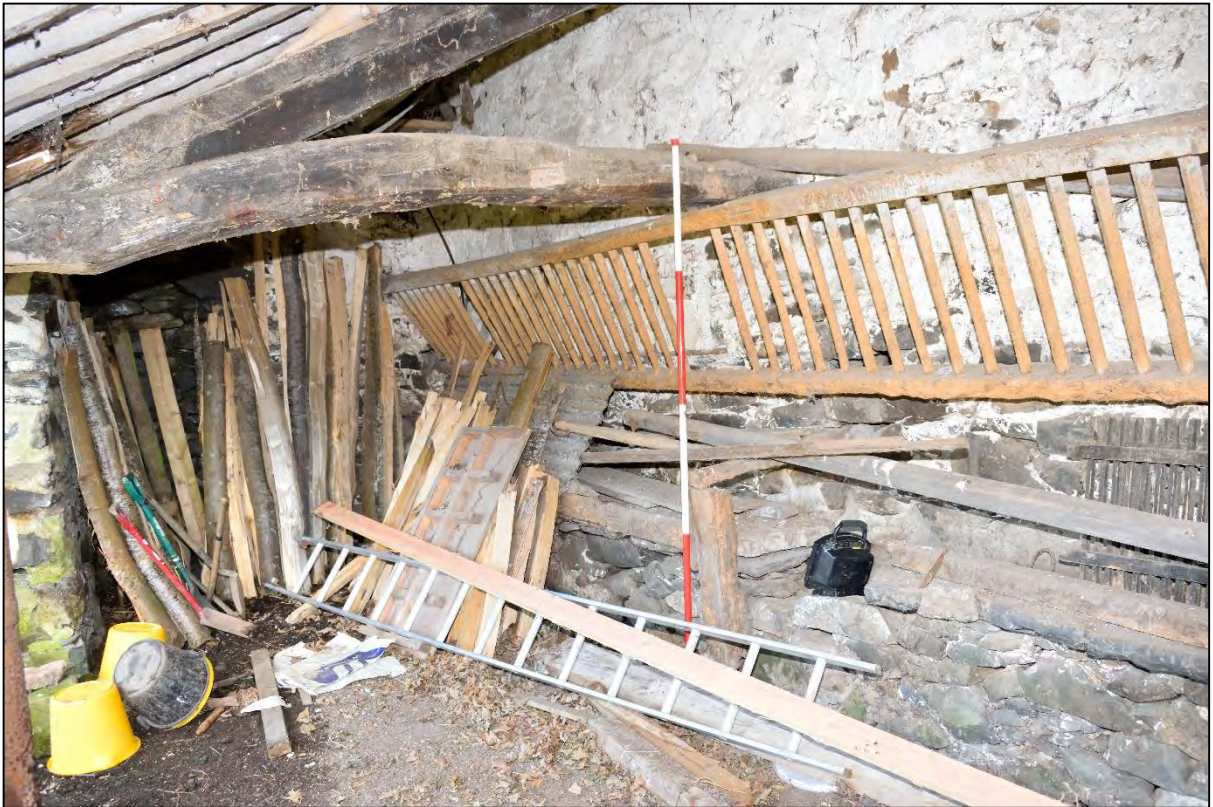
Along the eastern wall of the Byre there is a hay rack (Plate 9) over a stone platform. There are also the remains of a wooden structure below the northern end of the hay rack which, at the time of this report, is obscure by timber stored within the building. Further recording will be undertaken as part of the watching brief.

Plate 9: Hay rack along the eastern wall of the byre

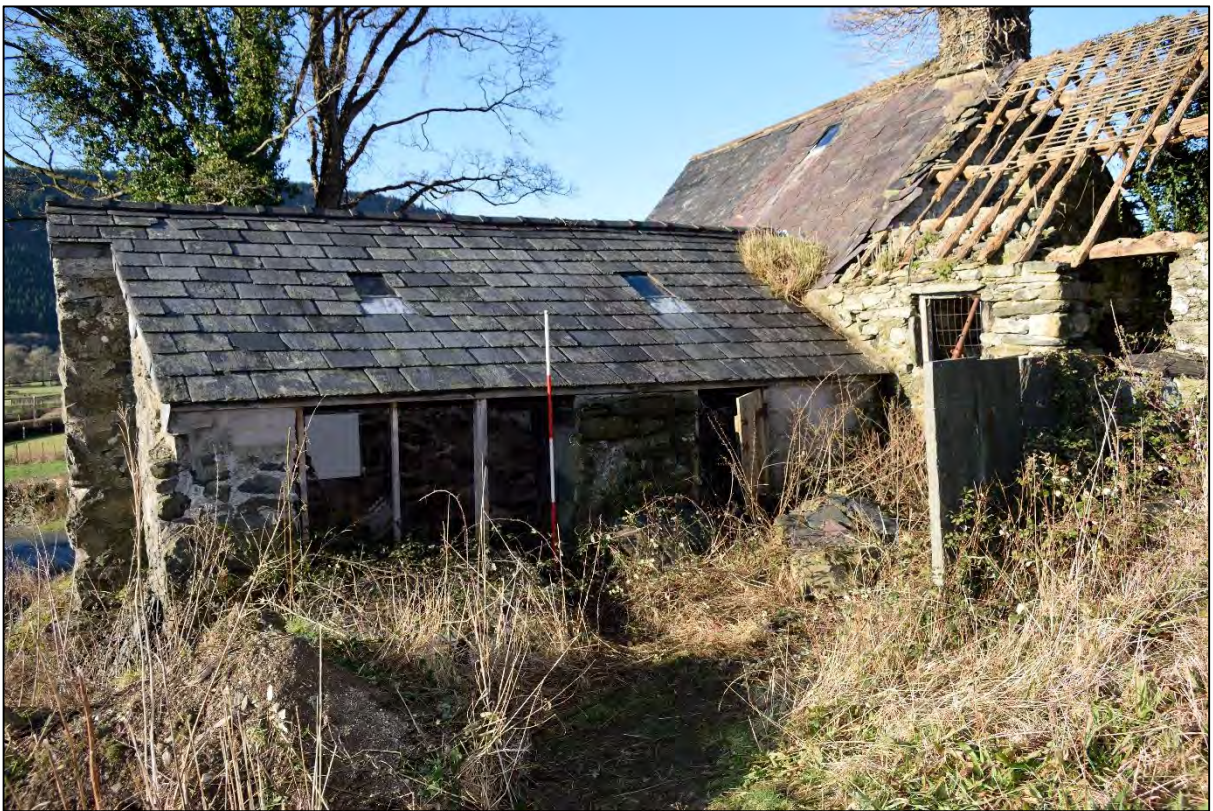
The Calf Shed (Plate 10) to the west of the byre has been added at a later date than the byre. In 2012 the southern opening was partly blocked with breeze blocks (Plate 11), which presumably date to a similar time to the breeze blocks used to construct the northern end of the building including the northern gable end. Dividing the two rooms of the Calf Shed is a half partition constructed of four slate slabs below a simple truss (Plate 12) consisting of a straight principle rafter and a brace. The slate slabs have been cut with a circular saw demonstrating that they date from after 1850's (Gwyn 2015, 115). There is also part of a restraining chain mounted on the southern side of the partition, whilst a crude feeding trough, on the northern side of the partition (Plate 13), was made of a wooden box supported by breeze blocks. Resting on top of the wooden trough is a wooden ammunition box which has had several phases of use. Originally stencilled with "3 RKT BREAKDOWN" in white it has been over stencilled, in yellow, which is less clear but appears to include "4160—", "PROPF", "NF'S 164.848" and RNP—".

Plate 10: The calf shed, looking NW

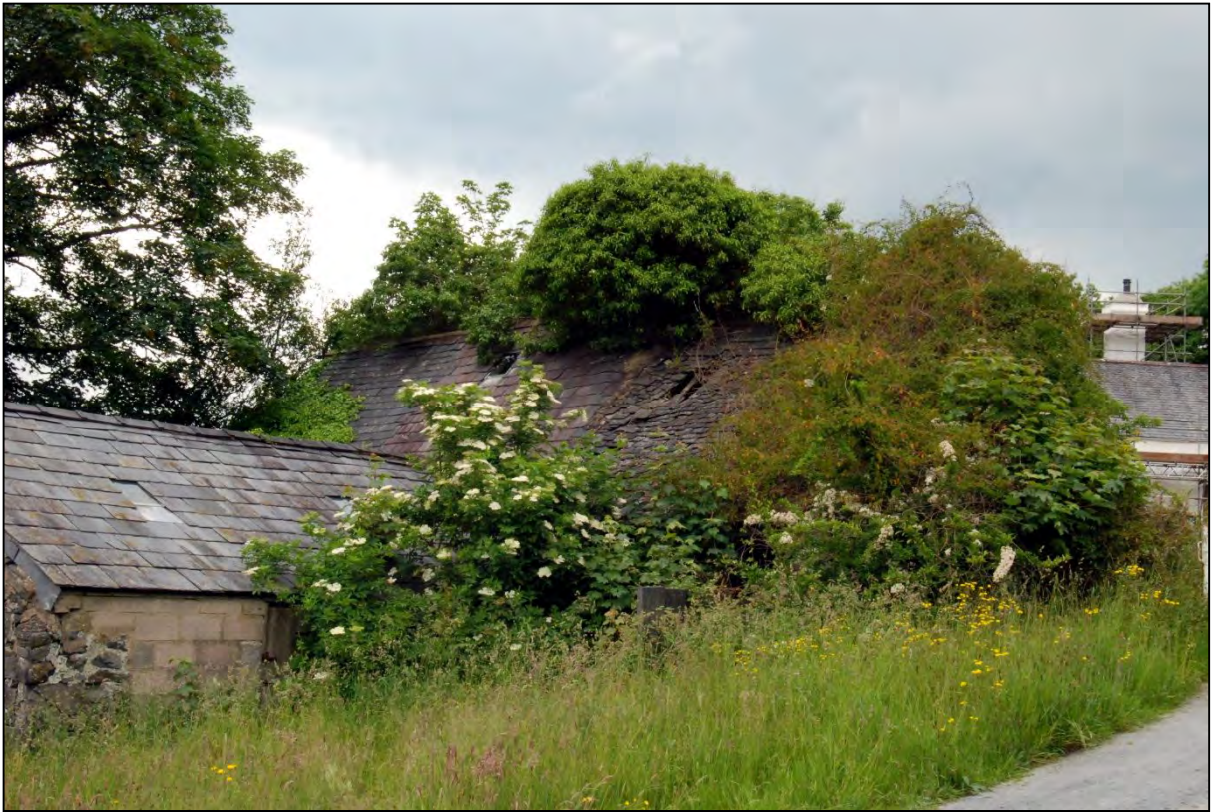
Plate 11: The calf shed in 2012

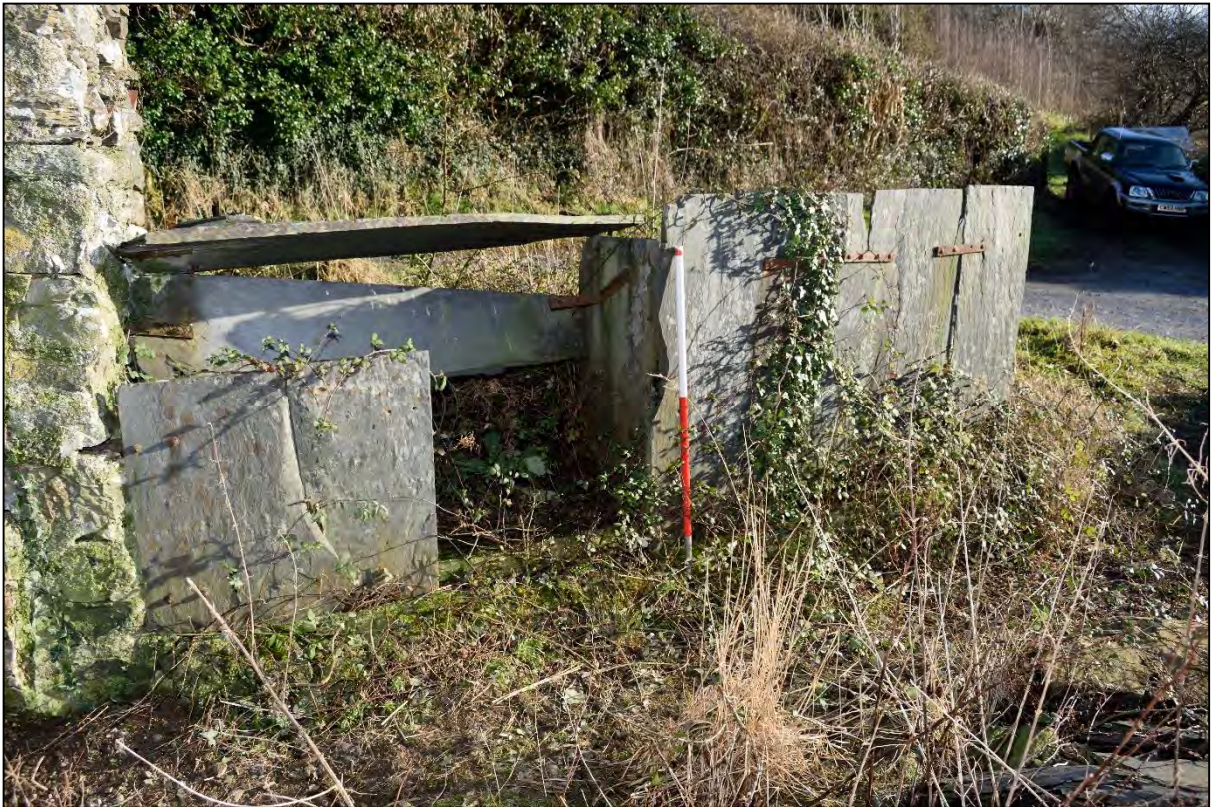
Attached to the south-eastern corner of the surviving portion of the Old House is the remains of a slate partition (Plate 15) which incorporates a feeder, typical of a type used for pig sties. It is constructed of large slate slabs with sawn ends, sawn with a circular saw (Plate 16), held together with iron clamps. One of these slabs has the initials "RO" punched into its surface, twice (Plate 17). This presumably is the same R Owen recorded in the graffiti in the west room of the old house.

Plate 15: Slate partition and feeder

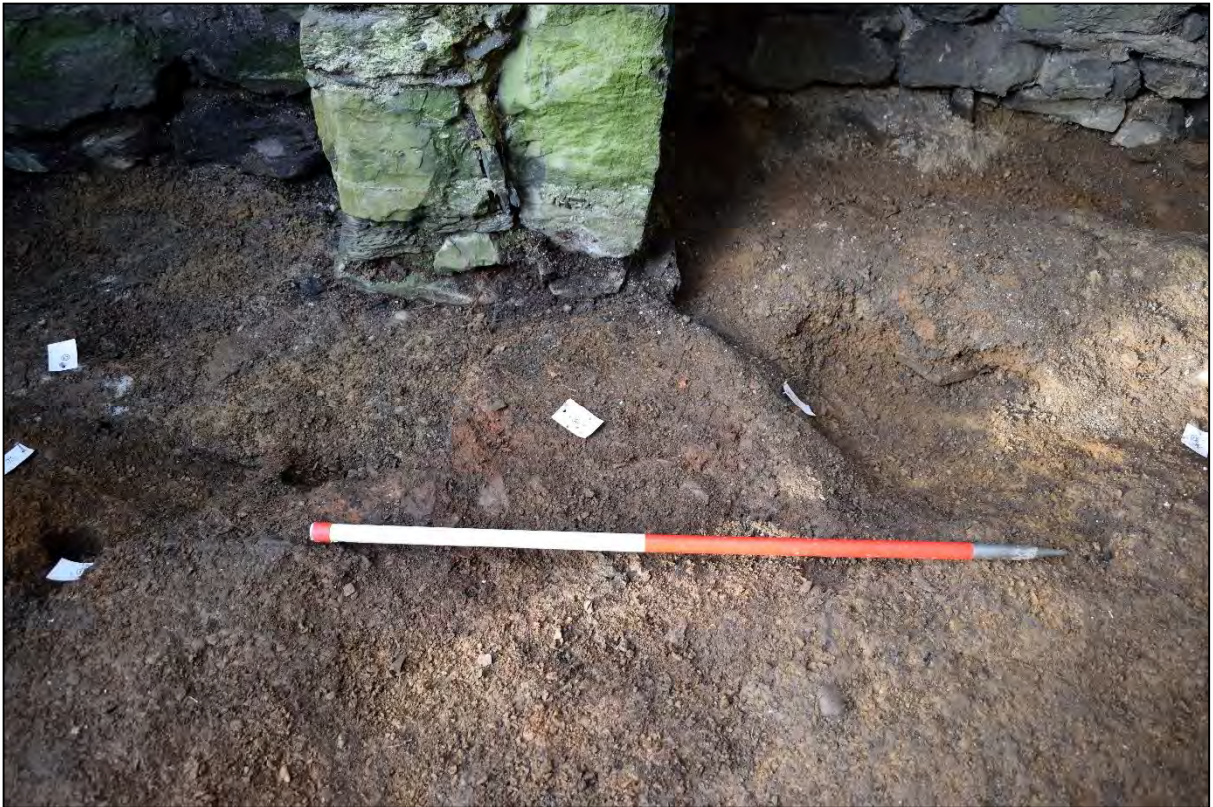
Both sides of the partition cut an area of burnt clay (Context 25, Plate 22) which appears to represent the position of a disturbed hearth. The location of this feature, below the ridge piece of the room and within the assumed upper room of the original hall house suggests this may represent the original position of the hearth for the Old House. If so it is probable that this feature is contemporary with the cruck frame dated to 1498 by dendrochronology (Miles and Bridge 2012)

Plate 22: Hearth, Context 25

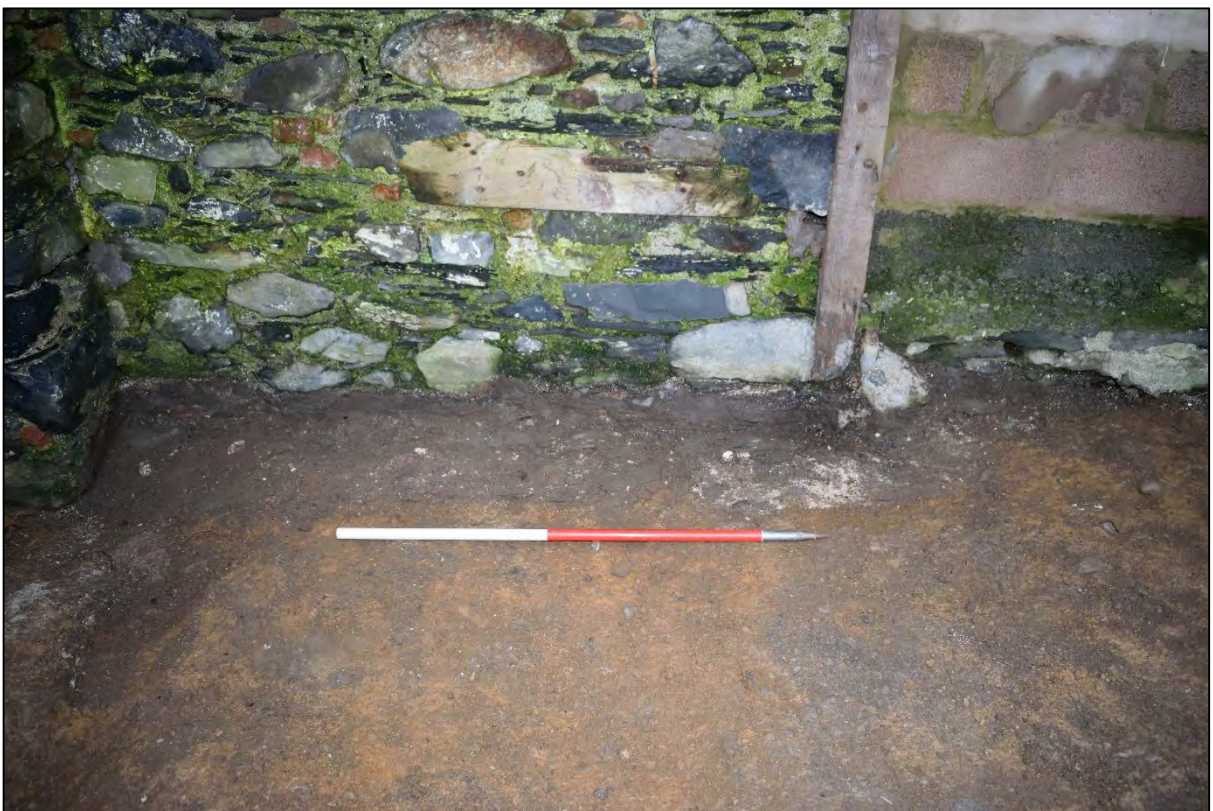
Along the northern wall of the East Room the footing of a wider wall was recorded (Context 33, Plate 23). The southern side of this feature aligns with a break in the stonework of the western gable wall and a wider section of walling seen outside the building to the east. It also aligns with the northern side of the fireplace; however, this may be coincidental. Only the base of the footings survives; however, the eastern end retains some of the lime mortar bonding. This area also has a straight edge suggesting the position of a doorway in this part of the wall.

Plate 23: Wall footing, Context 33

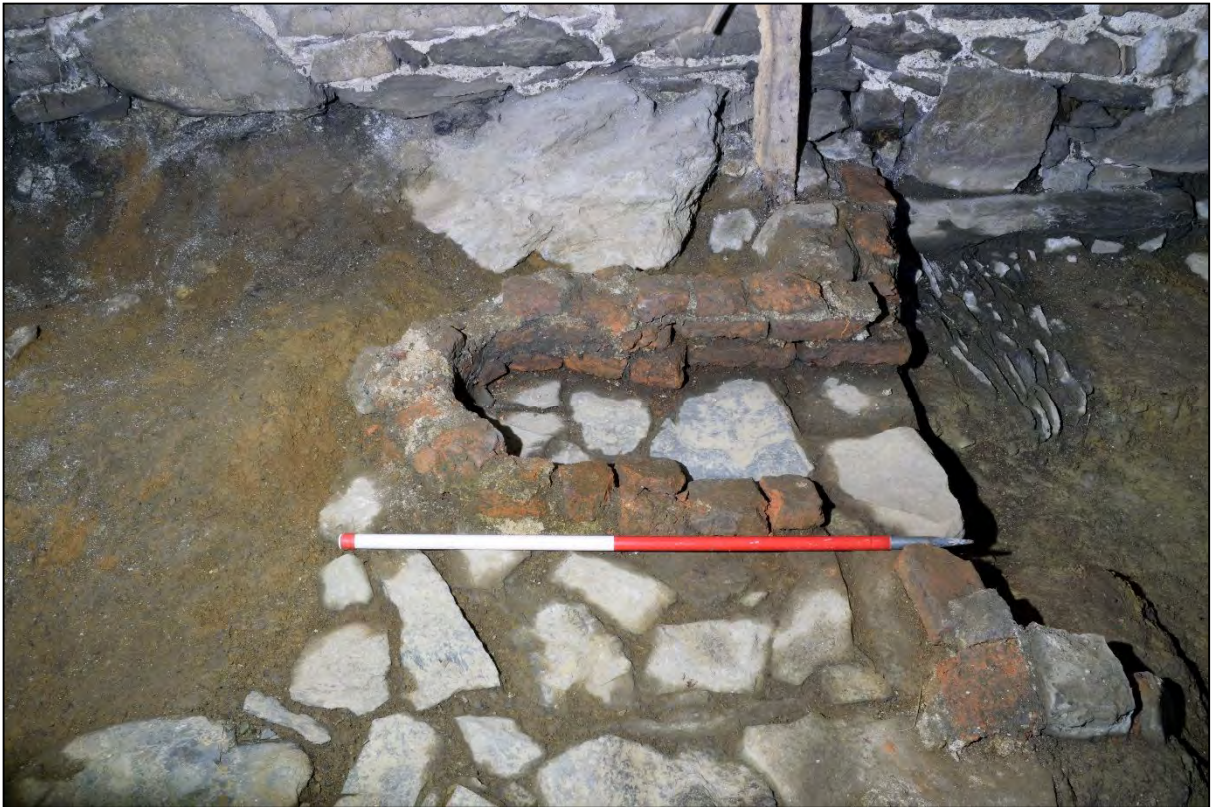
Plate 24: Brick structure, Context 1

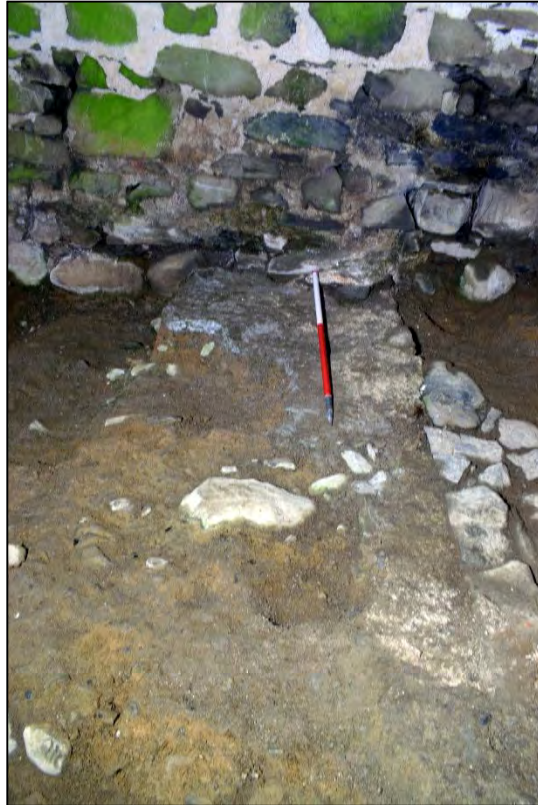
The platform (Context 3) is bounded on its western side, by a band of lime mortar 0.3 m wide which is considered to be the remains of a wall (Context 4, Plate 26) and to the west of this feature is the remains of a rammed clay floor (Context 5). It is not certain how the discoloured northern wall of the room, to the east of Context 4 (Plate 27) relates to the features at this end of the room. Whilst it is possible that this discolouration may relate to a possible corn dryer (Context 1) it does not extend along the eastern wall of the room and may therefore possibly relate to whatever structure is defined by Context 4.

Plate 26: Context 4

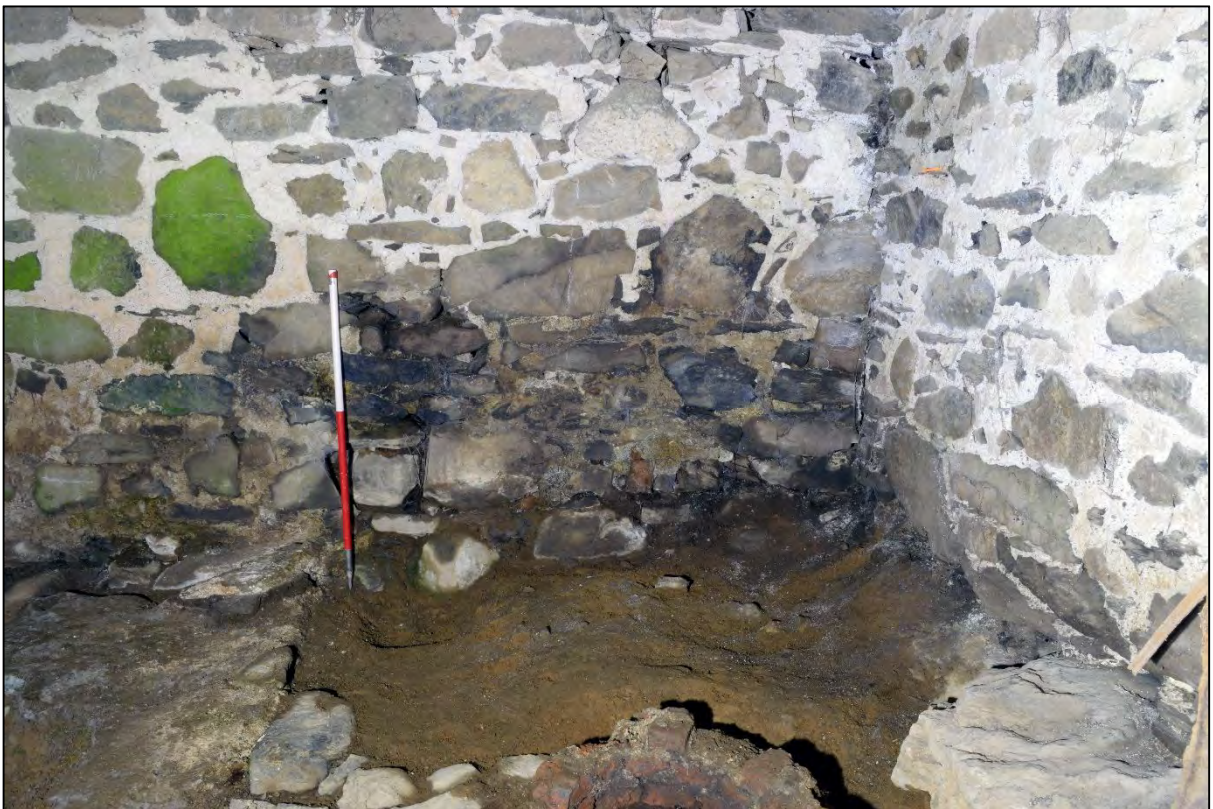
Plate 27: Discolouration on the north-eastern wall

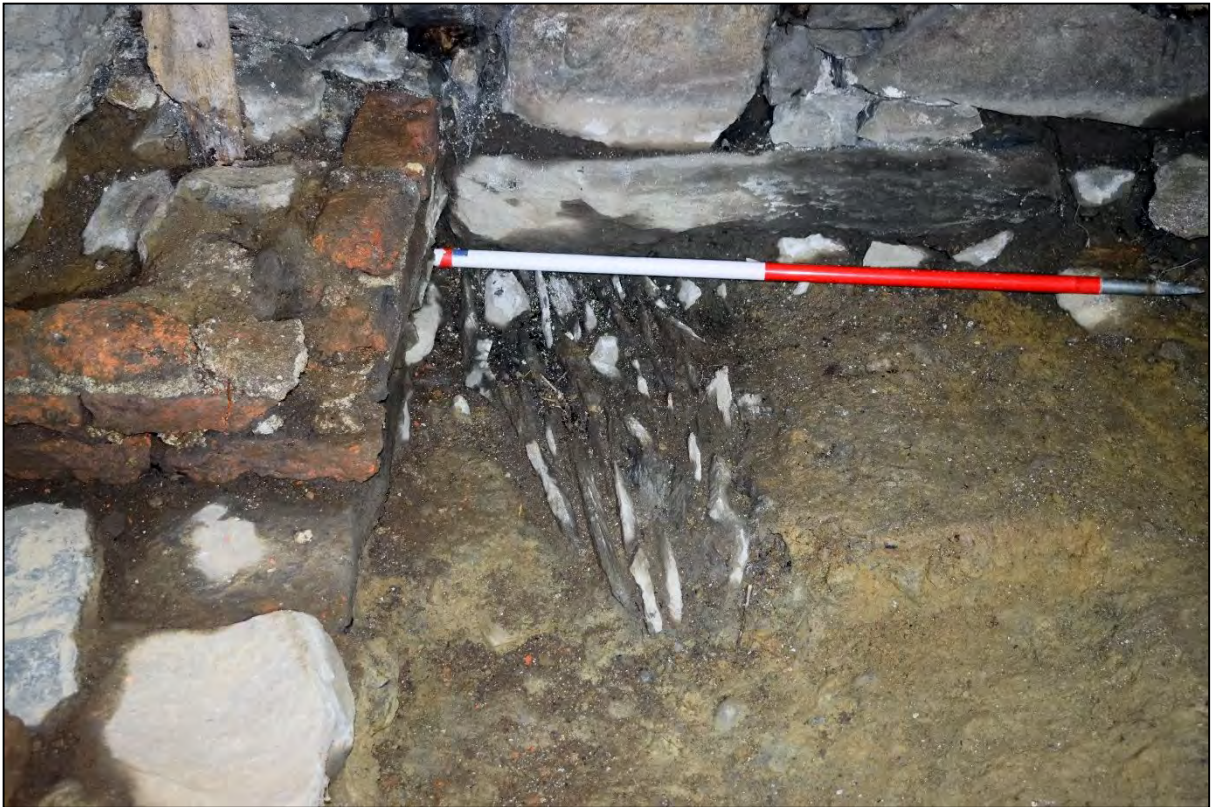
Plate 28: Pitched stone drain (Context 6)

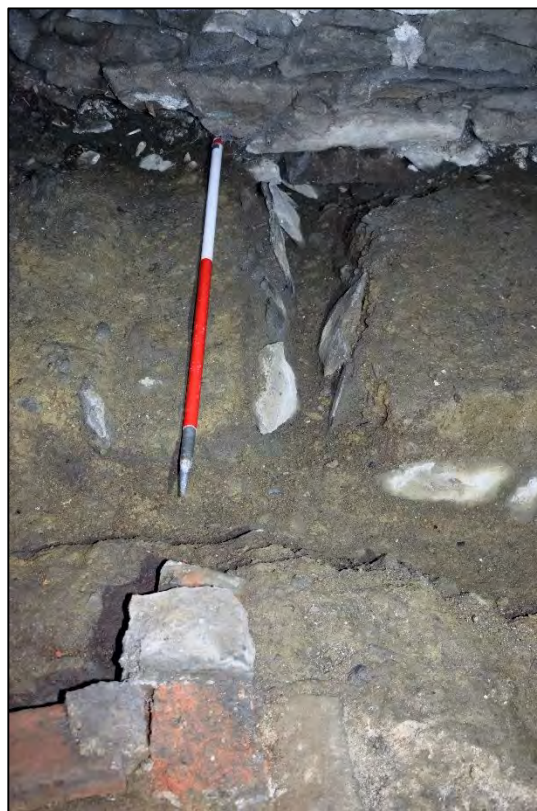
Plate 29: Drain, Context 8

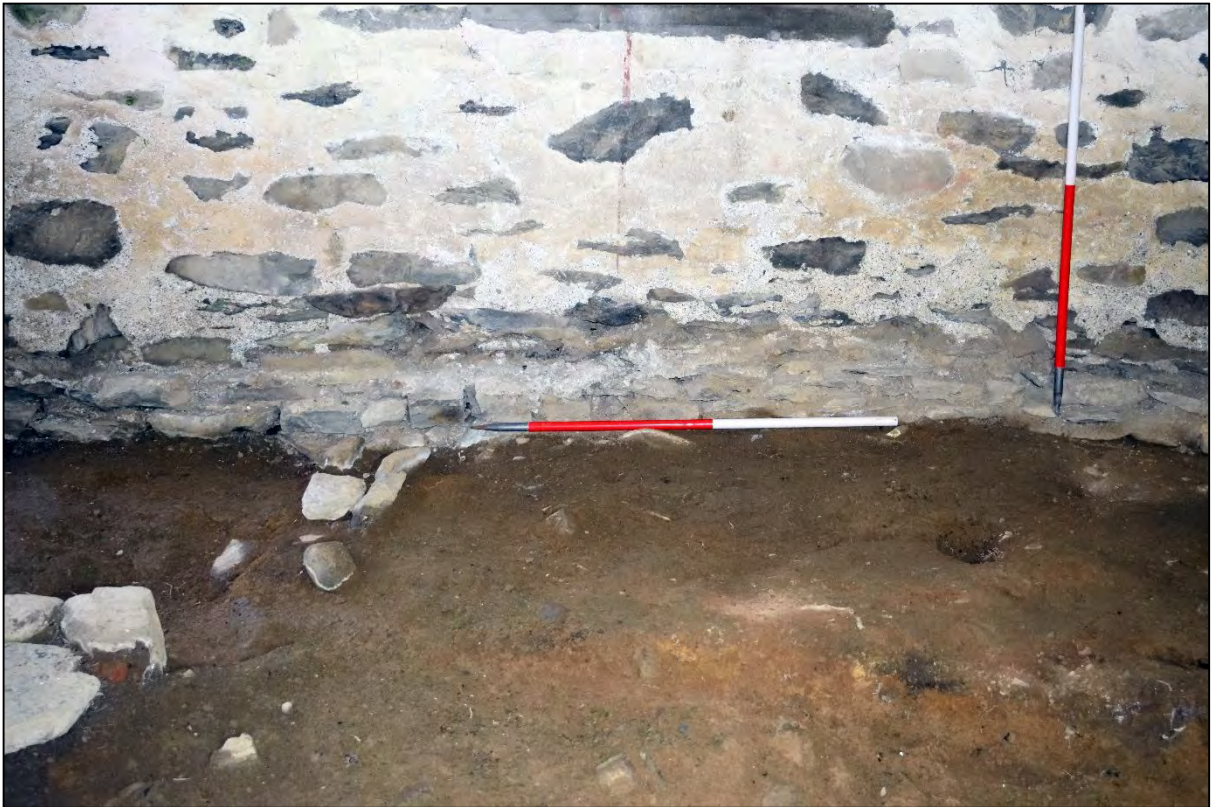
Plate 30: Drain, Context 10 and footings of the western gable wall
