**Penrhyn Mawr Archaeological  
Assessment**

***EAS Client report 2018/11***

**Project Commissioned  
by  
The National Trust**

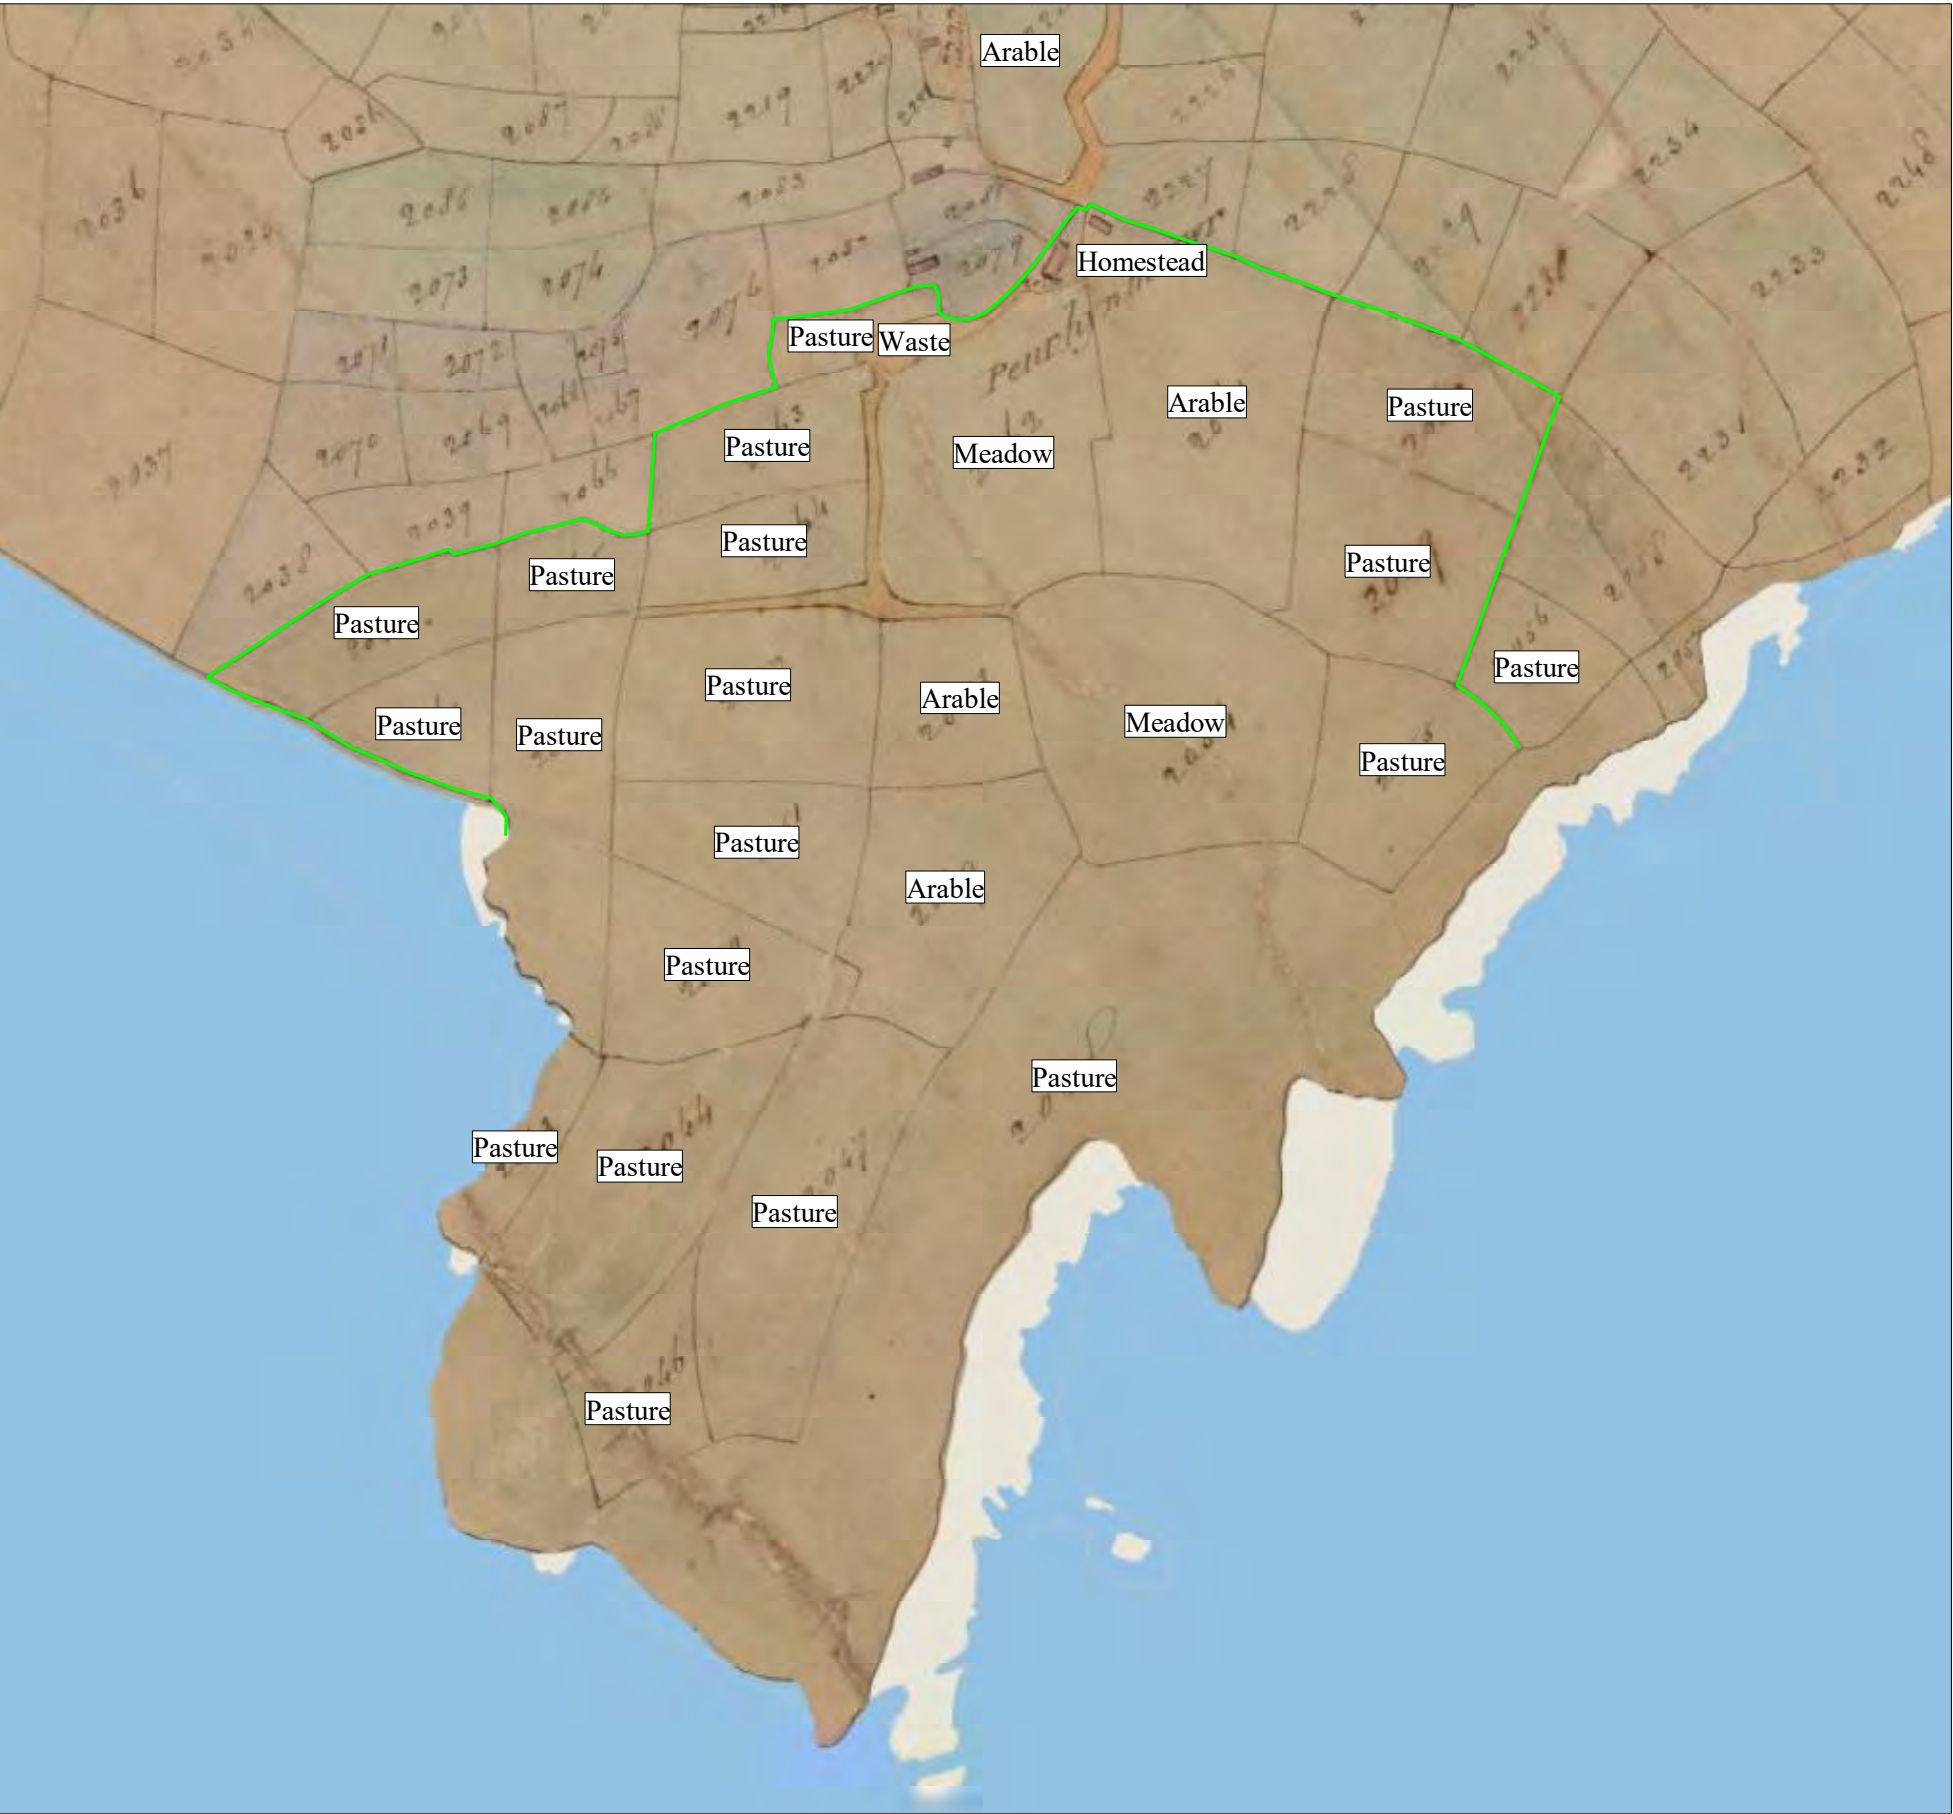
Figure 3: 1841 Tithe Map  
Scale 1:5000 (approx.)

By the time of the Tithe Map in 1841 the tenant was William Roberts. The apportionment for this map records the land use for each of the fields (Figure 3). The majority of the fields were set down to pasture, however there were four arable field and two fields described as meadows ([https://places.library.wales/browse/53.228/-3.414/16?page=1&alt=&occupier\\_facet%5B%5D=William+Roberts&landowner\\_facet%5B%5D=Edwards%2C+Richard+Lloyd](https://places.library.wales/browse/53.228/-3.414/16?page=1&alt=&occupier_facet%5B%5D=William+Roberts&landowner_facet%5B%5D=Edwards%2C+Richard+Lloyd)). This presumably suggest that the meadows were set aside for the production of hay rather than being pasture used for directly feeding animals. The buildings shown on this map are difficult to relate to the current buildings, however the main role of the Tithe maps was to record the agricultural land on which the Tithe could be levied, rather than the buildings.

The barn (Plate 3) is a tripartite building with the barn proper at the eastern end and a cart shed at the western end. Above the cart shed is a granary which preserves some of its wooden storage bins. Access to these bins was via a set of stone steps (Plate 4) on the western gable end of the building. Both this building and the farmhouse can be shown to have been constructed before 1889 as they appear on the First Edition Ordnance Survey map (Figure 4) and possibly on the Tithe Map of 1841 (Figure 3).

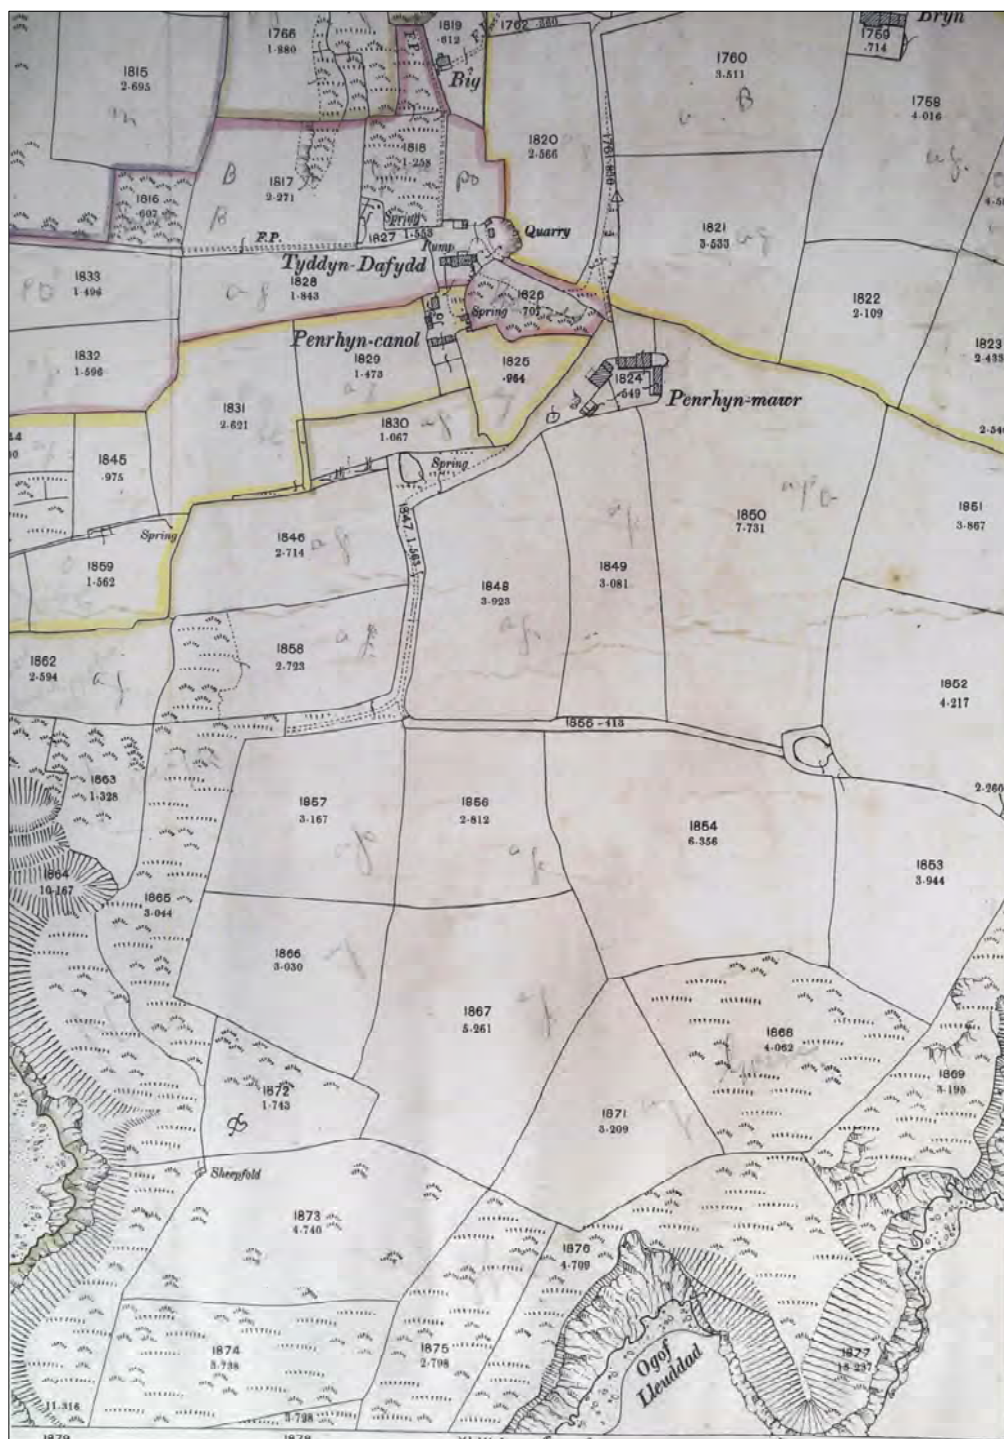
Figure 5: 1900 Carnarvonshire XLIII.16 Map  
Re-scaled to 1:5,000

The Ordnance Survey maps published between 1889 and 1918 (Figures 4 – 6) show some development of the farm during this period (Figure 7). The 1889 map (Figure 4) shows that the house and the barn range had already been built, but there are also two other buildings within the complex that have been demolished by 1900 (Figure 5). A dotted line to the north of the house shown only on the 1889 map possibly suggests there was a horse gin on the farm. The 1900 map shows the addition of the cow house and the pig sties to the south-west of the house; however, the possible horse gin has been lost, presumably reflecting the increased availability of small agricultural engines in the early part of the 20<sup>th</sup> century. No further changes to the farmyard are recorded on the map published in 1918 (Figure 6). There are, however differences between the layout of the fields today when compared with the historic mapping. These “lost” boundaries are shown on Figure 2. One feature, on the historic mapping that does not survive to such a degree are the lanes leading from the farmyard to the ponds within the property.

The cowshed (NT PRN 48401, Plate 5) forms the eastern side of the farmyard. It was constructed between 1889 and 1900 (Figures 4 and 5). This is a single storeyed stone built building, however the yard to the rear of this building is of later date.

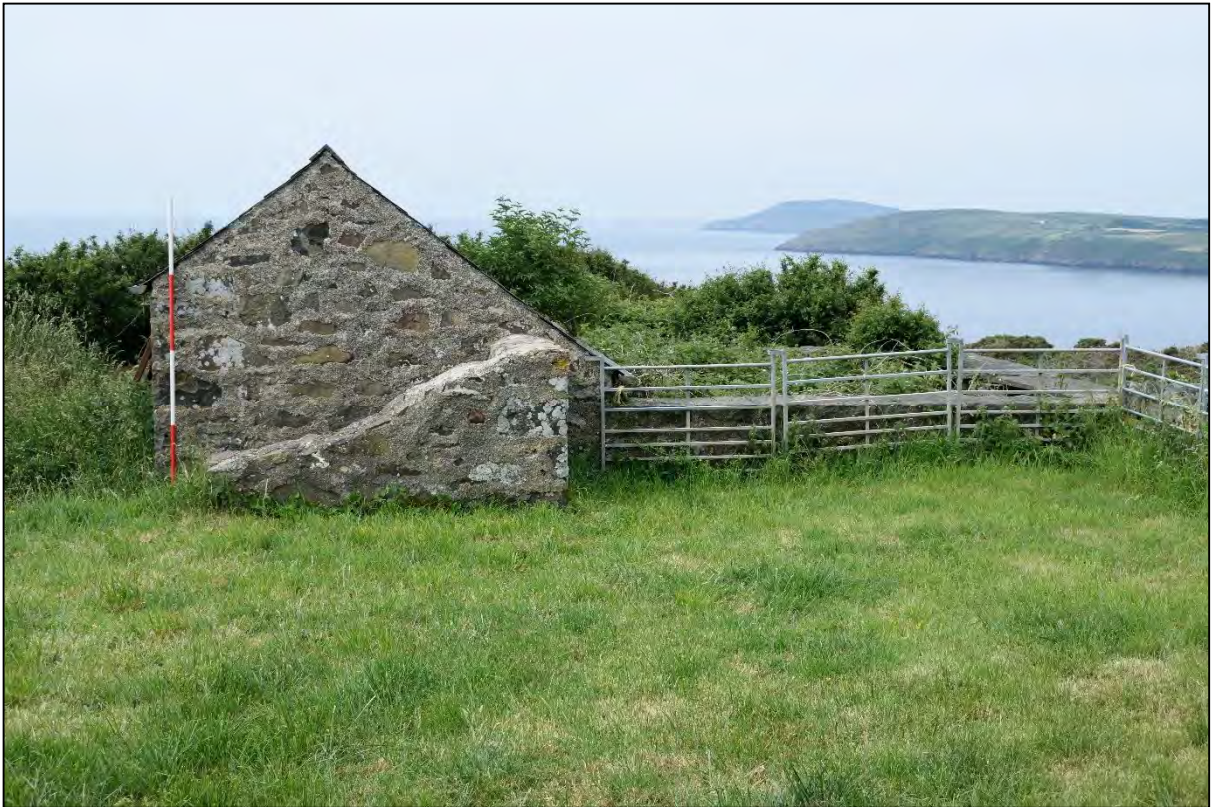
Plate 7: Pig sties (NT PRN 48405) looking SW

The last building is the pig sties (NT PRN 48405, Plates 7 and 8) to the south-west of the farmhouse. This was constructed between 1889 and 1900 and has a set of pens with feeders (Plate 8) to the north west. The roof of the pig sties has been replaced in the recent past, however no maintenance has taken place in the pens which means they are now being damaged by shrubby vegetation growing in the pens and on their walls. The pig sties are linked to the farmhouse by a stone wall (NT PRN 48407, Plate 9) which has a series of chambers in its base on the northern side. These are not drains as they do not run through the wall. One possibility is that they were designed to take bee skeps.

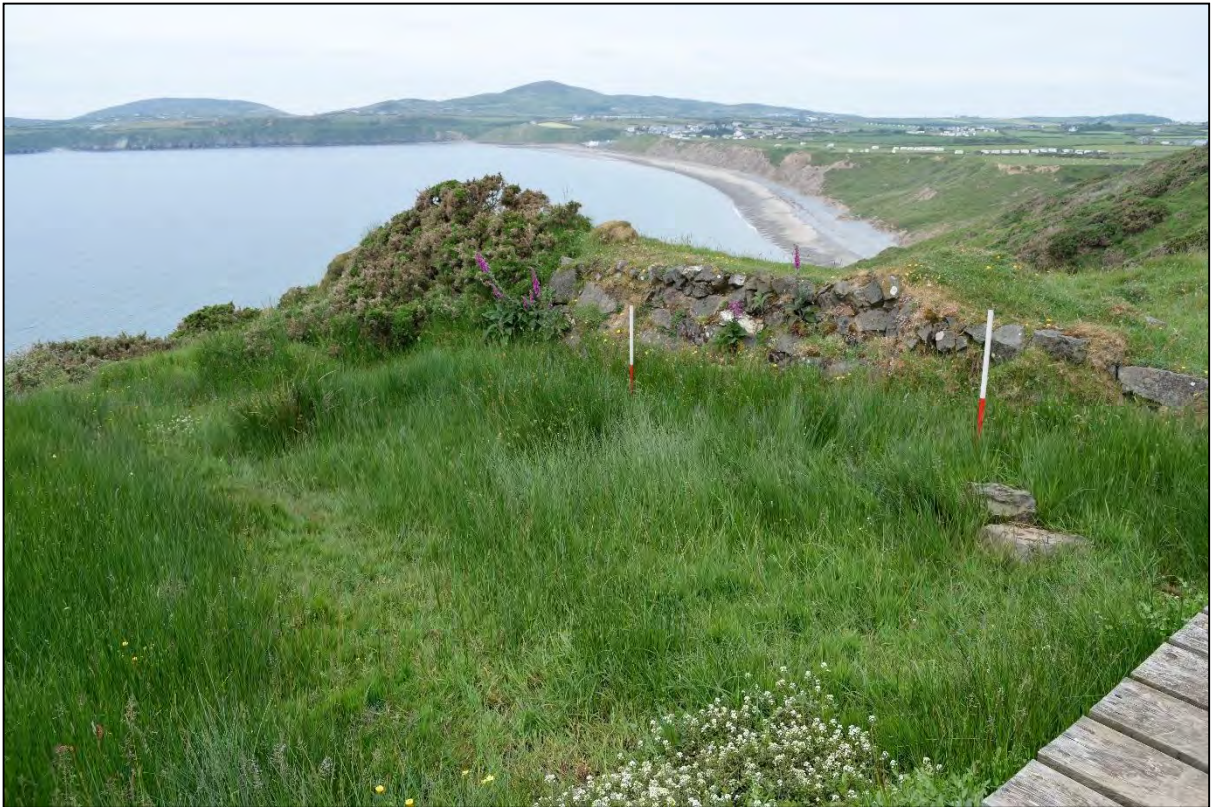
Plate 13: Drainage channel (NT PRN 48416), looking NW

A major drain from the fields (NT PRN 48416, Plate 13) on the western side of the property appears to continue the line of a clawdd wall crossing the property. This wall is shown in cyan on Figure 8.

<b>NT PRN</b>	48416	<b>Name</b>	Penrhyn Mawr Channel 2
<b>Grid Reference</b>	SH 18715 25648

<b>SAM Number.</b>			
<b>Listed Building Number</b>			
<b>NPRN</b>			
<b>PRN</b>			
<b>Monument Type</b>	Channel		
<b>Record Type</b>	Boundary		
<b>Date</b> Post medieval			
<b>Description</b> Channel up to 5 m wide with a dry-stone wall up to 1 m high on its northern side. Wall 1 m wide and partly revetted into the slope. Channel drains farmland over the cliff.			
<b>Survival</b>	Moderate	<b>Condition</b>	Fair
<b>Stability</b>	Slow Deterioration	<b>Vulnerability</b>	Low
<b>Significance</b>	Local		
<b>Comment</b>			
<b>Recommendations</b> Maintain wooden bridge over channel			
<b>Photographs</b>	Penrhyn Mawr_027		
<b>Recorded by</b>	IB	<b>Date</b>	13/6/2018

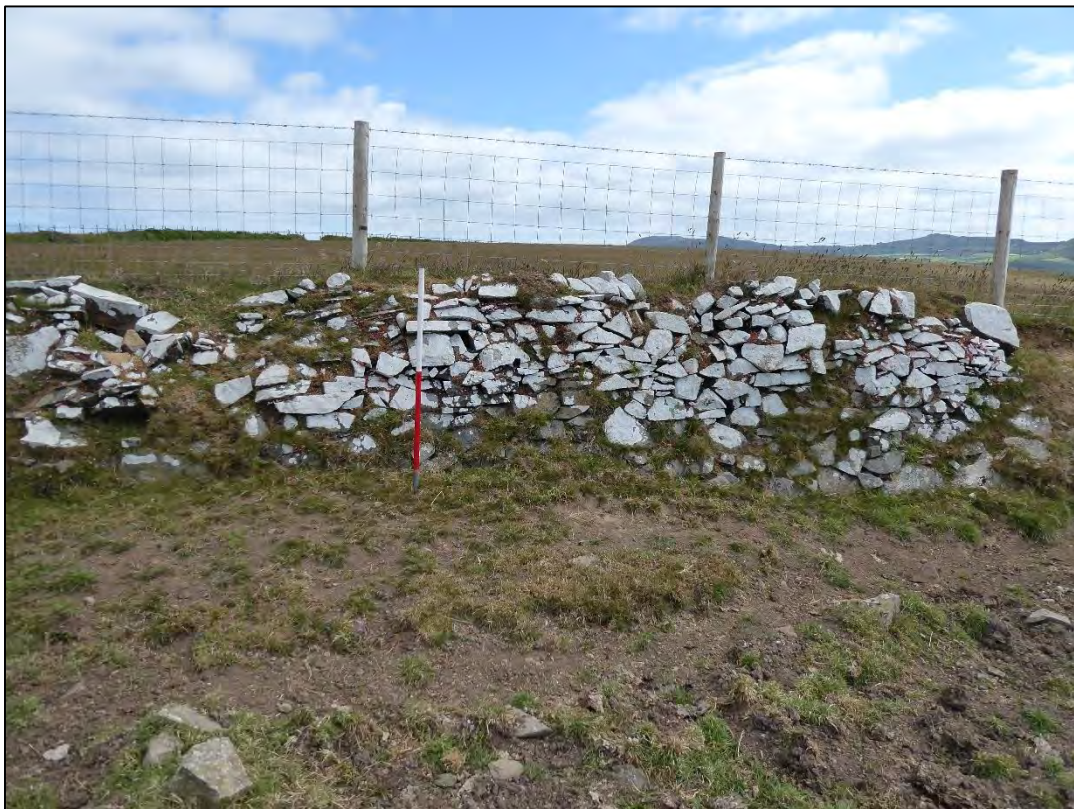
Plate 14: Clawdd wall

One boundary stands out as having more survival of stone facing and in general being slightly larger (wider and higher) than the other boundaries on the property (Plate 14). This boundary is shown in cyan on Figure 8 as is other areas where the stone facing to the banks is more evident. This boundary, however, appears to be a major boundary and may mark the limits of an early field system.

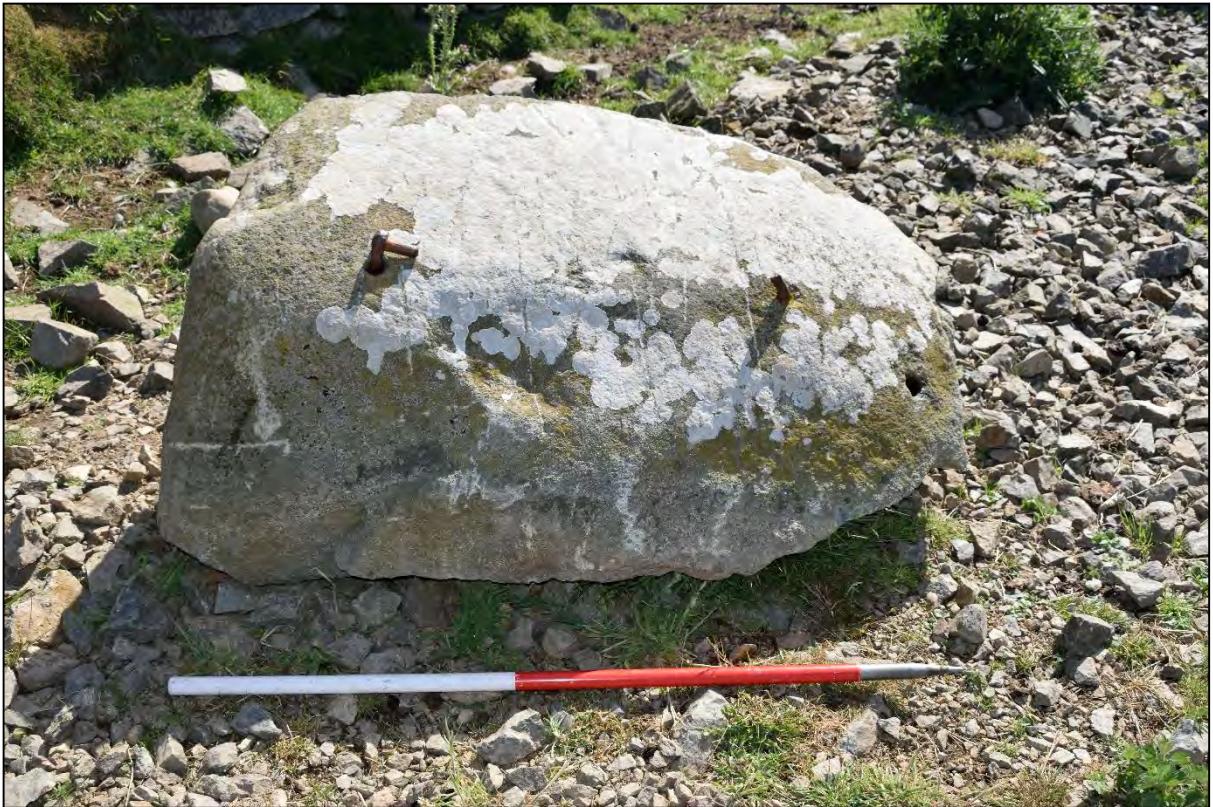
Plate 15: Boulder gate post NT PRN 48436

Some of the gateways between the fields retain their stone boulder gate posts (NT PRN 48430 – 48436, 48443 and 48445). These are made from large glacial boulders, some of which have been split to produce a flat face and some retain evidence of their original fittings. It is thought that many of these may have been moved as gateways have been widened, however a few may still be *in situ*. One boulder, now lying loose in the fields, appears to have a series of parallel lines running across its face (Plate 15) which may be deliberate markings, but are more likely to be natural marks.

1. A more detailed desktop study looking at the records of the Nanhoron Estate held by the National Library of Wales may reveal more details of the history of the property
2. The loose boulder gate post (NT PRN 48436) should be re-positioned so that it is protected from further damage
3. More detail recording of the buildings might be considered to fully record these structures
4. The barn is in need of some maintenance and the bins above the cart shed should be recorded and if possible re-constructed.
5. The yards in front of the pig sties should be cleared of invasive vegetation
6. The promontory fort should be considered for scheduling
7. The area of the promontory fort and the possible hut platforms are at risk from coastal erosion. This area should be recorded in more detail with at least a detailed topographic survey as a base-line for any further work considered.

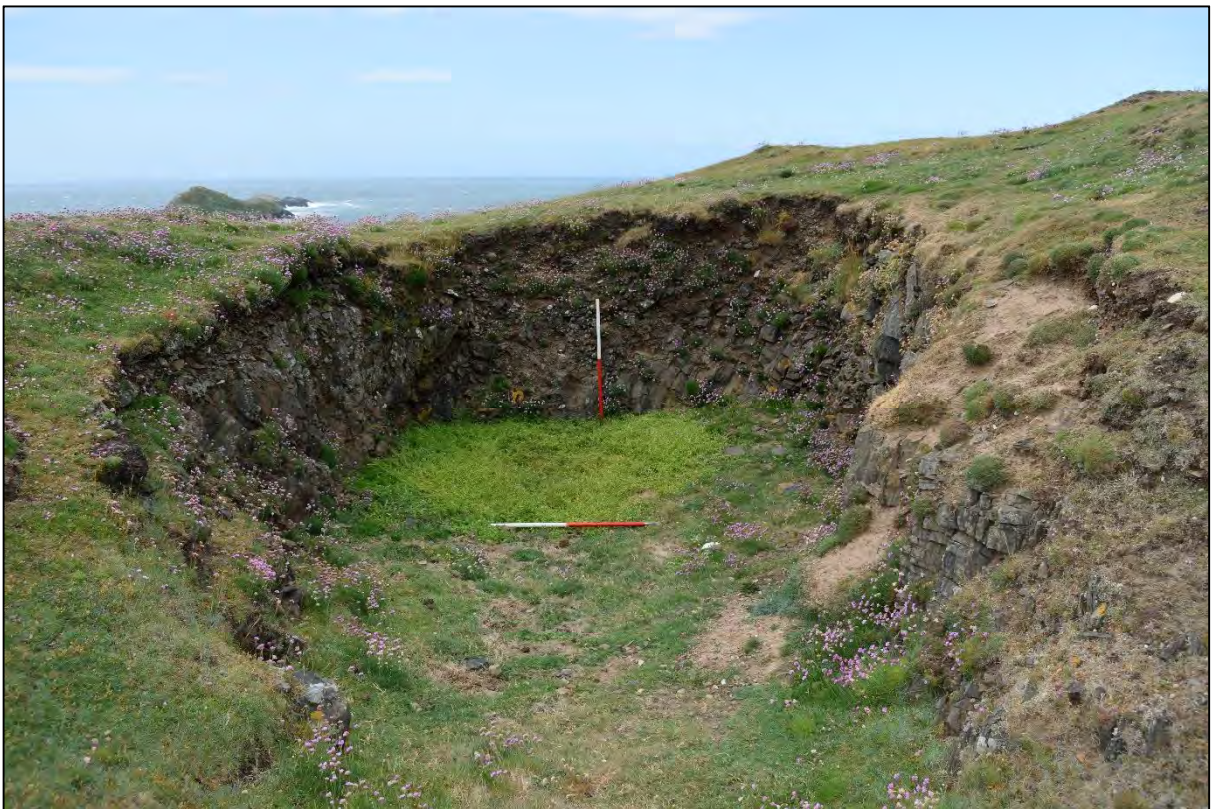
Plate 16: Quarry NT PRN 48437

A limited amount of quarrying has taken place along the coastal strip. A group of small, informal quarries (NT PRN 48425, 48427 – 48429) are likely to have been dug to provide stone for the construction or maintenance of the clawdd walls. NT PRN 48437, however, is distinctive, forming a neat rectangle approximately 6 x 3 m in size and up to 1.5 m deep with an entrance to the east. It has previously been suggested that this may be a hut platform (PRN 770), however this seems unlikely. There is also some evidence for a causeway leading to this feature across the ditch of the promontory fort created by infilling the ditch. The function and date of this feature is unknown, however the uneroded nature of the faces of the quarry would suggest it is a post-medieval feature.

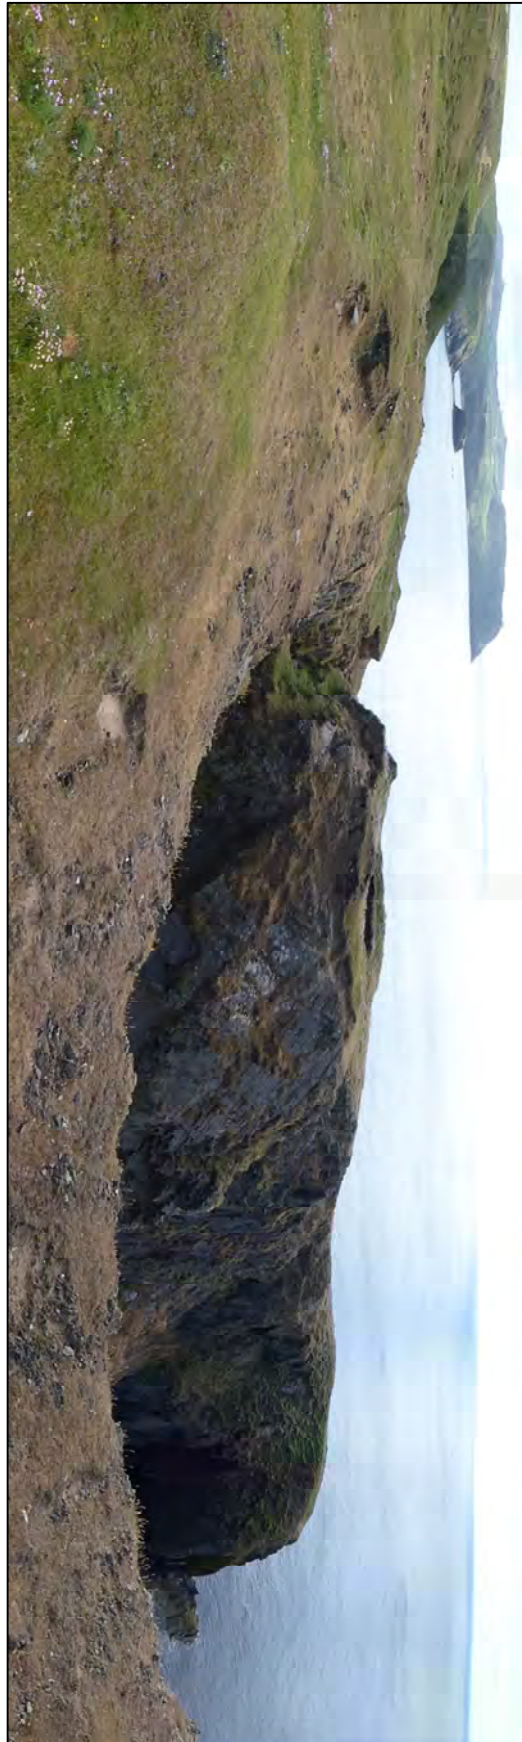
Plate 17: Panorama of Trwyn Gwningaer Promontory Fort NT PRN 48438

The only feature of probable prehistoric date is the Trwyn Gwningaer Promontory Fort (NT PRN 48438, Plates 17 – 19). A deep, rock cut ditch (Plate 18) cuts off the promontory which takes advantage of a natural rock cleft to form the northern side of the ditch at the western end. Within this feature are the remains of two possible ramparts (Plate 19), one of which follows the line of the ditch whilst the other forms an “L” shaped feature diverging from the line of the ditch. No features were recorded from within the promontory fort, however a cave (Plates 20 and 21) was noted partway down the cliff on the western side of the promontory. There are many sea caves along this part of the coast, however caves at this higher level are unusual. It was not possible to inspect this cave, but the apparent flat top may suggest some form of human manipulation to this feature.

PRN	NPRN	Listed Building Number	Grid	Name	Description
	408644		SH 1886 2521	Trwyn Gwningaer Promontory Fort	Probable remains of coastal promontory fort, comprising deep ditch cutting up neck of promontory, now eroding on its west side, and crossed by a minor causeway giving access to the interior. Recorded during RCAHMW aerial reconnaissance on 9th Feb 2006 but not investigated on the ground

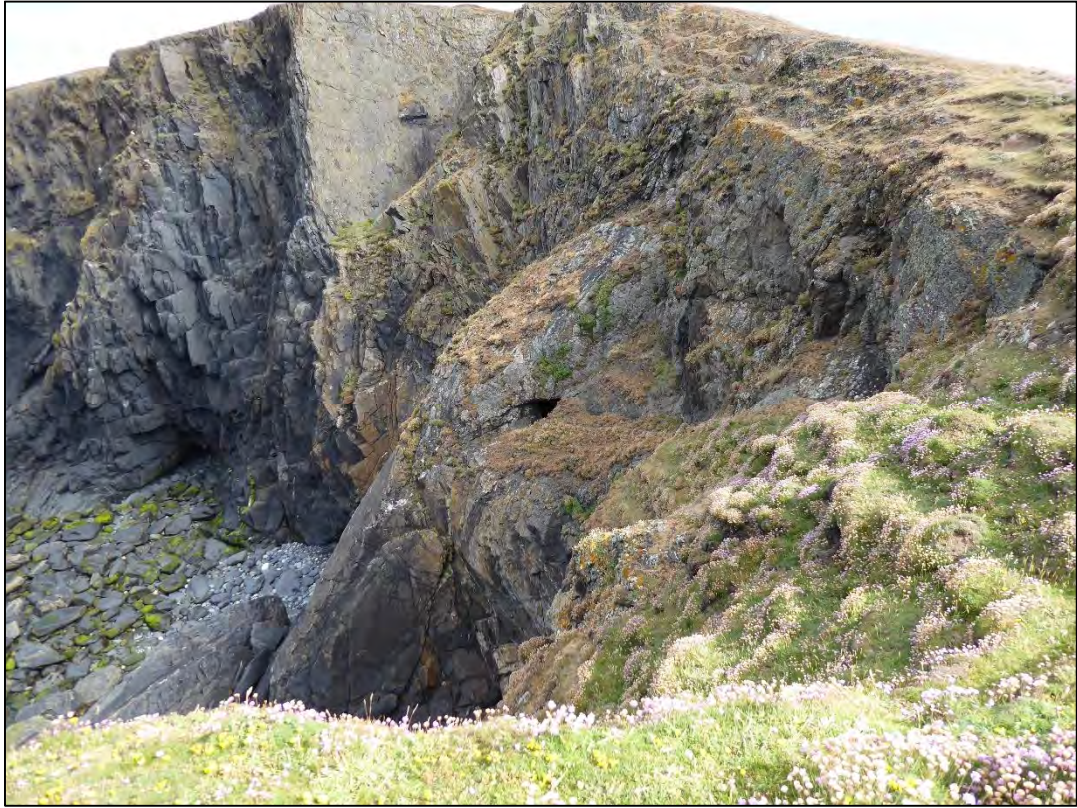
Plate 20: Possible cave below the Trwyn Gwningaer Promontory Fort

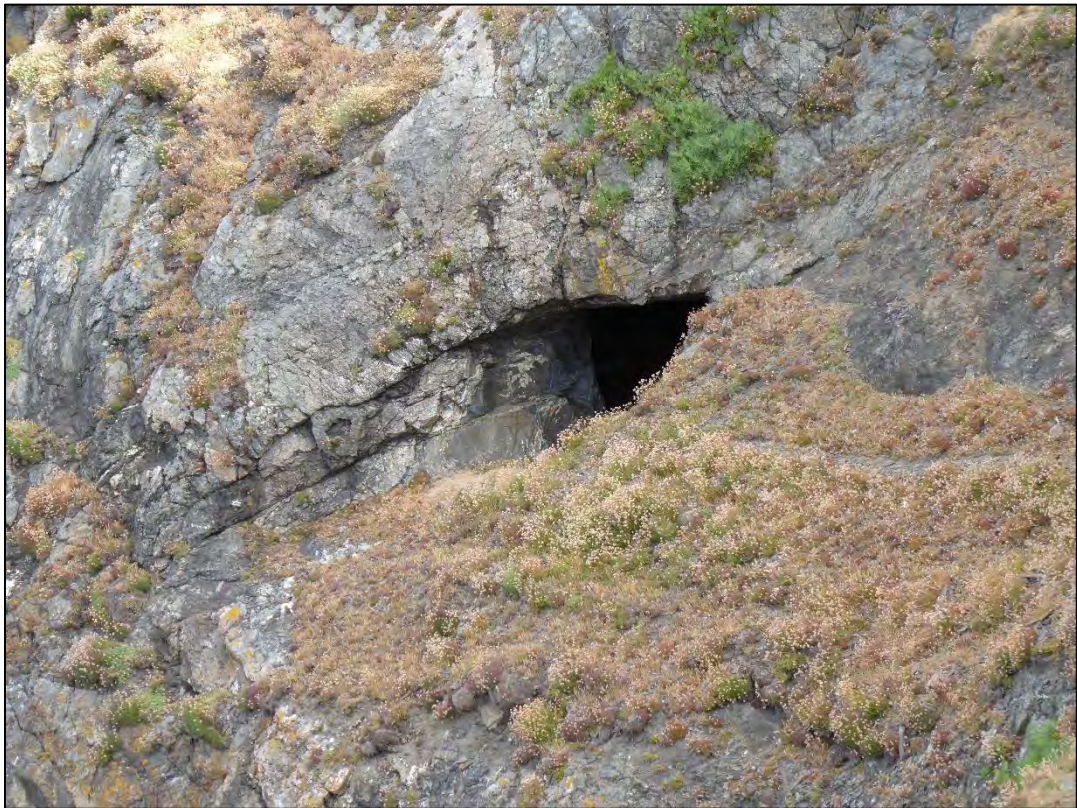
Plate 21: Detail of the possible cave below Trwyn Gwningaer Promontory Fort

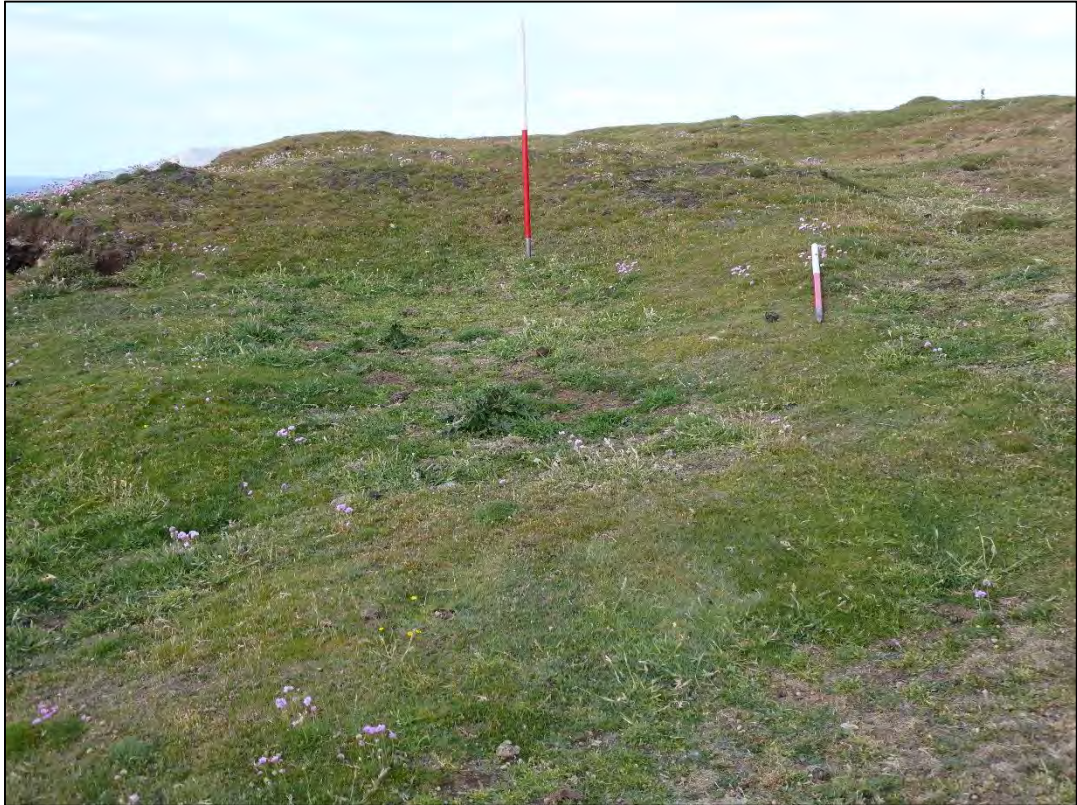
Plate 24: Possible hut platform NT PRN 48440

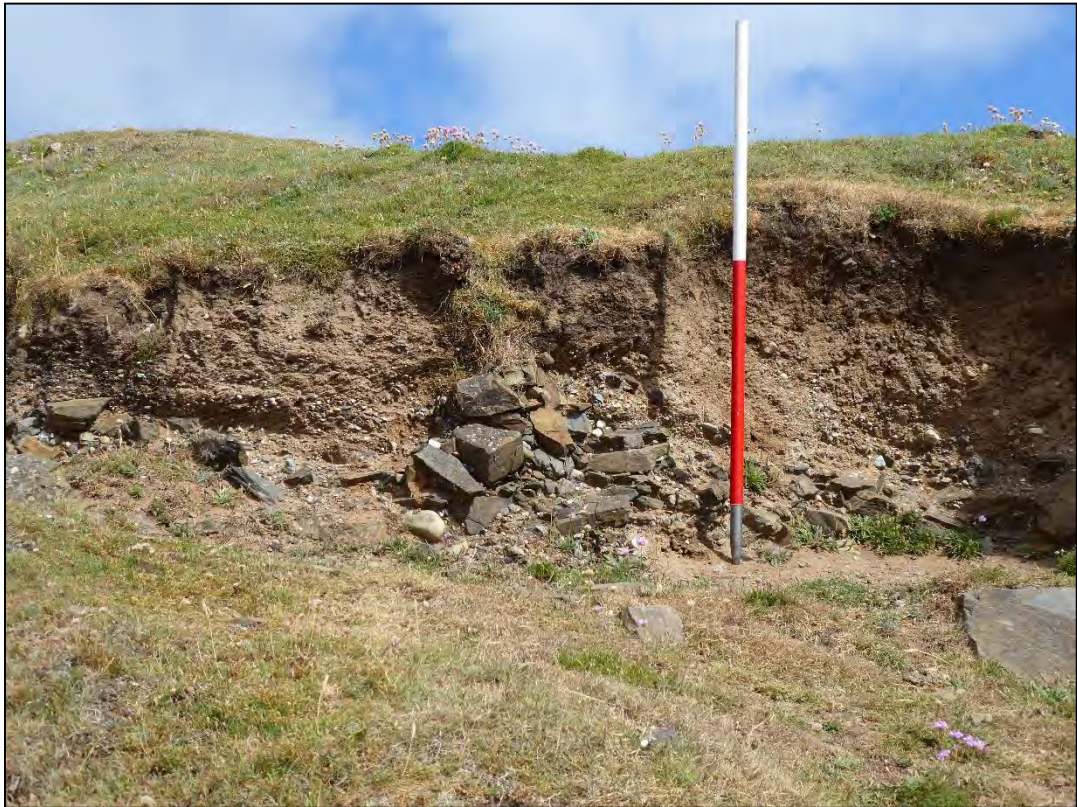
Plate 26: Possible wall for NT PRN 48439

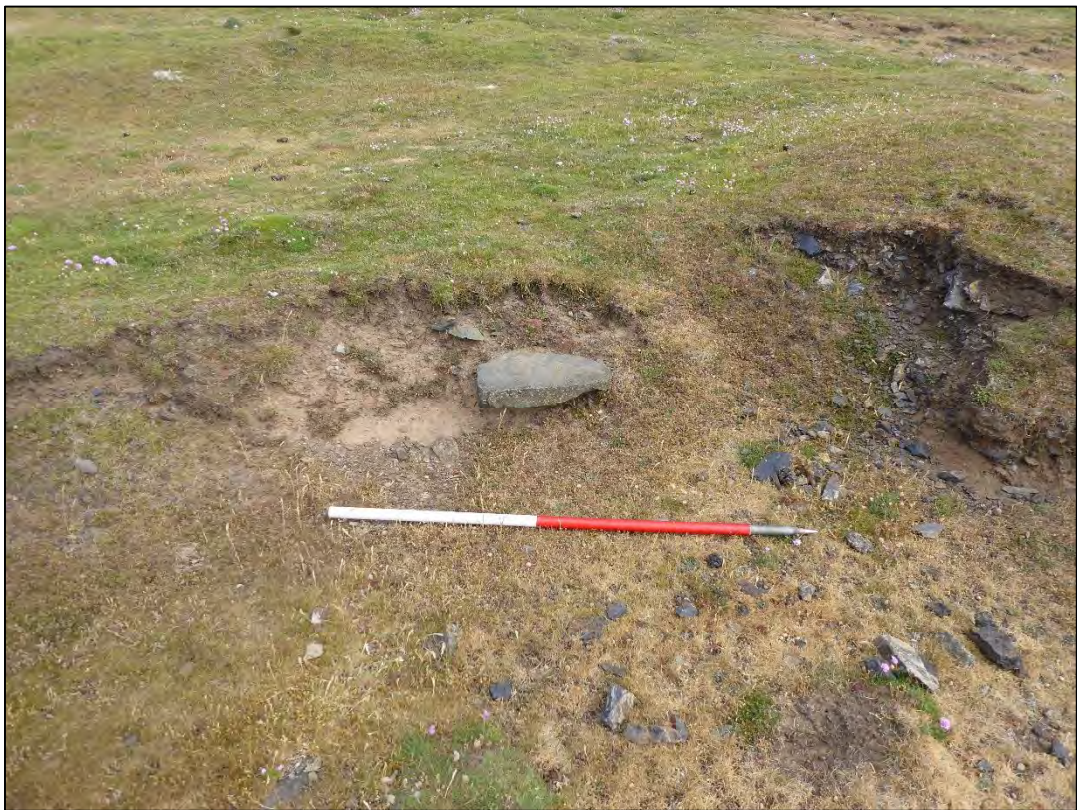
Plate 27: Flat stone suggesting a stone floor to NT PRN 48440

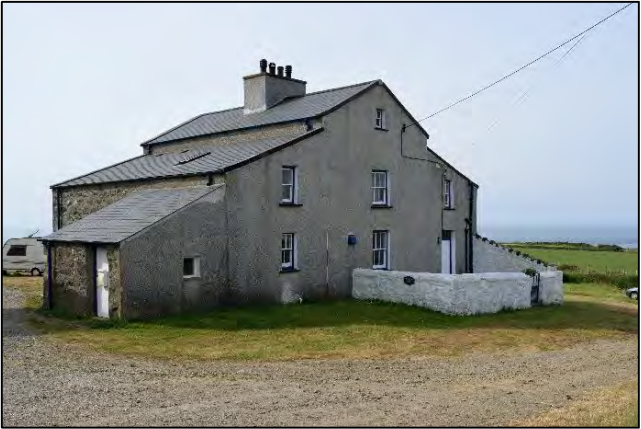
<b>NT PRN</b>	MNA184502	<b>Name</b>	Penrhyn Mawr
<b>Grid Reference</b>	SH 18997 26159

<b>SAM Number.</b>			
<b>Listed Building Number</b>	19997		
<b>NPRN</b>			
<b>PRN</b>	62903		
<b>Monument Type</b>	Farmhouse		
<b>Record Type</b>	Building		
<b>Date</b> Post-medieval			
<b>Description</b> Grade II listed building. Two and a half storey farmhouse orientated NW - SE with an unusual gable form similar to a central nave with flanking aisles. Stone built but with pebble dash coating. Lean too extension to the NE. Central chimney, modern slate roof. Sash windows			
<b>Survival</b>	Good	<b>Condition</b>	Good
<b>Stability</b>	Stable	<b>Vulnerability</b>	Low
<b>Significance</b>	Regional		
<b>Comment</b> Now used as a holiday let at least in part			
<b>Recommendations</b> Maintain			
<b>Photographs</b>	Penrhyn Mawr_001 - 003		
<b>Recorded by</b>	IB	<b>Date</b>	13/6/2018

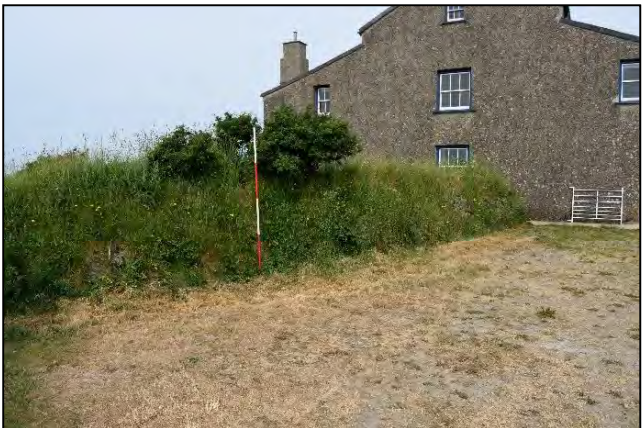
<b>NT PRN</b>	48402	<b>Name</b>	Penrhyn Mawr Farmyard Boundary
<b>Grid Reference</b>	SH 19002 26157 – SH 19036 26142

<b>SAM Number.</b>			
<b>Listed Building Number</b>			
<b>NPRN</b>			
<b>PRN</b>			
<b>Monument Type</b>	Clawdd Wall		
<b>Record Type</b>	Boundary		
<b>Date</b> Post Medieval			
<b>Description</b> Clawdd wall up to 1.5 m high and 1.5 m thick with dry stone facing. Cut by modern access to the fields adjacent to modern cowshed/build			
<b>Survival</b>	Moderate	<b>Condition</b>	Fair
<b>Stability</b>	Stable	<b>Vulnerability</b>	Medium
<b>Significance</b>	Local		
<b>Comment</b>			
<b>Recommendations</b> Maintain in current condition. Try not to destroy any more			
<b>Photographs</b>	Penrhyn Mawr_009		
<b>Recorded by</b>	IB	<b>Date</b>	13/6/2018

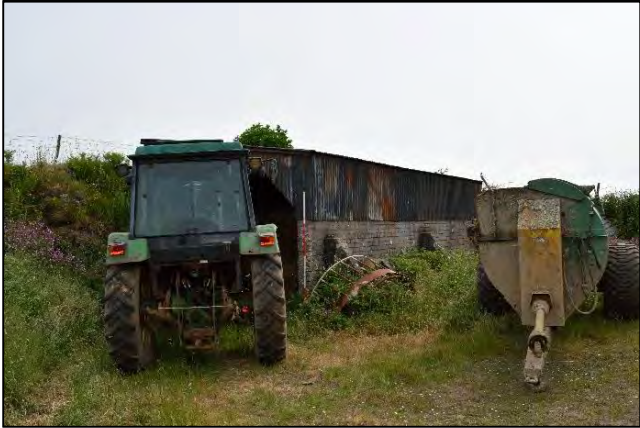
<b>NT PRN</b>	48403	<b>Name</b>	Penrhyn Mawr Shed
<b>Grid Reference</b>	SH 19027 26196

<b>SAM Number.</b>			
<b>Listed Building Number</b>			
<b>NPRN</b>			
<b>PRN</b>			
<b>Monument Type</b>	Building		
<b>Record Type</b>	Building		
<b>Date Modern</b>			
<b>Description</b> Open gable ended building with concrete brick walls to about 1.5 m and corrugated iron roof and superstructure. There are two buttresses on the southern wall			
<b>Survival</b>	Moderate	<b>Condition</b>	Fair
<b>Stability</b>	Slow Deterioration	<b>Vulnerability</b>	Low
<b>Significance</b>	Local		
<b>Comment</b> Part of farm yard, style suggests it pre-dates the large framed farm buildings			
<b>Recommendations</b> Maintain			
<b>Photographs</b>	Penrhyn Mawr_010		
<b>Recorded by</b>	IB	<b>Date</b>	13/6/2018

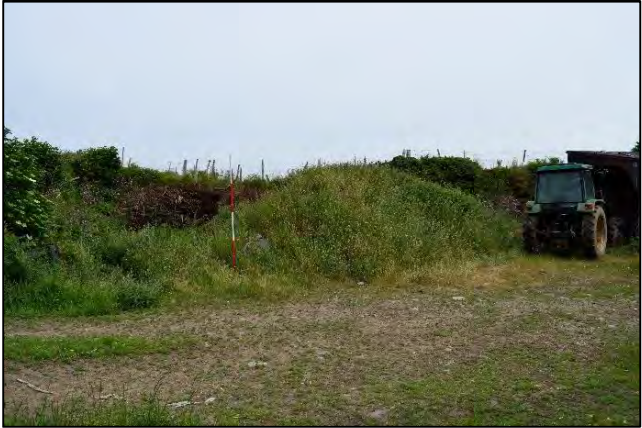
<b>NT PRN</b>	48404	<b>Name</b>	Penrhyn Mawr Farm Quarry
<b>Grid Reference</b>	SH 19016 26195

<b>SAM Number.</b>			
<b>Listed Building Number</b>			
<b>NPRN</b>			
<b>PRN</b>			
<b>Monument Type</b>	Quarry		
<b>Record Type</b>	Landscape Feature		
<b>Date Modern</b>			
<b>Description</b> Northern end of the yard, to the north of the farm buildings quarried to a depth of about 3 m to produce a flat area behind the buildings			
<b>Survival</b>	Good	<b>Condition</b>	Fair
<b>Stability</b>	Stable	<b>Vulnerability</b>	Low
<b>Significance</b>	Local		
<b>Comment</b> Now partly used as a dumping area for the farm			
<b>Recommendations</b> Maintain			
<b>Photographs</b>	Penrhyn Mawr_011		
<b>Recorded by</b>	IB	<b>Date</b>	13/6/2018

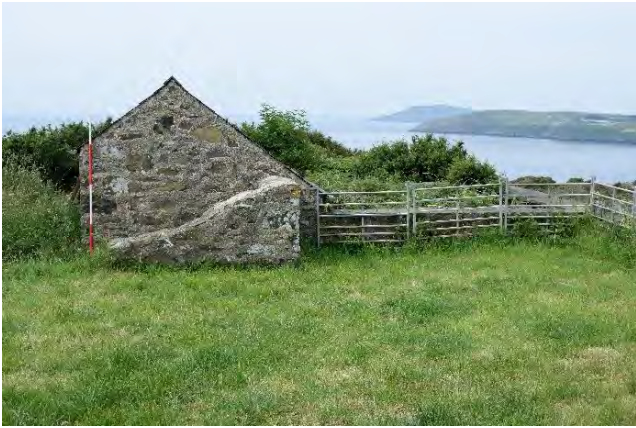
<b>SAM Number.</b>			
<b>Listed Building Number</b>			
<b>NPRN</b>			
<b>PRN</b>			
<b>Monument Type</b>	Pig Sty		
<b>Record Type</b>	Building		
<b>Date</b> Post Medieval			
<b>Description</b> Range of stone-built pig sties with attached yards to the NW and possible Ty Bach on gable end nearest to the house. Slate feeding baffles fitted to the front of the yards. Modern slate roof			
<b>Survival</b>	Good	<b>Condition</b>	Fair
<b>Stability</b>	Stable	<b>Vulnerability</b>	Medium
<b>Significance</b>	Local		
<b>Comment</b> It looks as if the roof has been replaced in the recent past			
<b>Recommendations</b> Although the building appears to be in good condition the yards are bramble choked and elder and other shrubs starting to grow. Remove			
<b>Photographs</b>	Penrhyn Mawr_012, 013 and 015		
<b>Recorded by</b>	IB	<b>Date</b>	13/6/2018

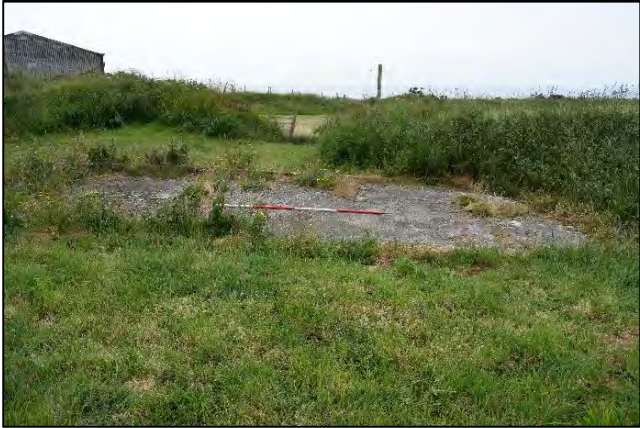
<b>NT PRN</b>	48406	<b>Name</b>	Penrhyn Mawr Concrete Platform
<b>Grid Reference</b>	SH 19005 26144

<b>SAM Number.</b>			
<b>Listed Building Number</b>			
<b>NPRN</b>			
<b>PRN</b>			
<b>Monument Type</b>	Concrete Base		
<b>Record Type</b>	Building		
<b>Date Modern</b>			
<b>Description</b> Concrete base 8 x 4 m in size with single skin brick walling surviving to one course. Within the garden. Possible greenhouse base.			
<b>Survival</b>	Moderate	<b>Condition</b>	Poor
<b>Stability</b>	Slow Deterioration	<b>Vulnerability</b>	Low
<b>Significance</b>	Minimal		
<b>Comment</b> Probably the base for a green house within the garden			
<b>Recommendations</b> None			
<b>Photographs</b>	Penrhyn Mawr_014		
<b>Recorded by</b>	IB	<b>Date</b>	13/6/2018

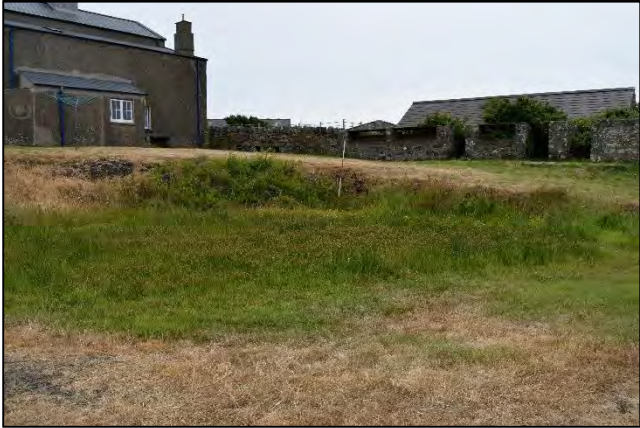
<b>NT PRN</b>	48408	<b>Name</b>	Penrhyn Mawr Pond 1
<b>Grid Reference</b>	SH 18982 26153

<b>SAM Number.</b>			
<b>Listed Building Number</b>			
<b>NPRN</b>			
<b>PRN</b>			
<b>Monument Type</b>	Pond		
<b>Record Type</b>	Landscape Feature		
<b>Date</b> Post Medieval			
<b>Description</b> Sub-rectangular pond (9 x 10 m), cut into the slope by 1.5 m on its eastern edge. Now largely silted up			
<b>Survival</b>	Moderate	<b>Condition</b>	Fair
<b>Stability</b>	Stable	<b>Vulnerability</b>	Low
<b>Significance</b>	Local		
<b>Comment</b> Pond largely infilled, although the area is still damp.			
<b>Recommendations</b> Maintain, do not destroy. Consider re-opening			
<b>Photographs</b>	Penrhyn Mawr_017		
<b>Recorded by</b>	IB	<b>Date</b>	13/6/2018

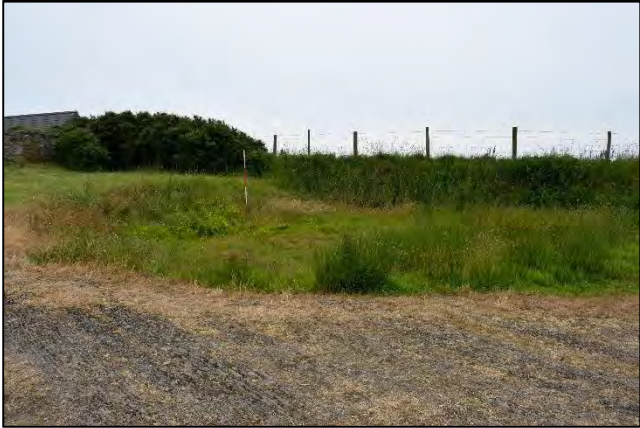
<b>NT PRN</b>	484809	<b>Name</b>	Penrhyn Mawr Pond 2
<b>Grid Reference</b>	SH 18970 26134

<b>SAM Number.</b>			
<b>Listed Building Number</b>			
<b>NPRN</b>			
<b>PRN</b>			
<b>Monument Type</b>	Pond		
<b>Record Type</b>	Landscape feature		
<b>Date</b> Post medieval			
<b>Description</b> Roughly circular pond, cut into the slope by approximately 1 m. 10 m diameter. Now largely silted up. Possibly used as a soak away			
<b>Survival</b>	Moderate	<b>Condition</b>	Fair
<b>Stability</b>	Stable	<b>Vulnerability</b>	Low
<b>Significance</b>	Local		
<b>Comment</b> A deliberately dug pond cut into the hillslope.			
<b>Recommendations</b> Maintain, do not destroy. Consider re-opening			
<b>Photographs</b>	Penrhyn Mawr_018		
<b>Recorded by</b>	IB	<b>Date</b>	13/6/2018

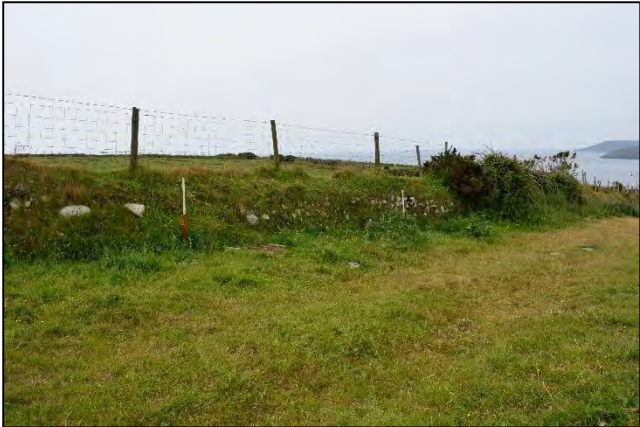
<b>NT PRN</b>	48410	<b>Name</b>	Penrhyn Mawr Clawdd Wall 1
<b>Grid Reference</b>	SH 18985 26132 – SH 18865 26951

<b>SAM Number.</b>			
<b>Listed Building Number</b>			
<b>NPRN</b>			
<b>PRN</b>			
<b>Monument Type</b>	Clawdd wall		
<b>Record Type</b>	Boundary		
<b>Date</b> Post medieval			
<b>Description</b> Clawdd wall on southern side of track to the west of the farm. 1 m high 1.5 m wide. Land much higher on southern side of the boundary.			
<b>Survival</b>	Moderate	<b>Condition</b>	Fair
<b>Stability</b>	Slow deterioration	<b>Vulnerability</b>	Low
<b>Significance</b>	Local		
<b>Comment</b> This boundary also contains the stone gate posts 48430 and continues to become the eastern side of the lane 48412			
<b>Recommendations</b> Maintain			
<b>Photographs</b>	Penrhyn Mawr_019		
<b>Recorded by</b>	IB	<b>Date</b>	13/6/2018

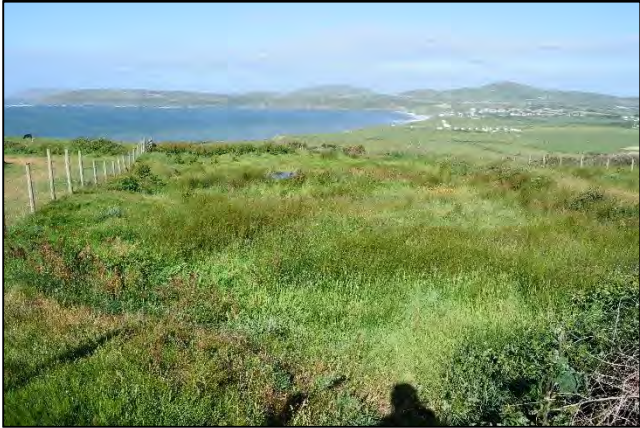
<b>NT PRN</b>	48411	<b>Name</b>	Penrhyn Pond 3
<b>Grid Reference</b>	SH 18871 26101

<b>SAM Number.</b>			
<b>Listed Building Number</b>			
<b>NPRN</b>			
<b>PRN</b>			
<b>Monument Type</b>	Pond		
<b>Record Type</b>	Landscape Feature		
<b>Date</b> Post medieval			
<b>Description</b> Two ponds set one above the other, each about 20 m in diameter. The upper pond is largely silted up whilst the lower pond, although silted retains water. Each of the ponds is dug into the hillslope with the western side dug into the slope and the western end built up.			
<b>Survival</b>	Moderate	<b>Condition</b>	Fair
<b>Stability</b>	Stable	<b>Vulnerability</b>	Low
<b>Significance</b>	Local		
<b>Comment</b> A deliberately dug set of ponds.			
<b>Recommendations</b> Maintain, consider cleaning out the upper pond.			
<b>Photographs</b>	Penrhyn Mawr_052		
<b>Recorded by</b>	IB	<b>Date</b>	13/6/2018
