**Penrhyn Mawr Archaeological  
Assessment**

***EAS Client report 2018/11***

**Project Commissioned  
by  
The National Trust**

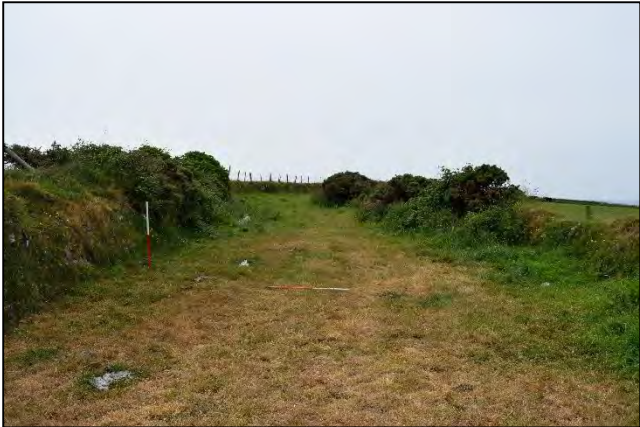
<b>NT PRN</b>	48412	<b>Name</b>	Penrhyn Mawr Lane
<b>Grid Reference</b>	SH 18941 26112 – SH 18861 25953

<b>SAM Number.</b>			
<b>Listed Building Number</b>			
<b>NPRN</b>			
<b>PRN</b>			
<b>Monument Type</b>	Lane		
<b>Record Type</b>	Route way		
<b>Date</b> Post medieval			
<b>Description</b> Lane to the west of the house typically 8 m wide and flanked by clawdd walls			
<b>Survival</b>	Moderate	<b>Condition</b>	Fair
<b>Stability</b>	Slow deterioration	<b>Vulnerability</b>	Medium
<b>Significance</b>	Local		
<b>Comment</b> The eastern boundary is made of 48410			
<b>Recommendations</b> Maintain			
<b>Photographs</b>	Penrhyn Mawr_020		
<b>Recorded by</b>	IB	<b>Date</b>	13/6/2018

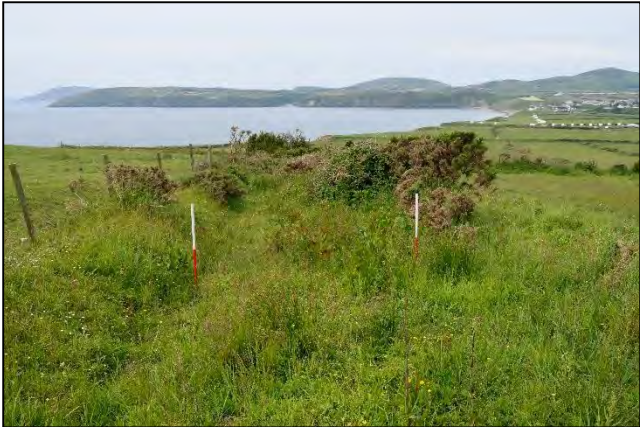
<b>NT PRN</b>	48413	<b>Name</b>	Penrhyn Mawr Channel 1
<b>Grid Reference</b>	SH 18856 26104 – SH 18805 26091

<b>SAM Number.</b>			
<b>Listed Building Number</b>			
<b>NPRN</b>			
<b>PRN</b>			
<b>Monument Type</b>	Water course		
<b>Record Type</b>	Landscape feature		
<b>Date</b> Post medieval			
<b>Description</b> Probable over flow channel from Pond complex 48411. Flat based channel between two low earthen banks, each approximately 0.5 m high and 1.5 m wide. To the south there is a slight hollow, 0.25 m deep and up to 4 m wide from which the earth for the southern bank was dug			
<b>Survival</b>	Moderate	<b>Condition</b>	Fair
<b>Stability</b>	Stable	<b>Vulnerability</b>	Low
<b>Significance</b>	Local		
<b>Comment</b> Overgrown towards the western end			
<b>Recommendations</b> Ideally remove gorse and brambles			
<b>Photographs</b>	Penrhyn Mawr_021		
<b>Recorded by</b>	IB	<b>Date</b>	13/6/2018

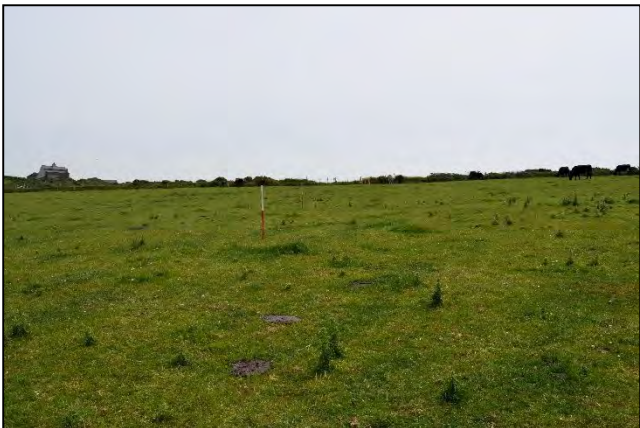
<b>NT PRN</b>	48414	<b>Name</b>	Penrhyn Mawr Old Field Boundary 1
<b>Grid Reference</b>	SH 18870 26022 – SH 18718 26004

<b>SAM Number.</b>			
<b>Listed Building Number</b>			
<b>NPRN</b>			
<b>PRN</b>			
<b>Monument Type</b>	Old boundary		
<b>Record Type</b>	Boundary		
<b>Date</b> Post medieval			
<b>Description</b> Very slight linear hollow on the line of one of the boundaries shown on rage 1889 OS map. The hollow is approximately 3 m wide and less than 0.1 m deep			
<b>Survival</b>	Bad	<b>Condition</b>	Poor
<b>Stability</b>	Stable	<b>Vulnerability</b>	Medium
<b>Significance</b>	Local		
<b>Comment</b>			
<b>Recommendations</b> Avoid further ploughing			
<b>Photographs</b>	Penrhyn Mawr_022		
<b>Recorded by</b>	IB	<b>Date</b>	13/6/2018

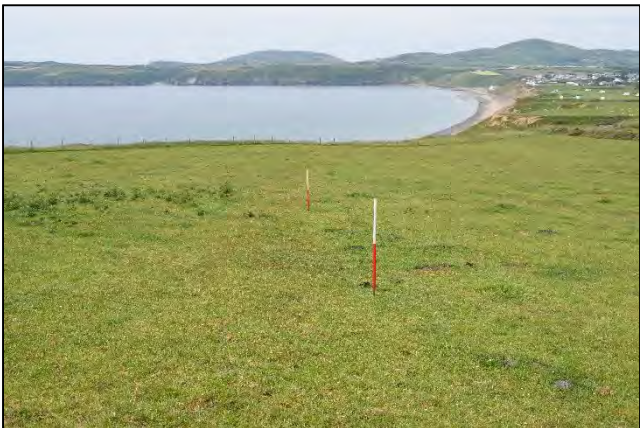
<b>NT PRN</b>	48415	<b>Name</b>	Penrhyn Mawr Old Field Boundary 2
<b>Grid Reference</b>	SH 18699 25933 – SH 18594 25944

<b>SAM Number.</b>			
<b>Listed Building Number</b>			
<b>NPRN</b>			
<b>PRN</b>			
<b>Monument Type</b>	Earthen bank		
<b>Record Type</b>	Boundary		
<b>Date</b> Post medieval			
<b>Description</b> Very low (0.1 m) earthen bank about 2 m wide. On line of field boundary on the 1889 OS			
<b>Survival</b>	Bad	<b>Condition</b>	Poor
<b>Stability</b>	Stable	<b>Vulnerability</b>	Medium
<b>Significance</b>	Local		
<b>Comment</b>			
<b>Recommendations</b> Avoid further ploughing			
<b>Photographs</b>	Penrhyn Mawr_023		
<b>Recorded by</b>	IB	<b>Date</b>	13/6/2018

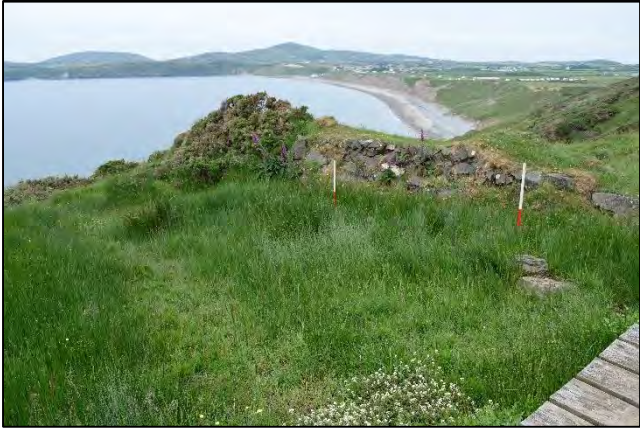
<b>NT PRN</b>	48416	<b>Name</b>	Penrhyn Mawr Channel 2
<b>Grid Reference</b>	SH 18715 25648

<b>SAM Number.</b>			
<b>Listed Building Number</b>			
<b>NPRN</b>			
<b>PRN</b>			
<b>Monument Type</b>	Channel		
<b>Record Type</b>	Boundary		
<b>Date</b> Post medieval			
<b>Description</b> Channel up to 5 m wide with a dry-stone wall up to 1 m high on its northern side. Wall 1 m wide and partly revetted into the slope. Channel drains farmland over the cliff.			
<b>Survival</b>	Moderate	<b>Condition</b>	Fair
<b>Stability</b>	Slow Deterioration	<b>Vulnerability</b>	Low
<b>Significance</b>	Local		
<b>Comment</b>			
<b>Recommendations</b> Maintain wooden bridge over channel			
<b>Photographs</b>	Penrhyn Mawr_027		
<b>Recorded by</b>	IB	<b>Date</b>	13/6/2018

A major drain from the fields (NT PRN 48416, Plate 13) on the western side of the property appears to continue the line of a clawdd wall crossing the property. This wall is shown in cyan on Figure 8.

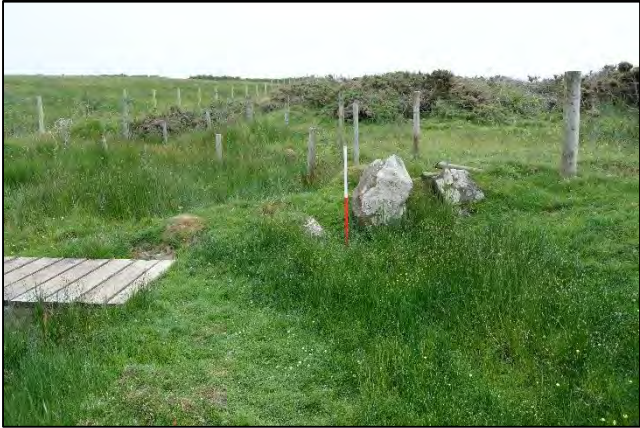
<b>NT PRN</b>	48417	<b>Name</b>	Penrhyn Mawr Structure
<b>Grid Reference</b>	SH 18732 25646

<b>SAM Number.</b>			
<b>Listed Building Number</b>			
<b>NPRN</b>			
<b>PRN</b>			
<b>Monument Type</b>	Wall		
<b>Record Type</b>	Boundary		
<b>Date</b> Post medieval			
<b>Description</b> Fragment of a clawdd wall linking to the southern side of the drain (18) a couple of orthostatic blocks up to 0.75 m high facing the fragment of an earthen bank up to 1.5 m wide. Highly disturbed. Possibly part of the sheep fold shown on the 1889 OS map			
<b>Survival</b>	Bad	<b>Condition</b>	Poor
<b>Stability</b>	Stable	<b>Vulnerability</b>	Medium
<b>Significance</b>	Local		
<b>Comment</b> Possibly part of the sheep fold shown on the 1889 OS map			
<b>Recommendations</b> Maintain, avoid further destruction			
<b>Photographs</b>	Penrhyn Mawr_028		
<b>Recorded by</b>	IB	<b>Date</b>	13/6/2018

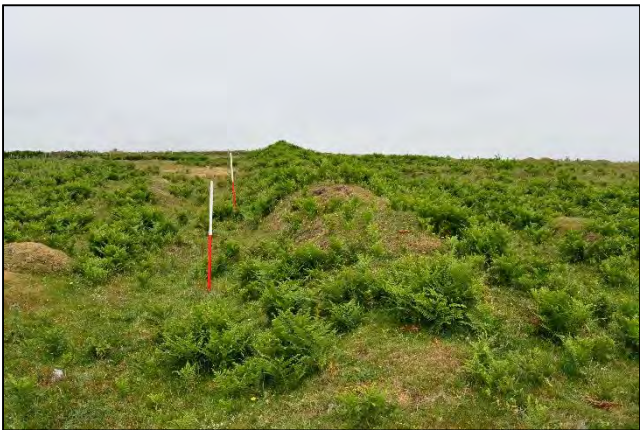
<b>NT PRN</b>	48418	<b>Name</b>	Gwningaer Bank 1
<b>Grid Reference</b>	SH 18810 25375 – SH 18788 25279

<b>SAM Number.</b>			
<b>Listed Building Number</b>			
<b>NPRN</b>			
<b>PRN</b>	7341		
<b>Monument Type</b>	Earthen bank		
<b>Record Type</b>	Boundary		
<b>Date</b> Post medieval			
<b>Description</b> Earthen bank running down to the cliff line. 2 m wide and up to 0.5 m high with slight ditch on both sides. Highly disturbed by rabbits in places			
<b>Survival</b>	Moderate	<b>Condition</b>	Poor
<b>Stability</b>	Slow deterioration	<b>Vulnerability</b>	Medium
<b>Significance</b>	Local		
<b>Comment</b> Crossed by coastal path. Disturbed by rabbits			
<b>Recommendations</b> Monitor, if possible reduce the rabbit number to restrict the damage			
<b>Photographs</b>	Penrhyn Mawr_030 and 031		
<b>Recorded by</b>	IB	<b>Date</b>	13/6/2018

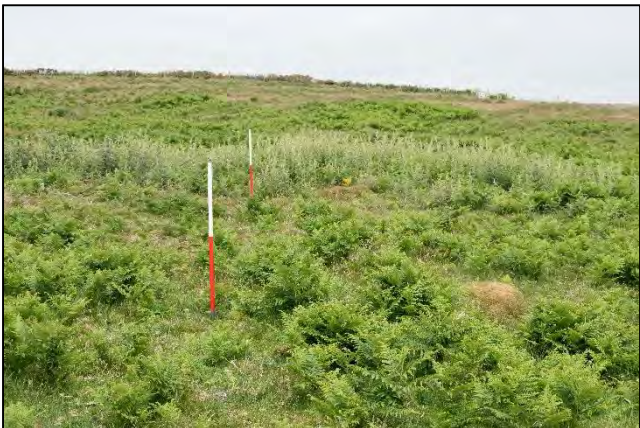
<b>NT PRN</b>	48419	<b>Name</b>	Gwningaer Bank 2
<b>Grid Reference</b>	SH 18842 25359 – SH 18847 25388

<b>SAM Number.</b>			
<b>Listed Building Number</b>			
<b>NPRN</b>			
<b>PRN</b>			
<b>Monument Type</b>	Earthen Bank		
<b>Record Type</b>	Boundary		
<b>Date</b> Post medieval			
<b>Description</b> Very slight earthen bank, approximately 1 m wide and 0.1 m high running NNE -SSW			
<b>Survival</b>	Bad	<b>Condition</b>	Poor
<b>Stability</b>	Stable	<b>Vulnerability</b>	Low
<b>Significance</b>	Local		
<b>Comment</b> Part of earlier field system			
<b>Recommendations</b> Monitor for further damage			
<b>Photographs</b>	Penrhyn Mawr_032 and 033		
<b>Recorded by</b>	IB	<b>Date</b>	13/6/2018

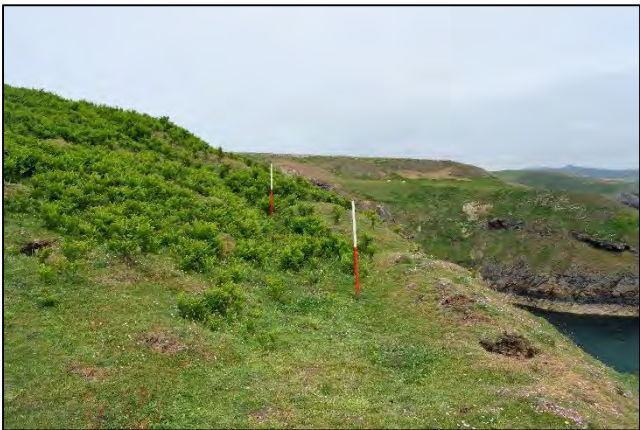
<b>NT PRN</b>	48420	<b>Name</b>	Carreg Gybi Bank
<b>Grid Reference</b>	SH 18940 25369 – SH 18917 25443

<b>SAM Number.</b>			
<b>Listed Building Number</b>			
<b>NPRN</b>			
<b>PRN</b>			
<b>Monument Type</b>	Earthen Bank		
<b>Record Type</b>	Boundary		
<b>Date</b> Post medieval			
<b>Description</b> Earthen bank, 2 m high and 0.5 m high running along the top of the cliff. Slight ditch on the landward side.			
<b>Survival</b>	Moderate	<b>Condition</b>	Fair
<b>Stability</b>	Rapid Deterioration	<b>Vulnerability</b>	High
<b>Significance</b>	Local		
<b>Comment</b> Eroding over the cliff			
<b>Recommendations</b> Monitor, consider sampling			
<b>Photographs</b>	Penrhyn Mawr_036		
<b>Recorded by</b>	IB	<b>Date</b>	13/6/2018

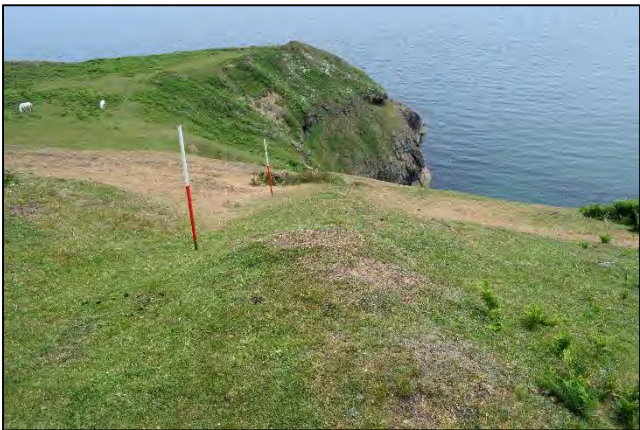
<b>NT PRN</b>	48421	<b>Name</b>	Trwyn Bychestyn Bank 1
<b>Grid Reference</b>	SH 19003 25616 – SH 19015 25601

<b>SAM Number.</b>			
<b>Listed Building Number</b>			
<b>NPRN</b>			
<b>PRN</b>			
<b>Monument Type</b>	Earthen bank		
<b>Record Type</b>	Boundary		
<b>Date</b> Post medieval			
<b>Description</b> Very slight earthen bank running towards the cliff. 2 m wide 0.4 m high. Part of a system with 48422			
<b>Survival</b>	Bad	<b>Condition</b>	Poor
<b>Stability</b>	Slow deterioration	<b>Vulnerability</b>	Medium
<b>Significance</b>	Local		
<b>Comment</b> Appears to predate 1889 survey			
<b>Recommendations</b> Monitor			
<b>Photographs</b>	Penrhyn Mawr_039		
<b>Recorded by</b>	IB	<b>Date</b>	13/6/2018

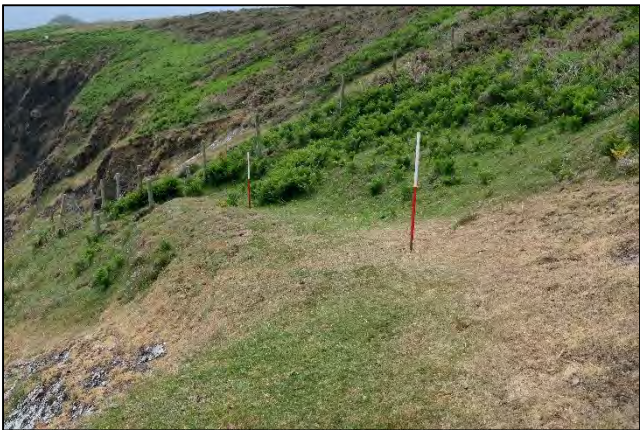
<b>NT PRN</b>	48422	<b>Name</b>	Trwyn Bychestyn Bank 2
<b>Grid Reference</b>	SH 19005 25590 – SH 19034 25594

<b>SAM Number.</b>			
<b>Listed Building Number</b>			
<b>NPRN</b>			
<b>PRN</b>			
<b>Monument Type</b>	Earthen bank		
<b>Record Type</b>	Boundary		
<b>Date</b> Post medieval			
<b>Description</b> Remnant of earthen bank running along the cliff line. 2 m wide, up to 0.2 m high. Part of earlier system with 48421			
<b>Survival</b>	Bad	<b>Condition</b>	Poor
<b>Stability</b>	Rapid deterioration	<b>Vulnerability</b>	High
<b>Significance</b>	Local		
<b>Comment</b>			
<b>Recommendations</b> Monitor			
<b>Photographs</b>	Penrhyn Mawr_040		
<b>Recorded by</b>	IB	<b>Date</b>	13/6/2018

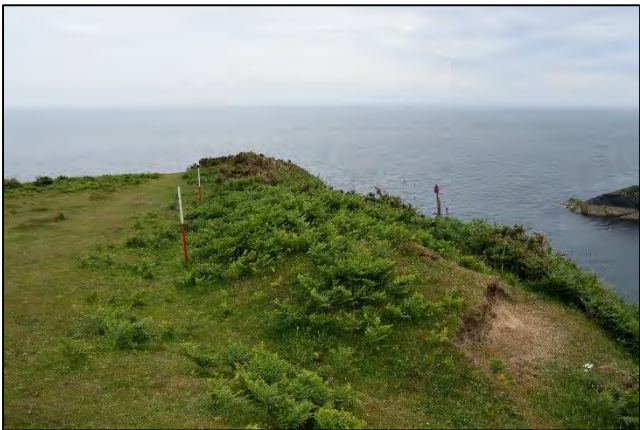
<b>NT PRN</b>	48423	<b>Name</b>	Trwyn Bychestyn Bank 3
<b>Grid Reference</b>	SH 19098 25547 – SH 19116 25511

<b>SAM Number.</b>			
<b>Listed Building Number</b>			
<b>NPRN</b>			
<b>PRN</b>			
<b>Monument Type</b>	Earthen bank		
<b>Record Type</b>	Boundary		
<b>Date</b> Post medieval			
<b>Description</b> Large earthen bank 3 m wide and up to 1 m high running above the cliff. South end lost through natural erosion			
<b>Survival</b>	Moderate	<b>Condition</b>	Fair
<b>Stability</b>	Slow deterioration	<b>Vulnerability</b>	High
<b>Significance</b>	Local		
<b>Comment</b> Forms western side of large natural platform			
<b>Recommendations</b> Monitor			
<b>Photographs</b>	Penrhyn Mawr_041		
<b>Recorded by</b>	IB	<b>Date</b>	13/6/2018

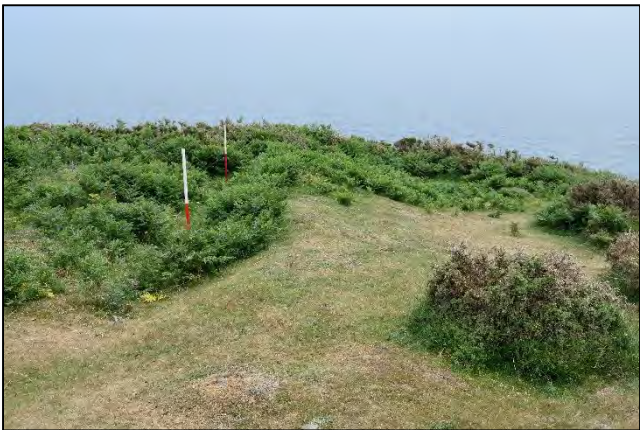
<b>NT PRN</b>	48424	<b>Name</b>	Trwyn Bychestyn Bank 4
<b>Grid Reference</b>	SH 191135 25639 – SH 19128 25648

<b>SAM Number.</b>			
<b>Listed Building Number</b>			
<b>NPRN</b>			
<b>PRN</b>			
<b>Monument Type</b>			
<b>Record Type</b>			
<b>Date</b> Post-medieval			
<b>Description</b> Short length of earthen bank, 2 m wide and up to 0.5 m high running towards the cliff			
<b>Survival</b>	Moderate	<b>Condition</b>	Fair
<b>Stability</b>	Slow deterioration	<b>Vulnerability</b>	Medium
<b>Significance</b>	Local		
<b>Comment</b> Crossed by coastal path			
<b>Recommendations</b> Monitor			
<b>Photographs</b>	Penrhyn Mawr_042		
<b>Recorded by</b>	IB	<b>Date</b>	13/6/2018

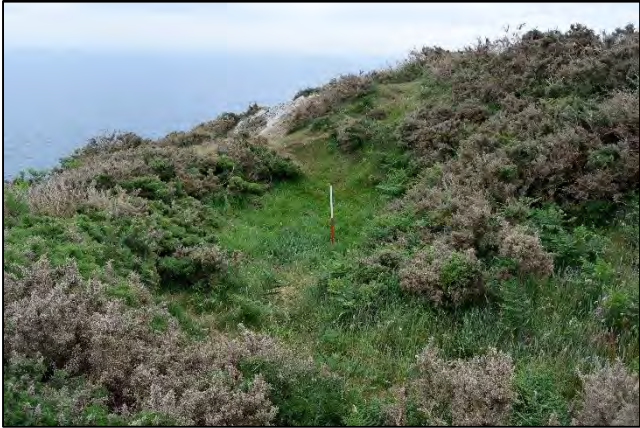
<b>NT PRN</b>	48425	<b>Name</b>	Trwyn Bychestyn Quarry 1
<b>Grid Reference</b>	SH 19147 25650

<b>SAM Number.</b>			
<b>Listed Building Number</b>			
<b>NPRN</b>			
<b>PRN</b>	59580		
<b>Monument Type</b>	Quarry		
<b>Record Type</b>	Landscape feature		
<b>Date</b> Post Medieval			
<b>Description</b> Two small interconnected quarry pits, each 5 x 3 m in size with some spoil heaps to the south. Rock face up to 2.5 m high			
<b>Survival</b>	Good	<b>Condition</b>	Fair
<b>Stability</b>	Stable	<b>Vulnerability</b>	Low
<b>Significance</b>	Local		
<b>Comment</b> Probably for stone walls			
<b>Recommendations</b> Monitor			
<b>Photographs</b>	Penrhyn Mawr_045		
<b>Recorded by</b>	IB	<b>Date</b>	13/6/2019

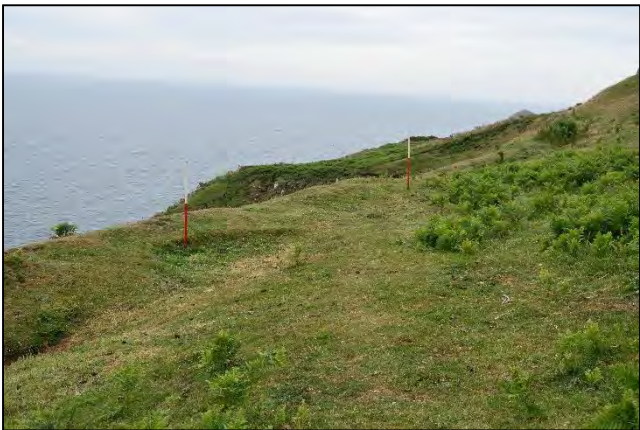
<b>NT PRN</b>	48426	<b>Name</b>	Trwyn Bychestyn Bank 5
<b>Grid Reference</b>	SH 19186 25635 – SH 19158 25617

<b>SAM Number.</b>			
<b>Listed Building Number</b>			
<b>NPRN</b>			
<b>PRN</b>			
<b>Monument Type</b>	Earthen Bank		
<b>Record Type</b>	Boundary		
<b>Date</b> Post-Medieval			
<b>Description</b> Remnants of an earthen bank along the cliff top. 2 m wide up to 0.25 m high			
<b>Survival</b>	Bad	<b>Condition</b>	Poor
<b>Stability</b>	Rapid deterioration	<b>Vulnerability</b>	High
<b>Significance</b>	Local		
<b>Comment</b> Already lost north end			
<b>Recommendations</b> Monitor			
<b>Photographs</b>	Penrhyn Mawr_046		
<b>Recorded by</b>	IB	<b>Date</b>	13/6/2018

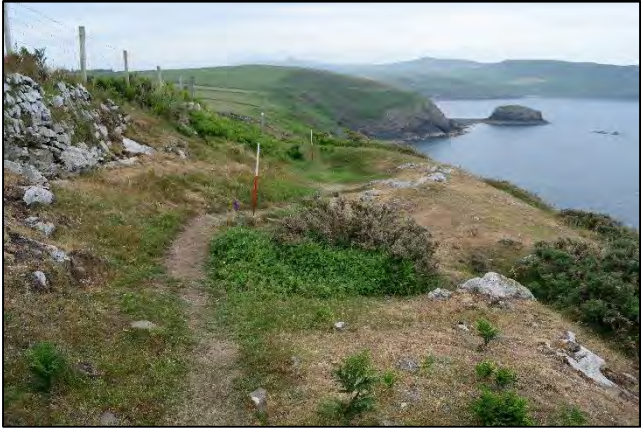
<b>NT PRN</b>	48427	<b>Name</b>	Trwyn Bychestyn Quarry 2
<b>Grid Reference</b>	SH 19203 25718

<b>SAM Number.</b>			
<b>Listed Building Number</b>			
<b>NPRN</b>			
<b>PRN</b>			
<b>Monument Type</b>	Quarry		
<b>Record Type</b>	Landscape Feature		
<b>Date</b> Post-medieval			
<b>Description</b> Two intercutting small quarry pits, one 5 x 5, the other 8 x 4m in size rock face to the west has a clawdd wall built on top			
<b>Survival</b>	Moderate	<b>Condition</b>	Fair
<b>Stability</b>	Stable	<b>Vulnerability</b>	Low
<b>Significance</b>	Local		
<b>Comment</b> Crossed by coastal path			
<b>Recommendations</b> Monitor			
<b>Photographs</b>	Penrhyn Mawr_ 046, 047		
<b>Recorded by</b>	IB	<b>Date</b>	13/6/2018

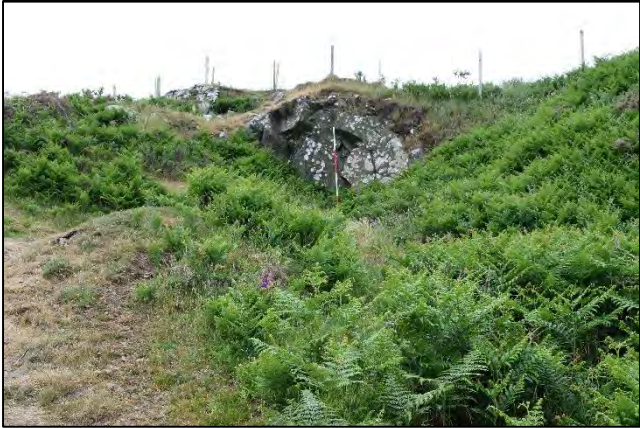
<b>NT PRN</b>	48428	<b>Name</b>	Trwyn Bychestyn Quarry 3
<b>Grid Reference</b>	SH 19225 25747

<b>SAM Number.</b>			
<b>Listed Building Number</b>			
<b>NPRN</b>			
<b>PRN</b>			
<b>Monument Type</b>	Quarry		
<b>Record Type</b>	Landscape Feature		
<b>Date</b> Post-medieval			
<b>Description</b> Medium sized quarry covering approximately 10 x 10 m with a 3 m rock face to the west. Some spoil dumped on the floor of the quarry			
<b>Survival</b>	Good	<b>Condition</b>	Fair
<b>Stability</b>	Stable	<b>Vulnerability</b>	Low
<b>Significance</b>	Local		
<b>Comment</b> Probably related to 48429			
<b>Recommendations</b> Monitor			
<b>Photographs</b>	Penrhyn Mawr_049		
<b>Recorded by</b>	IB	<b>Date</b>	13/6/2018

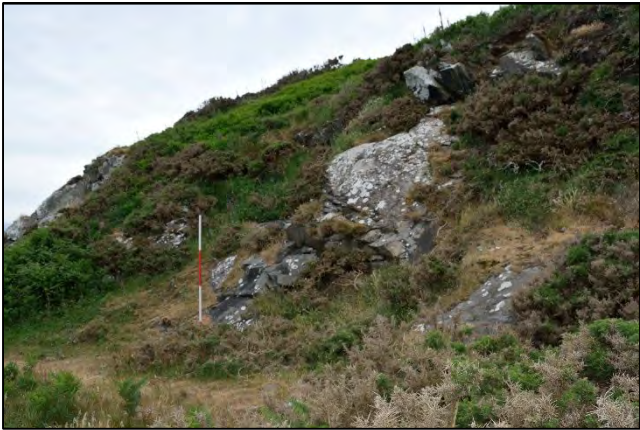
<b>NT PRN</b>	48429	<b>Name</b>	Trwyn Bychestyn Quarry 4
<b>Grid Reference</b>	SH 19237 25733

<b>SAM Number.</b>			
<b>Listed Building Number</b>			
<b>NPRN</b>			
<b>PRN</b>			
<b>Monument Type</b>	Quarry		
<b>Record Type</b>	Landscape Feature		
<b>Date</b> Post-medieval			
<b>Description</b> Medium sized quarry covering approximately 20 x 5 m with a 5 m face. Spoil appears to have been tipped over the cliff			
<b>Survival</b>	Good	<b>Condition</b>	Fair
<b>Stability</b>	Slow deterioration	<b>Vulnerability</b>	Low
<b>Significance</b>	Local		
<b>Comment</b> Probably related to 484428.			
<b>Recommendations</b> <b>Monitor</b>			
<b>Photographs</b>	Penrhyn Mawr_050		
<b>Recorded by</b>	IB	<b>Date</b>	13/6/2018

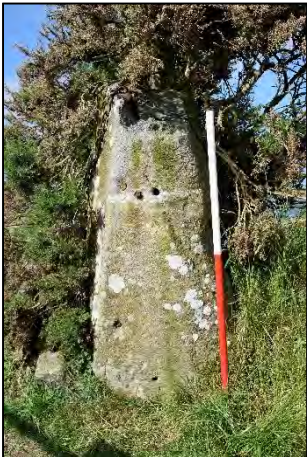
<b>NT PRN</b>	48430	<b>Name</b>	Penrhyn Mawr Gate Posts 1
<b>Grid Reference</b>	SH 18962 26123

<b>SAM Number.</b>			
<b>Listed Building Number</b>			
<b>NPRN</b>			
<b>PRN</b>			
<b>Monument Type</b>	Stone gate posts		
<b>Record Type</b>	Landscape feature		
<b>Date</b> Post-medieval			
<b>Description</b> Stone gate posts either side of gateway. The western post is 1.2 m high with a ground plan of 0.55 x 0.35 m. Various drilled holes and remnant iron fittings show multiple re-hanging. The eastern stone is lower 0.75 m but is 1 m wide. Single drilled hole at the top			
<b>Survival</b>	Good	<b>Condition</b>	Good
<b>Stability</b>	Stable	<b>Vulnerability</b>	Medium
<b>Significance</b>	Local		
<b>Comment</b>			
<b>Recommendations</b> Retain, protect form damage			
<b>Photographs</b>	Penrhyn Mawr_053, 054		
<b>Recorded by</b>	IB	<b>Date</b>	14.6.2018

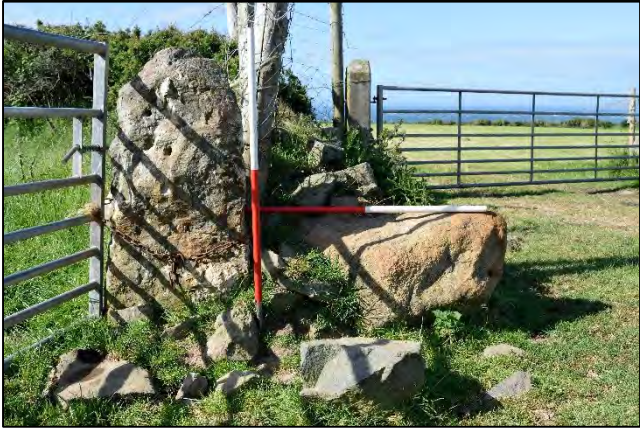
<b>NT PRN</b>	48431	<b>Name</b>	Penrhyn Mawr Gate Posts 2
<b>Grid Reference</b>	SH 18962 25935

<b>SAM Number.</b>			
<b>Listed Building Number</b>			
<b>NPRN</b>			
<b>PRN</b>			
<b>Monument Type</b>	Stone gate post		
<b>Record Type</b>	Landscape feature		
<b>Date</b> Post-medieval			
<b>Description</b> Two large boulders on the southern side of the gateway. Upright granite slab 1 x 0.5 x 0.25 m currently in use with two drill holes. Recumbent stone of local lithology 0.7 x 0.5 x 0.5 m with single drill hole. Probably original gate post			
<b>Survival</b>	Good	<b>Condition</b>	Fair
<b>Stability</b>	Stable	<b>Vulnerability</b>	Medium
<b>Significance</b>	Local		
<b>Comment</b>			
<b>Recommendations</b> Preserve <i>in situ</i>			
<b>Photographs</b>	Penrhyn Mawr_055		
<b>Recorded by</b>	IB	<b>Date</b>	14/6/2018

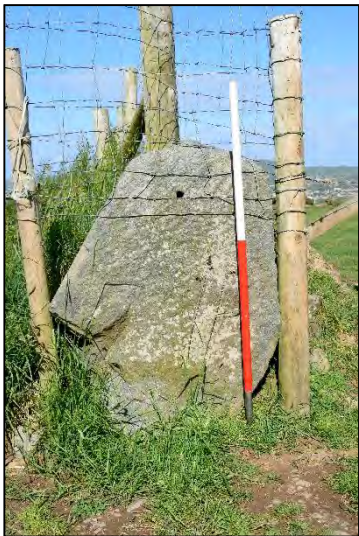
<b>NT PRN</b>	48432	<b>Name</b>	Penrhyn Mawr Gate Posts 3
<b>Grid Reference</b>	SH 18957 25932

<b>SAM Number.</b>			
<b>Listed Building Number</b>			
<b>NPRN</b>			
<b>PRN</b>			
<b>Monument Type</b>	Stone gate post		
<b>Record Type</b>	Landscape feature		
<b>Date</b> Post-medieval			
<b>Description</b> Split stone boulder used as a gate post. 1 x 0.75 x 0.4 m. Probably repositioned when the gate was widened			
<b>Survival</b>	Good	<b>Condition</b>	Good
<b>Stability</b>	Stable	<b>Vulnerability</b>	Low
<b>Significance</b>	Local		
<b>Comment</b>			
<b>Recommendations</b> Preserve in situ			
<b>Photographs</b>	Penrhyn Mawr_056		
<b>Recorded by</b>	IB	<b>Date</b>	14/6/2018

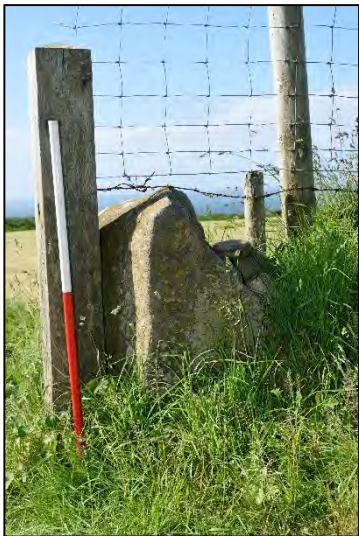
<b>NT PRN</b>	48433	<b>Name</b>	Penrhyn Mawr Gate Posts 4
<b>Grid Reference</b>	SH 18970 25825

<b>SAM Number.</b>			
<b>Listed Building Number</b>			
<b>NPRN</b>			
<b>PRN</b>			
<b>Monument Type</b>	Stone gate post		
<b>Record Type</b>	Landscape feature		
<b>Date</b> Post-medieval			
<b>Description</b> Large boulder originally used as a gate post 0.75 x 0.60 x 0.40 m			
<b>Survival</b>	Good	<b>Condition</b>	Good
<b>Stability</b>	Stable	<b>Vulnerability</b>	Low
<b>Significance</b>	Local		
<b>Comment</b> Gate post probably repositioned			
<b>Recommendations</b> Preserve <i>in situ</i>			
<b>Photographs</b>	Penrhyn Mawr_056		
<b>Recorded by</b>	IB	<b>Date</b>	14/6/2018

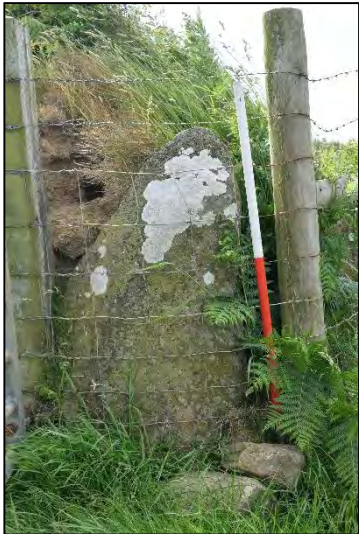
<b>NT PRN</b>	48434	<b>Name</b>	Penrhyn Mawr Gate Posts 5
<b>Grid Reference</b>	SH 18832 25701

<b>SAM Number.</b>			
<b>Listed Building Number</b>			
<b>NPRN</b>			
<b>PRN</b>			
<b>Monument Type</b>	Stone gate post		
<b>Record Type</b>	Landscape feature		
<b>Date</b> Post-medieval			
<b>Description</b> Upright stone boulder. 1 x 0.5 x 0.2 m in end of clawdd wall. Probably repositioned			
<b>Survival</b>	Good	<b>Condition</b>	Good
<b>Stability</b>	Stable	<b>Vulnerability</b>	Local
<b>Significance</b>	Local		
<b>Comment</b>			
<b>Recommendations</b> Preserve <i>in situ</i>			
<b>Photographs</b>	Penrhyn Mawr_057		
<b>Recorded by</b>	IB	<b>Date</b>	14/6/2018

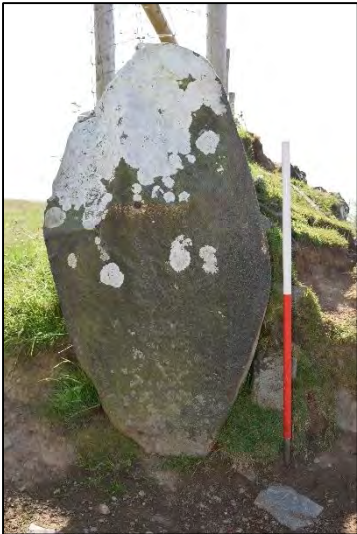
<b>NT PRN</b>	48435	<b>Name</b>	Penrhyn Mawr Gate Posts 6
<b>Grid Reference</b>	SH 18925 25629

<b>SAM Number.</b>			
<b>Listed Building Number</b>			
<b>NPRN</b>			
<b>PRN</b>			
<b>Monument Type</b>	Stone gate post		
<b>Record Type</b>	Landscape feature		
<b>Description</b>			
Large split boulder 1,5 x 0.75 x 0.5 m used as a gate post. The splitting was done with a wedge and feathers, scar of which on the northern side.			
<b>Survival</b>	Good	<b>Condition</b>	Good
<b>Stability</b>	Stable	<b>Vulnerability</b>	Low
<b>Significance</b>	Local		
<b>Comment</b>			
<b>Recommendations</b>			
Preserve <i>in situ</i>			
<b>Photographs</b>	Penrhyn Mawr_059		
<b>Recorded by</b>	IB	<b>Date</b>	14/6/2018

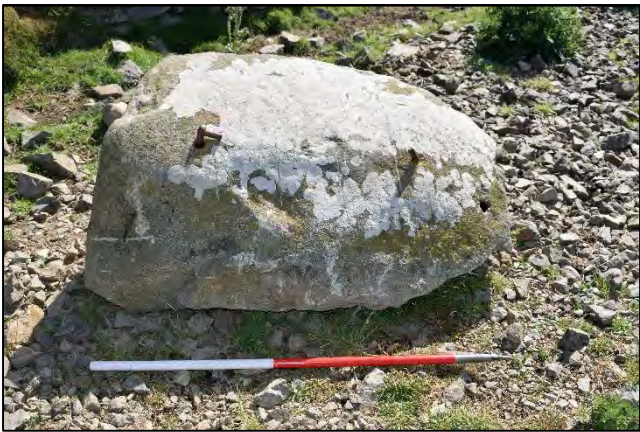
<b>NT PRN</b>	48436	<b>Name</b>	Penrhyn Mawr Gate Posts 7
<b>Grid Reference</b>	SH 18925 25625

<b>SAM Number.</b>			
<b>Listed Building Number</b>			
<b>NPRN</b>	Possibly 406289		
<b>PRN</b>			
<b>Monument Type</b>	Stone gate post		
<b>Record Type</b>	Landscape feature		
<b>Date</b> Post-medieval			
<b>Description</b> Large split granitic boulder once used as a gate post, but now lying adjacent to a clawdd wall. 1.3 x 0.6 x 0.6 m with iron pointless and a drill hole near the top. There are a series of sub-parallel scratches on the face of the boulder			
<b>Survival</b>	Good	<b>Condition</b>	Fair
<b>Stability</b>	Stable	<b>Vulnerability</b>	Medium
<b>Significance</b>	Local		
<b>Comment</b> Probably related to nearby gate			
<b>Recommendations</b> Do not remove or destroy. Consider repositioning nearer to the boundary to make it safer			
<b>Photographs</b>	Penrhyn Mawr_060		
<b>Recorded by</b>	IB	<b>Date</b>	14/6/2018

1. A more detailed desktop study looking at the records of the Nanhoron Estate held by the National Library of Wales may reveal more details of the history of the property
2. The loose boulder gate post (NT PRN 48436) should be re-positioned so that it is protected from further damage
3. More detail recording of the buildings might be considered to fully record these structures
4. The barn is in need of some maintenance and the bins above the cart shed should be recorded and if possible re-constructed.
5. The yards in front of the pig sties should be cleared of invasive vegetation
6. The promontory fort should be considered for scheduling
7. The area of the promontory fort and the possible hut platforms are at risk from coastal erosion. This area should be recorded in more detail with at least a detailed topographic survey as a base-line for any further work considered.

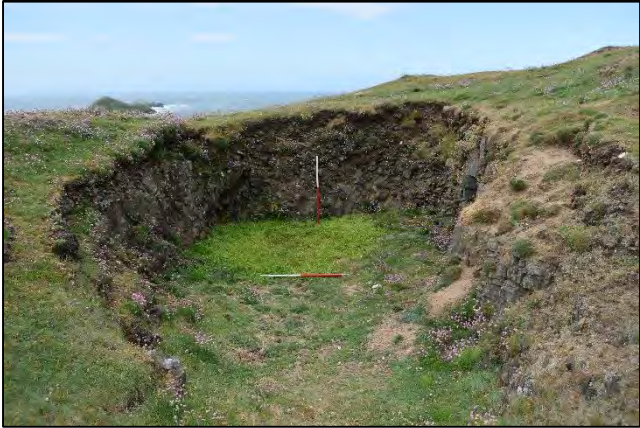
<b>NT PRN</b>	48437	<b>Name</b>	Trwyn Gwingaer Quarry
<b>Grid Reference</b>	SH 18857 25246

<b>SAM Number.</b>			
<b>Listed Building Number</b>			
<b>NPRN</b>			
<b>PRN</b>	770		
<b>Monument Type</b>	Quarry		
<b>Record Type</b>	Landscape feature		
<b>Date</b> Post-medieval			
<b>Description</b> Rectangular quarry 6 x 3 m in size and up to 1.5 m deep partly cut through the possible rampart of the property fort. Some spoil dumped on the southern side. Entrance to the east where the ditch for 48438 has been partly infilled			
<b>Survival</b>	Good	<b>Condition</b>	Good
<b>Stability</b>	Stable	<b>Vulnerability</b>	Medium
<b>Significance</b>	Local		
<b>Comment</b> Cut partly through breccia in to the rock below			
<b>Recommendations</b> Monitor			
<b>Photographs</b>	Penrhyn Mawr_061		
<b>Recorded by</b>	IB	<b>Date</b>	14/6/2018

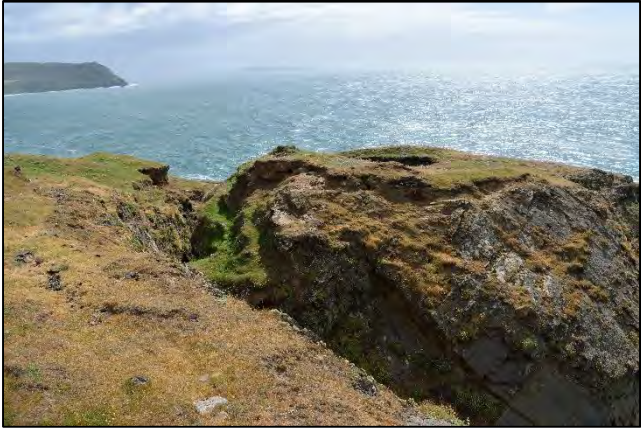
<b>SAM Number.</b>			
<b>Listed Building Number</b>			
<b>NPRN</b>	408644		
<b>PRN</b>			
<b>Monument Type</b>	Promontory fort		
<b>Record Type</b>	Monument		
<b>Date</b> Prehistoric (probably Iron Age)			
<b>Description</b> Short length of possible rampart, 4 m wide and up to 1.5 m high cutting off the promontory. Large rock cut ditch to the north, 3 m wide and 3 m deep partly taking advantage of a natural fissure. Few lumps and bumps suggest some outworks. A second probable rampart runs along the southern side of 48437 before turning to the south. This possible rampart is also up to 4 m wide and 1.0 m high in places. No internal features were located			
<b>Survival</b>	Moderate	<b>Condition</b>	Fair
<b>Stability</b>	Slow deterioration	<b>Vulnerability</b>	Medium
<b>Significance</b>	National		
<b>Comment</b> Consider the site for scheduling

<b>Recommendations</b> Monitor. Consider for more detailed recording			
<b>Photographs</b>	Penrhyn Mawr_062-066, 070, 078, 080		
<b>Recorded by</b>	IB	<b>Date</b>	14/6/2018

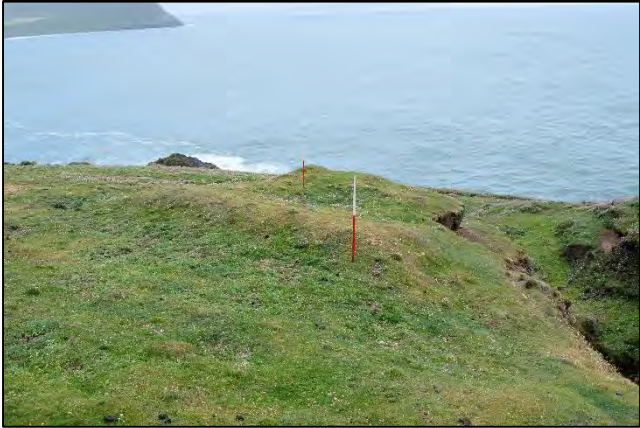
<b>SAM Number.</b>			
<b>Listed Building Number</b>			
<b>NPRN</b>	15196		
<b>PRN</b>	6739		
<b>Monument Type</b>	?Hut Platform		
<b>Record Type</b>	Monument		
<b>Date</b> Unknown			
<b>Description</b> <p>Low earthen bank up to 1.2 m wide and 0.5 m high forming an “L” shape on the northern side the rock cut ditch of 48438. This feature appears to be part of a group of three earthworks (48439 – 48441). The bank defines an area approximately 6.5 x 6 m. The relationship with the ditch is uncertain as it appears to have been cut by the ditch. A pile of stone in the eroding northern edge of the ditch for 48438 suggests there may be some structure existing below ground.</p>			
<b>Survival</b>	Moderate	<b>Condition</b>	Poor
<b>Stability</b>	Slow deterioration	<b>Vulnerability</b>	Medium
<b>Significance</b>	?Regional

<b>Comment</b>			
<b>Recommendations</b> <p>Monitor. Topographic survey should be undertaken covering 48438 - 48441</p>			
<b>Photographs</b>	Penrhyn Mawr_067-069, 085 -087		
<b>Recorded by</b>	IB	<b>Date</b>	14/6/2018

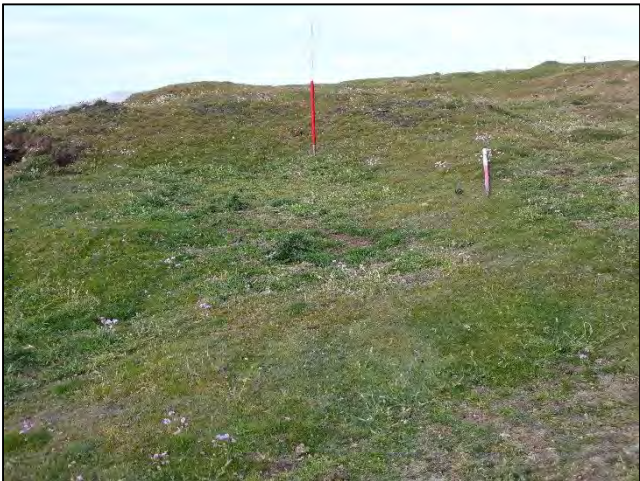
<b>NT PRN</b>	48440	<b>Name</b>	Trwyn Gwyingaer Platform 2
<b>Grid Reference</b>	SH 18847 25260

<b>SAM Number.</b>			
<b>Listed Building Number</b>			
<b>NPRN</b>	15196		
<b>PRN</b>	6739		
<b>Monument Type</b>	?Hut Platform		
<b>Record Type</b>	Monument		
<b>Date</b> Unknown			
<b>Description</b> Low, "L" shaped earthen bank defining an area 5 x 5.5 m. The bank is approximately 1.2 m wide and up to 0.5 m high. This feature appears to be part of a group of three earthworks (48439 – 48441). A flat stone eroding out of the southern side of the feature suggests there may be a floor surface surviving in at least part of this feature.			
<b>Survival</b>	Moderate	<b>Condition</b>	Poor
<b>Stability</b>	Slow deterioration	<b>Vulnerability</b>	Medium
<b>Significance</b>	?Regional		
<b>Comment</b> Probably part of a small group of at least three structures			
<b>Recommendations</b> Monitor. Topographic survey should be undertaken covering 48438 - 48441

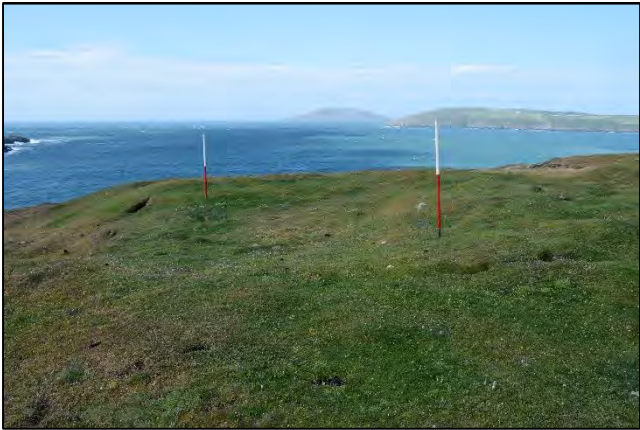
<b>NT PRN</b>	48441	<b>Name</b>	Trwyn Gwingaer Platform 3
<b>Grid Reference</b>	SH 18833 25257

<b>SAM Number.</b>			
<b>Listed Building Number</b>			
<b>NPRN</b>	15196		
<b>PRN</b>	6739		
<b>Monument Type</b>	Hut Platform		
<b>Record Type</b>	Monument		
<b>Date</b> Uncertain			
<b>Description</b> A low earthen bank forming three sides of rectangular area 8 x 4.5 m. The bank is approximately 1.5 m wide and stands up to 0.5 m high. This feature appears to be part of a group of three earthworks (48439 – 48441).			
<b>Survival</b>	Moderate	<b>Condition</b>	Poor
<b>Stability</b>	Slow deterioration	<b>Vulnerability</b>	Medium
<b>Significance</b>	?Regional		
<b>Comment</b> Part of a group of three features			
<b>Recommendations</b> Monitor. Topographic survey should be undertaken covering 48438 - 48441			
<b>Photographs</b>	Penrhyn Mawr_071, 086, 089		
<b>Recorded by</b>	IB	<b>Date</b>	14/6/2018

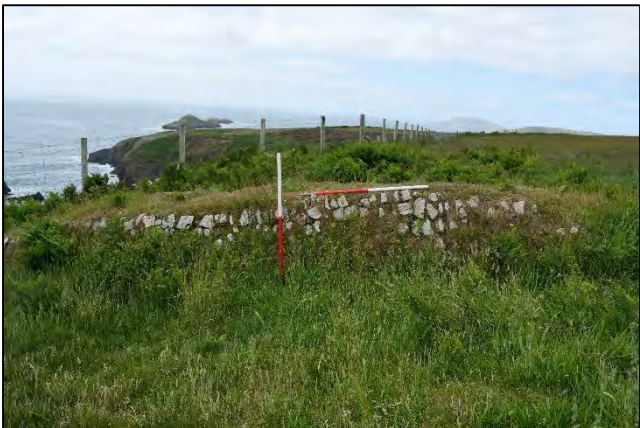
<b>NT PRN</b>	48442	<b>Name</b>	Penrhyn Mawr Clawdd Wall 2
<b>Grid Reference</b>	SH 19072 25659 – SH 19076 25651

<b>SAM Number.</b>			
<b>Listed Building Number</b>			
<b>NPRN</b>			
<b>PRN</b>			
<b>Monument Type</b>	Clawdd Wall		
<b>Record Type</b>	Boundary		
<b>Date</b> Post-medieval			
<b>Description</b> Short length of clawdd wall on the line of a boundary shown on the 1889 OS. 1.2 m wide, standing to 0.75. Small pitched stone facing on both sides			
<b>Survival</b>	Moderate	<b>Condition</b>	Fair
<b>Stability</b>	Slow deterioration	<b>Vulnerability</b>	Medium
<b>Significance</b>	Local		
<b>Comment</b> Remnant from earlier boundary			
<b>Recommendations</b> Preserve <i>in situ</i>			
<b>Photographs</b>	Penrhyn Mawr_ 072		
<b>Recorded by</b>	IB	<b>Date</b>	14/6/2018

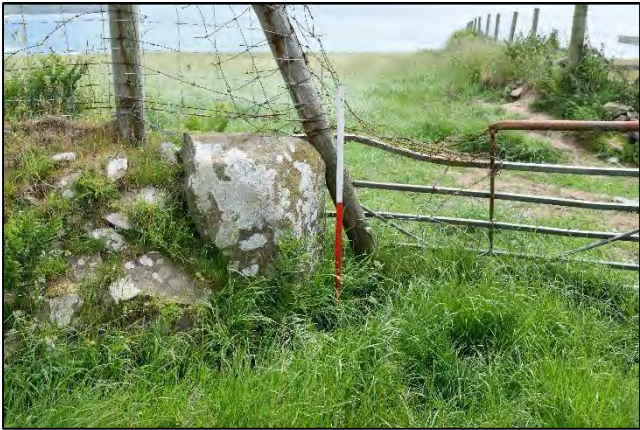
<b>NT PRN</b>	48443	<b>Name</b>	Penrhyn Mawr Gate Post 8
<b>Grid Reference</b>	SH 19145 25770

<b>SAM Number.</b>			
<b>Listed Building Number</b>			
<b>NPRN</b>			
<b>PRN</b>			
<b>Monument Type</b>	Stone gate post		
<b>Record Type</b>	Landscape feature		
<b>Date</b> Post-medieval			
<b>Description</b> Large boulder used as a gate post. 0.75 x 0.5 x 0.6 m. Marked shelf cut into the top of the boulder on the eastern side			
<b>Survival</b>	Good	<b>Condition</b>	Good
<b>Stability</b>	Stable	<b>Vulnerability</b>	Low
<b>Significance</b>	Local		
<b>Comment</b> One of the few gates not to have been widened			
<b>Recommendations</b> Preserve <i>in situ</i>			
<b>Photographs</b>	Penrhyn Mawr_073		
<b>Recorded by</b>	IB	<b>Date</b>	14/6/2018

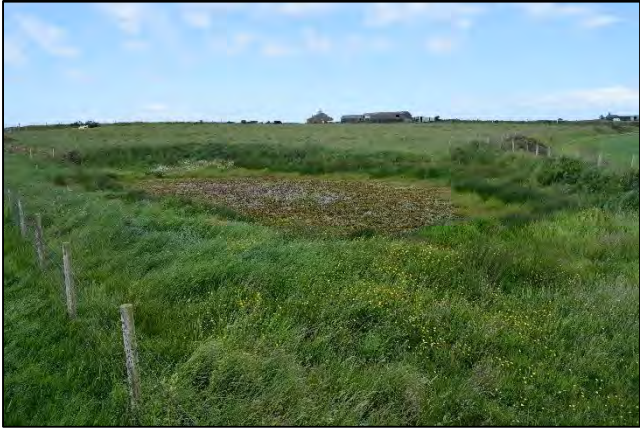
<b>NT PRN</b>	48444	<b>Name</b>	Penrhyn Mawr Pond 4
<b>Grid Reference</b>	SH 19131 25909

<b>SAM Number.</b>			
<b>Listed Building Number</b>			
<b>NPRN</b>			
<b>PRN</b>			
<b>Monument Type</b>	Pond		
<b>Record Type</b>	Landscape feature		
<b>Description</b>			
Large pond with a slight bank around it, particularly on the eastern side. Originally there was a lane leading to this pond			
<b>Survival</b>	Good	<b>Condition</b>	Fair
<b>Stability</b>	Slow deterioration	<b>Vulnerability</b>	Low
<b>Significance</b>	Local		
<b>Comment</b>			
<b>Recommendations</b>			
Maintain			
<b>Photographs</b>	Penrhyn Mawr_074		
<b>Recorded by</b>	IB	<b>Date</b>	14/6/2018

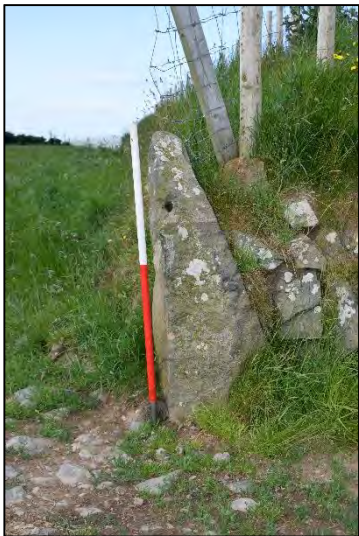
<b>NT PRN</b>	48445	<b>Name</b>	Penrhyn Mawr Gate Post 9
<b>Grid Reference</b>	SH 19043 25934

<b>SAM Number.</b>			
<b>Listed Building Number</b>			
<b>NPRN</b>			
<b>PRN</b>			
<b>Monument Type</b>	Stone gate post		
<b>Record Type</b>	Landscape feature		
<b>Date</b> Post-medieval			
<b>Description</b> Split boulder 1 x 0.5 x 0.3 m used as a gate post. Single drilled hole on eastern face. Probably <i>in situ</i>			
<b>Survival</b>	Good	<b>Condition</b>	Good
<b>Stability</b>	Stable	<b>Vulnerability</b>	Medium
<b>Significance</b>	Local		
<b>Comment</b>			
<b>Recommendations</b> Retain <i>in situ</i>			
<b>Photographs</b>	Penrhyn Mawr_075		
<b>Recorded by</b>	IB	<b>Date</b>	14/6/2018

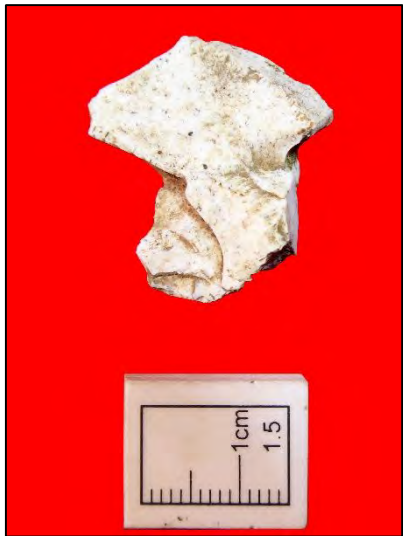
<b>SAM Number.</b>			
<b>Listed Building Number</b>			
<b>NPRN</b>			
<b>PRN</b>			
<b>Monument Type</b>			
<b>Record Type</b>	Find Spot		
<b>Description</b> Single flint flake. Tertiary flake 28.4 x 25.7 x 4.7 mm in size with small area of polish on the distal end suggesting the flake was produced from the re-working of a polished tool.			
<b>Survival</b>	Good	<b>Condition</b>	Good
<b>Stability</b>	Stable	<b>Vulnerability</b>	Low
<b>Significance</b>	Local		
<b>Comment</b> Found in the erosion from the boundary bank alongside the Coastal Path			
<b>Recommendations</b>			
<b>Photographs</b>	Penrhyn Mawr_076		
<b>Recorded by</b>	IB	<b>Date</b>	13/6/2018
