Evaluation of the archaeological potential of the Minffordd Good Shed

I.P. Brooks
Engineering Archaeological Services Ltd

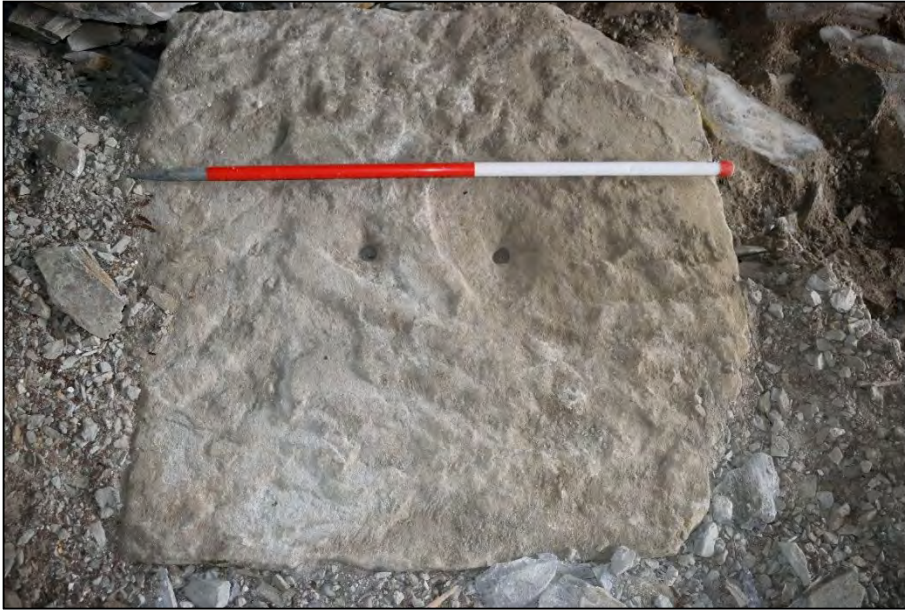
The trench was located so that one end was below the pivot point for the crane and it extended out towards the expected position of the standard gauge rail bed (Figure 1). Before the excavation took place a stone block, approximately 1.09 m square and at least 200 mm thick was exposed (Plate 1). This has two holes in its upper surface, each 40 mm in diameter and 250 mm apart. The level of flaking around these holes would suggest that the holes were drilled from the other surface of the block and possibly the block is lying upside down.

Plate 1: The stone block

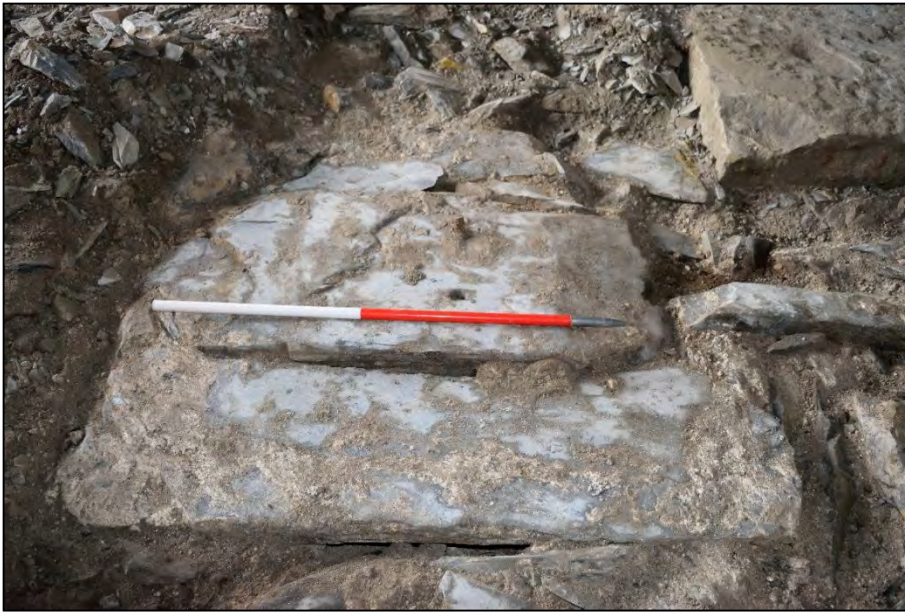
Within the excavated area (Figure 2), below the crane bearing are two large slate slabs (Plate 2), one of which is 1.3 x 0.7 m in size and the other 1.49 x 0.41 m. The wider of the two slabs has two holes drilled in its surface, one of which retains the remains of an iron rod 35 mm in diameter. These holes are directly below the bearing for the upper crane support on the beam above. These holes are spaced at the same distance to those of the stone block and it is assumed that the stone block was originally placed over the slate slabs and linked by iron rods. The gap between these two elements is unknown, however the displaced stone block is of a similar size to the block shown as the crane pivot on the cross section drawing suggesting there may have originally been a metre, or more, between the slate slabs and the stone block. There are also fragments of slate immediately to the north which suggest there may have been a third slate slab.

A gap between the two slate slabs shows that there is a void below the slabs. When probed this proved to be at least 350 mm deep. No attempt was made to lift one of the slate slabs and thus the form of the void is uncertain. One possible explanation for this void is related to the iron rods holding the crane base together. It is possible that these rods were added during the construction of the crane, thus a void would be needed to allow a nut to be attached to the lower end of the iron rods securing the lower end of the crane support.

Plate 2: The crane base

The base of the crane structure survives with at least two slate slabs siting over a chamber. It is assumed this chamber allowed the metal rods, which held the crane support together, to be fixed in place and the assumed nuts under the slabs tightened. It is also clear that stone block to the north and east was part of the crane support, possibly the stone block shown on the cross section drawing acting as a base for the crane itself.

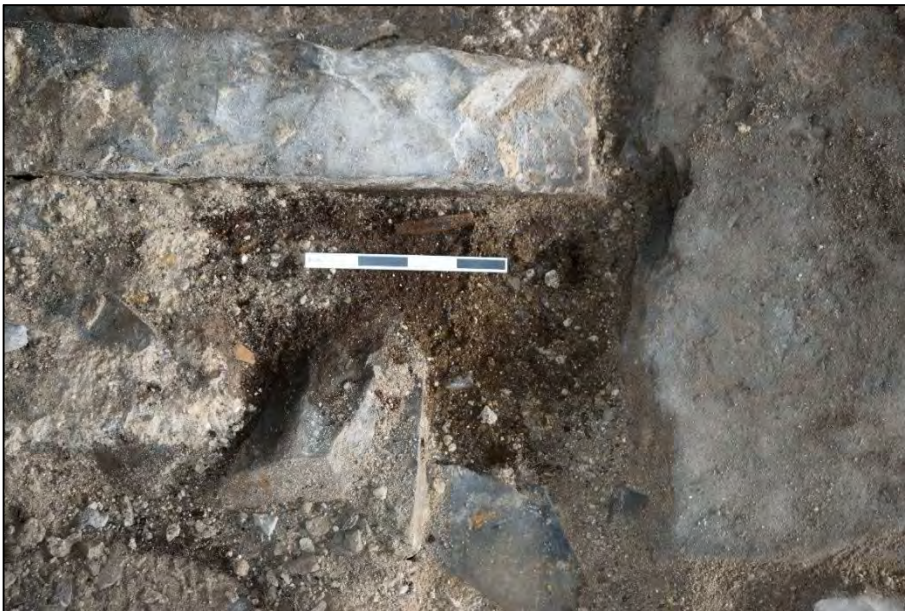
Immediately to the east of the slate slab with the holes was the remains of a timber (Plate 3). This was a dark stain, containing the occasional fragment of wood, forming a rough “L” shape. It has a maximum size of 0.25 x 0.39 m in size. It is assumed this was a vertical timber and part of the crane support, although this interpretation remains tentative. The lack of significant timber means that it is not possible to determine whether this was an upright post or a fragment of timber lying flat within the deposits.

Plate 3: The timber

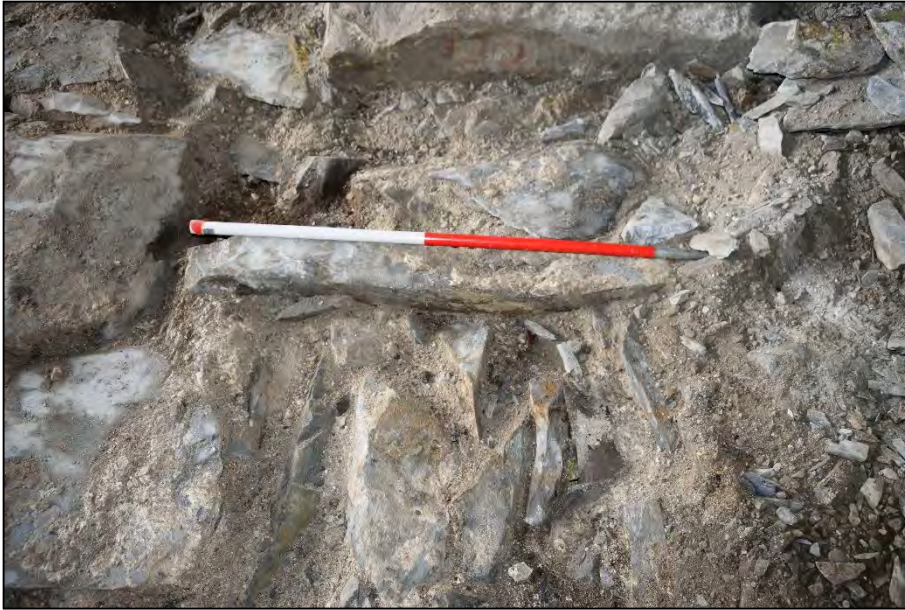
Also, adjacent to this possible timber is a stone block 0.09 m wide and at least 1.14 m long (Plate 4) which runs longitudinally along the centre line of the building and probably acted as a part of the central support for platform. This block is partly set in lime mortar.

Plate 4: The longitudinal block

The platform had a stone retaining wall and probably a central spine wall within a deposit of packed stones within a thin lime mortar matrix. There also appears to have been a spread of lime mortar below the standard gauge rail bed.

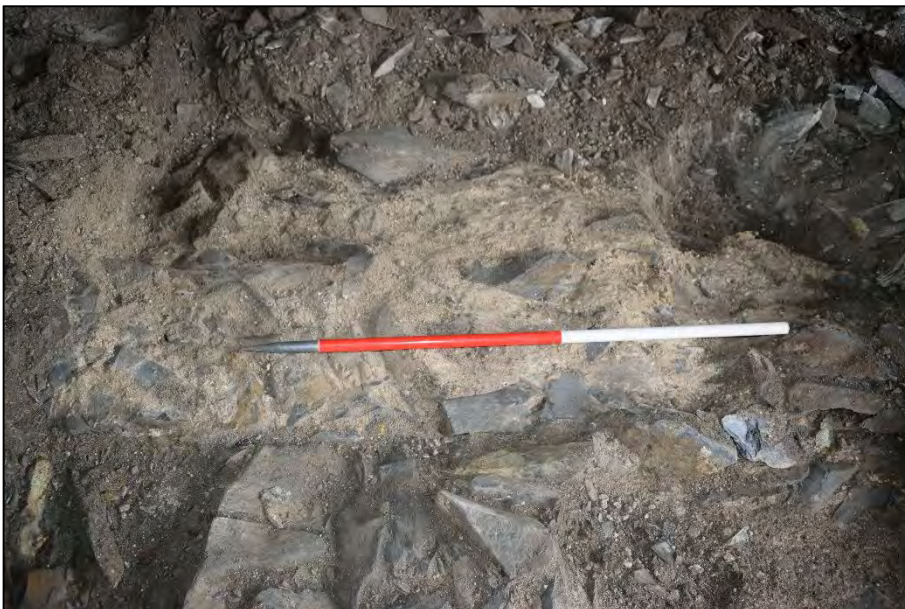
Further to the south is the remains of a stone wall, 0.38 m wide, running longitudinally along the building approximately 3.12 m from the southern wall of the building (Plate 5). It is assumed this is the retaining wall of the platform, although the short length exposed appears to be at a slight angle to the building. To the south of this wall is a spread of lime mortar, the function of which is unknown. Between the crane base and this wall there is a deposit of irregularly arranged stone blocks with some lime mortar which is assumed to be infill within the platform structure.

Plate 5: The platform wall

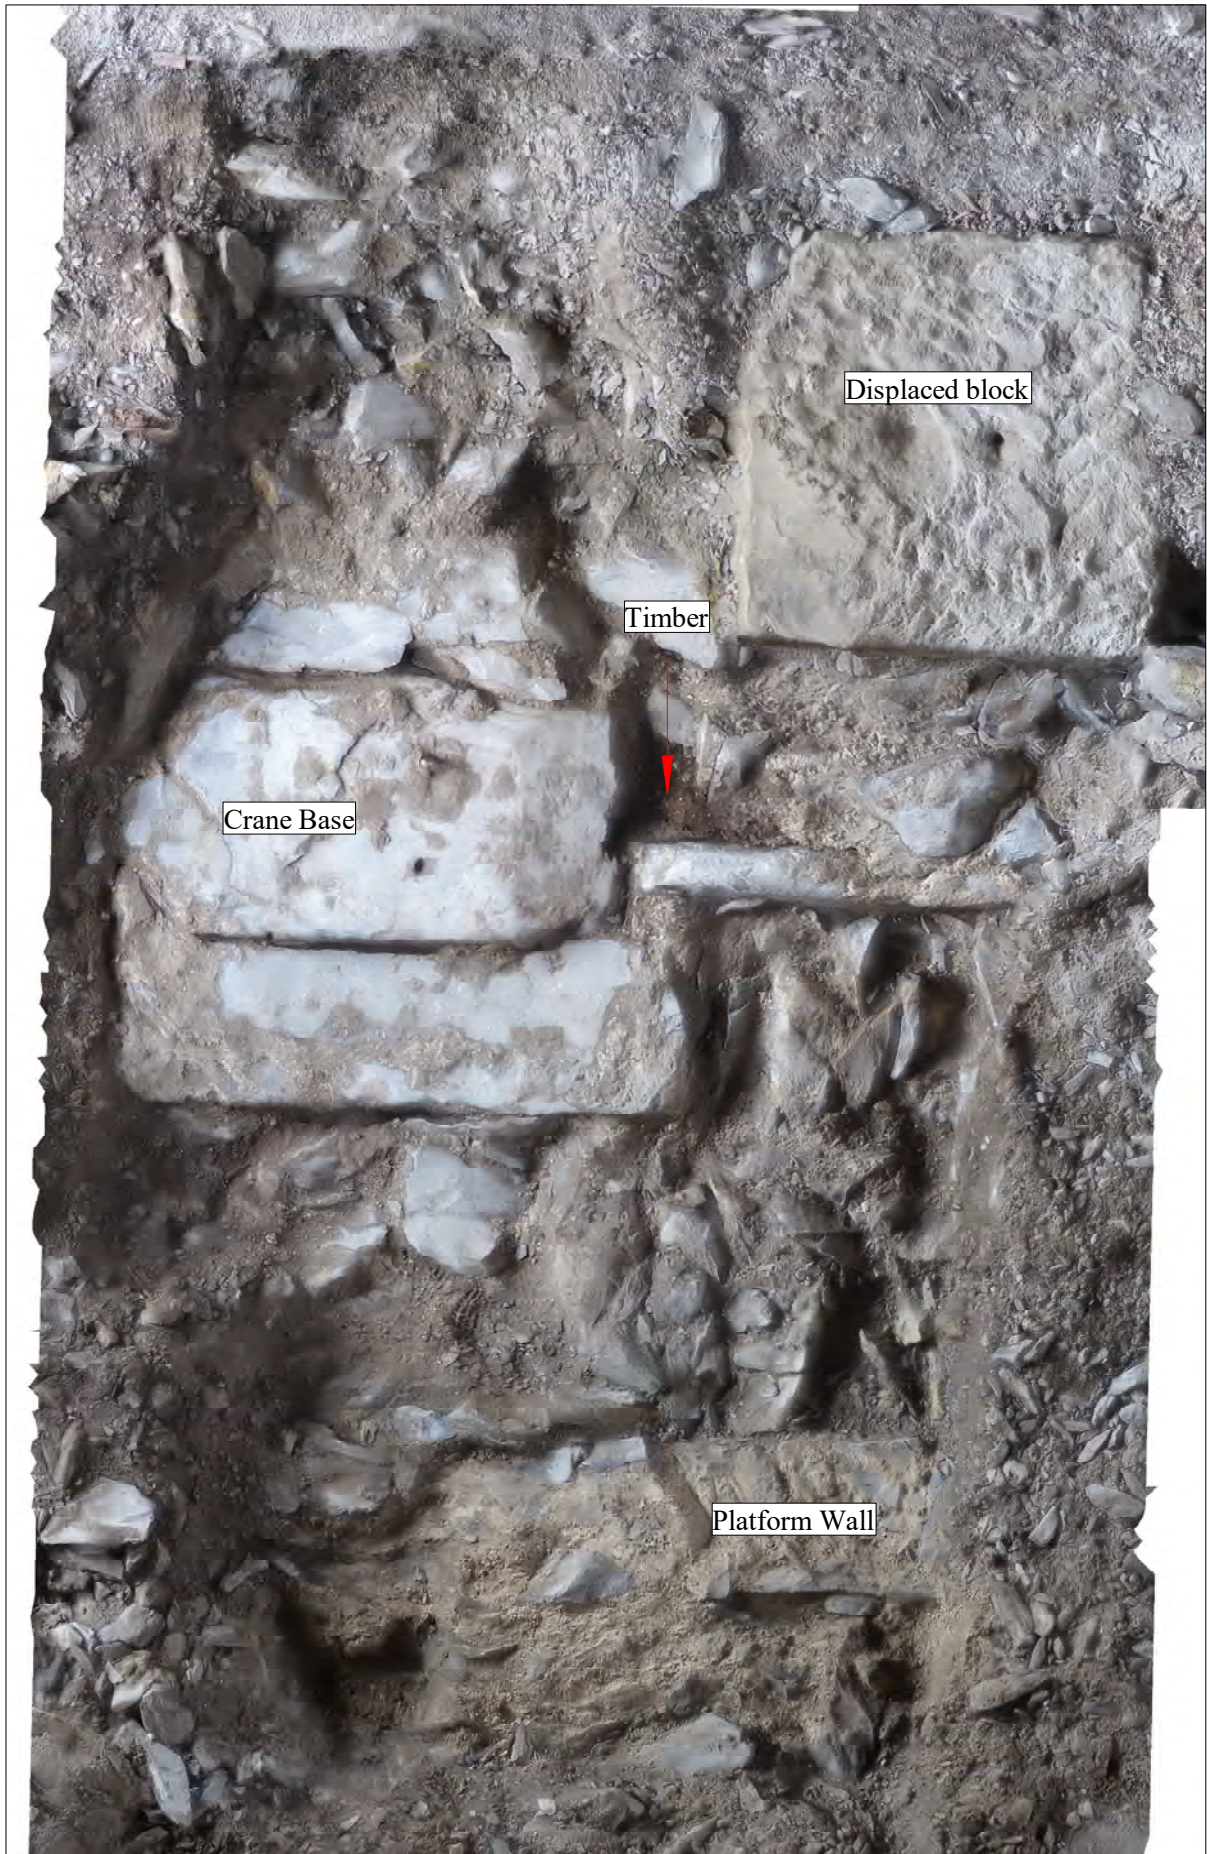
Figure 2: Plan of Trench
Scale 1:20
