**Porth Mawr, Caernarfon
Archaeological Watching Brief
March/April 2019**

EAS Client report 2019/05

Grid Reference:	SH 47904 62808
Listed Building No.	3869
Scheduled Monument reference number	CN034
NPRN	302416
PRN	3098

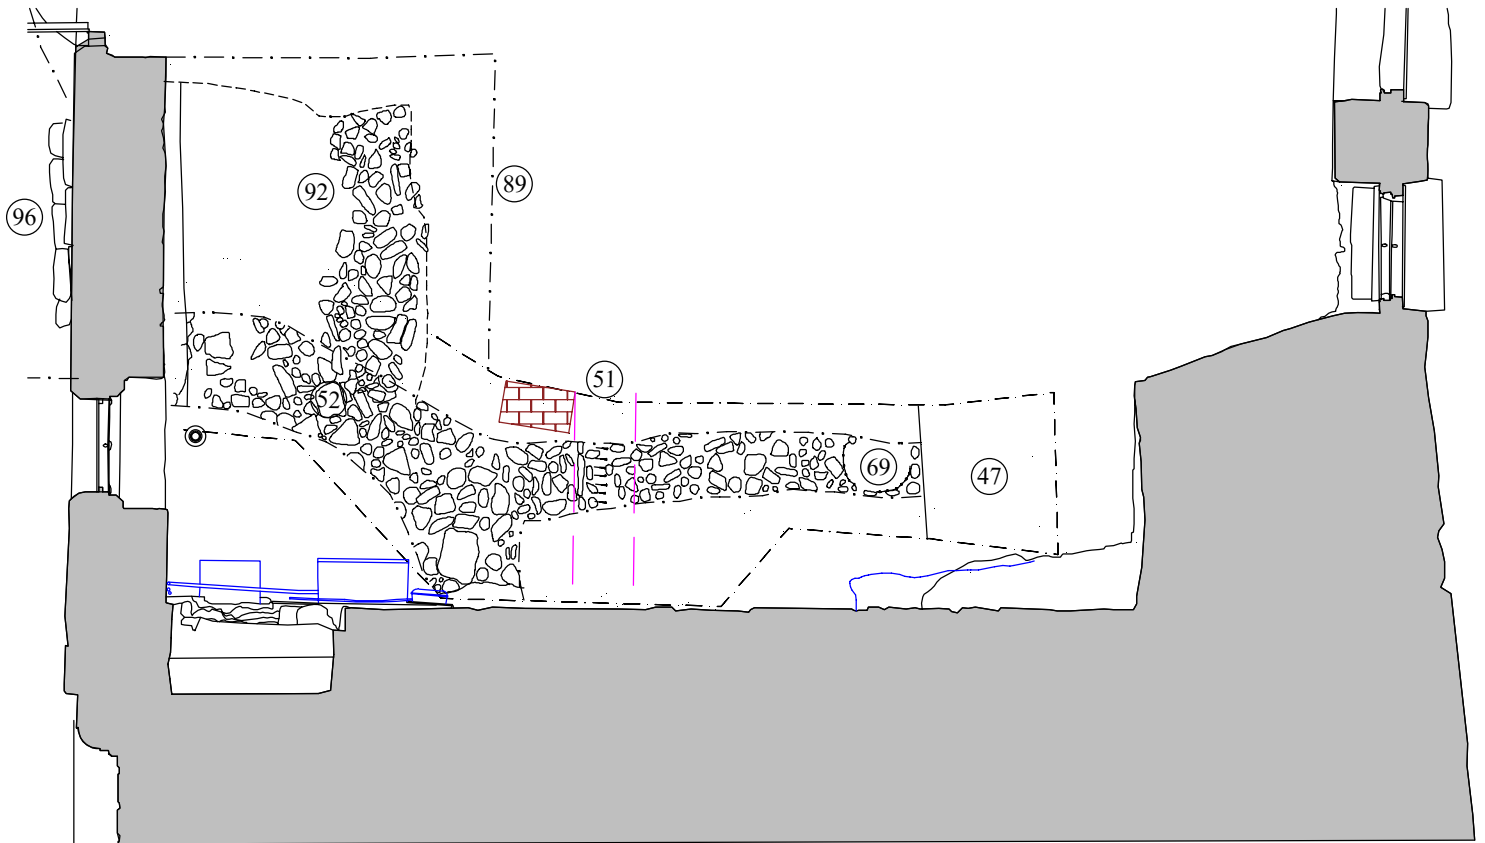
Figure 3: Pitched Stone surface within
3 Hole in the Wall Street
Scale 1:50

Within 3 Hole in the Wall Street a continuation of the previously recorded pitched stone surface was recorded. The footings of the western walls of 3 Hole in the Wall Street and the South Gatehouse were also recorded.

It became necessary to extend the initial trench as the space required by the boring machine had been underestimated. The initial trench was widened to approximately 2.0 m revealing the stratigraphy destroyed by the initial trench. Below approximately 100 mm of concrete (Context 88), that formed the floor of 3 Hole in the Wall Street, was a thick layer of dumped material containing modern bricks and other building debris (Context 90) up to 650 mm thick. This abutted the line of a brick wall (Context 89), which continued the line of the standing dividing wall within the building, and sat on a thin layer of trampled soil (Context 91) which, in turn, sat on and amongst a surface of pitched stones (Context 92, Figures 3 and 4, Plate 3). Context 91 contained a few sherds of Buckley Ware and Brown Glazed Earthenware together with a single clay pie stem and an oyster shell (Plate 9) suggesting a broadly nineteenth century date. The pitched stone surface (Context 92) is a continuation of a surface recorded in the trench dug in 2017 (Context 52), Brooks and Jones 2017, 6-7) which does not appear to be an internal floor, having the characteristics of an external yard surface.

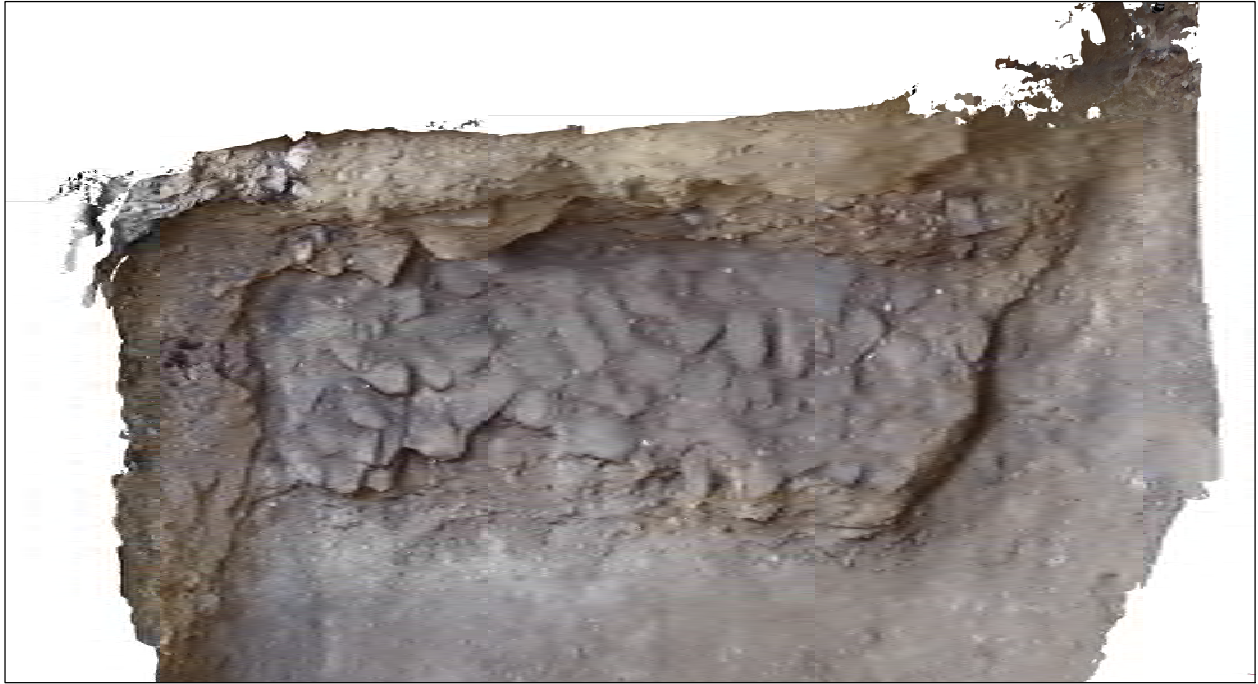
Figure 4: Photogrammetric Plan of Context 92
Scale 1:20

Overlapping digital photographs were also taken to record a pitched stone surface within 3 Hole in the Wall Street. These were processed using Agisoft Metashape Standard v 1.5.1 to produce a three-dimensional model from which the photogrammetric plans (Figure 4) could be extracted

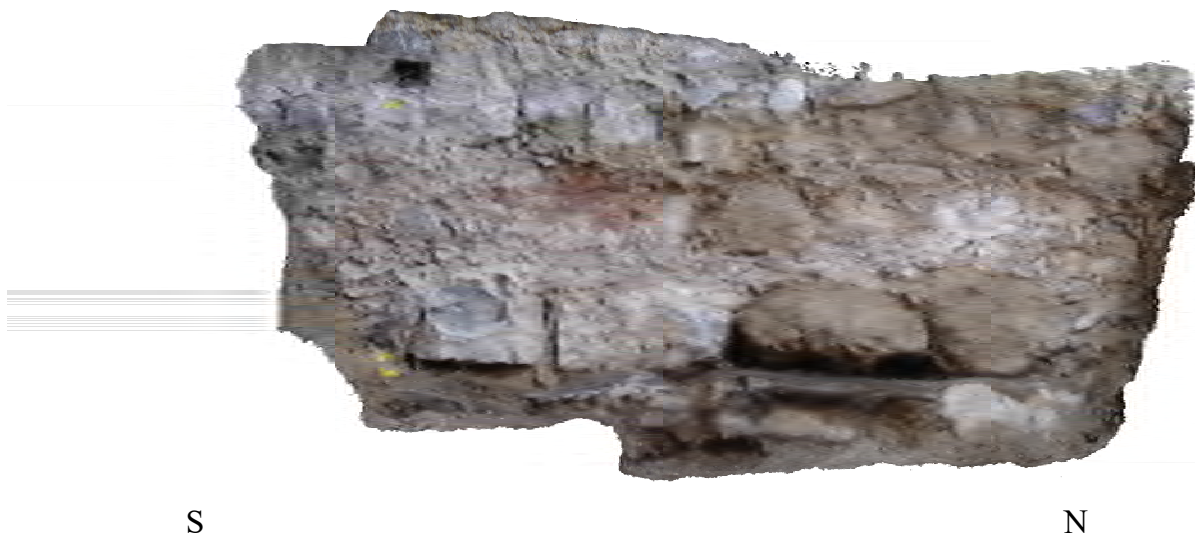
Figure 5: Wall Footings in 3 Hole in the Wall Street
Scale 1:20

Where exposed the footings of the western wall to 3 Hole in the Wall Street (Context 96, Plate 6) were of larger stone blocks than the rest of the wall above. Located approximately 500 mm below the street level, the footings protrude from the line of the general wall by 280 mm and form a block of masonry at least 360 mm deep which possibly sits on the natural clay. The small size of the exposure of this possible natural clay, however, makes this assumption difficult to confirm. Three boreholes were drilled through this section of wall, from the inside of the building.

It is assumed that the walling exposed where the proposed services from 3 Hole in the Wall street exit into the road, is the footing for the current structure. This would give well made footings approximately 850 mm thick on which the superstructure was built with a wall approximately 620 mm thick.

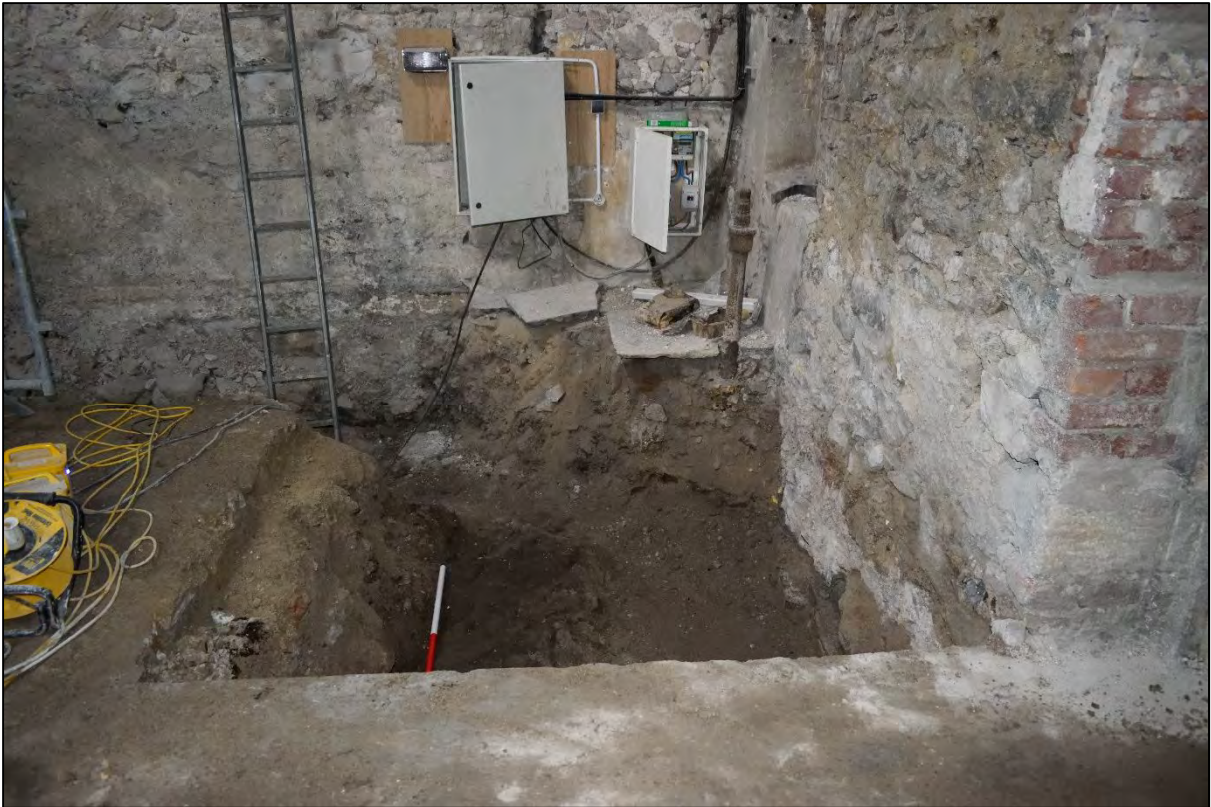
Plate 1: Trench within 3 Hole in the Wall Street

Before the archaeologist was appointed to the project a trench had been dug, by mistake, on the inside of the western wall of 3 Hole in the Wall Street as preparatory works to allow the boring of holes through the wall to link the proposed services to those within Hole in the Wall Street. This extended to area already examined in 2017 (Brooks and Jones 2017) forming a trench approximately 1.75 x 1 m and 0.90 m deep along the western wall of the building. It revealed the back face of the western wall of the building. (Figure 5, Plate 2) including two courses of larger stones (up to 570 x 200 mm in size) which protrudes from the main line of the wall by approximately 100 mm (Context 96). It is assumed that this is the footings for the wall above and the same context was also evident in the new sewer trench outside (see below).

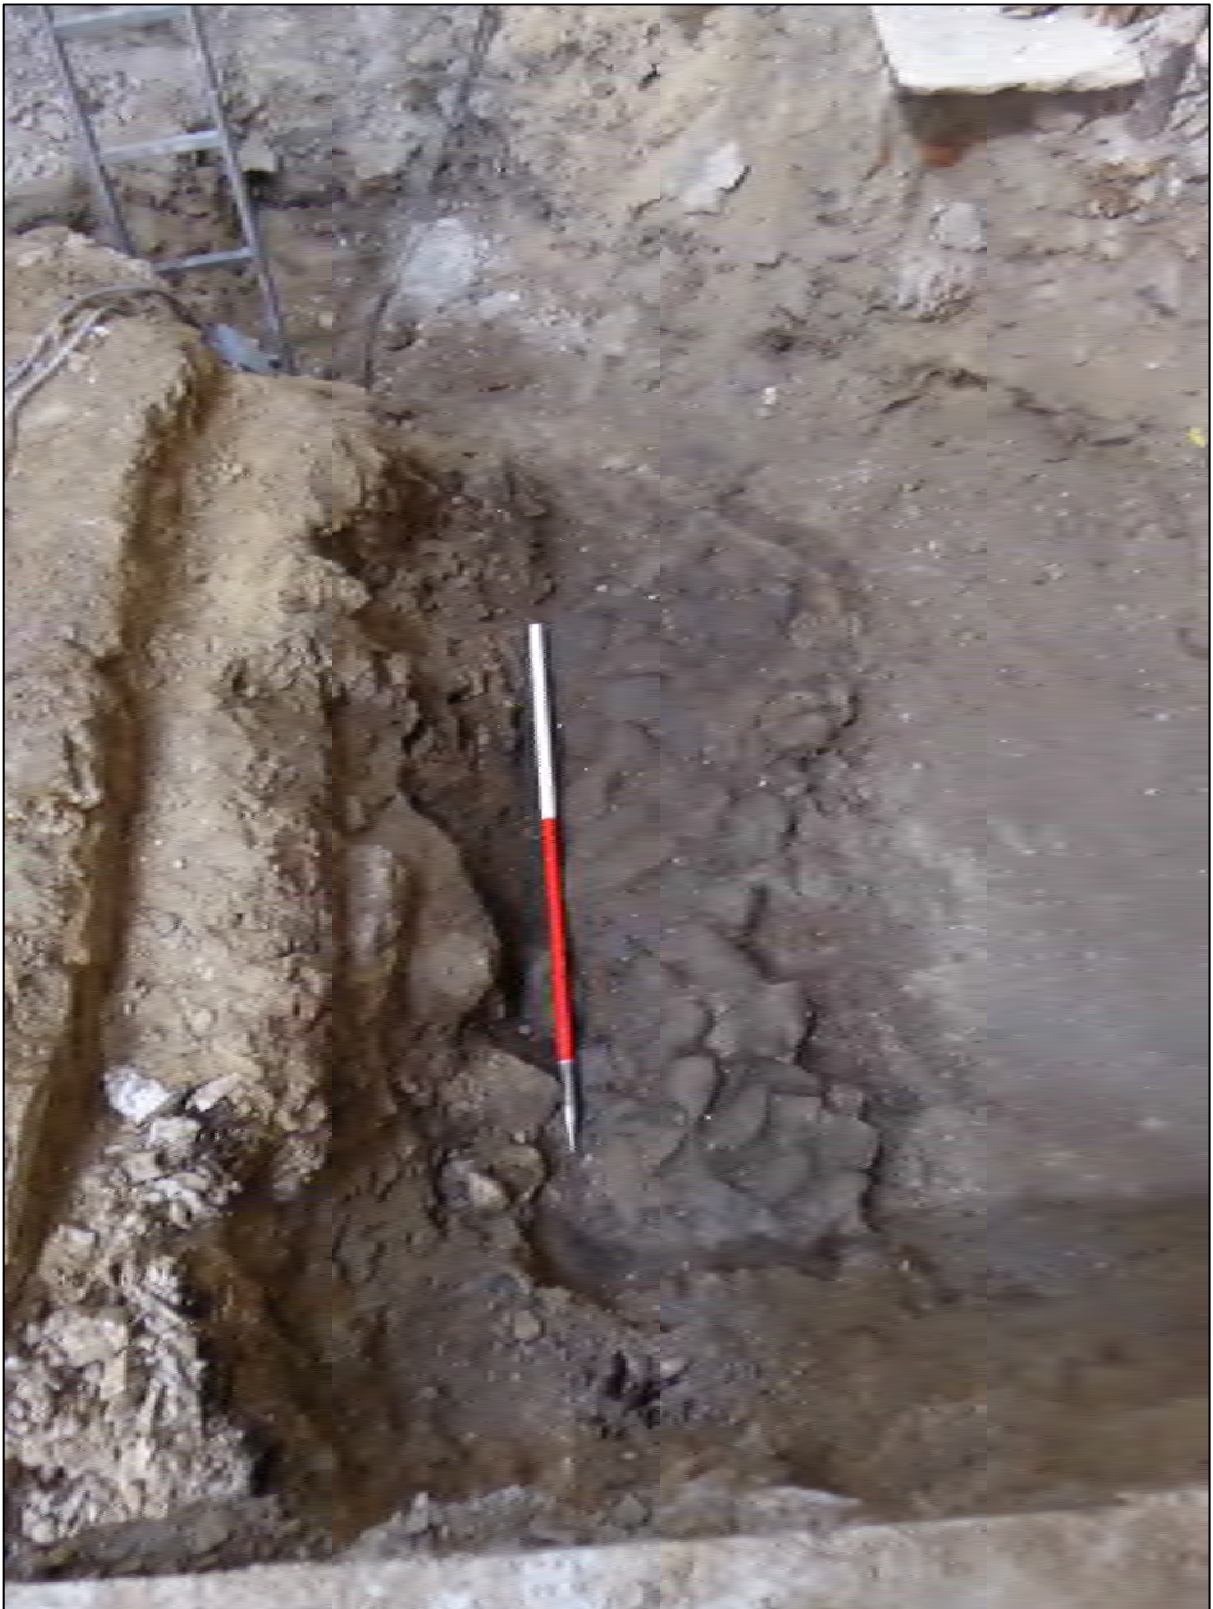
Plate 3: Pitched stone surface (Context 92)

The watching brief on the groundworks associated with new services in the South Gatehouse and 3 Hole in the Wall Street revealed relatively little new archaeology. Within the 3 Hole in the Wall Street the pitched stone surface extended the area known where this feature was exposed. It is unfortunate that the initial trench within 3 Hole in the Wall Street was dug without archaeological monitoring as it is likely that the pitched stone surface extended over the whole of this area and the relationship between the pitched stone surface and the western wall of the building has been lost. It would seem probable that the current structure of the building cut through the pitched stone surface and is therefore later, however this remains pure speculation. Given its character, one possibility is that the pitched stone surface relates to the “Exchequer Dunghill, adjoining the New Town Hall” recorded in a lease granted to Henry Jones Mercer in 1785 (Evans 1972, 133).

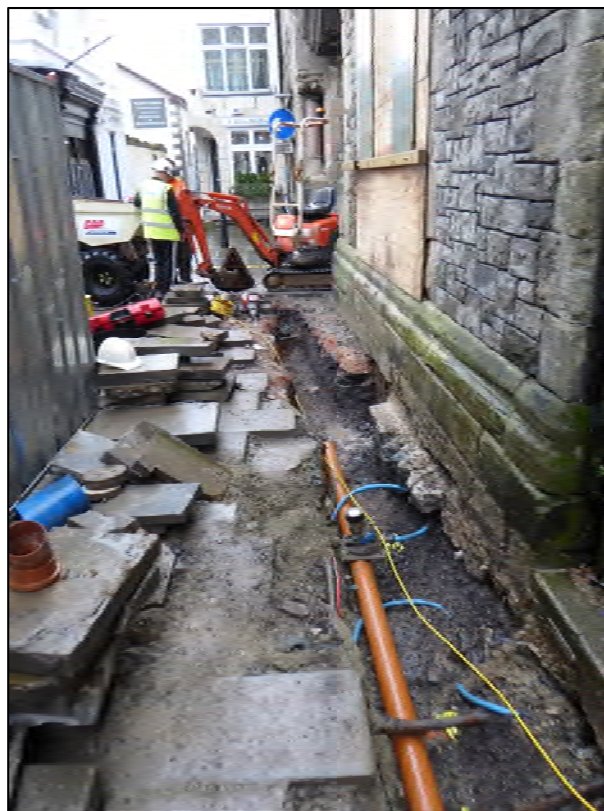
Plate 5: The new sewer trench during construction

The trench for the new sewer ran for approximately 12 m alongside the western wall of 3 Hole in the Wall Street and the South Gatehouse (Figure 2, Plate 5). Although it ran nearly parallel to the wall it only joined it at two places where the holes were to be bored to link the internal services with their supplies. At the southern end of the trench it was slightly wider (approximately 1.8 m) reaching the outer wall of the cellars for Porth Mawr Jewellers on the opposite side of the street. More typically the trench was 700 mm wide and 500 mm deep.

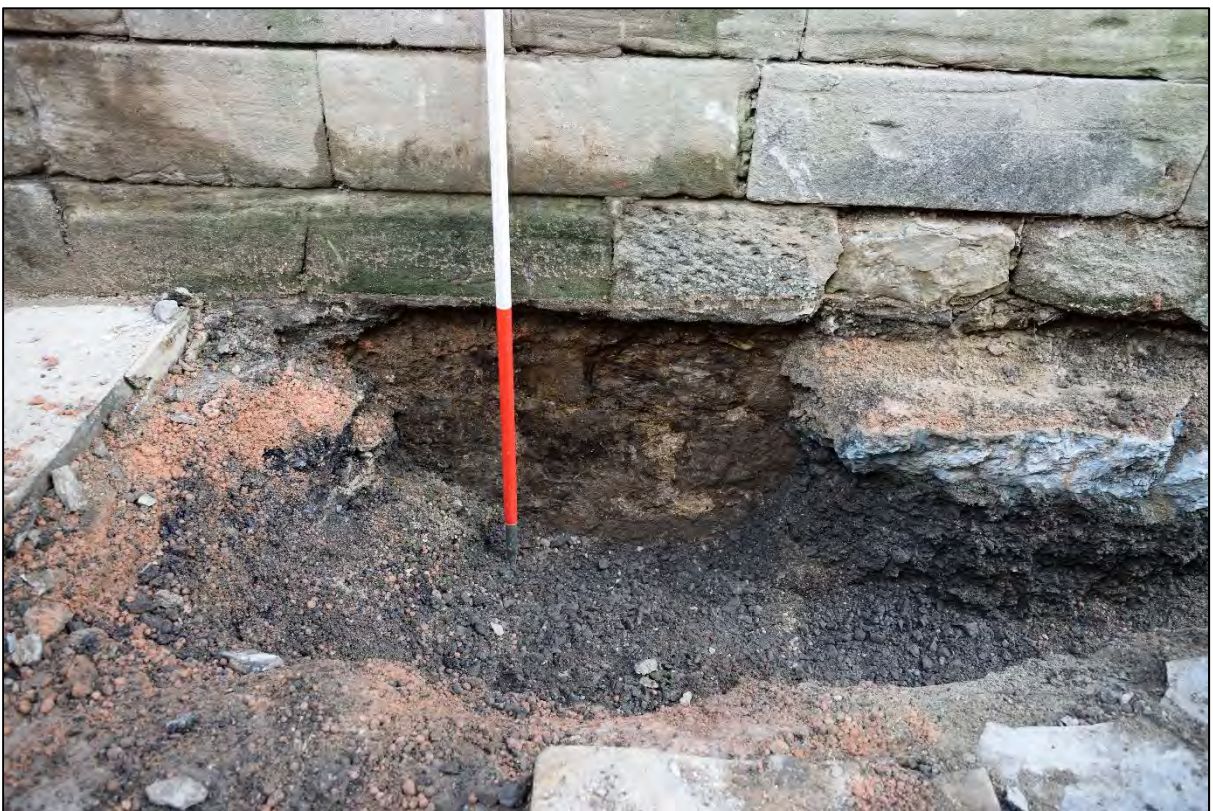
Plate 7: Footings of the South Gatehouse

Below the window in the western wall of the South Gatehouse the new sewer trench also exposed the below ground walling (Context 97, Plate 7). In this case the exposed wall was set back (under) from the wall above, by approximately 50 mm, and appeared to be of built with more care. Although it is difficult to determine the size of the blocks used, partly because of the small size of exposure, but largely because of the lime mortar slopped over the surface. This wall is the outer face of the wall (Context 45) exposed in the western end of the trench dug in the South Gatehouse in 2017 (Brooks and Jones 2017, 6) giving a total thickness of this wall of 1.20 m. Two boreholes, each 167 mm in diameter were drilled through this wall (Plates 8 and 9) giving some indication of the construction of the wall. Because of the restrictions of the size of the trench inside the gatehouse and the morphology of the deposits exposed, these boreholes were drilled at an angle of approximately 33° from the top surface of the wall inside the gatehouse.

The walling below the window in the western end of the South Gatehouse, may be the footings for the current structure, however, it would seem more likely that this is the remains of an earlier structure, probably medieval in date. The character of this section of walling, being 1.20 m thick and of similar appearance to the wall at the western end of the North Gatehouse (Context 6, Brooks and Jones 2017, 4, Figures 3 and 12) would suggest that they may be part of a single phase of construction and relate to one of the earlier phases of the gatehouse.
