Engineering Archaeological Services Ltd.

**Antur Stiniog Downhill Cycle Tracks Extension, Blaenau Ffestiniog,
Gwynedd: Archaeological Watching Brief**

EAS Client report 2019/08

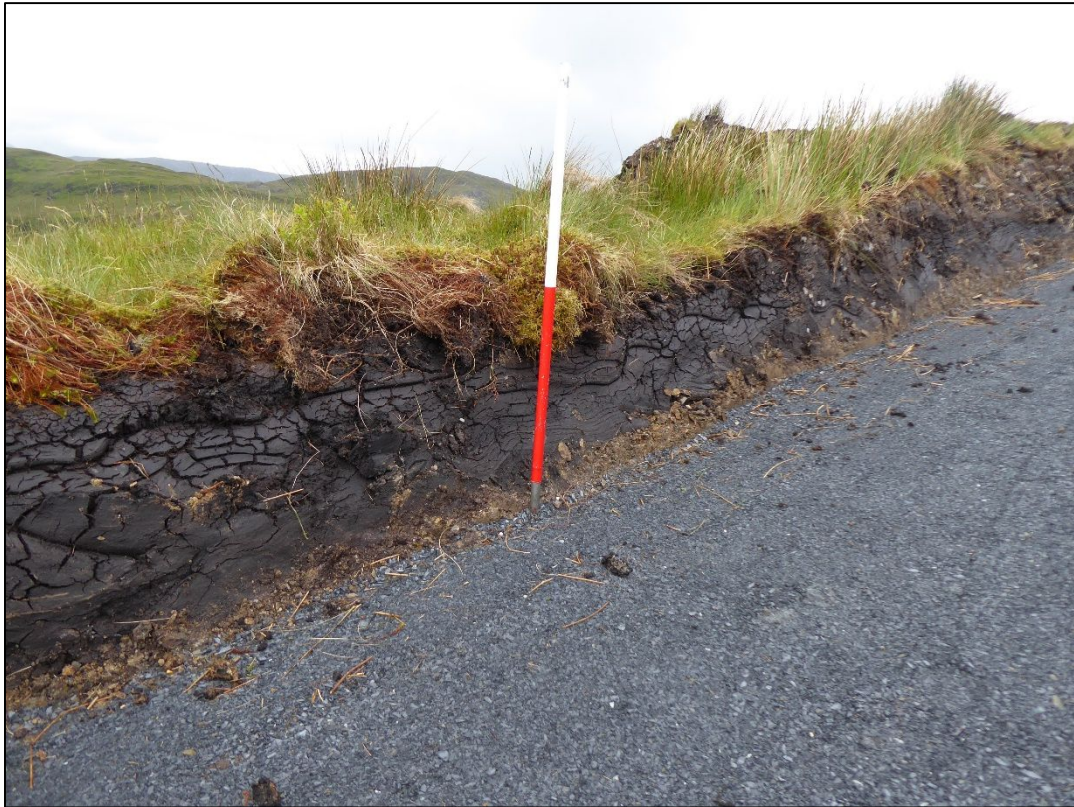
No new archaeological features or deposits were recorded along the Red Route, however, there is a deposit of peat, up to 500 mm deep between SH 70188 47936 and SH 70166 47902 on the top of Cribau (Plate 1). This covers approximately 40m of the route near to its start on the top of the hill and forms part of a much larger peat deposit recorded in the original watching brief (Brooks 2013).

Plate 1: Peat deposits between SH 70188 47936 and SH 70166 47902 on the Red Route

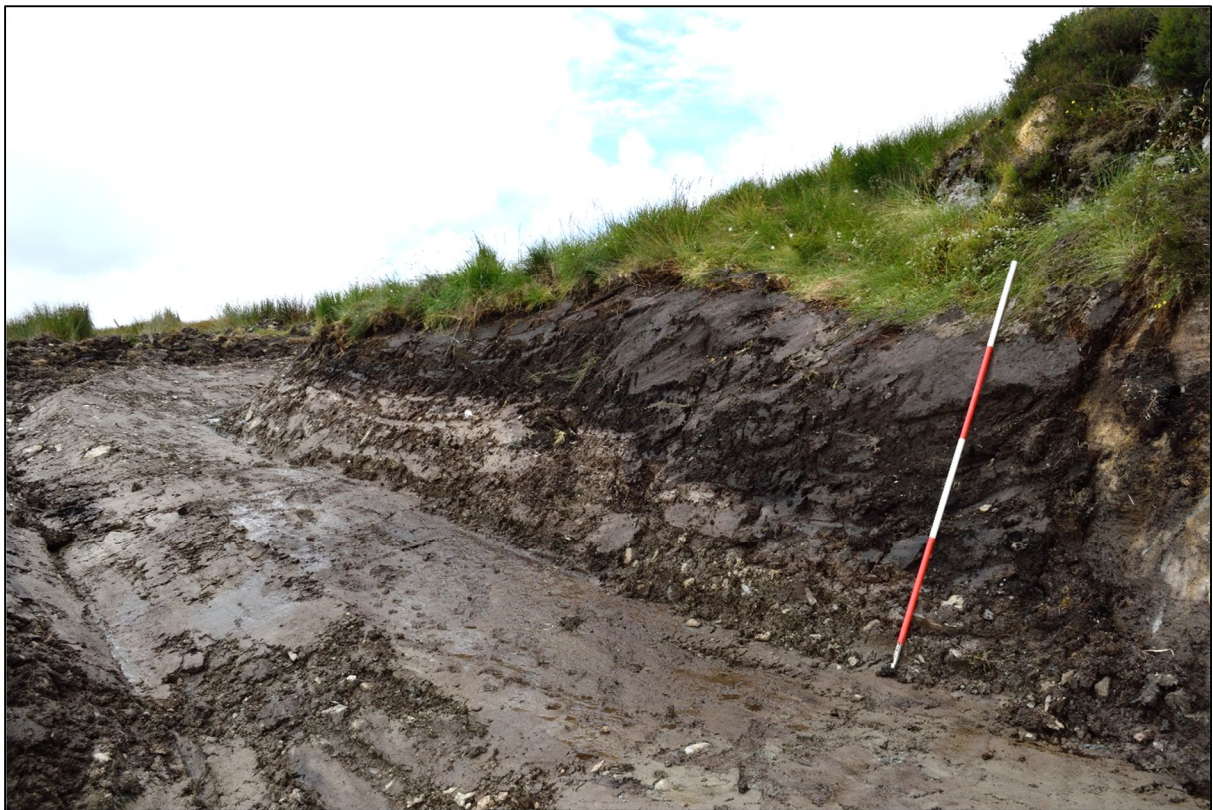
Even with the re-routes the new Black Route cut through two peat deposits greater than 0.5 m deep. Between SH 70094 47684 and SH 70069 47667 (Plate 2) was a deposit covering approximately 31 m of the Black Route. This deposit tended to be deeper on the uphill side of the track and was thicker at its north eastern end where the peat deposit rested on a rock exposure. A second peat deposit was located between SH 70080 47617 and SH 70086 47621, an 8 m long section of the route.

Plate 2: Peat Deposit between SH 70094 47684 and SH 70069 47667 on the Black Route

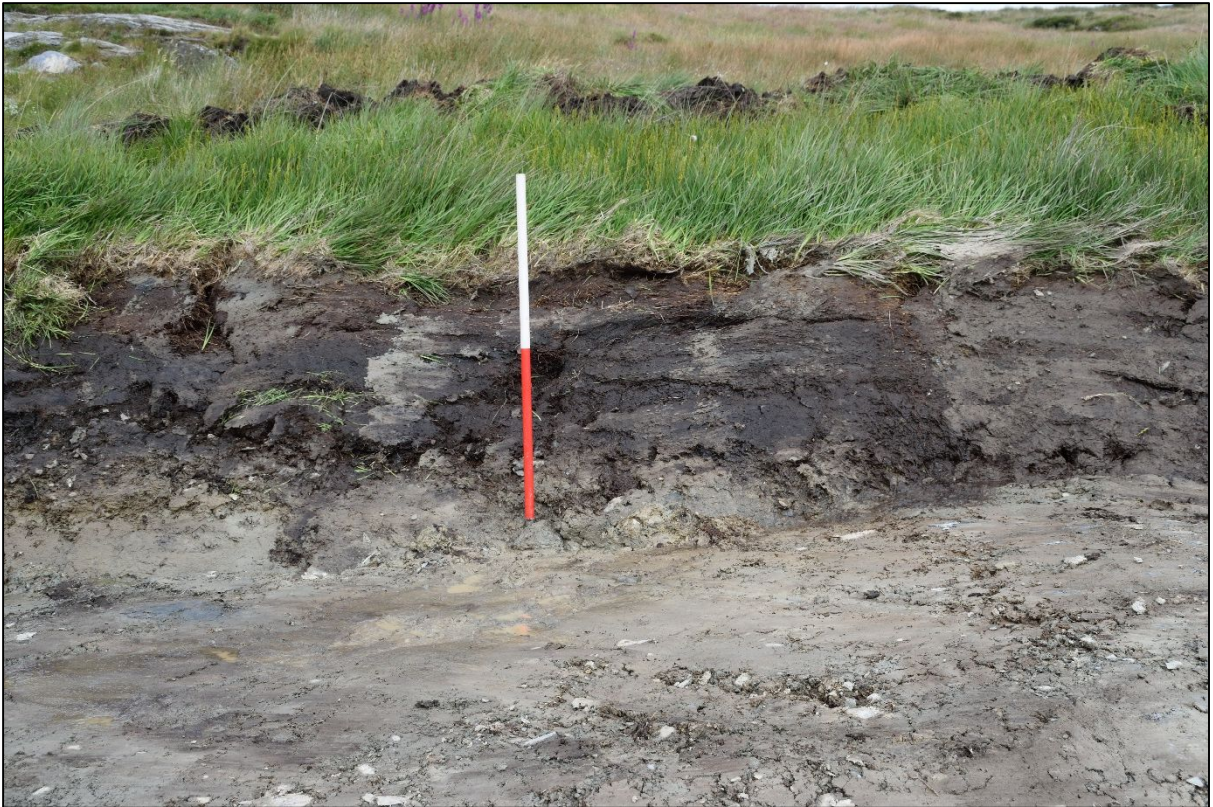
Plate 3: Peat deposits between SH 70080 47617 and SH 70086 47621 on the Black Route

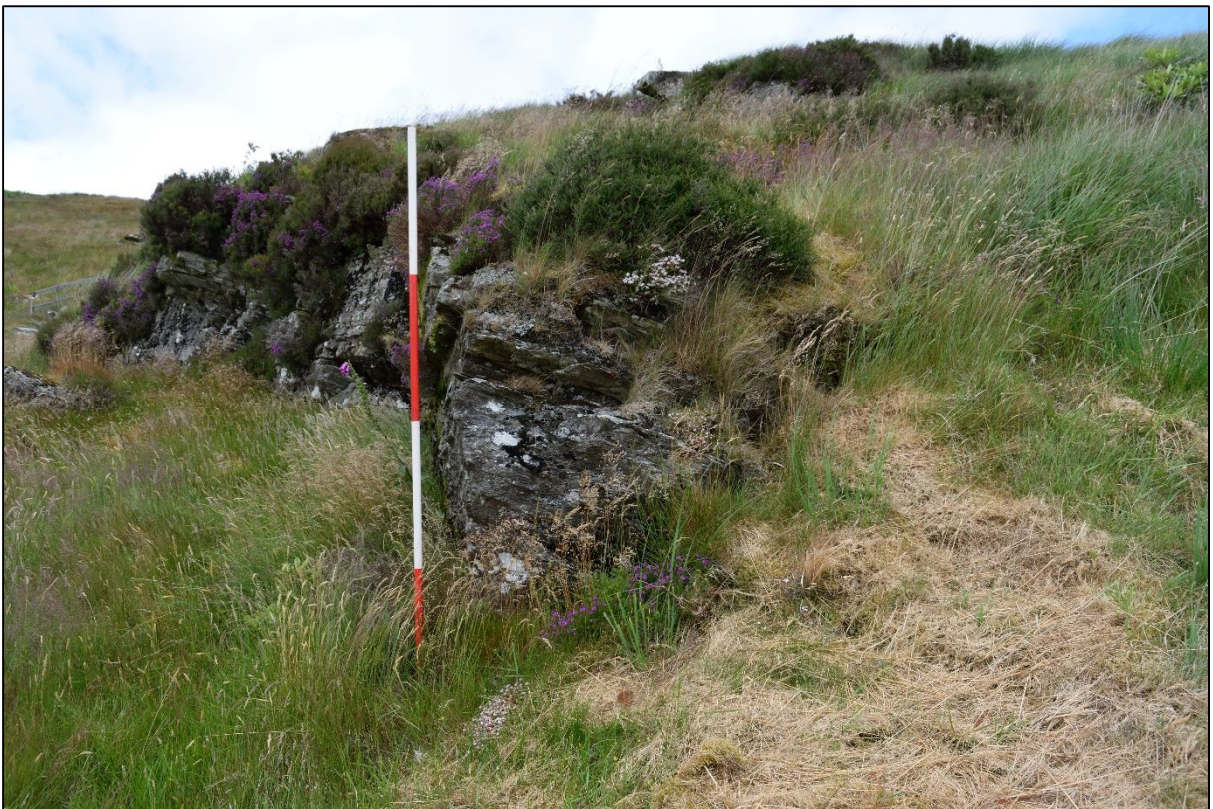
Only one new archaeological feature was located on the Black Route. The re-route away from the shaft (PRN 30200) forced the constructed route through a gap between a natural rock face (Plate 4) and one of the drainage ditches (PR 302256, Plate 5) feeding water down to the Cribau farm complex. Linking these two features was the remains of a stone wall (Plate 6). This wall centred on SH 70130

Plate 4: Rock face at one end of the wall crossing the Black Route

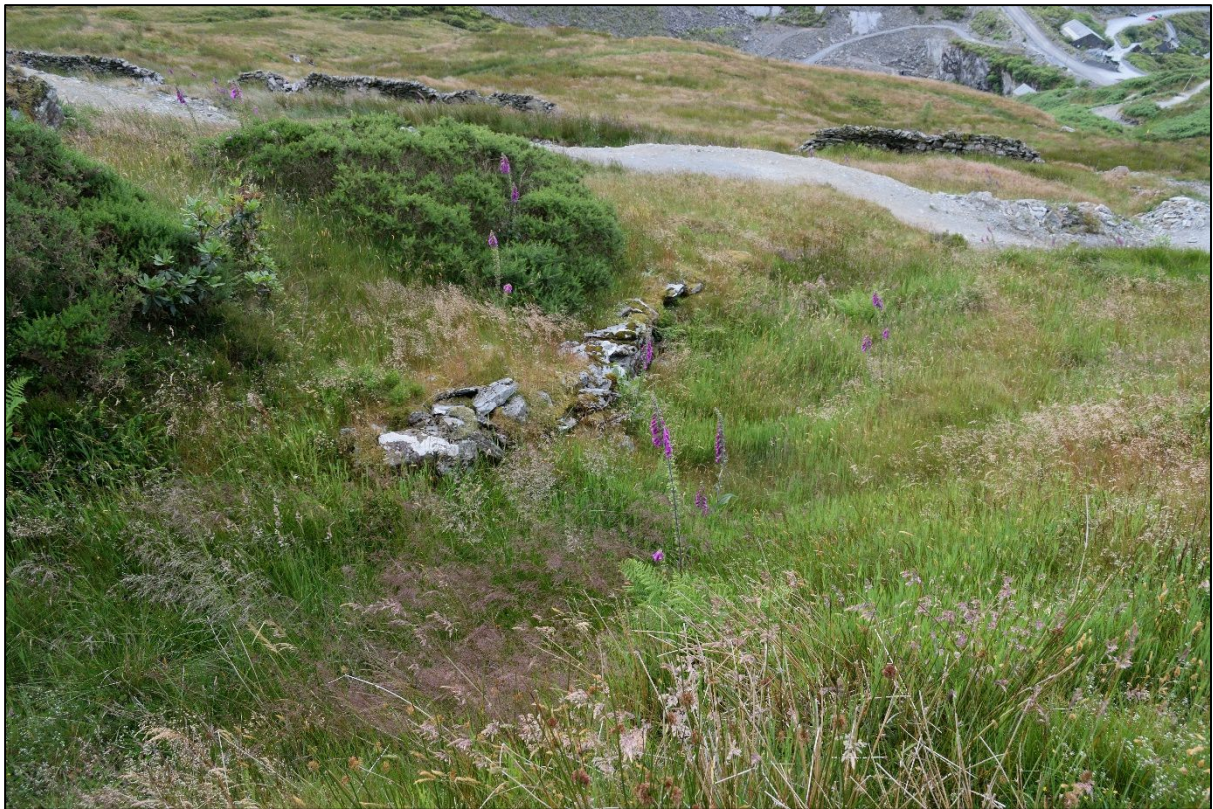
Plate 5: Ditch with revetting wall (PRN30225) at one end of the wall crossing the Black Route

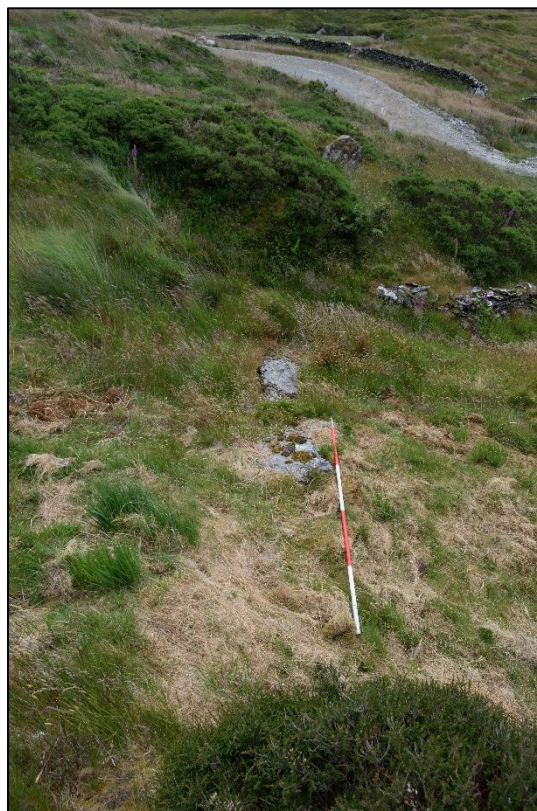
47439 and ran for approximately 6 m. It consisted of a series of earth-fast rocks with the wall only surviving at ground level. It was possible to preserve this feature by burying it beneath the spoil from the construction of the route.

Plate 6: Remains of wall crossing the Black Route

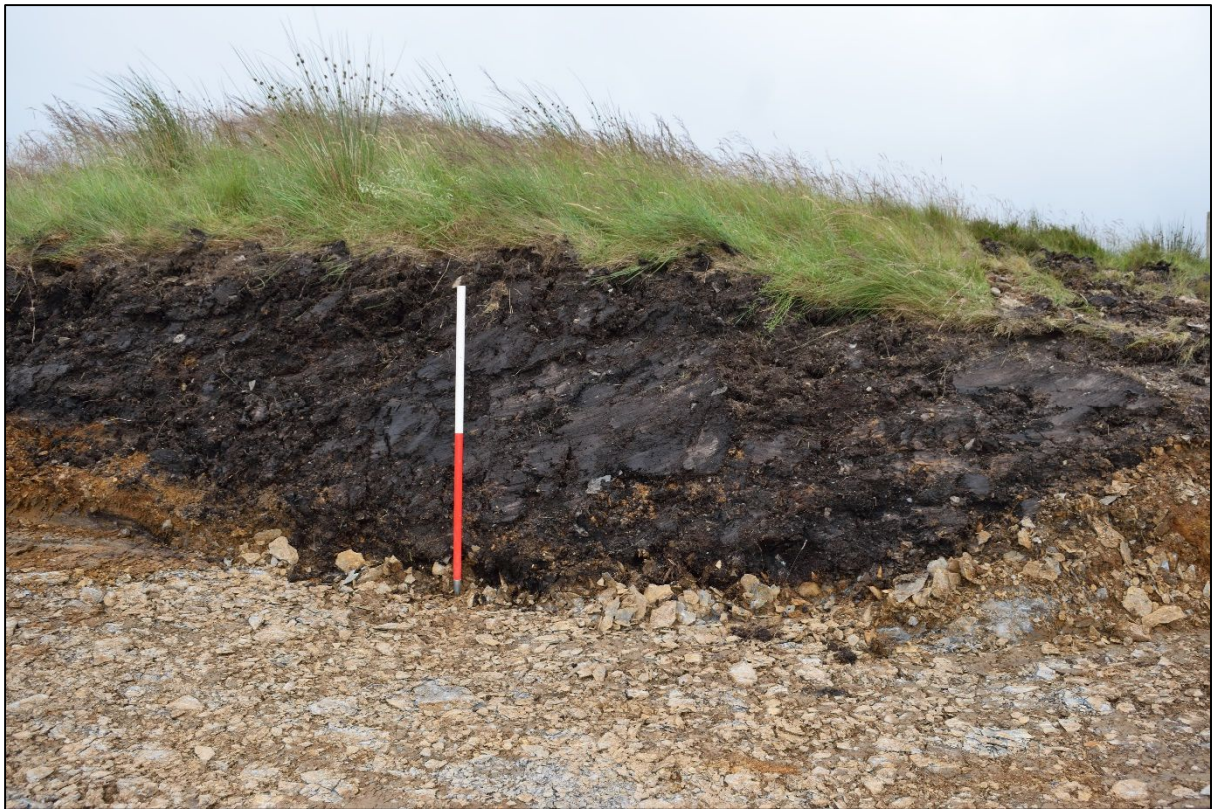
Even so it was not possible to avoid all of the peat deposits along the route. A peat filled channel, crossed the route at SH 70457 48072. This was approximately 4.5 m wide and contained up to 1.2 m of peat deposits. It was one of a series of peat filled channels draining the northern plateau of Cribau. More extensive peat deposits were encountered between SH 70433 47898 and SH 70438 47850 (Plate 8) a distance of approximately 75 m. This deposit was the western edge of a more extensive deposit with the constructed route skirting around its edge. A further channel fill with peat was also recorded at SH 70435 47818 which was associated with an active stream which crossed the route at this point.

Plate 7: Peat filled channel centred on SH 70457 48072 on the Green Route

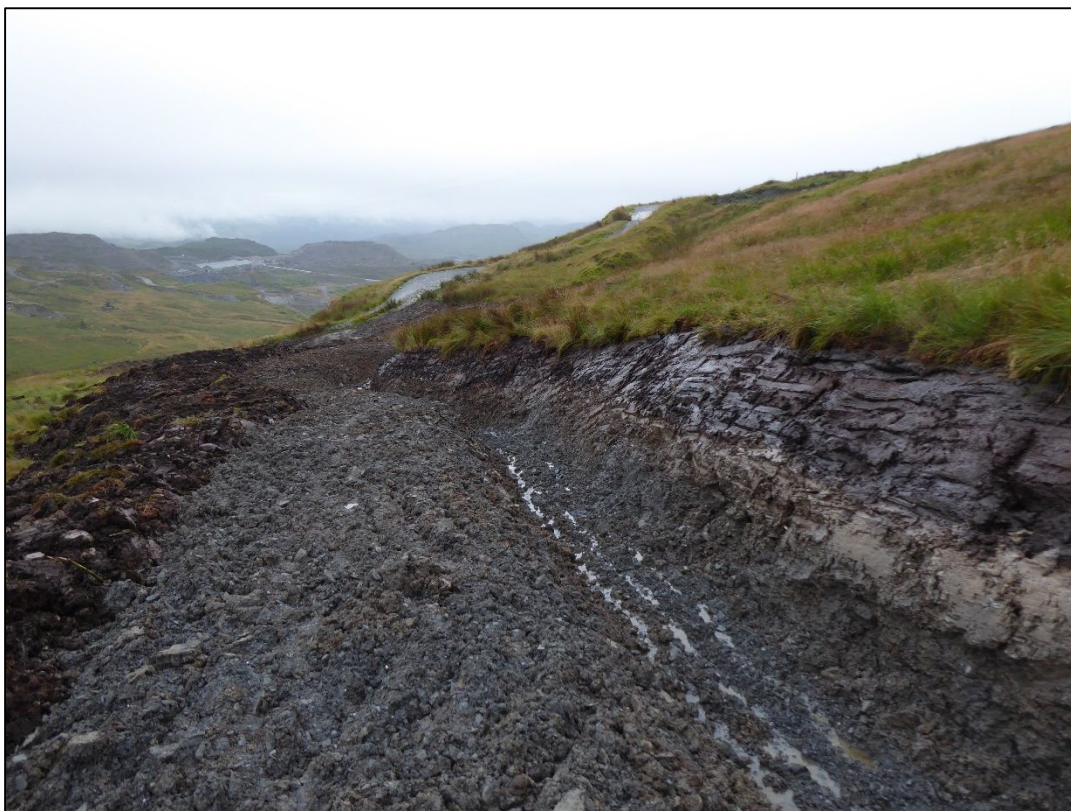
Plate 8: Peat deposit between SH 70433 47898 and SH 70438 47850 on the Green Route

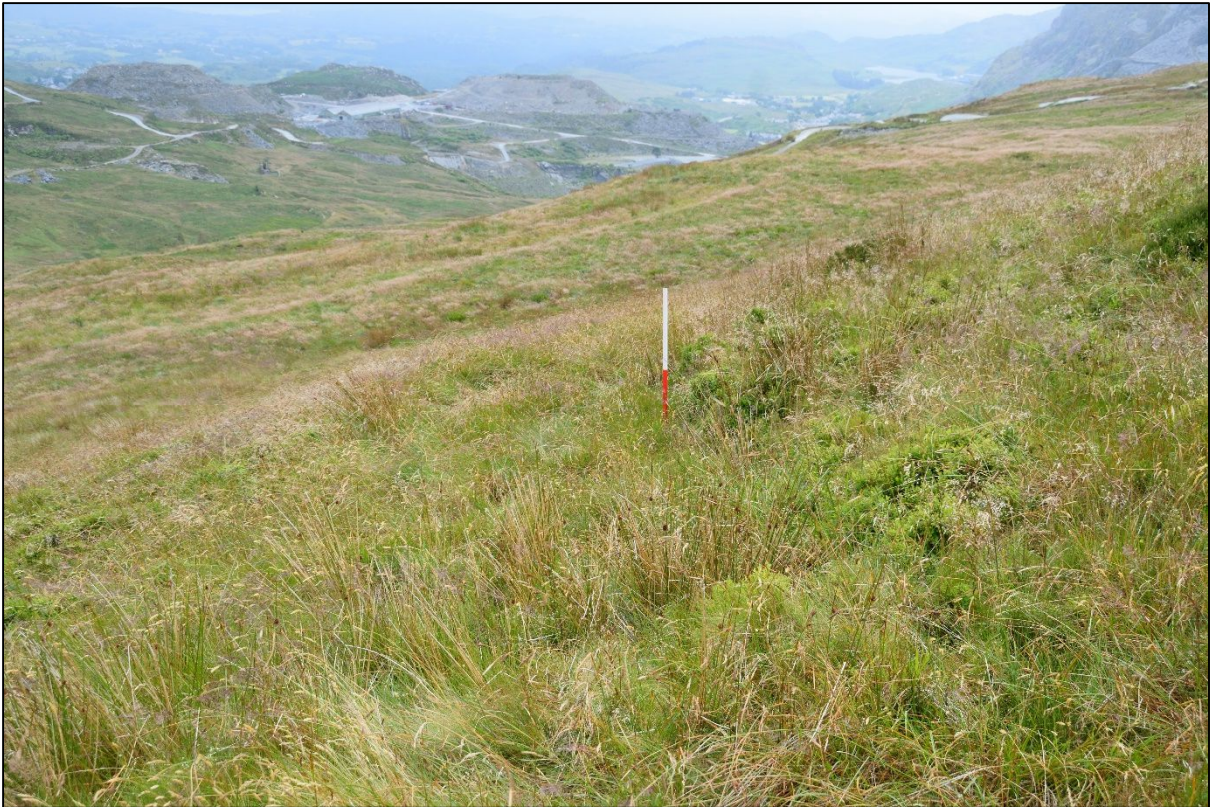
Two potential archaeological features were encountered along the route of the Green Route. Between SH 70535 48063 and SH 70514 48028, a distance of approximately 40 m, there was a shelf cut into the slope (Plate 9). This was approximately 3 m wide and was cut into the hillside by approximately 0.4 m along its upper (western) edge. The initial impression was that this was a farm track, looping around the eastern knoll of Cribau. Whilst this interpretation may still be valid, no metaling or other hardening of the possible track surface was recorded when the Green route was constructed along this platform.

Plate 9: Possible trackway on the Green Route

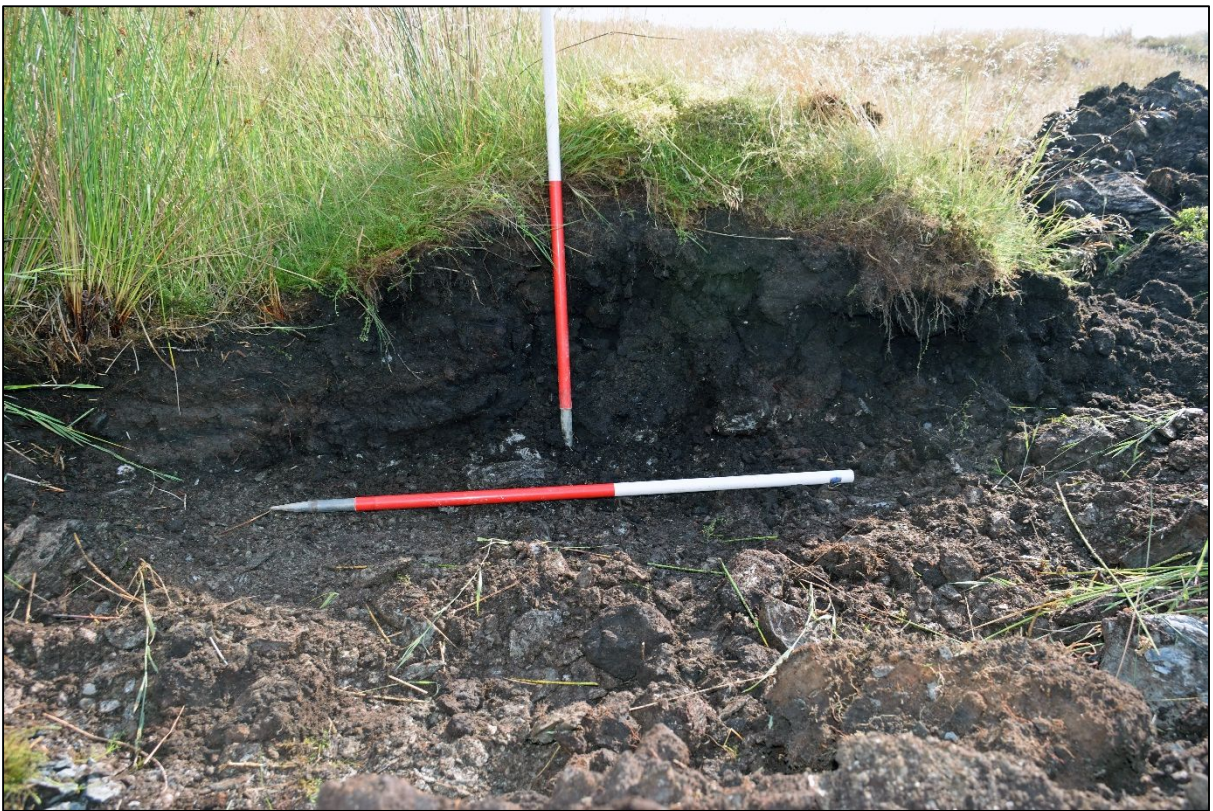
On the edge of the Cribau Farmstead complex at SH 70107 47339 was a linear mound running NE – SW, 1.5 m wide and 4 m long. When sectioned (Figure 4, Plate 10), the mound had a layer of topsoil (Context 1) composed largely of degraded peat. Below this was a stack of peat (Context 2), partly in the form of cut peat “bricks (Plate 11) forming a stack 0.5 m high. Although slightly degraded it was possible to determine the structure within this mound with a central, level stack against which further blocks were rested at an angle of approximately 45°. Each of the bricks were approximately These “bricks” were up to 230 mm long, 60 mm wide and 100 mm thick. The “bricks” rested on a platform of slate slabs 30 mm thick (Context 3). These slabs, in turn, sat on a layer of rough gravel (Context 4) consisting of sub-angular stones up to 130 mm in size. It is assumed that this gravel layer and the slate slabs acts as a firm, dry base for the peat stack which was used as a fuel supply for the farmstead of Cribau.

Plate 10: Peat stack on the Green Route

The other feature is a peat stack, presumably the supply of fuel for the farmstead of Cribau. The turves within this mound had been carefully stacked and then covered by a layer of soil, presumably to keep the turves dry.

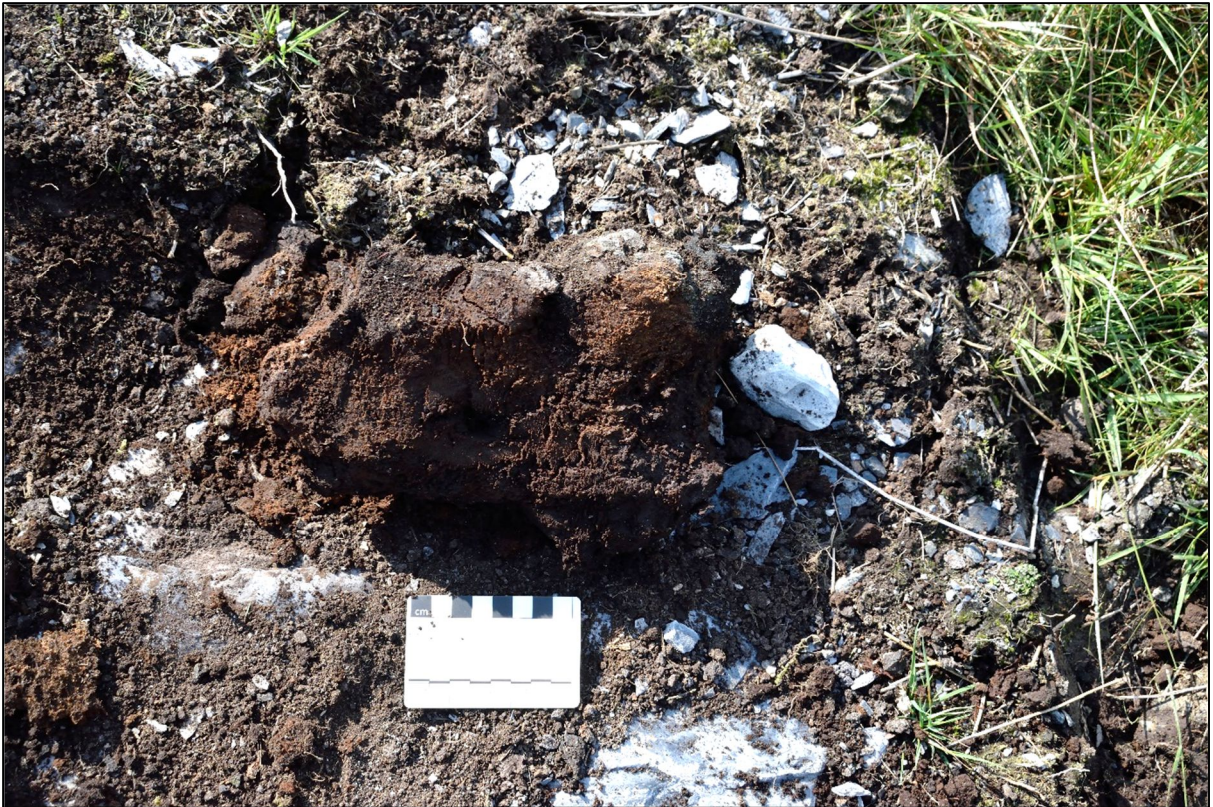
Plate 11: Peat block
