Archaeological Watching Brief

EAS Client report 2020/01

**Canolfan y Gwystil, Y Ffôr
Archaeological Watching Brief**

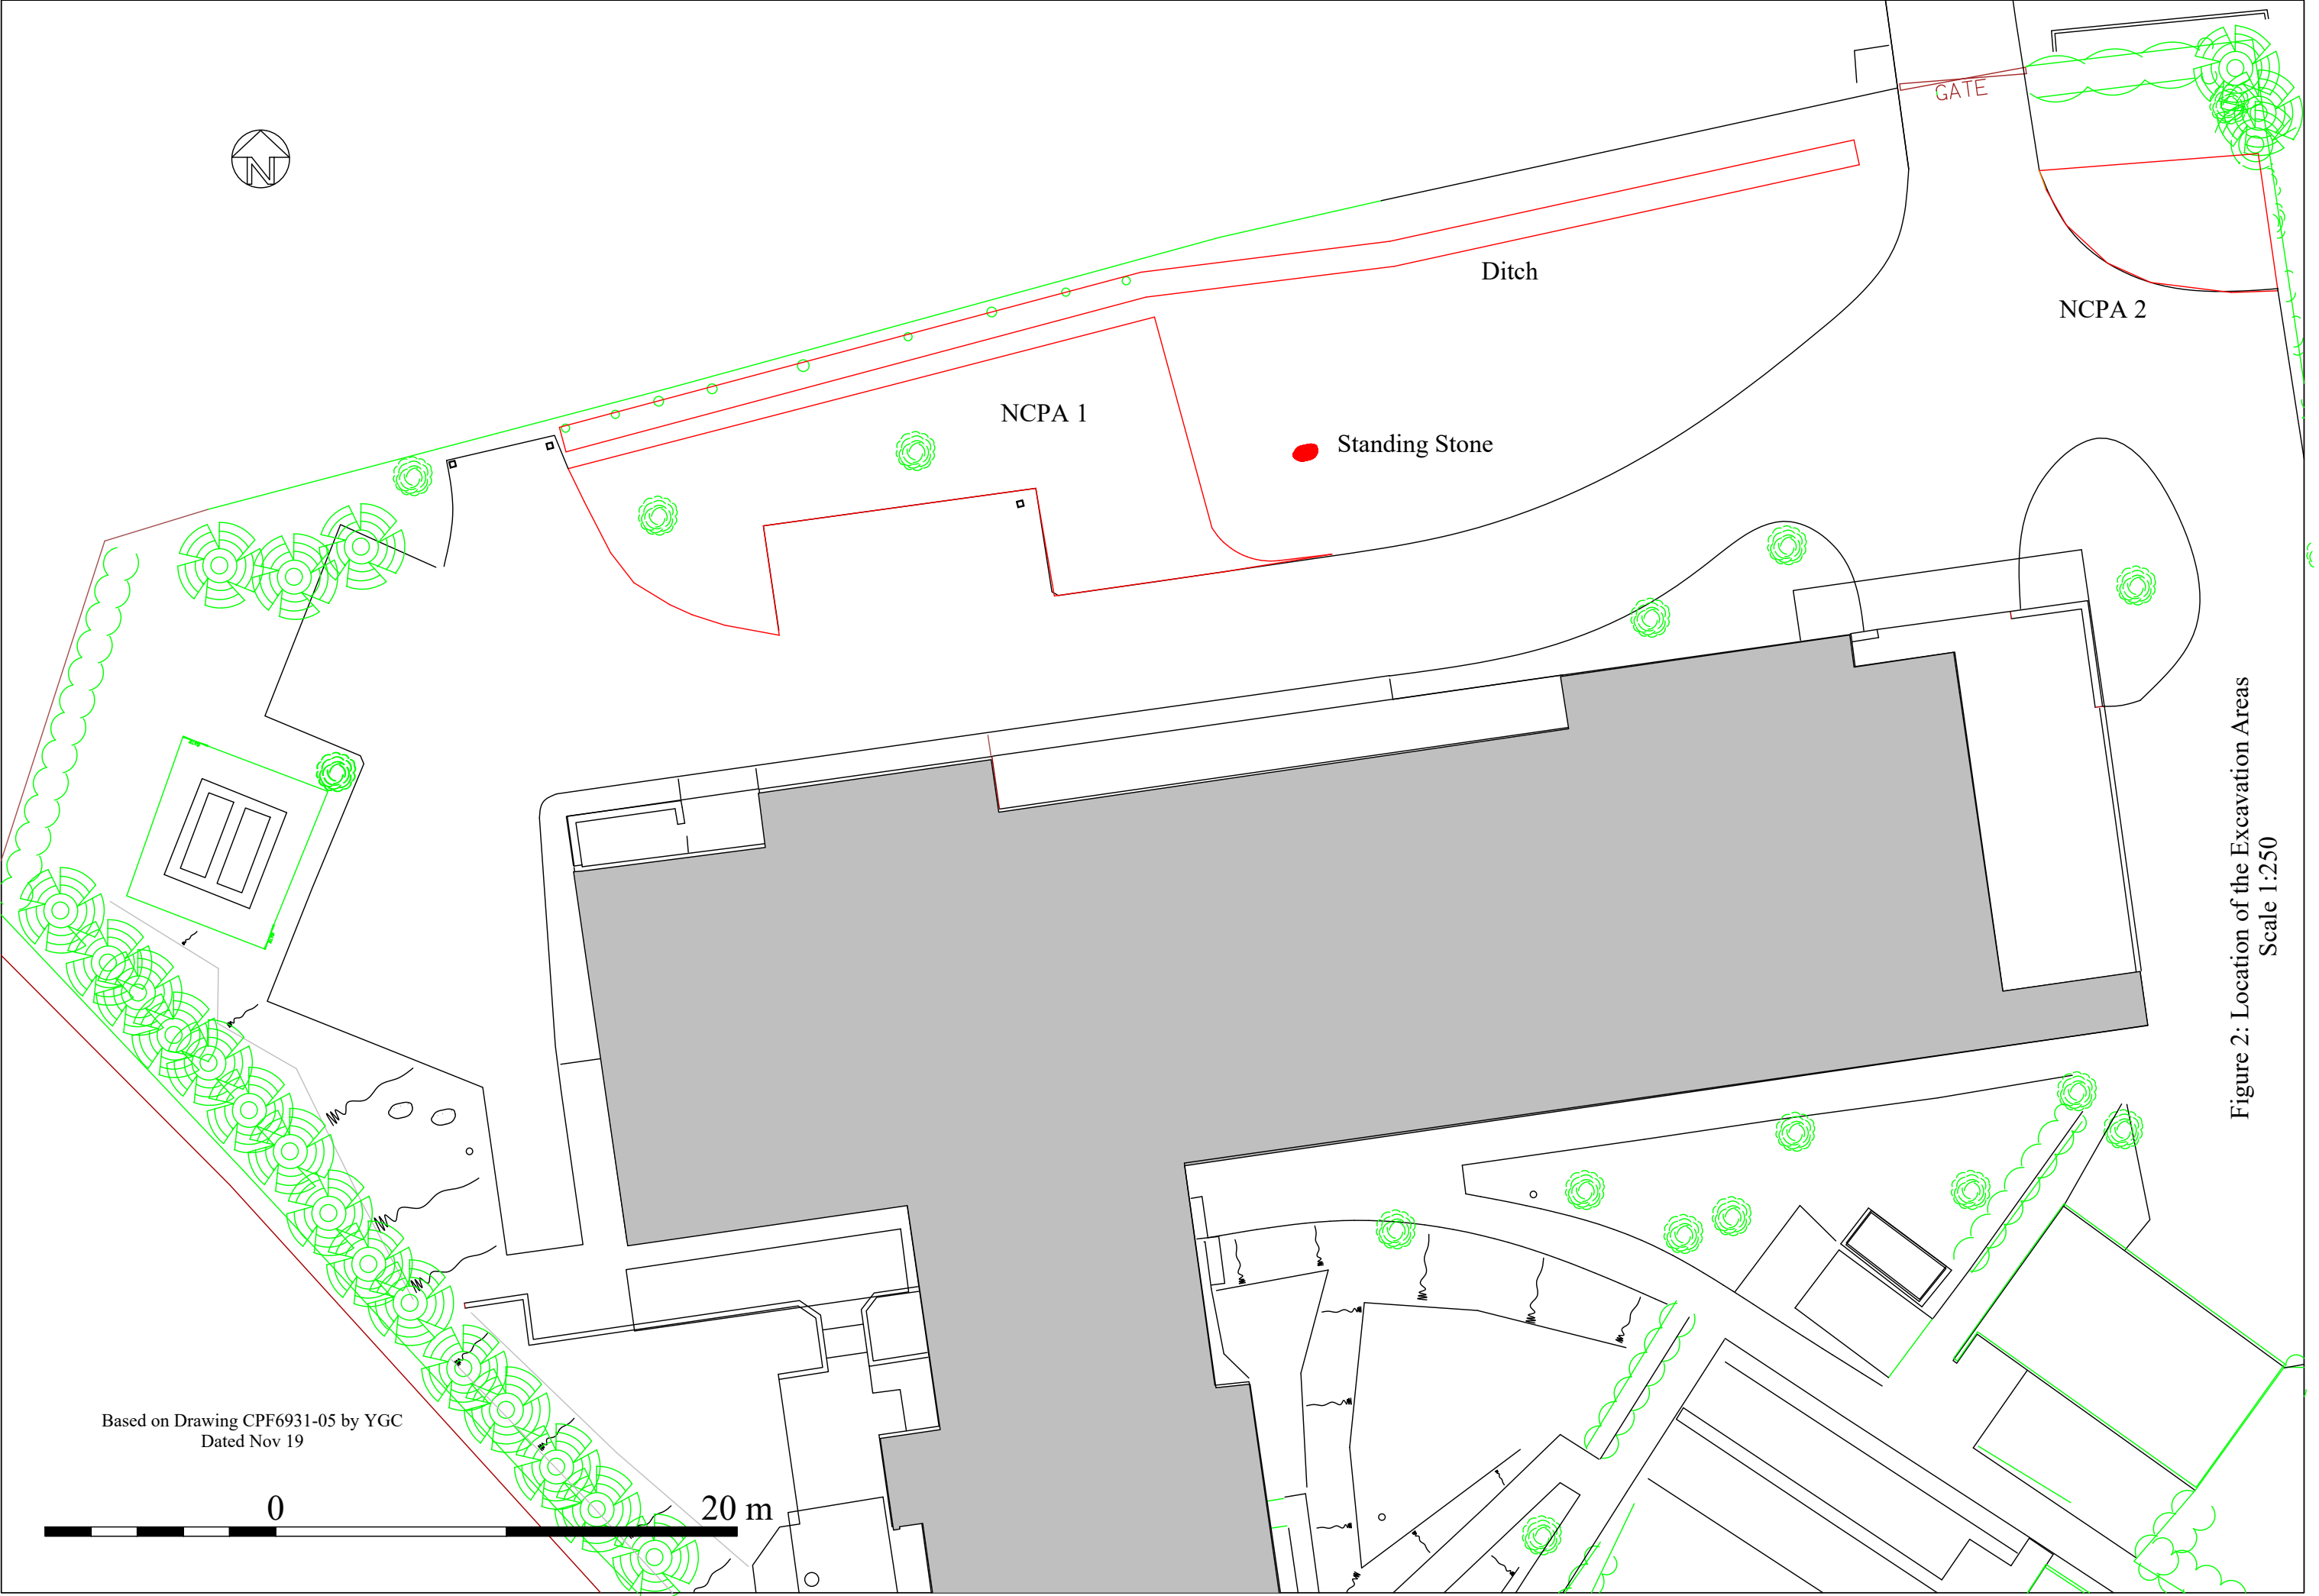
Figure 2: Location of the Excavation Areas
Scale 1:250

The western carpark (NCPA 1) consisted of an area 26.25 x 11 m in size to the west of the standing stone (Figure 2). Prior to the excavation, there was two beds for shrubs or small trees which were, at least partly, surrounded by boulders (Plates 1 and 2) and the remains of a mature hedge or line of trees along the northern boundary of the plot. The eastern tree/shrub had a large boulder, to the north (Plate 2), which on excavation proved to be 2.5 x 0.8 x 1.5 m in size (Plates 3 and 4). One end and one side had an unworn, broken, appearance (Plate 5), whilst the other was worn with the occasional glacial scoring. Near to one end, however, was a slight notch, 0.7 m from one end, (Plate 6) which is possibly signs of differential wear. If so, this boulder may have been part of a standing stone. There was no sign of a pit for the boulder, indeed the presence of fragments of machine-made bricks below the boulder would suggest it had been moved to its position in the relatively recent past.

NCPA 2 was located on the eastern side of the gate into the property (Figure 2). Before excavation it was a lawn with a single small tree planted centrally in the space (Plate 8). The development area was approximately 5.8 x 9.6 m in size with a curved southern edge following the line of the existing kerbs on the edge of the access road.

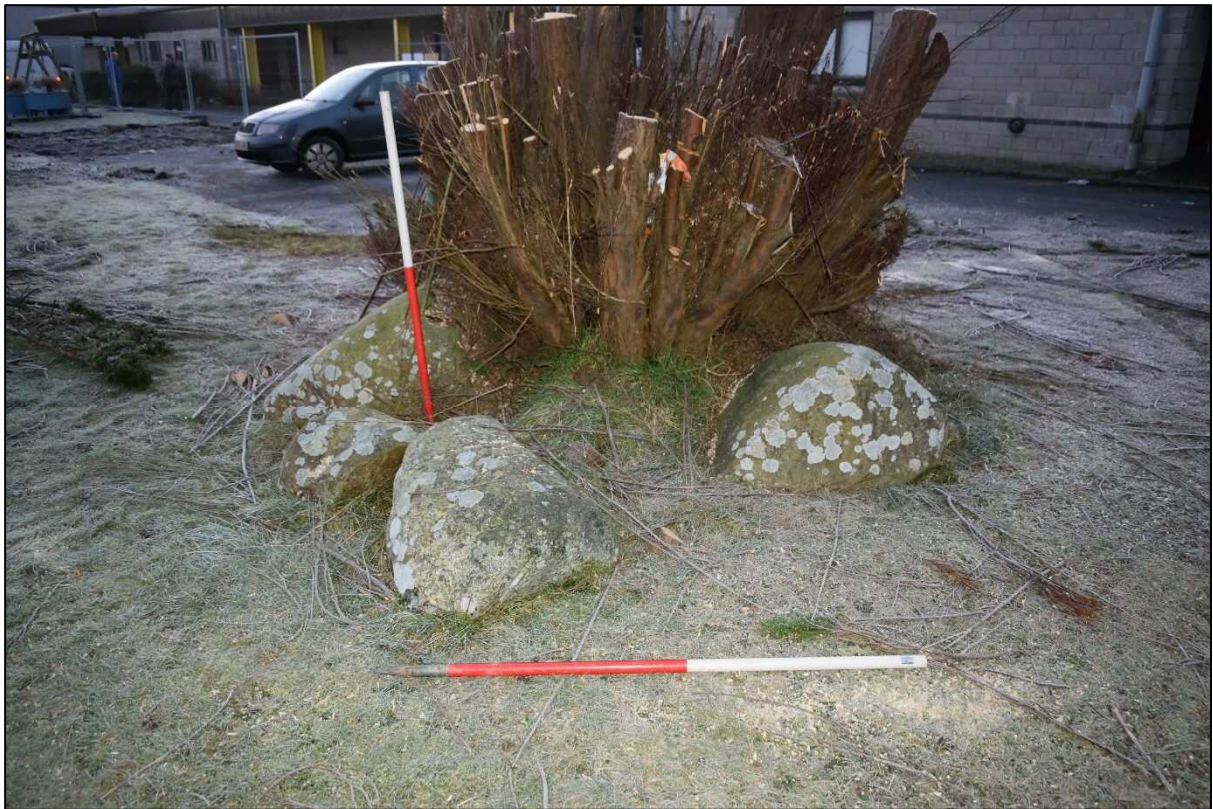
Plate 1: The western group of boulders around a small tree/bush in NCPA 1.

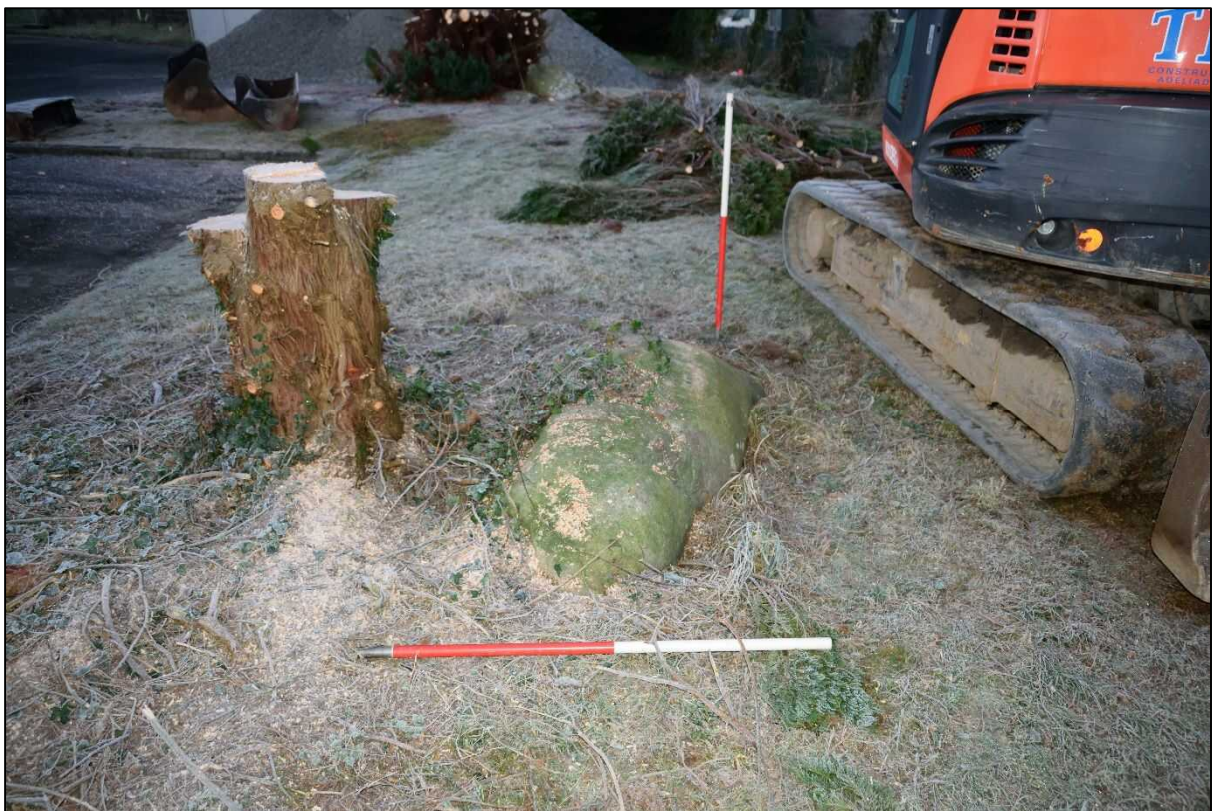
The only possible exception to the generally modern nature of the archaeology recorded is the large boulder which was originally used as an edge to the eastern tree/bush in NCPA 1. Even so it is clear that it was deposited relatively recently, probably having been moved from elsewhere. Its size is similar to the Four Crosses Standing Stone, although one face, and probably one end, has been broken with a series of fresh breaks evident. However, on the naturally smoothed face there is a slight notch which suggest a different level of wear. One speculative interpretation is that this may have been a standing stone at some point in its history. There is an outside possibility that this is part of the standing stone recorded as having been lost by 1972, by the Royal Commission on the Ancient and Historic Monuments of Wales (<https://coflein.gov.uk/en/site/308128/details/four-crosses-standing-stone-destroyed>). It is likely to have been moved to its position on the lawn to the north of Canolfan y Gwystil during the construction of that building.

Plate 2: Large boulder adjacent to the eastern tree/bush in NCPA 1.

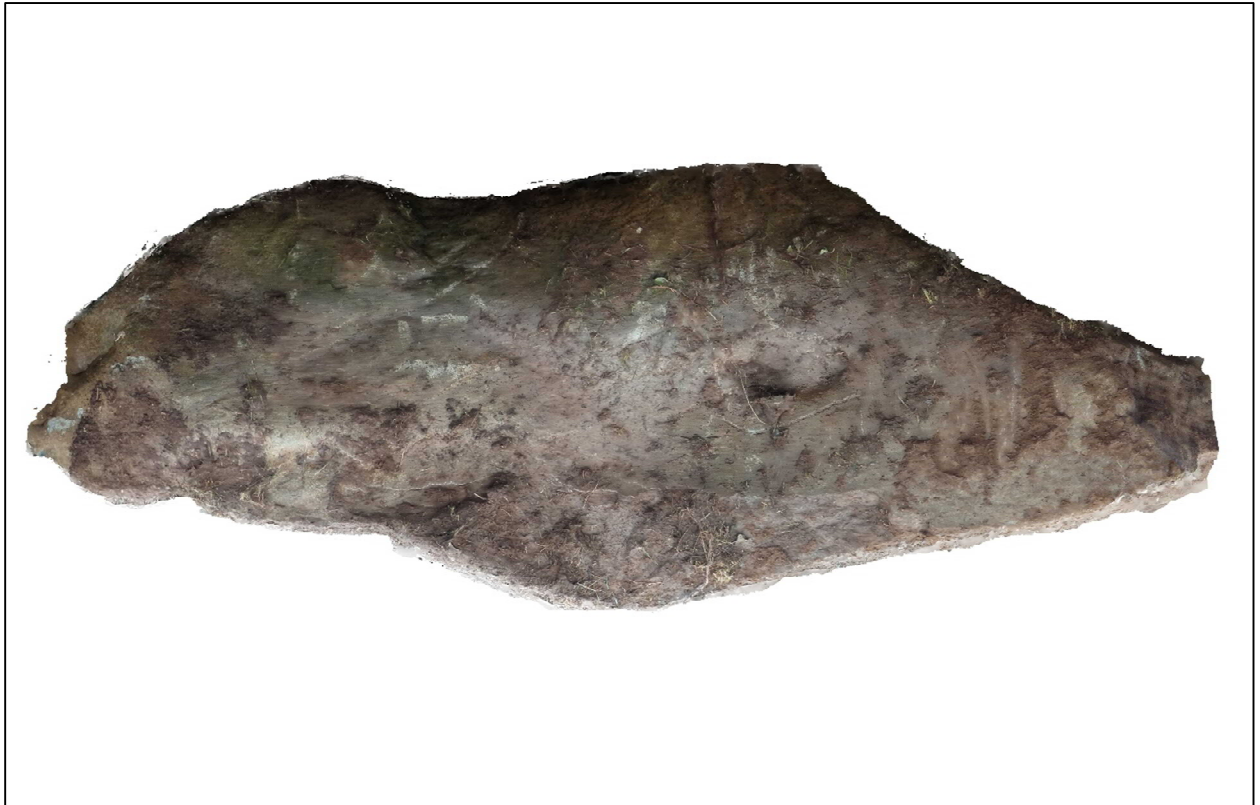
Plate 5: Composite picture of the worn face of the boulder from NCPA 1

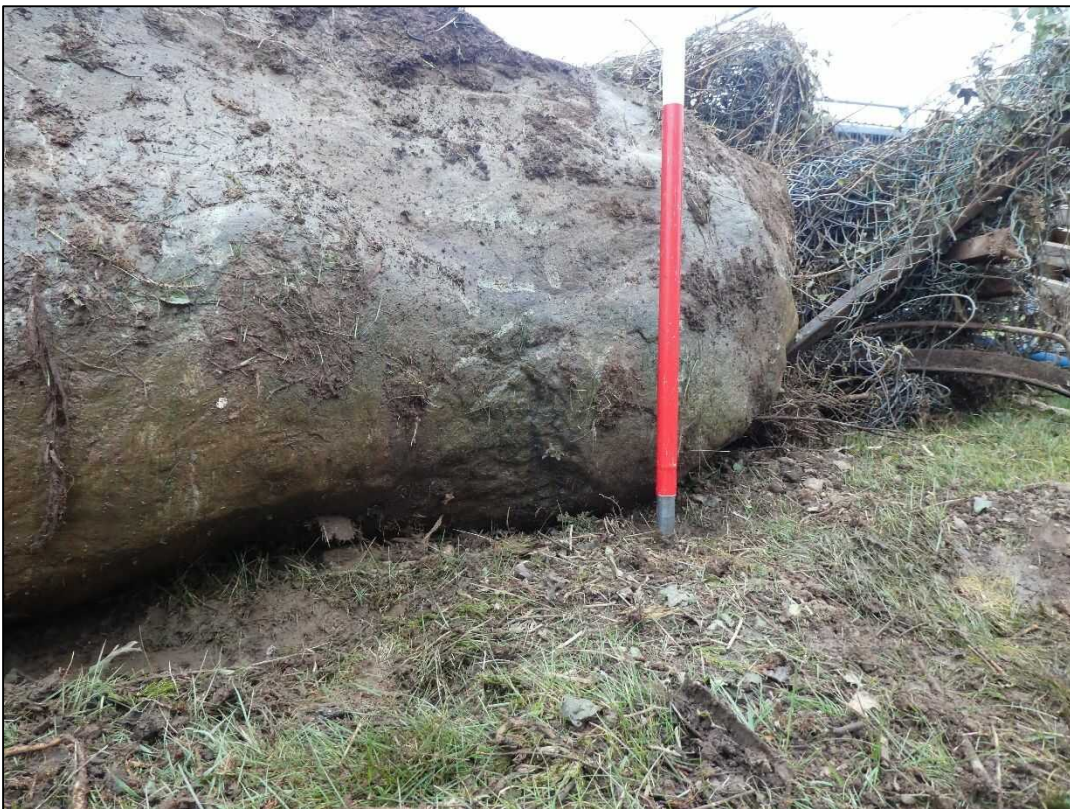
Plate 6: Possible wear on the boulder from NCPA 1

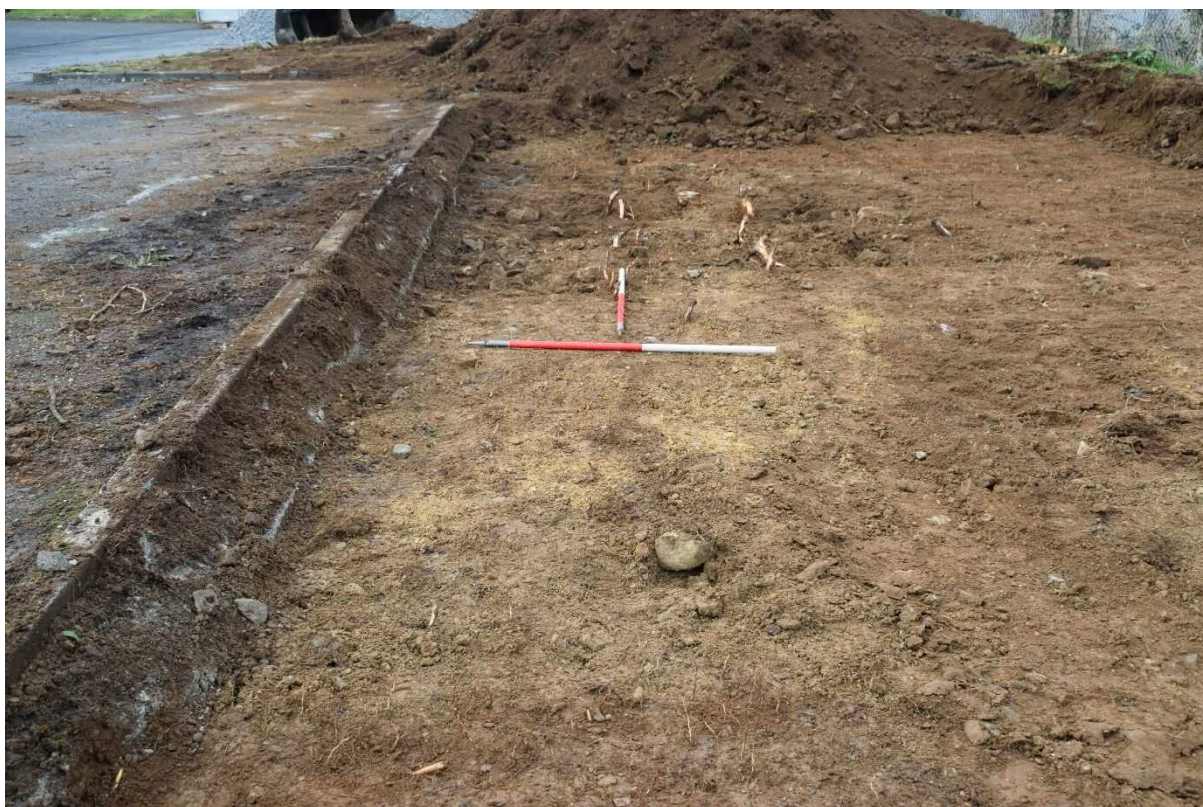
Below the topsoil (Context 1) was a spread of pale yellowish-brown mortar rich gravel with the occasional concrete fragment (Context 2) on the southern side of NCPA 1 (Figure 3, Plate 7). This appears to be the remains of a sub-base layer, possibly for a hard standing. Context 2

was very thin (typically 20 mm thick and it sat on a yellowish-brown silty loam (Context 3) which had the occasional fragment of machine-made brick and tiles and concrete fragments impressed into its surface and is therefore relatively modern.

Plate 7: Context 2 in NCPA 1

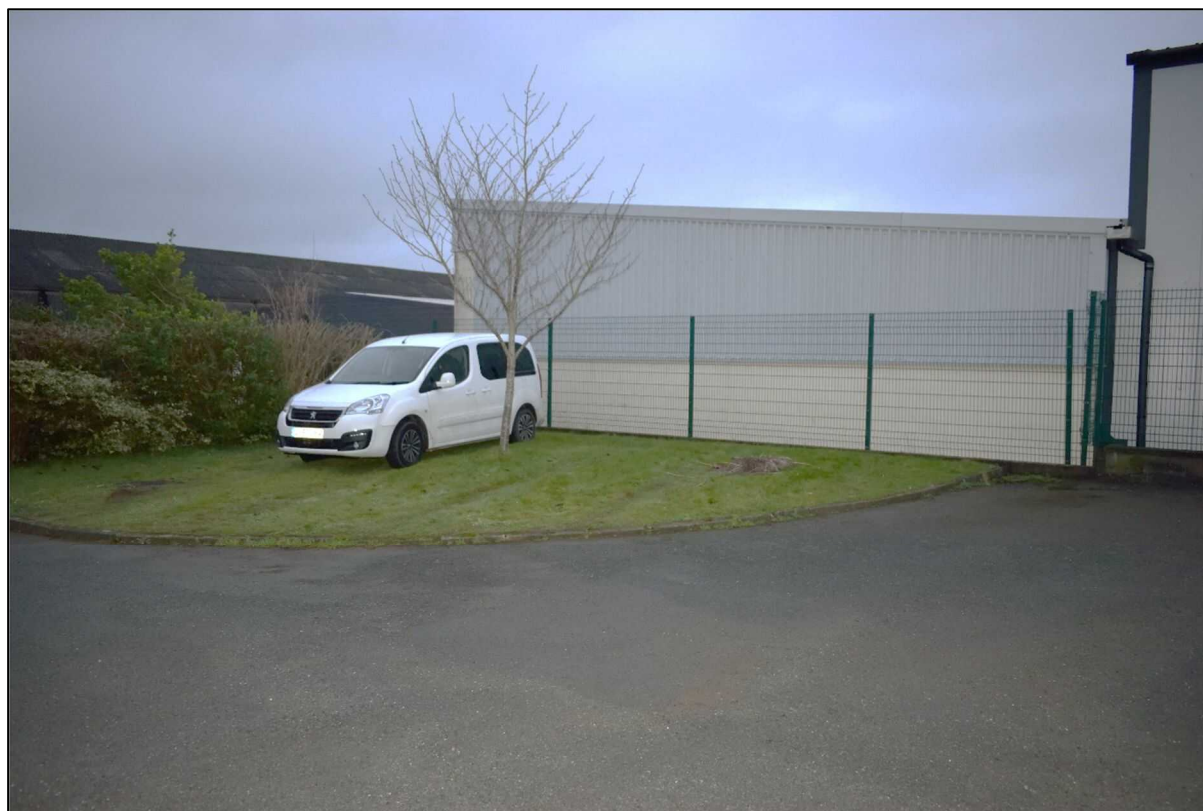
Plate 8: NCPA 2 before excavation

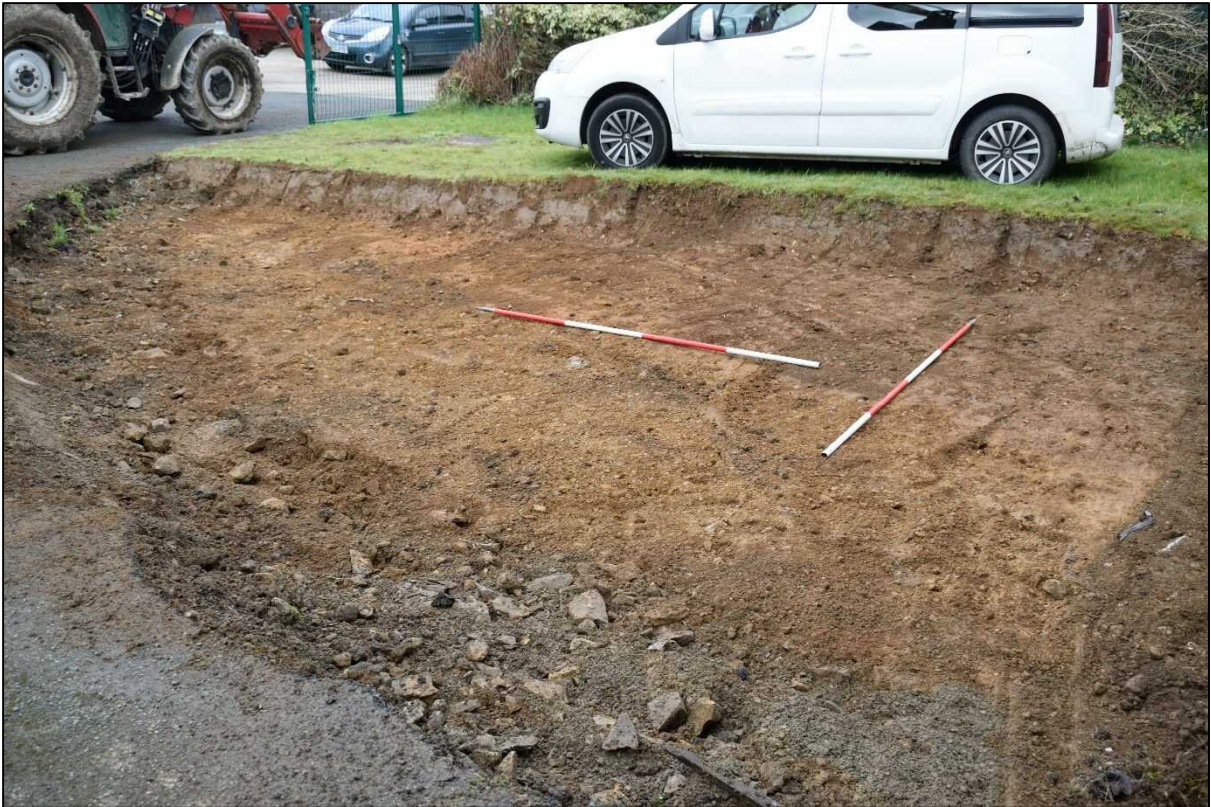
Below the topsoil (Context 4) a limited number of contexts were defined (Figure 3). Along the southern side of NCPA 2 was a zone of modern disturbance, up to 1.2 m wide (Context 5) which appears to be associated with the kerb stone defining the edge of lawn in this area. This cut a zone of yellowish-brown clayey silt (Context 6) which was overlain by Context 7. This is the base of the topsoil (Context 4) in this part of the site. Along the eastern side of NCPA 2 was a sharp cut feature for the construction of the boundary wall between different areas of the industrial estate (Context 8). This was filled with a modern fill including plastic bottles and concrete fragments (Context 9).

Plate 9: NCPA 2, looking north

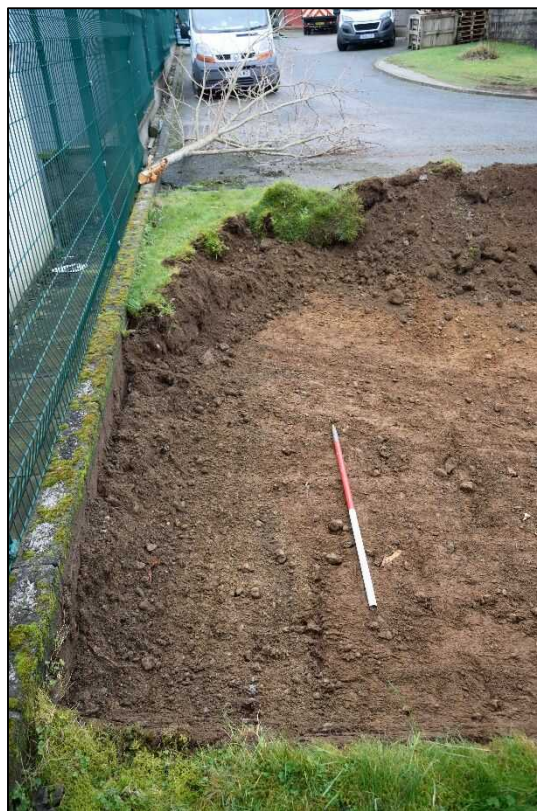
Much of the disturbance within NCPA 2 can be related to the modern layout of the site with a disturbed area associated with the kerb stones defining the edge of access road and the infill behind the retaining wall between Canolfan y Gwystil and the adjacent property. The differentiation between the layers of in this area is a function of the slight slope in the plot with the base of the topsoil (Context 7) being exposed in the northern part of the area.

Plate 10: Disturbance along the eastern side of NCPA 2

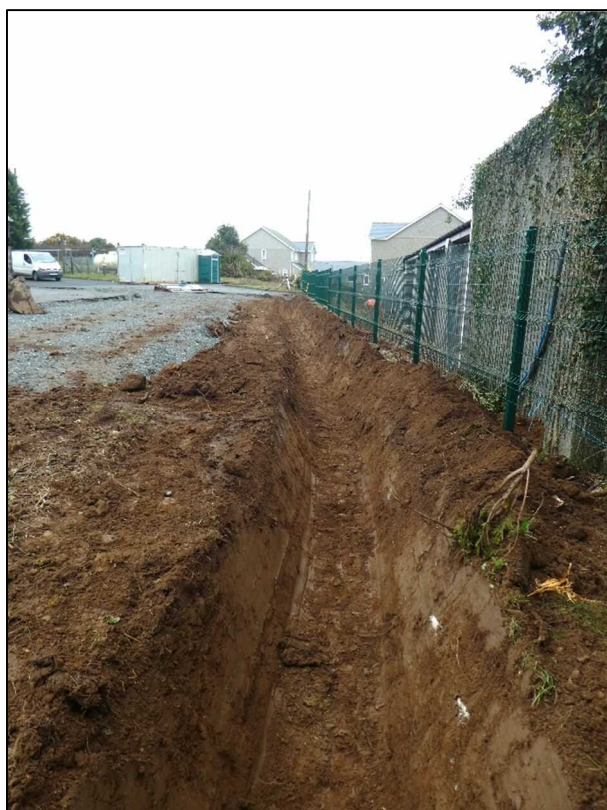
The ditch runs for approximately 57.5 m along the northern side of the development area (Figure 3, Plate 11). At its western end it ran along the line of a hedge which previously was the northern boundary and then roughly parallel with the buildings and concrete block wall which marks the northern boundary of the plot. The ditch was 1.1 m wide at its top with sloping sides down to a flat base 0.4 m wide. At the western end it was dug to a depth of 0.75 m below the topsoil level. The local topography of the plot means that the relative depth of the ditch was only 0.25 m at its eastern end, barely reaching the bottom of the topsoil.

Plate 11: The ditch looking west

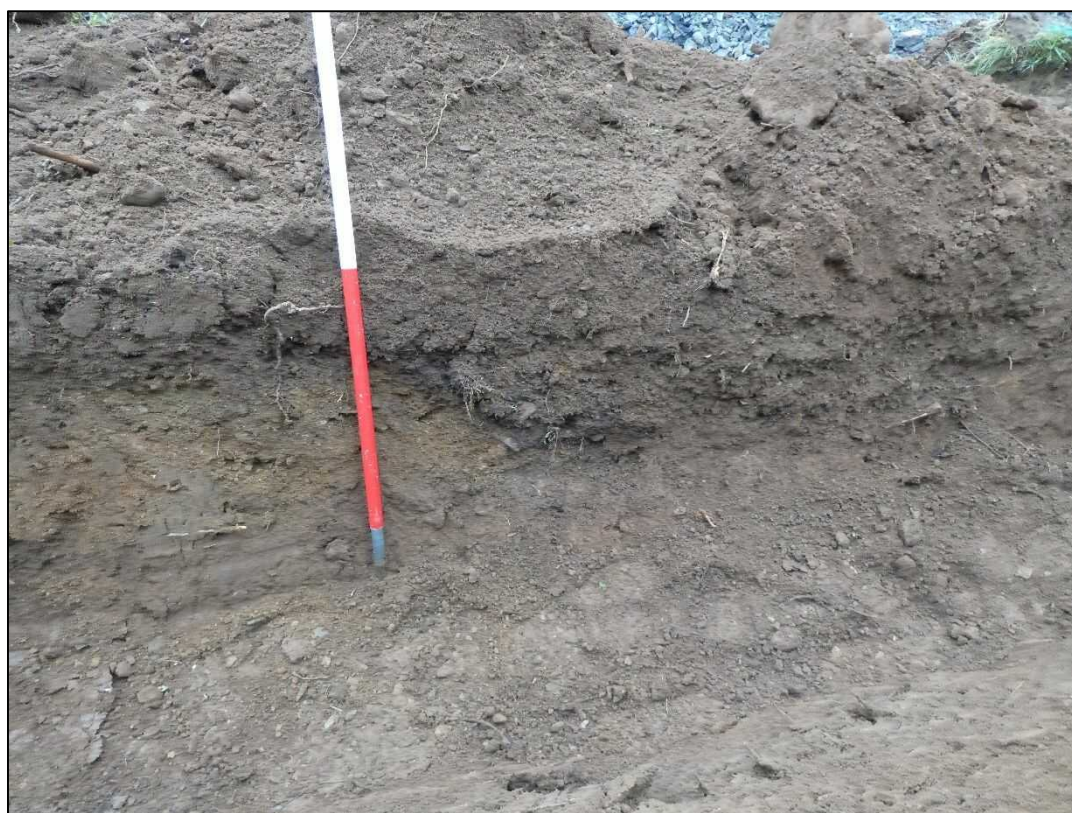
Below the topsoil (Context 1) the same deposit (Context 3) was exposed as in NCPA 1. This proved to be 0.45 m thick at the western end of the ditch, thinning to 0.3 m at the point in line with eastern edge of NCPA 1. This proved to be within a deliberate cut (Context 10, Plate 12) forming a roughly level platform in the western part of the site.

Plate 12: Cut (Context 10) in the southern side of the ditch.
