**Cefnamwch, Tudweiliog, Gwynedd,  
LL53 8AX  
Archaeological Evaluation**

***EAS Client report 2020/03***

**Cefnamwlch, Tudweiliog, Gwynedd, LL53 8AX**  
**Archaeological Evaluation**

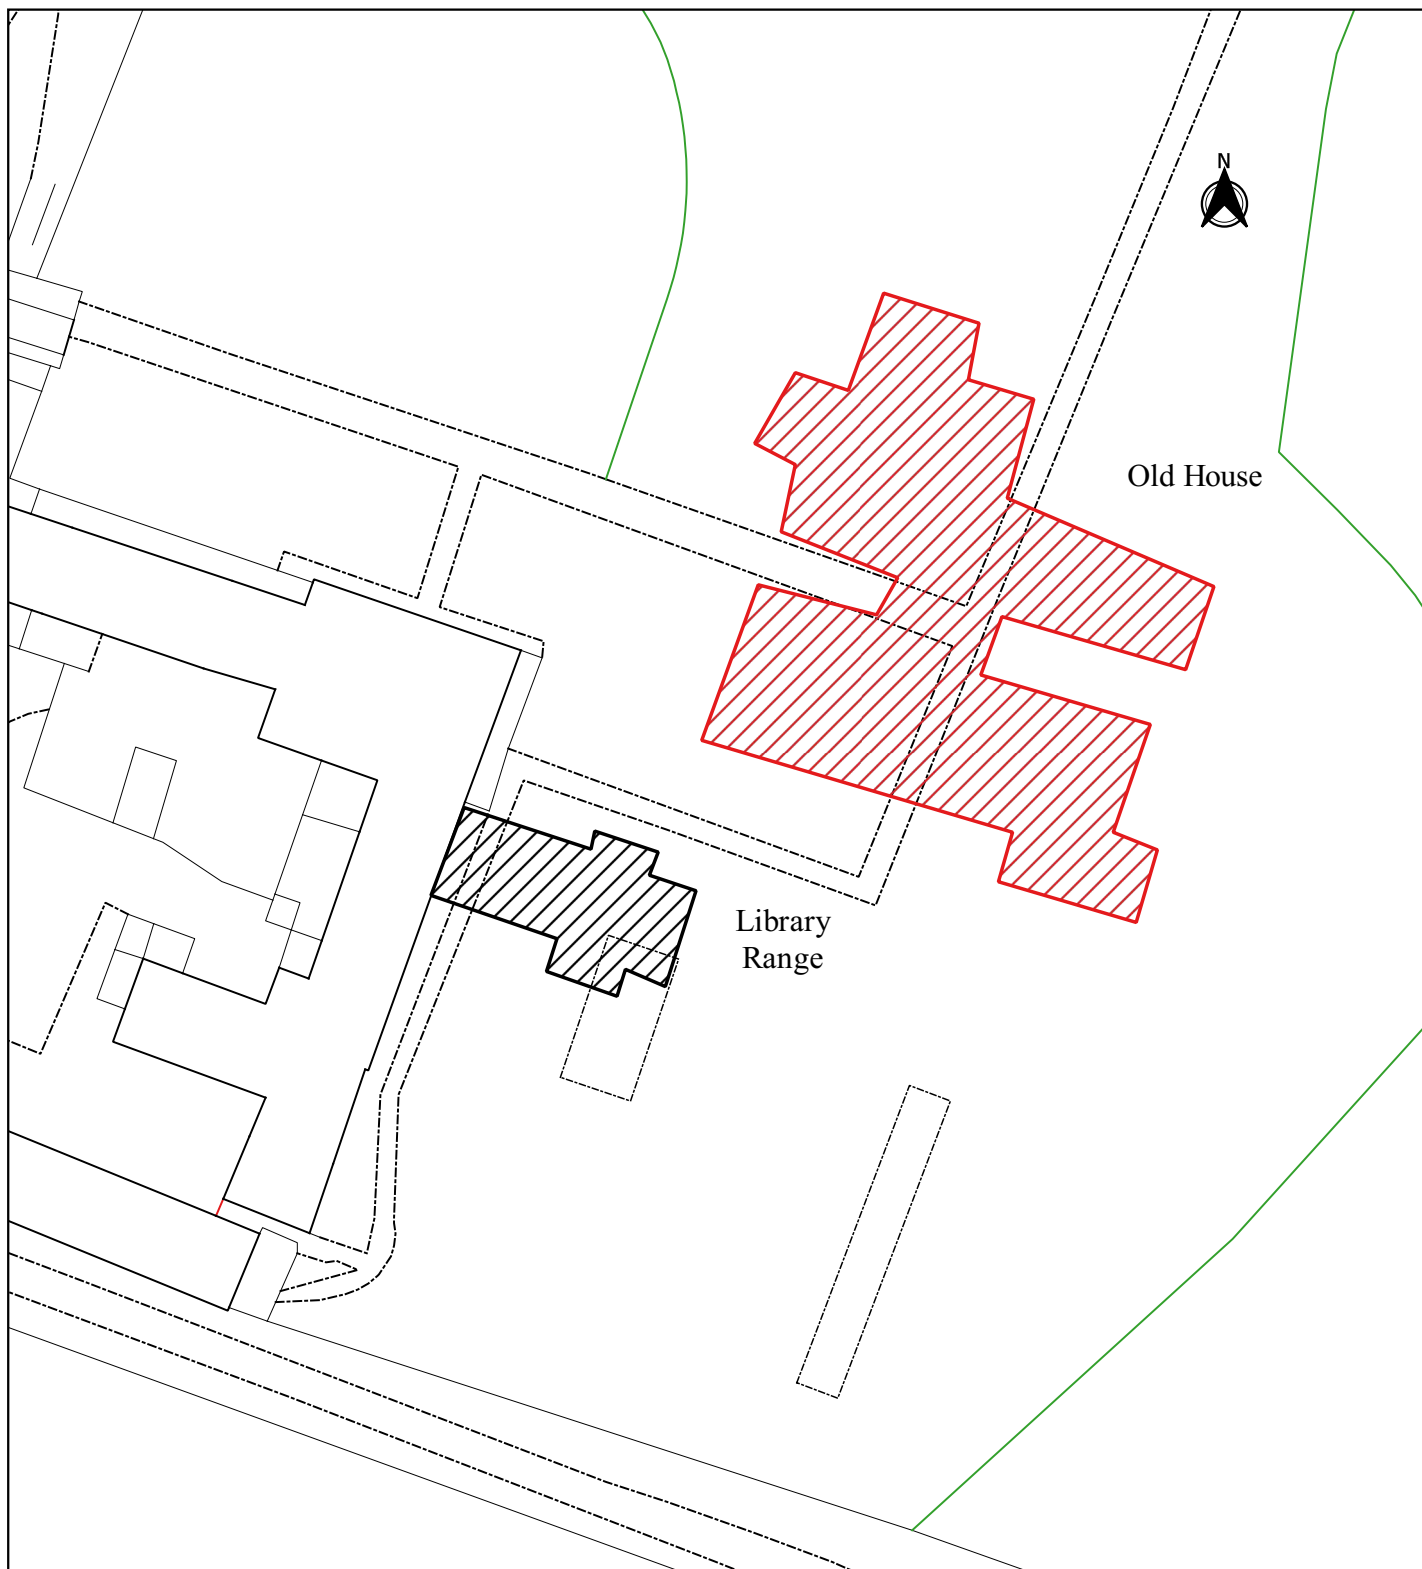
Figure 5: Possible Locations of the Demolished Ranges  
Scale 1:500

A library wing, was erected to the east of the south east wing in *circa* 1877 (Figure 5). It was demolished in the late twentieth century, but its extent is shown on the Ordnance Survey Caernarvonshire XXXIX.6 map published in 1900 and on a dyeline plan held by the family thought to date from the 1970’s. The Library Range also appears on an aerial photo, thought to date from the early 1980’s (Donald Insall Associates 2019, 31). This photograph also has a parch mark in the lawn north of the Library Range which may indicate the position of one of the walls associated with the early house on the site.

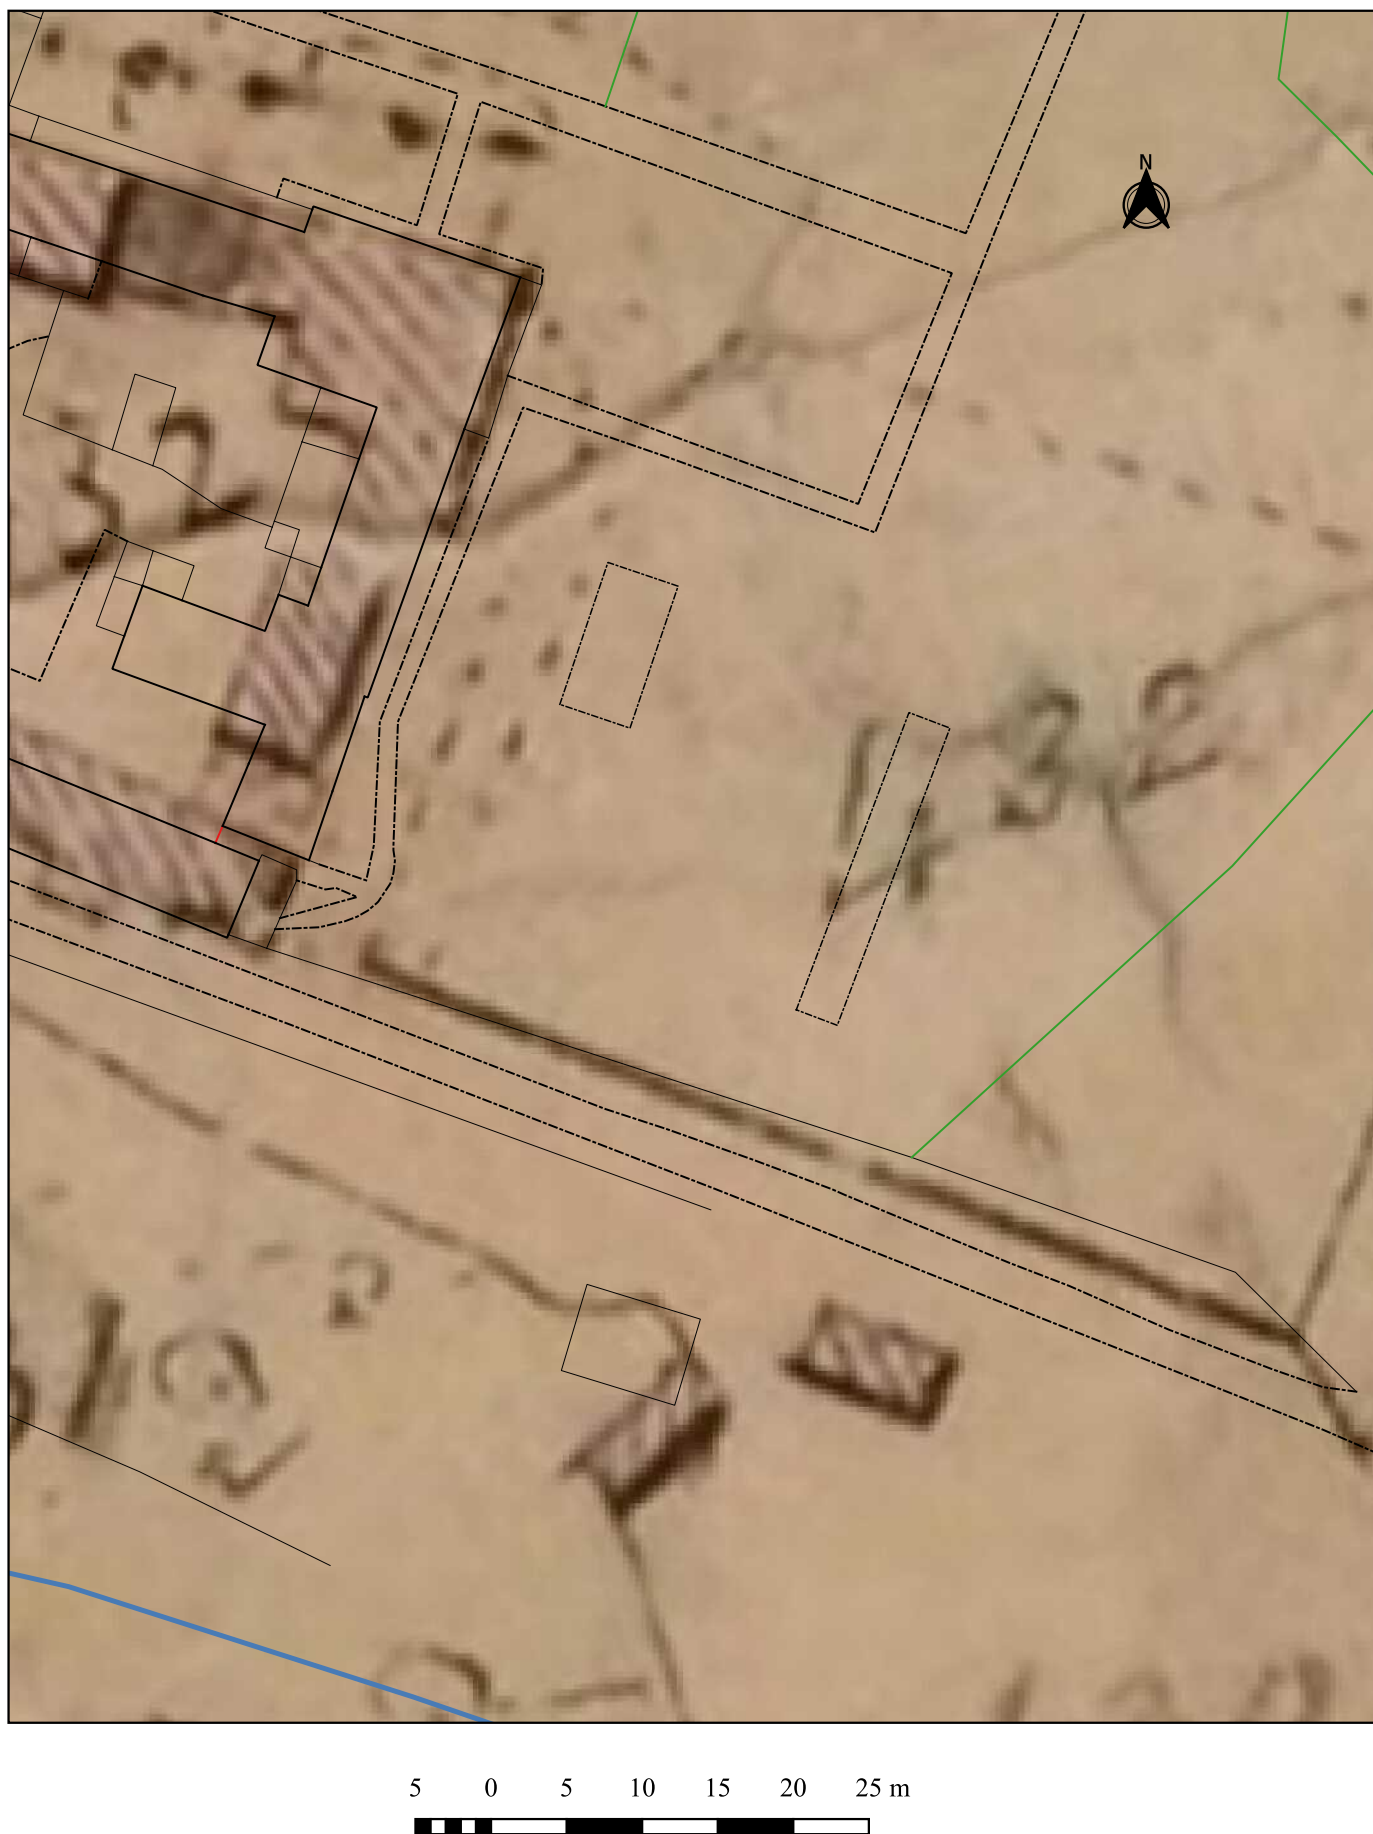
Figure 12: Extract from the 1840 Tithe Map of Penllech  
(Source <https://places.library.wales>)  
Scale 1:500

Cut into the top of Context 9 is the end of a cobble path or surface (Context 10 and 11) which extends out of the trench to the east. The cobble surface (Context 10, Plates 9 and 10) occupies a shallow feature 210 mm deep. There appears to be three layers of cobbles, up to 160 x 120 x 50 mm in size, the lowest level of which was partly held in place with lime mortar. The upper layers of cobbles were bedded in a fine gravel. It would seem likely that this path/surface has been re-surfaced at least once given the layering within the cobbles. One possibility is that this path is that shown on the 1840 Tithe Map of Penllech (Figure 12).

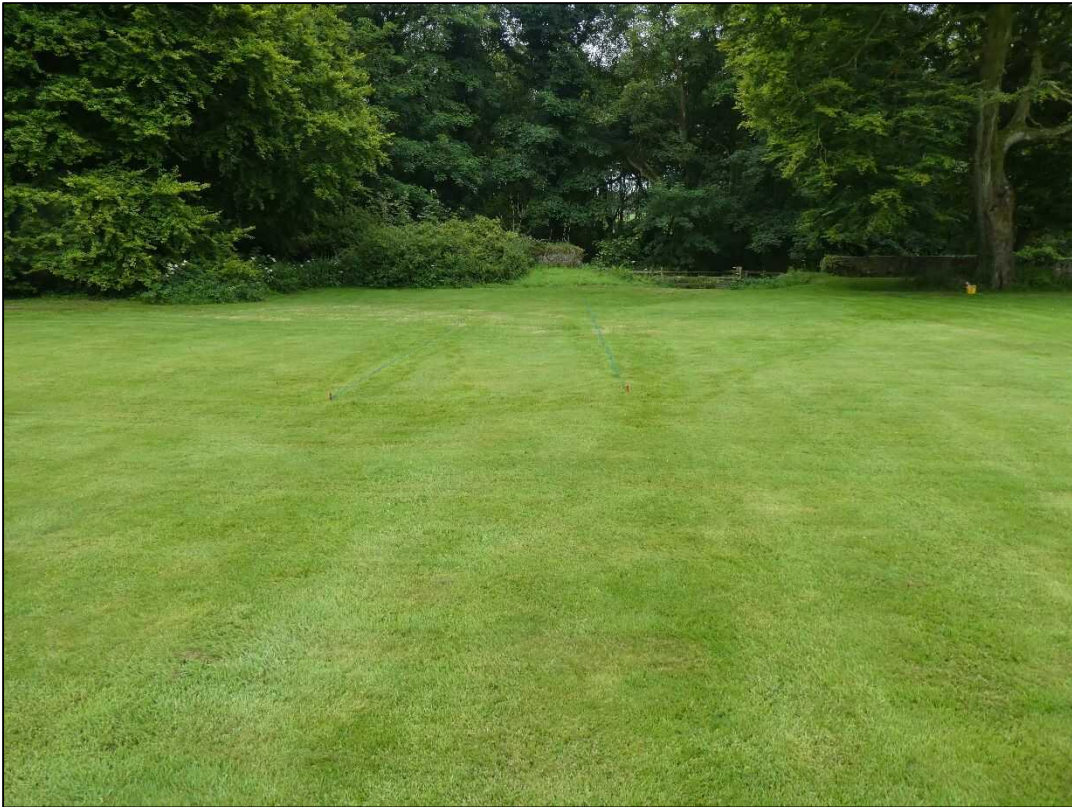
Plate 1: Area of Tr 1 before excavation

Cefnamwlch is located approximately 250 m south of the village of Tudweiliog, Gwynedd (Figure 1). The proposed pool is to be located to the east of the house on well-kept lawns (Plates 1 and 2) which are divided by gravel paths (Figure 2). To the south of the evaluation is a lane which runs to the south of the building ranges and gives access to the western side of the gardens. This lane is approximately 1 m below the level of the lawns which are essentially flat.

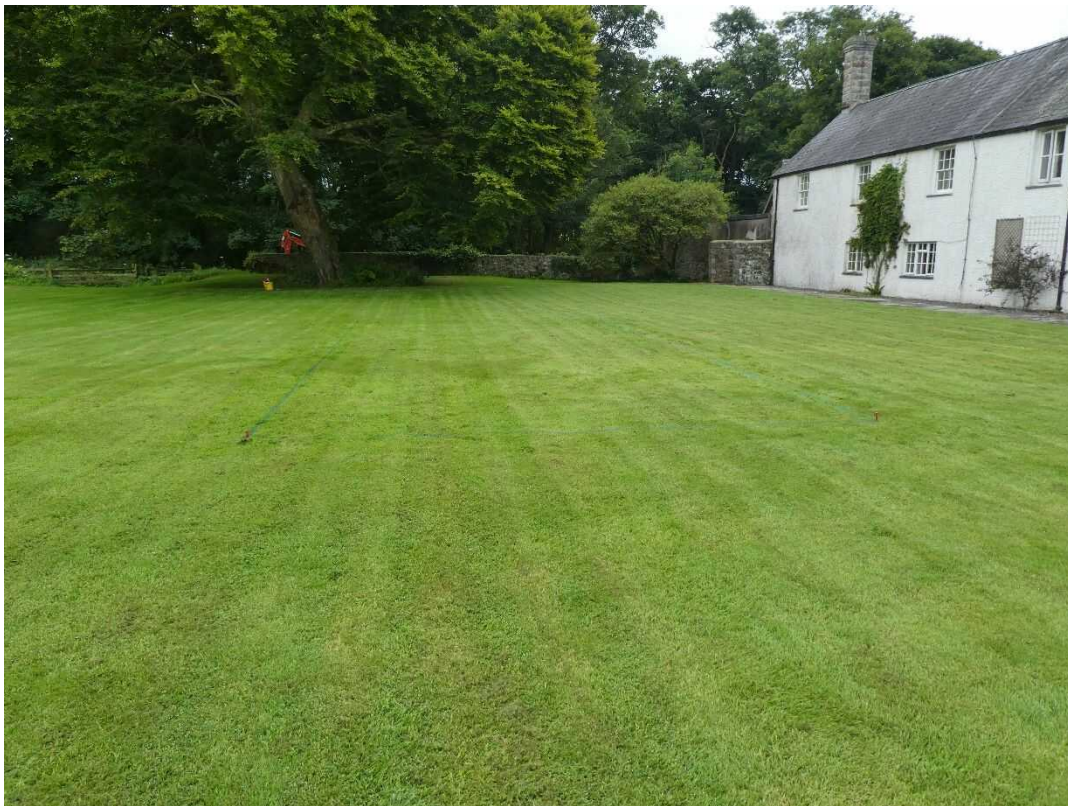
Plate 2: Area of Tr 2 before excavation

Trench 2 (Figure 8, Plate 2) was located nearer to the house and was positioned to cover the area of a proposed soak-away (Drawing SK-C-02) for the roof run-off and backwash from the pool complex. The topsoil (Context 8) varied in depth between 180 and 400 mm with a tendency to become deeper towards the south (Figure 6). At this end of the trench the topsoil was over a layer of yellowish-brown sandy silt with the occasional fleck of charcoal (Context 9) which was up to 200 mm deep. Context 9 merges with Context 8 above and these two layers suggest that the level of the lawn was increased along the southern boundary in order to produce a flatter lawn.

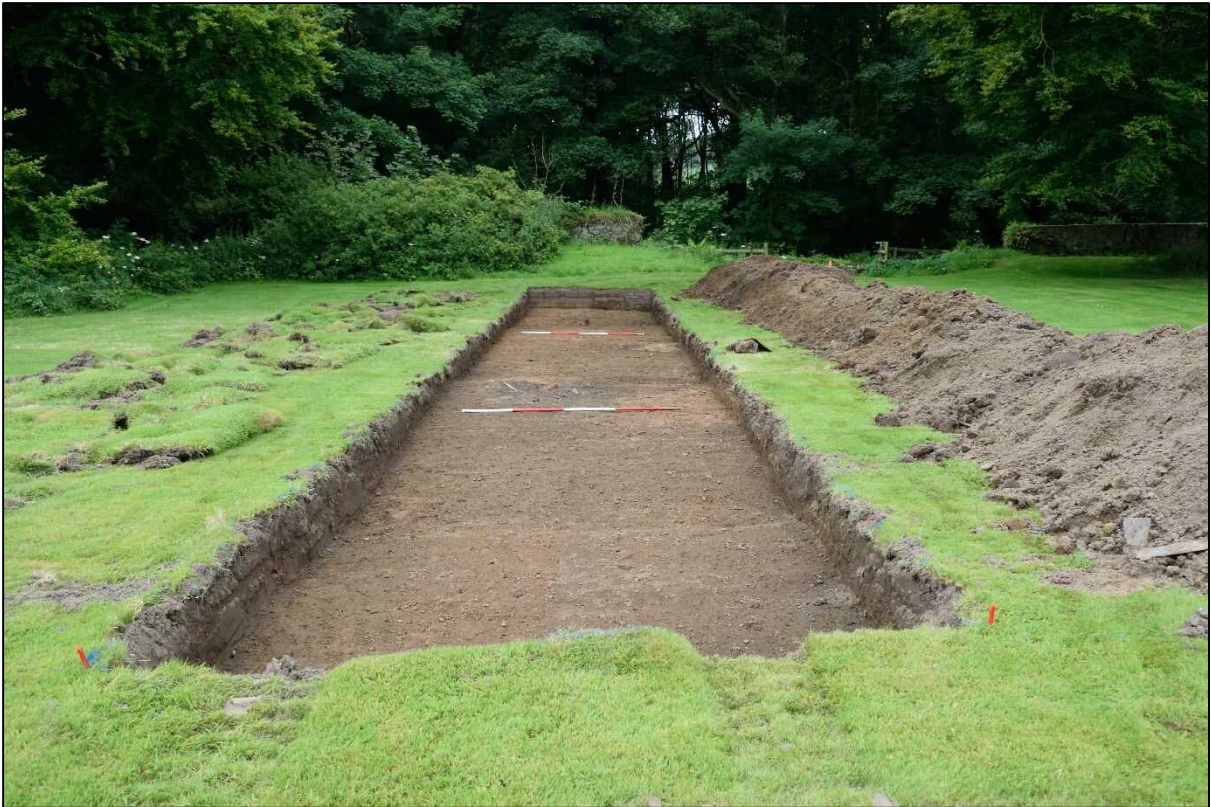
Trench 1 was positioned to sample the area of the proposed pool house and pool (Plate 3). It was 22 m long and 3 m wide. The topsoil (Context 1) depth varied along the trench (Figure 6), but tended to become deeper to the south. It would seem likely that this reflects a levelling of the lawn along the southern boundary of the garden.

Plate 3: Trench 1, looking south

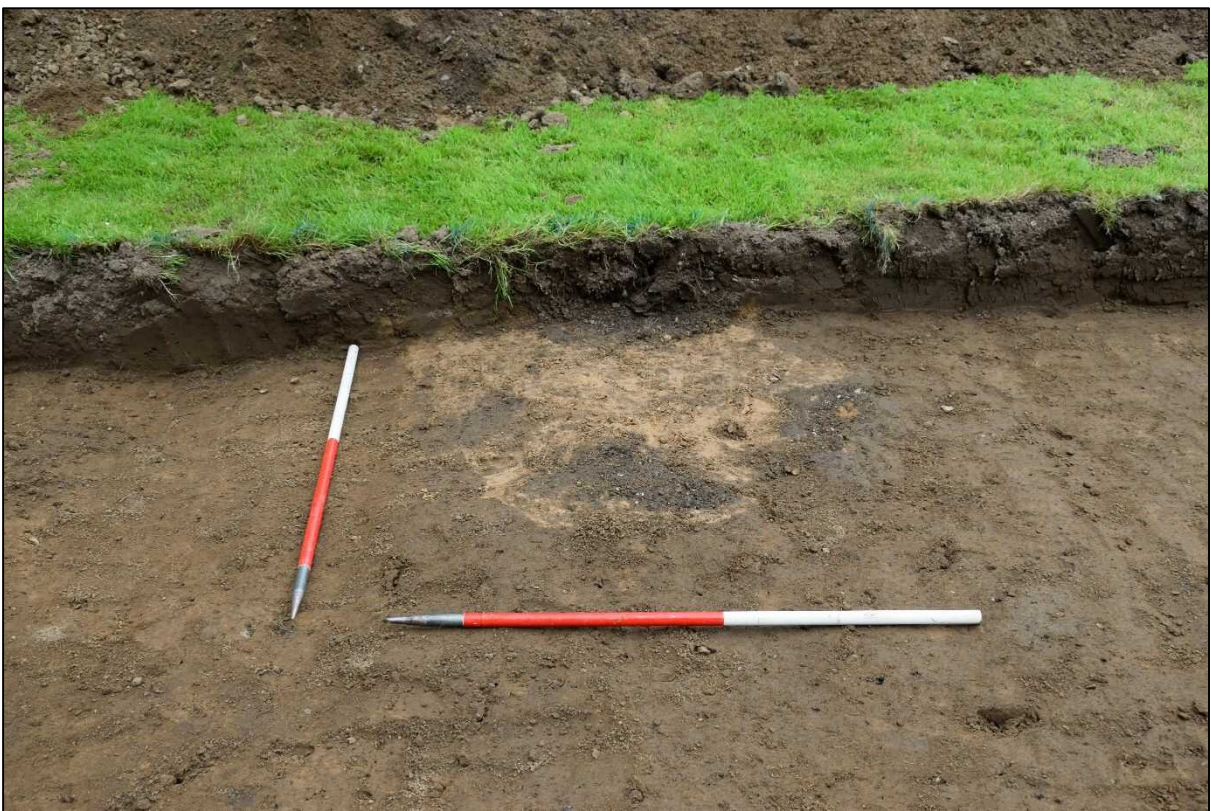
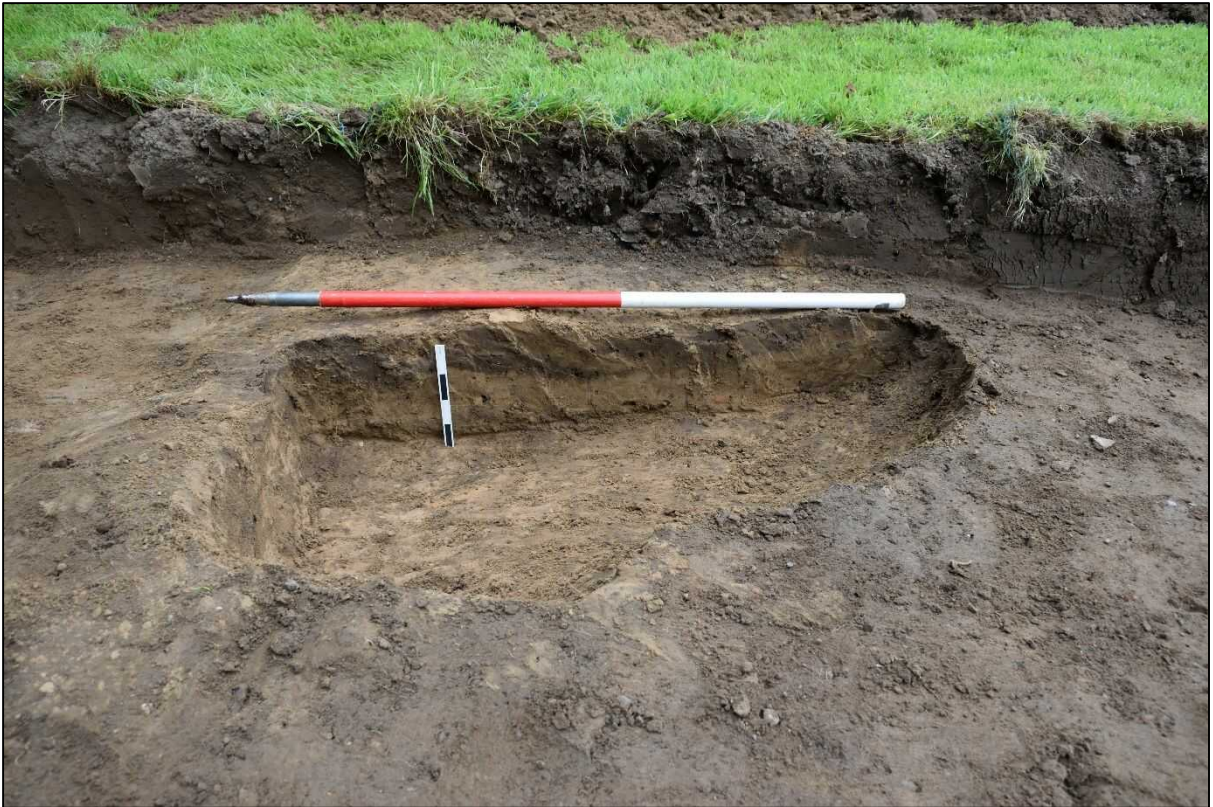
Below the topsoil only two features were located (Figure 7), both of which are considered to be relatively recent in origins. Context 5 (Plates 4 and 5, Figure 9.1) was either a shallow pit or the end of a linear feature which extended beyond the western edge of the trench. It had relatively steep sides and a flat base. It was filled by two layers (Contexts 3 and 4) of relatively clean sand, but was sealed by a thin layer of dark grey brown, sandy soil (Context 2) with a moderate density of small (less than 10 mm), angular stones, a few flecks of charcoal, and fragments of split slate. This layer is thought to be relatively recent in origins and the only artefact found within this feature was a single, handle sherd of a black glazed ceramic of 19<sup>th</sup> or 20<sup>th</sup> century date from Context 8.

Plate 4: Context 5, before excavation

Plate 5: Context 5, after excavation

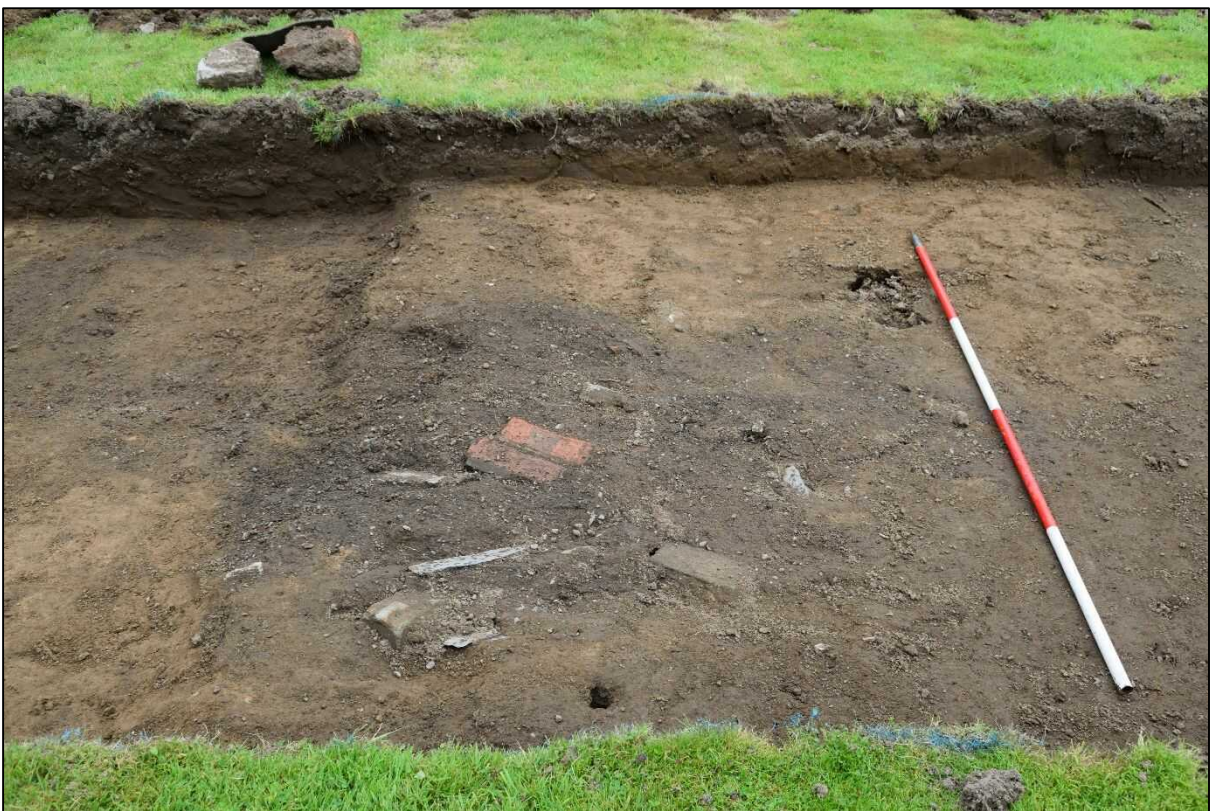
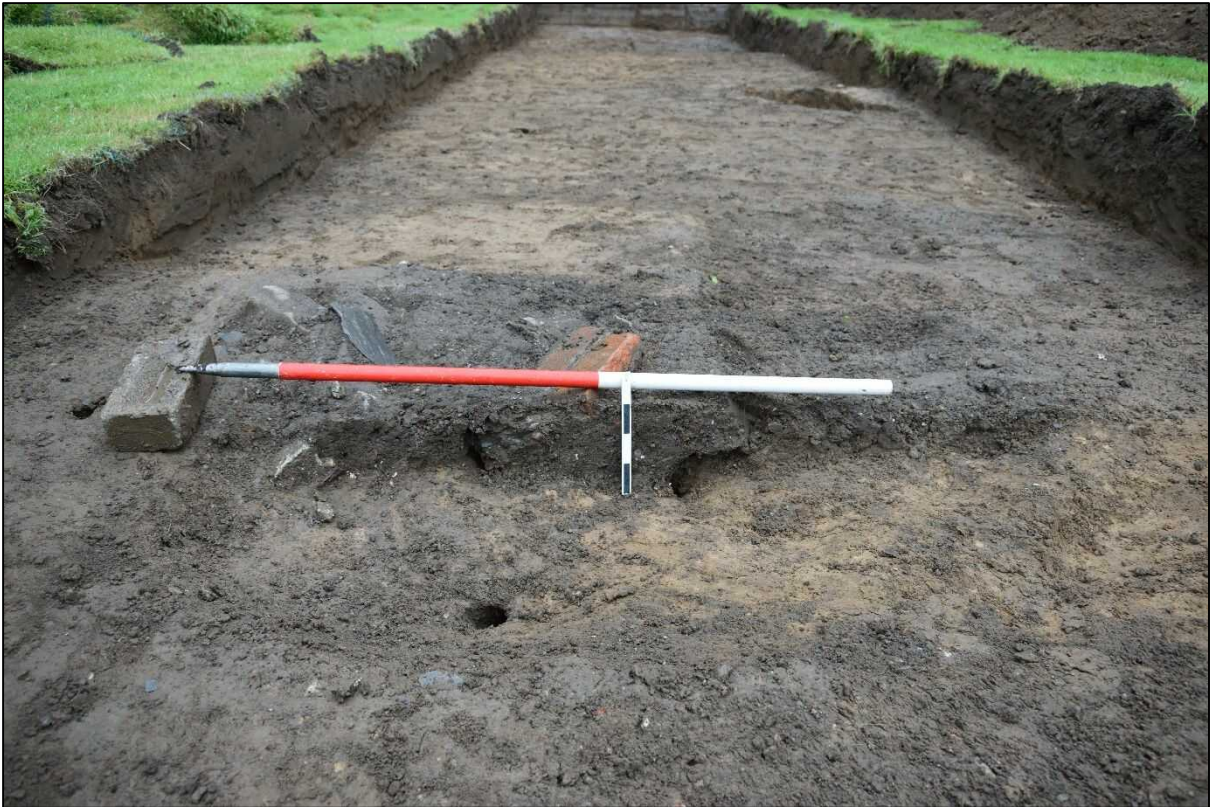
The second feature, Context 2, (Plates 6 and 7, Figure 9.2) was filled with a single context (Context 6). It was a shallow hollow, 1.4 x 1.3 m in size and up to 140 mm deep with a slightly irregular shape. Context 6 included a number of modern, machine made bricks, some of which were still mortared together, suggesting a relatively modern date for this feature. The fill also included a fragment of a plastic label moulded with the inscription “...S SEEDS”. The feature sits within an area with a series of open and collapsing animal burrows and it would seem likely that this feature was an attempt to level the lawn after a series of animal burrows had collapsed.

Plate 6: Context 7, before excavation

Plate 7: Context 7, after excavation.

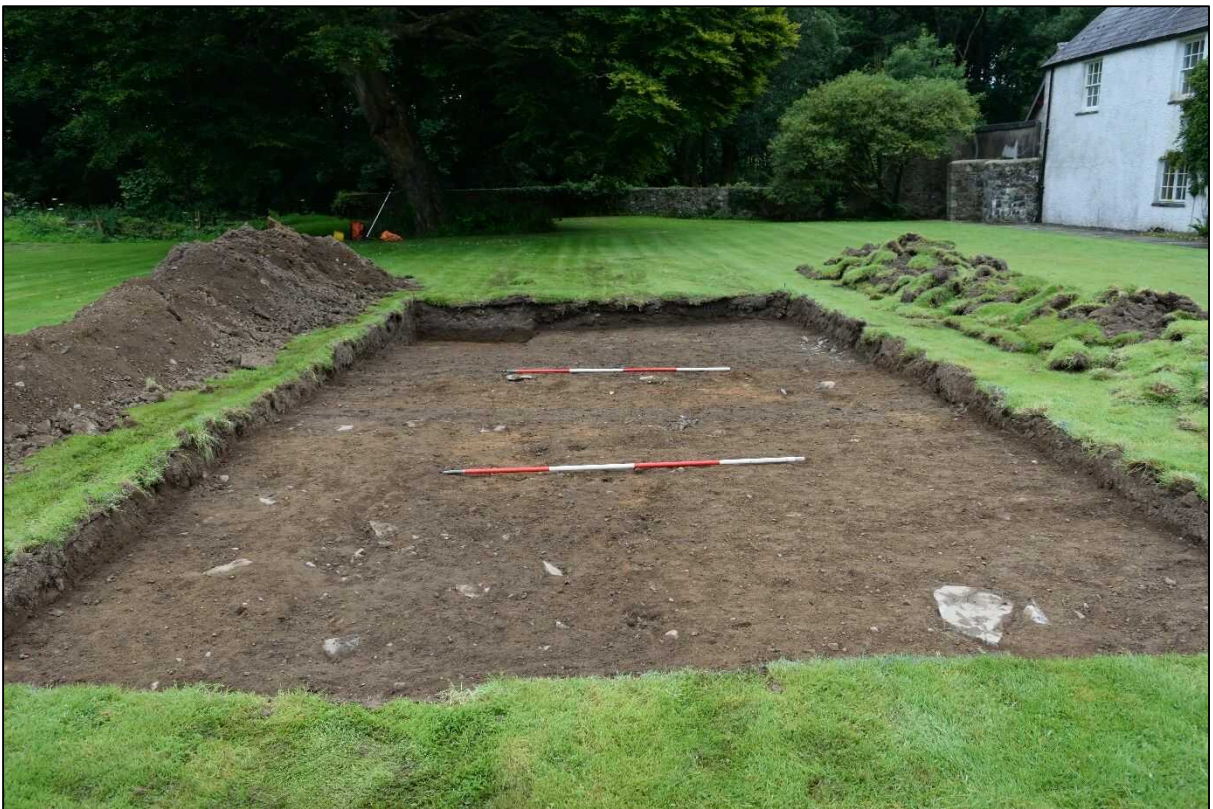
Plate 8: Trench 2 looking south

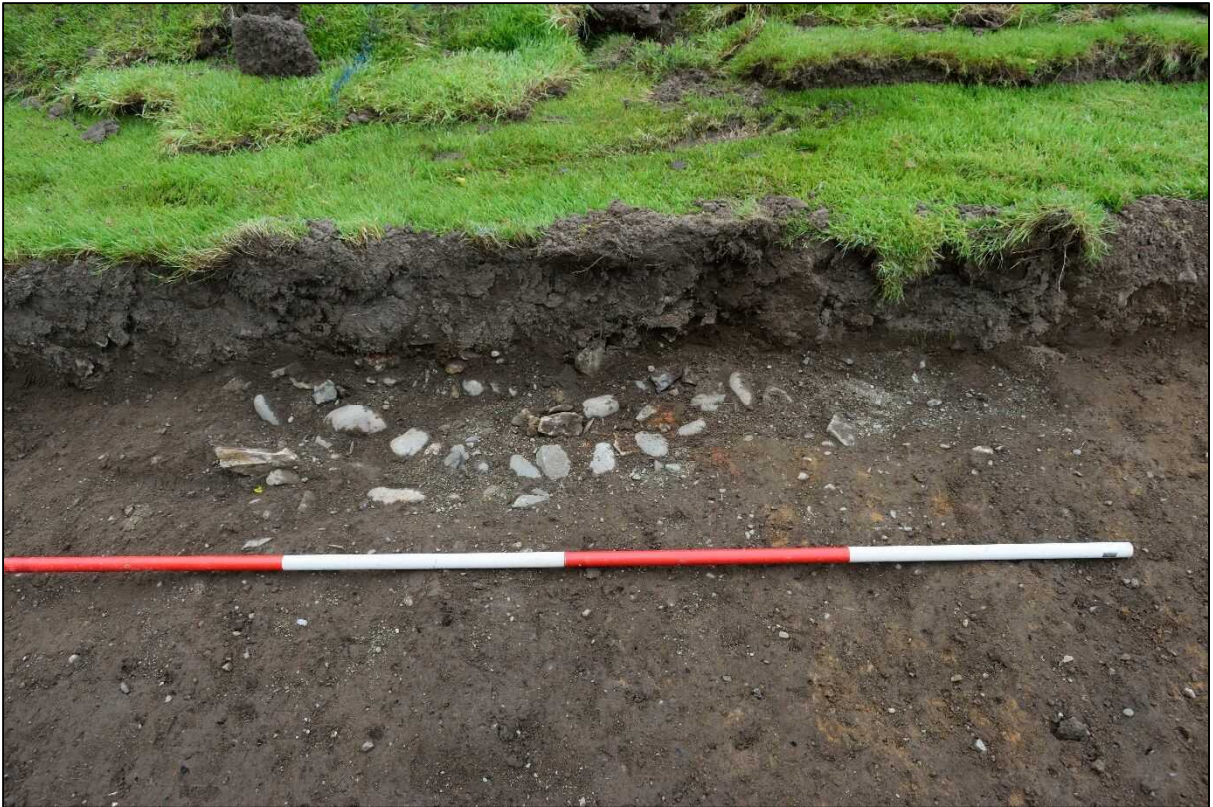
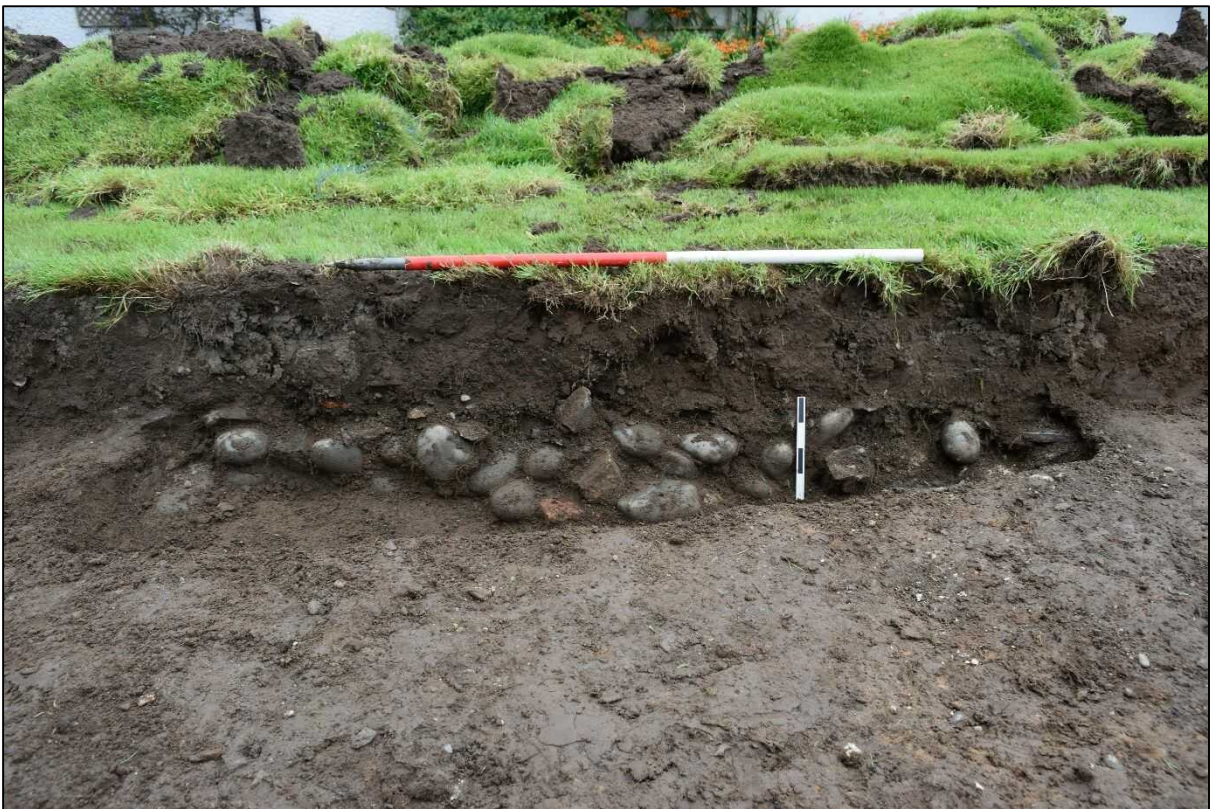
Plate 9: Contexts 10 and 11

Plate 10: Context 10 section

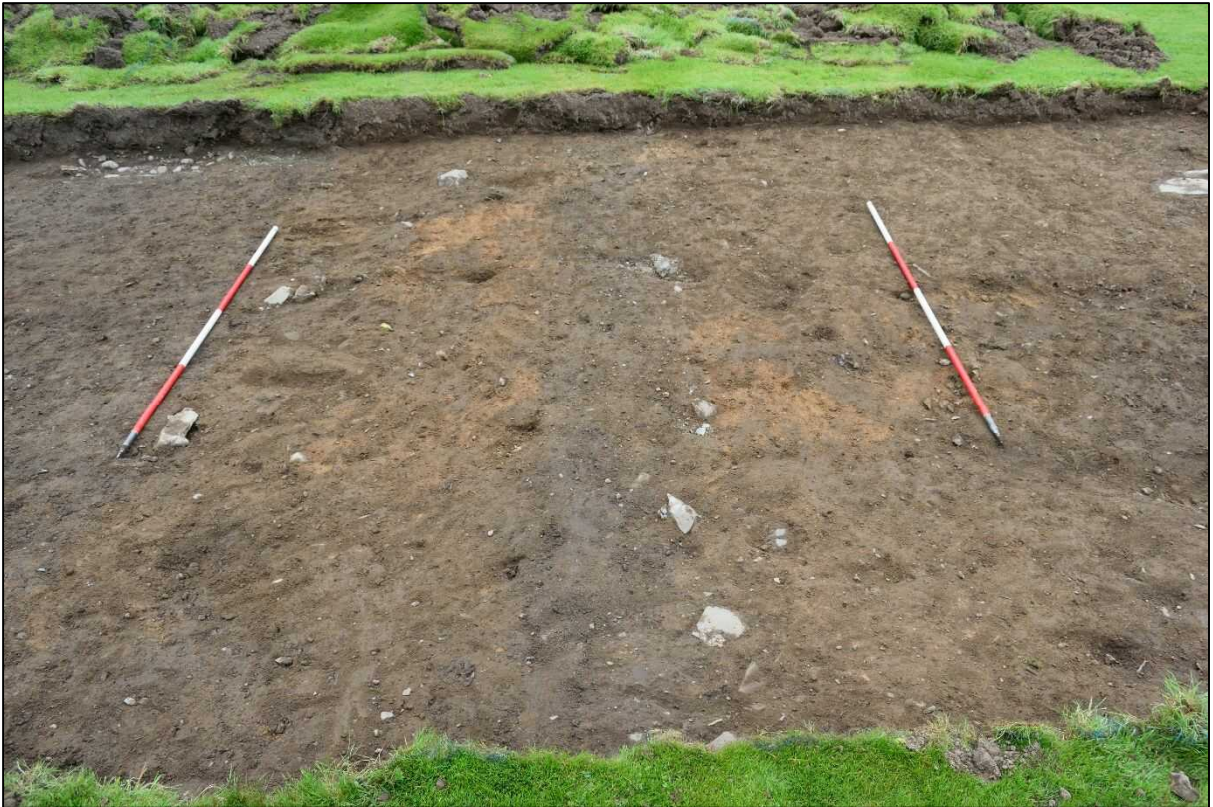
After the removal of the topsoil (Context 8) there was a dark strip crossing the trench (Context 12, Plate 11) which was assumed to be a linear feature such as a gully. However, on excavation this proved to be one of a series of layers within a large feature (Context 17) covering the northern 4.65 m of the trench. A one metre wide trench was dug into Context 17 which showed that the feature has a shelf approximately 250 mm deep running for a distance of approximately 650 mm. At this point the feature becomes deeper reaching depths of up to 570 mm (Figure 9.4 and 9.5, Plate 12). At the break of slope between the two levels there is a stone drain (Context 19). This consists of two upright, dry stone walls capped with a slab of slate. The internal drain measures 280 mm wide and 280 mm high and has a split slate floor (Context 16, Figure 9.6, Plate 14). The split slate floor (Context 16) extended beyond the surviving drain structure forming a curved band 310 mm wide running across the bottom of the sampled area (Figure 10, Plate 13). This would appear to have been the floor of a drain from which the large stonework has been removed. It is likely that the surviving structure (Context 19) is a spur off the main drain which originally ran around the eastern end of the library range. The eastern section of the cut has natural sandy at its base suggesting this may be close to the eastern edge of the drain around the library range.

Plate 11: Context 12, before excavation

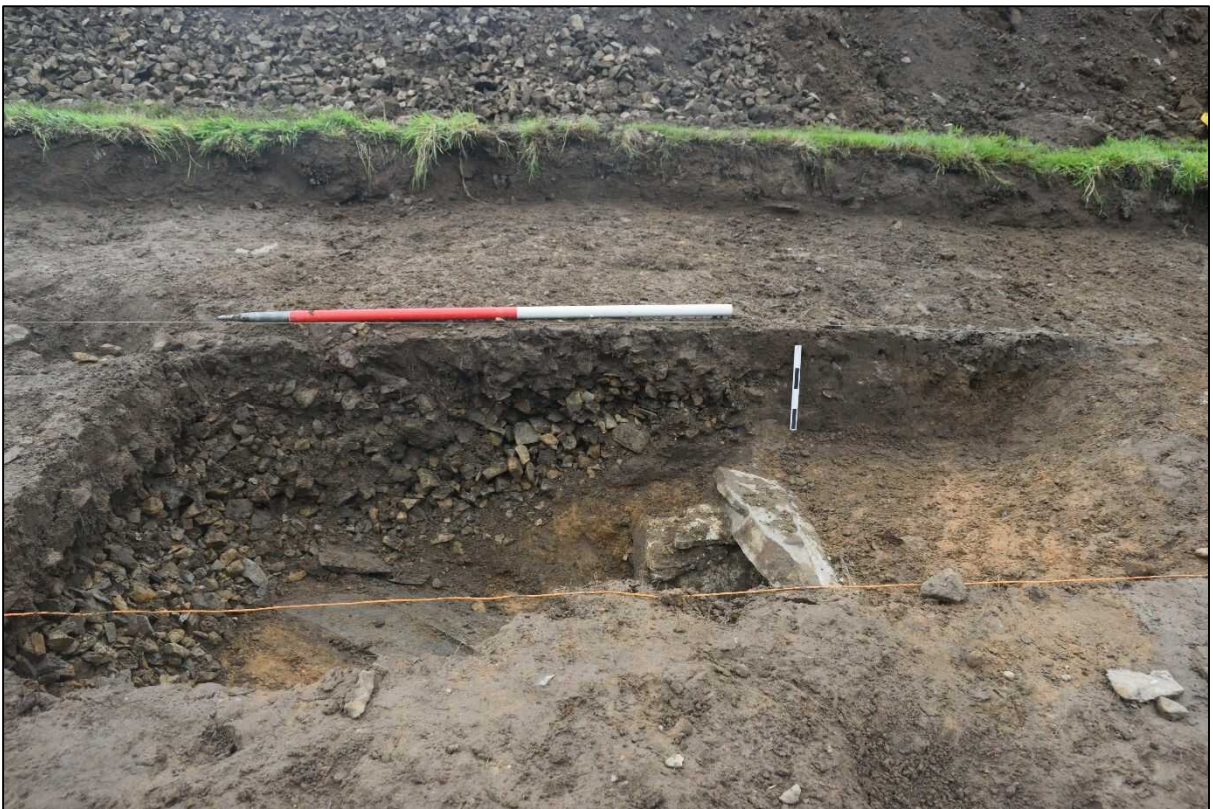
Plate 12: Contexts 12, 13, 17, 18 and 19 looking east

1. The soak-away for the roof run-off and backwash from the pool complex be moved at least 2 m to the south to avoid the disturbance related to the destruction of the library range
2. An archaeological watching brief be commissioned during the construction phase to record any archaeological features not located in the evaluation.

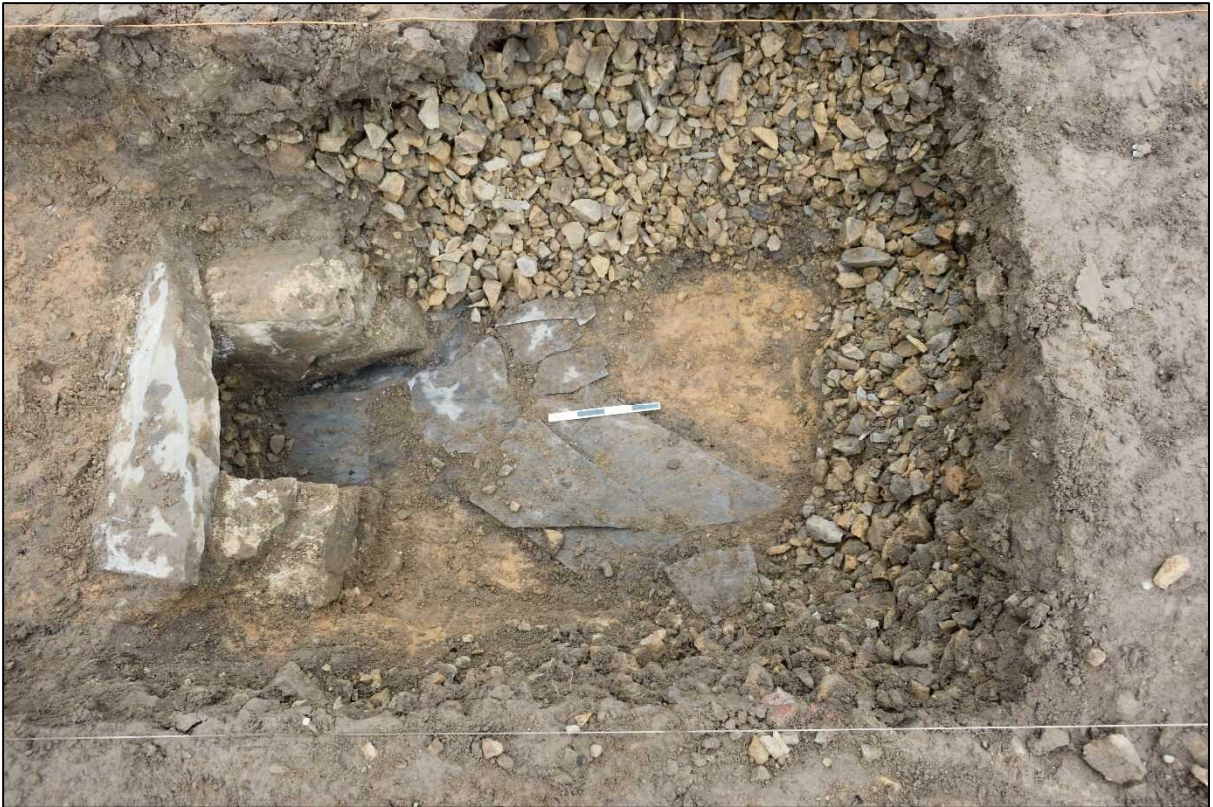
Plate 13: Drains, Contexts 18 and 20 from above

| Context | Location | Context type | Description | Relationships |
|---|---|---|---|---|
| 19 | Tr 2 | Other | Stone drain running north-south. Constructed of large stone blocks up to 450 x 270 x 200 mm in size forming a channel 270 mm wide and 260 mm deep. Sealed by a large slate slab 580 x 200 x 70 mm in size. It also has a slate base sealed by at least 300 mm of soil. | Below 12<br>Contains 14 and 16 |

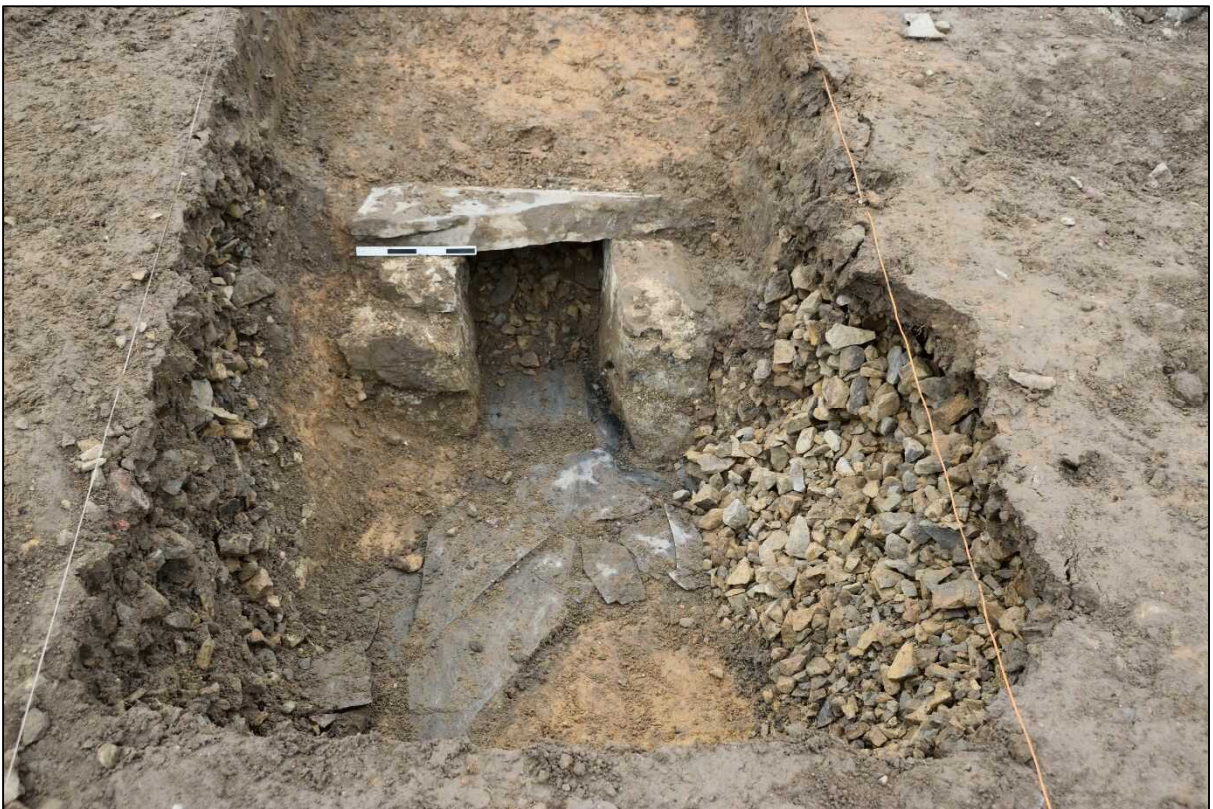
Plate 14: Drain, Context 20, looking south

| Context | Location | Context type | Description | Relationships |
|---|---|---|---|---|
| 20 | Tr 2 | Cut | Cut for drain running north-south. At least 700 mm wide and 350 mm deep the extent of this feature could not be determined. | Below 12<br>Contains 14 and 19 |
