Coleg Harlech

EAS Client report 2024/25

To record four rooms within Coleg Harlech that had suffered considerable water damage, before they were restored.

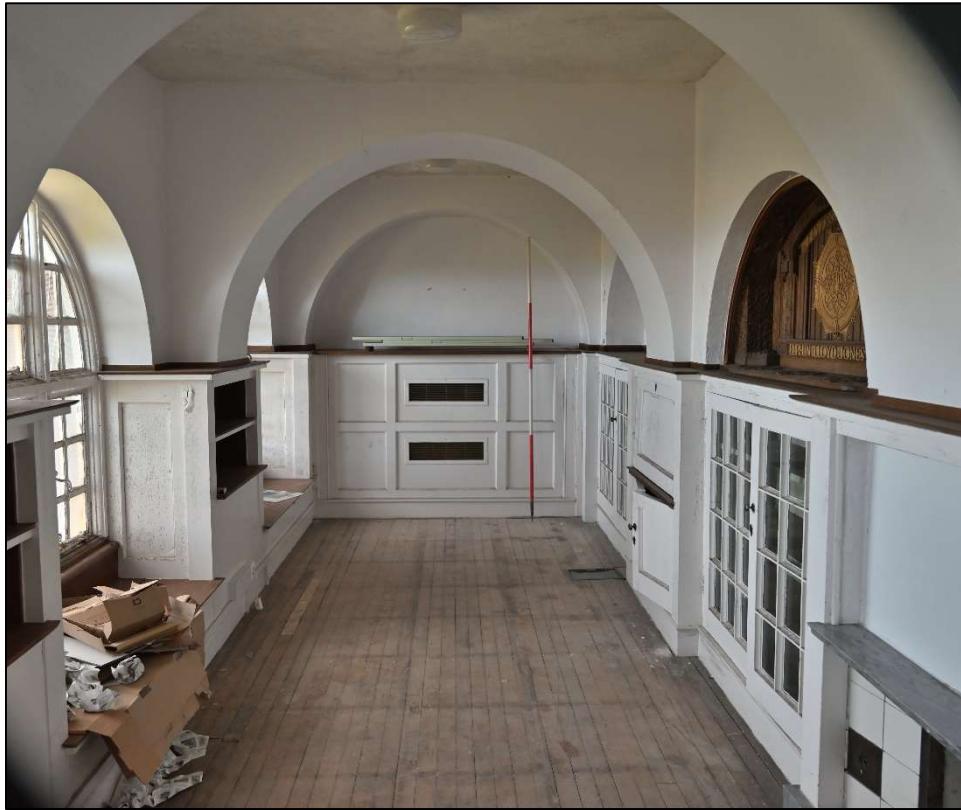
Plate 1: The Elphin Jones Library, looking north

The Elphin Jones Library (Plates 1 and 2) is a 6.78 m long, but only 2.46m wide and is linked to the “Staff Room”, to the south, but not to the Elphin Lloyd Jones Room to the north. The room is divided into three bays by semi-circular arches and there are two heating/ventilation grills in the northern wall (Plate 1)

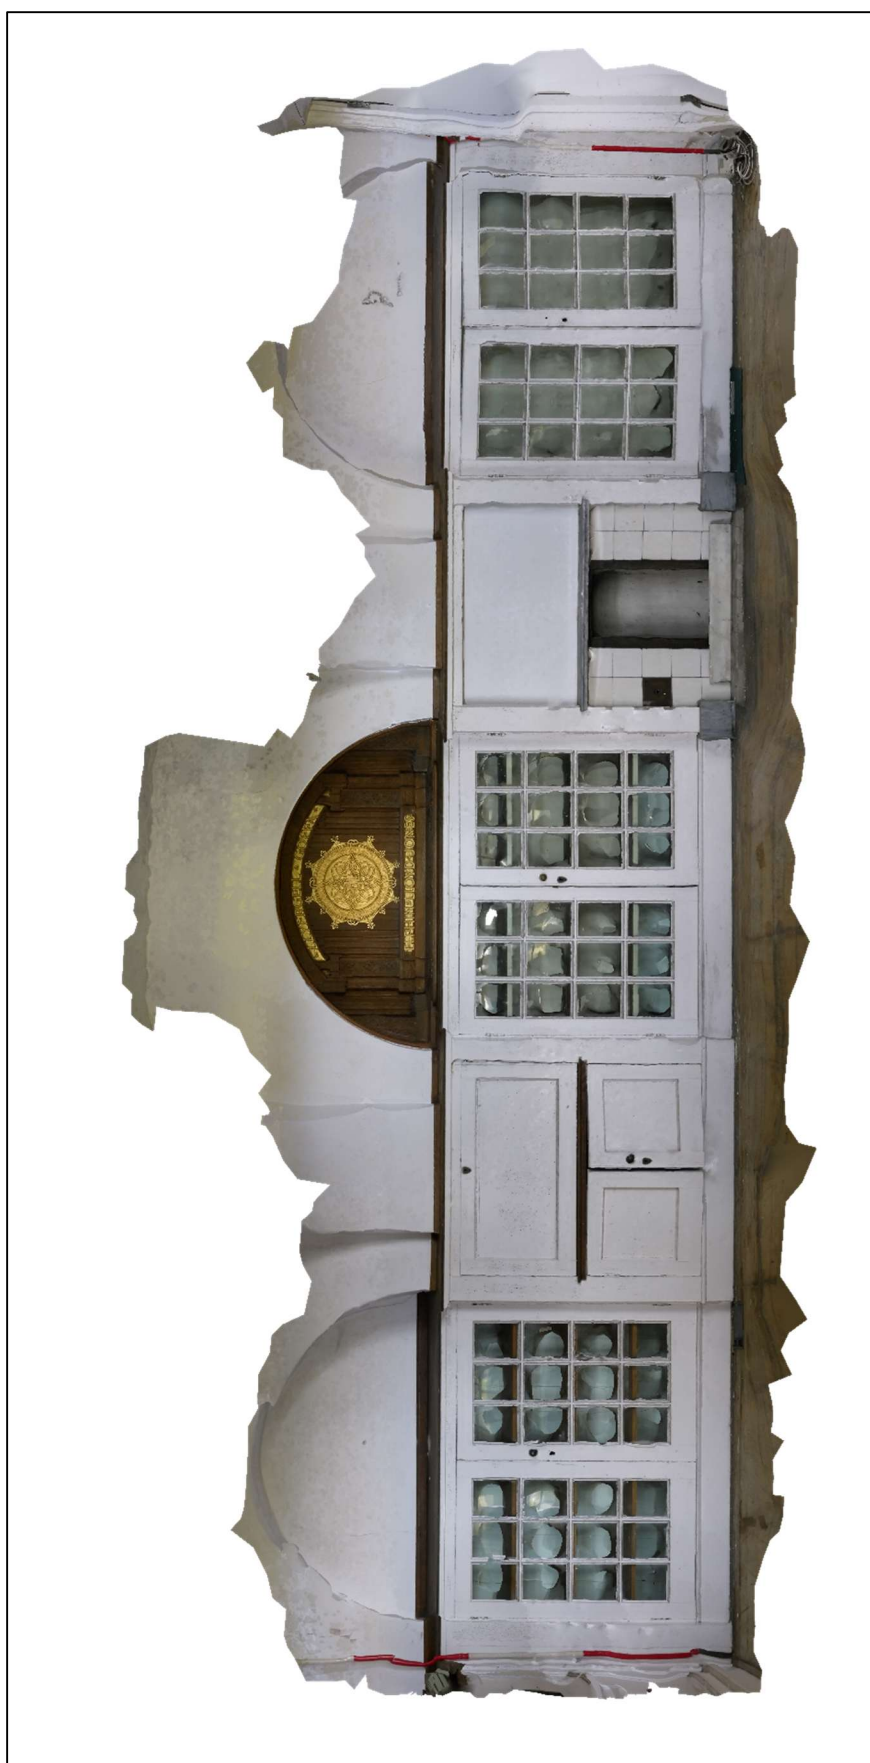
Plate 3: Rectified composite of the eastern wall of the Elphin Jones Library

On the eastern wall of the room are three, glazed cupboard/bookshelves (Plates 3 - 5) within arch topped niches. The cupboards reach a height of approximately 1.30 m and are topped with a wooden shelf that runs along the eastern wall of the room. Between the northern and middle cupboards is a small fireplace with plain white glazed tile surrounds. Between the middle and southern bookshelves is a block of closed cupboards with a large, vertically opening, single cupboard over two, opposed cupboard doors (Plate 4).

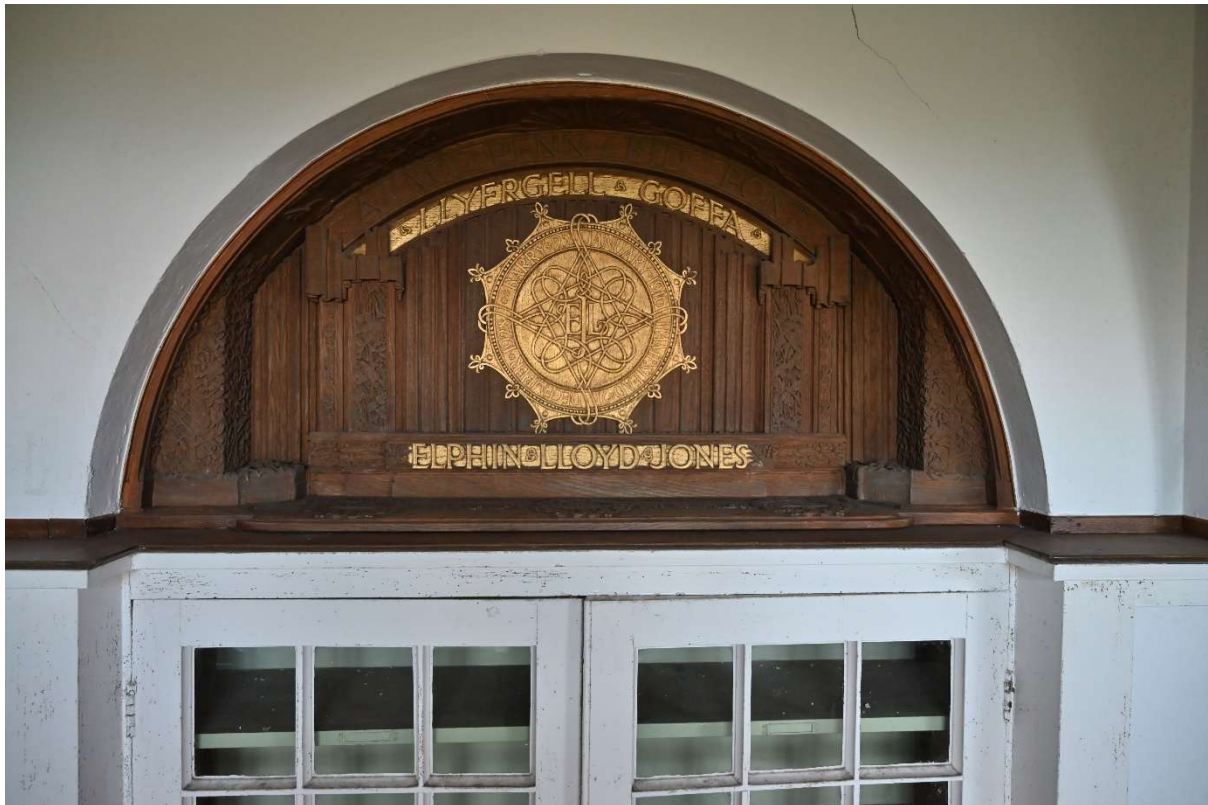
Plate 6: The central niche in the Elphin Jones Library

The central niche (Plate 6) is panelled in wood and contains a gilded decoration (Plate 7) consisting of an elaborated disc with the interlinked letters “EJS” at the centre of the disc. Around the periphery of the disc is the inscription “** BARRY * 22 JANUARY * 1916

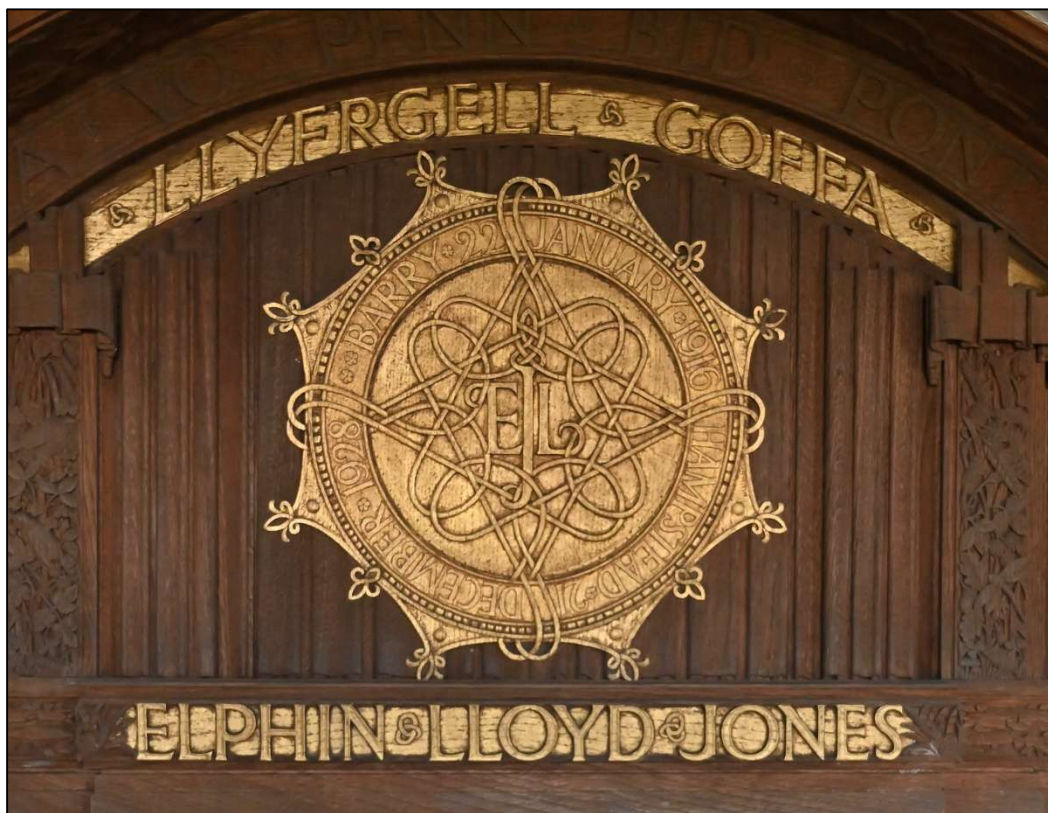
Plate 7: Detail of the inscription in the central niche of the Elphin Jones Library

HAMPSTEAD * 21 DECEMBER * 1928". Above the disc is a gilded, curved banner with "LLYFRGELL GOFFA" inscribed and below a straight banner with "ELPHIN LLOYD JONES" with each of the names separated with a knot symbol. This plaque is a memorial to Elphin Loyd Jones, the second son of Thomas Jones, a university professor, civil servant, administrator and author. Thomas Jones was also one of the founders of The Welsh Outlook and its first editor (1914-1916), of the Gregynog Press in 1922 and the principal founder of Coleg Harlech in 1927 (<https://biography.wales/article/s2-JONE-THO-1870>). Elphin died in 1928 at the age of 12 in a motoring accident ([https://en.wikipedia.org/wiki/Thomas_Jones_\(civil_servant\)](https://en.wikipedia.org/wiki/Thomas_Jones_(civil_servant))).

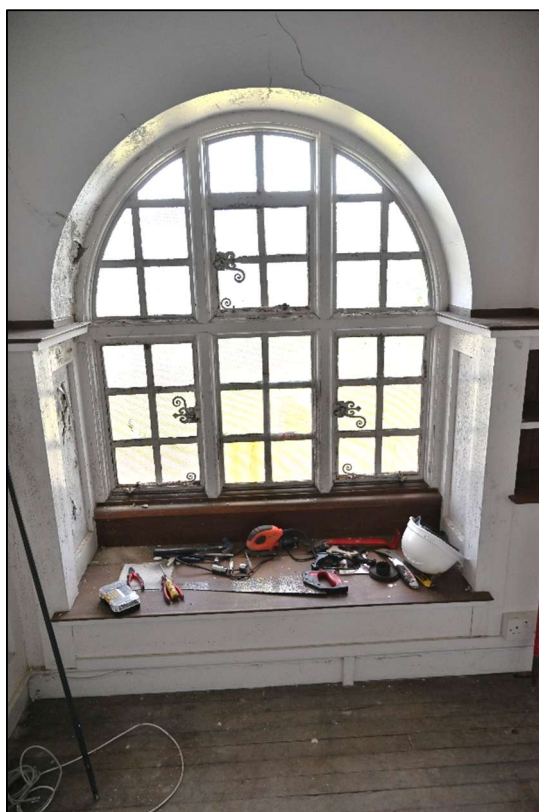
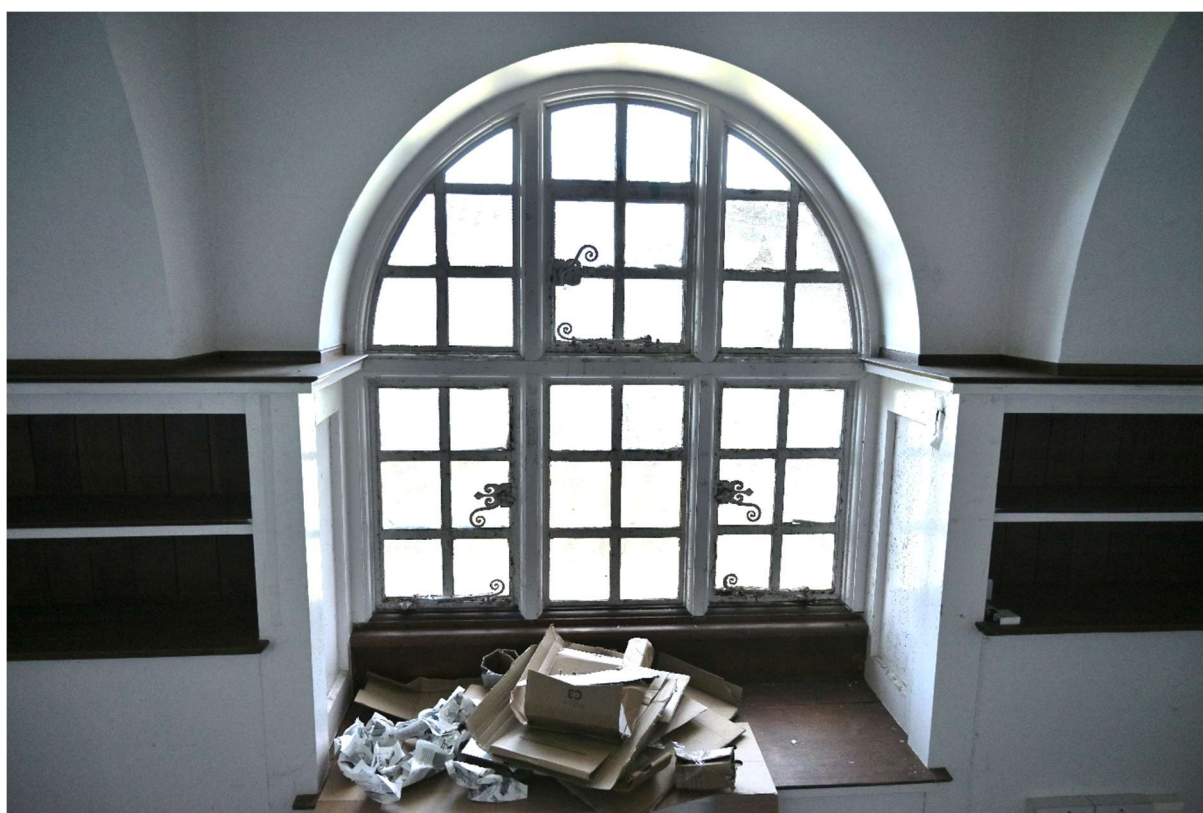
The opposite wall of the library holds three windows (Plates 8 – 10) separated by shelving (Plate 11). All the windows have round arched heads and multi-paned windows separated by mullions. The southern and central windows (Plates 8 and 9), each have three casement openings with each of these having elaborate fasteners and stays with spiral handles. The northern window (Plate 10) has no openings.

Plate 8: Southern window within the Elphin Jones Library

Plate 9: Middle window within the Elphin Jones Library

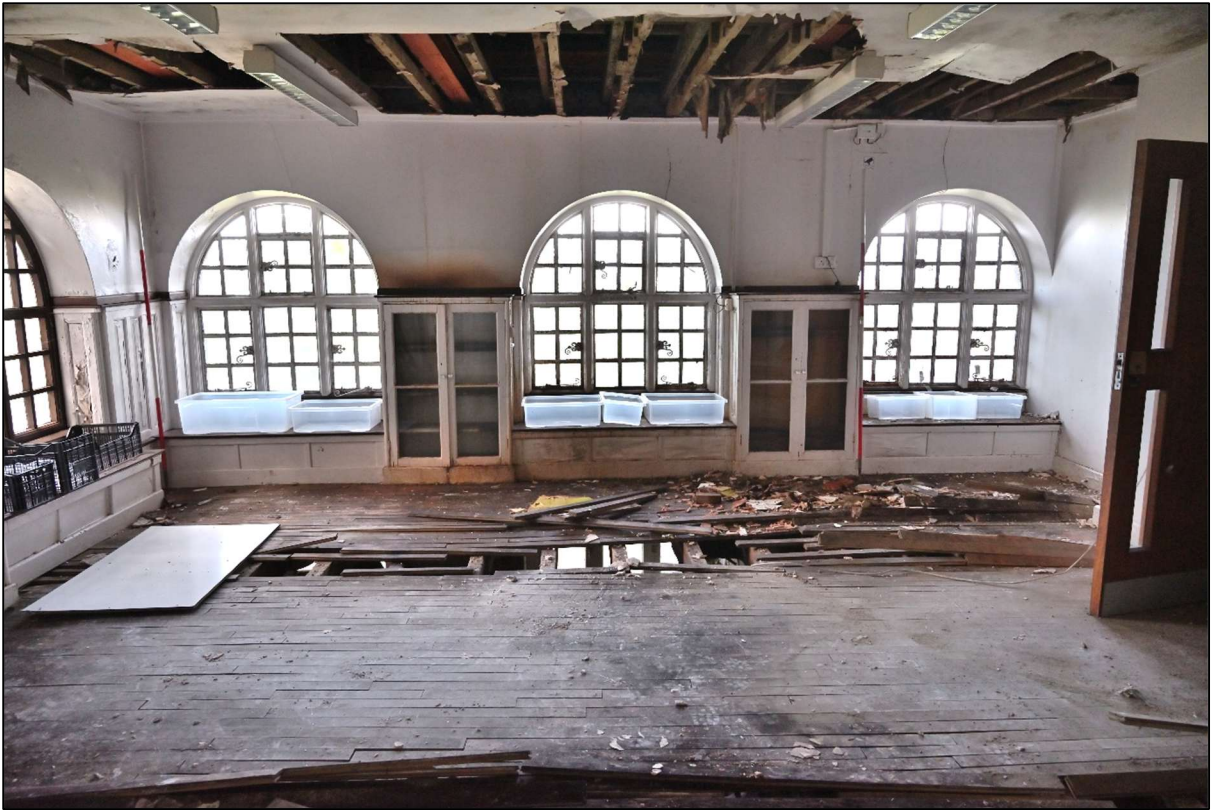
Plate 12: The Elphin Lloyd Jones Room, looking west

The Elphin Lloyd Jones Room (Green Room) is a much larger room (6.99 x 5.97 m) which has suffered considerable damage from the water ingress (Plate 12). There are semi-circular topped windows on two sides of the room and a glazed shelving unit along a third wall. The western wall of the room has three, semi-circular arched windows, each with multi-paned openings and three casement openings. Two of these casement windows were in the lower portion of the windows, whilst the third was centrally placed in the upper, arched, section. Between each of the windows are cupboards with glazed doors containing shelving (Plate 13). There is also a small section of wooden panelling in the south western corner of the room, effectively between the southern window of the western wall and the window in the southern wall (Plate 14).

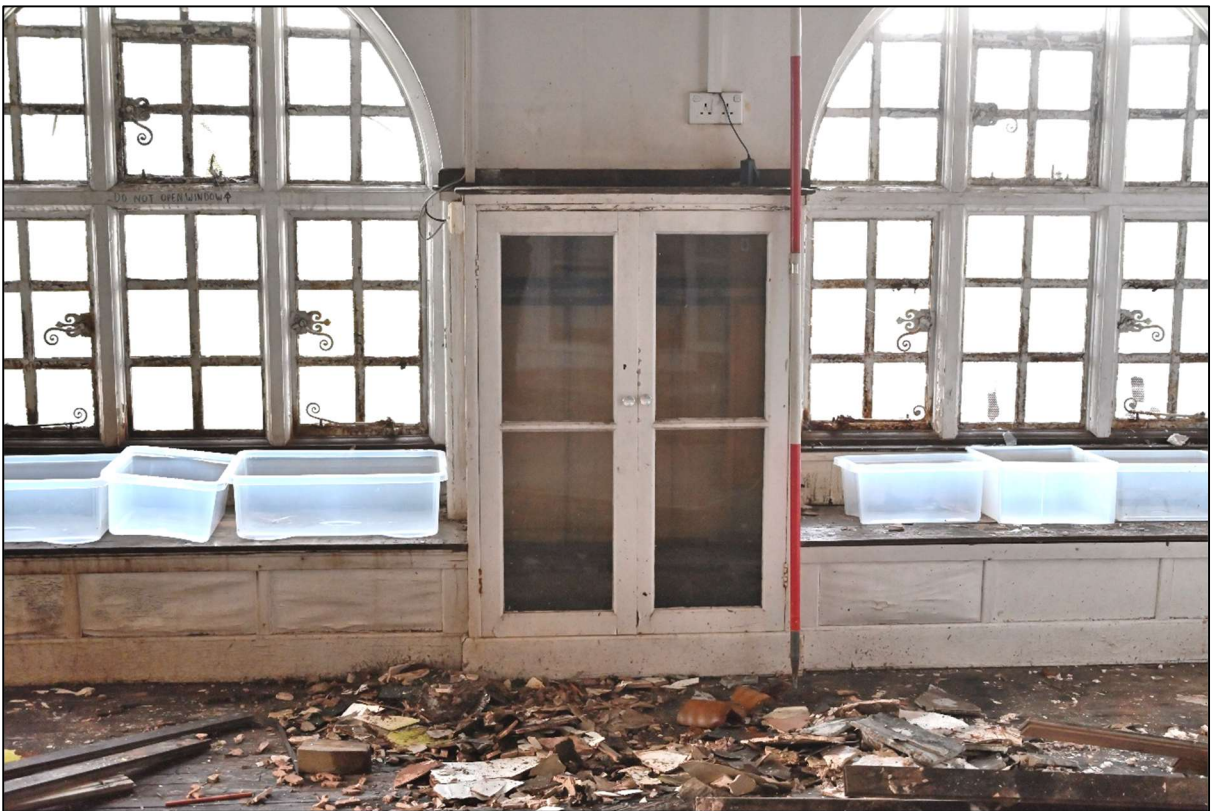
Plate 13: One of the cupboards between the windows of the Elphin Lloyd Jones Room

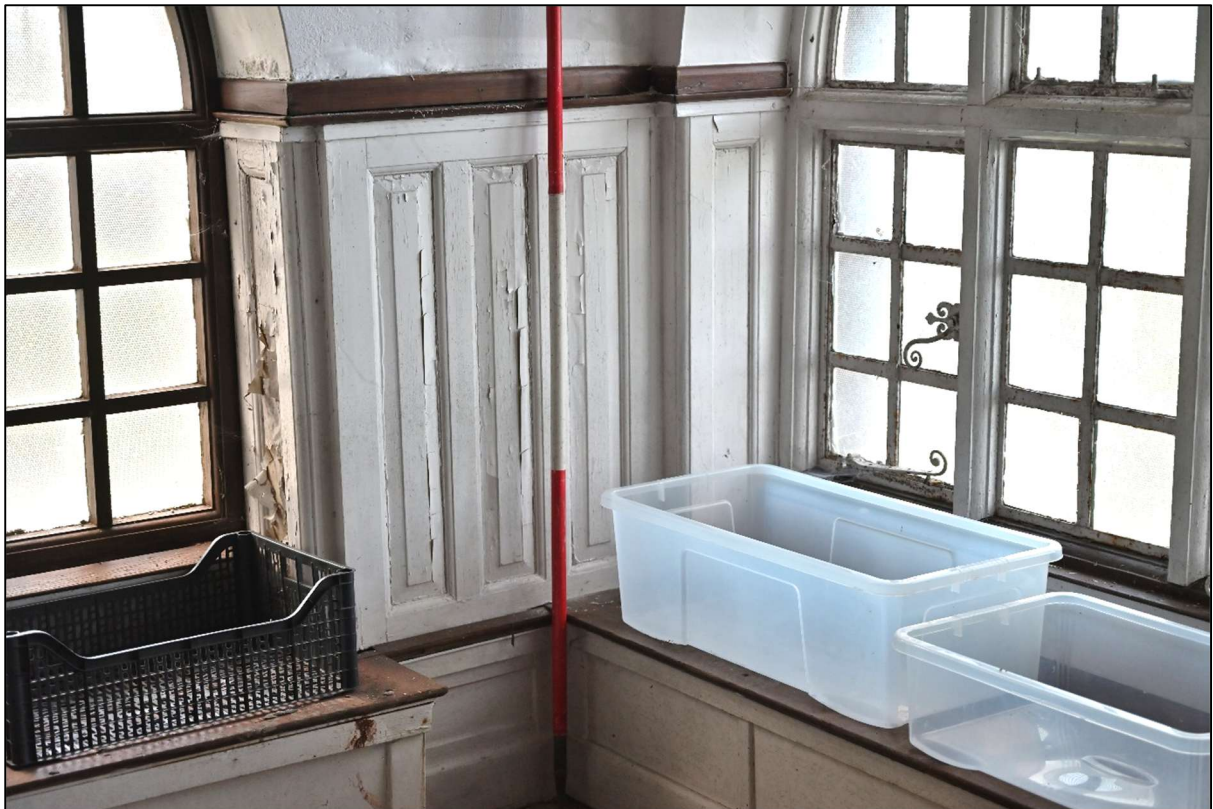
Plate 14: Detail of the panelling in the Elphin Lloyd Jones Room

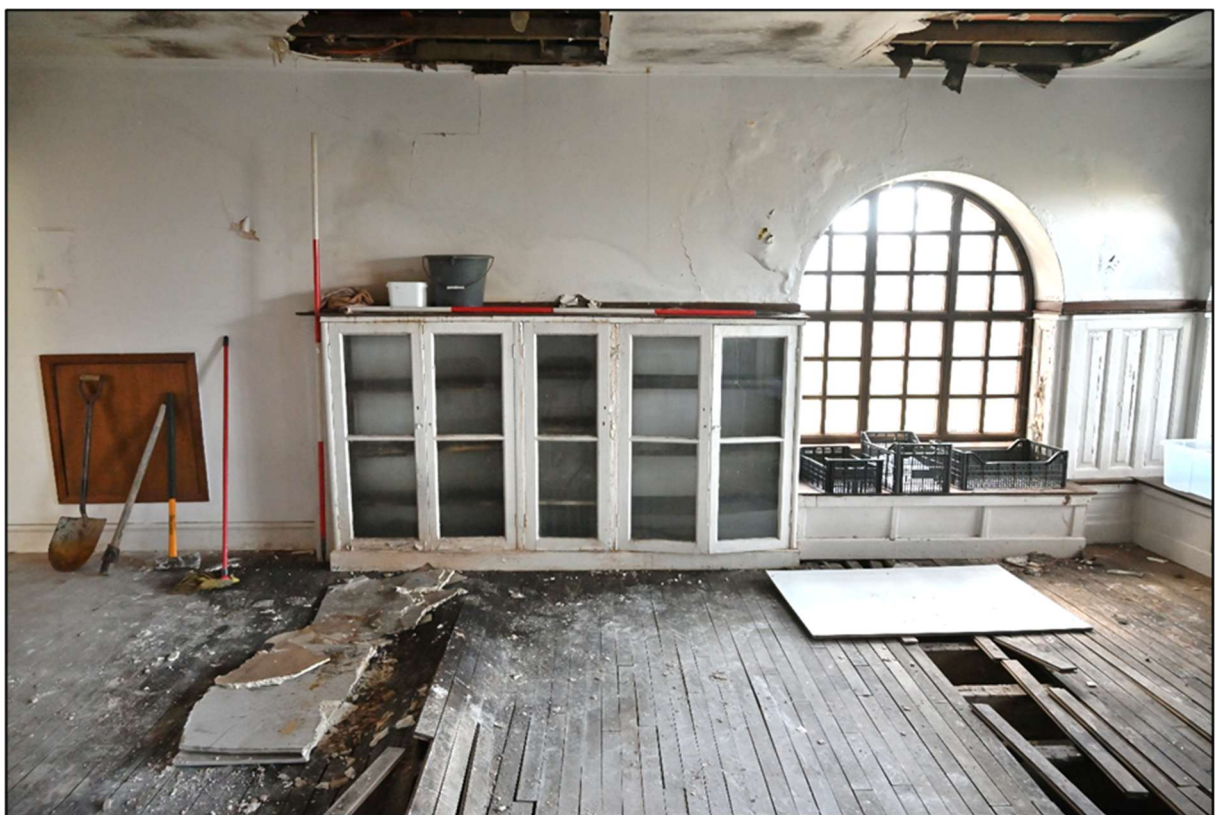
Plate 15: Southern wall of the Elphin Lloyd Jones Room

There is also a single semi-circular topped window in the southern wall of the room (Plate 15). Adjacent to which is a cupboard unit with two, double, glazed, doors opening at each end and a central, single glazed door in the middle (Plate 16). Each section of the unit has three shelves. The unit is 1.26 m high and 2.4 m long.

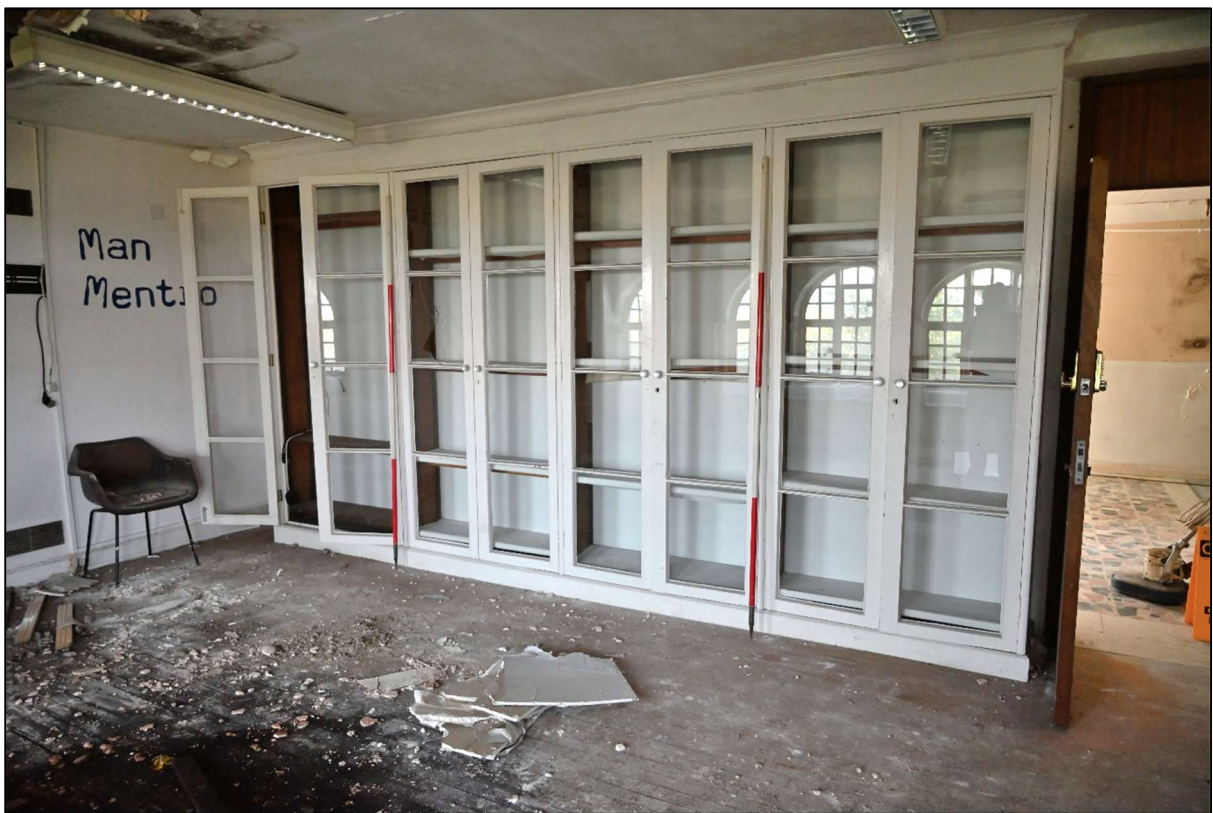
Plate 17: The eastern wall of the Elphin Lloyd Jones Room

Along the eastern wall is a full height, glazed shelving unit with four, double doors (Plate 17) and in the northern wall the doorway to the spiral stair leading down to the dressing rooms.

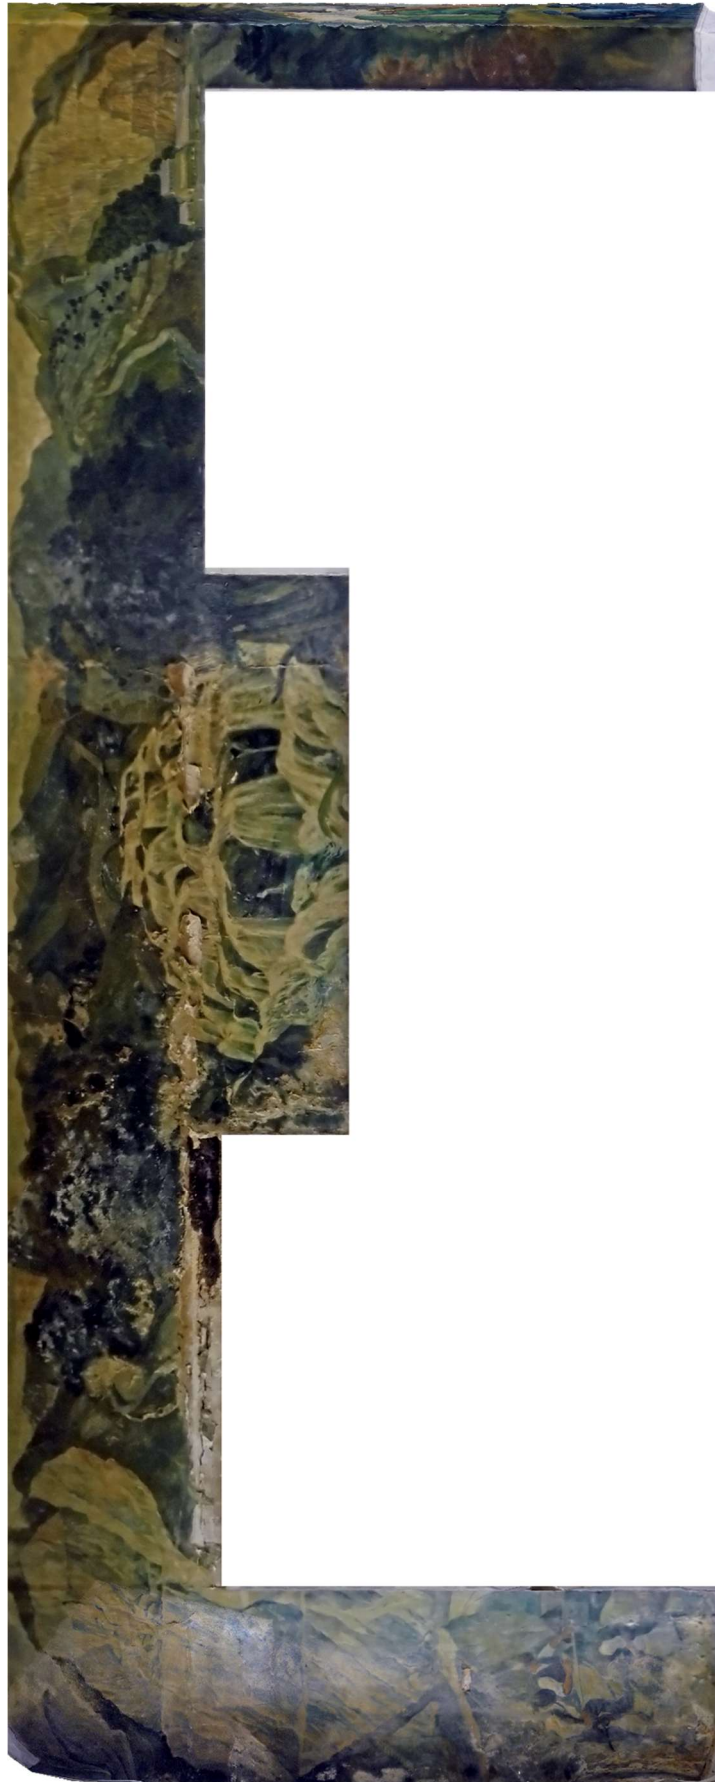
Plate 18: Mural on the northern wall of the Staff Room

Whilst not part of the commissioned survey, the Staff Room is distinctive because of its wall paintings. A composite landscape runs around three sides of the room (Plates 18 – 20), whilst each of the piers between the windows on the western side of the room have pictures of three Welsh characters; a man holding a book, a shepherd and an harp player (Plates 21 – 23). The murals were painted by Robert Baker in the early 1930's and are reported as telling the story of a young miner leaving home to go to the college and his subsequent experience there (https://www.facebook.com/photo.php?fbid=3624571314228008&id=146120328739808&set=a.238166046201902&locale=en_GB). They show two main scenes with the eastern wall concentrating on rural (probably North Walian) scenes including druids and sheep (Plate 19); whilst the southern wall has industrial scenes and a harbour (possibly representing South Wales).

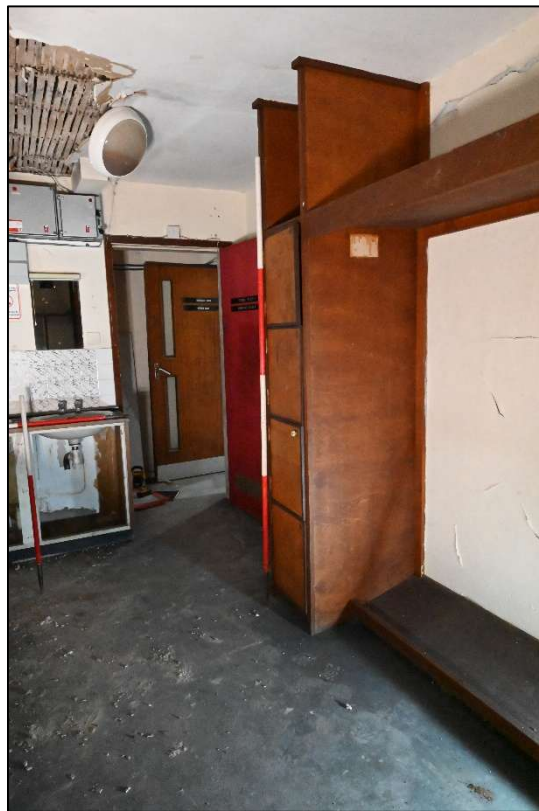
Plate 26: Dressing Room 1, looking NNE

The eastern wall dominated by a locker/dresser (Figure 4, Plates 26, 27 and 29). This is constructed of a soft wood with a mahogany veneer and a dark wood banding defining the edges of the lockers. At one end are four lockers, forming a block, one locker wide. Each of these are 360 x 590 x 400 mm in size with a wooden door with a yale lock in the top, right hand corner. The bulk of this piece of furniture, however is divided into three spaces vertically. A top shelf, 600 mm high, sits over an area for hanging clothes. The rail is missing, however, the scar for the mount was seen. At the bottom of the furniture was an angled shelf, presumably for holding shoes.

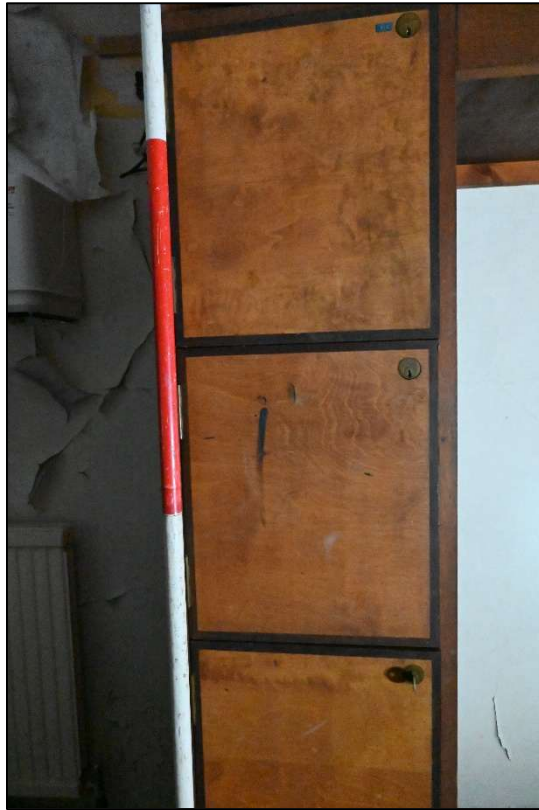
Plate 27: Detail of the lockers in Dressing Room 1

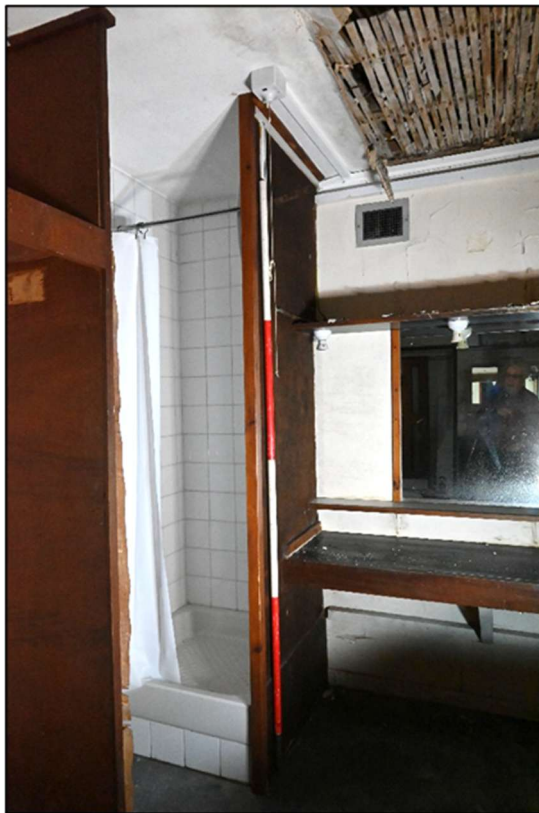
Plate 28: Shower in Dressing Room 1

In the NE corner of the room is a shower (Plate 28) and a double hand basin unit (Plate 30) is on the north wall (Plate 29).

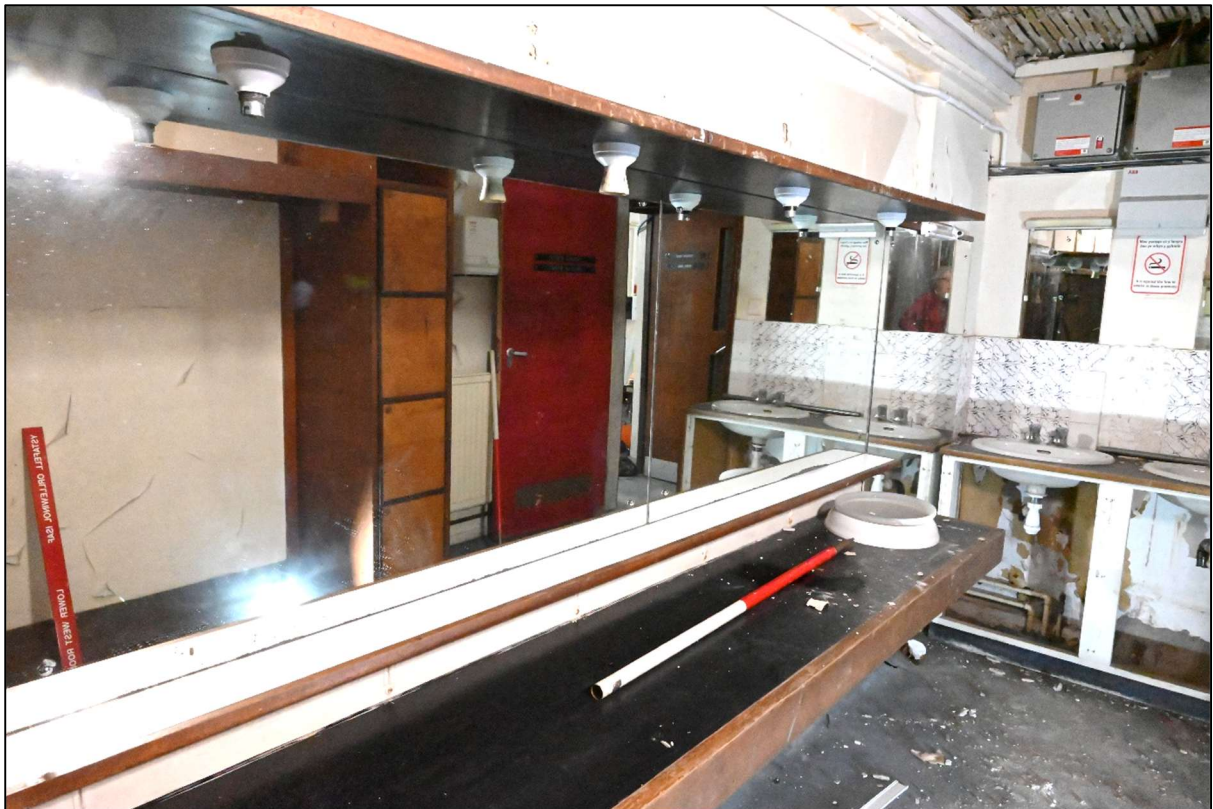
Plate 30: The vanity unit in Dressing Room 1

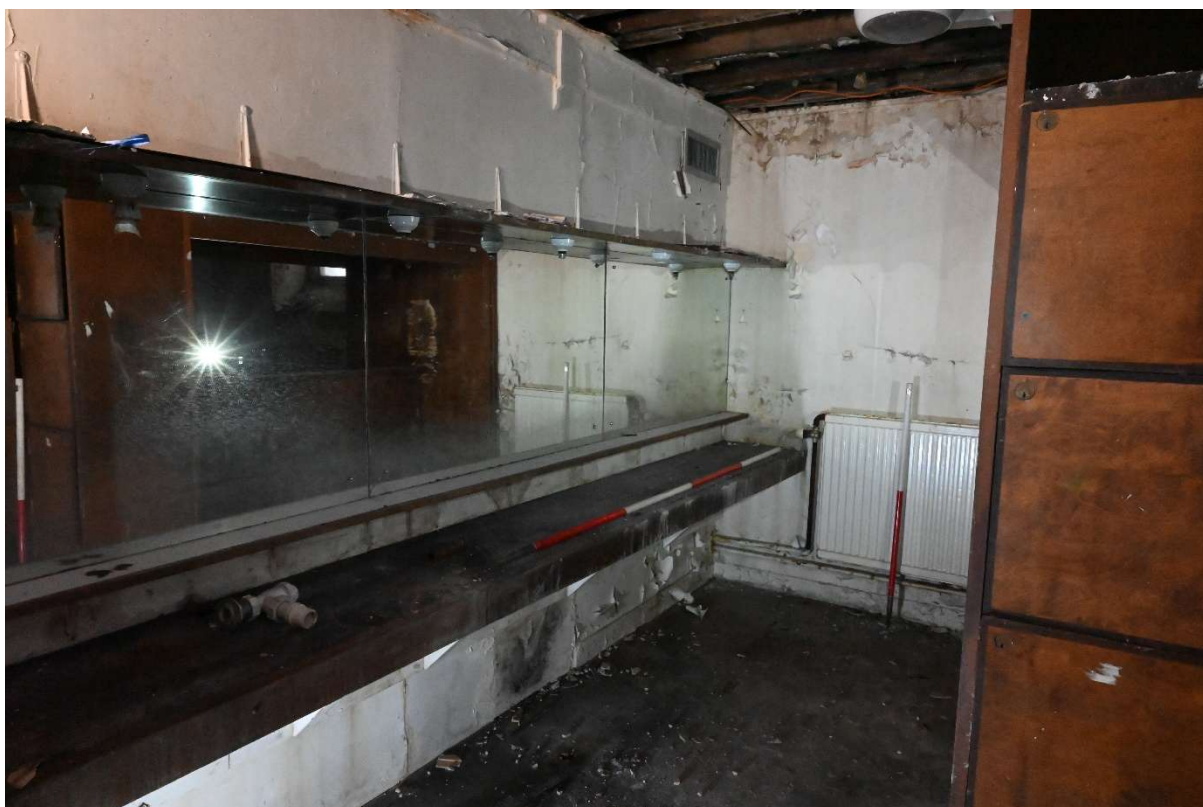
Plate 32: Vanity unit on the eastern side of Dressing Room 2

This is the larger of the two dressing rooms being 5.1 x 4.52 m in size. It has vanity units along the eastern side of the room and part of the western wall (Plates 31 and 32) and a short vanity unit on the eastern wall (Plate 33). A shower occupied the NW corner (Plate 33) and there was a double basin unit on the northern wall (Plate 34).

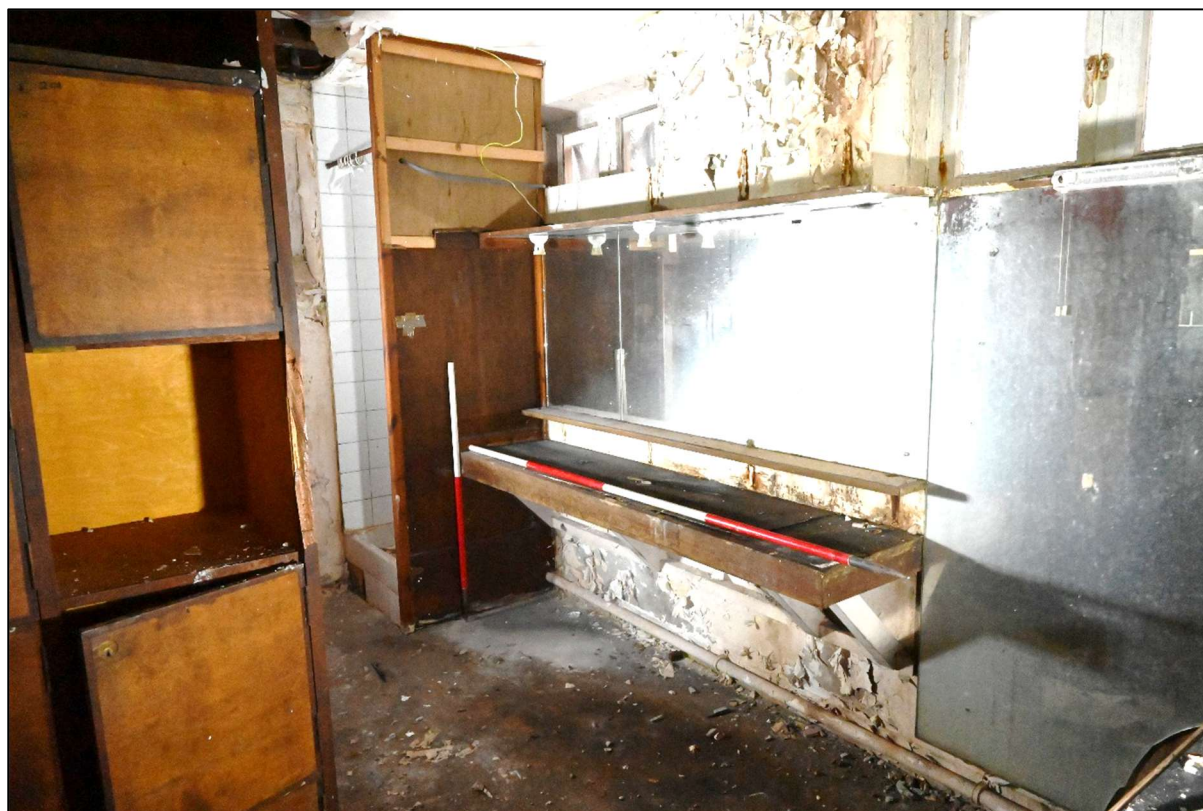
Plate 33: Vanity unit on the western side of Dressing Room 2

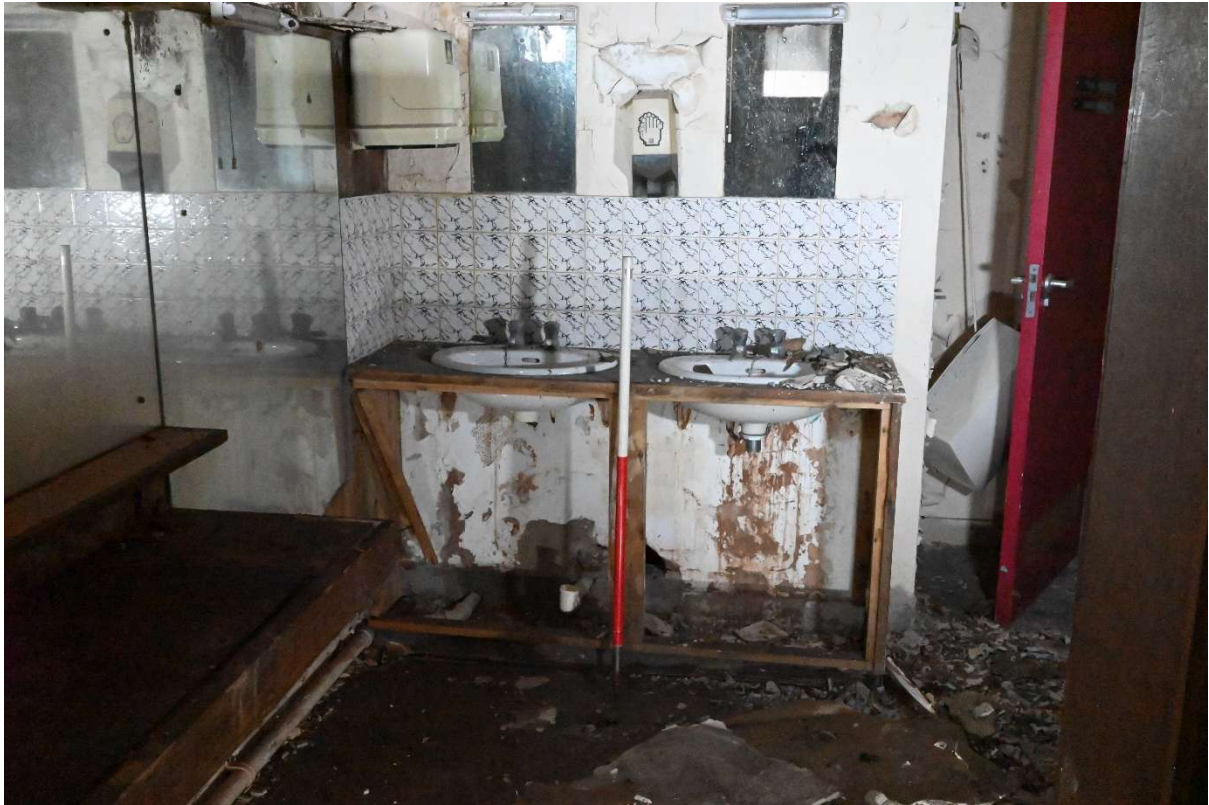
Plate 34: Sink unit in Dressing Room 2

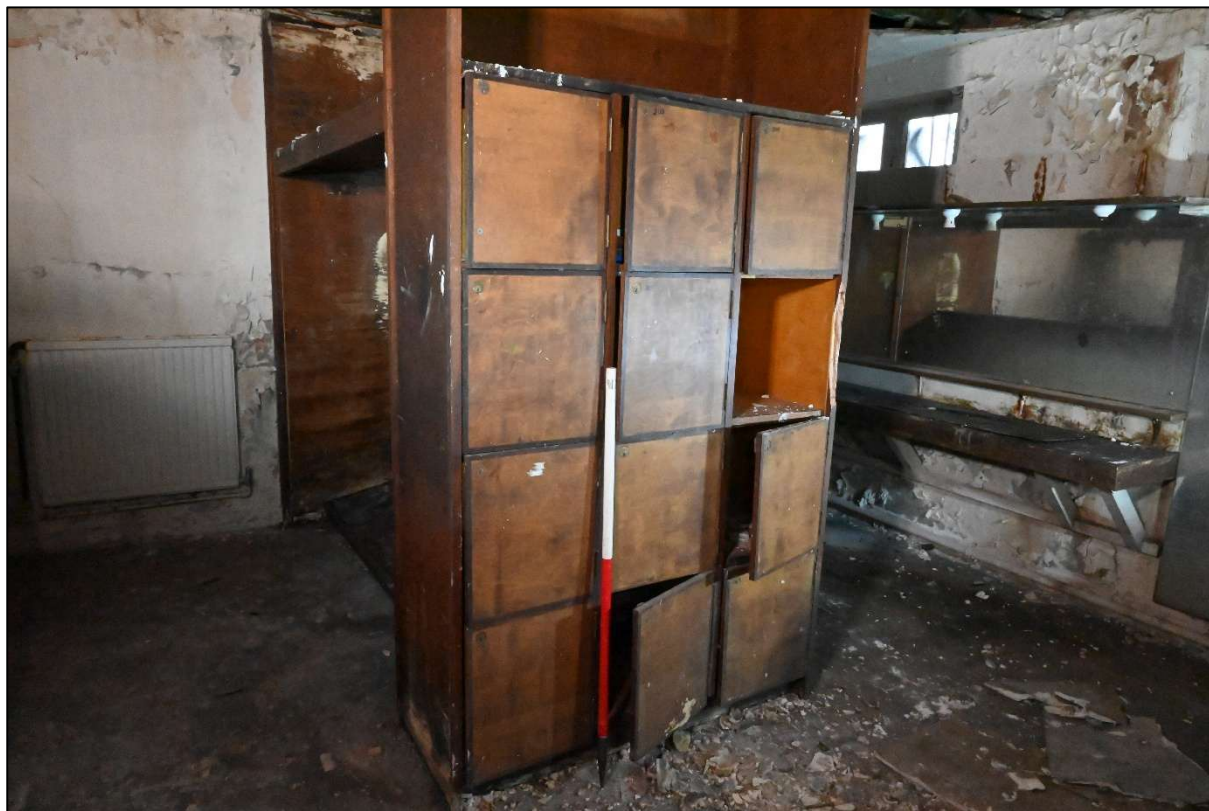
Plate 35: Lockers in Dressing Room 2

The centre of the room is dominated by a double-sided locker/dresser unit (Figure 5, Plates 35 – 36, 41). The northern end of this piece of furniture has a block of twelve lockers (Plates 35 and 41), arranged in four rows, over which there is an open shelf. Each of the lockers has a wooden door with a yale lock in its top left-hand corner. One of these retained a “post it” note inscribed “Avril’s Personal Locker” (Plate 39).

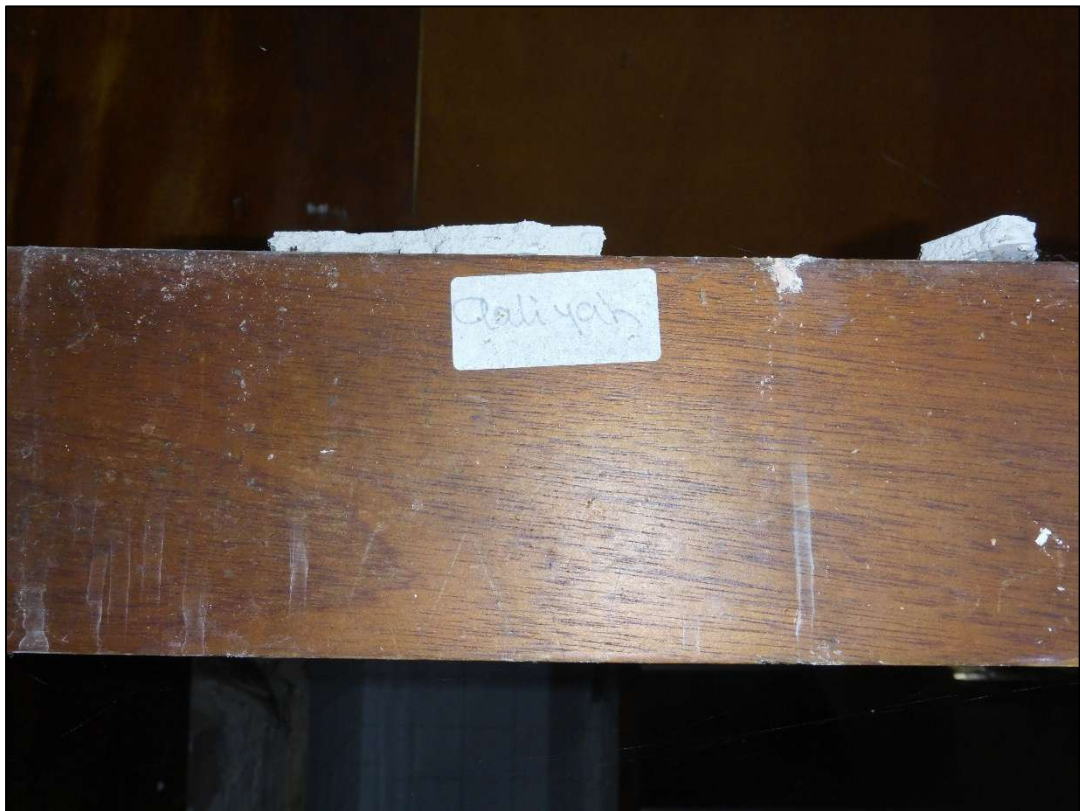
Plate 37: Name tag on the eastern side of the dresser unit in Dressing Room 2

The bulk of this piece of furniture consisted of opposed hanging spaces with open shelves above and raking shelves below (Plate 36). Neither of the hanging spaces retained its rail, however the scars for the fittings remains. The open shelf on the eastern side retained sticky labels with the names “Eva” and “Aaliyah” written on them (Plates 37 and 38).

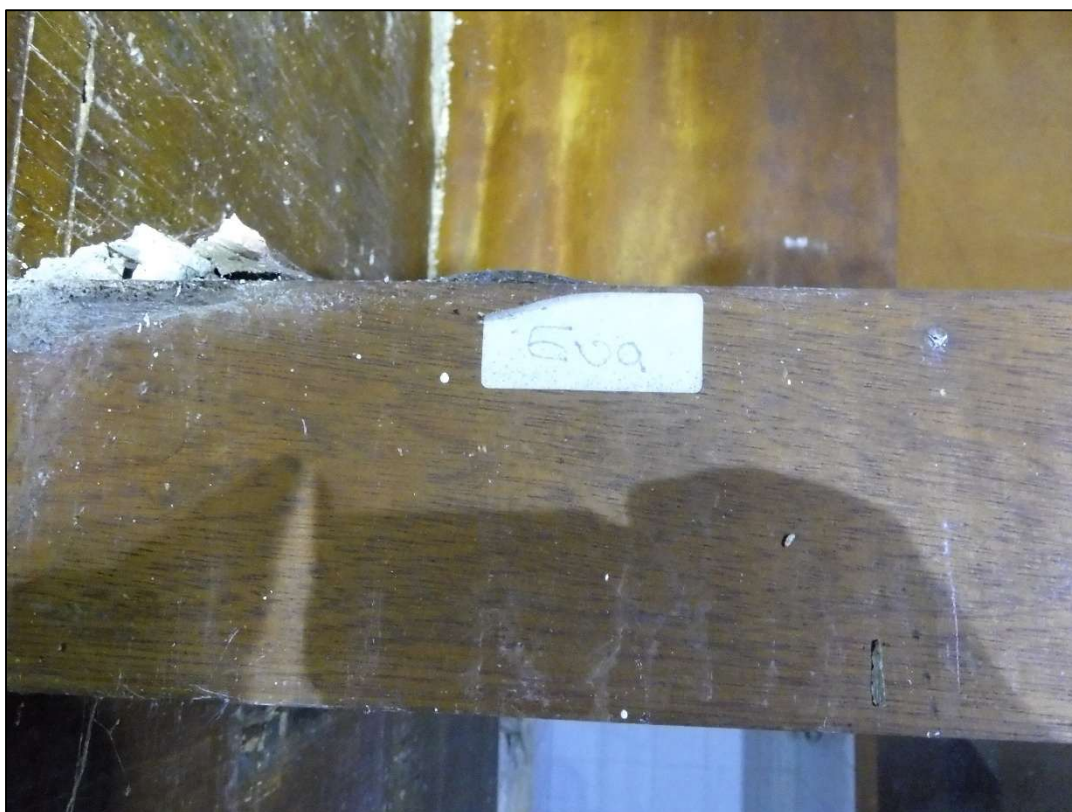
Plate 38: Name tag on the eastern side of the dresser unit in Dressing Room 2

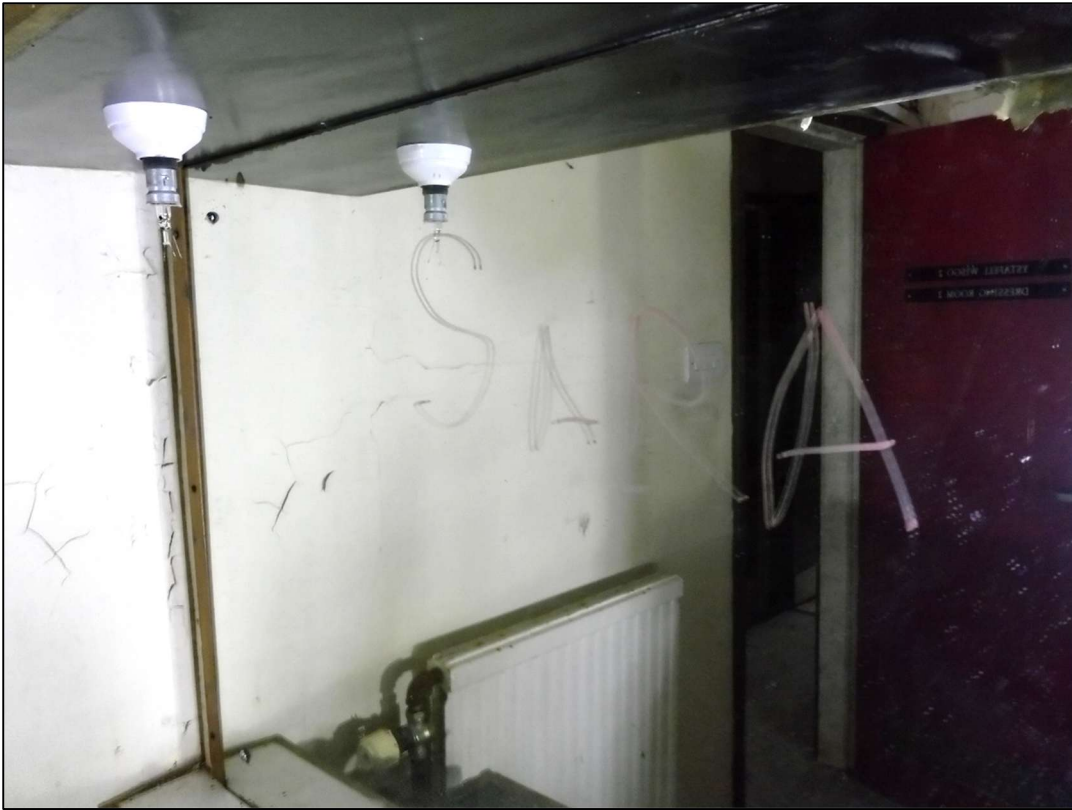
Plate 40: Mirror with lipstick name “SARA”

Further graffiti is on the mirror of the western vanity unit where the word “SARA” is written in lipstick (Plate 40).
