Coleg Harlech

EAS Client report 2024/25

To record four rooms within Coleg Harlech that had suffered considerable water damage, before they were restored.

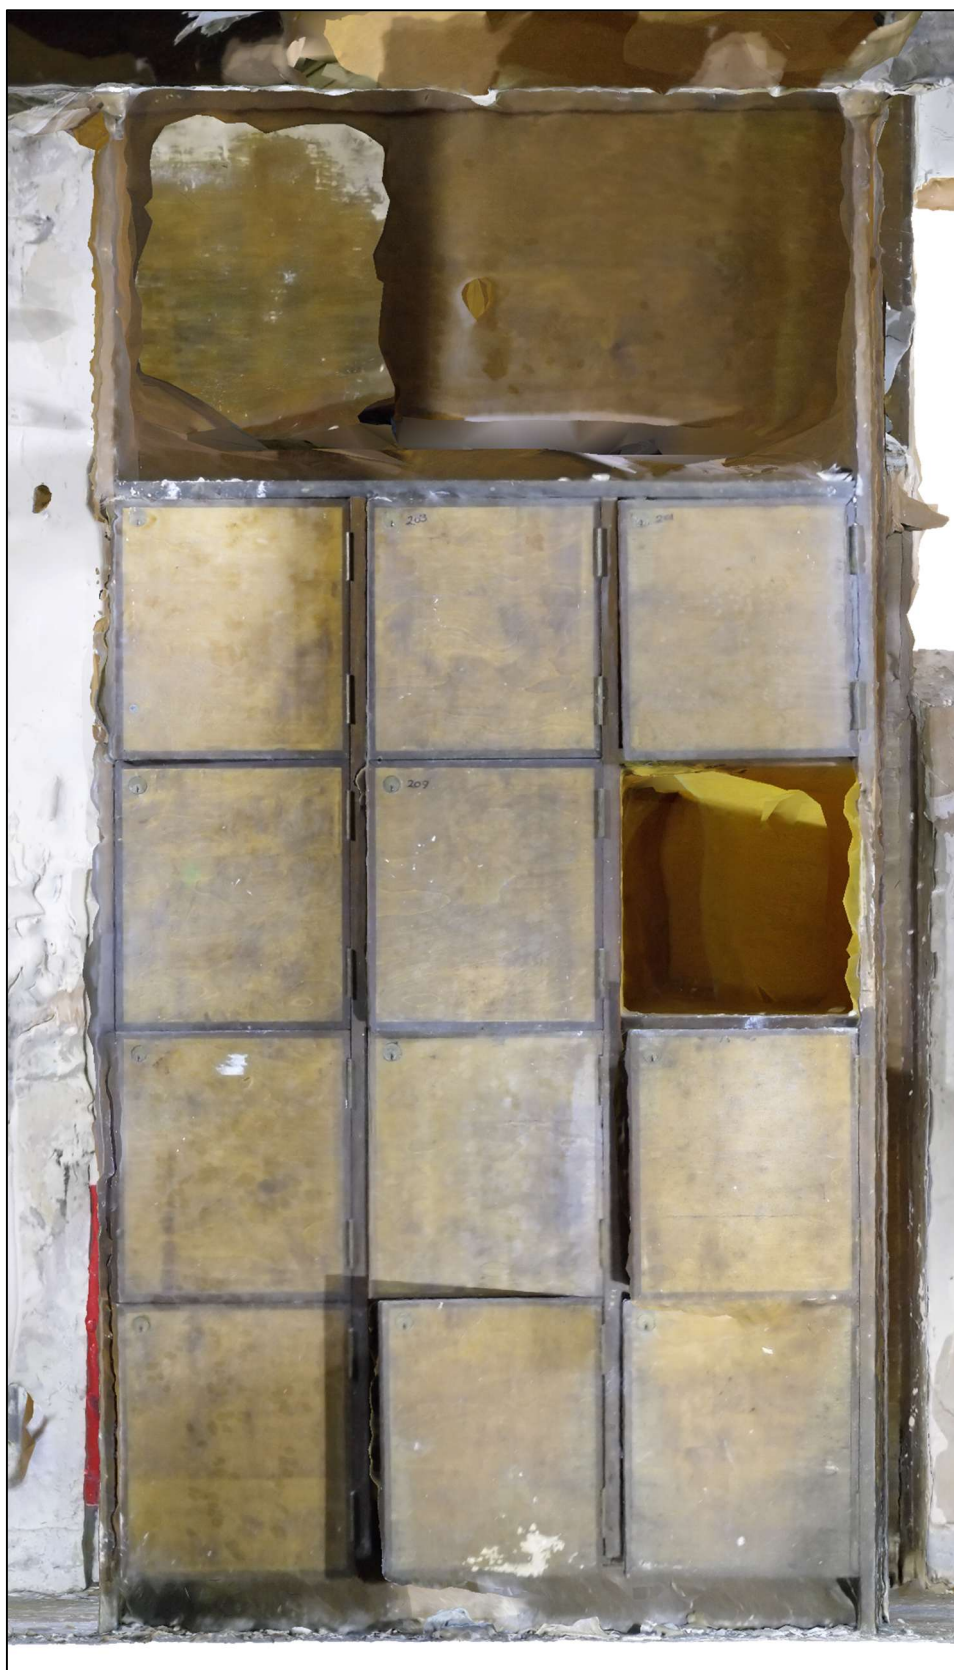
Plate 41: Composite, rectified image of the lockers in Dressing Room 2

The centre of the room is dominated by a double-sided locker/dresser unit (Figure 5, Plates 35 – 36, 41). The northern end of this piece of furniture has a block of twelve lockers (Plates 35 and 41), arranged in four rows, over which there is an open shelf. Each of the lockers has a wooden door with a yale lock in its top left-hand corner. One of these retained a “post it” note inscribed “Avril’s Personal Locker” (Plate 39).

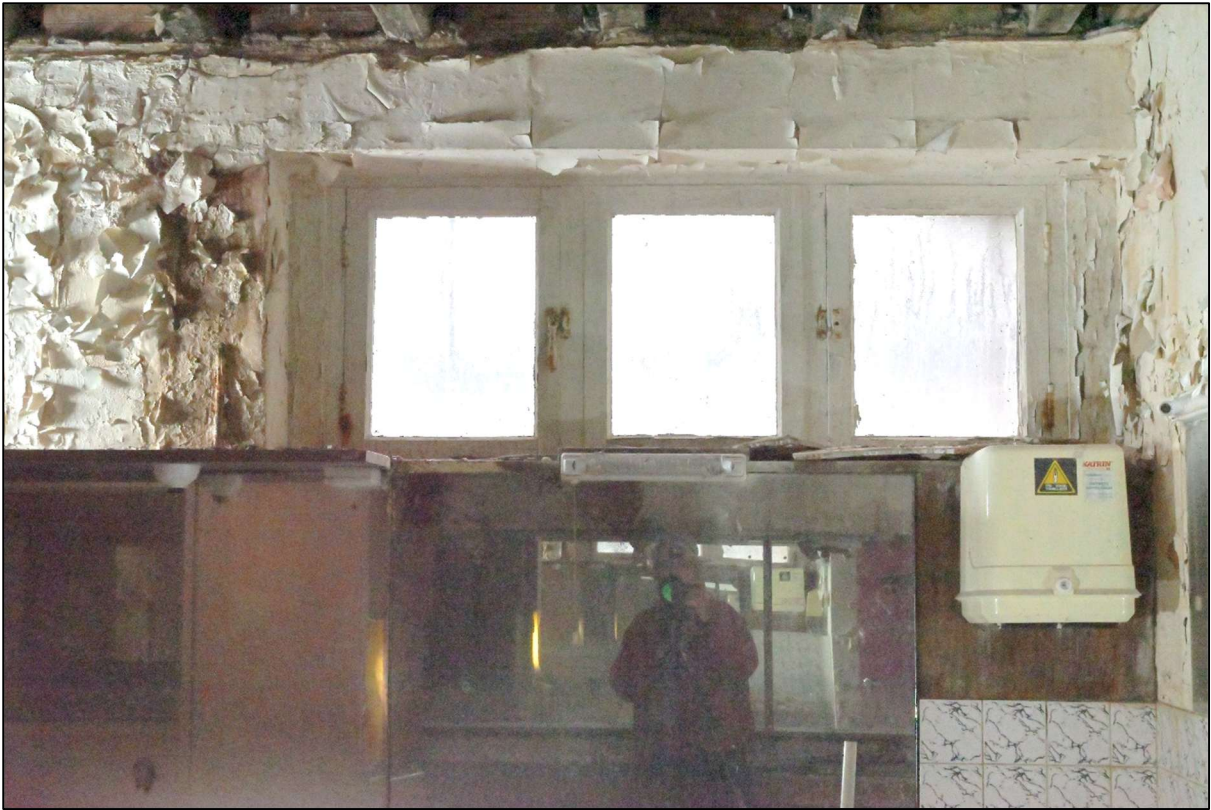
Plate 42: Windows in the north west corner of Dressing Room 2

It is likely that the dressing rooms were fitted into a single, earlier, room which had high level windows (Plate 42). These were originally casement windows with cast iron drop handles

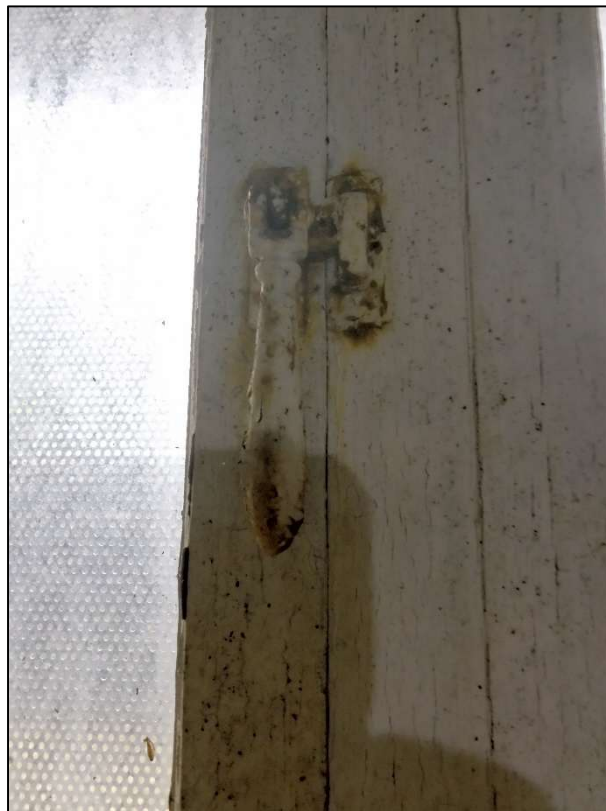
Plate 43: Window latch in Dressing Room 2

(Plate 43), however some of these windows have been replaced by fan lights, particularly on the southern side of the room.

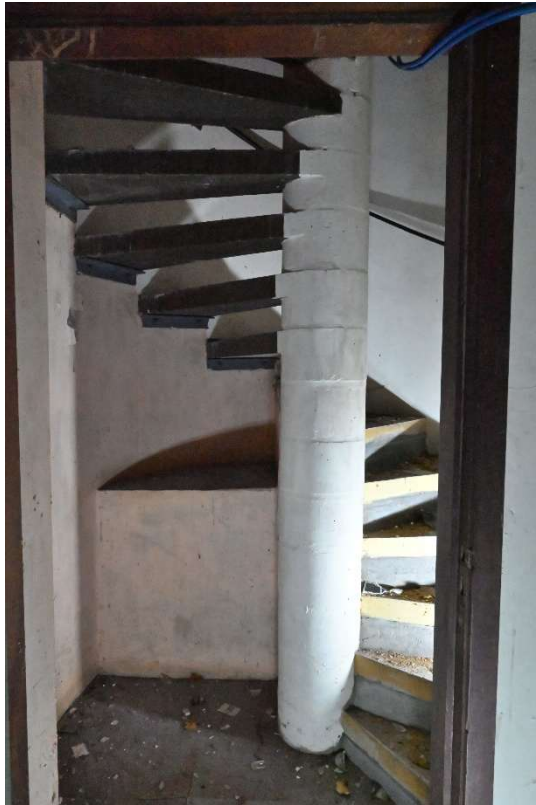
Plate 44: Spiral staircase

North of the dressing rooms is a corridor which links the dressing rooms to the spiral staircase leading to the Elphin Lloyd Jones Room above (Plate 44). This staircase is constructed of precast concrete and is part of the additions made to the complex when Theatr Ardudwy was added to the northern end of the building. The corridor also links the Dressing Rooms to the toilets (Plate 45). The Gents toilet is at the western end of the corridor, whilst the Ladies toilet is in between the spiral staircase and the Gents toilet on the northern side of the corridor. Where they survive the toilets had modern fittings.

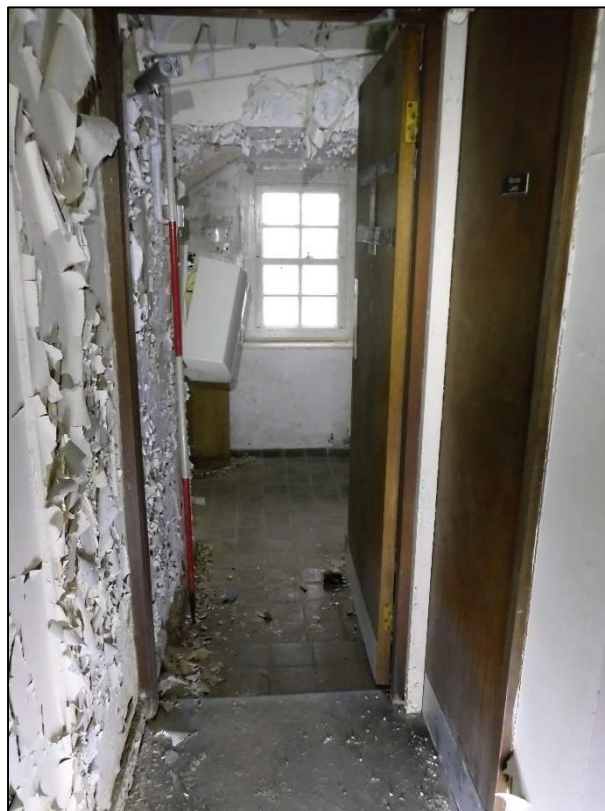
Plate 45: Corridor leading to the Gent's toilet
