**Plas Dol-y-Moch, Maentwrog, LL41 3YT,
Standing Building Record**

EAS Client Report 20243/09

Recording of the Chimneys and the Northern Gable of the Eastern Range

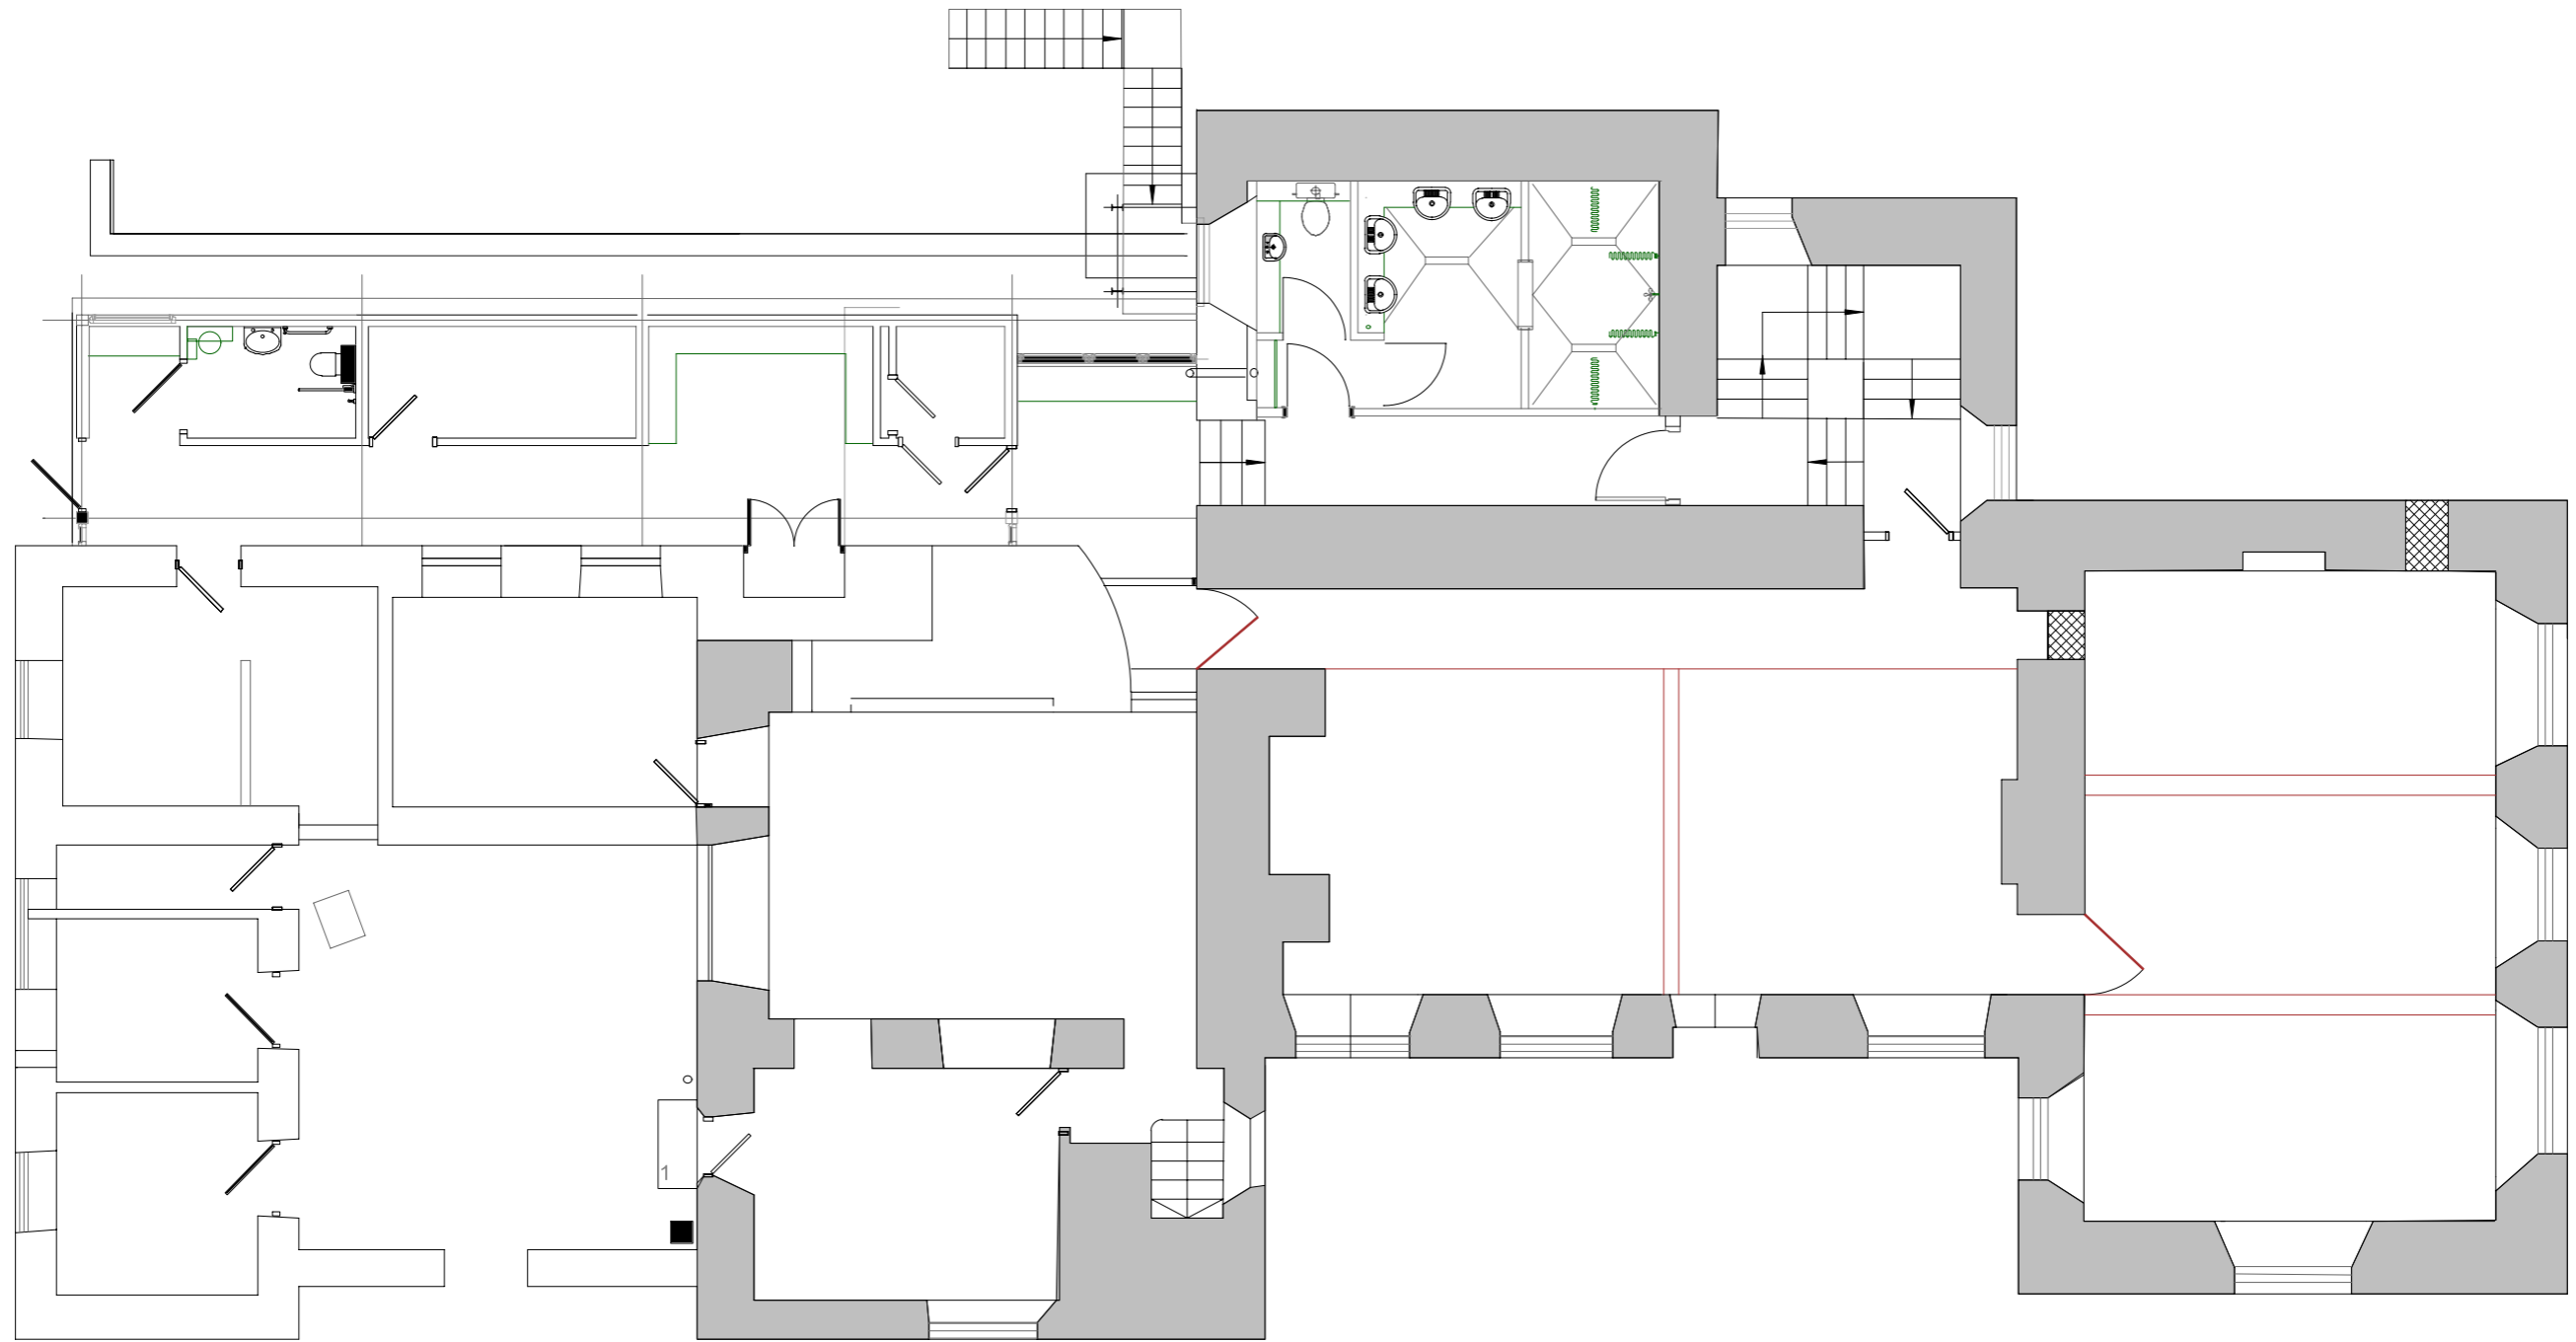
Figure 6: Ground Floor Plan
Scale 1:100

Plas Dol y Moch is entered through the main door in the central range. This gives access to the, stone floored, hall (Figure 6, Plates 23 – 25). This room has a large fireplace in its western end and a smaller fireplace (Plate 25) in the east end. Whilst the western fireplace is large, but its lintel has been covered, the eastern fireplace is relatively small and has a modern fire surround. There are three beams crossing the ceiling. Which are chamfered and have diagonal cut stops (Plate 26). The middle beam (Plate 27) has iron strapping to stabilise a crack in its centre consisting of two iron plates on either side of the beam and a strap which wraps around the beam. In the south eastern corner of the room is a blocked opening which originally was the doorway to the parlour. The current doorway must have been inserted after 1914 as the Royal Commission plan (Figure 9) only shows the now blocked, northern doorway.

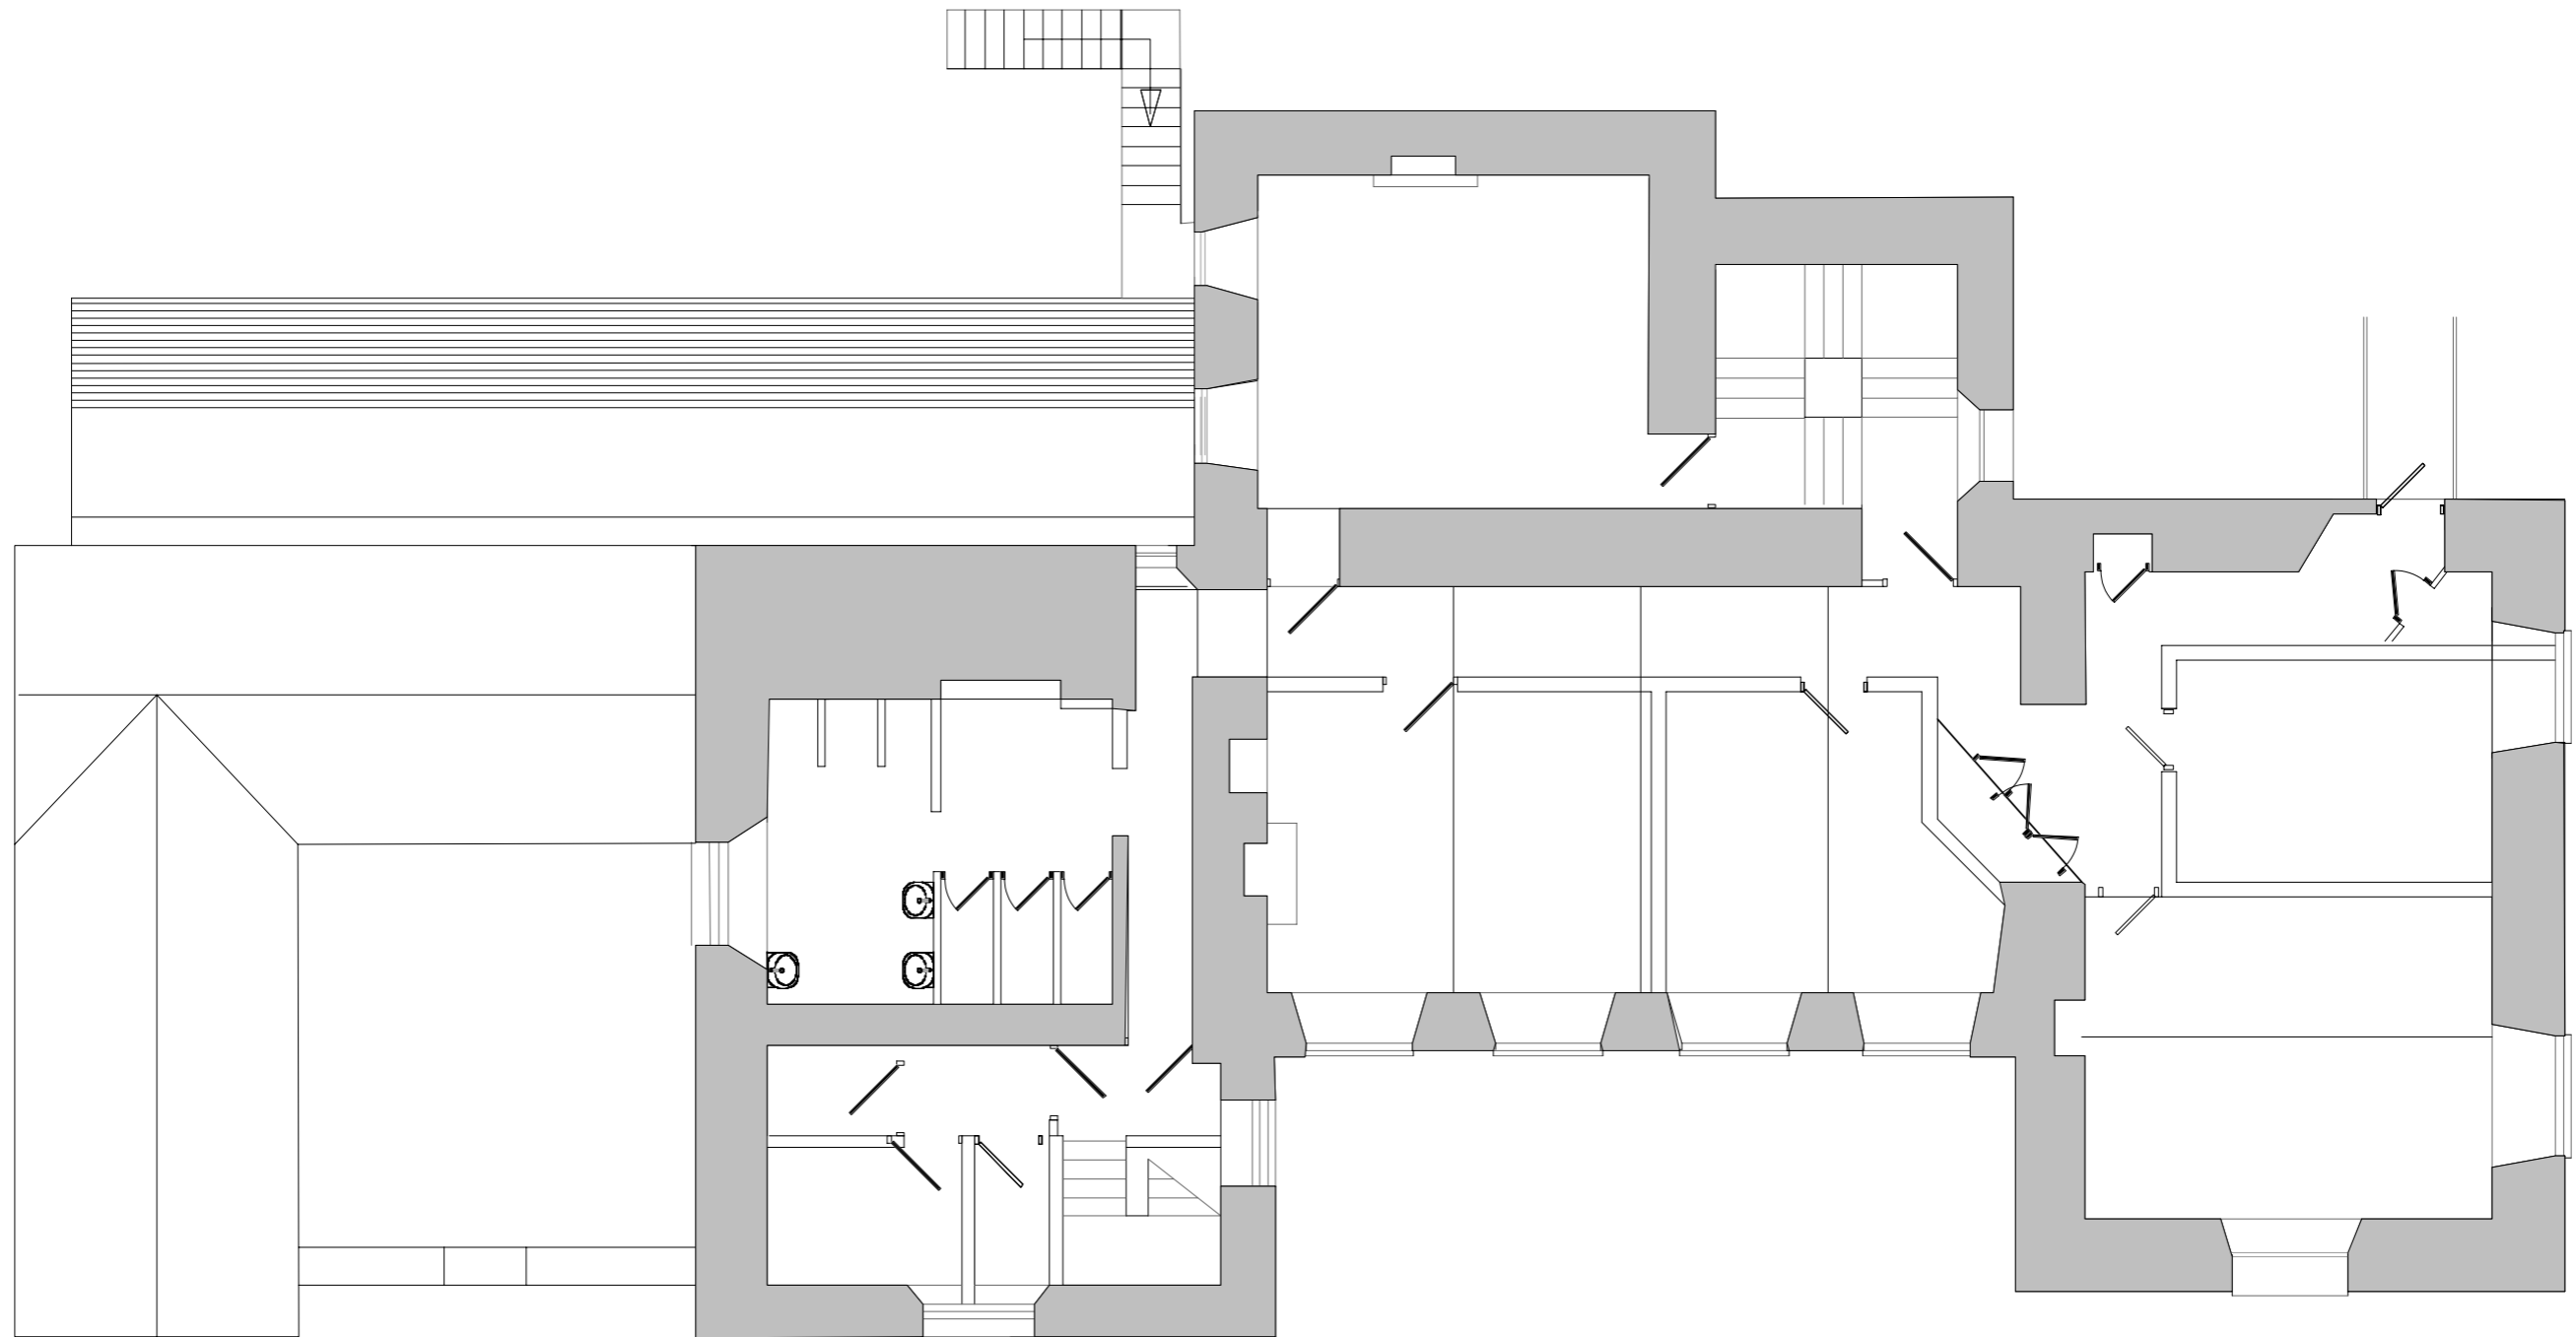
Figure 7: First Floor Plan
Scale 1:100

The first-floor (Figure 7) has been converted into a series of bedrooms, both in the main and eastern ranges. This has led to a fireplace (Plate 45) being left in a passage to the fire escape at the northern end of the eastern range.

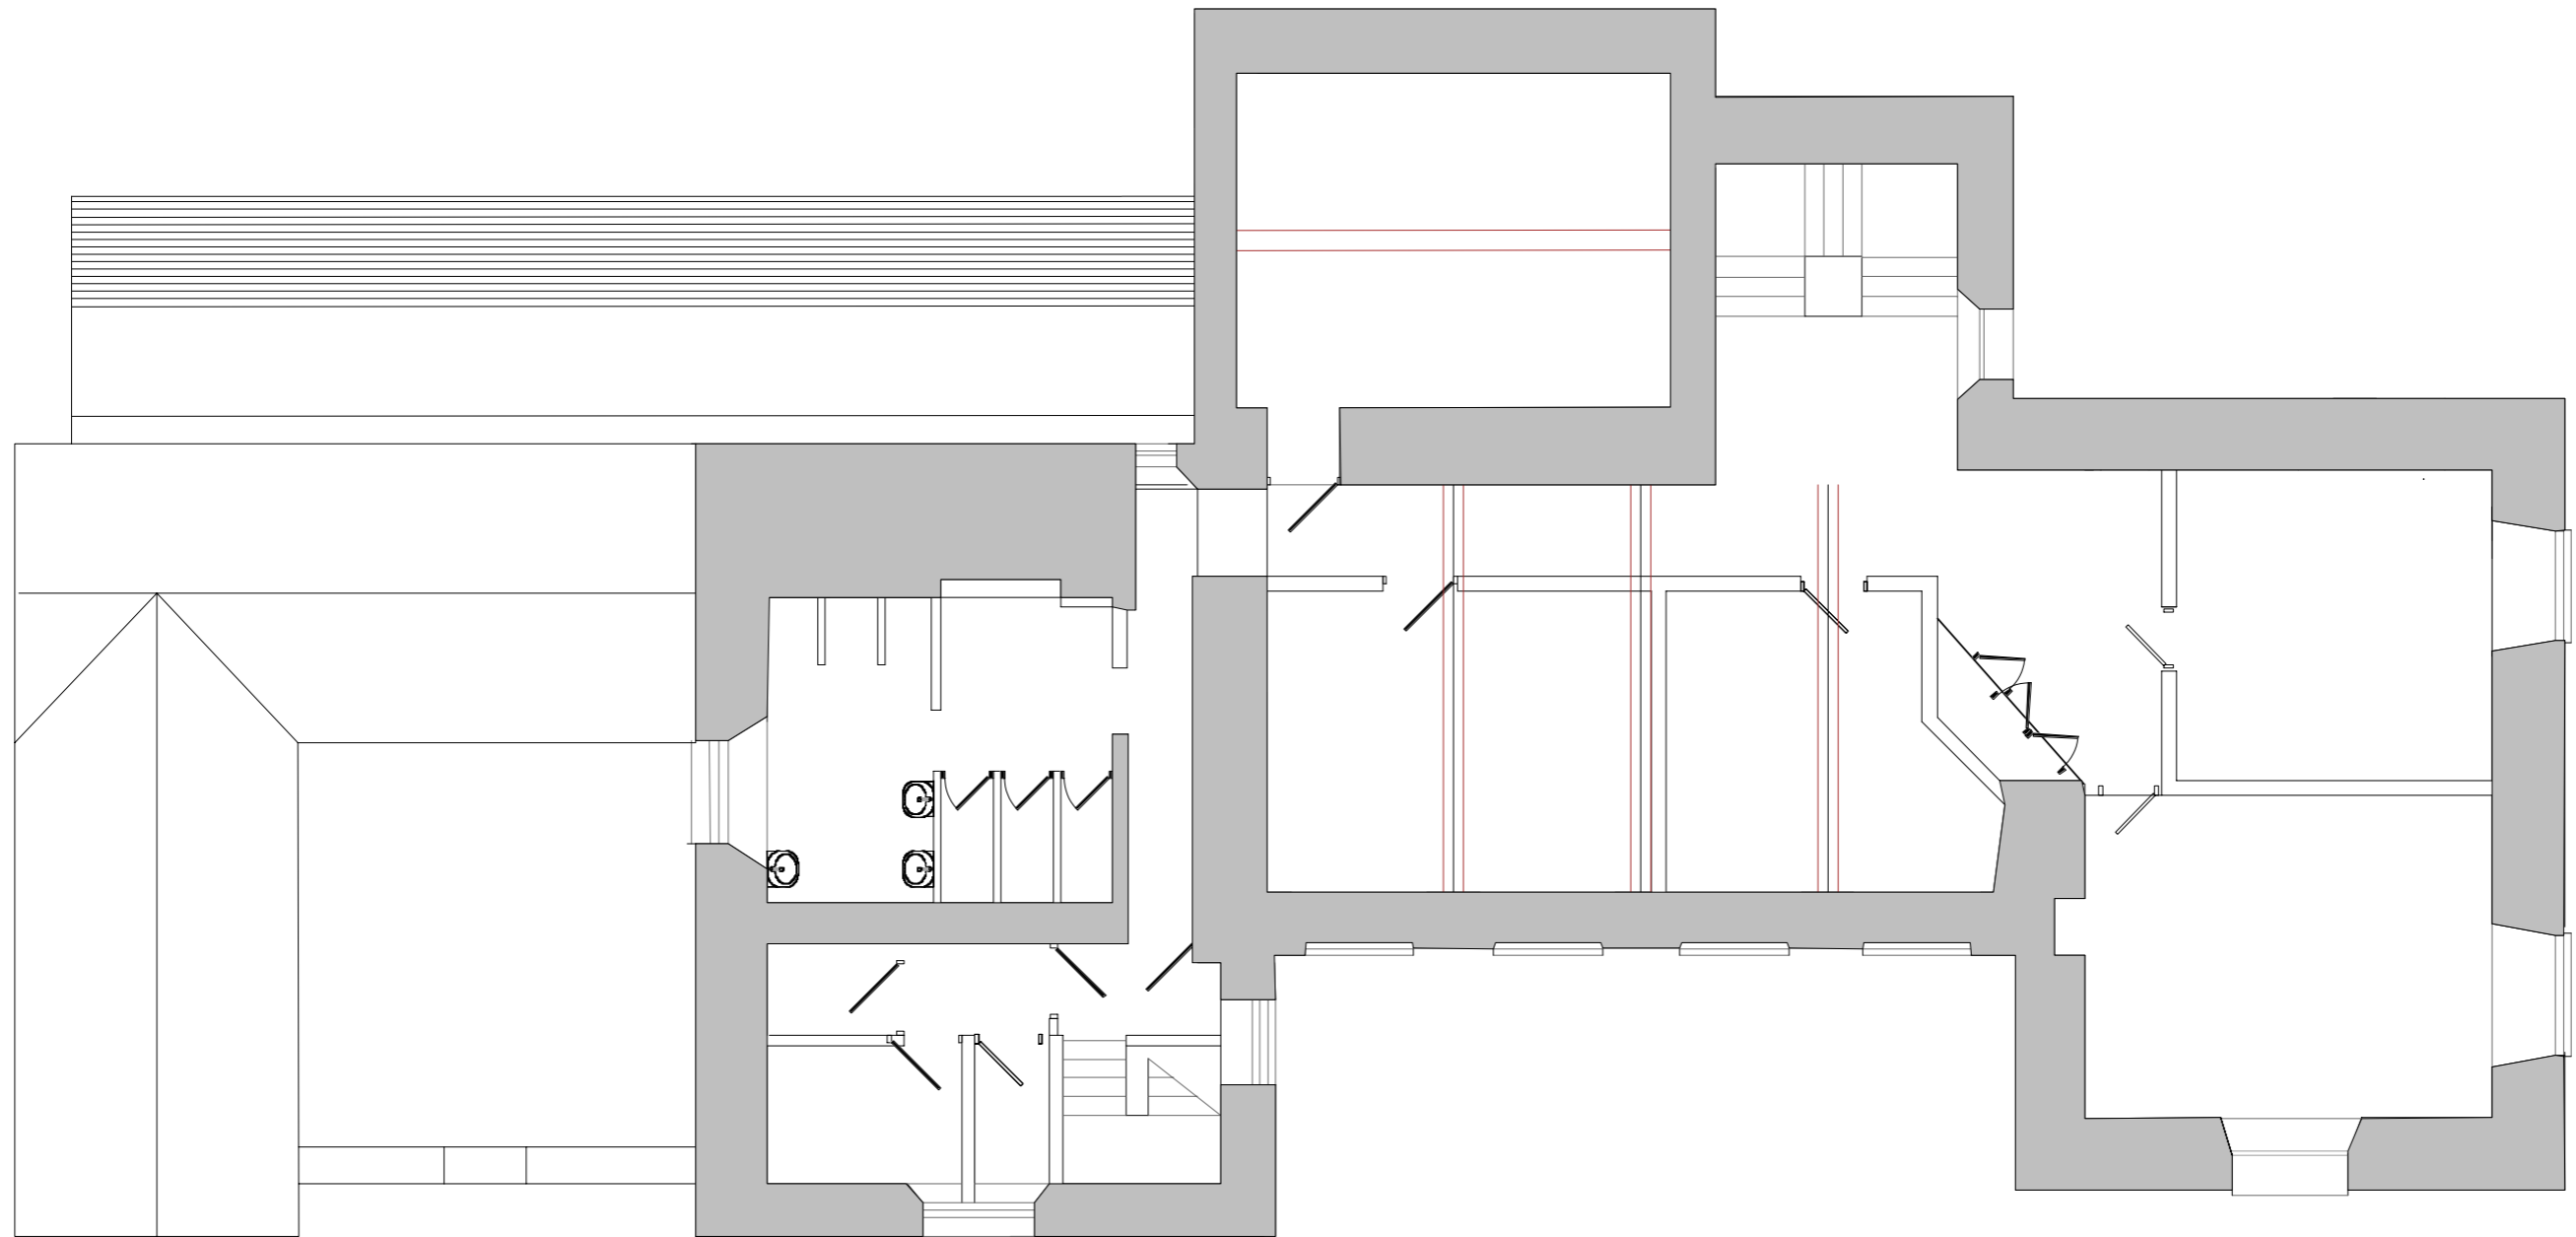
Figure 8: Second Floor Plan
Scale 1:100

The second floor (Figure 8) is effectively within the roof space of the house. The top of the stair tower (Plate 65) has a simple “A” form truss with slightly trenched purlins. Two windows light this space which are notable as being smaller than those in the rest of the building. The window in the eastern wall (Plate 66) is a two leafed casement window with each leaf holding six panes. The window in the northern (gable) has a single leafed casement window with nine panes which is set within a spayed opening (Plate 67).

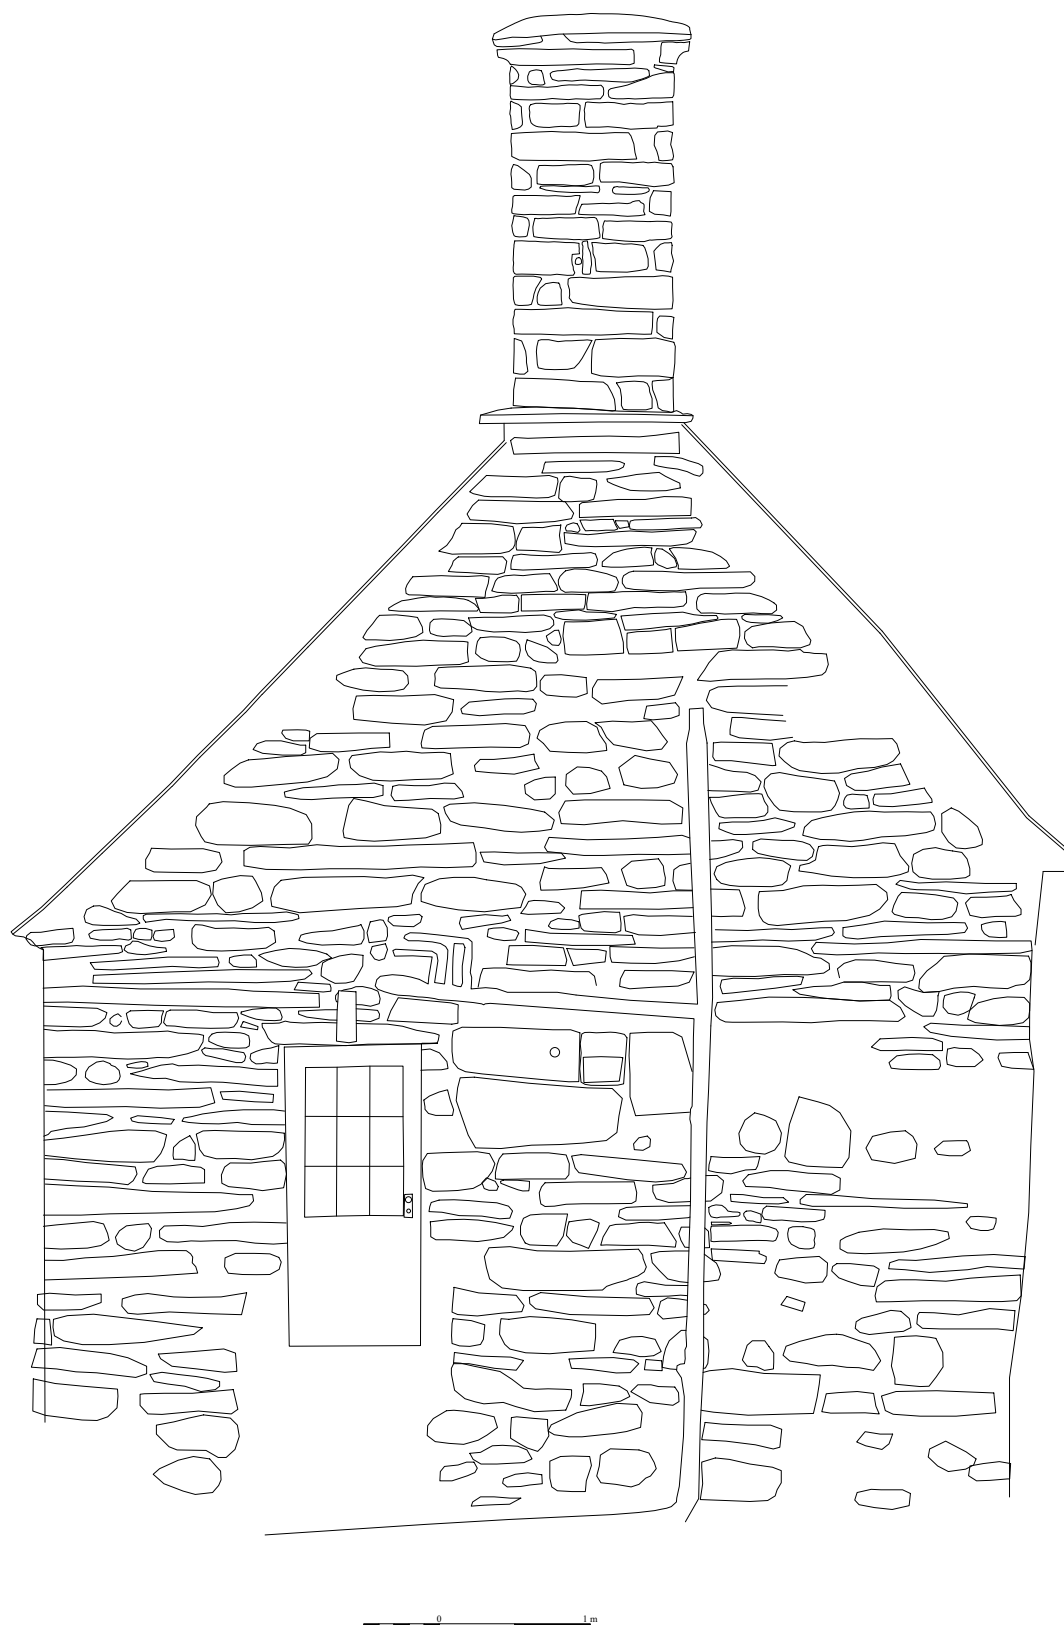
Figure 13: Northern Gable of the Eastern Range
Scale 1:50

Chimney 1 (Figures 13 - 15) was 2.69 m tall with a shaft 1.07 x 0.94 m in cross section. Below the flaunching was an oversailing stone slab (Figure 16) with a cavetto moulding. At the base of the shaft was a stone water tabling around the shaft. This had been partly replaced on the northern side by a slate slab without the tapered cross section of the stone tabling (Figure 17). Below this tabling the shaft becomes slightly wider (1.14 m) for a further 0.22 m before there is a second, stone water tabling slab. Whilst it is clear there had been some repairs to the upper stone tabling with the replacement of part of the tabling with a slate slab, it is likely that the shaft has been totally re-built at some point. This is suggested by the mismatch in the size of the shaft either side of the upper water tabling and the presence of a lower, less well-preserved set of water tabling.

It is clear that Chimney 1 (on the northern gable of the eastern range) has been repaired probably rebuilt at least once in its life. The slightly wider shaft below the upper water tabling suggests a slightly wider chimney at some place and the use of a slate slab to repair the water tabling suggests a nineteenth century repair. No similar phasing can be located for Chimney 2 (on the northern gable of the rear range), however the use of slate for the cap below the flaunching may suggest either repairs of a re-build having taken place in or after the nineteenth century.

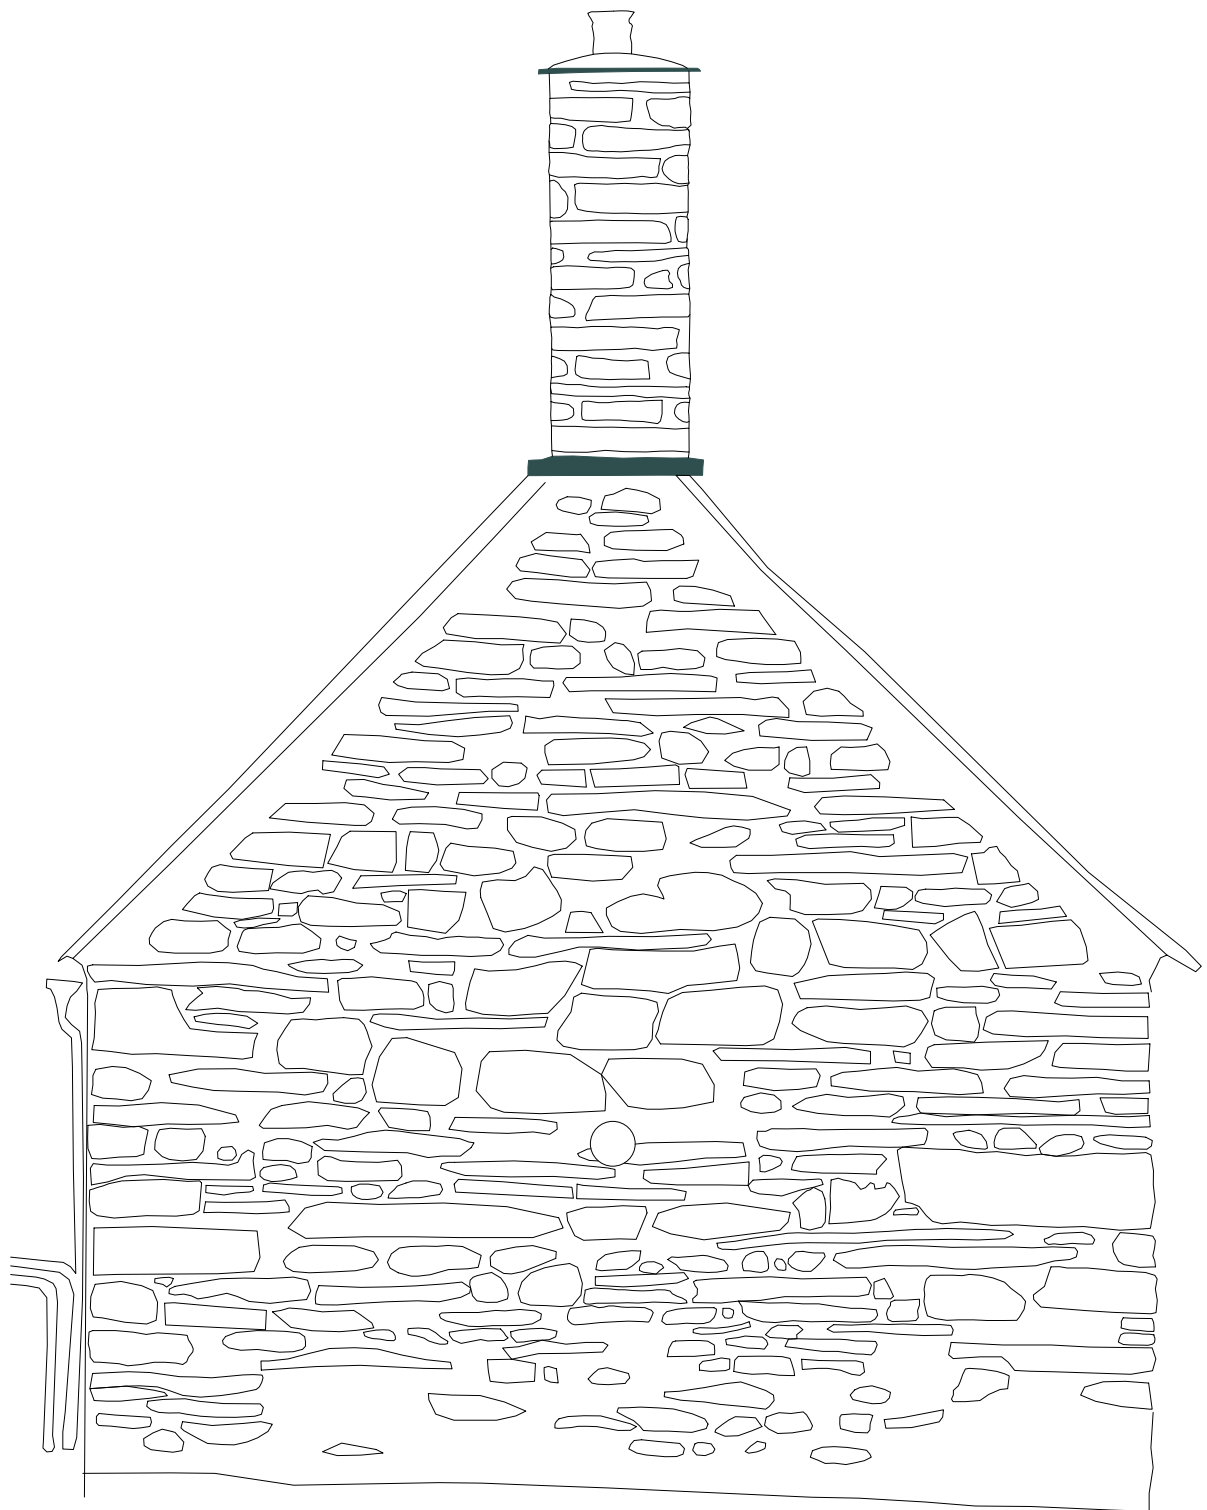
Figure 18: Northern Gable of the Rear Range
Scale 1:50

Chimney 2 was 2.63 m high with a shaft 0.90 m square in cross section (Figures 18 and 19). It had a slate cap below the flaunching and moulded, stone water tabling around three sides of the shaft. The fourth (southern face) of the shaft has lead flashing at a slightly higher level that serves as the water tabling on this side of the chimney.

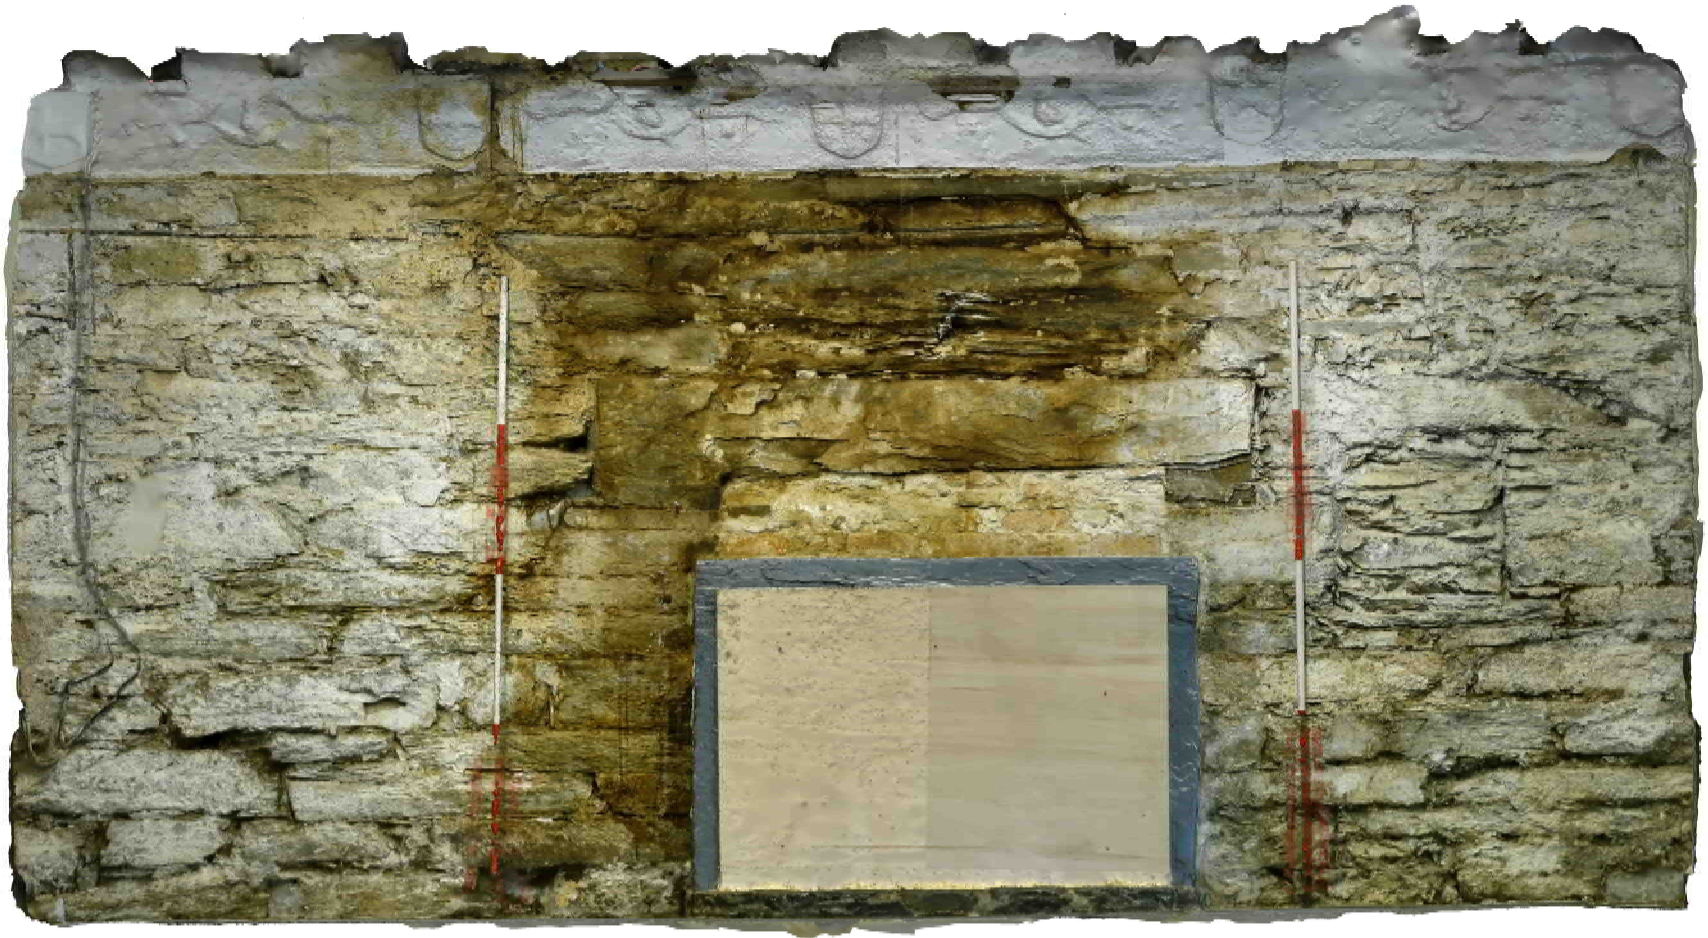
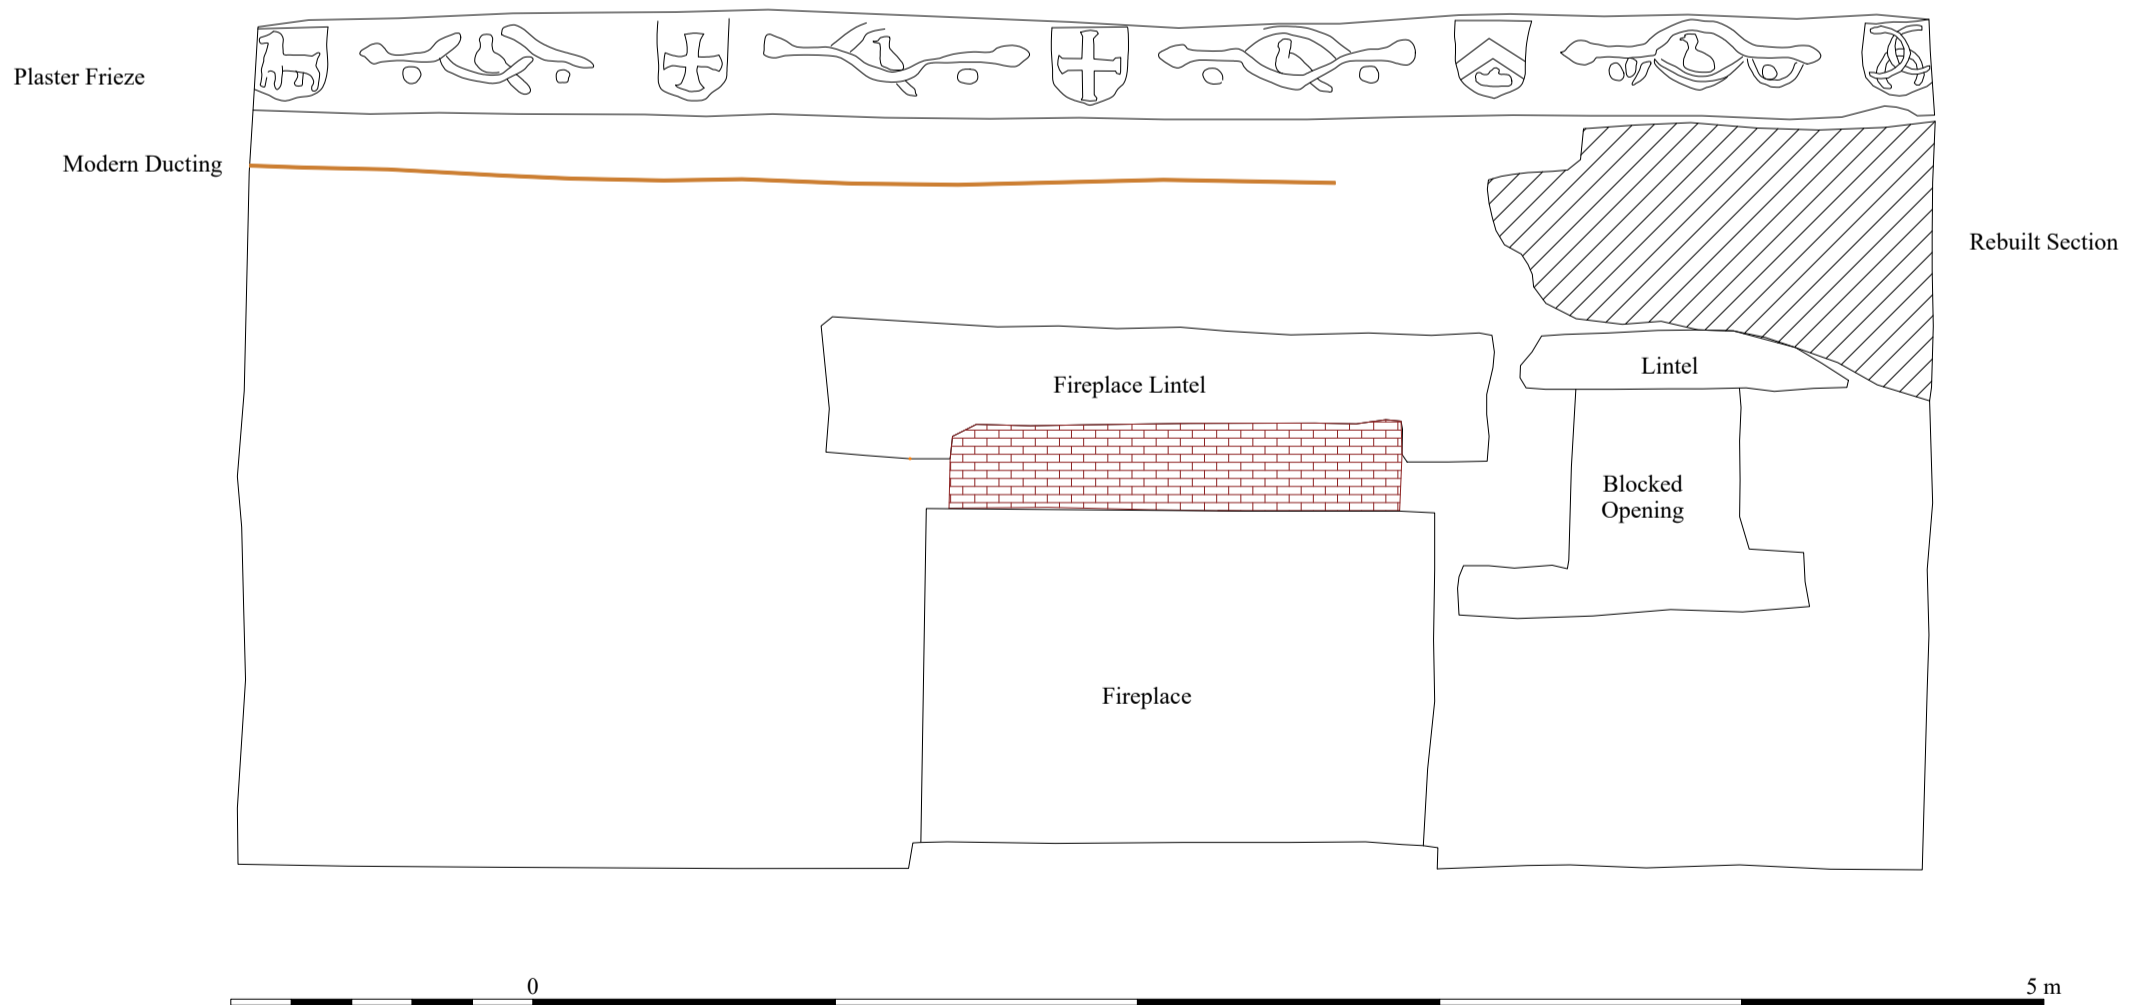
Figure 20: Northern Wall of the Parlour
Scale 1:25

Within the parlour, the removal of the plasterboard lining the northern wall (Figure 20, Plates 93 and 94) revealed a blocked opening to the east of the fireplace. This is 0.57 x 0.6 m in size below a large stone lintel. There is also a hint that there was a cill below the opening with a width of 1.13 m and height of 0.18 m. The function of this opening is uncertain, whilst it may

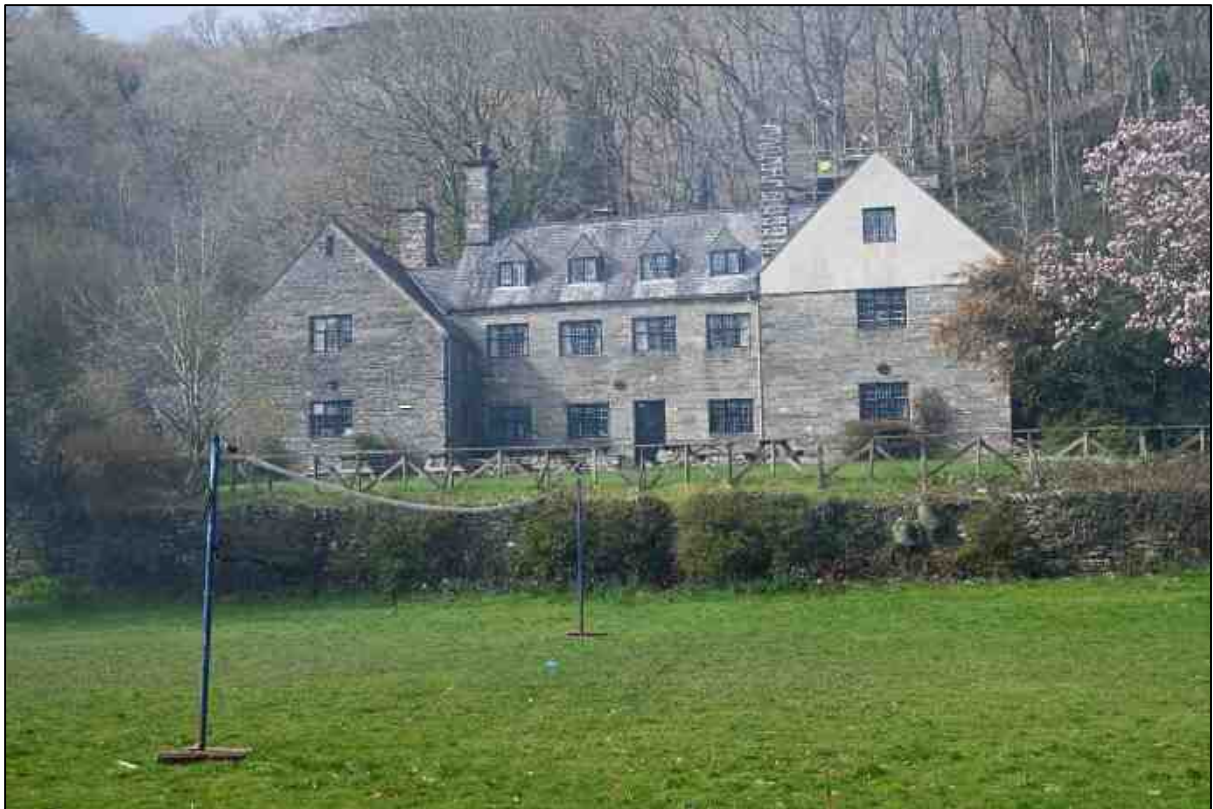
Plate 3: The front elevation

The front elevation of Plas Dol y Moch (Plate 3) can be divided into three with an eastern range, a slightly lower (later) western range and the core of the building. The main range and the eastern range are both of two and a half storeys, whilst the western range is of two storeys.

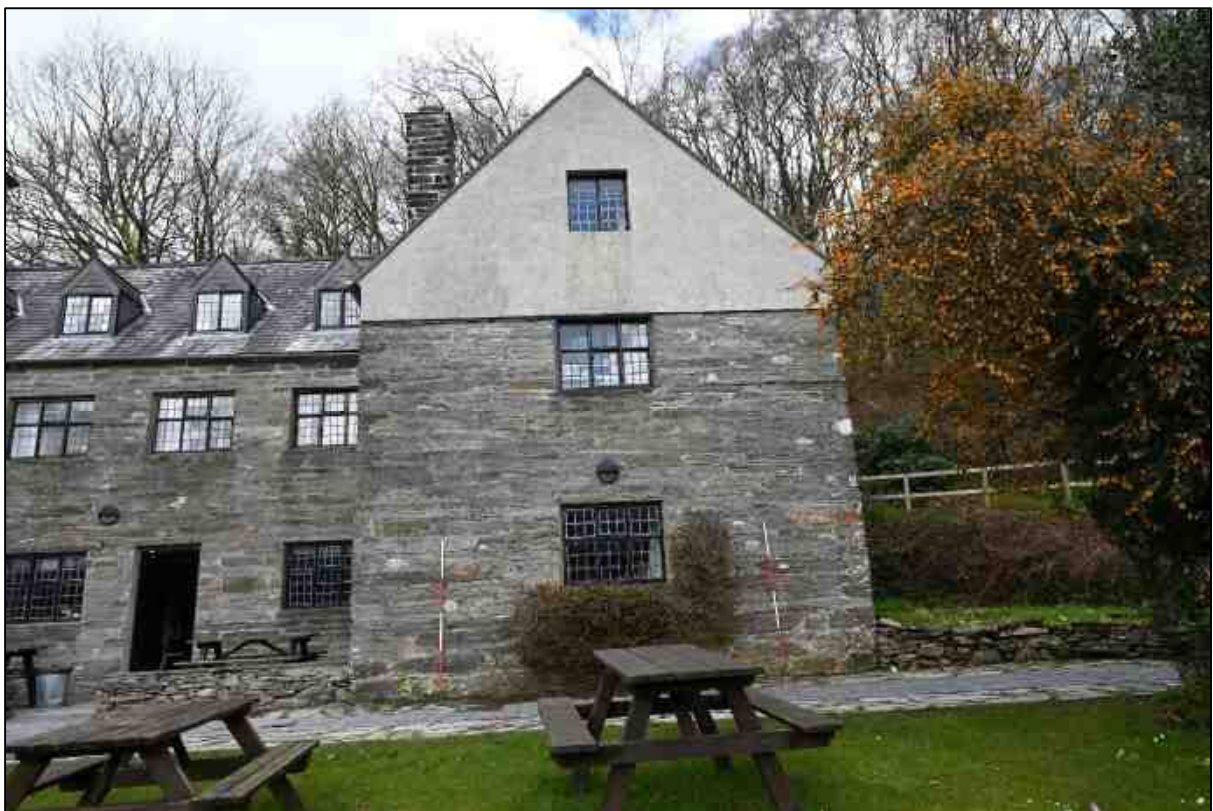
Plate 4: The southern gable of the eastern range

The eastern range (Plate 4) presents its gable to the front elevation. It has three centrally placed windows whose sizes reduce as they go up the building. The ground floor window occupies the space of a blocked doorway shown on the engraving of 1882 (Figure 3.1) and the undated painting in the National Library (Figure 3.2). These two images also show that the attic windows, in both the main and eastern ranges are later additions. The top sector of the eastern range gable is rendered, whilst the rest of the building has exposed stonework. Near to the northern edge of this elevation is a scratched date of 1643 (Plate 5). This date has been taken to date the construction of the eastern range (Haslam *et al* 2009, 675), although this is an assumption which cannot be confirmed. The western face of the eastern range (Plate 6) has a blocked first-floor window (Plate 7). This window does not appear on the 1882 engraving (Figure 3.1) and the blocking may pre-date this image.

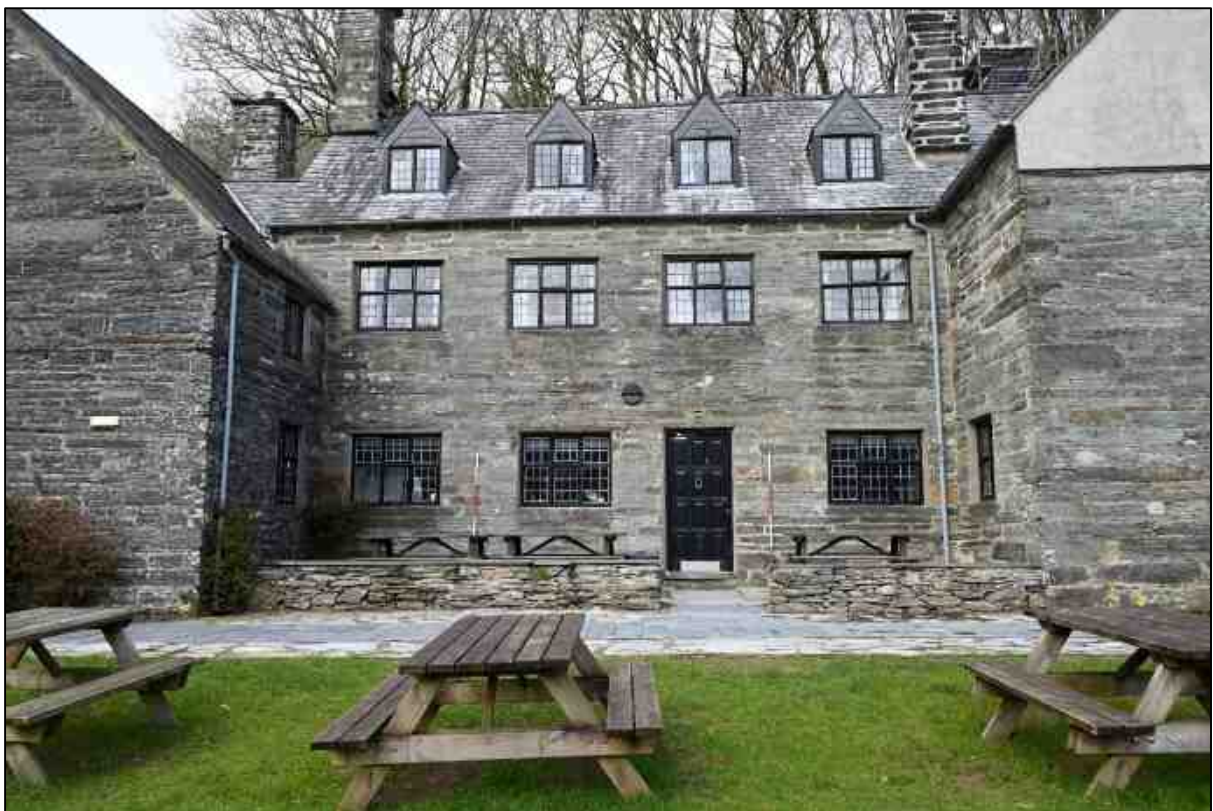
Plate 8: Front elevation of the central range

The central range has three, ground floor windows and a doorway that is set, off centre, to the east. Above, on the first floor, there are four windows and in the attic space four dormers wholly within the roof space (Plate 8). The front door (Plate 9) is a panelled door with a drop

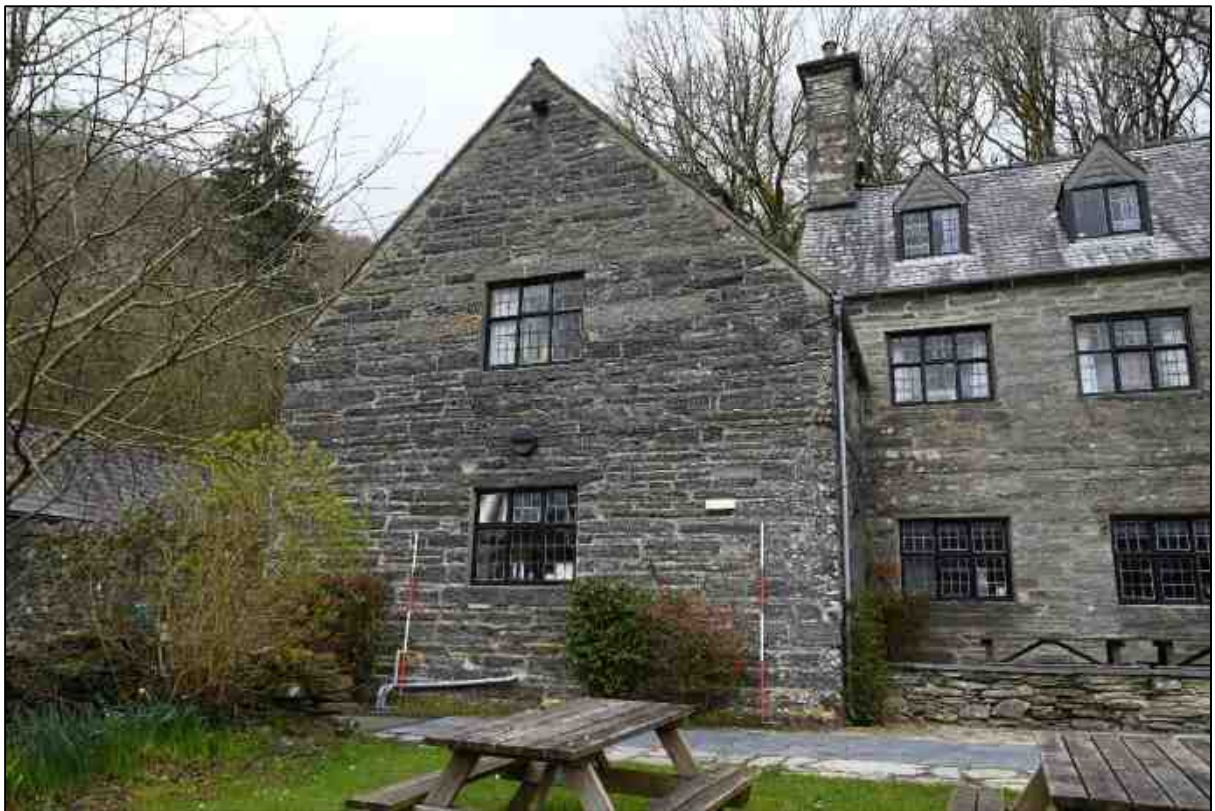
Plate 14: Gable end of the western range

The western range is clearly of a different build using smaller, darker stones (Plates 12-15) which have been extracted using explosives (Plate 13). It is likely that the source of this rock was one of the local slate quarries, using the county rock. This is unlike the earlier ranges which probably used immediately local sources, probably behind the house. The east facing elevation (Plate 12) has two windows, one above the other. The lower window is a multi-paned casement window in four main sections, whilst the first-floor window is somewhat shorter with two sections. These windows are similar in design to those in the rest of the house, possibly suggesting the whole of the building was defenestrated, possibly at the same time the dormers were added to the attic level. The gable end has two six-unit, casement windows set one above the other in the middle of the elevation.
