**Plas Dol-y-Moch, Maentwrog, LL41 3YT,
Standing Building Record**

EAS Client Report 20243/09

Recording of the Chimneys and the Northern Gable of the Eastern Range

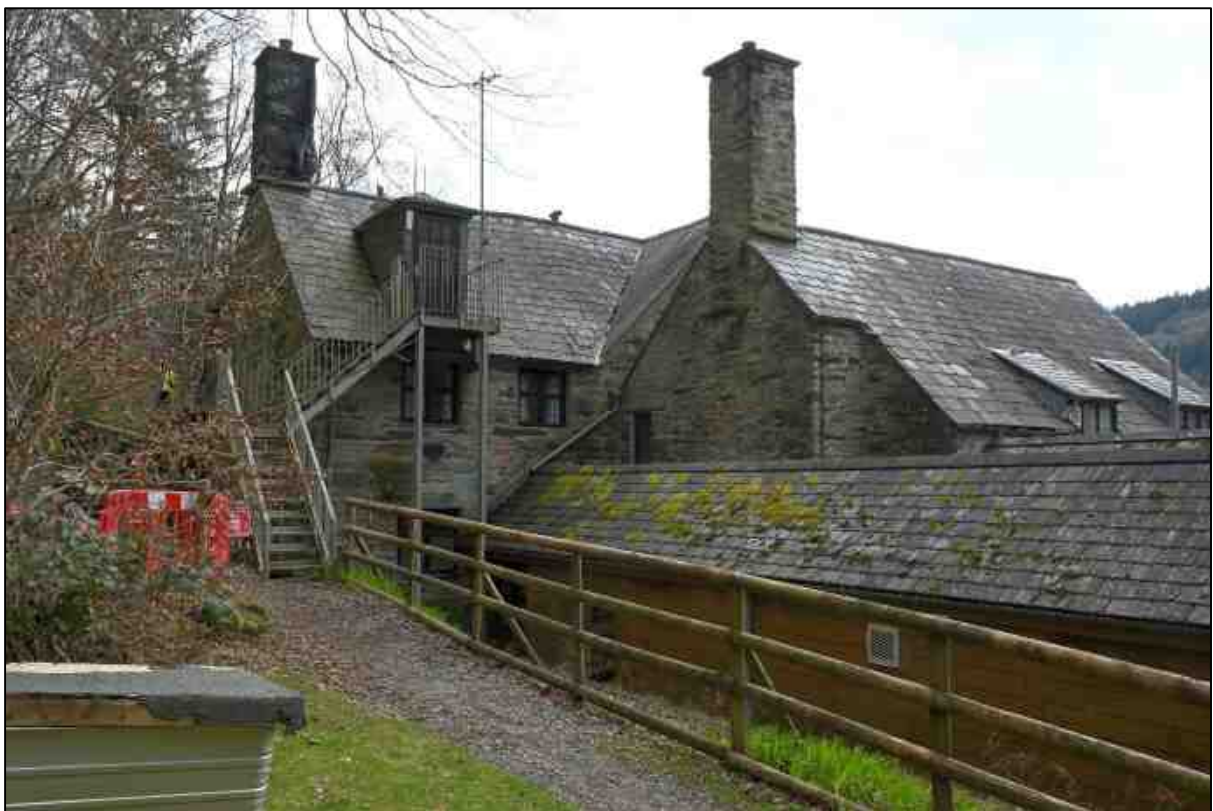
Plate 16: Northern end of the western range

The rear of the building presents as a series of four gable ends (Plates 16 – 20). To the west is the northern end of the twentieth century extension (Plate 16) with a tall, chimney in the gable wall with moulded stone cap with flaunching over. There is also tabling to the east and west of the stack.

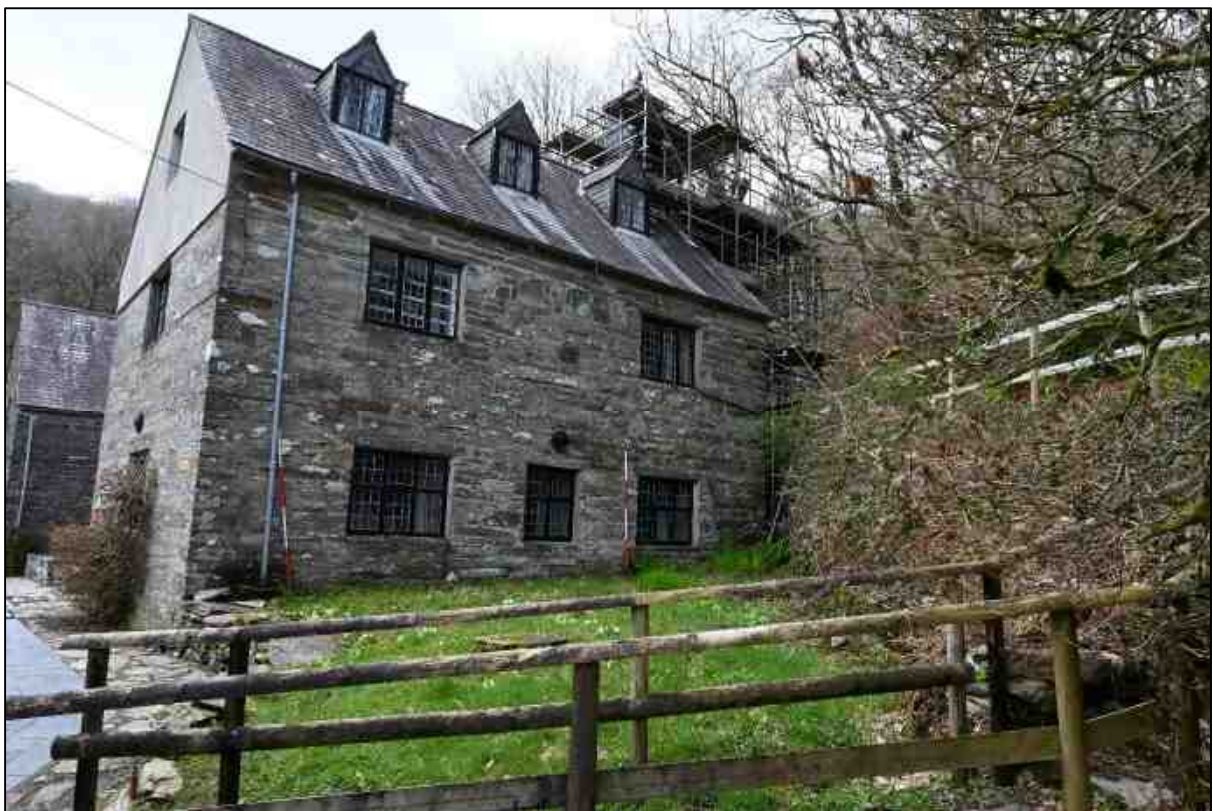
Plate 22 The eastern face of the eastern range

The eastern elevation of the eastern range (Plate 22) has three, windows on the ground floor, two larger windows to the north and south with a smaller window between. The northern and southern windows are multi paned casement windows divided into six leaves. These are three, lower nine-paned windows below and three, six-paned windows above, the central one of which acts as a fan light. The central window has four leaves, with two, lower, nine-paned

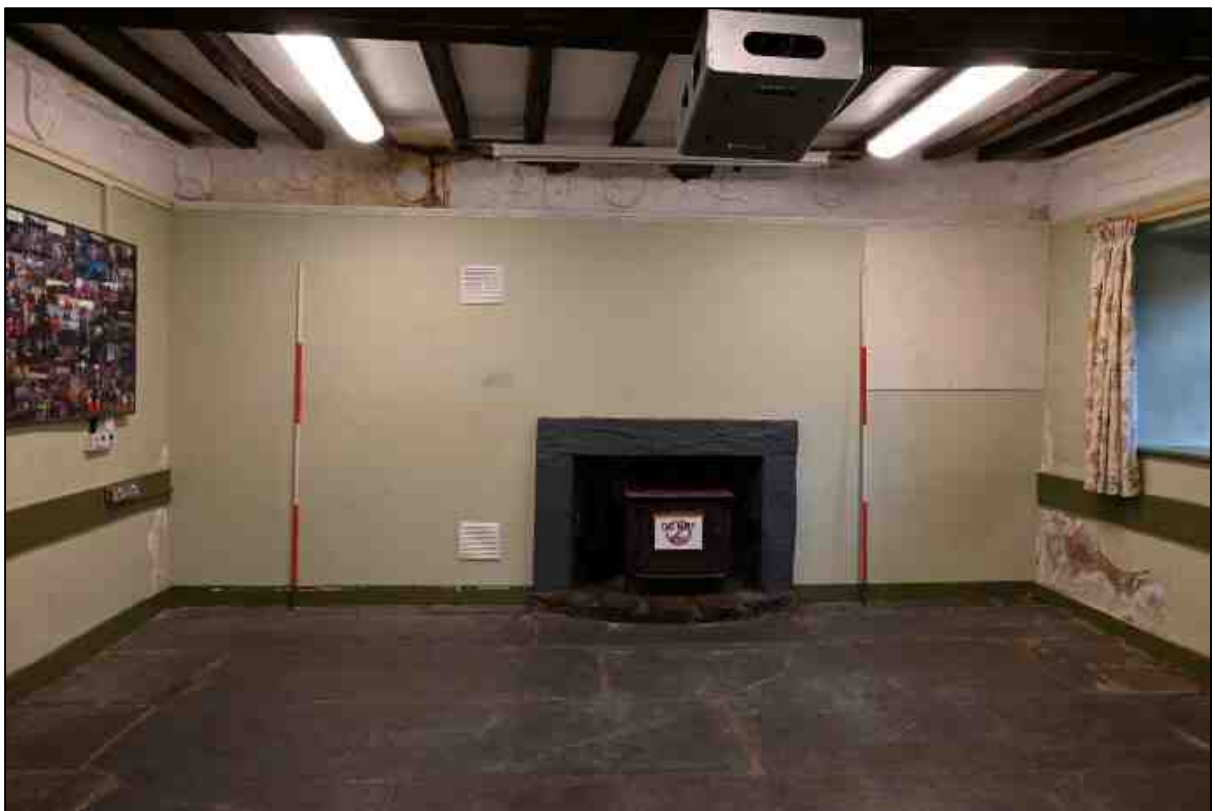
Plate 28: The Parlour, looking north

The parlour occupies the eastern range of the building (Plates 28 and 29). It has a fireplace in its northern wall (Plate 28) and a timbered ceiling with two beams supporting the joists. The beams are moderately chamfered and have either diagonal cut stops or run-out stops (Plates 30 and 31). The most impressive feature of the room, however is the frieze that runs around the room at ceiling level (Plate 33 – 37). This feature is heavily painted, obscuring many of the details, however, in one place the paint has flaked off (Plate 32) revealing that this is carved stone frieze. An engraving published in 1882 (William 1882, 209, 210) gives a better impression of the frieze before it was covered in white paint (Figure 10). The frieze is usually described as depicting the armorials of the Fifteen Tribes of North Wales (Haslam *et al* 2009, 675, Hemp, 1948-9, 300). Eight of the shields survive and seven of these appear to represent some of the Fifteen Tribes (Plate 37). Hedd Molwynog of Uwch-Aled, Braint Hir of Is-dulas, Ednowain Bendew, Ednowain Ap Bradwen, Gweirydd Ap Rhys Goch and Efnnydd are represented, however the remaining shield is nearest to that of Cilmin Troed-Du, but does not match the details shown by Pennant (1883 428 – 453). Between the shields is a repeated device of birds perching on swags which are attached to strapwork (Plate 38).

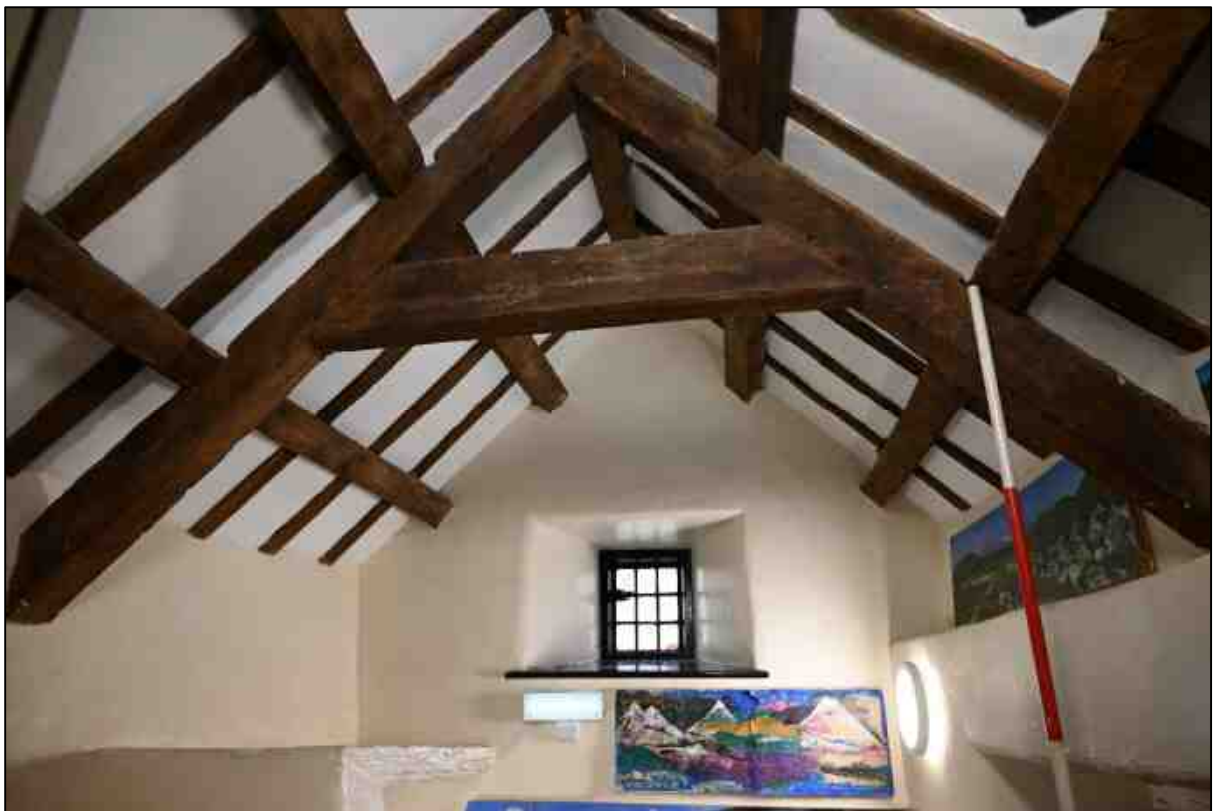
Plate 65: Truss over the stair turret

The second floor (Figure 8) is effectively within the roof space of the house. The top of the stair tower (Plate 65) has a simple “A” form truss with slightly trenched purlins. Two windows light this space which are notable as being smaller than those in the rest of the building. The window in the eastern wall (Plate 66) is a two leafed casement window with each leaf holding six panes. The window in the northern (gable) has a single leafed casement window with nine panes which is set within a spayed opening (Plate 67).

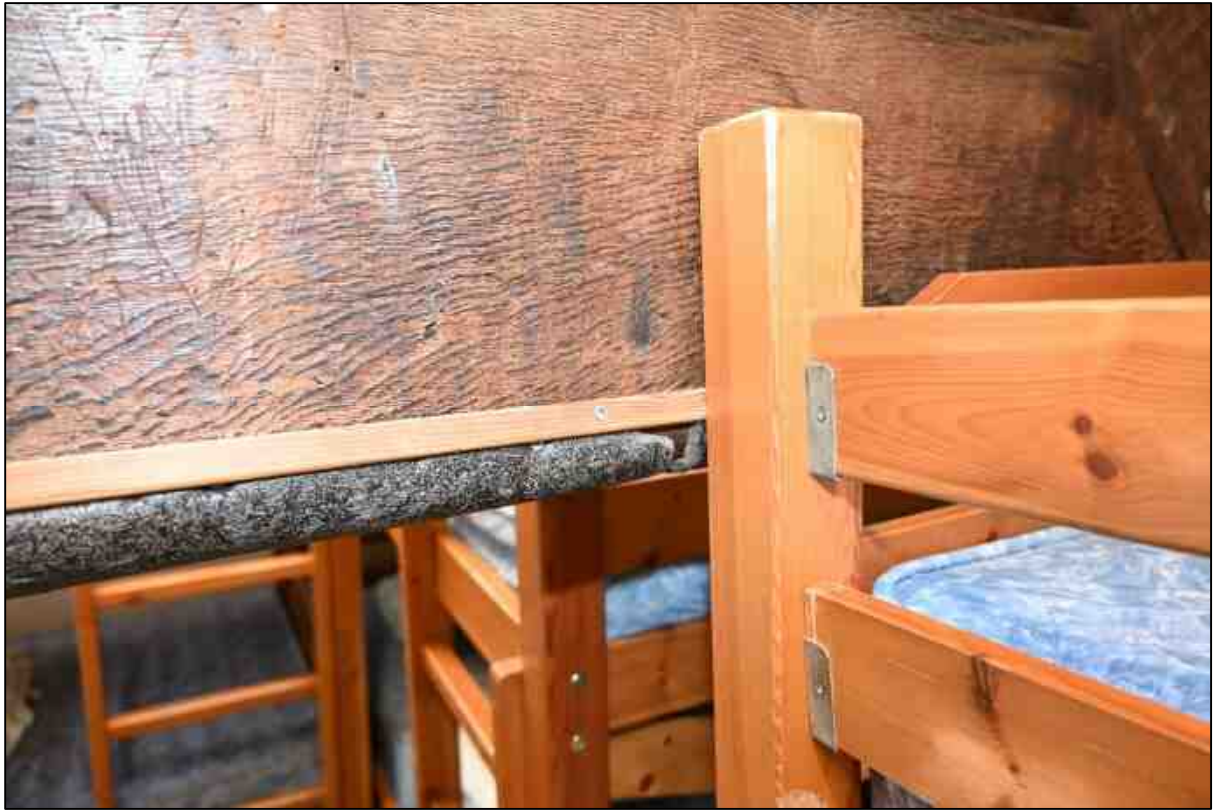
Plate 86: Apotropaic Mark on the collar of the truss of the rear bedroom

The best exposed truss is that in the western range, dividing the bedroom called “Moelwyn”. As previously stated, this is a truss with a collar which has splayed struts above. It has partly trenched purlins and carpenter’s marks on the joints between the struts and the principal rafters (Plates 87 and 88). On the collar there is also a “taper mark”, a small area of deliberate burning (Plate 86). This is thought to be an apotropaic mark, made deliberately and may well have been made whilst the building was under construction. The interpretation is to see them as a ritual protection against lightening and fire (<https://historicengland.org.uk/whats-new/features/discovering-witches-marks/types-of-marks/>).

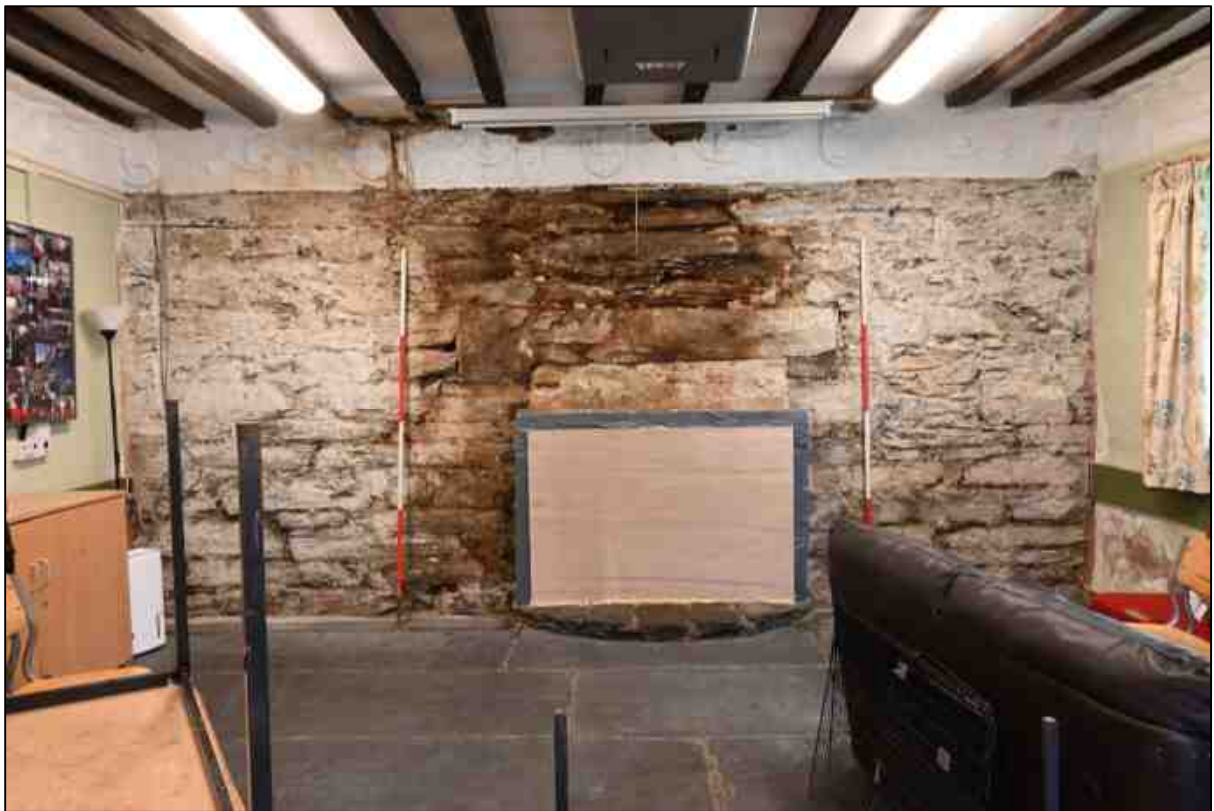
Plate 93: Parlour wall after the removal of the plasterboard sheets

Within the parlour, the removal of the plasterboard lining the northern wall (Figure 20, Plates 93 and 94) revealed a blocked opening to the east of the fireplace. This is 0.57 x 0.6 m in size below a large stone lintel. There is also a hint that there was a cill below the opening with a width of 1.13 m and height of 0.18 m. The function of this opening is uncertain, whilst it may
