**Conwy Vicarage Garden
Archaeological Watching Brief**

**Commissioned by
Donald Insall Architects
for
The Church in Wales
Analysis by
I.P. Brooks
Engineering Archaeological Services Ltd**

EAS Client Report 2024/11

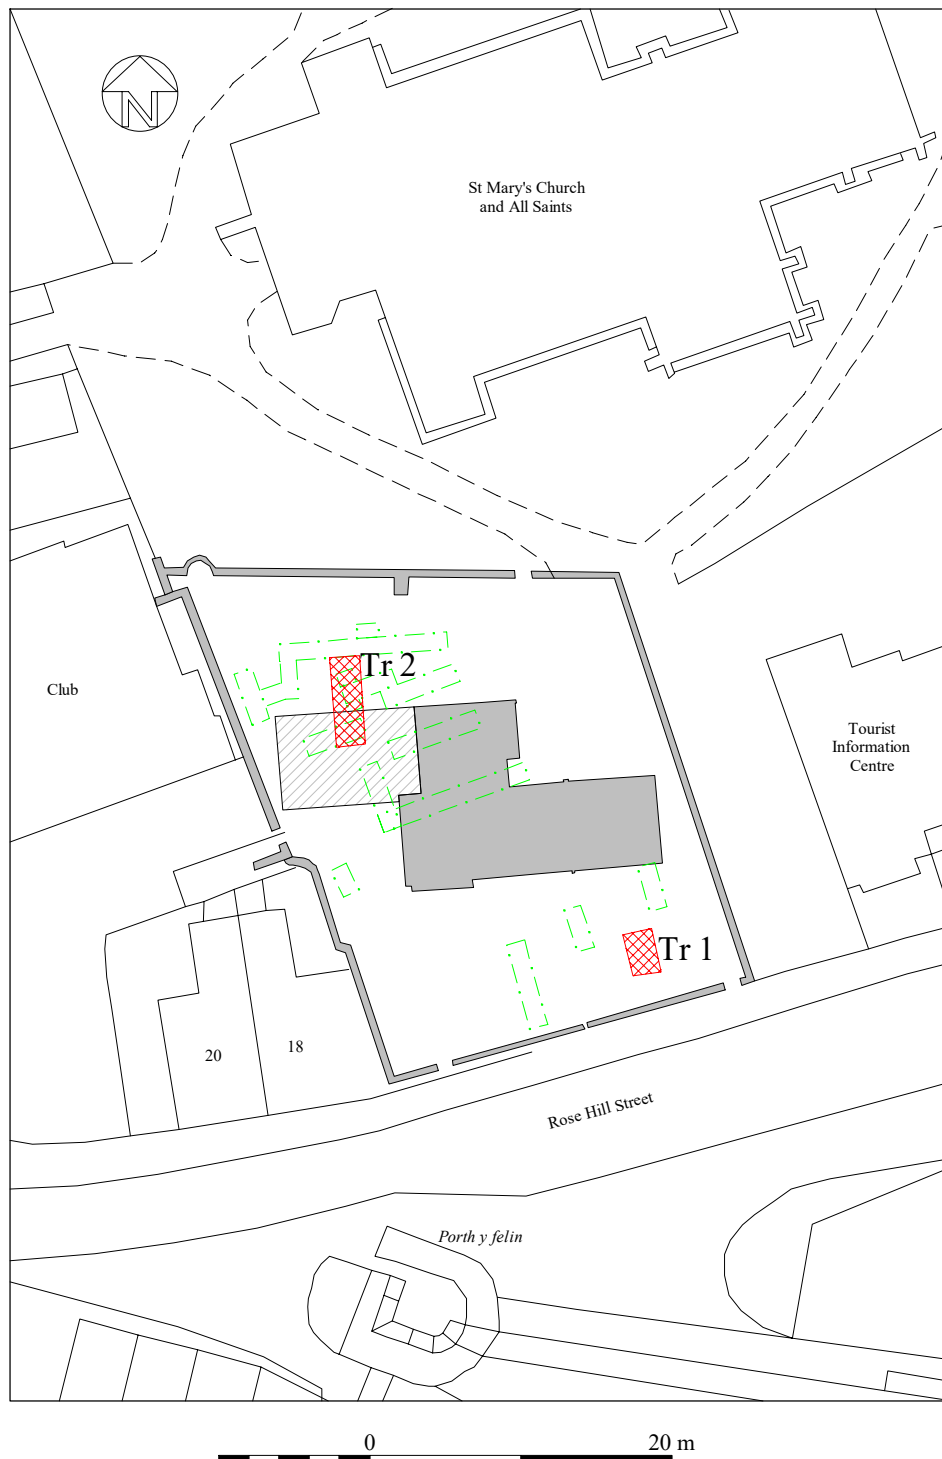
Figure 4: Location of the Trenches excavated in 2018
Scale 1:500
Approximate position of Butler's Trenches shown in green

Two trenches were excavated (Figure 4), the trench to the south of the vicarage had little archaeology apart from modern garden soils and what was thought to be a water pipe feeding the vicarage. The second trench was located to the north and west of the vicarage and was designed to sample two of the trenches from Butler's excavation in 1961 as well as investigate the stratigraphy in this part of the garden. Trench 2 had at least 1.75 m of stratigraphy in places with the top 0.85 m consisting of interleaved layers of soils and spreads of stone blocks. A series of probable post-medieval pits were located along the eastern side of the trench which were generally filled with loose stone fills. In the base of the trench a complex of masonry and packed clay deposits were located which can be related to Butler's Wall 22 (Butler 1964, Fig. 3).

This was thought to be a major boundary at least 2.7 m wide. South of this feature was a quarry ditch, the top fill of which was dated suggesting twelfth, or early thirteenth, century date for the quarry and associated wall complex. This would indicate that these features are pre-Edwardian in date and possibly pre-date the construction of the Aberconwy Abbey about AD 1192.

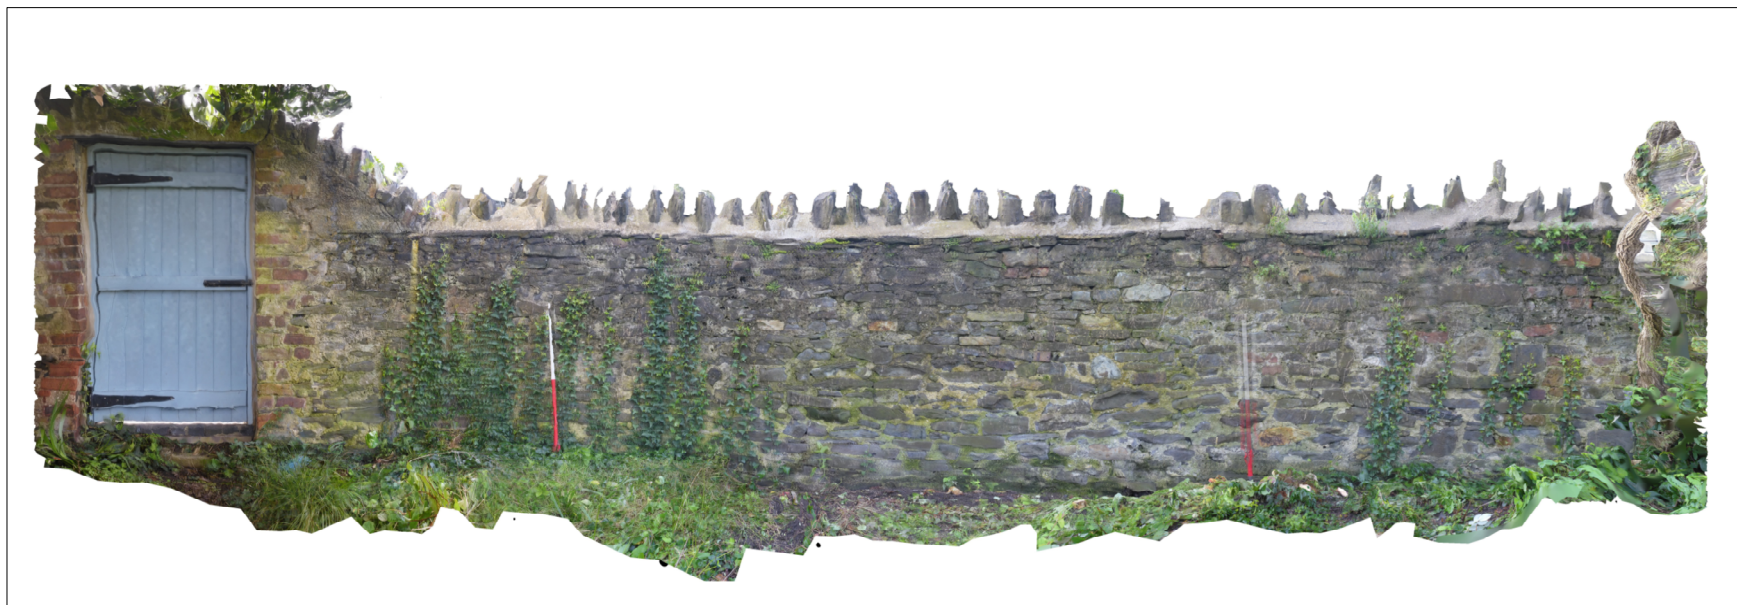
Figure 6: Photogrammetric Image of the Garden Wall before Demolition
Scale 1:50

Part of the wall between the garden and Rose Hill Street (Figure 6, Plate 1) was demolished, by hand. This had outer skins of stone blocks with the core being a mix of smaller angular stone fragments and mortar. In some places, particularly towards the base of the wall there were voids within the wall core.

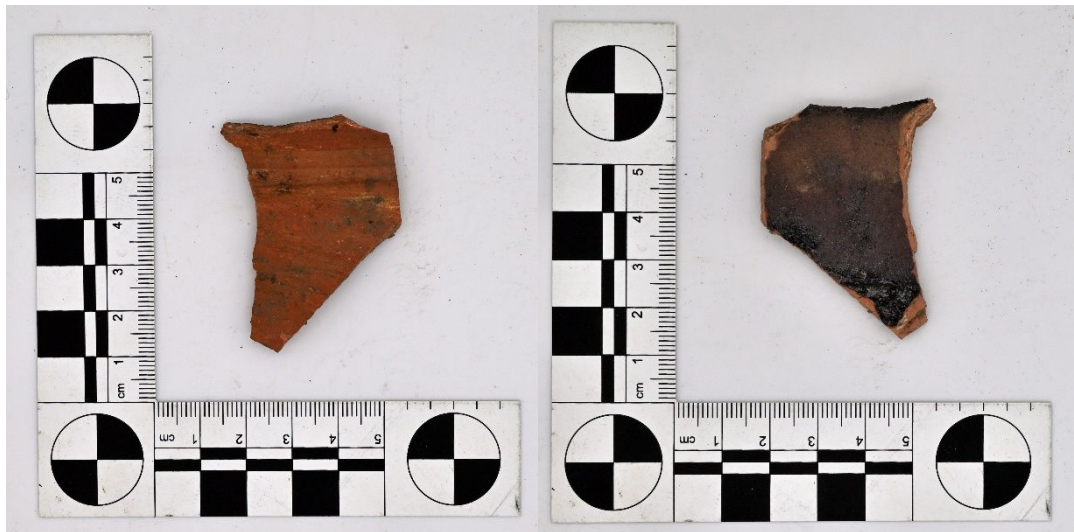
Plate 6: Pottery Sherd from Context 3

A single sherd of pottery was found in Context 3 (Plate 6). It is a fragment of the neck of a vessel with an applied strip with a triangular profile on the outer surface. On the inner surface there is the remains of a greyish black (5 YR 2/1). It is likely to be of late medieval or early post medieval date (M. Jones *pers. comm.*)

Whilst no dating evidence was gained for Context 5, Context 2 was cut by a small, shallow feature (Context 4, filled with Context 3) which contained a single sherd of pottery which has been dated as Late Medieval or early Post Medieval date.
