**New Shop at Twrcyhelyn Arms, Twr Cuhelyn Street,
Llanerchymedd, Ynys Môn**

Archaeological watching Brief

EAS Client report 2025/05

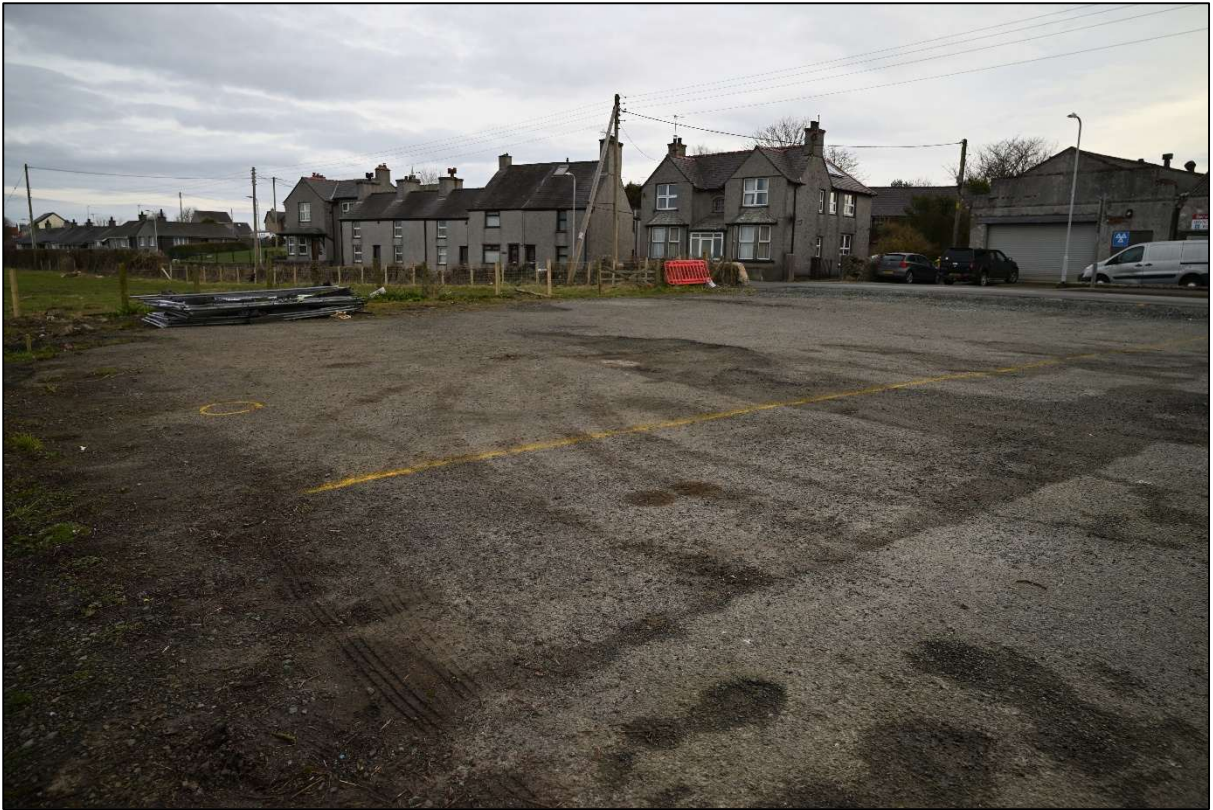
Plate 1: Development area, before the groundworks, looking NE

The new shop is being constructed in the northern end of what was the carpark of the Twrcyhelyn Arms public house, Twr Cuhelyn Street, Llanerchymedd, Ynys Môn. Prior to the construction the carpark was covered in a patchy layer of tarmac and was bounded to the north and west by an open, pasture field (Plates 1 - 3), to the east by Twr Cuhelyn Street and to the south by the Twrcyhelyn Arms public house.

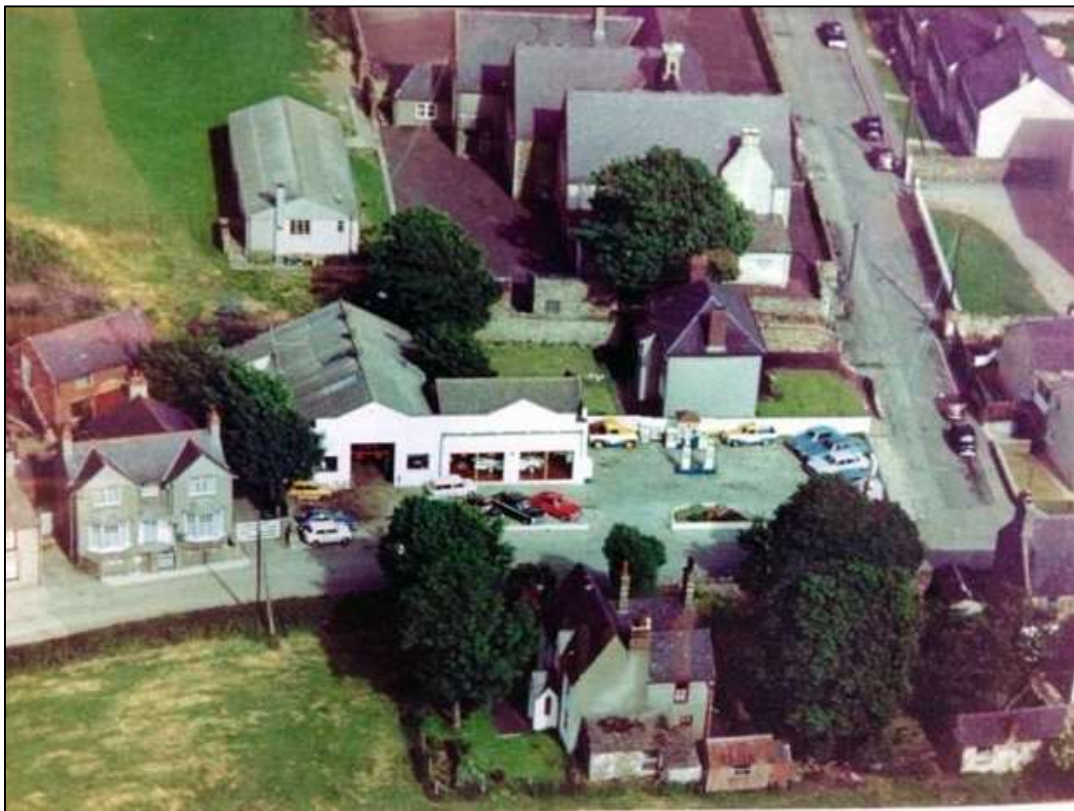
Plate 4: Photograph of Bryncuhelyn before its demolition (image supplied by R. Williams)

Until the late 1970's or early 1980's the site was occupied by a house Bryncuhelyn. A photograph taken before it was demolished (Plate 4) showed the house to have had a main range running at right angles to the road and two ranges at right angles to the south. There were, also lean too extensions to the west and a series of out buildings in the garden. The historic Ordnance Survey mapping shows that Bryncuhelyn was built before 1887 as it appears on the First Edition Anglesey Sheet VII.SW published in 1888, but surveyed a year earlier (Figure 2). The building is still standing in 1973 as it appears on the Ordnance Survey SH 4084 - SH 4184 map (Figure 3) published in that year, but revised in 1972.

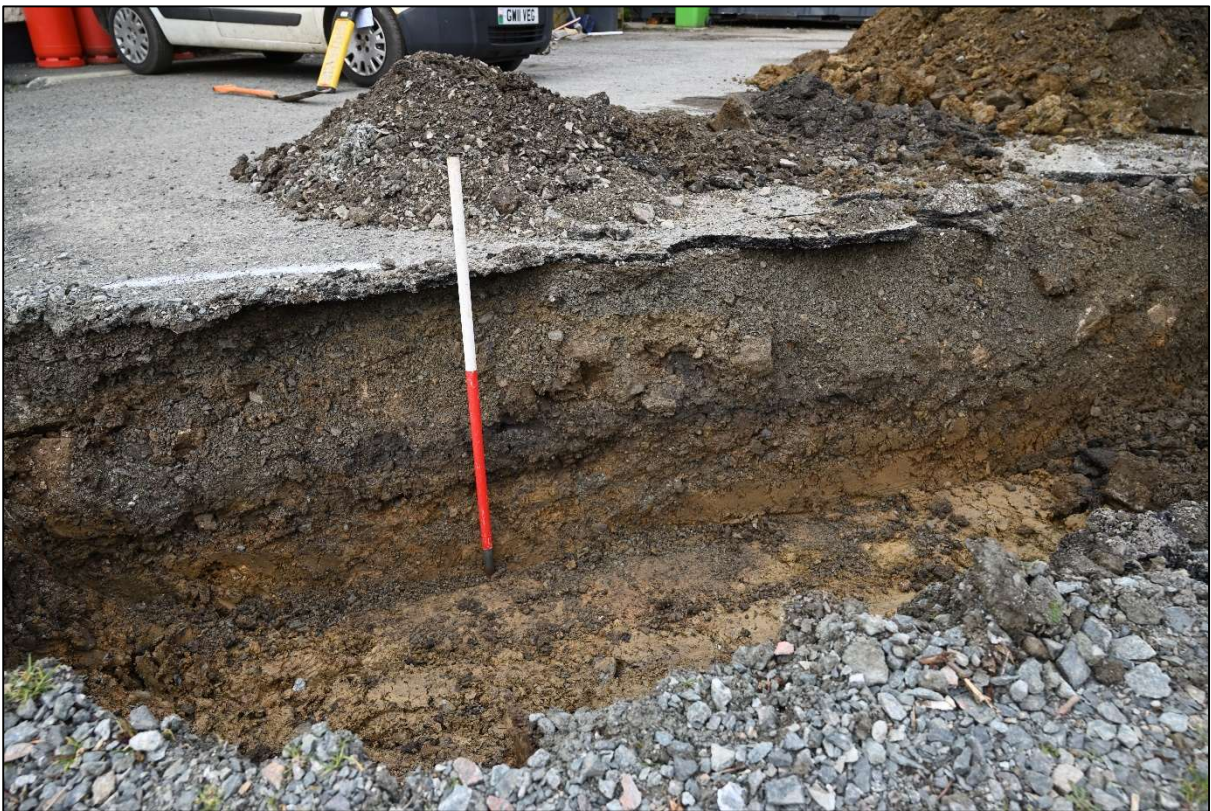
Plate 6: Section through Contexts 1 and 2

Prior to levelling the site, the development area was covered with a layer of tarmac (Context 1) which was up to 30 mm thick and had between 150 and 200 mm of yellow and grey gravel as a sub-base layer. This covered a thick layer of building debris (Context 2, Plates 5 and 6) resulting from the demolition of the Bryncuhelyn. Context 2 was up to 300 mm thick and extended over the whole of the area of the new shop. There was no sign of a soil layer below Context 2 suggesting the site may have been stripped before the house was demolished.

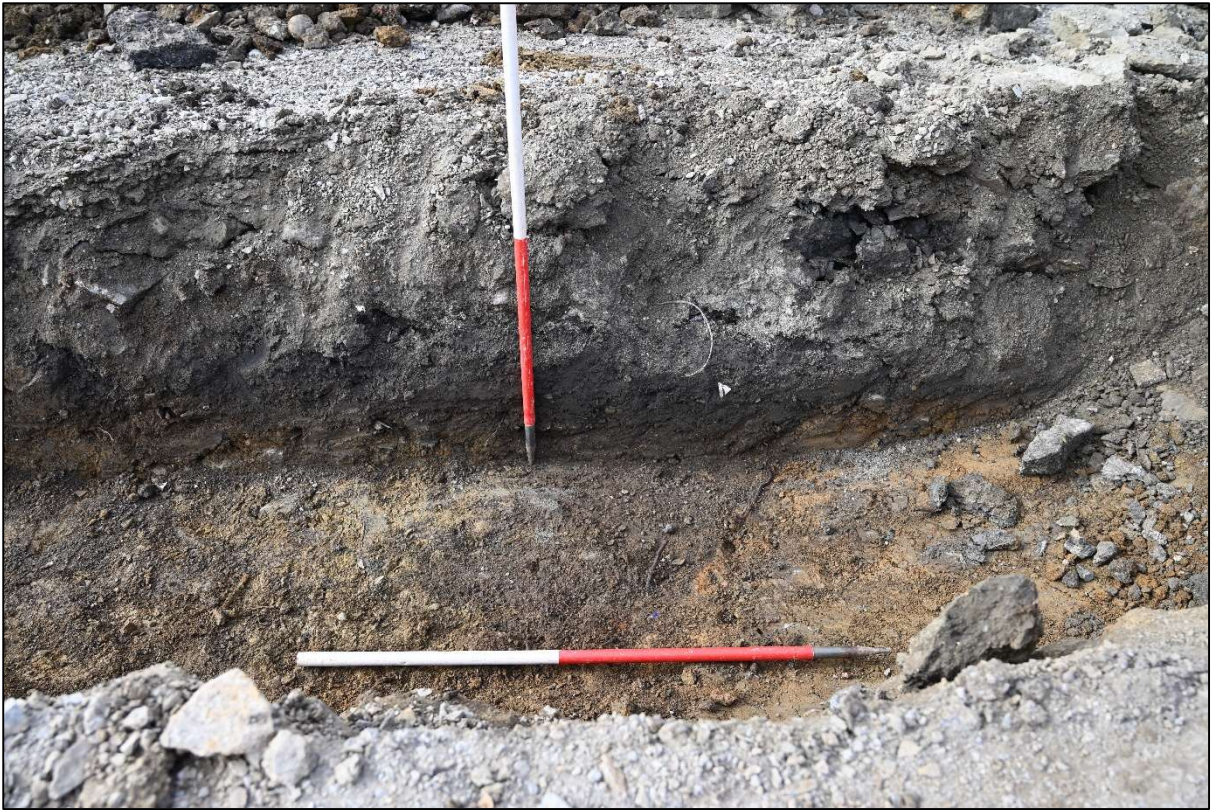
Plate 7: Feature, Context 3

Context 2 sealed a range of features and deposits which are assumed to related to the house which previously occupied the site. In the northern foundation trench a single feature was recorded (Context 3, Plate 7, Figure 5) which had two fills. The upper fill (Context 4) was a very dark clay which contained fragments of both charcoal and coal, whilst the lower fill (Context 5) was slightly paler in colour, but also contained fragments of coal, together with the occasional sherd of 19th century pottery and glass. This layer was also disturbed with tree root. It is probable that this feature marks the location of one of the trees which occupied the northern side of the house.

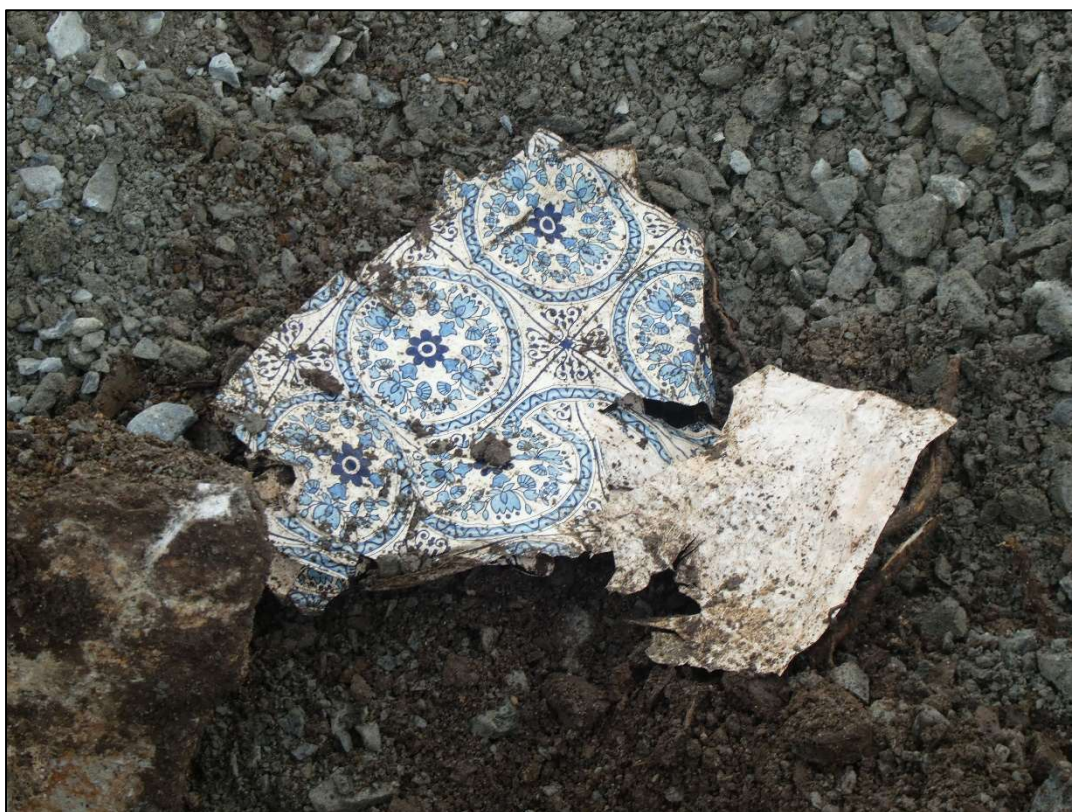
Plate 9: Wall paper within Context 6

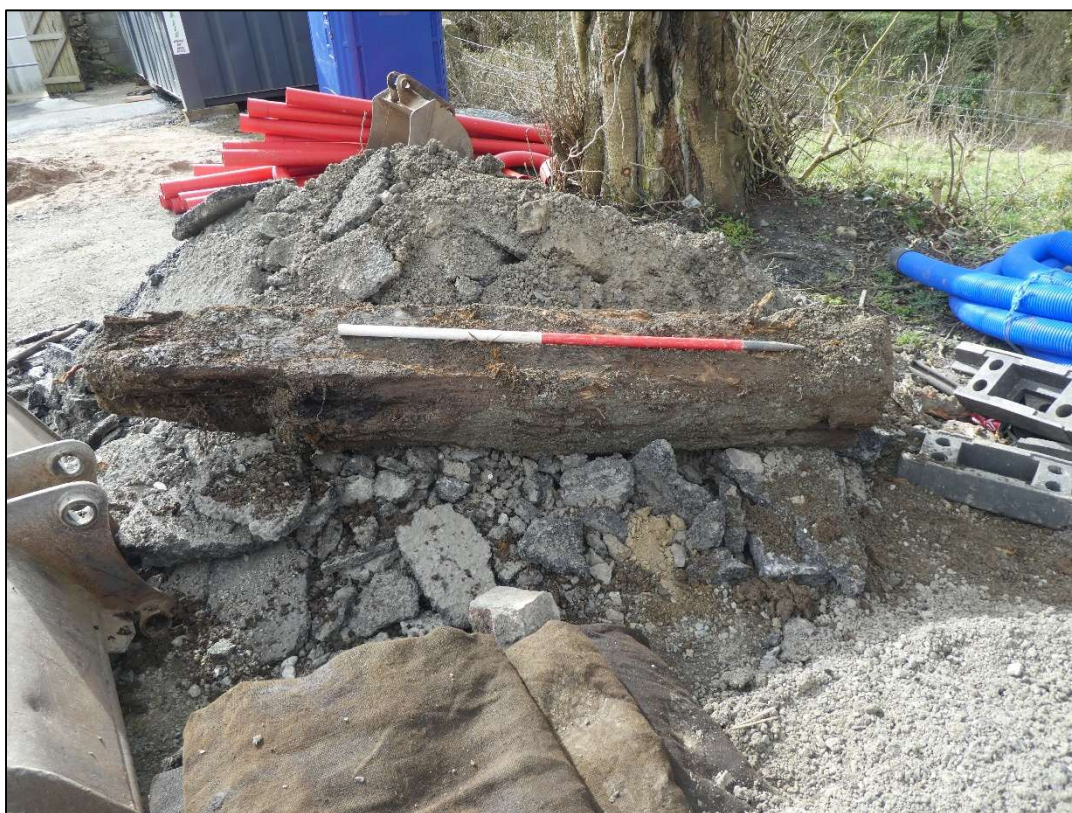
Plate 10: Bressumer from Context 6

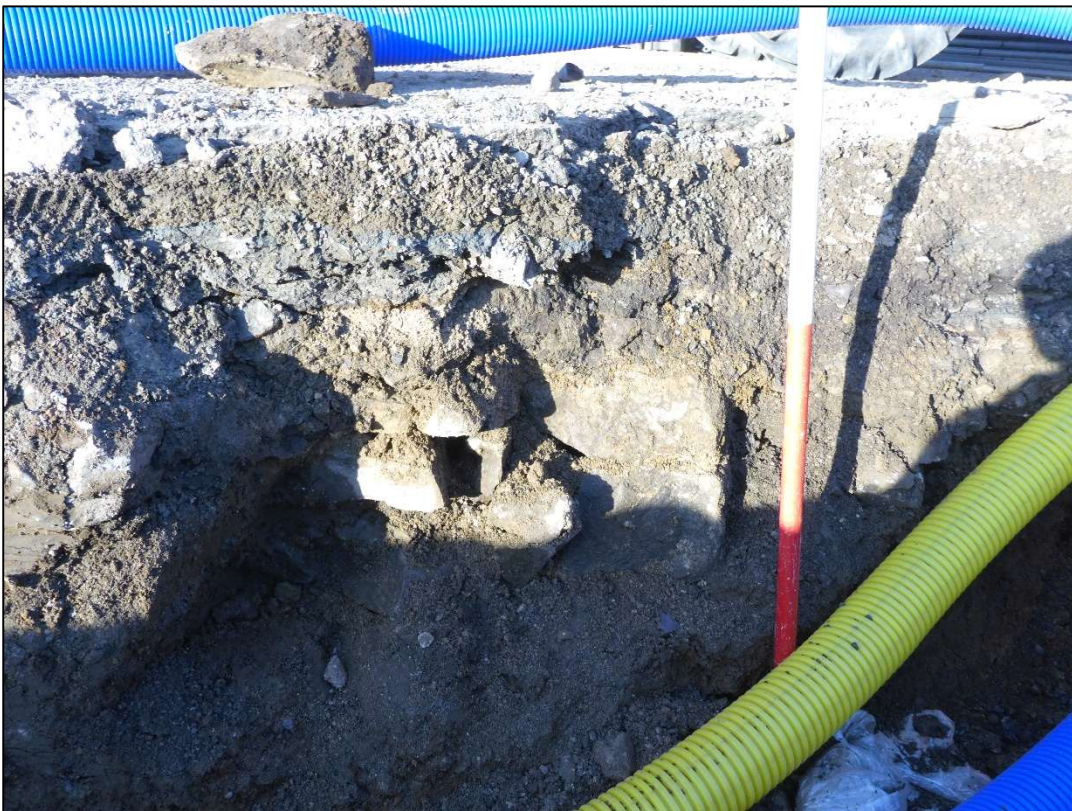
Plate 12: Wall, Context 8

Six fragments of stone walling have been recorded from the groundworks. Two of these (Contexts 8 and 9, Plates 12 and 13, Figure 6) were in the trench dug, diagonally across the site for the ducting associated with the services to the new shop. These two walls run parallel and can be related to the walls defining the drive to the house shown on the historic mapping,

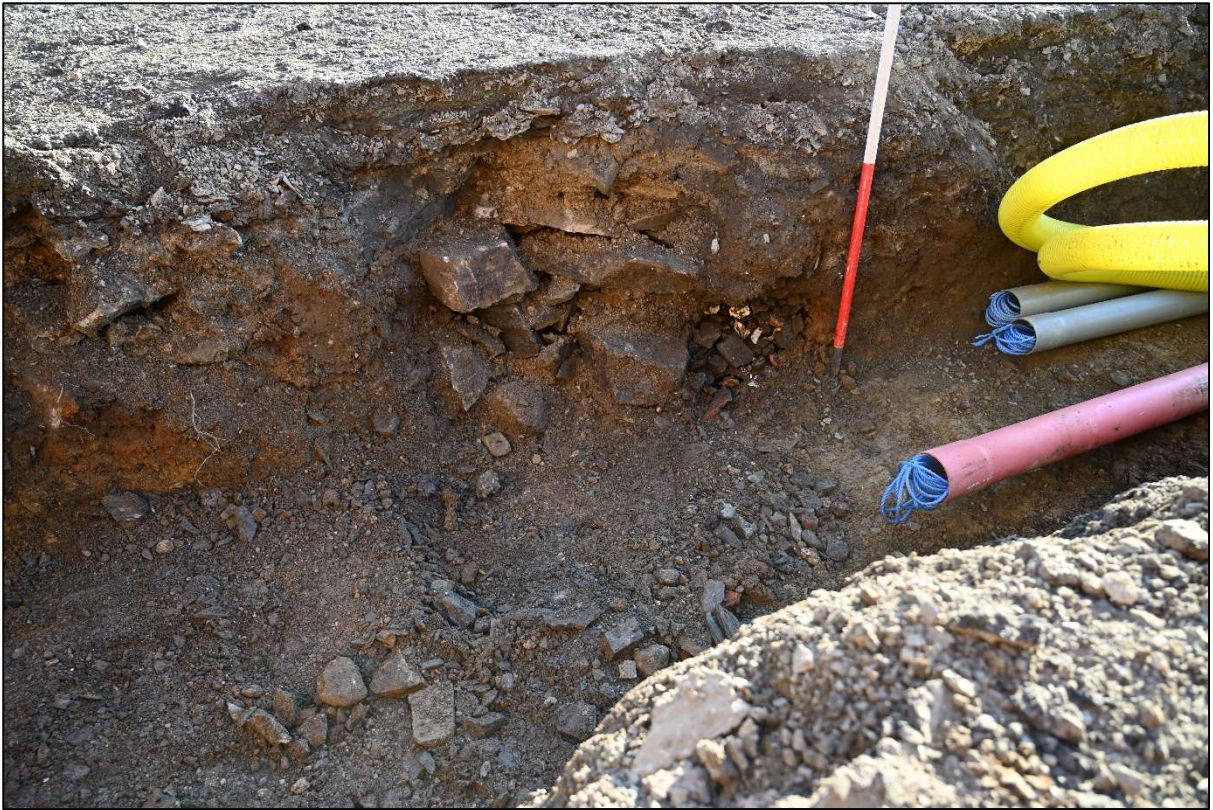
Plate 13: Wall, Context 9

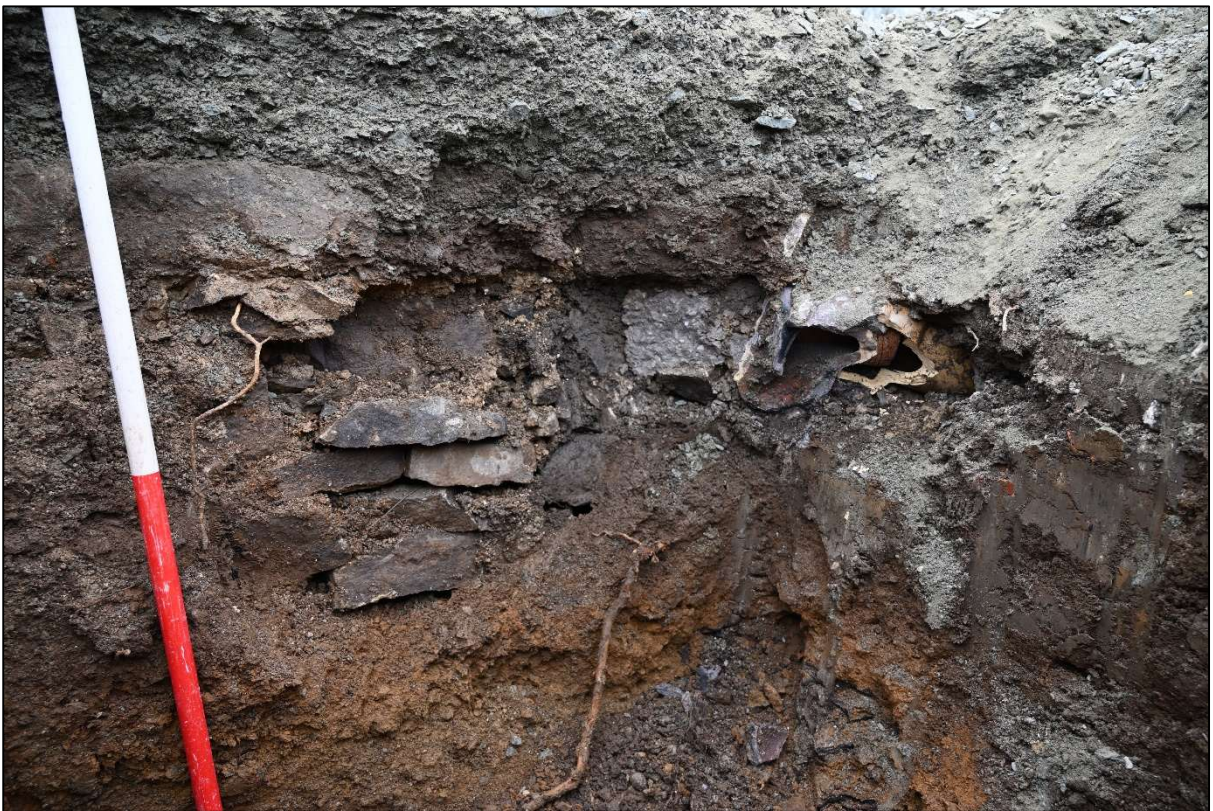
Plate 14: Wall, Context 10

particularly the Ordnance Survey SH 4084 - SH 4184 map Published in 1975 (Figure 3, Plates 12 and 13). The remaining wall fragments can be related to the house that occupied the site until the late 1970's or early 1980's (Plates 14 – 17, Figure 6). The walls vary in width between 495 mm and 960 mm, which is assumed to reflect the load bearing quality of the walls the thinner walls (Context 11 and possibly 12) representing internal walls whilst the thicker walls (particularly Context 13) marking an external, load bearing wall.

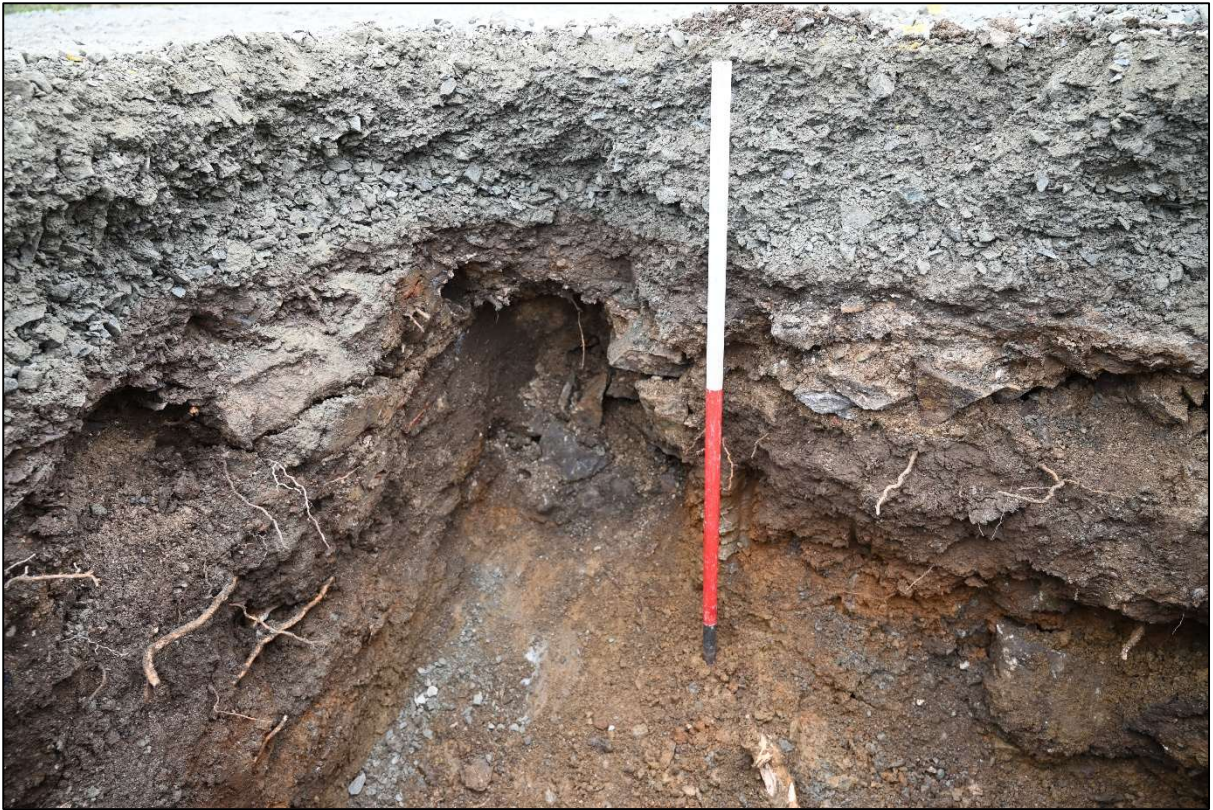
Plate 15: Wall, Context 11

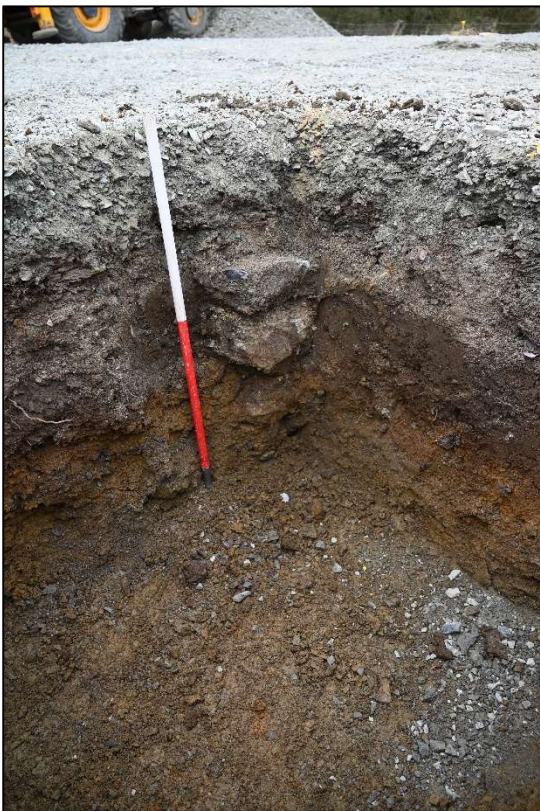
Plate 16: Wall, Context 12

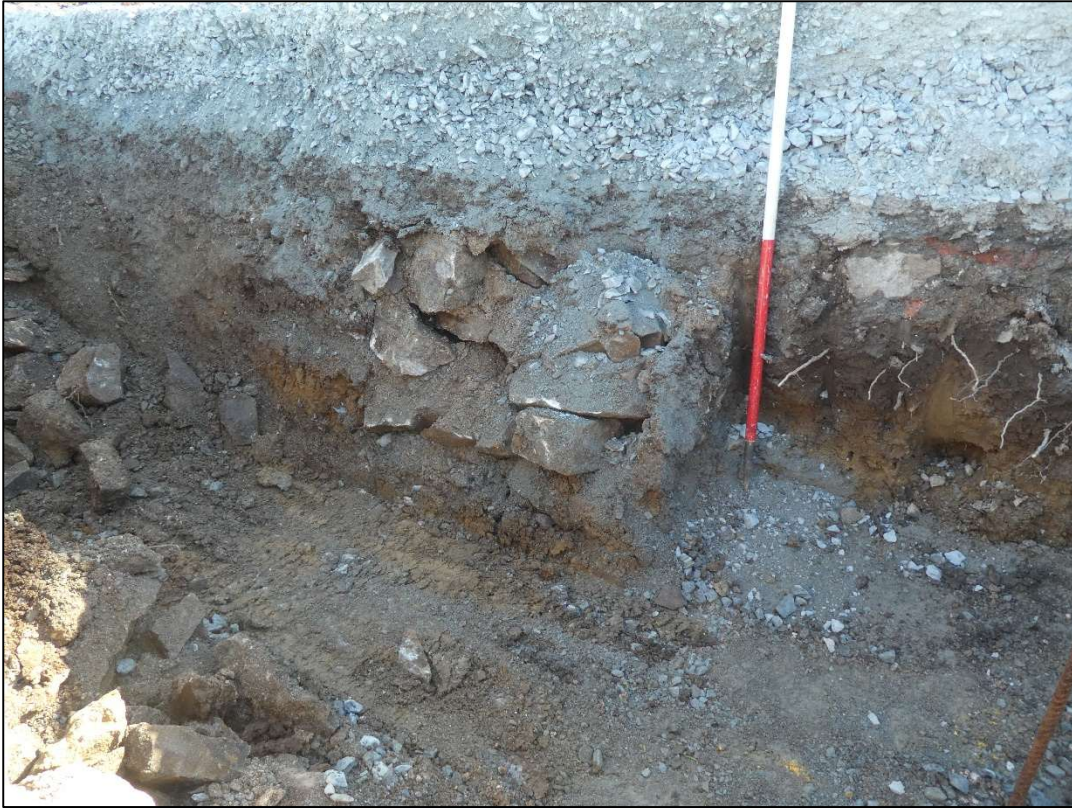
Plate 17: Wall, Context 13

13	Wall 6, 970 mm wide and up to 865 mm deep. It was constructed of angular stones up to 300 mm in size. This is probably one of the internal walls of Brynchelyn	Below 2
