# ARCHAEOLOGICAL ASSESSMENT DOL BEBIN, NANTLLE

April 2013

Govannon Report GC316A

## **ARCHAEOLOGICAL ASSESSMENT, TAN'RALLT QUARRY RUBBLE TIP, DOLBEBIN**

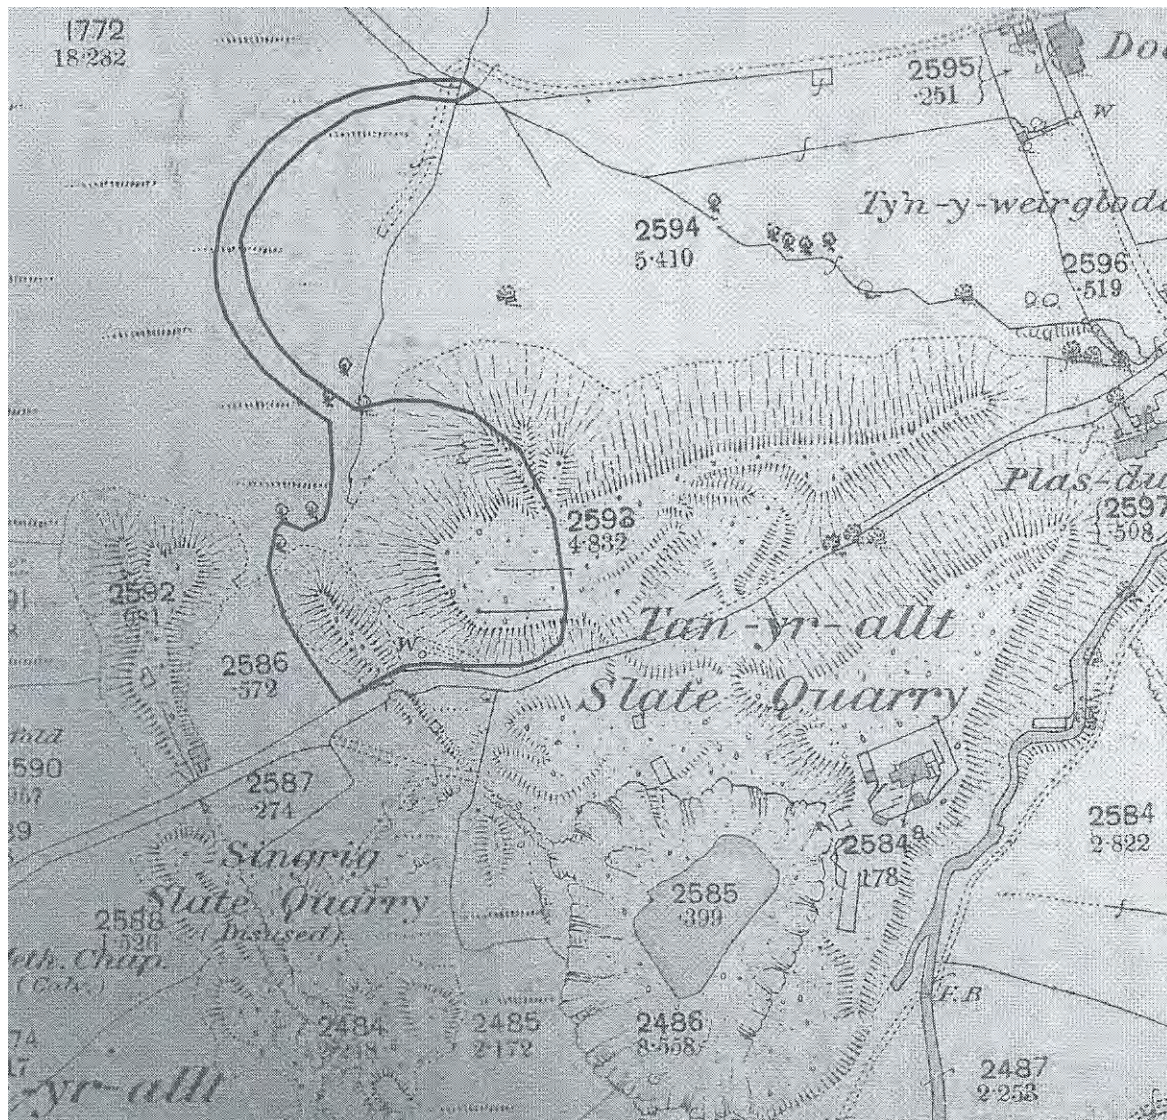
**Fig. 4. 25" ordnance survey 1889, showing site boundary**

The 1889 map (above) shows the quarry apparently out of use, in that the pit has been allowed to flood and railways have been removed. The complex to the north east of the pit is of unknown purpose but can plausibly be interpreted as the housing for a steam winding engine and its boiler, given its relationship with what appears to be a projecting bastion on the edge of the pit. It is evident that the tips to the north of the road have been developed, and that already three bridges have been built, and subsequently removed, to remove rubble from the pit area to where there is a good 'throw' for rubble. The rectangular structure on the west bank of the river to the east of the quarry workings and rubble tips which is aligned east-west appears to be the water-wheel pit which survives in situ. Its purpose is not clear but it is likely to have pumped the quarry pit.

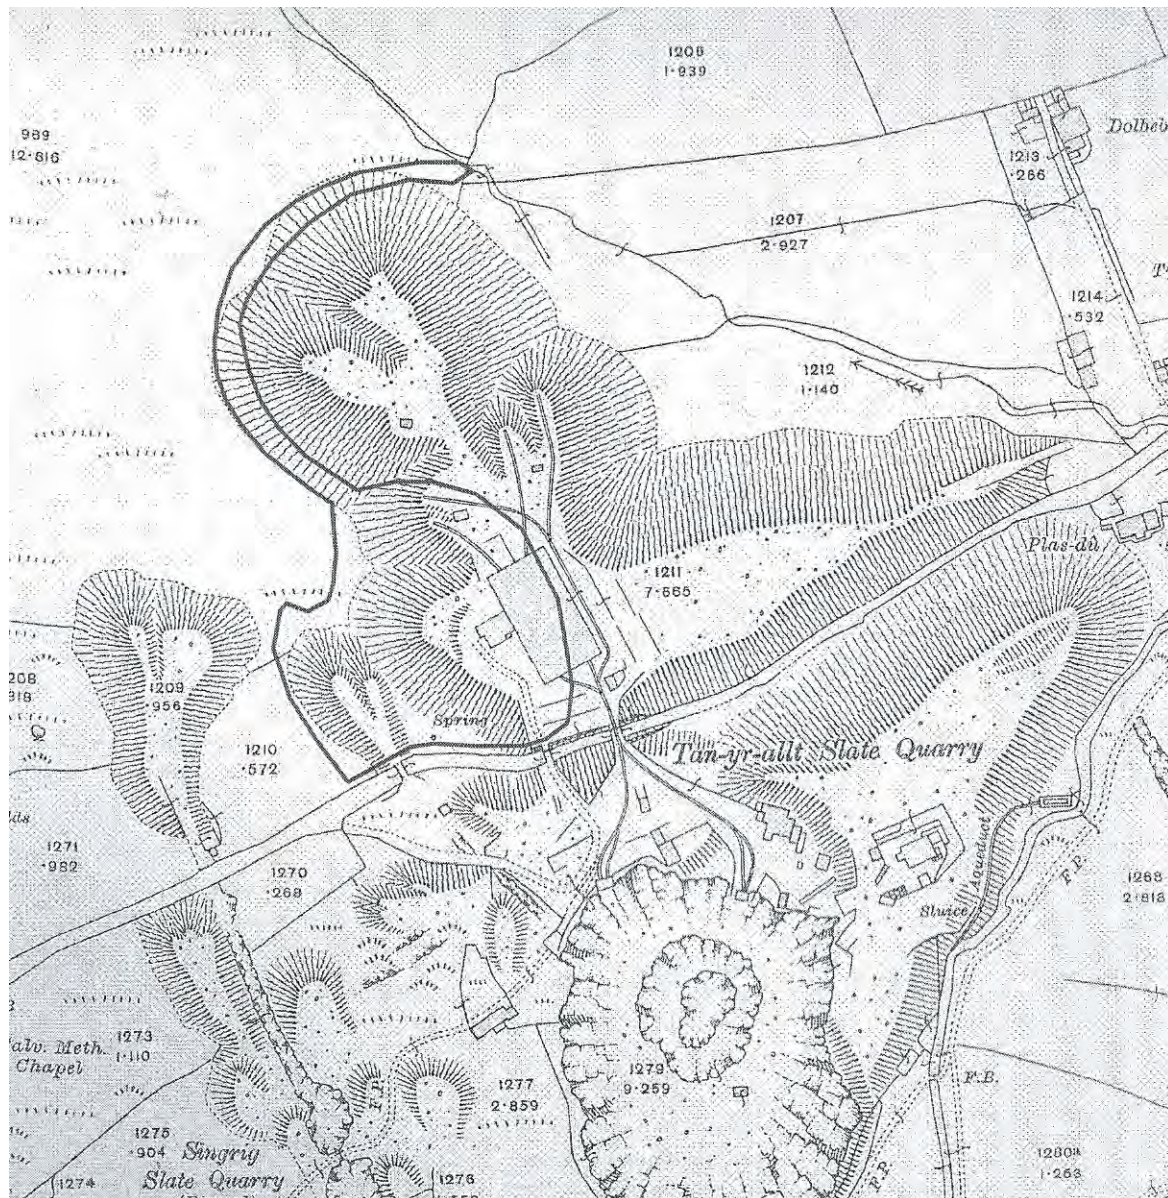
**Fig. 7. 25" ordnance survey 1916 , showing site boundary**

The 1916 map reflects intensive capitalisation of this small concern over the previous few years, with two *sincs* (deeper levels, one inside the other) having been created in the pit, now evidently clear of water, two bastions for ropeway systems on the northern side of the pit, and a mill on the tips to the north of the road. The arrangement of railway tracks suggest that unworkable rock from the pit was dumped to the north of the road (evidenced by the length of railway that avoids the mill to the east), as well as waste generated by processing in the mill itself.

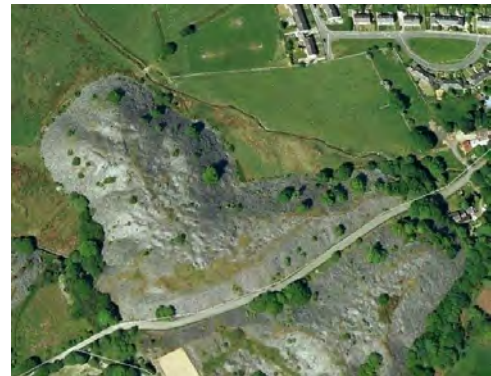
*Description:* A slate tip covering a total of 3.075 hectares which has clearly evolved over several different periods, but which is for convenience's sake here identified as having a tip run associated with feature [7] extending to SH 4897 5238, now very overgrown, one main tip-run extending north to a tipping-point at approximately SH 4899 5248 and another main tip run extending east to a tipping-point at approximately SH 4919 5243. Because it has been extensively reworked by tip contractors (see features [9] to [33], [40] to [41] and [44] to [45] below), the location of the northern tip-ends and other features from when it formed part of a working quarry are not clear. The tip contains unusable slate rock and trimming waste from the tip-contractor period.

*Significance:* Identified as priority 2 by CCW TECHNICAL Support project 73-03-061 (on a scale of 1\*, 1, 2 and 3) hence category B

*Threat:* Removal of 0.073 hectares of feature = 22.9% + possible attrition of other parts through secondary quarrying; possible erosion of feature through construction/operation of access road.

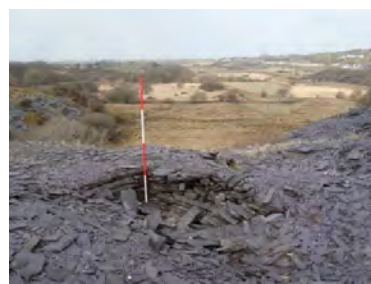
### 10 Gwal: PRN 37048

**Location:** SH 4901 5241  
**Period:** Industrial/Modern  
**Description:** A gwal constructed of slate rags on the west-facing slopes of the tip, approx. 2m by 2m in internal plan.  
**Significance:** B  
**Threat:** Removal  
**Mitigation:** Recording Level 2: basic recording in advance of work on site

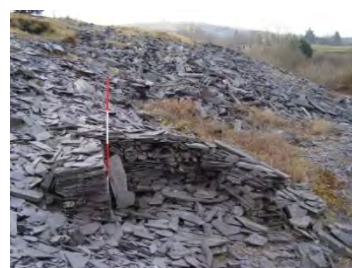
### 11 Gwal: PRN 37049

**Location:** SH 4902 5244  
**Period:** Industrial/Modern  
**Description:** A 'souterrain' gwal, built of slate rags, with steps leading down from the level of the tip. Overall the main chamber measures approx. 5m by 2m.  
**Significance:** B  
**Threat:** Removal  
**Mitigation:** Recording Level 2: basic recording in advance of work on site, to be undertaken as one programme of recording

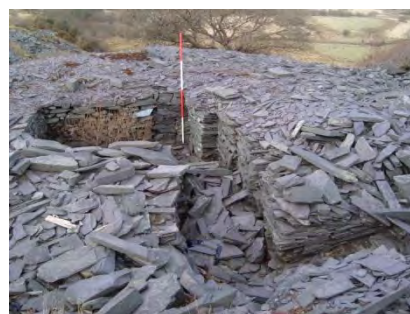
### 12 Gwal: PRN 37050

*Location:* SH 4900 5245  
*Period:* Industrial/Modern  
*Description:* A gwal built of thick (1.5m) walls made up of slate rags, associated with an adjacent shallow quarry in the tip immediately to the north-east (13).  
*Significance:* B  
*Threat:* Disturbance during secondary extraction; slumping of tip  
*Mitigation:* Recording Level 2: basic recording in advance of work on site, to be undertaken as one programme of recording

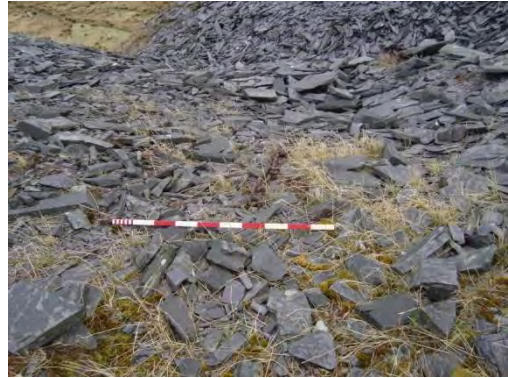
**17 Chain: PRN 37055**

*Location:* SH 4899 5248  
*Period:* Industrial/Modern  
*Description:* A chain set in the ground on the north-east side of feature (18).

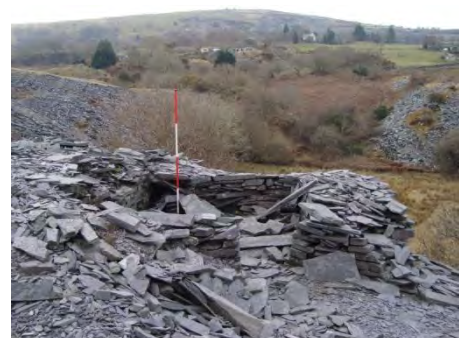
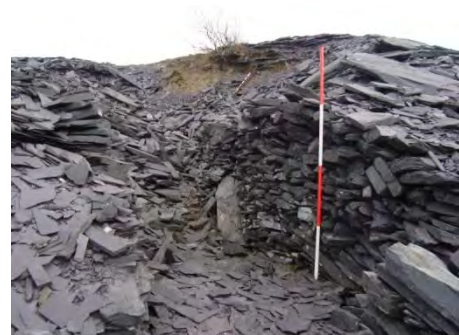
The top photograph (right) shows the gwal, the lower shows the barrow-way looking into the quarry. Feature (17) is indicated by the scale.

*Significance:* B  
*Threat:* N/a  
*Mitigation:* N/a

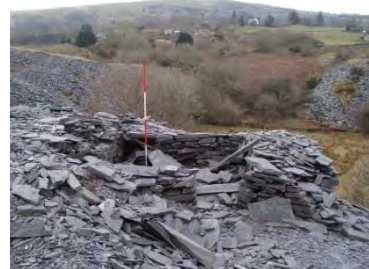
### 20 Gwal: PRN 37058

*Location:* SH 4900 5250

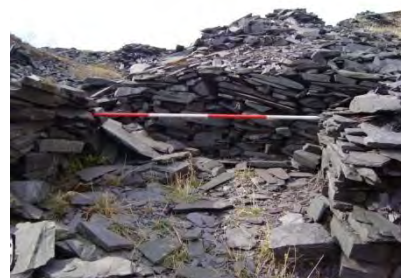
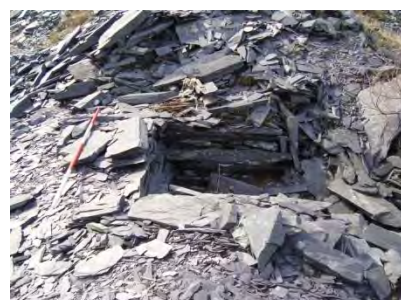
### 22 Gwal: PRN 37060

*Location:* SH 4903 5245

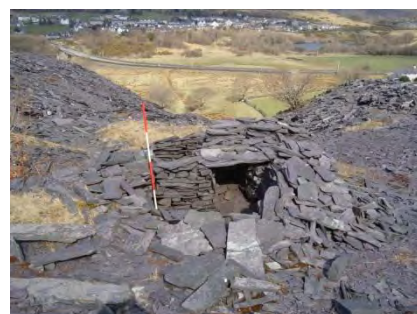
### 23 Gwaliau and secondary working area: PRN 37061

*Location:* SH 4904 5246  
*Period:* Industrial/Modern  
*Description:* An amorphous area of secondary working including some dilapidated structures that may have been part of gwaliau.  
*Significance:* B  
*Threat:* N/a  
*Mitigation:* N/a

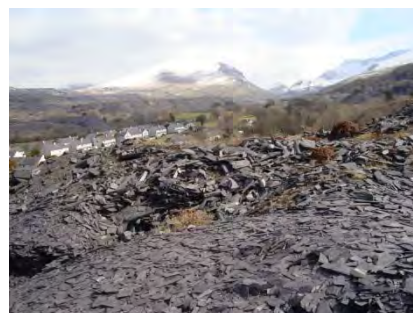
### 24 Gwaliau and secondary working area: PRN 37062

*Location:* SH 4904 5245  
*Period:* Industrial/Modern  
*Description:* An amorphous area of secondary working on the east-facing slope of the main tip including some dilapidated structures that may have been part of gwaliau.  
*Significance:* B  
*Threat:* N/a  
*Mitigation:* N/a

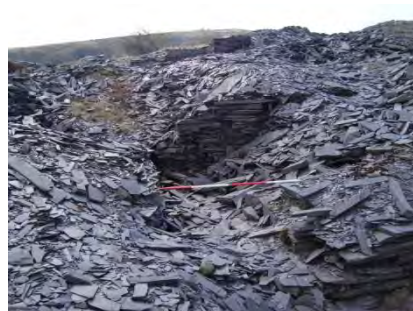
### 25 Gwal and secondary quarry: PRN 37063

*Location:* SH 4916 5242  
*Period:* Industrial/Modern  
*Description:* A gwal on the north-facing slope of the tip that extends to the east with a small secondary quarry immediately to the south-west.  
*Significance:* B  
*Threat:* N/a  
*Mitigation:* N/a

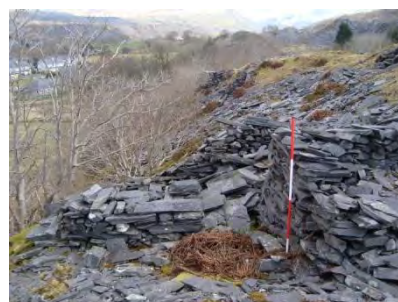
### 26: Gwal PRN 37064

*Location:* SH 4911 5241  
*Period:* Industrial/Modern  
*Description:* An east-facing tip surface gwal with an associated spread of trimming waste.  
*Significance:* B  
*Threat:* N/a  
*Mitigation:* N/a

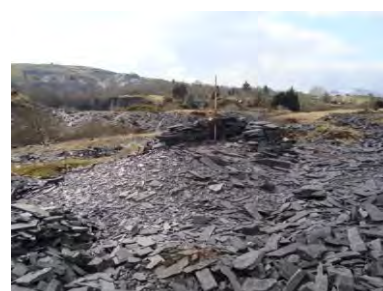
### 27 Gwal: PRN 37065

*Location:* SH 4908 5241  
*Period:* Industrial/Modern  
*Description:* A well-preserved tip surface gwal which has evidently seen some recent re-use as a shelter or a den, on the basis of some carpeting.  
*Significance:* B  
*Threat:* N/a  
*Mitigation:* N/a

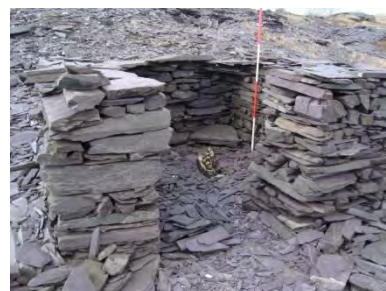
### 28 Gwal: PRN 37066

*Location:* SH 4899 5250  
*Period:* Industrial/Modern  
*Description:* A gwal located near the northern extremity of the tip, sunk into the slate rubble, 2m by 2m internally, accessed by stairs. Associated with this feature is a small level area immediately to the north, possibly also a processing area.  
*Significance:* B  
*Threat:* N/a  
*Mitigation:* N/a

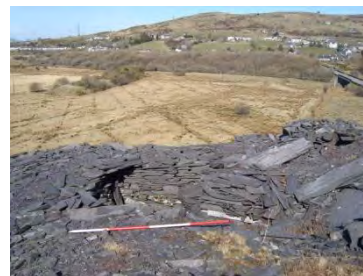
### 29 Gwal and secondary quarry: PRN 37067

*Location:* SH 4904 5249 – 4903 5247  
*Period:* Industrial/Modern  
*Description:* A gwal at SH 4904 5249 set on the north-east facing slopes of the tips, measuring approximately 4m by 2m internally, associated with a secondary quarry immediately to the south at SH 4903 5247.  
*Significance:* B  
*Threat:* N/a  
*Mitigation:* N/a

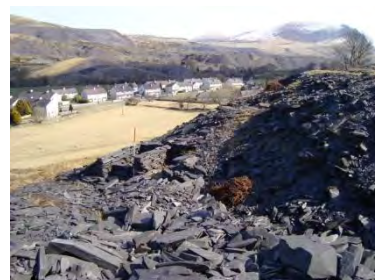
### 31 Gwal: PRN 37069

*Location:* SH 4906 5239  
*Period:* Industrial/Modern  
*Description:* A well-preserved gwal with associated pile of trimming waste to the north  
*Significance:* B  
*Threat:* Disturbance during secondary extraction; slumping of tip  
*Mitigation:* Recording Level 2: basic recording in advance of work on site, to be undertaken as one programme of recording

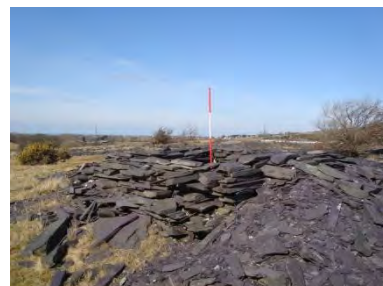
### 32 Gwal: PRN 37070

*Location:* SH 4906 5242  
*Period:* Industrial/Modern  
*Description:* A gwal on the north-east facing slope of the tip.  
*Significance:* B  
*Threat:* Disturbance during secondary extraction; slumping of tip  
*Mitigation:* Recording Level 2: basic recording in advance of work on site, to be undertaken as one programme of recording

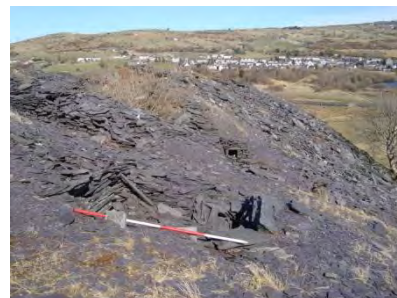
### 33 Structure: PRN 37071

*Location:* SH 4906 5243  
*Period:* Industrial/Modern  
*Description:* Possibly part of a gwal, but only evident now as a projecting rag-built wall with a distinctive alcove.  
*Significance:* B  
*Threat:* N/a  
*Mitigation:* N/a

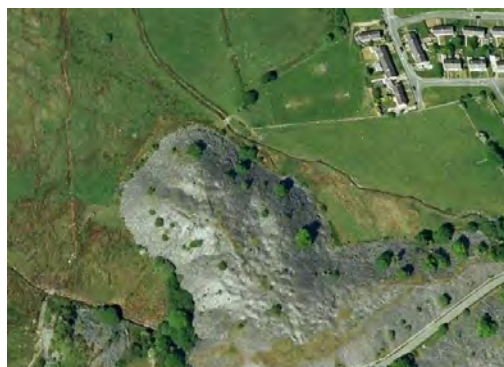
### 37 Field drainage system: PRN 37074

**Location:** SH 4903 5258

**Threat:** Disturbance

**Mitigation:** None, as extensive system

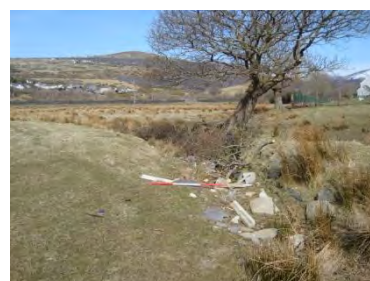
### 38 Gate: PRN 37075

**Location:** SH 4902 5256

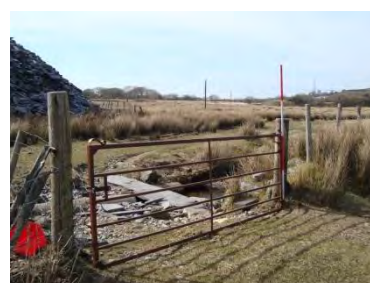
### 39 Bridge: PRN 37076

*Location:* SH 4902 5256  
*Period:* Industrial/Modern  
*Description:* A bridge over the Dol Bebin stream consisting of slate slabs and concrete piping.  
*Significance:* D  
*Threat:* Replacement  
*Mitigation:* Recording Level 1: basic recording in advance of work on site, to be undertaken as one programme of recording

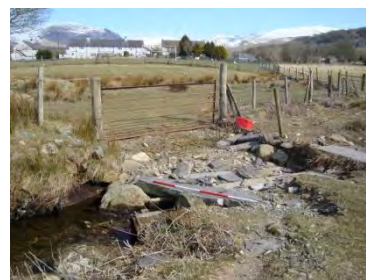
### 40 Gate: PRN 37077

*Location:* SH 4902 5256  
*Period:* Industrial/Modern  
*Description:* A re-used domestic steel or aluminium gate, with some decorative detail, set in post-and-wire fencing.  
*Significance:* D  
*Threat:* Replacement  
*Mitigation:* Recording Level 1: basic recording in advance of work on site, to be undertaken as one programme of recording

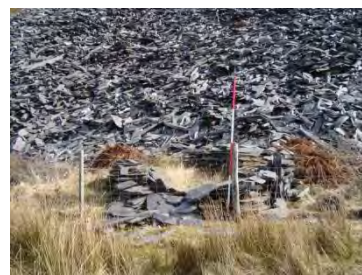
### 42 Gwal: PRN 37079

*Location:* SH 4893 5249  
*Period:* Industrial/Modern  
*Description:* A dilapidated gwal set at the foot of the quarry tip  
*Significance:* B  
*Threat:* Removal by proposed road  
*Mitigation:* Recording Level 1: basic recording in advance of work on site, to be undertaken as one programme of recording

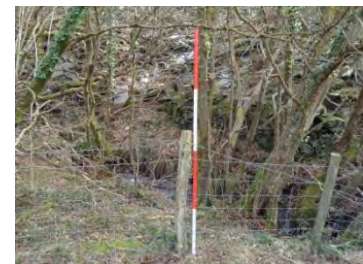
**46 Gwal: PRN 37082**

*Location:* SH 4906 5251  
*Period:* Industrial/Modern  
*Description:* A gwal at the foot of the tip, sub-ovoidal in plan, accessed from the south-east. Larger than most, but very dilapidated.  
*Significance:* C  
*Threat:* N/a  
*Mitigation:* N/a

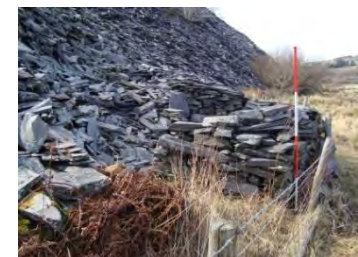
**47 Gwal: PRN 37083**

*Location:* SH 4909 5245  
*Period:* Industrial/Modern  
*Description:* A gwal at the foot of the tip, dilapidated, measuring approximately 4m by 4m internally.  
*Significance:* C  
*Threat:* N/a
