NORTH WEST WALES DENDROCHRONOLOGY PROJECT 2009-2012
PROSIECT DENDROCHRONOLEG GOGLEDD ORLLEWIN CYMRU

DATING OLD WELSH HOUSES / DYDDIO HEN DAI CYMREIG

Cwm Farm, Cwm Cynfal, Ffestiniog, Gwynedd

ARCHITECTURAL RECORD /COFNOD PENSARNIOL

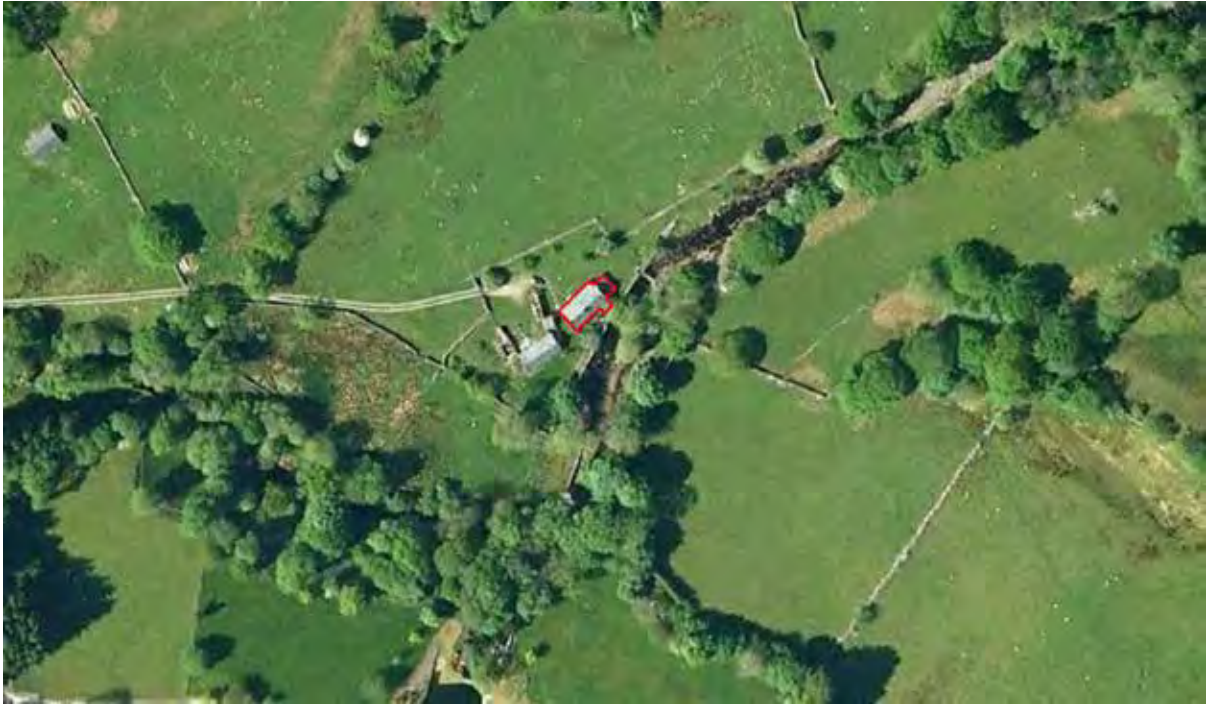
Figure 3: Aerial Image courtesy Google Earth

Cwm Farm: satellite view

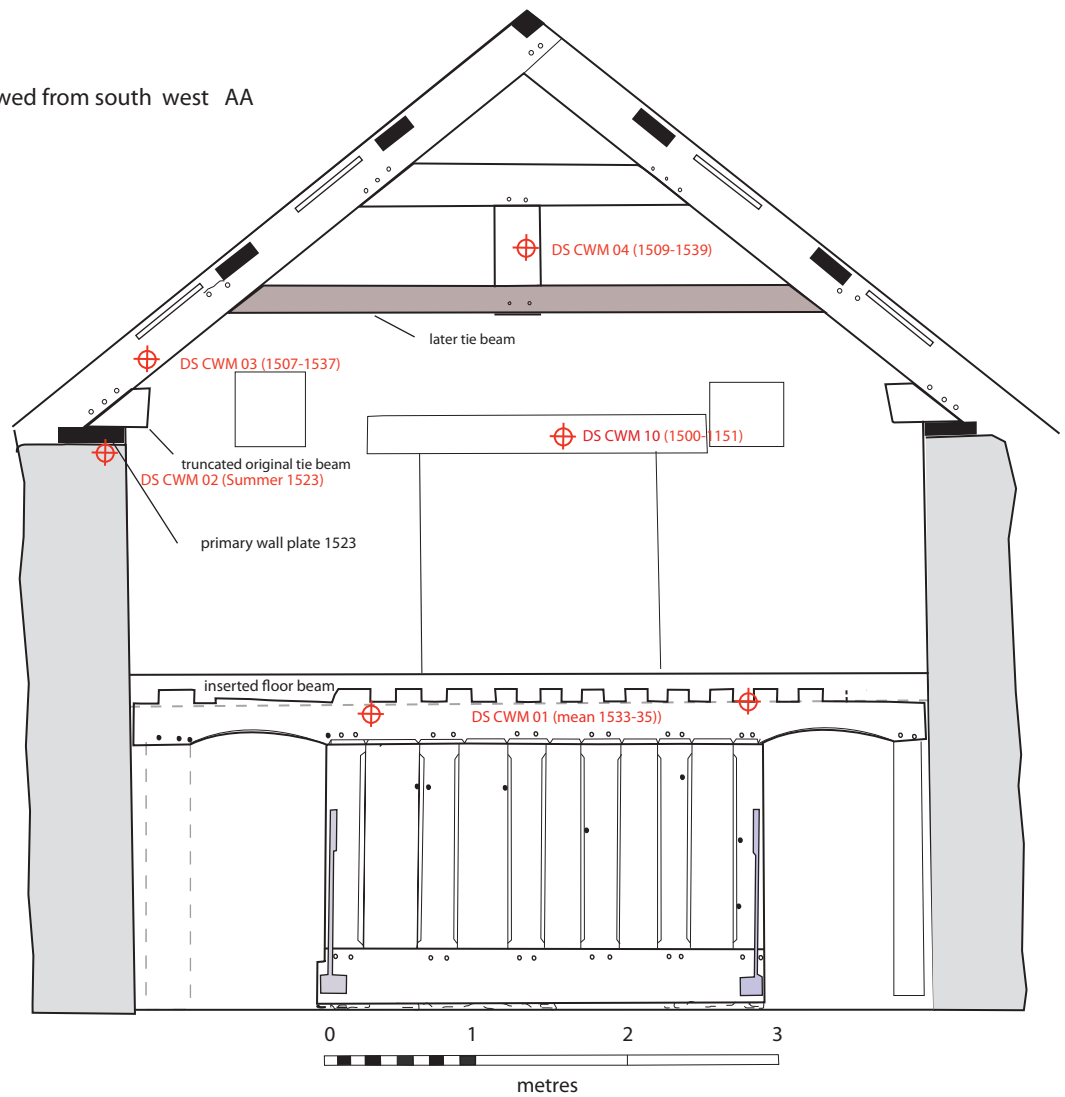
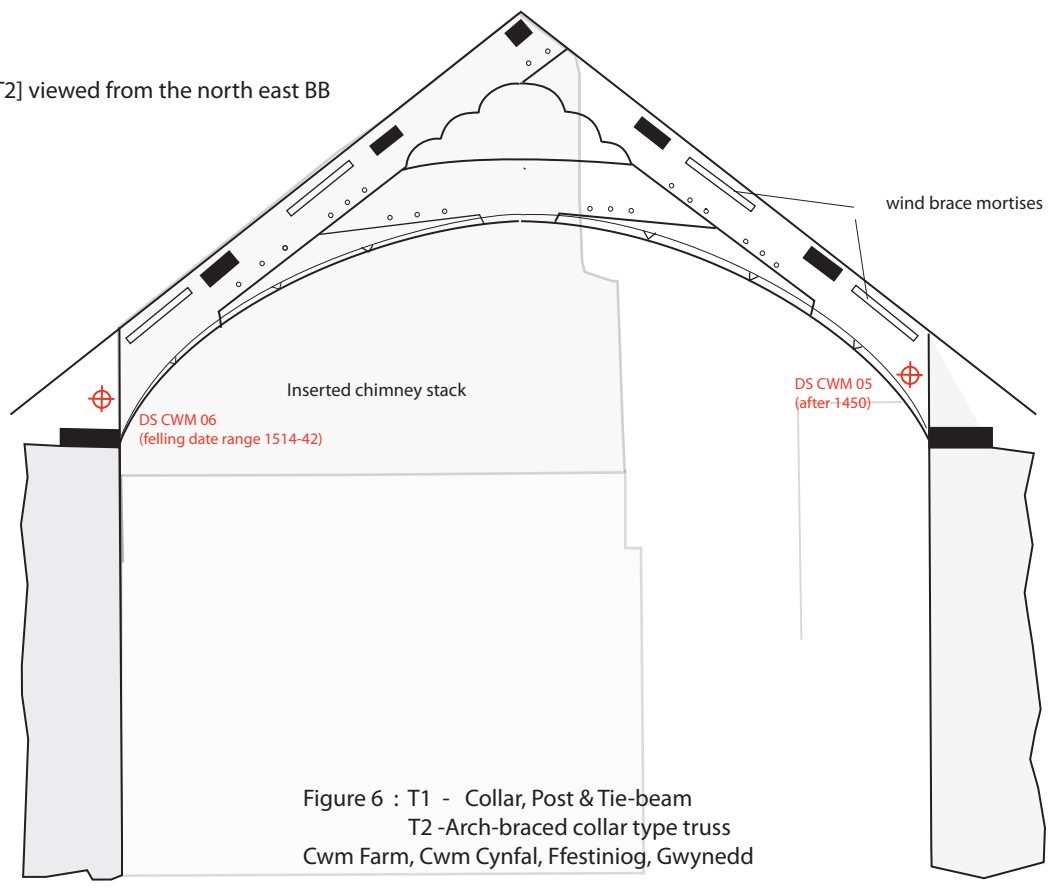
Figure 6 : T1 - Collar, Post & Tie-beam
T2 -Arch-braced collar type truss
Cwm Farm, Cwm Cynfal, Ffestiniog, Gwynedd

Truss 1 viewed from south west AA

Truss 2 [T2] viewed from the north east BB

- 4.3.1 The upper floor rooms [FF6] and [FF7] (Figures 4, 5) reveal clearly the roof structure from the primary build. There are three trusses from NE to SW [T1/T2/T3]. Trusses [T1] and [T3] comprise a collar, post and tie beam. Truss [T2] spanned the former hall and is an arch-braced collar type and the bay either side formed the hall. The principal rafters in [T2] are cusped above the collar but not the collar itself which is often seen. Visible on western principal rafter only. The principal rafters sit on continuous wall plates. The purlins are threaded and all seem to be primary although there is a repair with later timber to the upper purlin west in bay 1. There is evidence of smoke blackening on the hall timbers. All truss timbers are secured by three pegs through mortise and tenon joints.

- 4.3.2 Truss [T1] displays holes and grooves for staves and wattle that formed a closed truss within the A frame and a continuous mortise slot underneath the tie-beam for a partition below, possibly boarded rather than wattle and daub or a mixture of post and wattle. This truss has been severely truncated leaving just a stump of the tie-beam at either end. A portion of the post dropping from collar to tie beam was removed at the same time. A softwood, tie beam has been attached with bolts at a higher level to afford a more convenient circulation

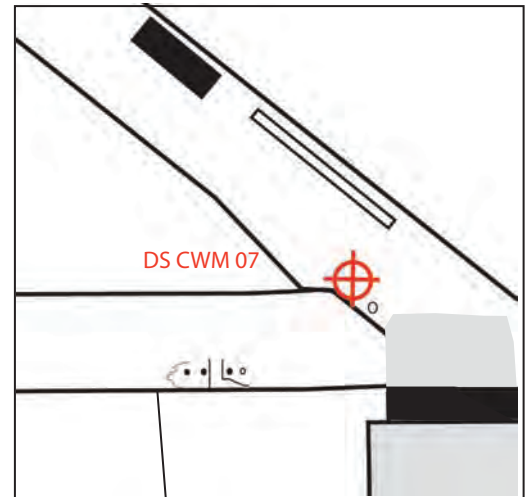
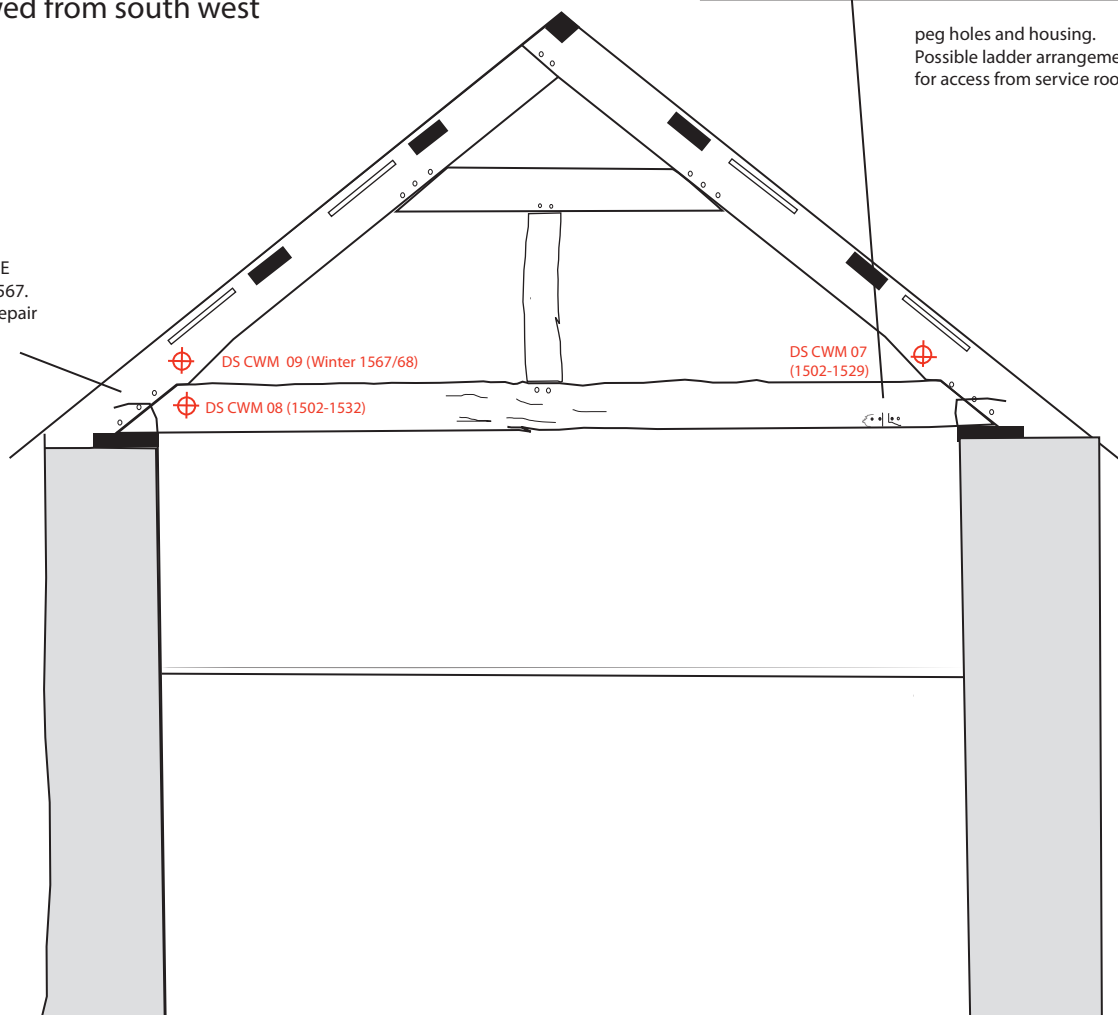
Figure 7 CC - Truss 3 [T3]
Cwm Farm, Cwm Cynfal, Ffestiniog, Gwynedd

Truss 3 viewing northwards
collar, king strut & tie beam.
Evidence of quite severe weather
erosion with PR west replaced c1567.

Viewed from south west

peg holes and housing.
Possible ladder arrangement
for access from service room

Principal rafter E
dated winter 1567.
Replacement/repair

- 4.3.8 The evidence of the mortises for wind bracing both on principals and purlins indicate that every truss was wind braced on both sides. Those that were visible from the hall were cusped while the two that exist on the service side of [T3] have only a plain board. (Plate 30, 33) This may be later. Remnants of the wind brace tenons remain in several of the mortises throughout the roof. On T3 SW side is a curious set of peg holes and rough housing (Plates 31,32) (figure 7).

- 5.1.2 Eleven timbers were sampled. A wallplate NW retained complete sapwood and gave a felling date of **Summer 1523**. It is felt that this dates the trusses. Five of the PRs were cut from the same tree. One principal rafter, (T3 W) however, dated to the **winter of 1567/68** and may have been a repair. The head beam for the partition gave a date of **1533-5** and the second sample from the fireplace lintel, which had complete sapwood, dated similarly to **c1535**.

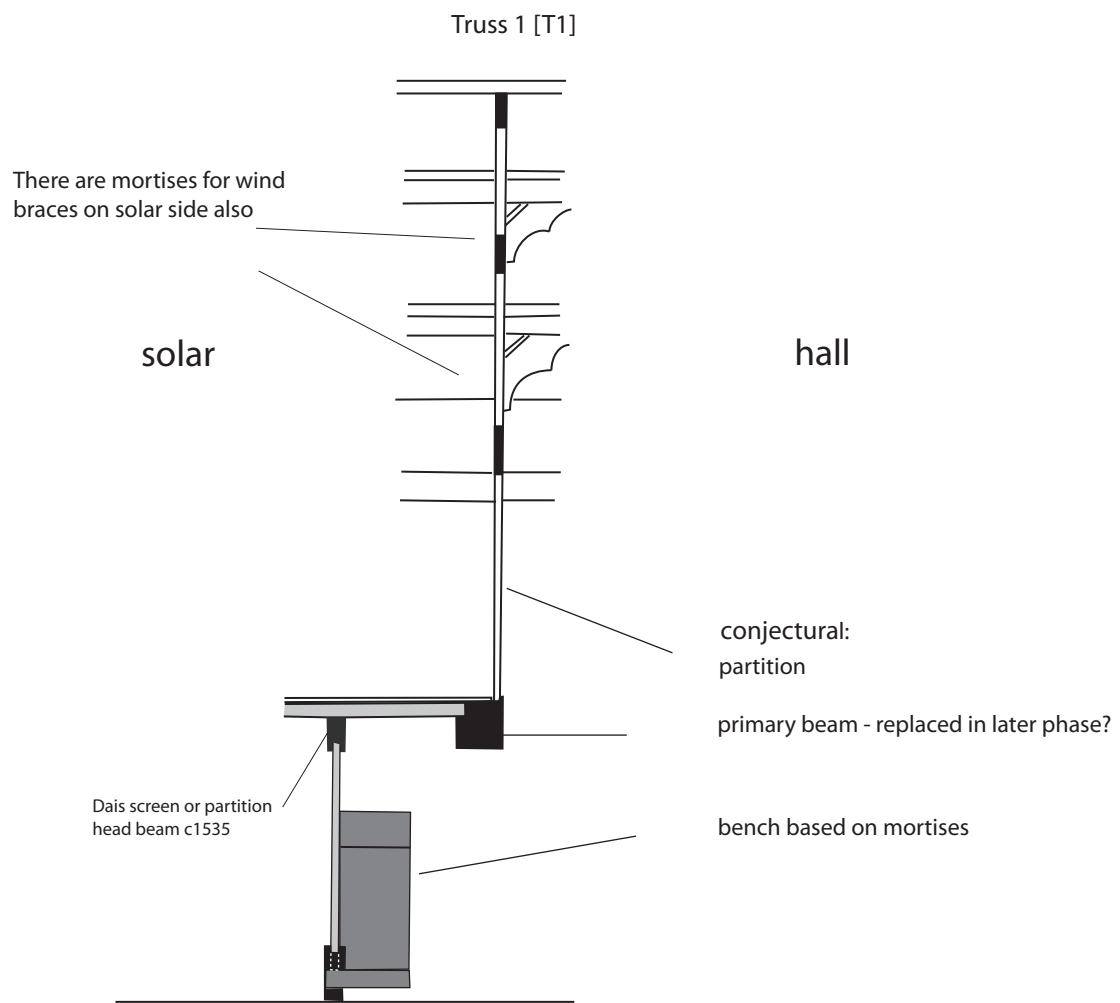
Figure 9: Closed partition - solar
Cwm Farm, Cwm Cynfal, Llan Ffestiniog, Gwynedd

Conjectural arrangement of dais partition and closed partition above (from Peter Smith, 2001). Dendrochronology suggests the dais screen was installed some years after the solar was constructed as primary phase?

- 4.3.3 Lifting the floorboards over the GF softwood beam show both the early joists over [GF4] and the later, wider spaced joists of the new floor over [GF3] fitted and pegged or nailed in their own housings into this beam . The joining of the older joists to the former partition can only be conjectural but is suggested by a drawing after Peter Smith (Figure 9)

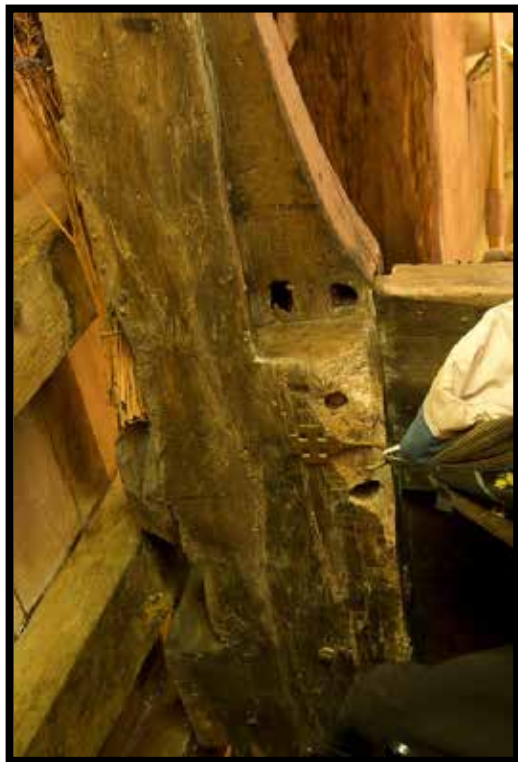
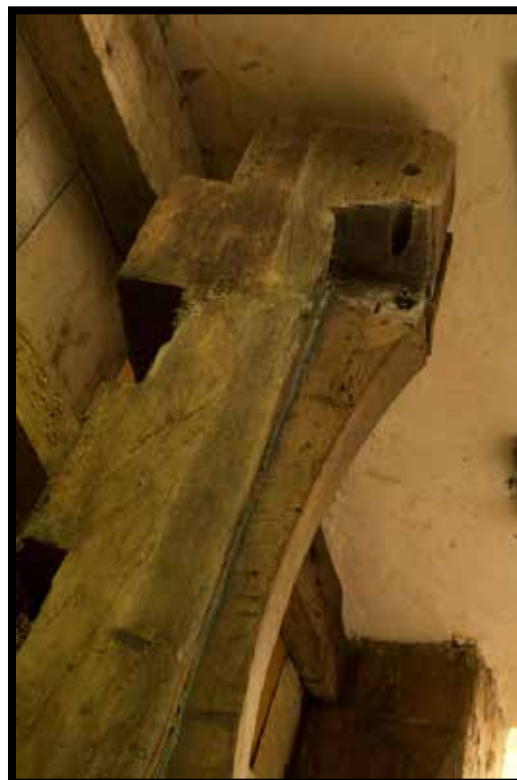
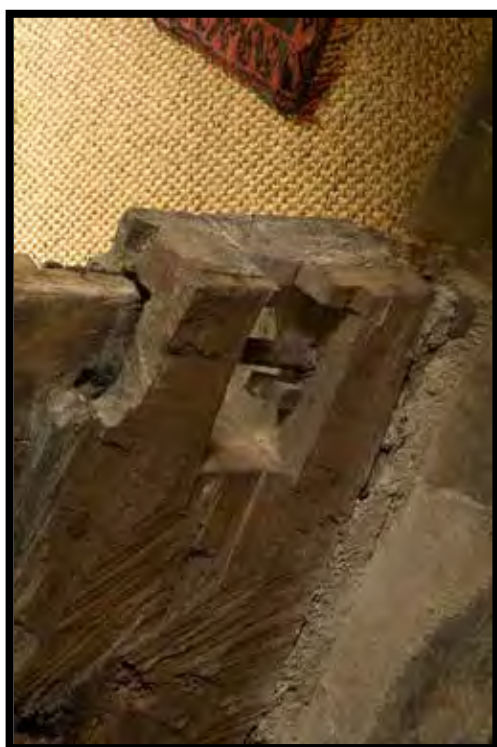
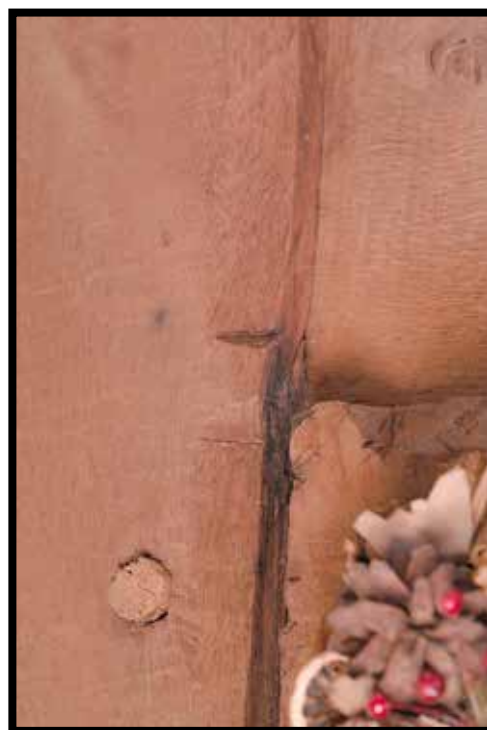
Plate 13: Rear side of dais partition; door head L

Plate 14: Rear side of dais – door head R

Plate 15: Truncated cill

Plate 16: Screen detail – nailhead stop & chamfers

and is fitted with 6 posts and 5 planks/panels. The cill has been crudely truncated at the bottom (Plate 13-16) of the inner door posts of the screen to afford a more convenient circulation. The partition posts are decorated with a plain stopped chamfer while the head beam also has a chamfer interrupted by 'nailhead' bosses. (Plate 16) The head beam and the joists that formerly sat in the housings cut out of the top of the head beam do not now meet, being raised approximately 110mm to sit on later inserted pine beam.) These joists were originally pegged into the head beam and sailed on to meet the bottom of the partition that travelled down from the truss [T1] directly above. This formed a canopy of around 380mm. (Plate 17) A bench was fixed to the partition and is clearly indicated by an arrangement of mortises. The partition has been moved back slightly. The joists over the partitions are now seated into a large, pine beam, squared and chamfered. This beam also supports the widely spaced and rather crude joists of the later floor that divided hall into ground and first floor spaces, running from this beam to the inserted chimney stack.

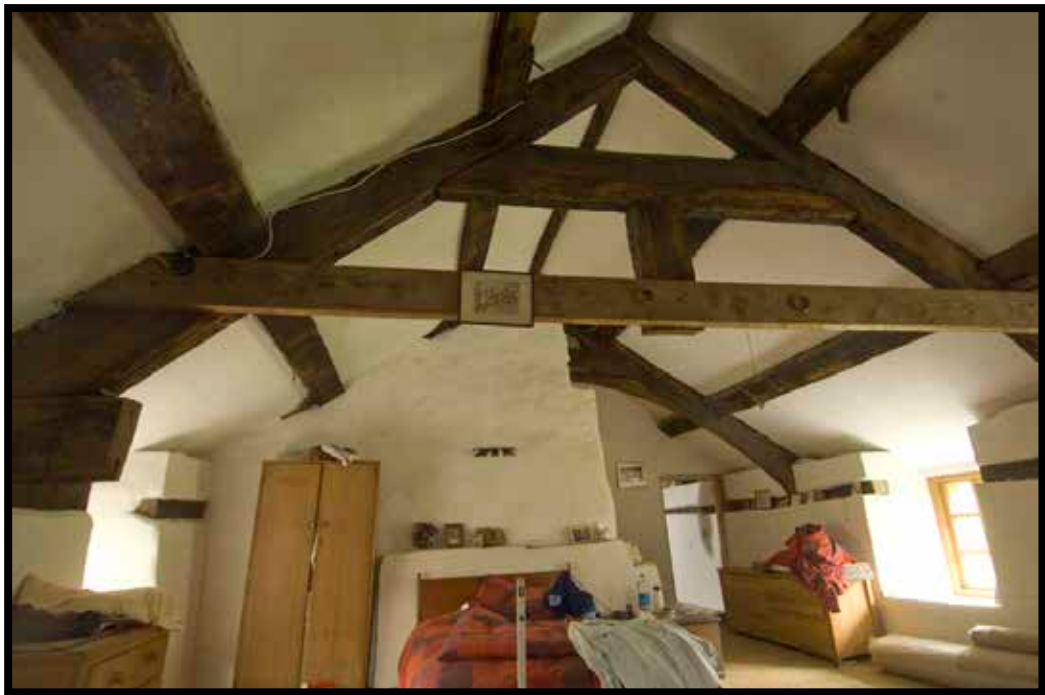
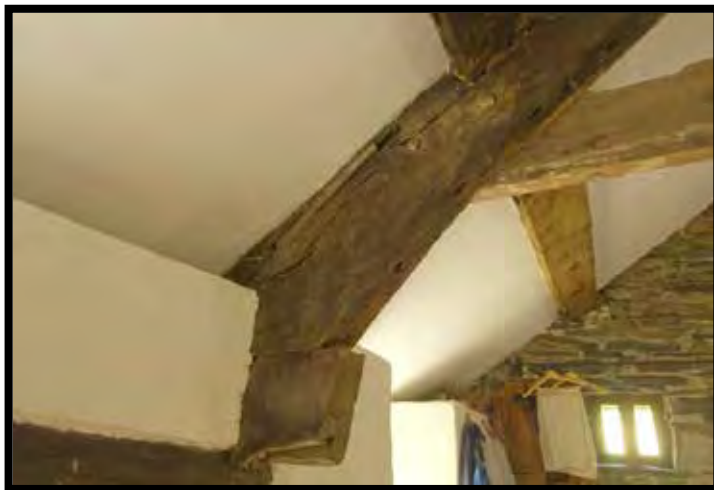
Plate 21: T1 – view to south

Plate 22: T1 – truncated tie beam

sometime after the floor had been inserted over the hall. (Plates 19, 21,22,) A modern partition from this later tie beam existed until recent years. (pers. Comm. owner)

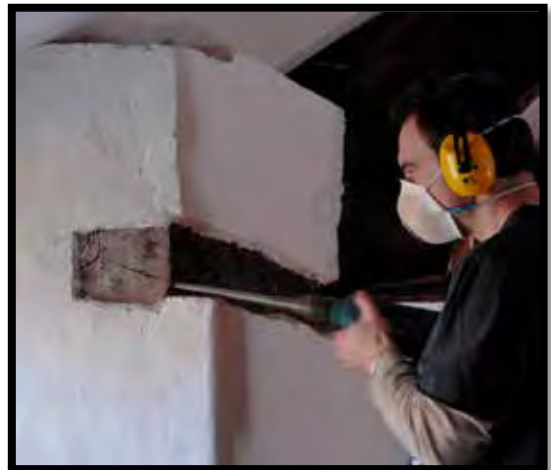
Plate 23: Matt Hurford sampling wall plate. Dated 1523.

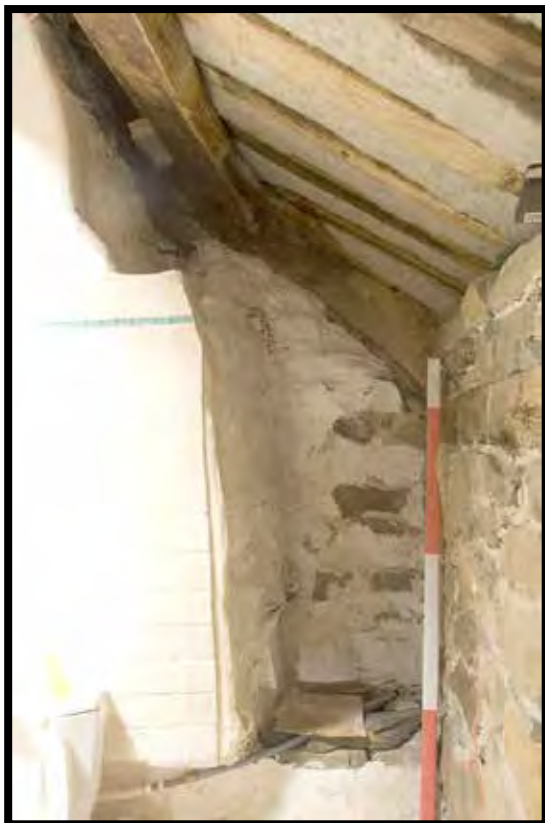
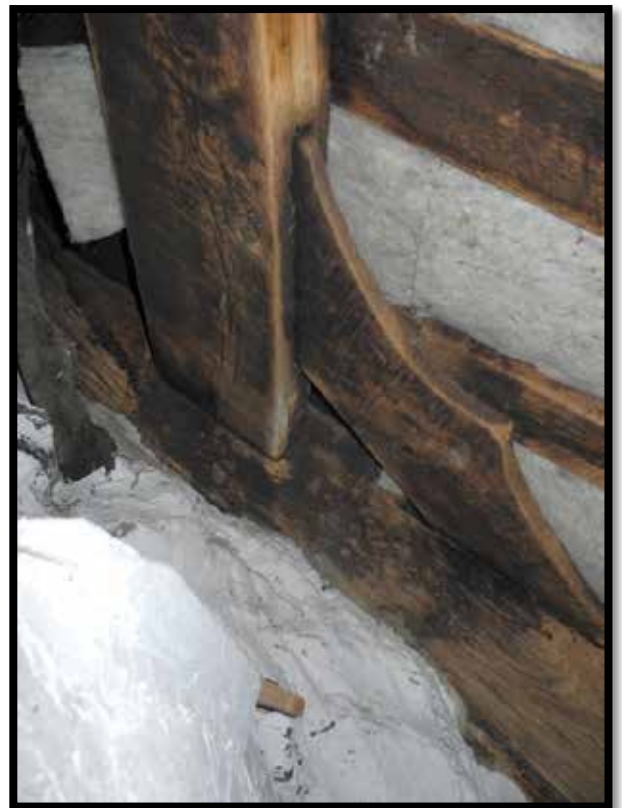
Plate 26: T2:E From SW – eastern principal by stack

Plate 27: T2E: eastern principal -wind brace detail

- 4.3.7 Room [FF7] and the hall [FF6] are divided by the inserted central stack and the rear of the stack in [FF7] has been plastered recently. A photograph belonging to the owner displays the whole stack from ground floor to chimney as being pointed and not plastered. On the SE side of the stack the lower part of eastern principal of [T2] is visible together with a wind brace at the lower purlin. (Plates 26, 27).

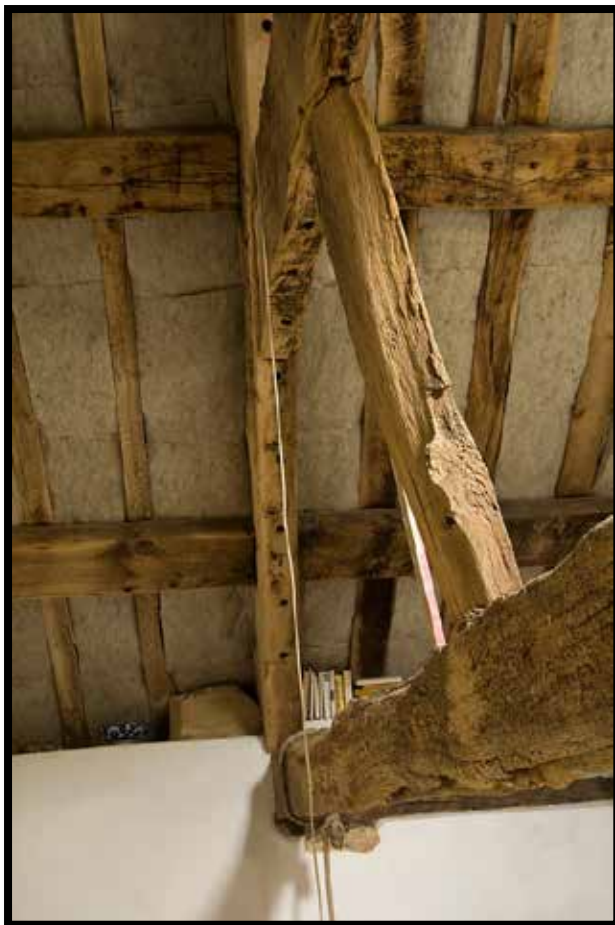
Plate 28: T3: From NE

Plate 29: T3: truss showing erosion, stave holes

- 4.3.6 Room [FF7] has truss [T3]. Similar to [T1], with collar, post and tie beam but showing considerable signs of wear/ erosion and distortion.(Plates 28, 29) It is holed and grooved in the same way as [T1] for staves and wattle to form another closed screen to ground floor level. It is not clear whether a post and panel or a post and wattle screen dropped below the tie beam. The NW principal of [T3], has dated with dendrochronology, to a precise felling date of the winter of 1567/68. Given the context of the truss and rafters it is probable that this date is explained by a repair/replacement. The rafters have been removed and re-positioned with some replacements. Some rafters 127mm wide.
