NEFYN ALLOTMENTS

Archaeological desk-based assessment and evaluation

C12/1372/42/LL

June 2013

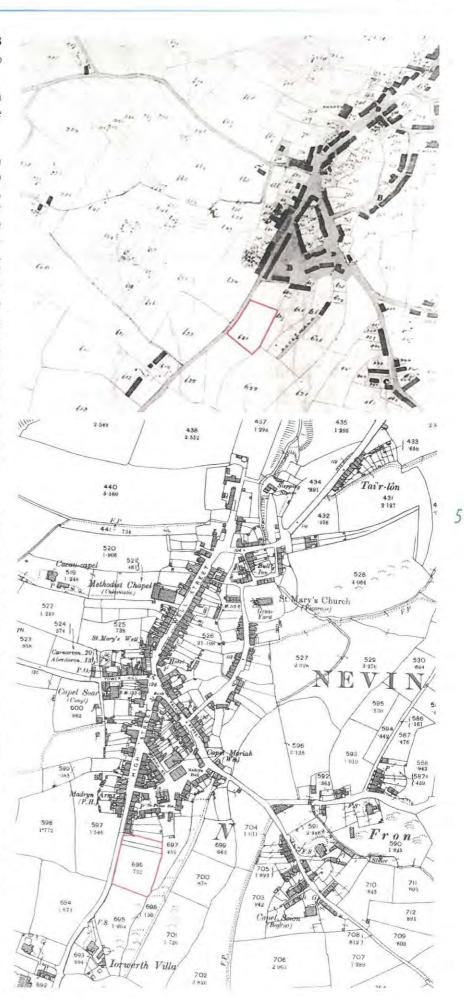
Illus 41900 2nd edition Ordnance Survey map

By the time of the 1900 Ordnance Survey (Illus 4), development had taken place in the north of field 631, with the extension of the row of terraced houses visible on the tithe map. A further two plots appear to have been earmarked for the southward extension of the terrace, but these properties had not been built by the time of the 1918 Ordnance Survey, and only one plot was still marked out. The remaining plot appears to have never been built upon and exists today as an overgrown strip of land in the north of the proposed development area separated from the remainder of the site by a mature hedgerow.

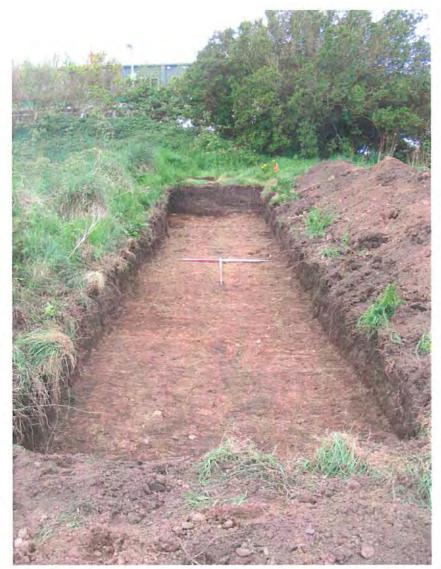
Illus 5

Trench 3; natural sands and gravels visible in base of trench

The geological sand and gravel deposits varied. Clean orange sand [103] was identified in Trench 1, whilst the deposits observed in trenches 2 and 3 contained a mixture of sand, gravel and larger subrounded stones (Illus 5). The level of the geological horizon mirrored the surface topography, sloping from south to north. Root penetration into the surface of the natural was observed in all three trenches.

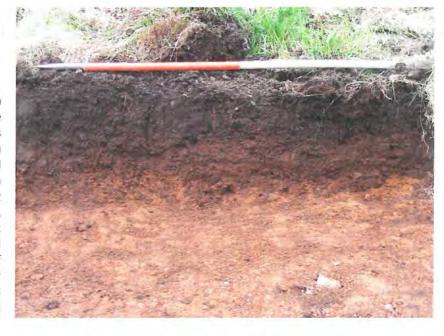
Illus 6

All trenches exhibited the same depositional sequence. A deep, black sandy clay loam topsoil [100, 200, 300] overlay a dark brown, sandy clay subsoil [101, 201, 301] which in turn sealed glacial sands and gravels [103, 203, 302]. A full description of each deposit is presented in Appendix 2.

Trench 2; east facing section through deposits
