Historic Building Recording at

ST DUNSTANS LLANDUDNO

For St Dunstons Enterprises Ltd

Doc Ref: LP0950C-HBR-v.1.2

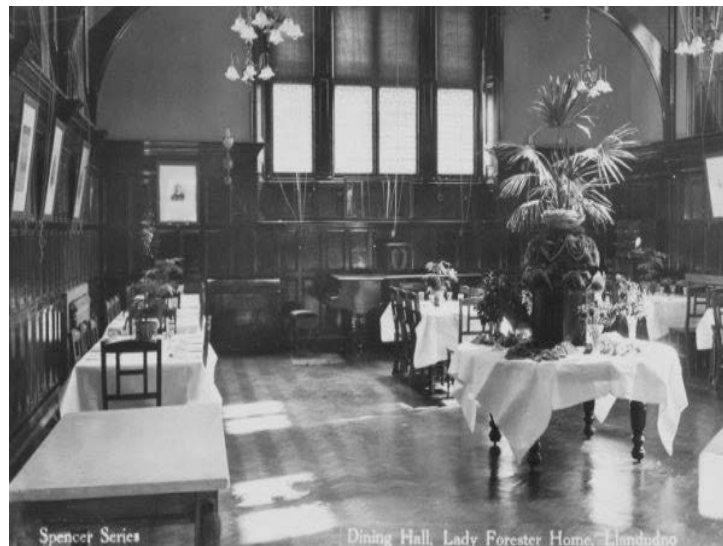
Plate 1 - Main Hall, early 20th century

2.3.14. The building was constructed in what has been termed a homely manner in order to make the patients as comfortable as possible with beneficial vistas across the bay (HALSAM, ORBACH & VOELCKER, 2009, 413). The materials selected included local oolitic carboniferous limestone and Red St Bees sandstone. Internally the two curved staircases were constructed of Teak and the main dining hall had pitch pine roof timbers and panelling.

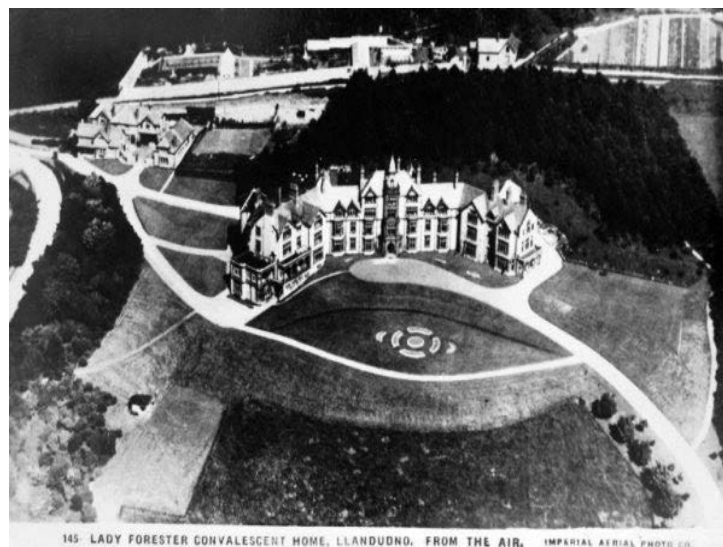
Plate 3 - Aerial photograph, early 20th century

2.3.18. On the south wing, to the east of the structure a small extension can be seen. This structure is not visible on early photographs of the building dated to between 1904 and 1912.

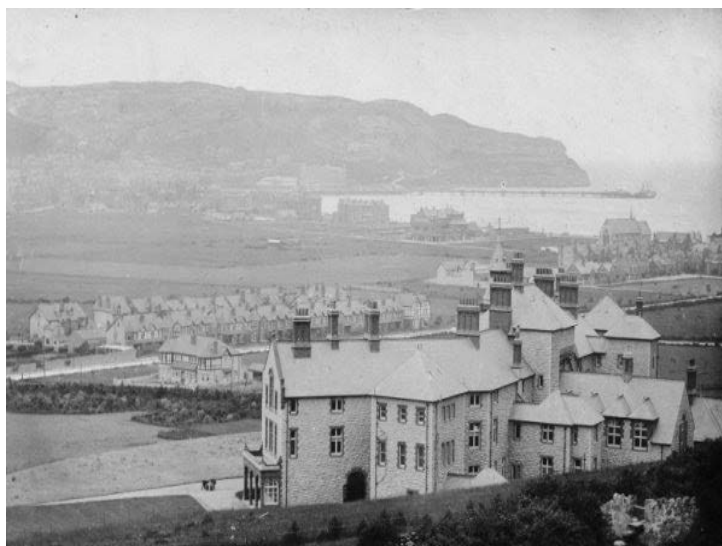
Plate 4 – Rear of south wing, looking west. Early 20th century.
Note the arched double door on the south wing, now obscured
by the theatre extension

4.2.39. Located to rear of the southern wing is a second three storey tower. This southern tower mirrors the northern tower, described in 4.2.23. above. The historic photograph shown in Plate 4 above shows the location of an arched double doorway. This has been replaced by the insertion of the theatre complex.

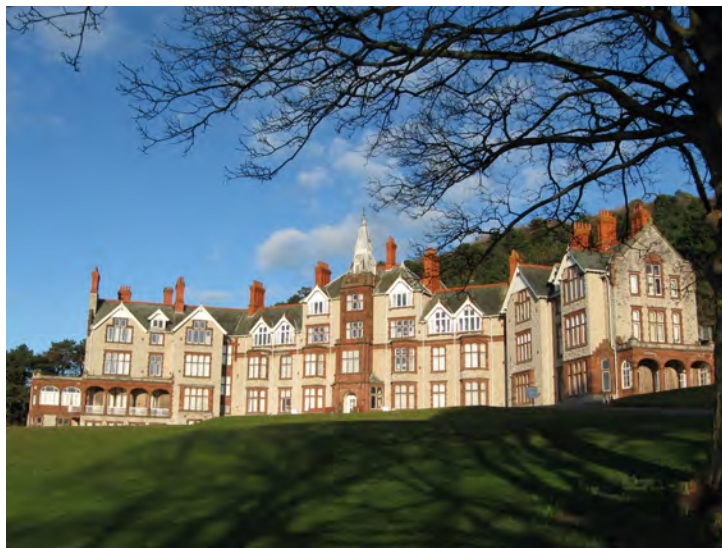
Plate 5 - General view of Lady Foresters Convalescent Home, looking northeast

4.2.2. The main frontage of the building faces Queen's Road to the south west and is made up of a symmetrical façade with two oblique wings extending to the north and south of a main central block. The central block comprises seven bays wide by three stories high, with the middle three bays extending to a fourth storey. The roof is of grey slate with a higher hipped slate roof over the fourth storey section to the centre. Rising up from the centre of the hipped section is a copper clad wooden centrepiece in the form of a spire. The apex of the roof is lined by decorative tiles.

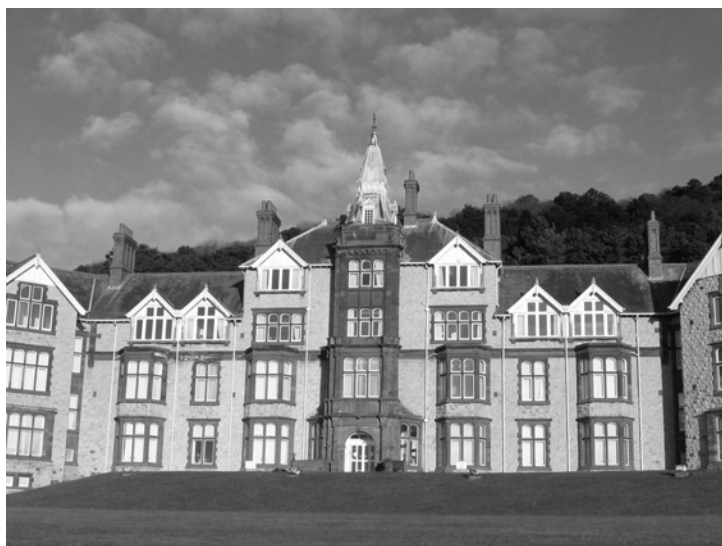
Plate 6 - Central block, looking east

- 4.2.3. The façade is of white limestone in a squared random ashlar construction with red sandstone dressings. The red sandstone has been used to form a projecting decorative central bay extending from the ground floor to the centrepiece. The main entrance is located within this central bay and is formed by a large red sandstone arch with prominent keystone. To either side of the arch decorative Tuscan columns are carved in relief onto the frontage. These columns frame a sandstone inscription which states,

- 4.2.5. Bays one, three, five and seven have mullioned eight pane transomed bay windows with the upper four panes being arched. Bays two and six have flush, mullioned, four pane transom windows also with arched upper panes. All windows have red sandstone lintels and sills and a decorative band of sandstone divides the first and second floors.

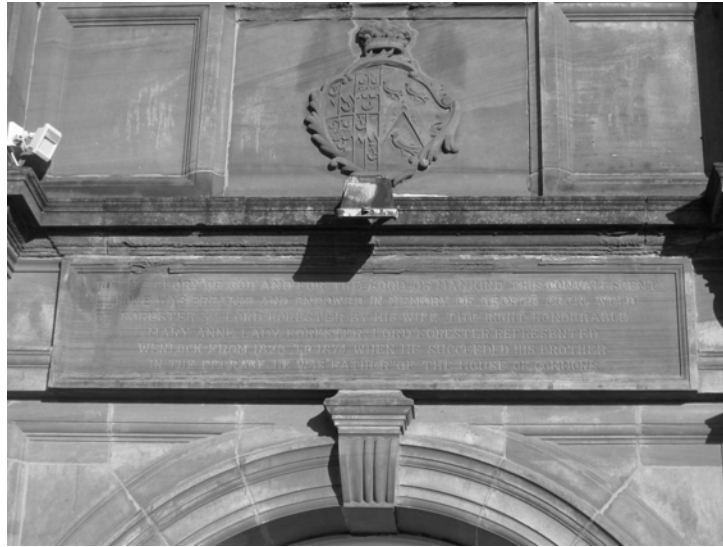
Plate 7 - Inscription above main entrance

- 4.2.4. Situated above this inscription is a the heraldic coat of arms of the Foresters carved in relief. A second inscribed stone, this one of granite, is situated beneath the southern window of the main entrance. This inscription reads,

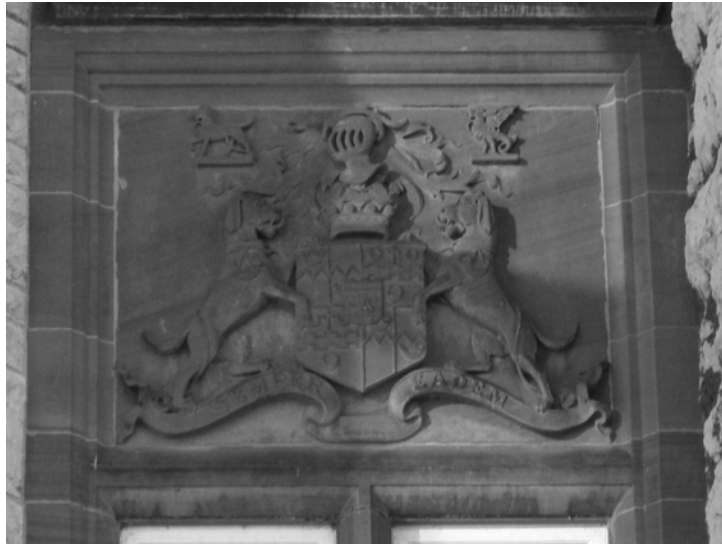
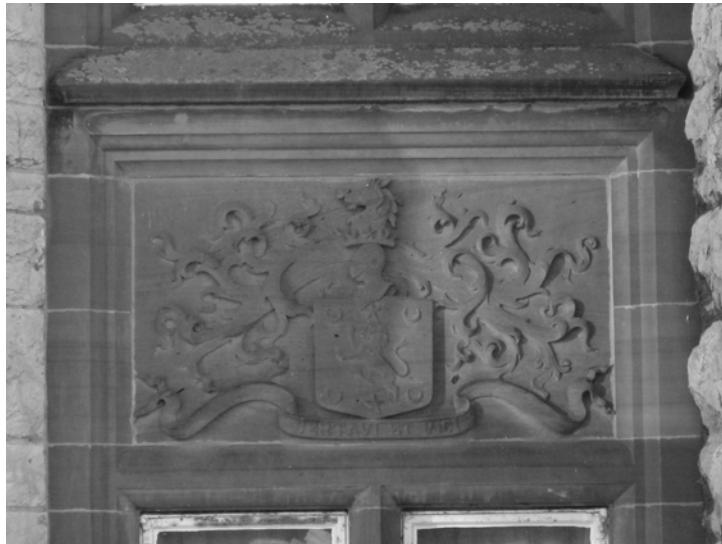
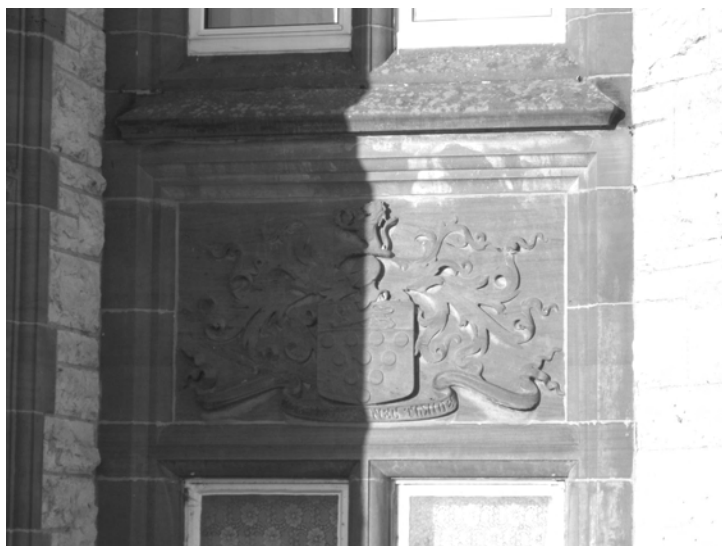
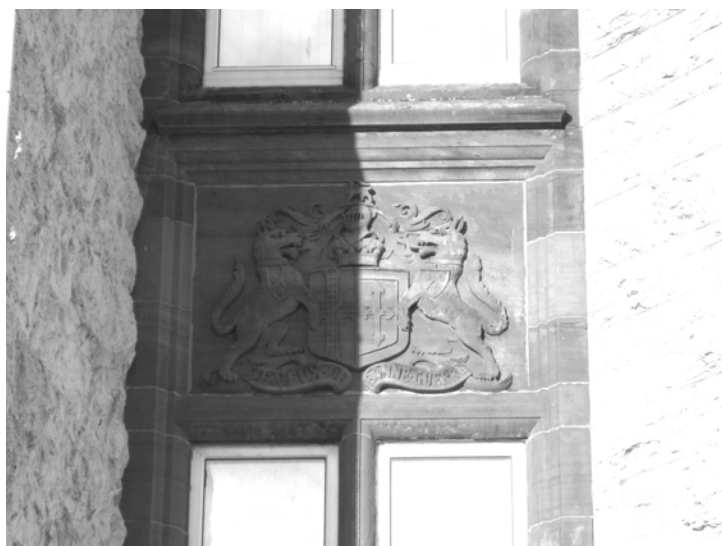
- 4.2.6. The upper windows of bays one, two, three, five, six and seven are all of wooden frame, with recent uPVC inserted units, with gabled pelmets.
- 4.2.7. At both north and south extents of the central block, where it butts the north and south wings, a recessed area can be seen. These recesses are located where the internal staircases are and as such the windows, four pane square mullion in form, are larger and offset from the other windows on this elevation. The recesses are of red sandstone and each have two sets of heraldic coats of arms in relief. It is thought that these coats of arms relate to the four other trustees in place when the home was founded.

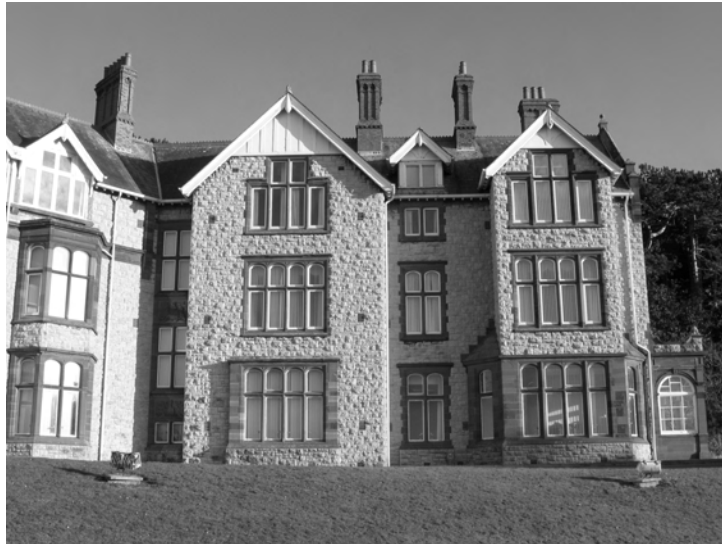
Plate 12 - South wing, looking southeast

4.2.9. The southern wing extends at an angle of 130° from the frontage and comprises three bays wide by three storeys high. The roof is of grey slate with crowning gables and decorative red tiles along the apex and red brick chimneys with multiple pots.

4.2.10. The frontage of the south wing is of white limestone in a squared random ashlar construction with red sandstone furniture. The first and third bays project out, forming a recessed central bay. The ground floor window of bay one project out to form a square red sandstone frame containing an eight pane transom window with arched upper panes. The ground floor on bay three extends out to form a large bay window of sandstone construction. The remaining windows on this elevation are flush, red sandstone, transom windows.

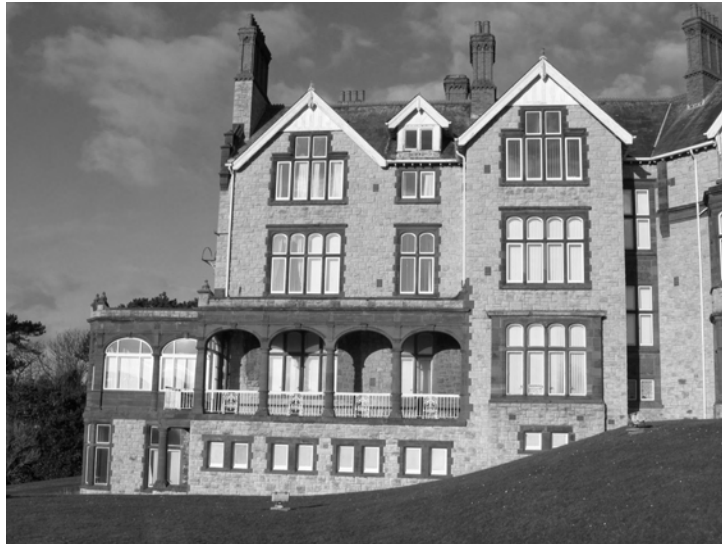
Plate 13 - North wing, looking north

4.2.13. The north wing is three bays wide by four storeys high. As the landscape of the garden drops significantly at this point the basement stands proud forming a lower ground floor façade. This wing sits at an angle to the central block mirroring that of the south wing.

4.2.14. As with the central block and south wing the bulk of the façade is constructed of white limestone in a squared random ashlar form with red sandstone features. A ground floor arched sandstone loggia is located in front of bays one and two.

- 4.2.15. Bay three matches bay one on the south wing with a projecting frontage forming a tower bay with flush sandstone window frames with transom eight pane windows with arched uppers. Bays one and two are flush with the frontage however these have the same window form as bay three.

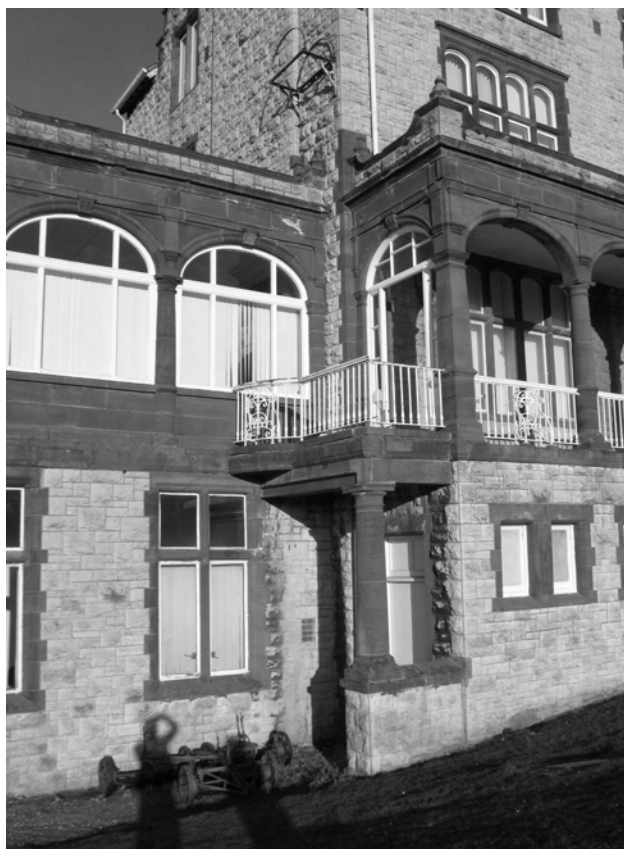
- 4.2.18. The construction form of this section indicates that it is an extension, albeit constructed within ten years of the original structure. The lower ground floor area can clearly be seen to butt the main structure and is not keyed in to the rest of the building. This is also evidenced by the sandstone extension of the loggia. Where the Tuscan column supports the loggia the sandstone block work does not match up in an unbroken course and is of slightly different material and form.

Plate 14 - North wing, where the extension butts the main structure, looking east

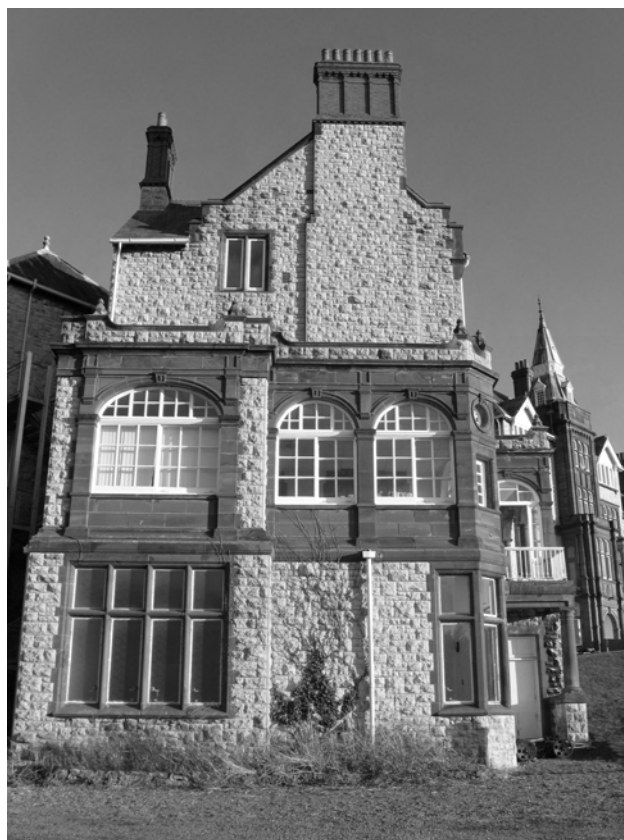
extension is chamfered with an angled six pane window on the lower ground floor.

Plate 15 - North wing, west end, looking south.
Chamfered corner visible to right

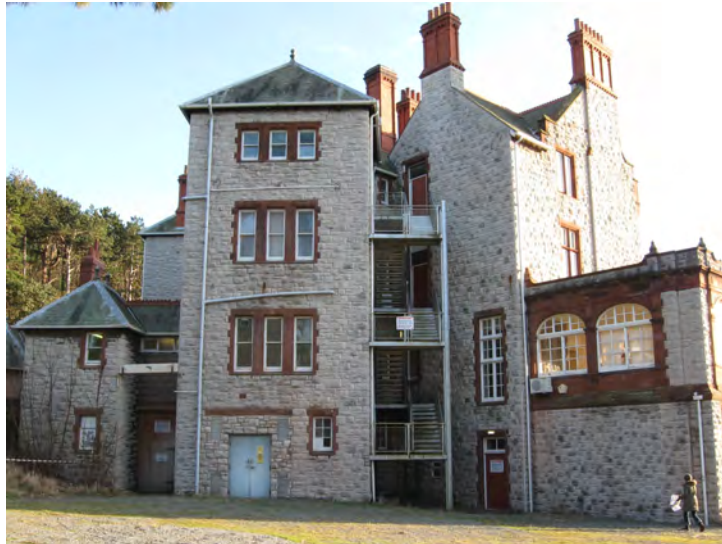
Plate 16 - North elevation, central area including tower, looking south

4.2.23. The central area contains the north elevation of the northern rear tower. At the north end and south end of the main building two towers can be seen, which are part of the original construction. The northern elevation of the north tower uses the same building materials and style as the frontage with flush mullioned transom windows on a limestone façade. The lower ground floor/basement contains a double metal doorway leading to the electrical supply room. Building scars around this doorway indicate that this is inserted and a wider doorway was originally in place here. A wider sandstone lintel is still in situ on the building and a small six pane window can be seen to the west of the doorway.

4.2.24. To the east of the tower a single storey wooden wall with a single width door can be seen at the lower ground floor level. This leads to the inner courtyard, discussed later in this document and can be seen to be a late 20th century insertion.

- 4.3.5. Room 1, the lower hallway, is located to the north of the north wing. This is accessed from the outside via a doorway seen on Plate 16 to the lower right of the image. The room contained a teak panelled stair case with small under stairs cupboard and large metal safe. The staircase led to the ground floor of the north wing.

4.3.23. In the northern corner of the courtyard was an isolated room, which forms the basement for the small tower seen on Plate 16. This tower is attached to the main north tower at ground floor level by a modern corridor. Plate 43 Shows the modern junction at ground floor level of the north tower, to the left, and the isolated tower, to the right.

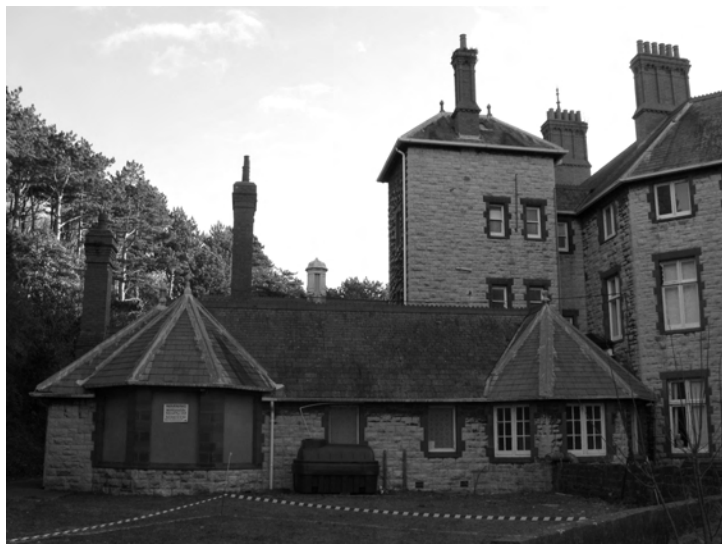
Plate 17 - North annex, looking southeast

4.2.25. To the rear of the main building is the north annex, a single storey structure with bay windows at the east and west ends.

4.2.26. The roof is of grey slate with decorative ridge tiles, matching the roof like of the main building. As the structure is single storey the roof fans out over the bay windows to create a canopy.

4.2.28. The windows on this elevation differ in form as they progress from west to east. The western bay window has been boarded up, the central two windows are single pane wooden framed windows of frosted glass. The eastern windows are a series of three, one on each face of the bay, twelve pane wooden framed windows.

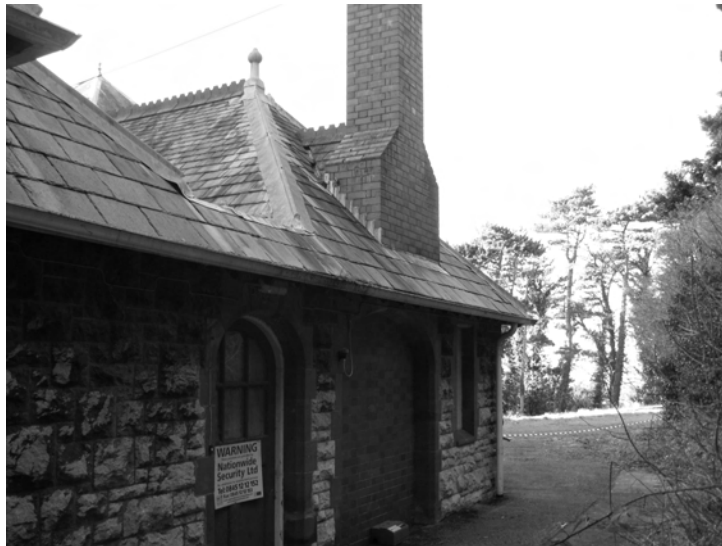
Plate 18 - Rear, eastern, elevation of the north annex, looking north

4.2.31. The entrance to the kitchen area is a wooden frames, arched, doorway with an outer sandstone frame. To the north of the kitchen entrance a larger sandstone arch and sandstone window frame have been bricked up with hard fired red brick.

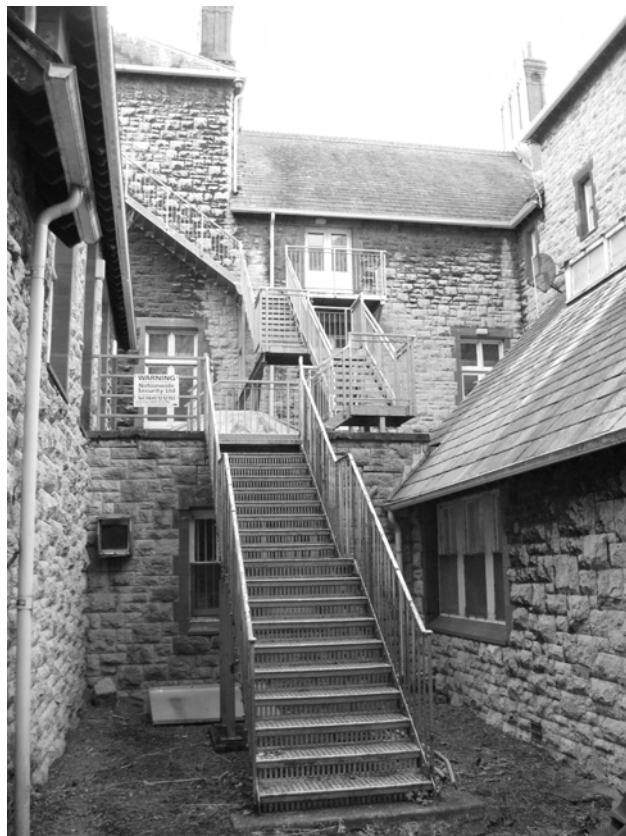
Plate 19 - Recess between north annex and main hall, looking west

4.2.32. Between the north annex and main hall to the south is a narrow recess that leads to the rear of the central block. This contains a series of modern metal fire escapes and can be seen in the plate below.

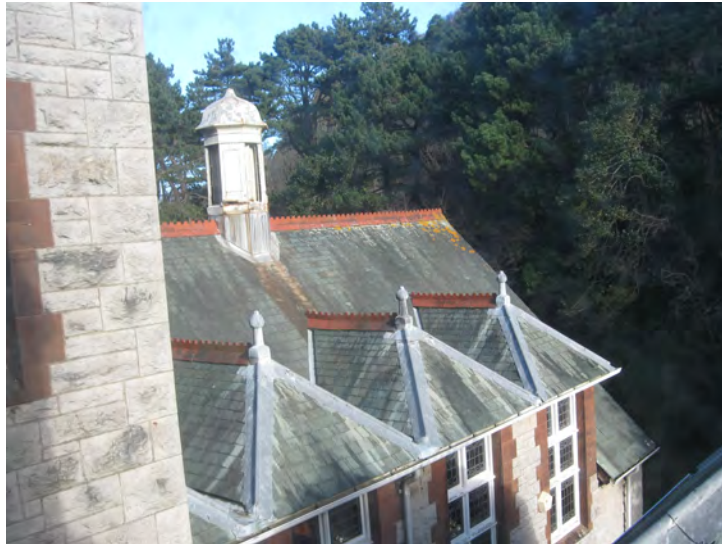
Plate 21 - Main hall roof line with cupola, looking east

4.2.35. The main hall extends up two storeys and has a large double height sandstone window divided into three elongated upright sections by large mullions. The central section has a rounded arched lintel.

4.2.36. Along both north and south faces of the hall at first floor level there are a series of sandstone framed six pane dormer windows with rounded lead finials at the gable apex.

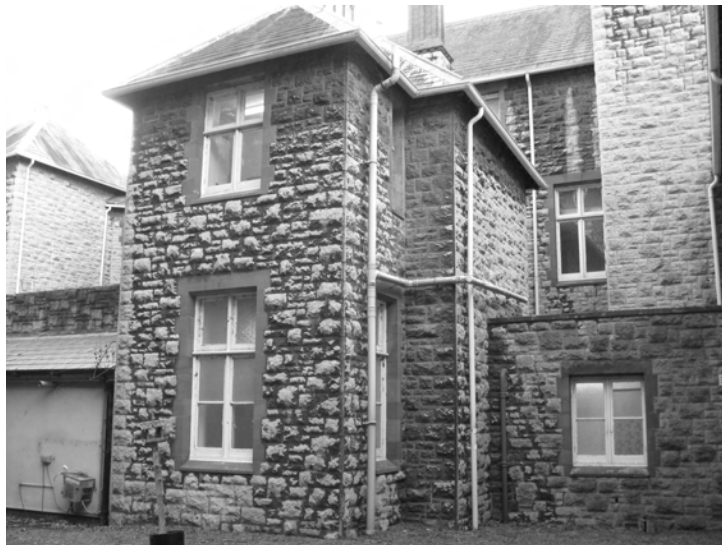
Plate 22 - Two storey annex, looking southwest

4.2.37. South of the main hall is a two storey annex projecting out from the south wing which has a hipped slate roof and is of white limestone construction with red sandstone decoration. This is contemporary with the original building and is keyed into the main structure. This is thought to have originally been a toilet block attached to the south wing, matching a similar annex off the north wing.

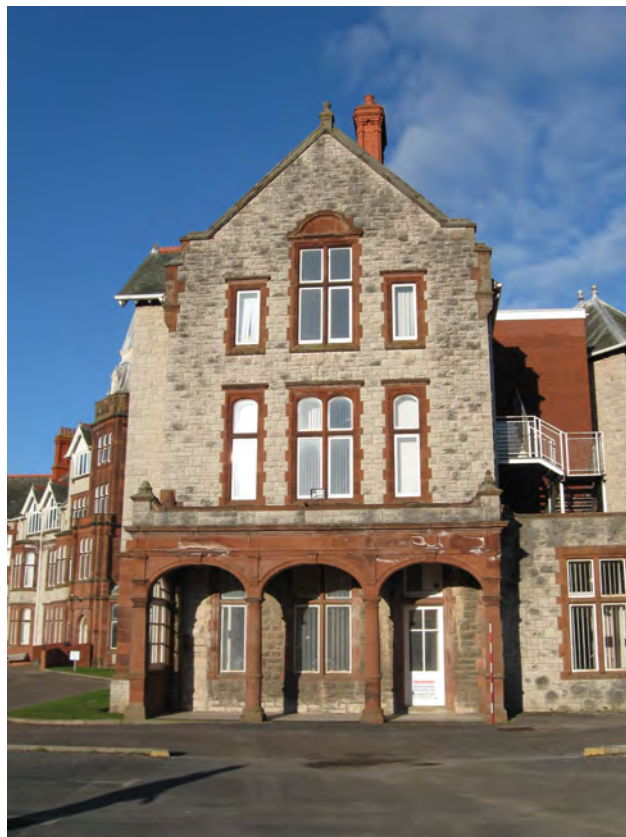
Plate 23 - South wing, looking north

4.2.41. The southern façade of the south wing is of white limestone in a squared random ashlar form with red sandstone decoration. This is the gable end of the south wing which has a kneelered gable with sandstone coping. The window frames are all sandstone, matching those seen on the other faces of the building. On the first floor a sandstone loggia mirroring the one seen on the north wing stands proud of the main structure. This is made of three sandstone

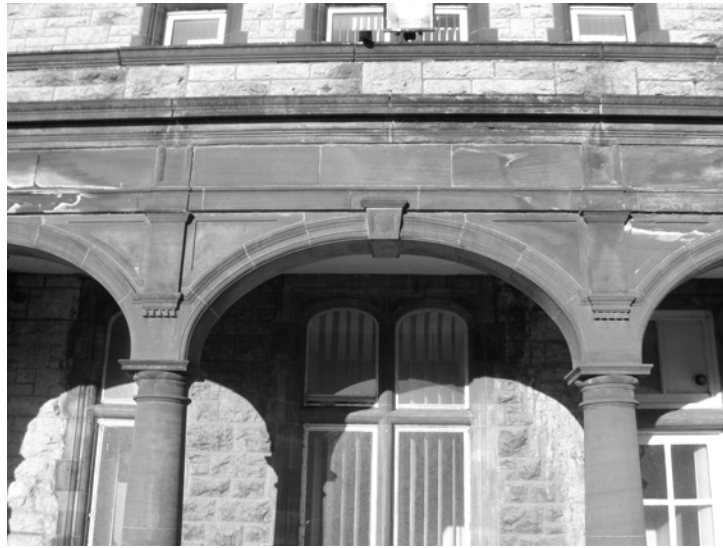
Plate 24 - Loggia arch detail

arches with Tuscan columns and prominent keystones.

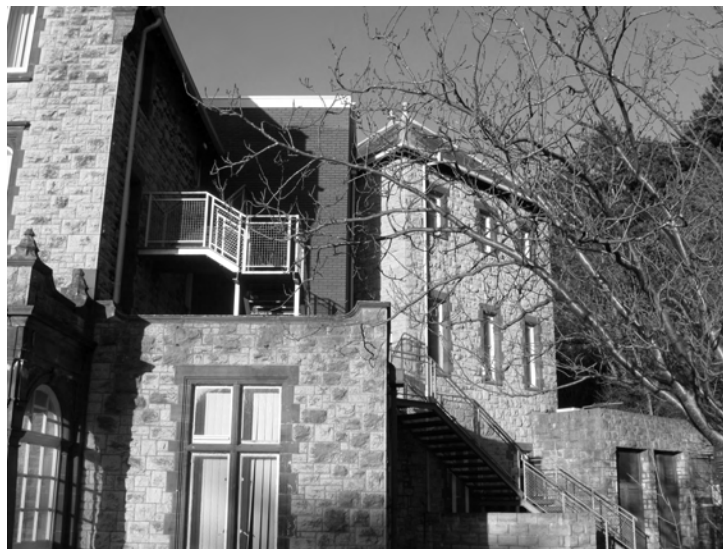
Plate 25 - Southern elevation of south tower and theatre extension

4.2.43. To the east of the loggia is a flat roofed single storey extension one bay wide which dates to the between 1904 and 1912. This is also constructed of white limestone with red sandstone decoration in order to match the main façade.

4.2.44. Behind the single storey extension is a late 20th century red brick addition housing the lift shaft mechanism.

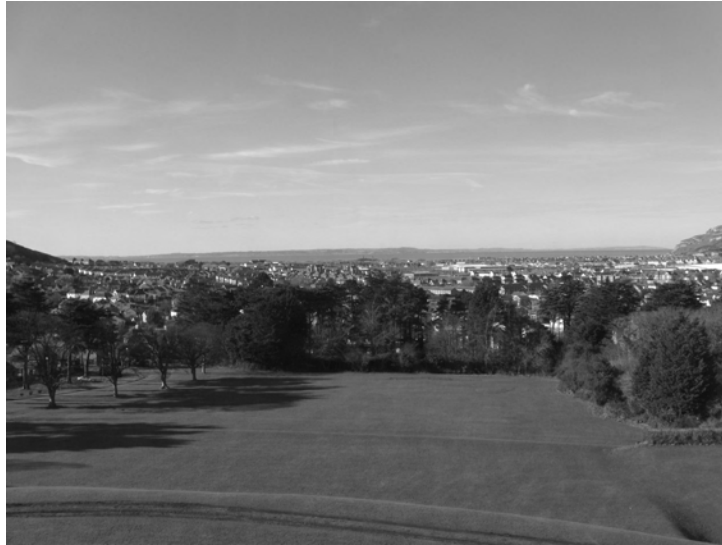
Plate 26 - Front landscaped garden, looking west

4.2.45. The area to the west of the building has been landscaped into a series of terraces leading to Queen's Road. In front of the main entrance is a level area following the later 19th century path alignment. This has been paved with tarmac to form the main access road to the property.

4.2.47. The lowest section of the garden is an open space gently sloping down to the level of Queen's Road (PLATE 26).

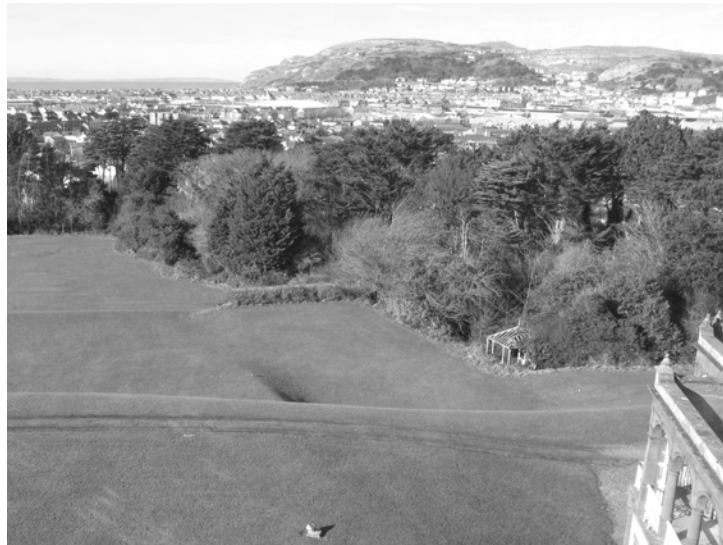
Plate 28 - Tennis court area and gazebo, looking west

4.2.46. The landscape steps down approximately 2m from this upper level onto a grassed garden area which has an access track leading to the rear of the property. At the northern end of this terrace is a level platform which was used as a tennis court in the past. This has a derelict wooden gazebo situated on its

north side.

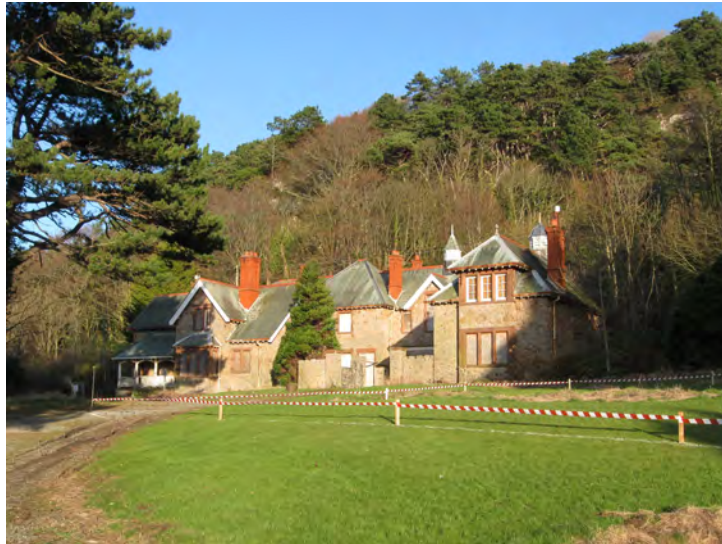
Plate 29 - Outbuildings to north west of main building,
looking north west

4.2.49. The buildings are of a rougher construction than the main building and are of grey limestone in a random irregular ashlar form. However they do retain the same decorative red sandstone features around the door and window frames. The roof is also in grey slate with decorative ridge tiles and red brick chimneys.

4.2.50. The structures also have decorative wooden cupolas with copper caps, matching the cupola atop the main hall of the convalescent home. A wooden porch on the north east corner of the northern outbuilding is reminiscent of the sandstone arched loggias of the main structure.

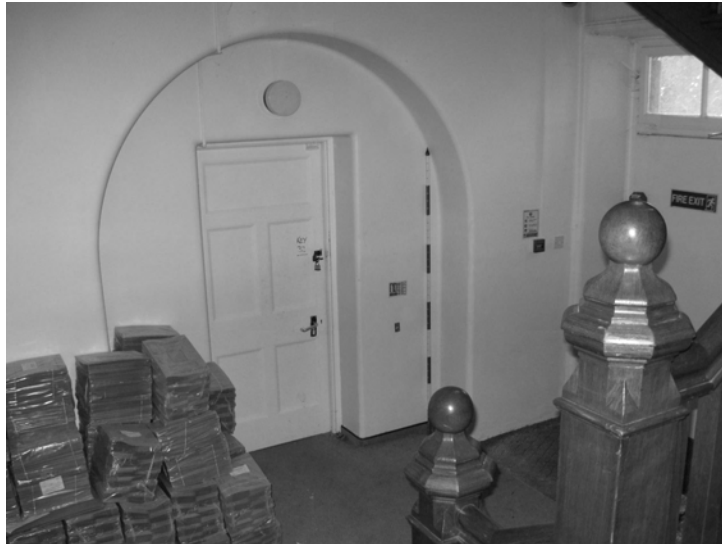
Plate 31 - Room 1, looking northeast. 2m scale

- 4.3.6. The room has been plastered and painted white, with teak high set skirting boards. On the northwest wall a large archway was prominent and it is clear that this was the original external wall.

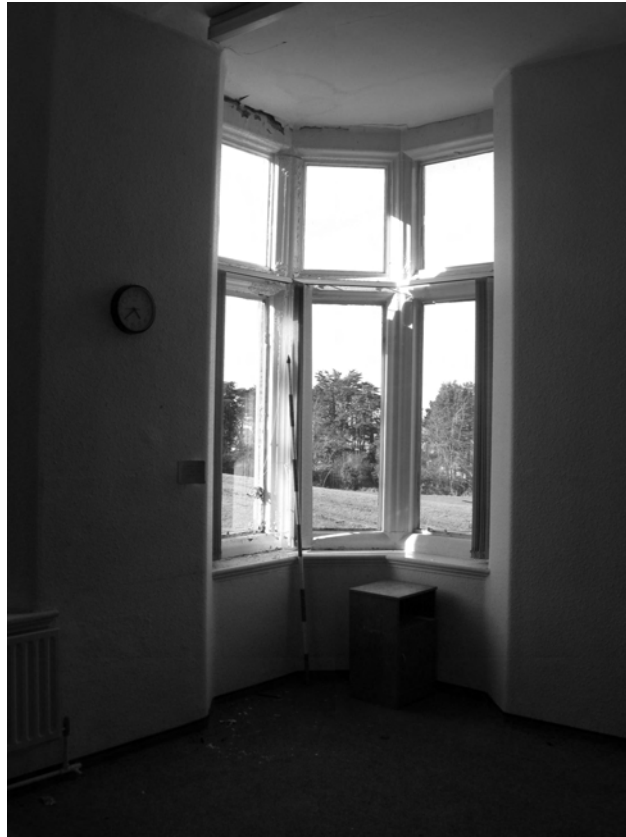
Plate 32 - Room 4 corner window, looking west

- 4.3.7. Room 2 is a narrow passageway leading to Rooms 3 and 4. These three rooms are divided by modern internal partition walls within the floor plan of the early 20th century northern extension discussed in 4.2.18.
- 4.3.8. Room 3 has eight pane, stone mullioned, windows with metal inset frames. These are deep set windows with chamfers on the stone frames leading back to the metal frames. It is thought that the windows are the original fittings dating to the early 20th century.
- 4.3.9. Room 4 was used as a staff room and has the same window form as Room 3, however the western corner had a wrap around stone mullioned window with metal inset frames.

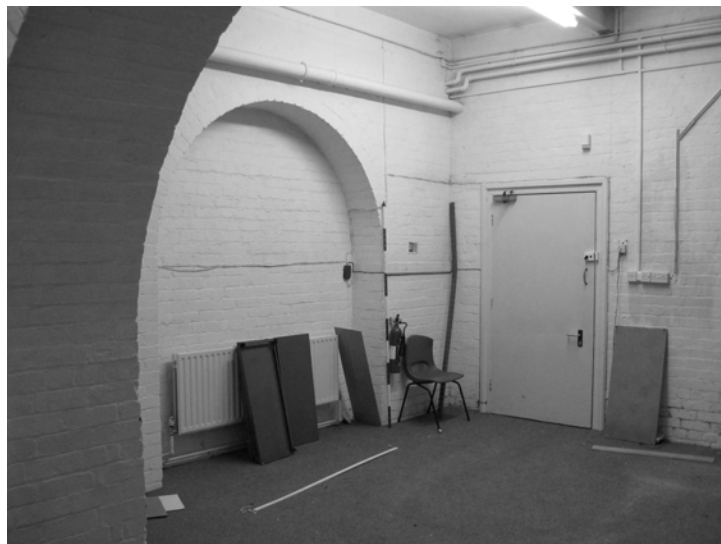
Plate 33 - Room 5, showing bricked up arch, looking northwest. 2m scale

4.3.10. Room 5 was a large square room to the south of Room 1 which has painted brick walls with a bricked up arch on the northwest wall. This supports the theory that this was originally an external wall. A second arch divides the smaller southern section of the room from the larger main area.

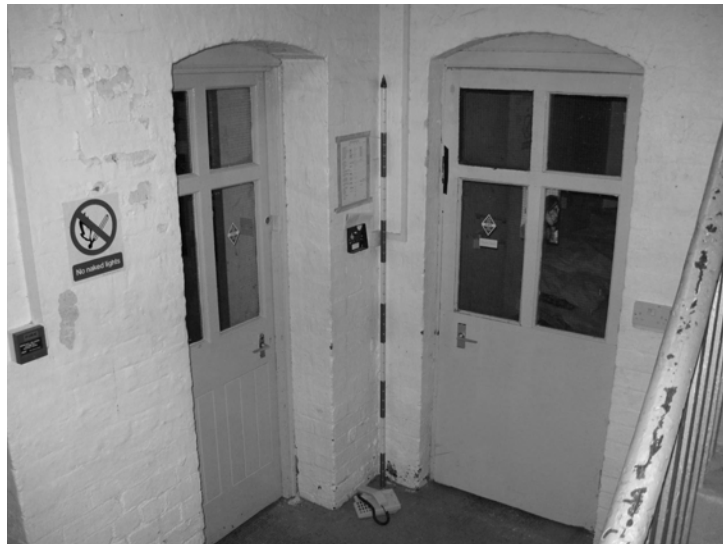
Plate 34 - Entrance to Rooms 14 and 13 respectively, from Room 12. Looking north. 2m scale

4.3.12. Internal access to the eastern section is via Room 12 which is a small utilitarian stairwell lit only by the electric light. Leading off Room 12 to the east is a small laundry room, 13, which had no windows and had plasterboard on all walls.

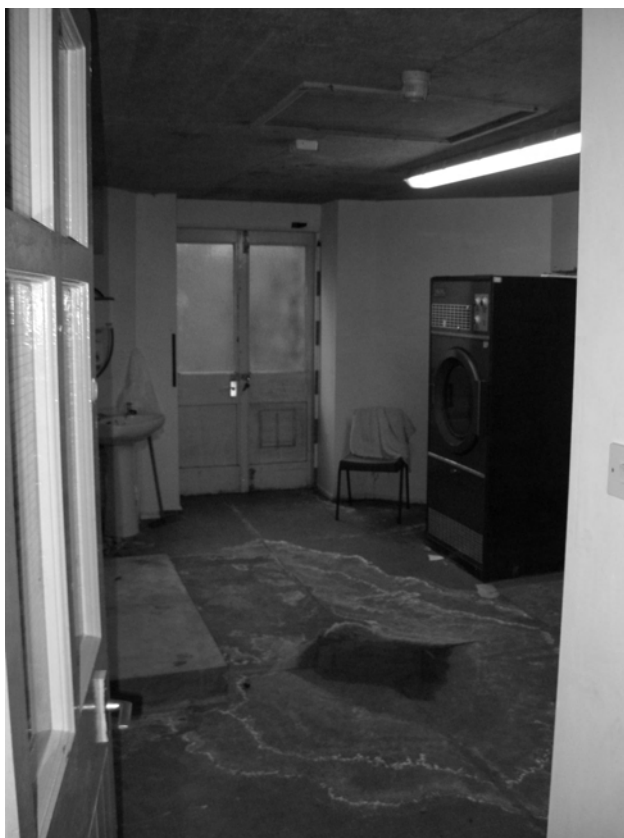
Plate 35 - Room 14, looking north. 2m scale

4.3.13. To the north of Room 12 is the main laundry room, 14, which contained the industrial washing machine and sink. The floor was a simple concrete floor with a drainage sump in the centre. The ceiling had been lowered using wooden boards, however in the northwest corner elements of the original ceiling could still be seen in tact approximatively 0.3m above the wooden boards. The northern end of the room formed a bay with a stone window to the east and a thin double door in the centre. This lead to the inner courtyard.

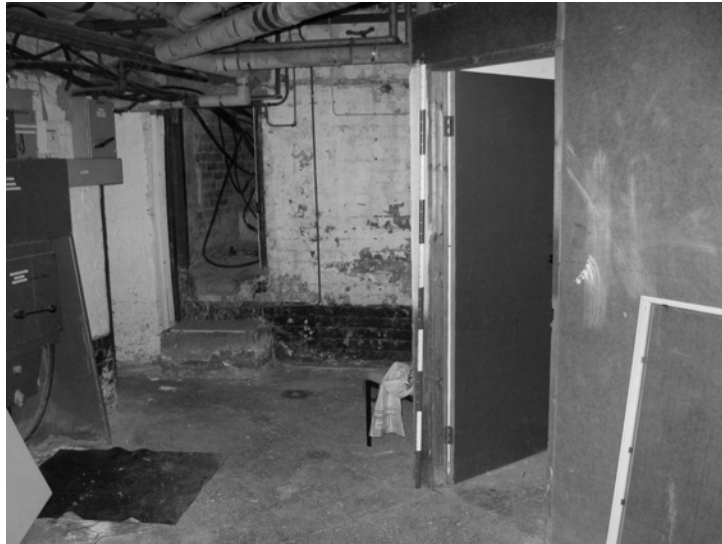
Plate 36 - Room 9, looking east. 2m, scale

4.3.14. Rooms 9 and 10 are a single unit room with a temporary wooden partition separating the area in two. The floor was an untreated concrete surface and the walls were painted brickwork in English Garden Wall bond. The wooden partition did not reach ceiling height as much of the large bore plumbing was located running along the ceiling. This area was set approximately 0.3m lower than the floor level for rooms 12 to 14.

4.3.15. The north wall of Room 9 housed the main electrical switch gear and fuse boards for the property.

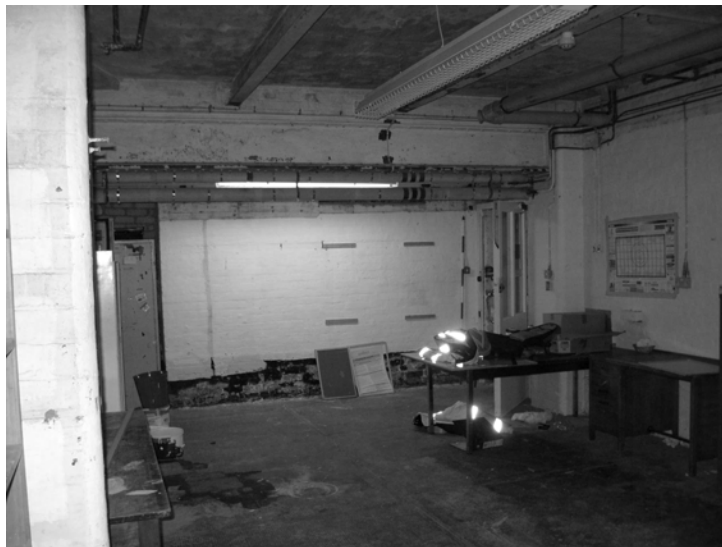
Plate 37 - Room 8, looking north. 2m scale

4.3.16. To the west of Room 9 was a large open space, Room 8, with a narrow annex at its southwest corner, Room 15. These have been treated as a single entity and are believed to be a workshop area and associated store room. The floor, as with the rest of this section of the lower ground floor, is of untreated concrete with painted brick walls in English Garden Wall bond.

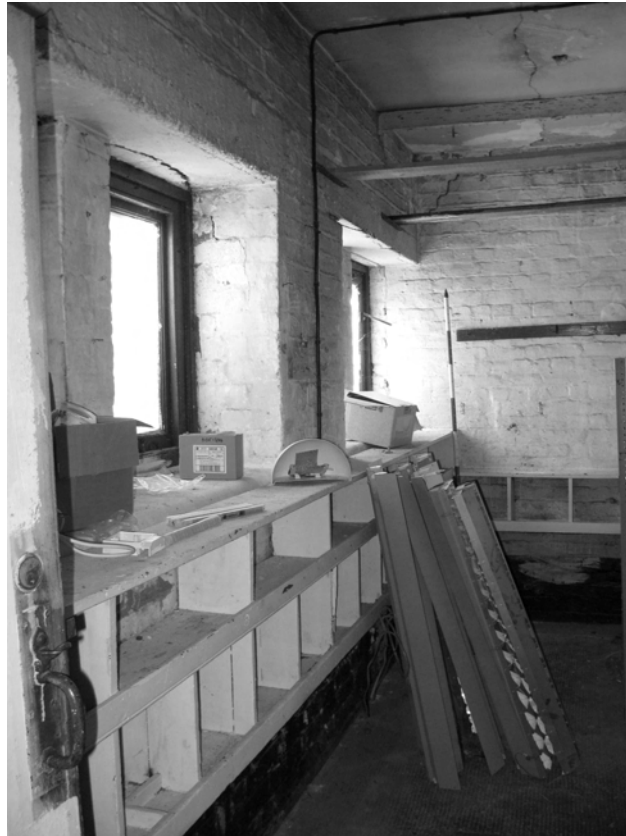
Plate 38 - Room 15, looking west. 2m scale

to Room 15 at the southwest corner of Room 8, which is a narrow storage area with two full size wooden framed windows along the south wall. This appears to be the area where the landscape drops outside the structure and as such larger windows have been employed to allow more light in. On the north wall of Room 15 a large brick arched window give a view into Room 6.

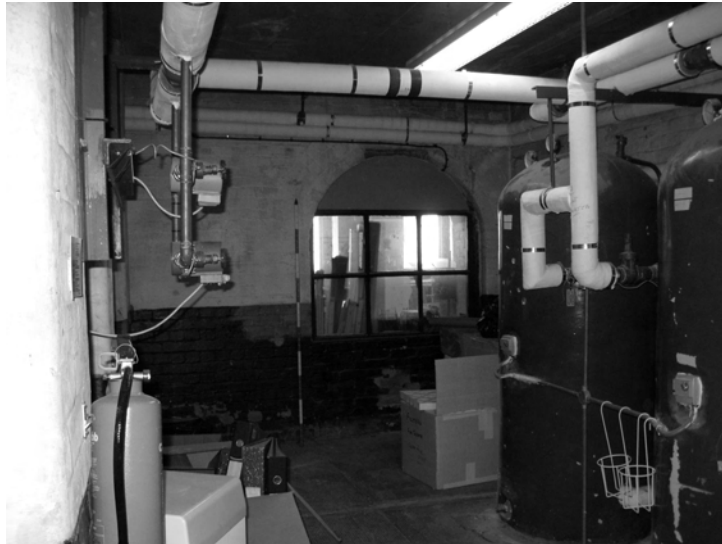
Plate 39 - Room 6, looking southwest. 2m scale

4.3.18. Room 6 contained the boilers supplying the building and associated plumbing. As with the other rooms it had a concrete floor with painted brick walls. The window noted above had an arch of three header courses of brick over a six pane wooden window. To the north of Room 6 was a short corridor which led to a narrow room, Room 7, with a screed floor and single window on the north wall. The east wall is clearly a modern brick partition wall inserted in the late 20th century. Originally this would have formed part of Room 17, which now contains electrical equipment with no access. Both Rooms 7 and 17 are within the floor plan of the north tower.

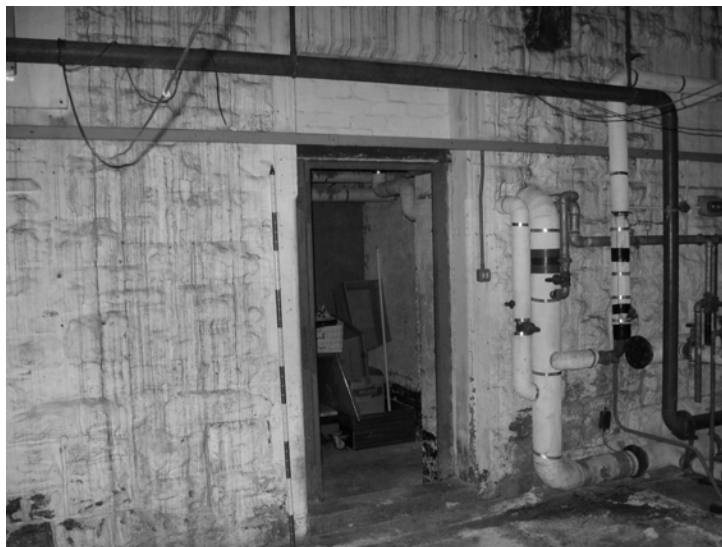
Plate 40 - South wall of Room 11, 2m scale

4.3.19. Room 11 is located to the north of Room 9 and is a lean to that has been built in the inner courtyard against the old north wall of the building. The south wall of Room 11 is clad in white limestone in a random squared ashlar form. This is clearly an earlier external wall that has been incorporated into the modern brick and timber lean to.

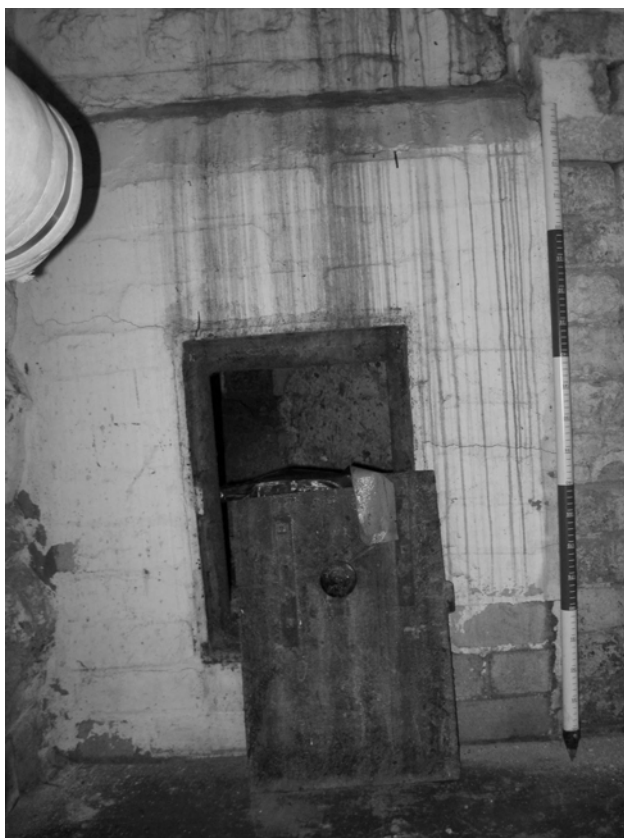
Plate 41 - Chimney access in Room 11, 1m scale

4.3.20. The room contains a row of modern boilers sat on a concrete slab with a sloping slate roof. The west wall houses an iron access panel to the large chimney situated in this part of the building and the south wall houses a large iron aperture, now blocked up, which would have given access to Room 8 for any external plumbing.

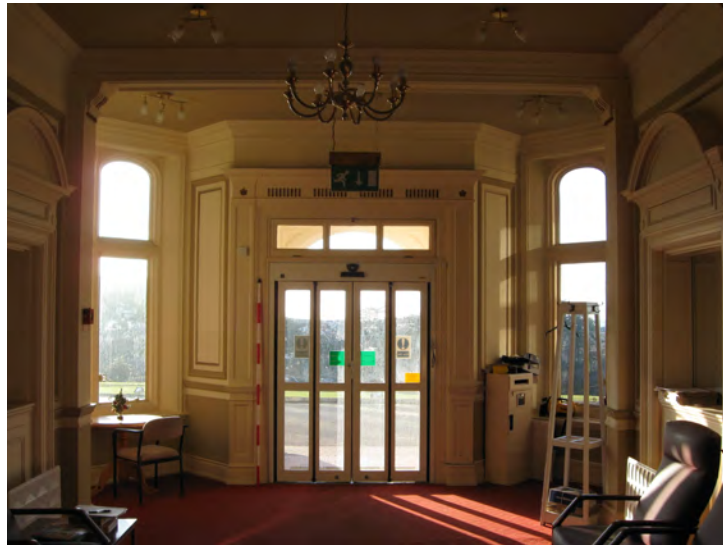
Plate 44 - Main entrance, Room 50, looking west

4.3.28. The main entrance, Room 50, has a wide windowed bay doorway. The windows on either side sit in small recesses and decorative architrave and panelling with gold trim dress the entire room. A series of three evenly spaced beams with supporting half buttresses line the room which have been decorated to match the panelling.

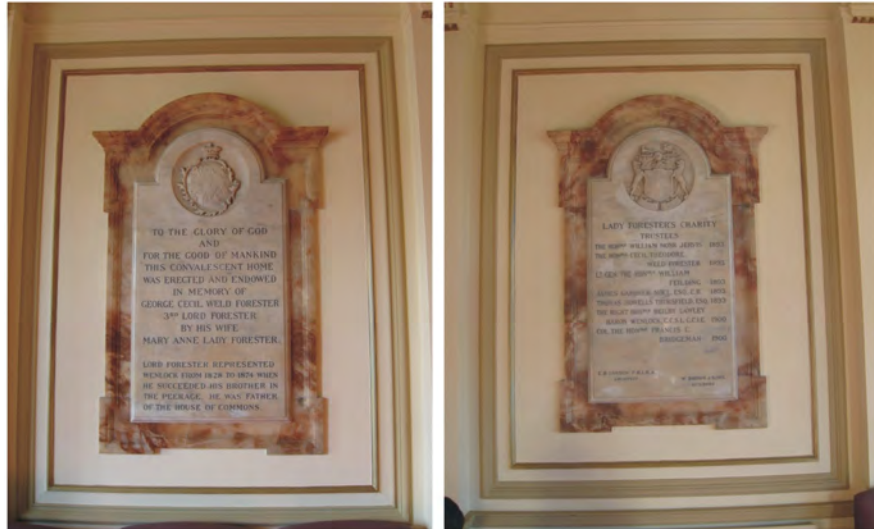
Plate 46 - Entrance hall plaques, north & south respectively

4.3.29. A series of two panels are located on the north and south walls respectively. Two of the panels house inscribed plaques. The northern plaque commemorates the construction of the convalescent home, whereas the southern plaque lists the

original trustees. The other two contain large mirrors with cowling above them mirroring the door frames by the reception desk. Above the reception desk are a series of four arched stained glass windows which open onto the main hall.

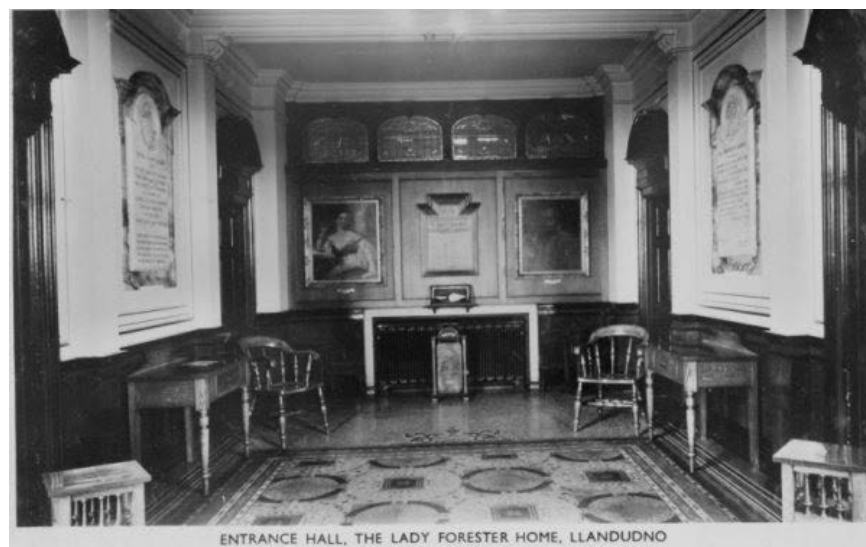
Plate 47 - Photograph of entrance hall dated to the early 20th century

4.3.31. Historic photographs of the entrance show that the area housing the reception desk once had a wood panelled wall with a third plaque.

4.3.32. Carpet has been put in place in the entrance so it is unclear as to whether the original mosaic floor seen in Plate 47 is still in situ.

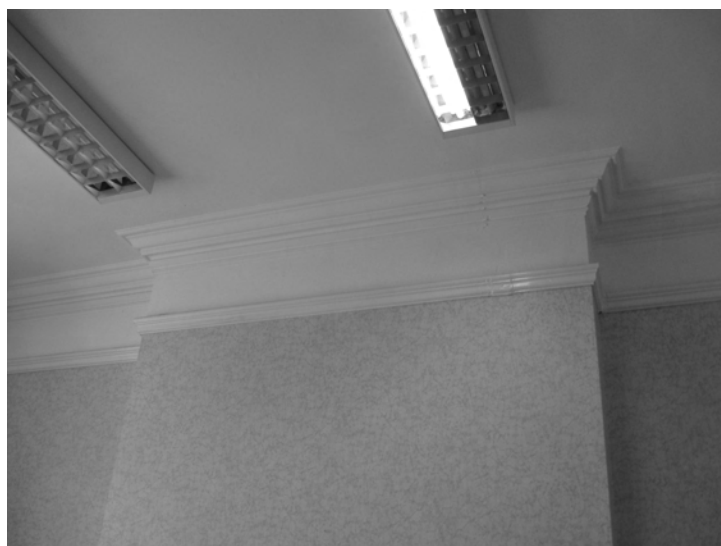
Plate 48 - Cornicing in Room 1 on chimney breast

4.3.34. Room 1 has a large chimney breast on the south wall and has a stone mullioned bay window on its western wall. Moulded cornicing surrounds the room at the ceiling and high, moulded, skirting board is located at floor level.
