Historic Building Recording at

ST DUNSTANS LLANDUDNO

For St Dunstons Enterprises Ltd

Doc Ref: LP0950C-HBR-v.1.2

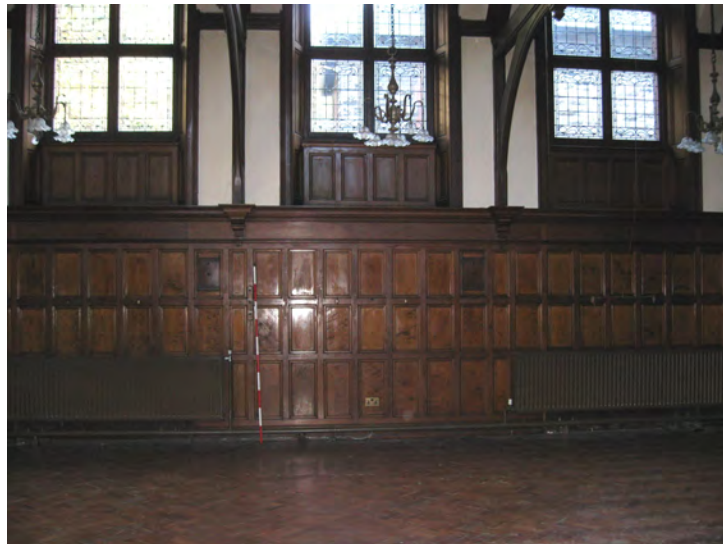
Plate 49 - South wall of main hall, showing panelling. 2m scale

4.3.40.The hall has a timber roof of pitch pine with pitch pine panelling to a height of approximately 2.5m around the room and pitch pine parquet flooring. A large leaded window takes up the bulk of the west wall and 1st floor windows allow a large amount of light in from the north and south walls.

4.3.41.Housed within the panels are a series of small metal vents, three on each wall, to allow air flow into the room. These are hinged at the base and have the makers mark of “Boyles air inlets, London”.

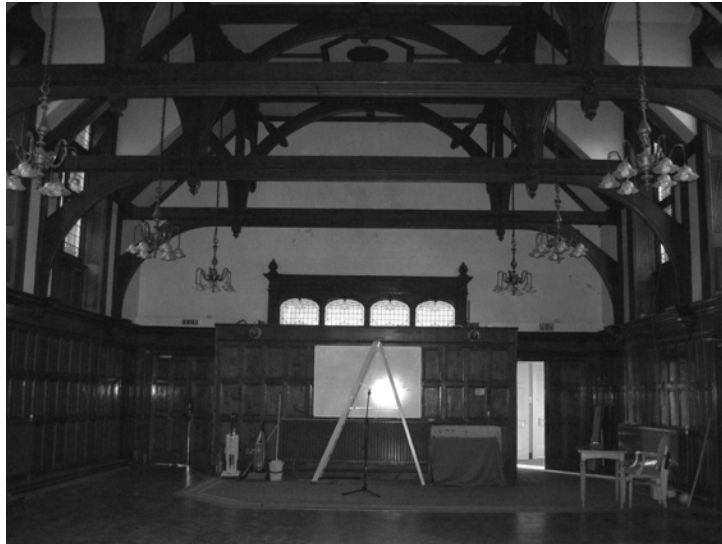
Plate 50 - West wall and vestibule of main hall

- 4.3.42. To the east end of the hall a pitch pine vestibule has been constructed to match the rest of the room. This is a modern insertion to house the reception desk seen in the main entrance.

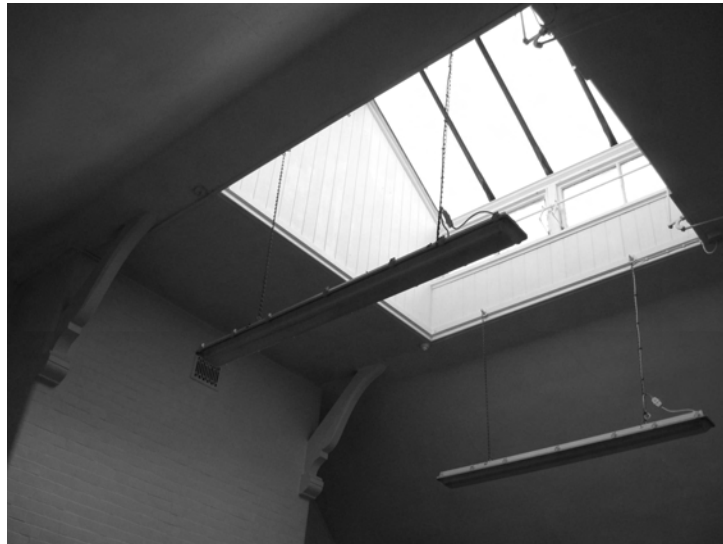
Plate 53 - Skylight in kitchen area, room 68

4.3.50.Allowing light into both rooms are large hipped skylights which straddle the chimney breast. These match the form of the smaller skylight seen in room 64 and retain the same pulley system to allow the skylights to open from the ground floor.

4.3.51.Decorative struts support the joists and skylight in the kitchen area to allow an open plan room with double height ceiling.

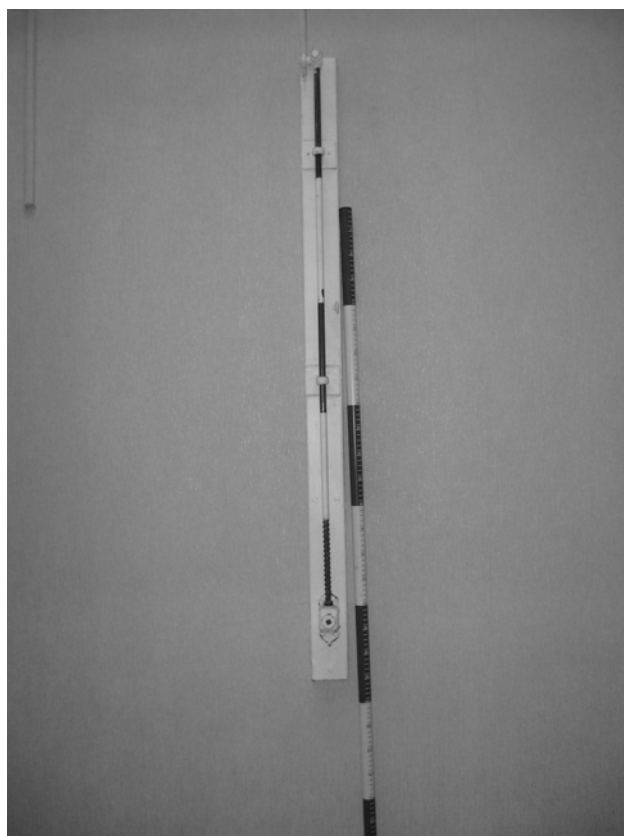
Plate 54 - Skylight pulley handle fixture

4.3.55. Within corridor 70 a skylight matching that seen in room 64 allows light into the area. As with the other skylights a mechanical pulley system with fixtures for a handle is located on the north wall.

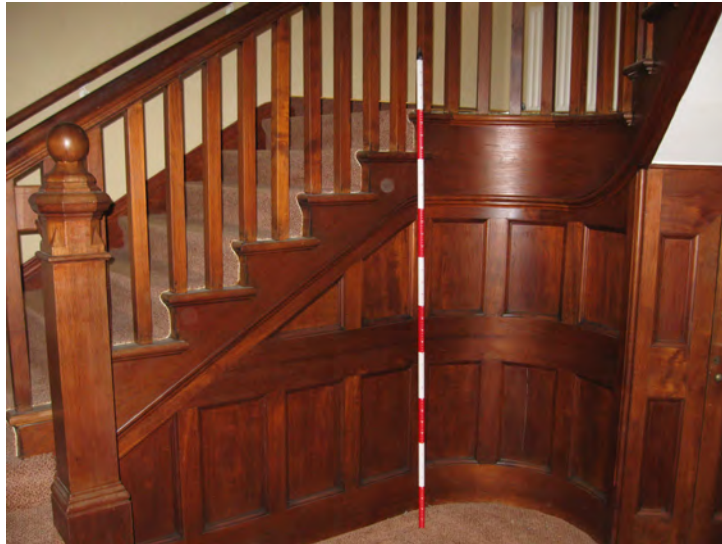
Plate 55 - Main staircase leading to the upper floors

4.3.57. At the southern end of the north wing a large teak panelled staircase gives access to the upper floors within room 82.

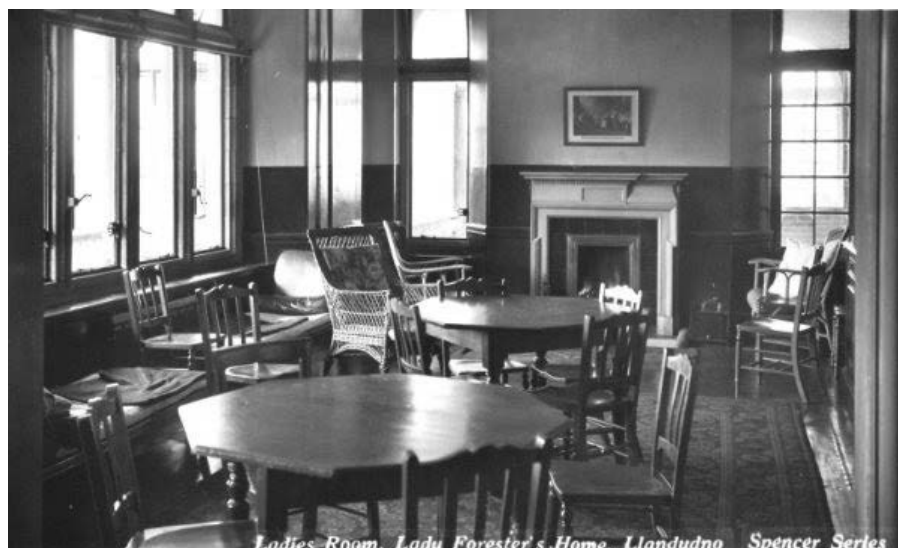
Plate 56 - Ladies room in the early 20th century, looking north

4.3.60. Rooms 90 and 91 are divided by a modern partition wall and these two rooms would have originally formed the ladies day room.

4.3.61. The windows on the north wall have since been blocked up, when the north

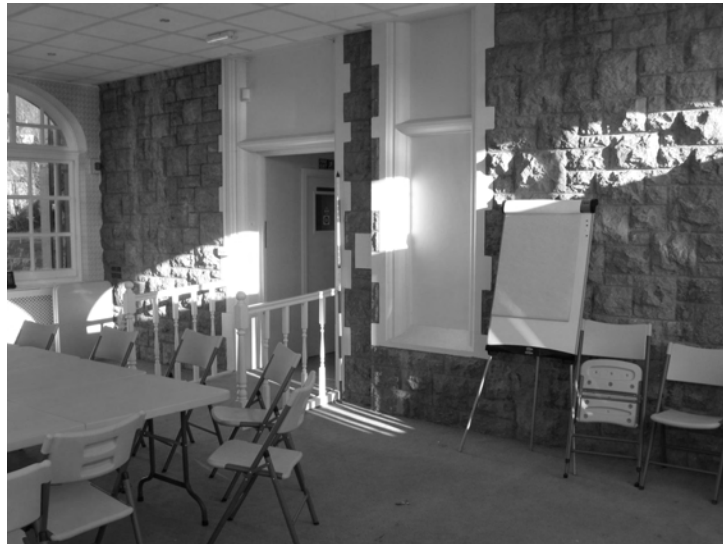
Plate 57 - South wall of room 92 showing blocked up window and entrance

4.3.63.. At the northern end of the north wing was a large open plan room, 92. The south wall of this room was of exposed limestone block with two boarded up windows. The windows had red sandstone frames and it is clear that this was once an external wall. The extension is thought to date to the early 20th century, certainly pre 1912 as it appears on the Ordnance Survey map of this date.

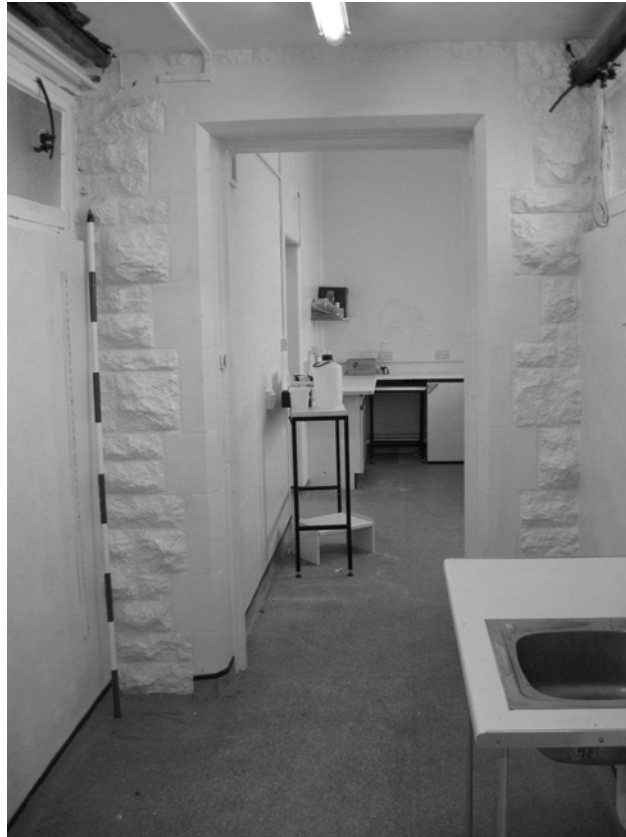
*Plate 58 - Junction between rooms 99 and 97,
looking west*

4.3.65. To the east of 97 is a small room, 99, which is used as a laboratory. Joining Rooms 97 and 99 is a short wood panelled corridor, 98. This is clearly a mid to late 20th century addition. These rooms would have been distinct from each other in the past, and topographically stand at different levels. The floor of Room 98 is a suspended floor traversing a gap over the north end of the inner courtyard (PLATE 43). Exposed stone walls indicate that these walls were once an external feature.

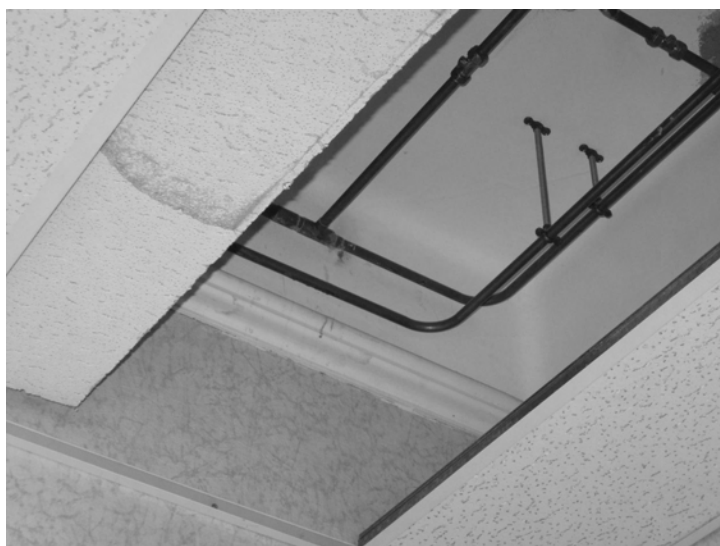
ground level. These are typical of the early 20th century construction. As with all of the rooms in the building the fireplace has been boarded over. A lowered ceiling of lightweight ceiling tiles in a metal frame has been inserted, however where the ceiling tiles are missing the original ceiling and architrave is visible in situ.

Plate 59 - Architrave hidden by lowered ceiling

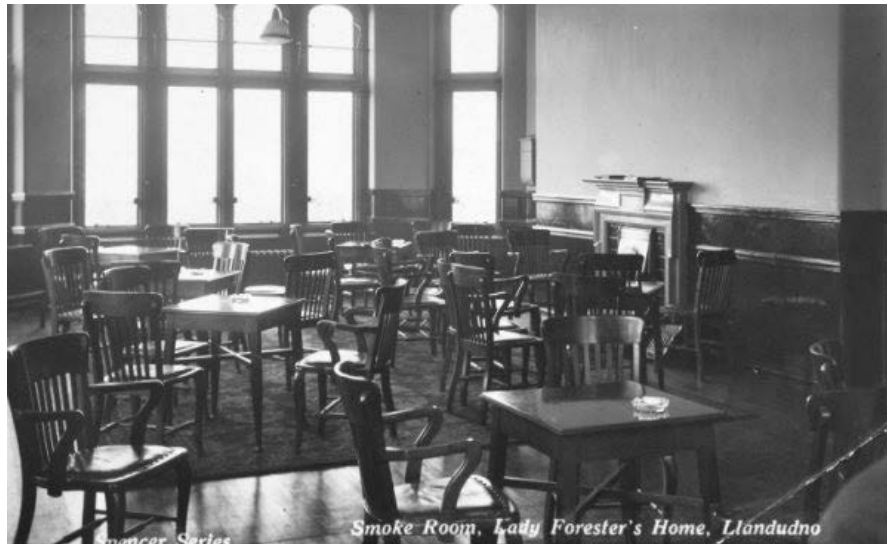
Plate 60 - Smoking room in the early 20th century, looking west

4.3.70. The final room to the south, 29, had been subdivided into four areas. Rooms 28, 30 and 31 are all modern subdivisions of 29, which was originally used as the smoking room in the male wing. The decorative skirting boards and architrave are also present, albeit hidden by the lowered ceiling in these rooms.

- 4.3.71. Historic photographs of the room show its original appearance.
- 4.3.72. Room 28 had also been modified to include the early 20th century extension to the east of the smoking room. Rooms 32, 33 and 34 relate to this extension, which had also been subdivided to form these three units.
- 4.3.73. To the southeast of the building, on the ground floor, a series of rooms have been constructed in the mid to late 20th century to form a series of operating and clean rooms to service the needs of the patients. As these are all clearly modern additions and hold no historic character they will not be discussed here.
- 4.3.74. The main corridor lining the day rooms on the west of the south wing retains several original features including a series of large arches on the east wall, now blocked up, and an octagonal skylight in area 37.

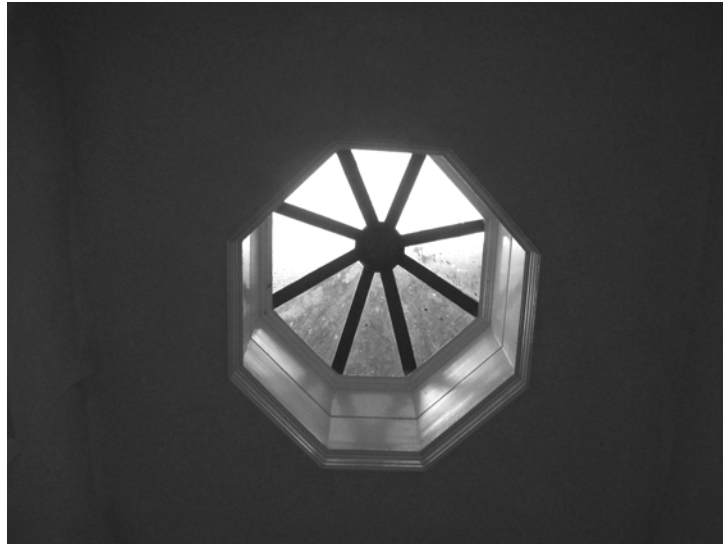
Plate 61 - Octagonal skylight in area 37

4.3.75. Area 37 leads to the south tower, which would have been part of the original structure. However, late 20th century modifications have obscured any of the features in this area and at least one of the original walls have been removed.

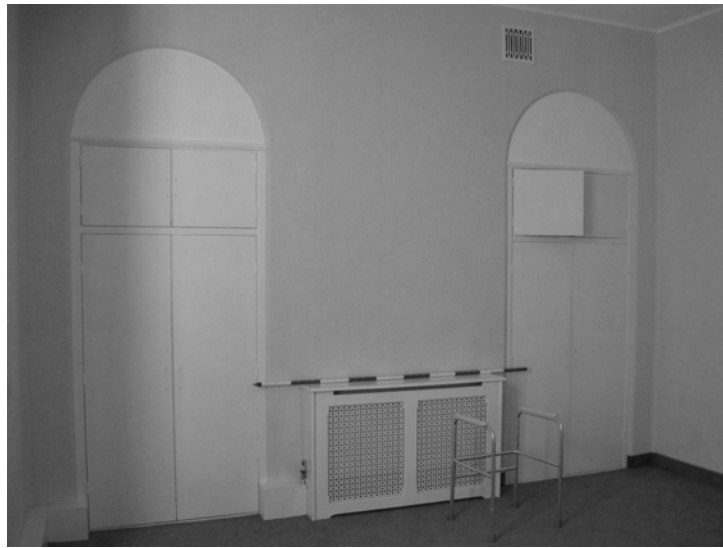
Plate 62 - Arched wardrobes in Room 1, looking north

4.3.80.In Rooms 1 and 13, the furthest north and south rooms respectively, the wall bounding the stair well had two arched cupboards built into the walls. Also present on these walls are small vents approximately 2m high. These appear to be contemporary with the construction of the building.

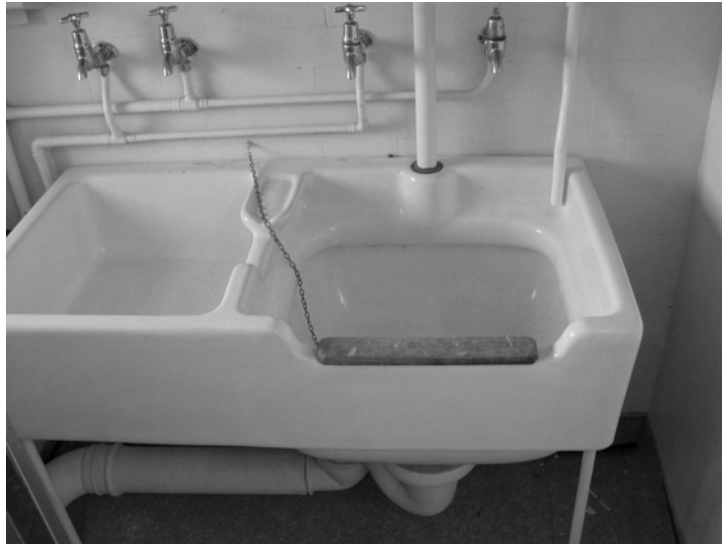
Plate 63 - Waste disposal unit in Room 38

4.3.82.To the north of the central block is a small northern annex which had tiled walls leading to two small rooms, 37 and 38. Room 37 was a store room for urinary equipment whereas Room 38 was the sluice room for disposal of waste. Within the room s a porcelain waste disposal unit which is thought to be an original fixture.

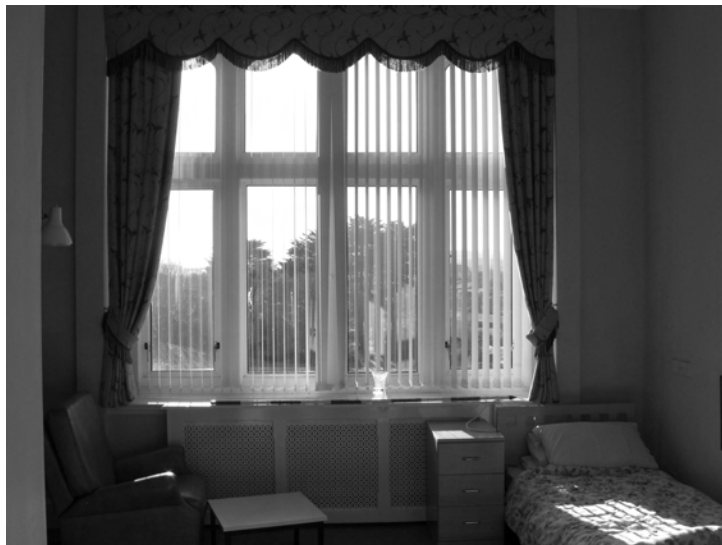
Plate 64 - General appearance of first floor bedrooms

4.3.84. The north wing comprised a series of five rooms and the north tower, which was subdivided into a further five rooms. Room 26 retains its footprint, however two smaller toilet areas had been inserted using modern partition walls.

4.3.85. Rooms 30, 31 and 33 all had modern en suite toilets inserted into the rooms, however the footprint of the original rooms is still clear.

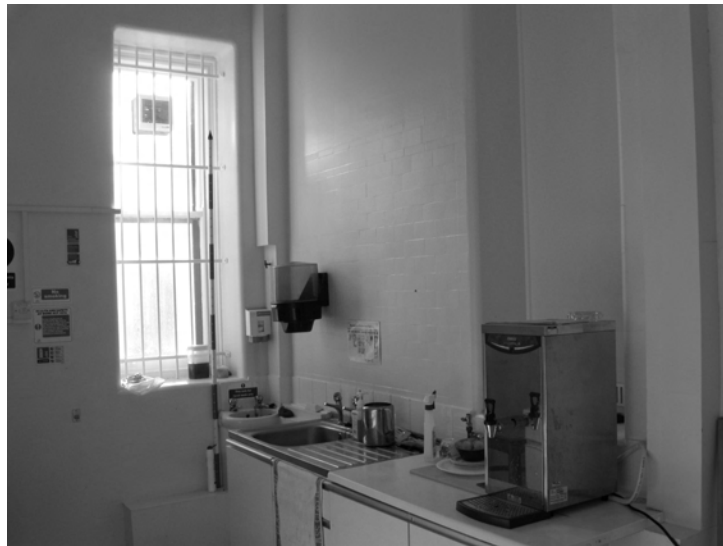
Plate 65 - Room 28, looking south

4.3.89.The south tower is divided into two main rooms with the southern room, 28, retaining the original tiled walls, as seen in the north tower. This does support the hypothesis that the two towers were used for the same function, one supplying the male wing with the other reserved for the female wing.

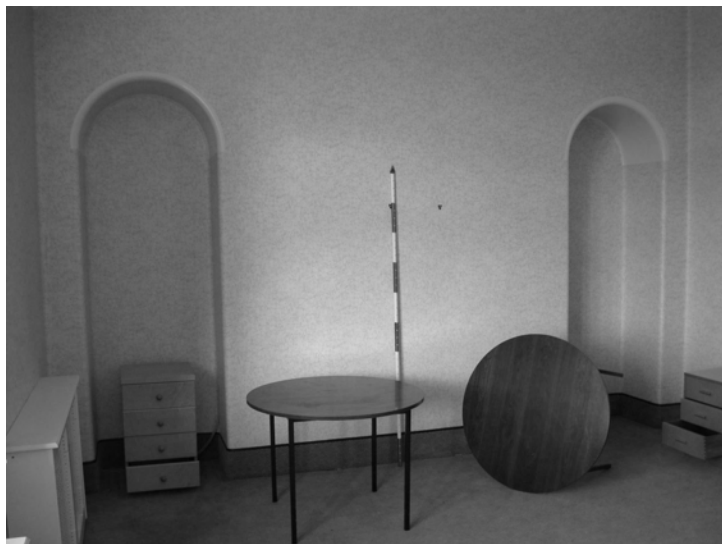
Plate 67 - Room 24, looking north

4.3.92. The second floor layout followed that of the first floor, with bedrooms lining the west side, off a corridor. The rooms all had later en suite additions of thin partition walls, allowing the original layout to be identified. Modern decoration hid much of the early features and the fireplaces had all be blocked up.

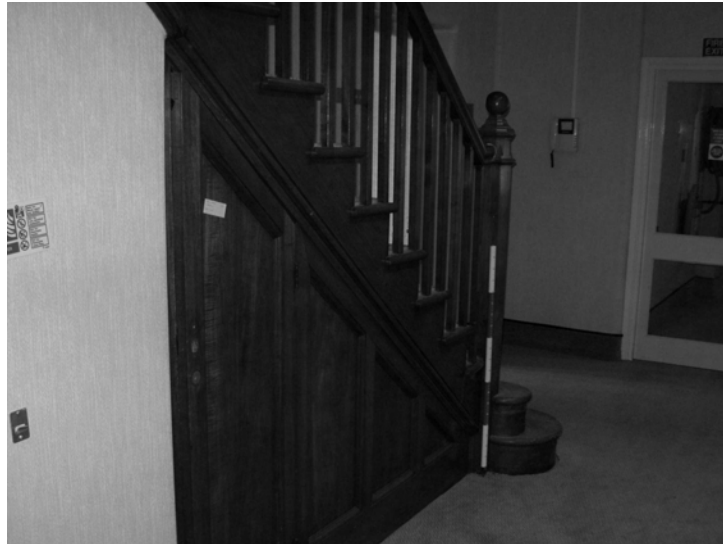
Plate 68 - Stairs to third floor, looking north

4.3.94.The only difference between the first and second floors is the addition of a single width staircase leading to the third floor located centrally to the structure. This means the central room is pushed forward slightly to accommodate the stairs.

4.3.95.Opposite the stairs to the third floor, on the east wall, is a small hatch at floor level. This hatch gives access to the roof space over the main hall.

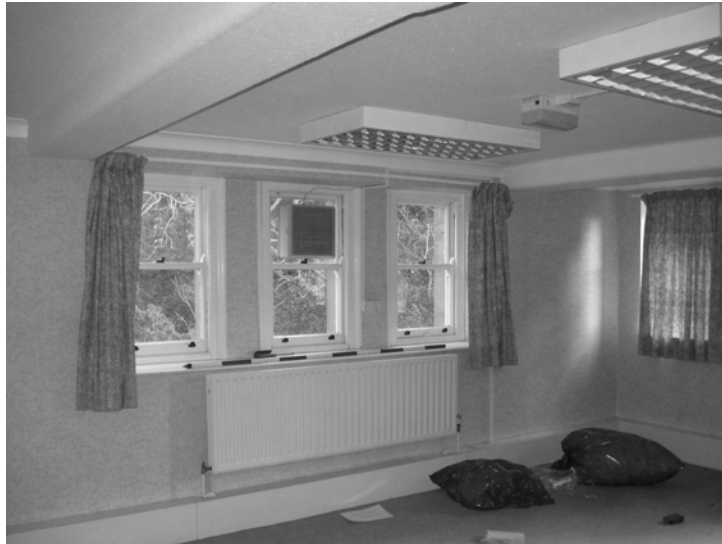
Plate 69 - Room 53, looking southeast

4.3.99.As with the north wing, the second floor layout of the south wing matches the first floor layout. The only difference is that the subdivided south tower retains its original single large room layout, Room 53.

4.3.100.Where the lift shaft has been added to the south of the tower, a small area has been used to form a small kitchen.

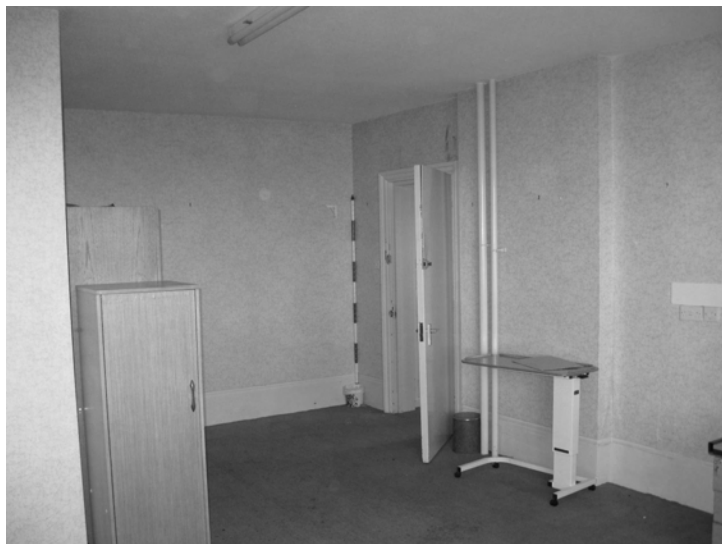
Plate 70 - Room 6, looking east

4.3.102. To the north of the stairwell is a second, larger, bedroom. This room also had a later inserted en-suite bathroom. This time to the northeast corner.

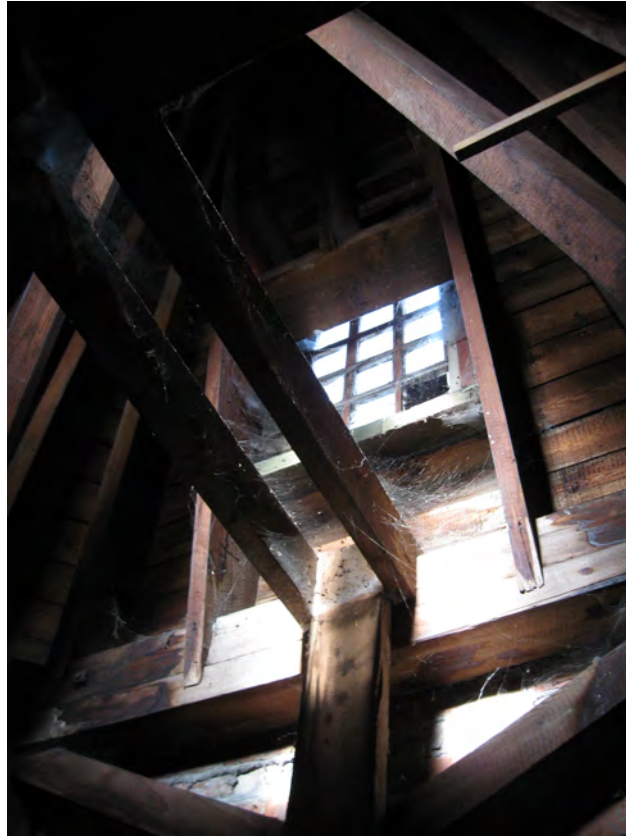
Plate 71 - High wooden centrepiece construction

to the southeast corner. This room had a projecting window area at the centre of the west wall, overlooking the garden. In the centre of the room was a hatch leading to the high wooden centrepiece seen from the outside.

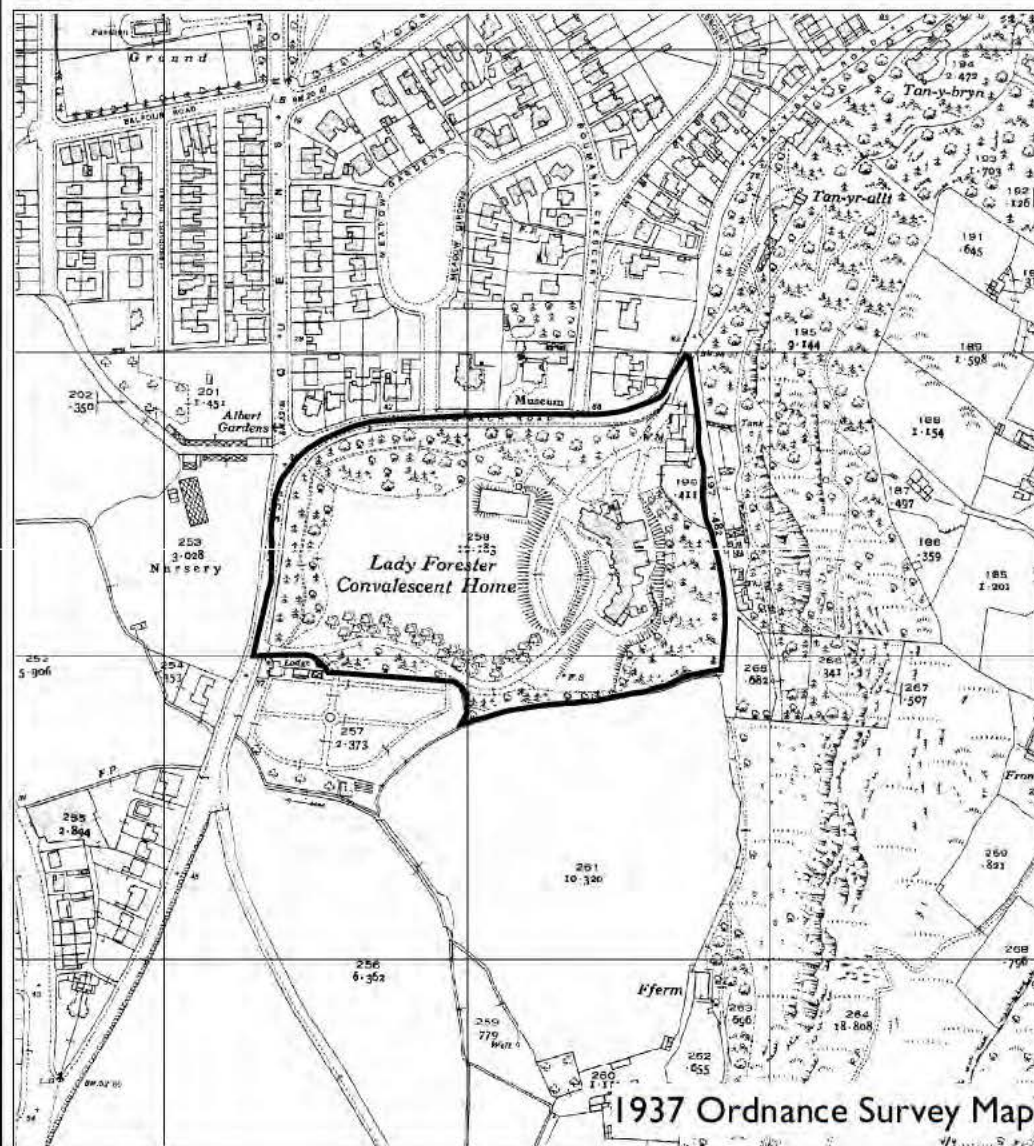
FIGURE 5 // 1937 and 1960 OS Maps

2.3.19. This layout is repeated on the 1919 Ordnance Survey map (FIGURE 4). By the 1937 Ordnance Survey map (FIGURE 5) a tennis court has been constructed to the west of the north wing, however the structure remains unchanged from the 1912 plan. There appears to have been no material changes to the footprint of the structure between the 1937 and 1960 Ordnance Survey maps (FIGURE 5). The major change between 1937 and 1960 appears to be the removal of the formal paths to the southwest of the site. This is shown as a large open area with a single path leading to a small outbuilding, possibly associated with the garden.

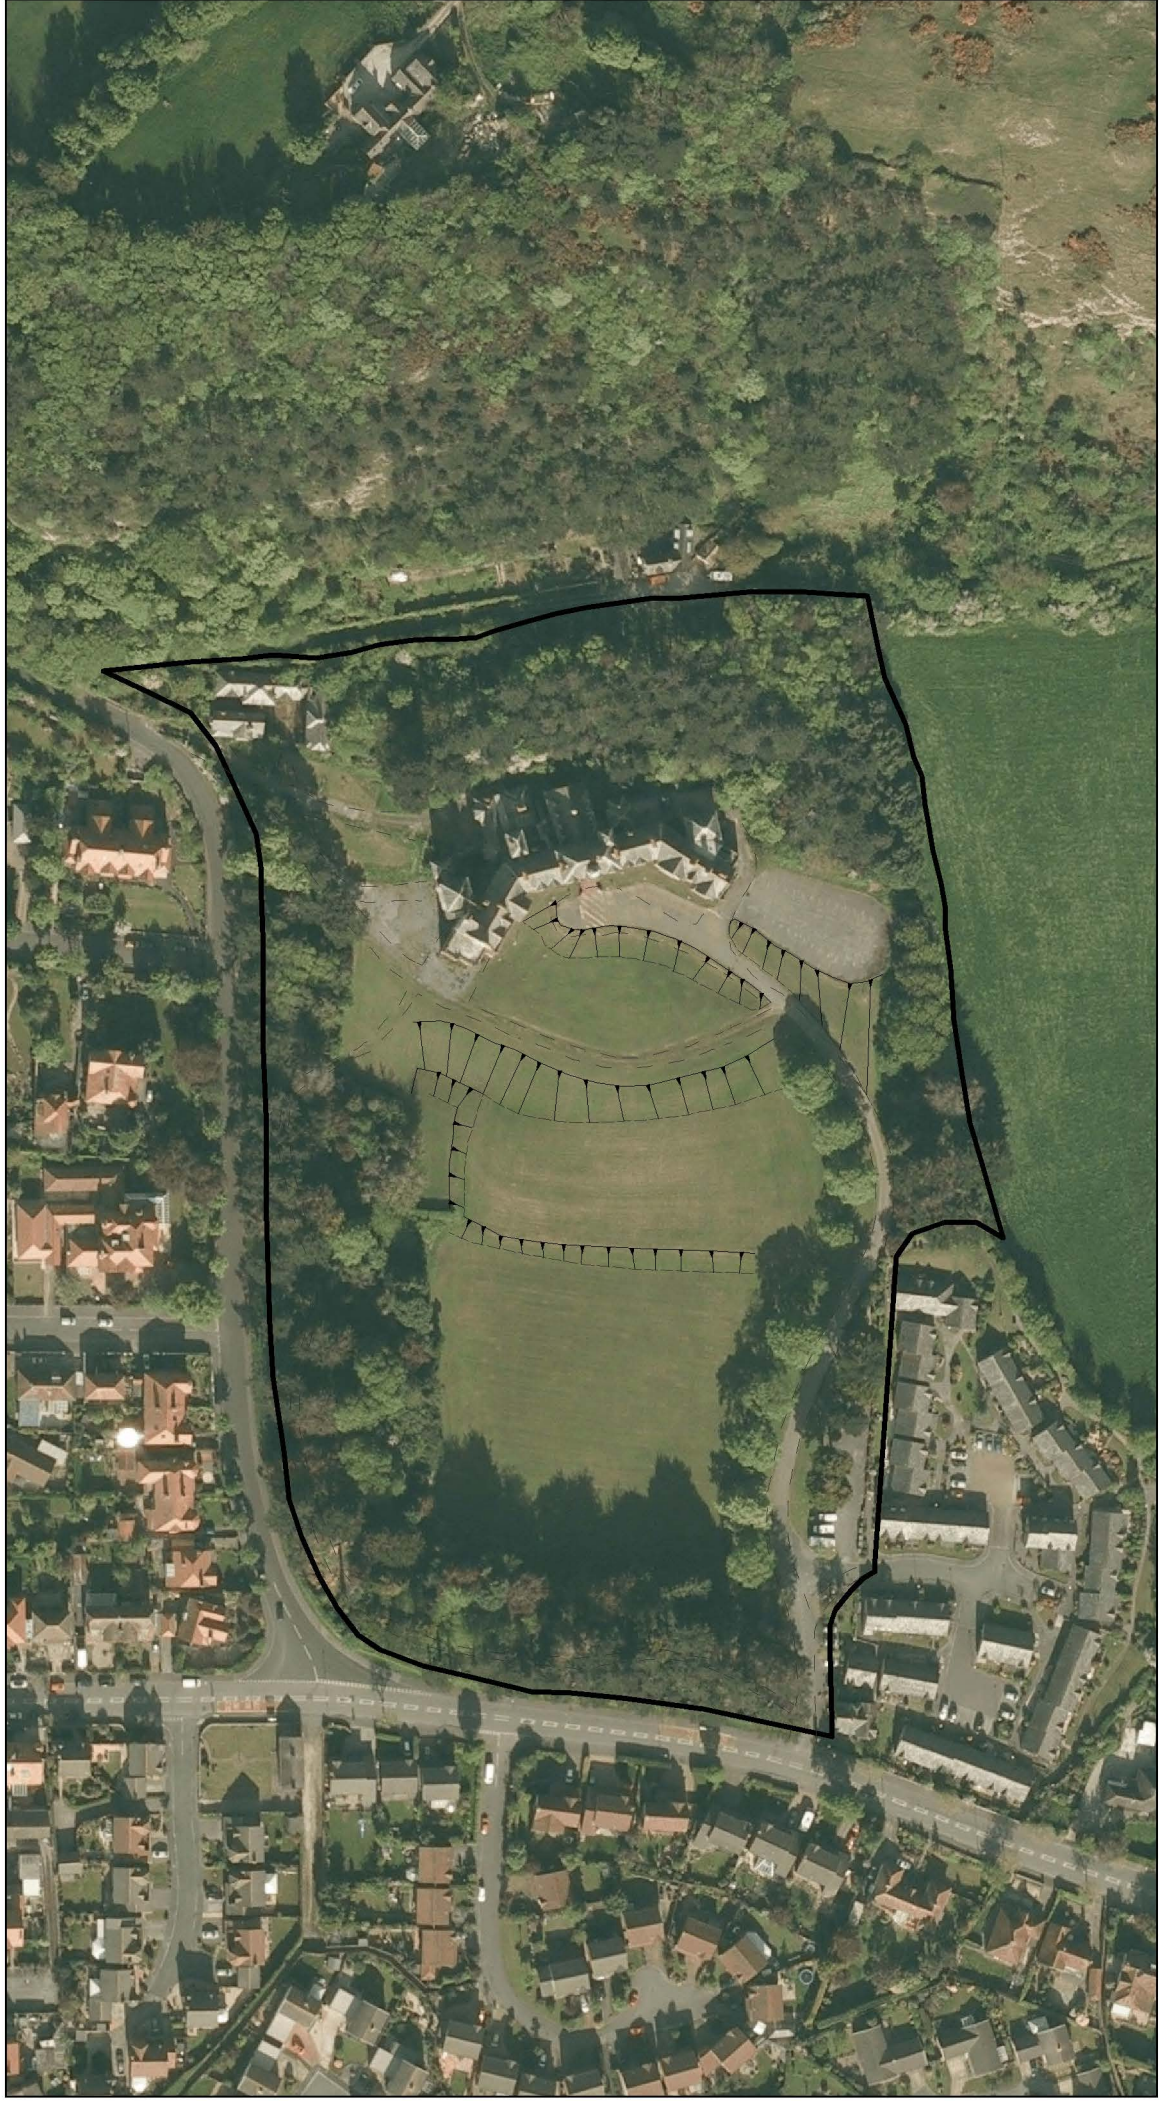
FIGURE 6 // Site landscaping

2.3.20. The early 20th century landscaping of the site has formed a series of four terraced platforms (FIGURE 6). The upper level houses the main building with a second platform slightly lower than the building containing a track leading to the rear of the structure. The third platform lies at the level of the tennis court. The fourth platform is the lowest level and has a gradual slope down toward Queen's Road to the west. The path leading to the main building and a track leading along the north and west boundaries, through the wooded area, can be seen to follow the same alignment as those paths shown on the 1901 edition Ordnance Survey map.
