**HENLLYS HALL**  
**BEAUMARIS**  
**ANGLESEY**

**Assessment Report**

Archaeological Assessment Report

Report no 2000-2001/065/AUA8109

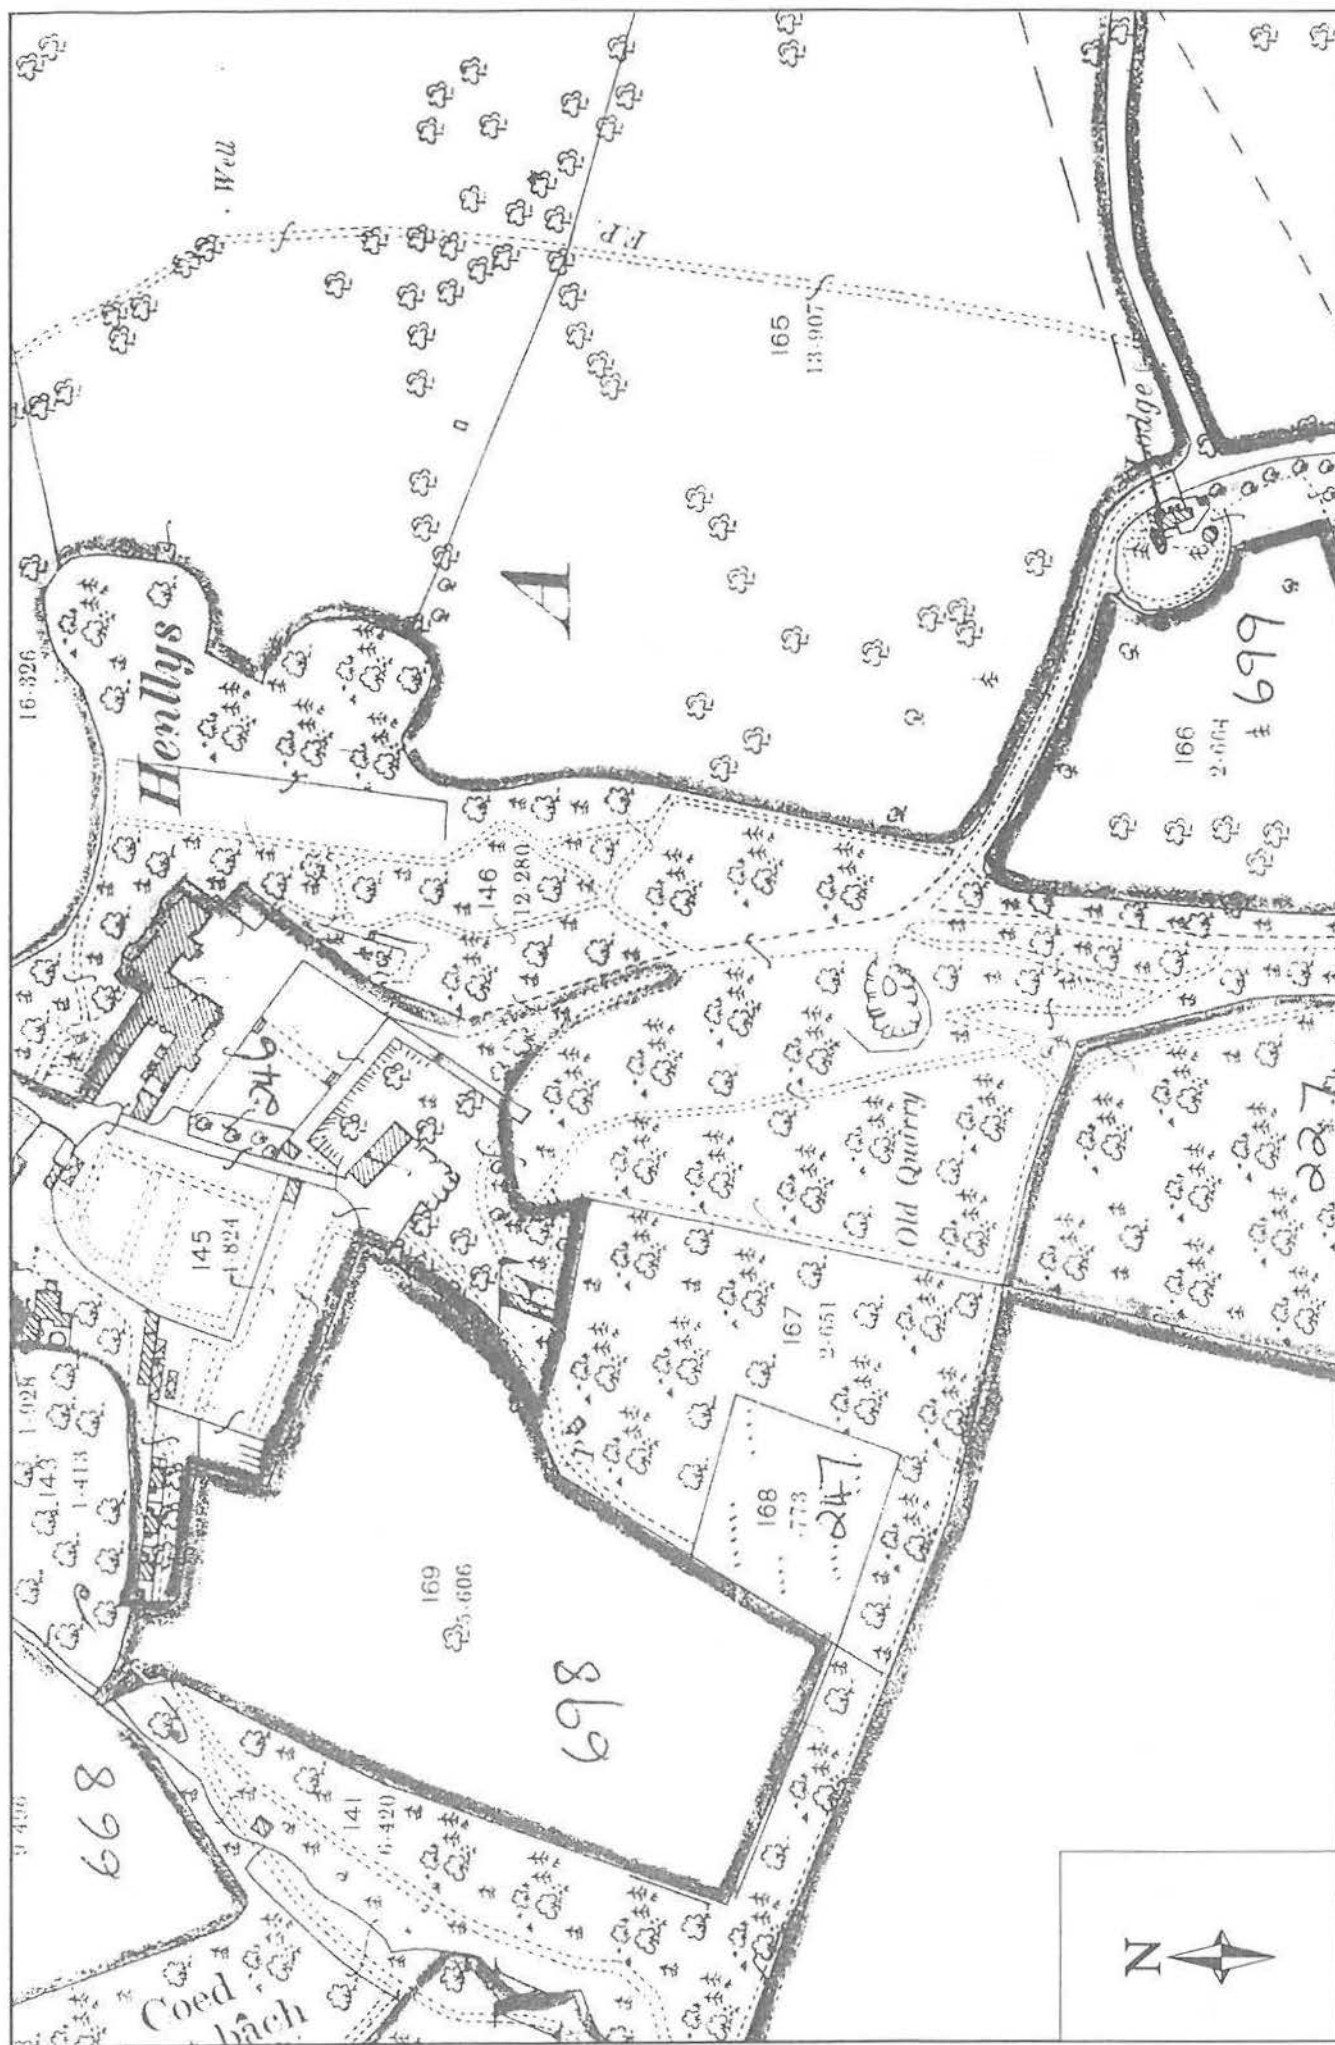
Figure 6: Excerpt from the OS Second Edition 1:2500 map, 1900

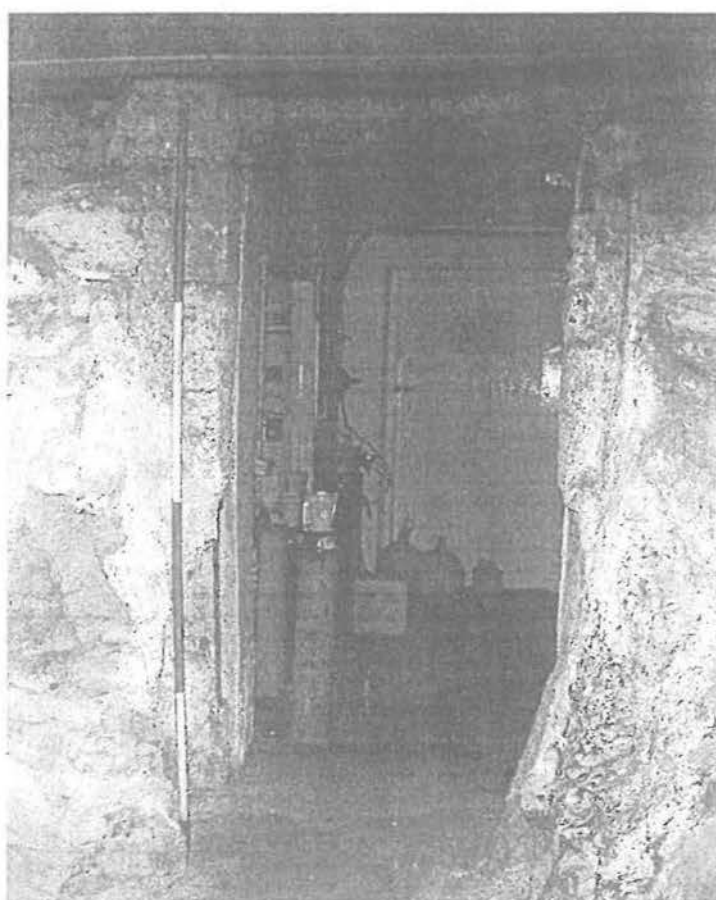
Plate 2: Early doorway in the basement of the present Henllys Hall

- 2.2.2 The basement of the Henllys Hall Hotel was also inspected, and a pair of stone door jambs was recorded; the jambs were associated with short lengths of stone wall, and neither the jambs nor these wall fragments appear to relate to the present build of the hall.

- 5.1.3 An estate map of 1830 shows the location of the house which stood on the site before the present hall was built, and may potentially have had medieval origins. A doorway which survives in the cellar of the present hall would appear to predate the present structure and almost certainly was a part of the earlier structure. Slight earthworks found in the southern and eastern parts of the subject site may relate to a drive and field boundary shown on the 1830 plan.

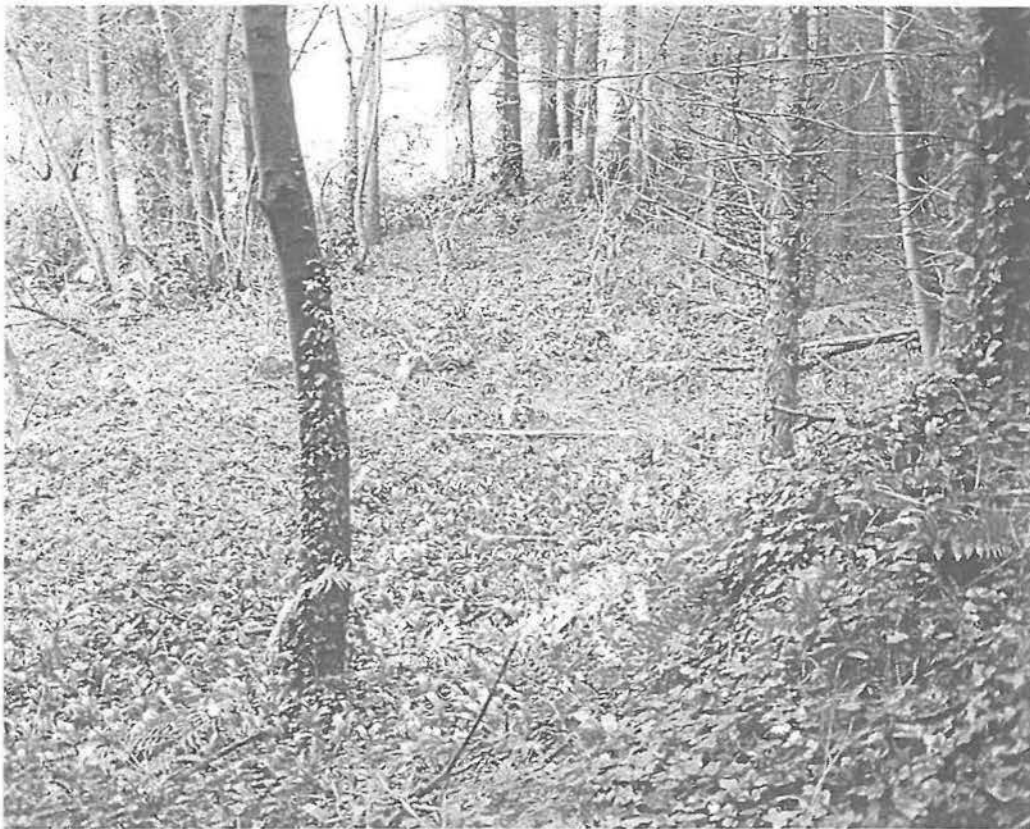
Plate 3: Site 28, Levelled platform within Henllys Hall grounds, looking south

- 6.2.1 **Detailed Survey:** it is recommended that a detailed survey should be conducted of the earthwork remains identified towards the south of the eastern part of the site (Site 28), in order that this feature might be better understood and related to historic maps. As this relates to relatively late landscaping it must be regarded as having a low priority in terms of the overall recording and evaluation programme.

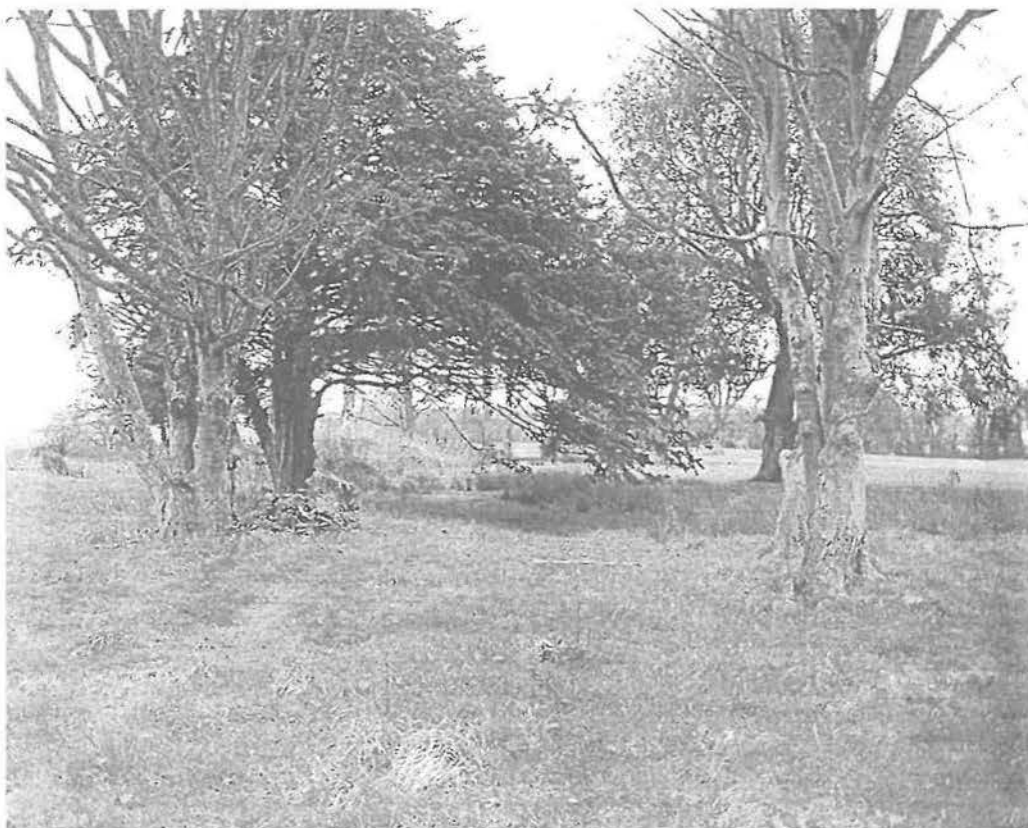
Plate 4: Site 31, tree lined avenue looking south-west

**Site number** 31  
**PRN** -  
**NGR** SH 60147757  
**Site name** Avenue 1, Henllys Hall grounds  
**Site type** Avenue?  
**Form** Alignment of trees  
**Period** Post-Medieval?, Modern?  
**Notes** Two parallel alignments of ash and yew trees were tentatively identified, suggesting the former presence of an avenue c8m wide. This feature was found to be close to the position of the former eastern boundary of the orchard shown on the estate map of 1830 (UWB Henllys ms 1191).  
**Sources consulted** LUAU field survey  
**Visit date** 22/02/01
