Proposed Visitor Centre, Henfaes, Aberdaron.

Archaeological Assessment

Kathy Laws

September 2012

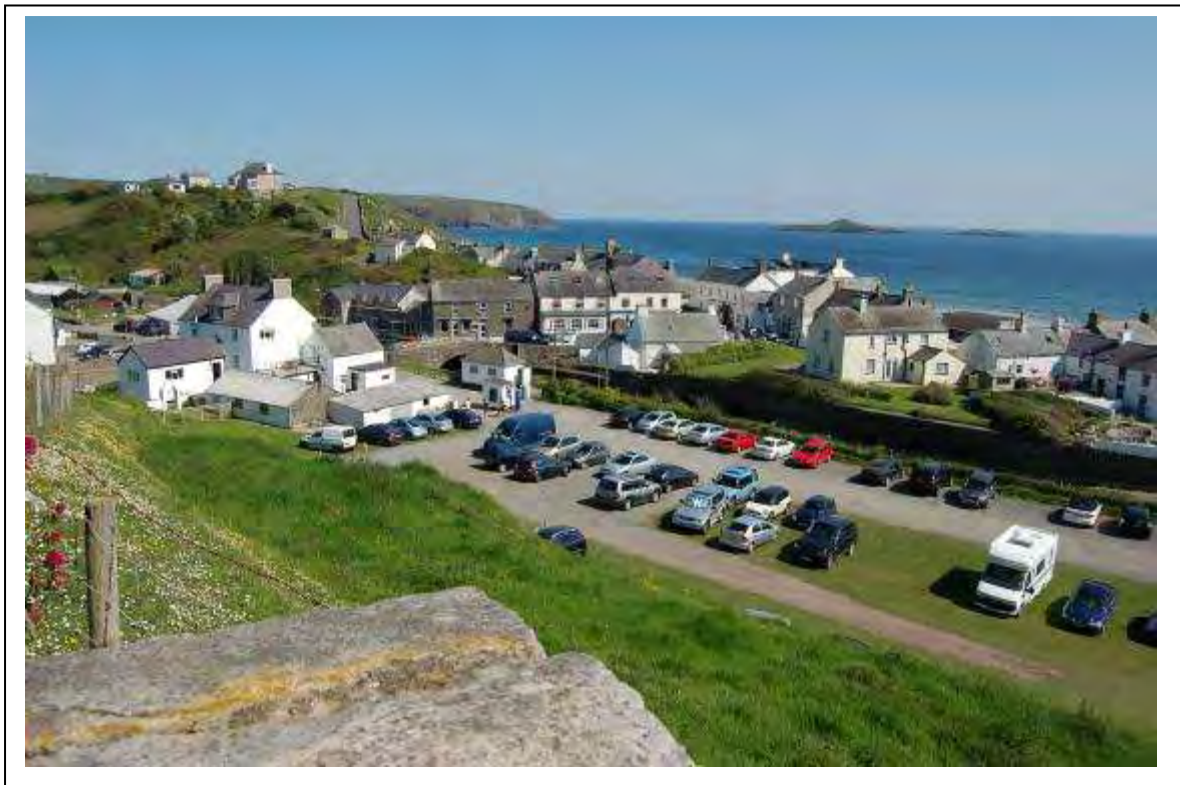
Plate 1: General View of Henfaes

Centred on SH 17242 26450 Henfaes car park is located immediately west of the centre of the village of Aberdaron at the southern end of the Llyn Peninsula (Figure 1). Topographically the car park sits on a level area, bounded by the base of a cliff to the north, and the Afon Daron, now canalised, to the south. The car park contains a series of relatively modern buildings, a large domestic building functioning as holiday apartments, two outbuildings currently used for storage, and a public toilet (Plate 1).

There will be an indirect visual impact on the historic setting of the village of Aberdaron. The greatest impact is likely to be from the approach to the village from the west (Plate 1) rather than from within the village. The use of traditional pitched roofs and traditional materials and the alignment of the building in tune with adjacent structures lessen the impact. The overall impact is assessed as being low.

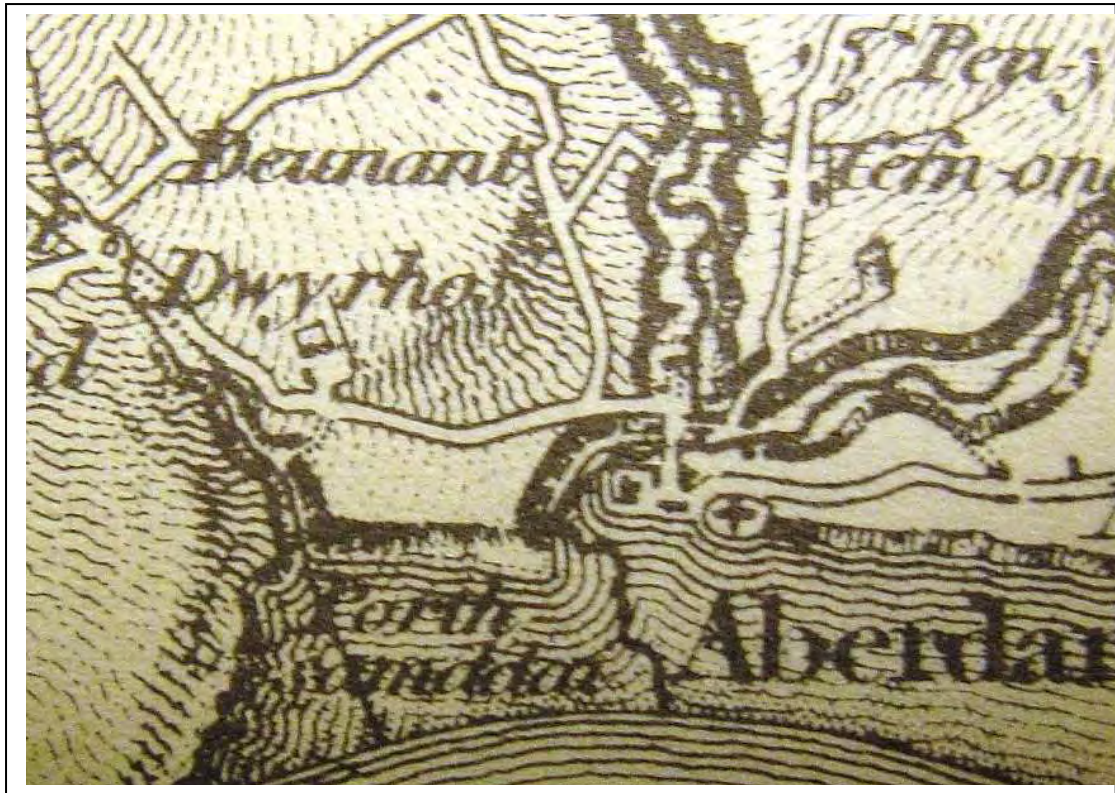
Figure 3: Extract from Ordnance Survey 2" Map of 1836

Historic mapping demonstrates that there has been a structure at Henfaes since at least 1836. Both the 1836 Ordnance Survey map (Figure 3) and the 1845 Tithe map (Figure 4) show a single building at the location of the Henfaes holiday apartments within the field immediately west of Aberdaron village centre. The 1845 Tithe schedule states that this field was partly waste, partly under arable cultivation at this time. Subsequent Ordnance Survey mapping shows developments and additions to the buildings and subdivisions appear within the adjacent land (Figures 5, 6 and 7).

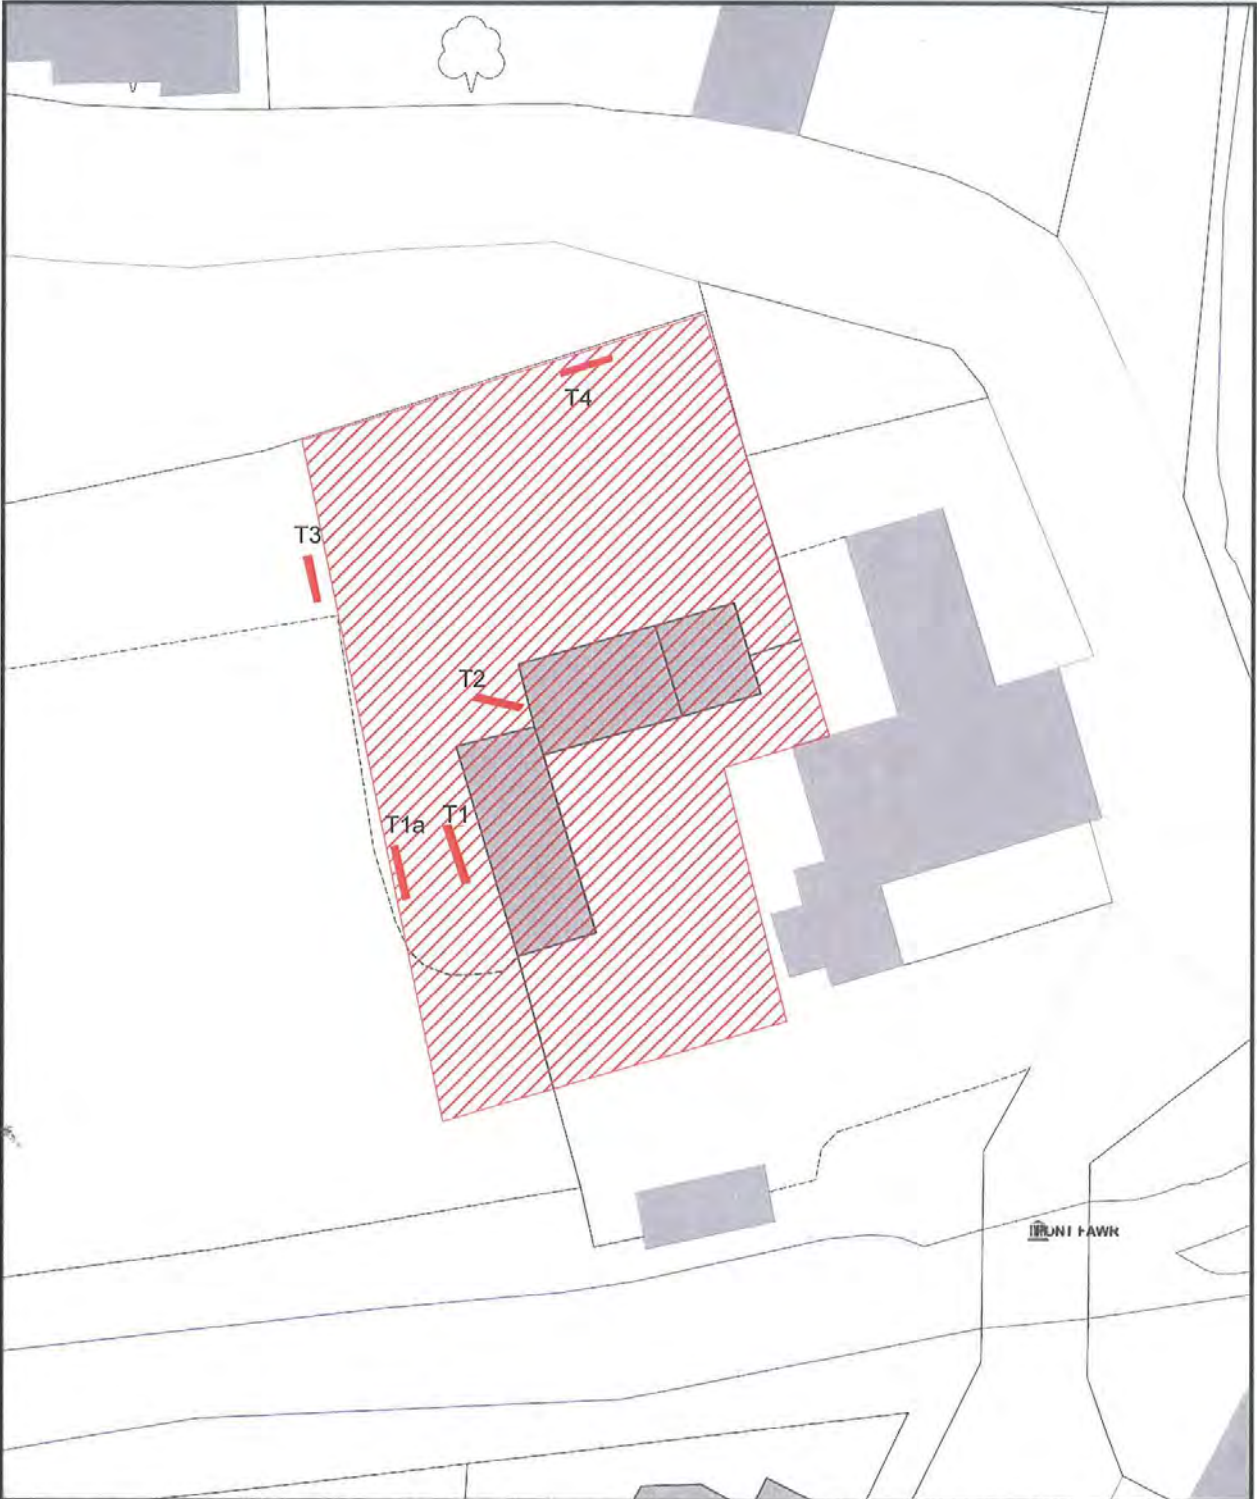
TITLE	Figure 8: Location of Geotechnical Test Pits

The test pits were located as shown in Figure 8. All five pits were 0.5 m wide and between 2.2 and 2.9 m in length. They were excavated to varying depths according to obstacles encountered and the stability of deposits, with the greatest depth being 2.7 m (T3). T1 was only excavated to a depth of 0.6 m because a modern service pipe was encountered.

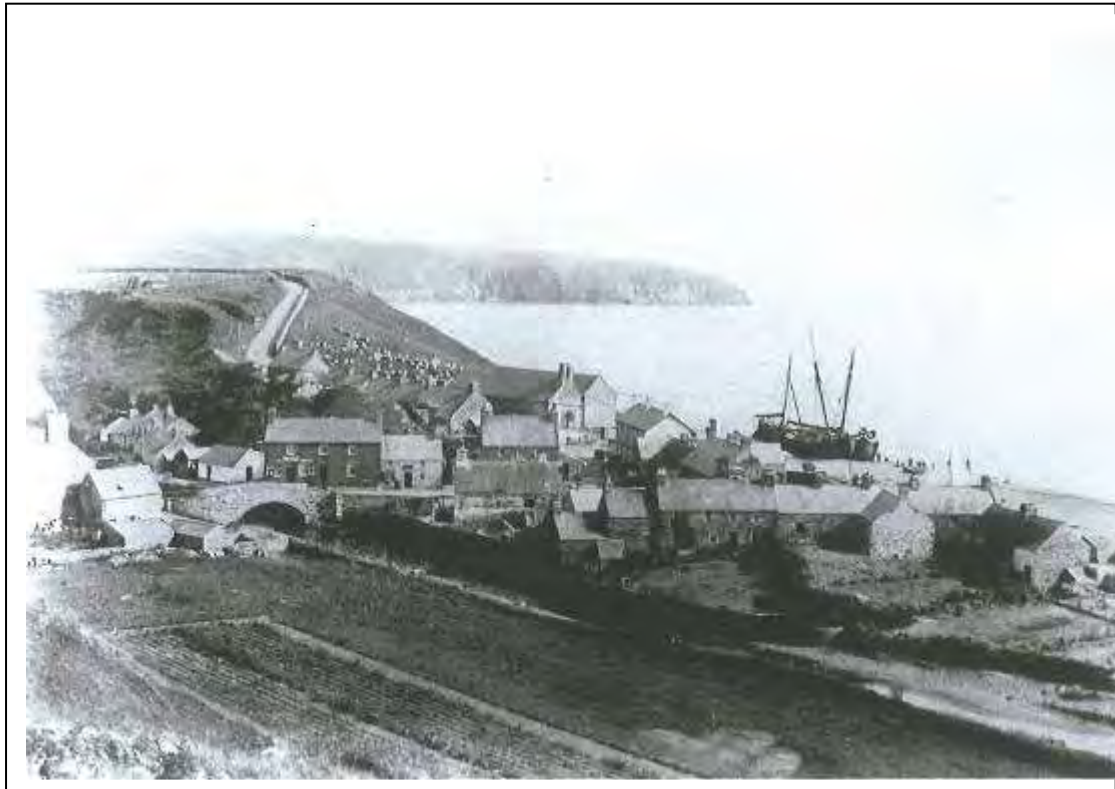
Plate 6: Early 20th Century photograph of Henfaes and Aberdaron

Early 20th Century photographs held at the Gwynedd Archives in Caernarfon show the field subdivided and variously ploughed or under grass (Plate 6). The photographs suggest that there is little in the way of physical boundaries, walls or banks, between the fields. Today the buildings are essentially modern in appearance although it is possible that some slightly older elements may be preserved within. Recently used as garages and for storage, local knowledge suggests that they were once cow houses (*pers com* Paul Lewis, Llyn Head Ranger). No evidence for subdivisions within the adjoining land, the car park, survives today.

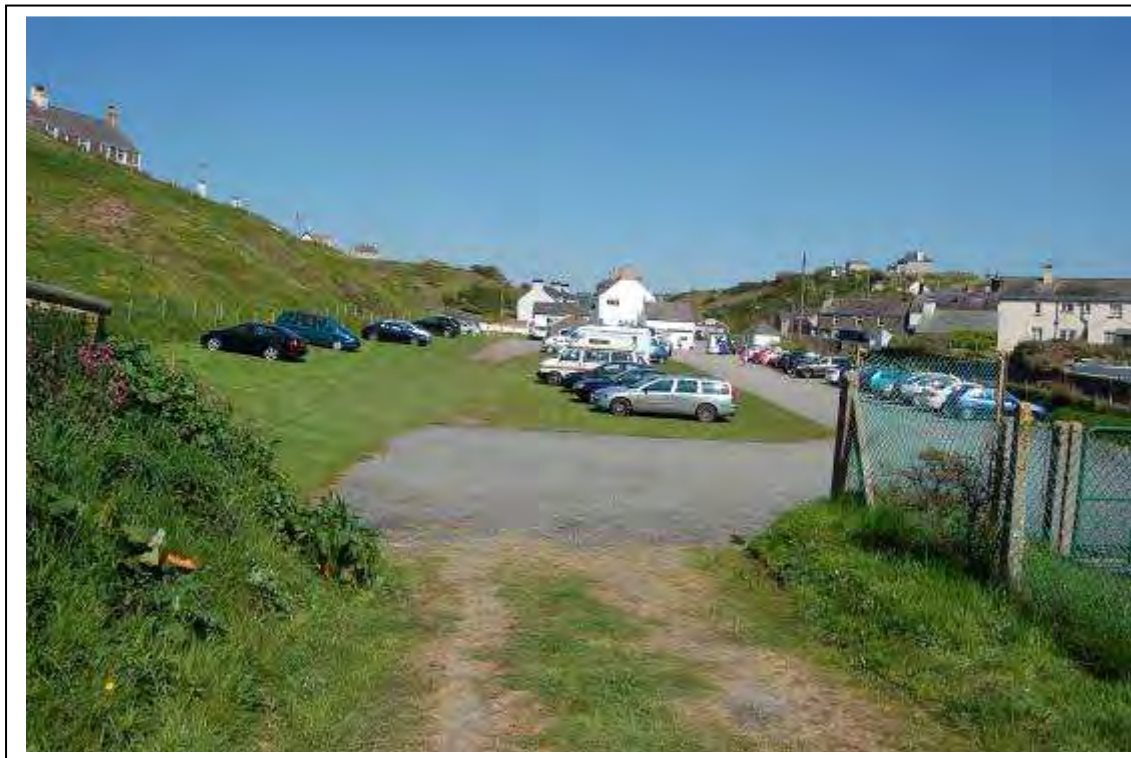
Plate 7: View of Henfaes from the west

The site was visited on 30th March 2012. There is no evidence on the site for upstanding archaeological features (Plate 7). Examination of weathered spoil around the top of a recently installed Propane tank, immediately west of the holiday apartments, revealed a flint artefact at SH 17260 26466.

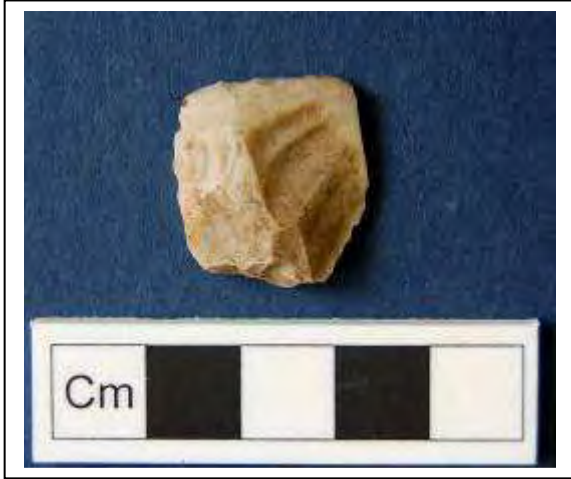
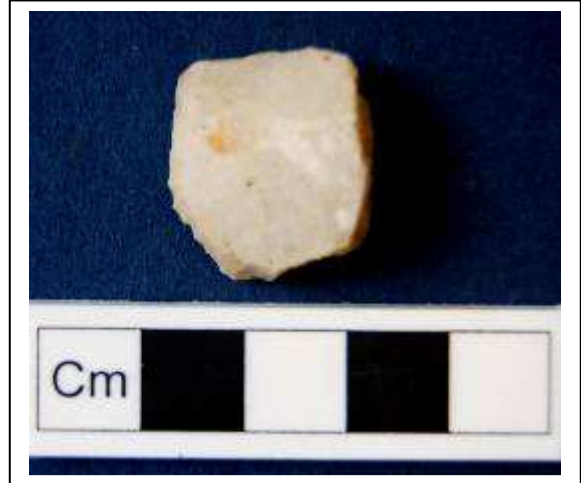
This is a flint end scraper with a straight distal end made on a fragment of polished tool, most likely an axe. There is a small area of inverse retouch. The scraper is very slightly rolled but not to a large extent. The scraper is likely to be a late Neolithic or early Bronze Age recycling of a Neolithic flint axe (*pers.com*. Dr I. P. Brooks) (Plate 8 and 9). The artefact is considered very likely to be residual as it is known that the previous site owner stored resurfacing materials close to this location.

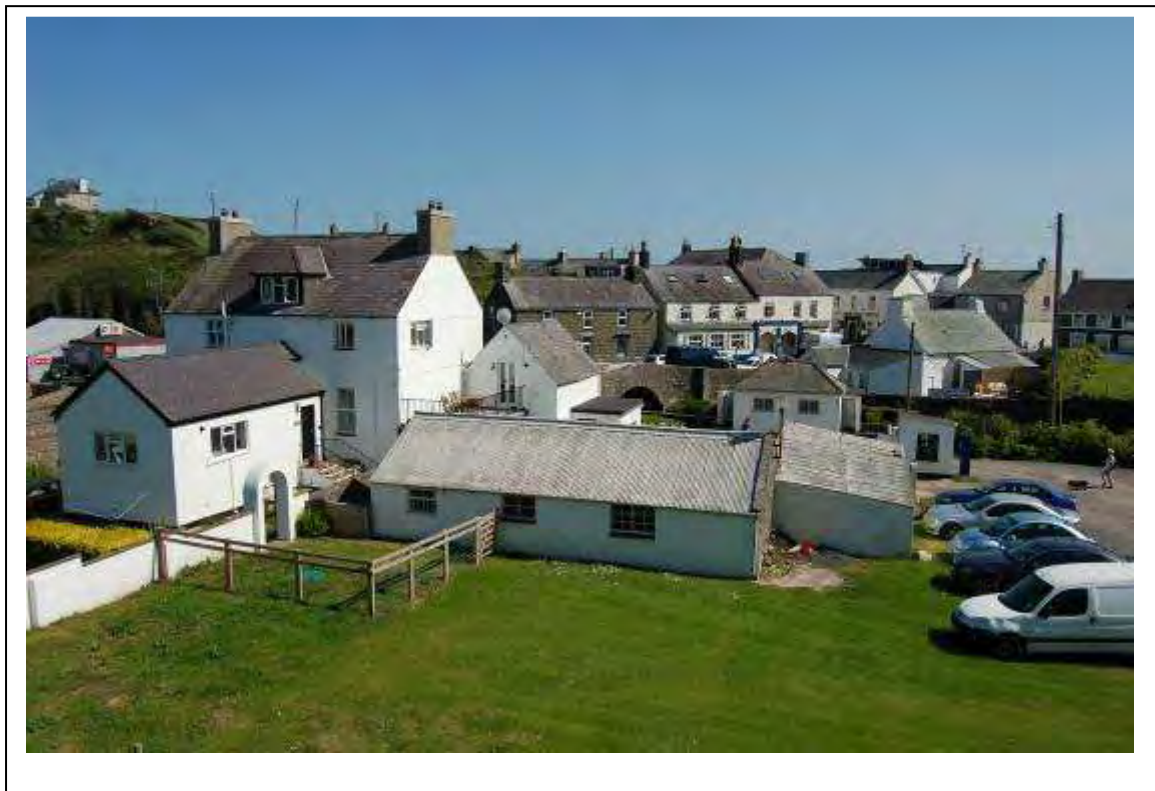
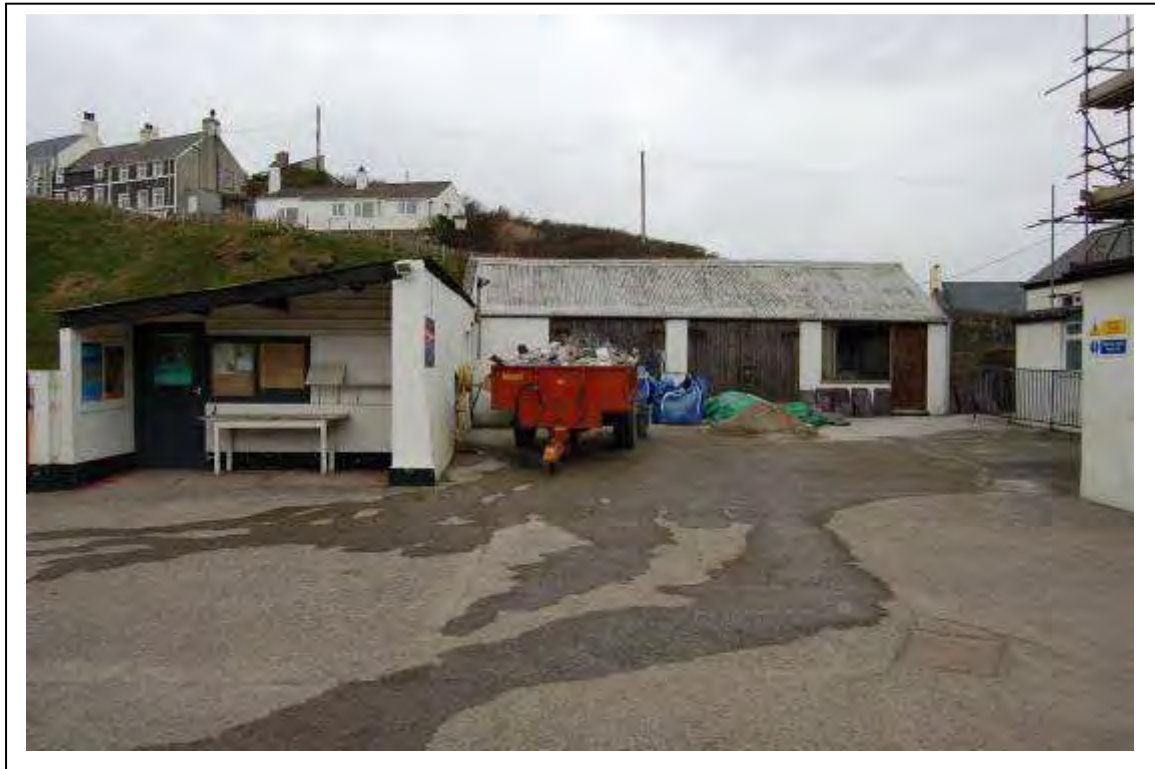
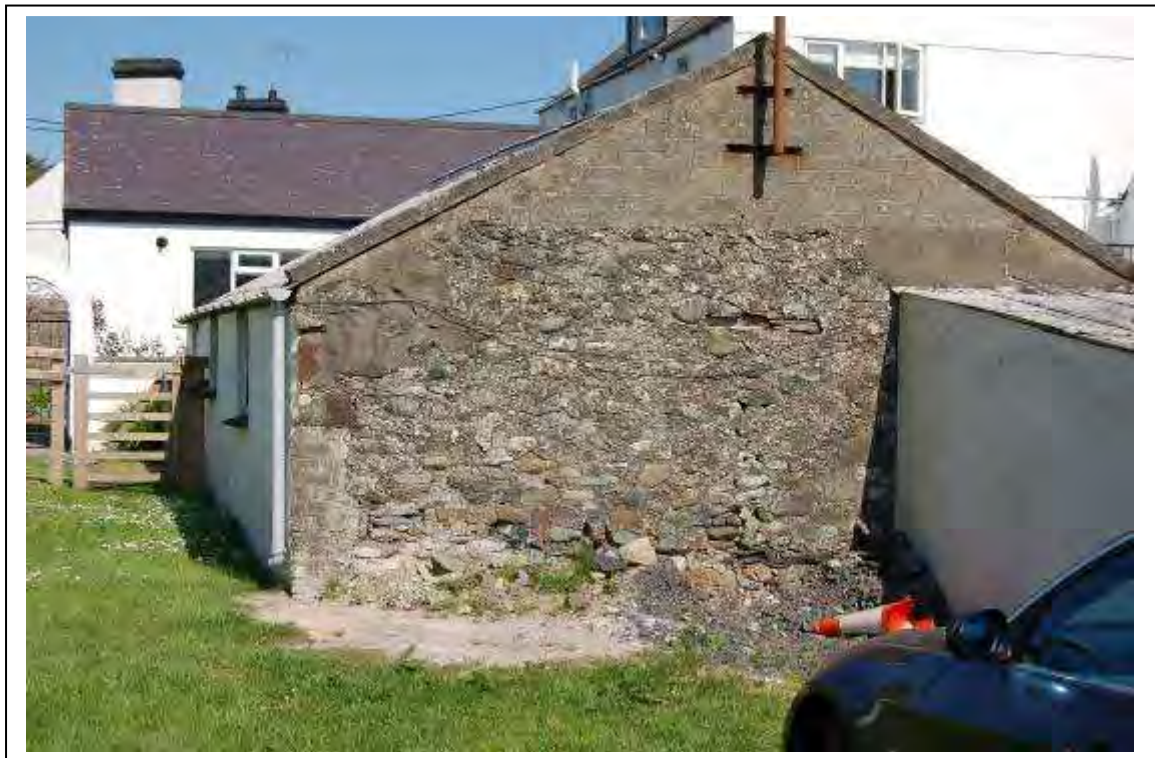
The desk top study indicates that outbuildings on the site first appeared in the late 19th century. The current layout of the outbuildings does not appear to conform to any of the layouts seen on early Ordnance Survey maps (Figures 5-8). Equally they do not appear to be the buildings shown in early 20th century images (Plate 6). The outbuildings are largely constructed of a modern grey brick. The western gable end of the more northerly structure incorporates a section of roughly constructed stone walling perhaps representing the partial remains of an earlier structure (Plate 10, 11 and 12).

It would seem therefore that these are later 20th century rebuilds possibly incorporating some remains of, or re-use of materials from late 19th century structures.

There will be a direct impact on the current out buildings at Henfaes as it is proposed that these will be demolished as part of the development. The buildings date to the C20th and are not considered to be of great architectural merit, the impact is therefore assessed to be low.

1. It is recommended that a photographic record of buildings to be demolished should be made.
2. It is recommended that an archaeological inspection be made immediately post demolition to record any remains of earlier structures.
3. It is recommended that an archaeological watching brief be carried out on all ground disturbance associated with the development to observe and record any sub surface archaeological deposits.

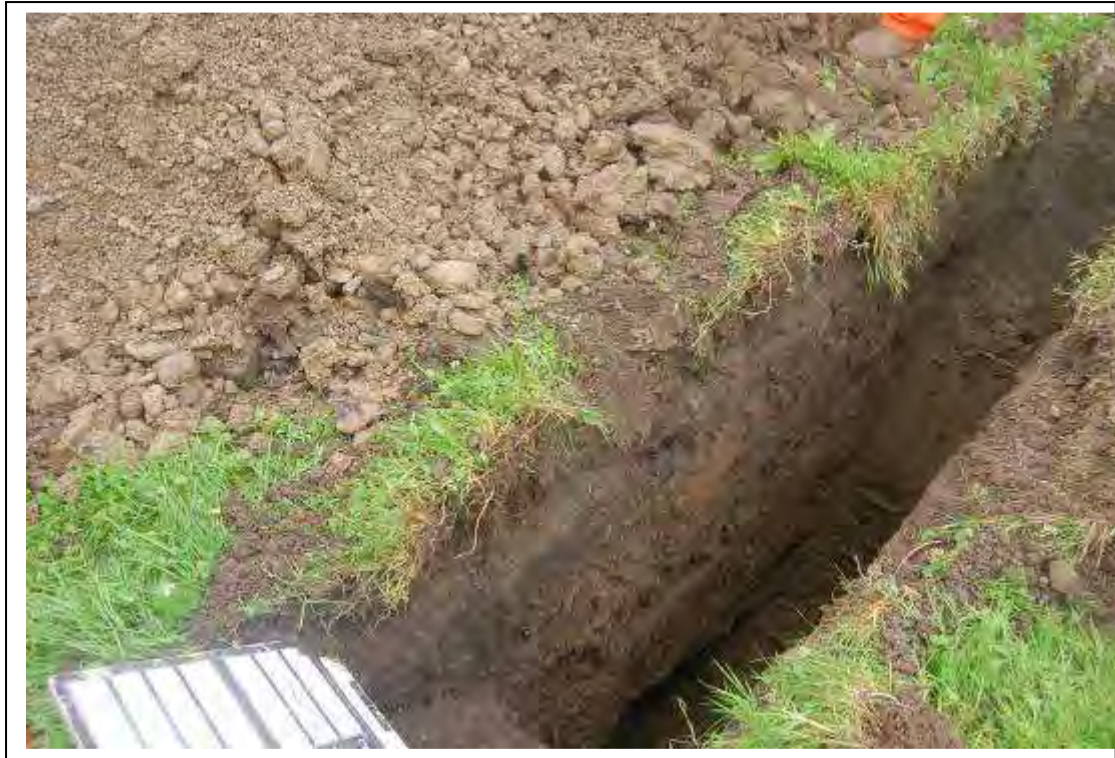
Plate 13: Test pit 2, looking west

The deposits were notably comparable between all five pits. A dark brown humic topsoil to between 0.3 and 0.5 m below the ground surface, above a red brown sandy clay subsoil to between 1.5 and 2 m below the ground surface. These sat above sands and gravels including water worn cobbles (Plates 13 - 15).

No archaeological deposits or artefacts were encountered with the exception of T2 where the topsoil contained a certain amount of demolition material, stone and mortar fragments, likely to be associated with the rebuilding of adjacent outbuildings which although of a relatively modern build may incorporate elements of earlier structures.
