# Oxford Dendrochronology Laboratory

**Trefadog, Llanfaethlu, Isle of Anglesey**

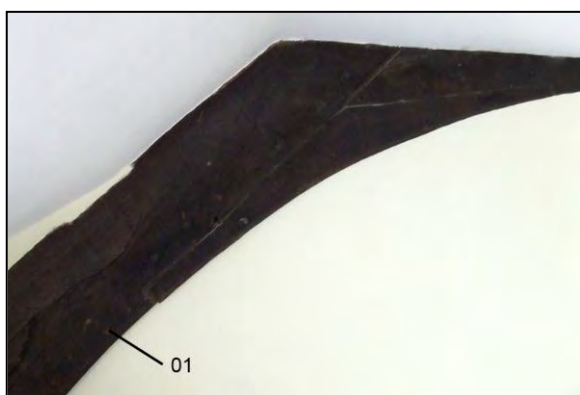
Figure 1: West cruck of central truss

It was decided that there were too few rings for dendrochronological dating, but two samples were taken in case it might be possible to carry out radiocarbon dating at a later stage. Sample 01 was taken from the west cruck of the central truss (Fig 1), next to the stairs, and had complete sapwood. Sample 02 was taken from a timber above the door on the east side of the truss (Fig 2).

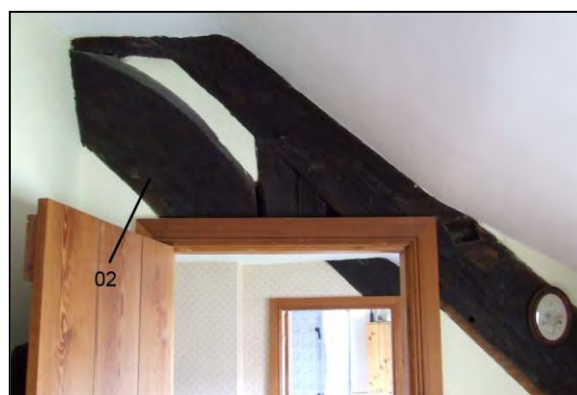
Figure 2: Timber above door, central truss
