Summary

The proposed project was outlined as 'some work on the north and east towers and the wall between the fort entrance and the east tower'. This included remedial work on the north tower, partial rebuilding of the lost outer arc of the east tower, of the south east curtain wall adjoining the tower and the north east jamb of the entrance, and of repairs to the buttresses on either side of the entrance. Further to this, repairs were also carried out to the rampart where it had been eroded on the interior side of the south east curtain wall. Consent was granted by Cadw under Section 2 and Schedule 1 of the Ancient Monuments and Archaeological Areas Act 1979 dated the 2nd. October 2015.

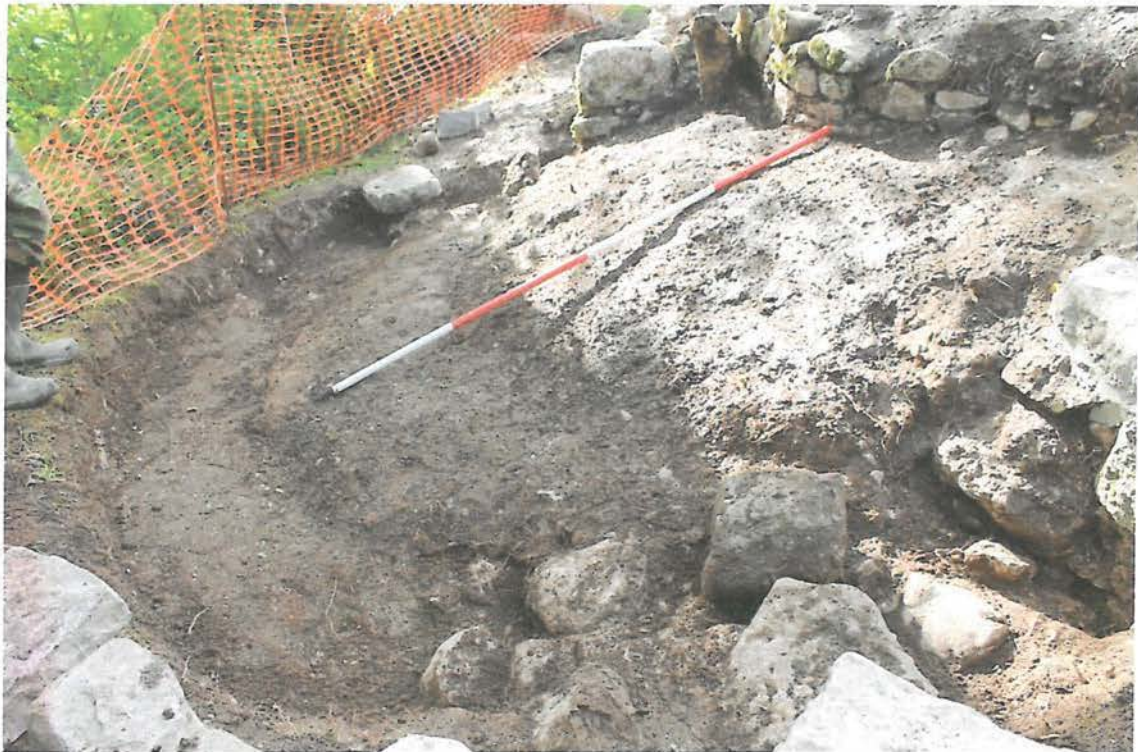
East Tower from North after clearance of vegetation and debris

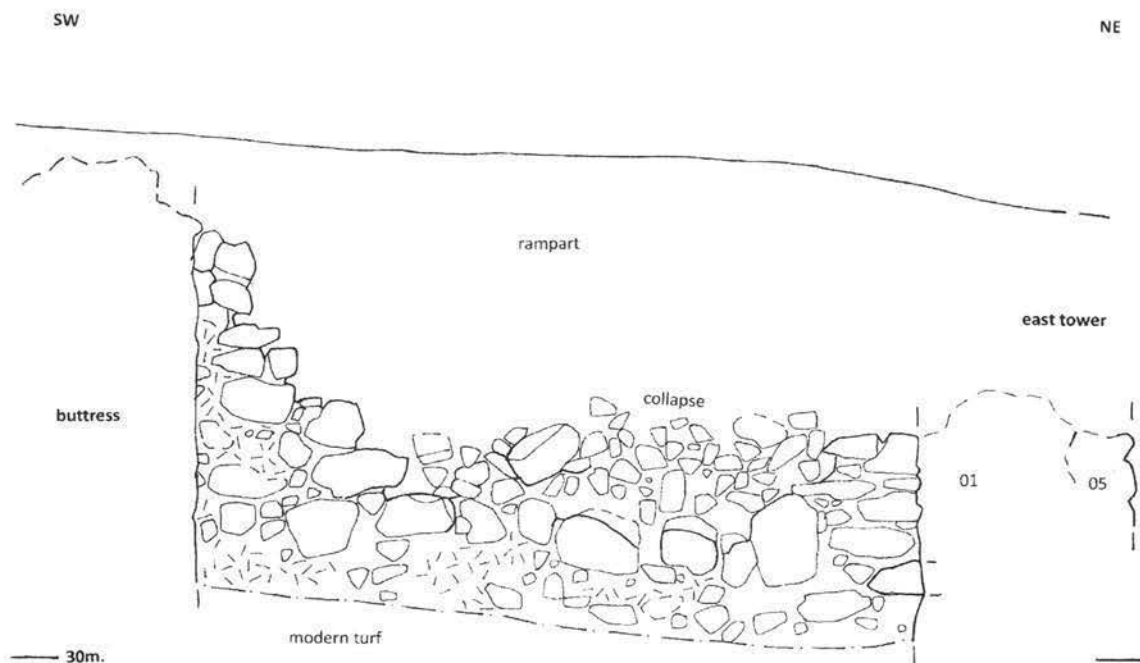
Fig.1: South East Curtain Wall

After preliminary strimming and removal of vegetation obscuring both the east tower and south east curtain wall, the section of the south east curtain adjoining the tower was duly recorded and dismantled. The only parts of its facing which had remained intact were at the base of the wall, but these had been displaced forwards of their original alignment probably as a result of pressure from the bank or 'rampart' and, perhaps, the historic collapse of the east tower. The foundations of the wall was surprisingly shallow and no more than 0.2 metres below the modern level of the turf, but the bank exposed by the dismantling could not be fully cleared for health and safety reasons. What could be seen was that there was no discernible straigraphy in the make-up of the bank and, apart from including a scatter of rubble, it consisted of a homogeneous clay. It thus appeared to be the result of a single event, perhaps contemporary with the building of the curtain wall, which was built as a revetment with a single, external face. The wall was rebuilt to a height not exceeding other sections of the south east curtain and to provide support for the bank.

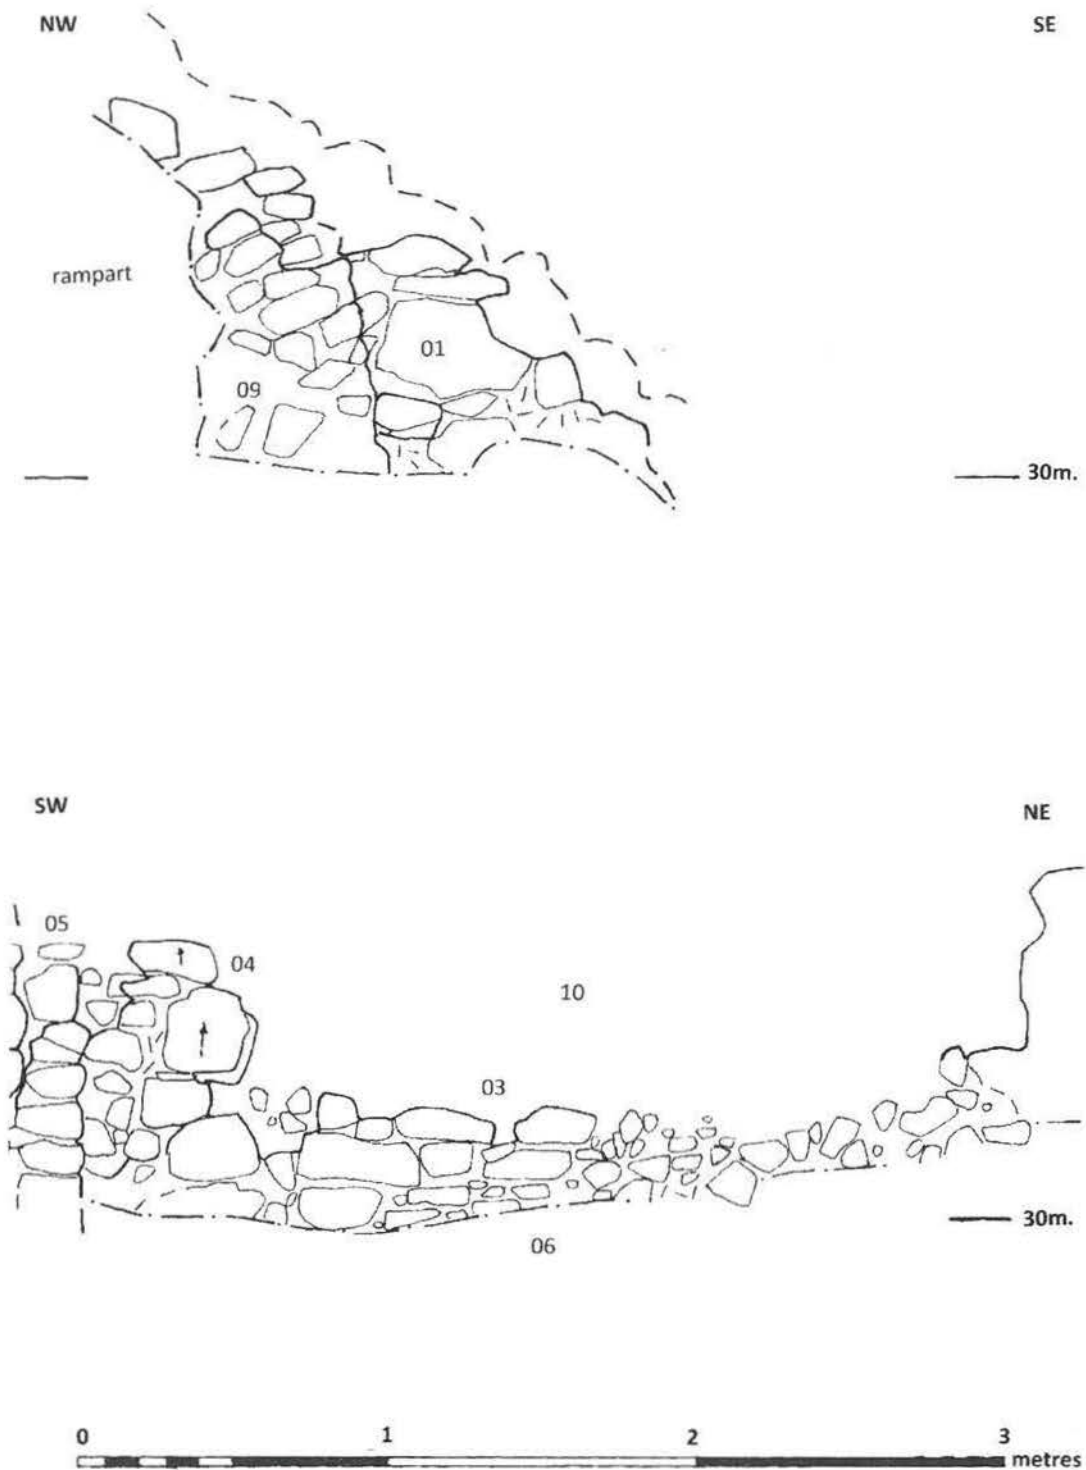
Removal of brambles, turf and debris more fully exposed the stumps of the south and north walls of the east tower 01 and 02. The lower courses of mortared walls extended, respectively, 1.85 and 1.65 metres from their junctions with the curtain walls beyond which nothing more than tumble stones and what appeared to be an appropriately curving and shallow robber trench 08. Built directly against the inner face of the south stump was a buttress 05 which was single faced and appeared to be tied into the upper part 04 of a low revetment wall 03 from which it projected 0.9 metres. The revetment wall closed off the east corner within the fill of the east tower. Although aligned with the curtain walls on each side the wall was built using distinctly small stones and did not continue through or into the core of the east tower walls, although close to the north stump of the east tower wall it had collapsed forwards over the lower fill 06 of the tower. There was no indication that a buttress had been built to support the internal angle of the east tower and north east curtain wall. The higher part 04 appeared to be bonded into the buttress and suggested that the revetment wall may once have been more than 1.1 metres in height, but it had collapsed against the upper fill 10 of the tower and could not be rebuilt. The lower part of the revetment wall was between 0.18 and 0.55 metres height; neither this nor the buttress were fully exposed since the lower fill was left in situ to support the repointed retaining wall.

Fig.2: Elevation of the junction of East Tower South Wall 01 and South East Curtain top and revetment wall 03/04 with buttress 05 bottom

Flecks of mortar were scattered across the lower fill at the base of the retaining wall 03, but this seemed to be the product of leaching rather than as any indication of staging in the

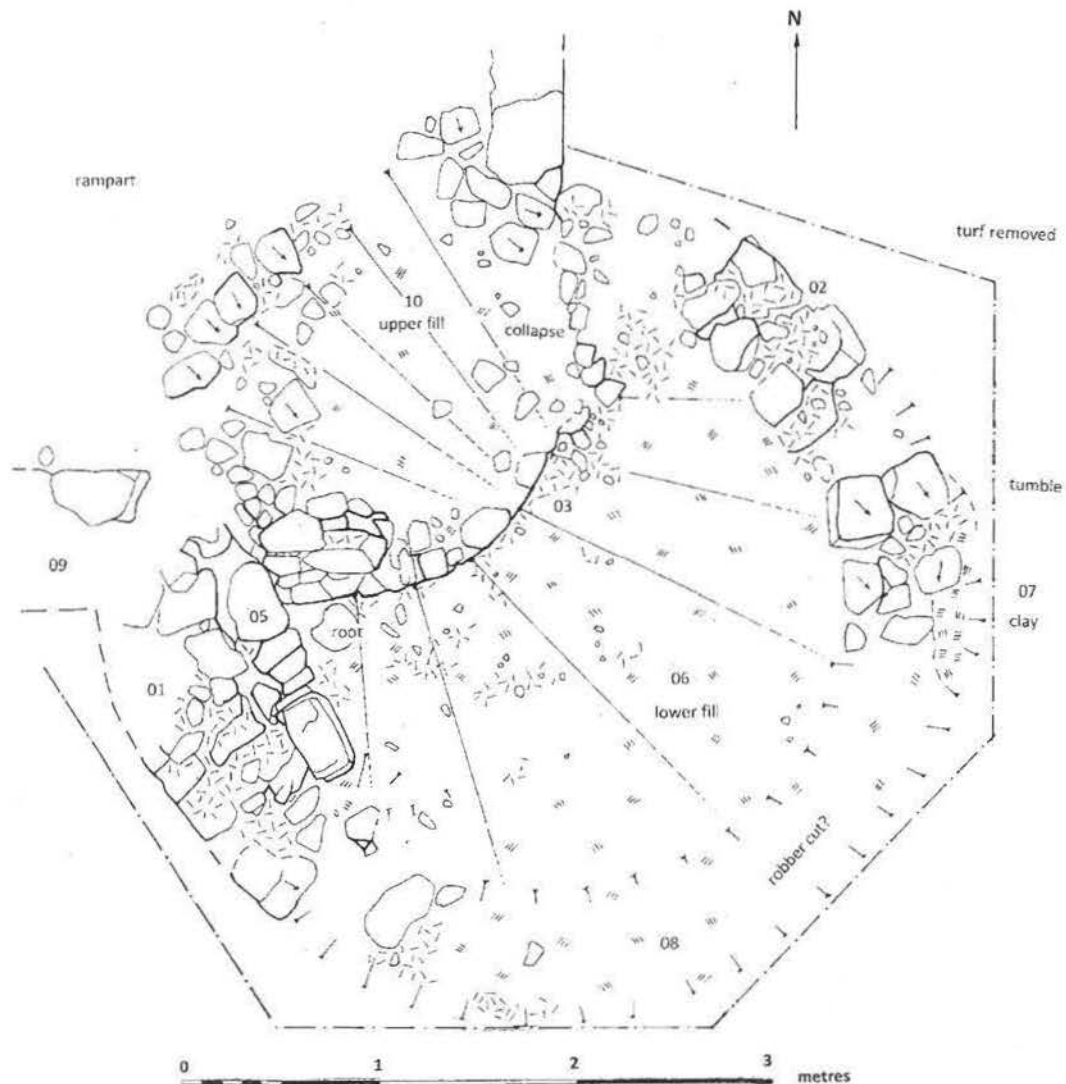
building of either the revetment wall itself or of the tower wall. Towards the bottom of this sloping fill more reddish and cleaner clay was evident and a shallow trench in which a single pad of clean red clay 07 was set indicated the lost outer arc of the east tower. The upper fill was not quite so resilient as the lower fill and required consolidation with a combination of rubble and a dry mix. A set of four stones (Fig.3: top left), which appeared to have slipped and been displaced, were probable remnants of the inner arc of the tower. This would confirm that the tower was circular like the north and south towers in appearance rather than penannular like the west tower.

Fig.3: Plan of East Tower after clearance

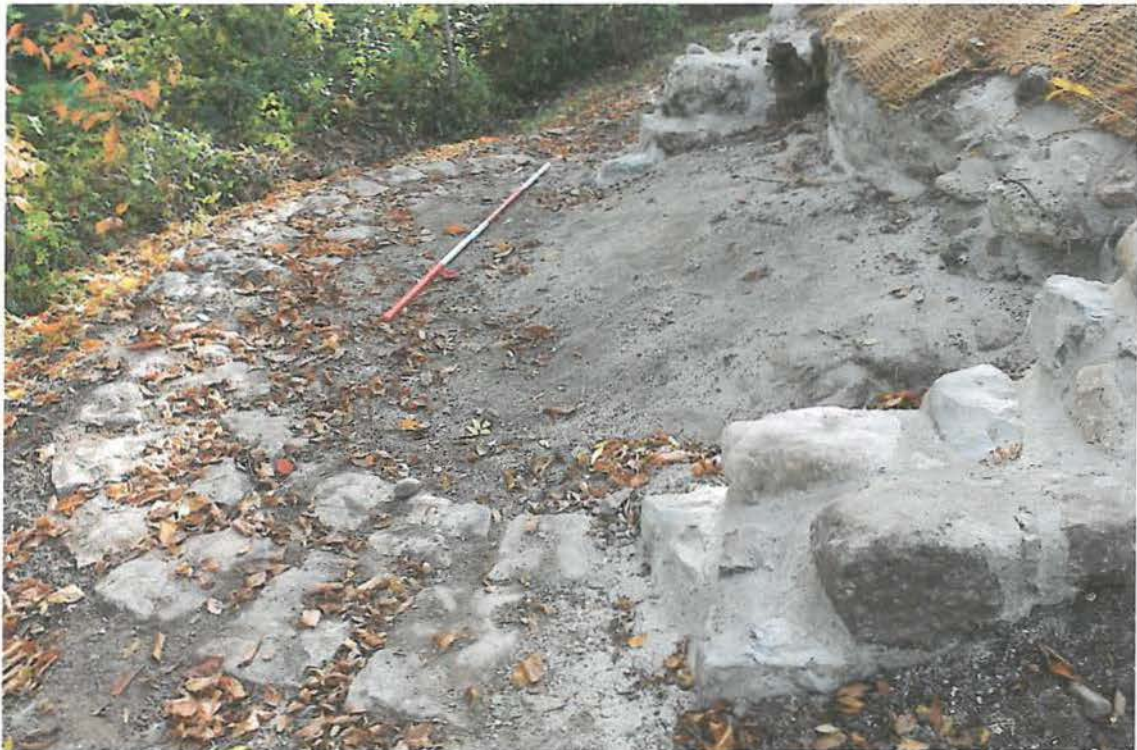
View of East Tower after reconstruction of lost outer wall from north east

The objectives of the work were carried out as agreed, although the original intention to pin together the north tower was considered unnecessary and abandoned. This enabled infilling of the eroded paths ascending the rampart within the south east entrance in order to support the terminals of the curtain walls. The stability of the earthen material within the east tower, with repointing to the revetment wall and 'buttress', and consolidation of the upper part of the fill, proved sufficient to support both these features and the remains of the east tower walls. Excavation was thus confined to removal of vegetation and topsoil in order to partially expose these features for recording purposes. No finds or other datable material was encountered except from unstratified fragments of roof slate and oyster shell, with a single modern coin, in the turf and topsoil. Dismantling of the section of the south east curtain wall adjoining the east tower exposed the rampart in section, but this was so obscured by debris and appeared to be so unstable that little new information on its stratigraphy was gained.
