**Deganwy Castle: Descriptive Survey and Watching Brief
October 2010-July 2011**

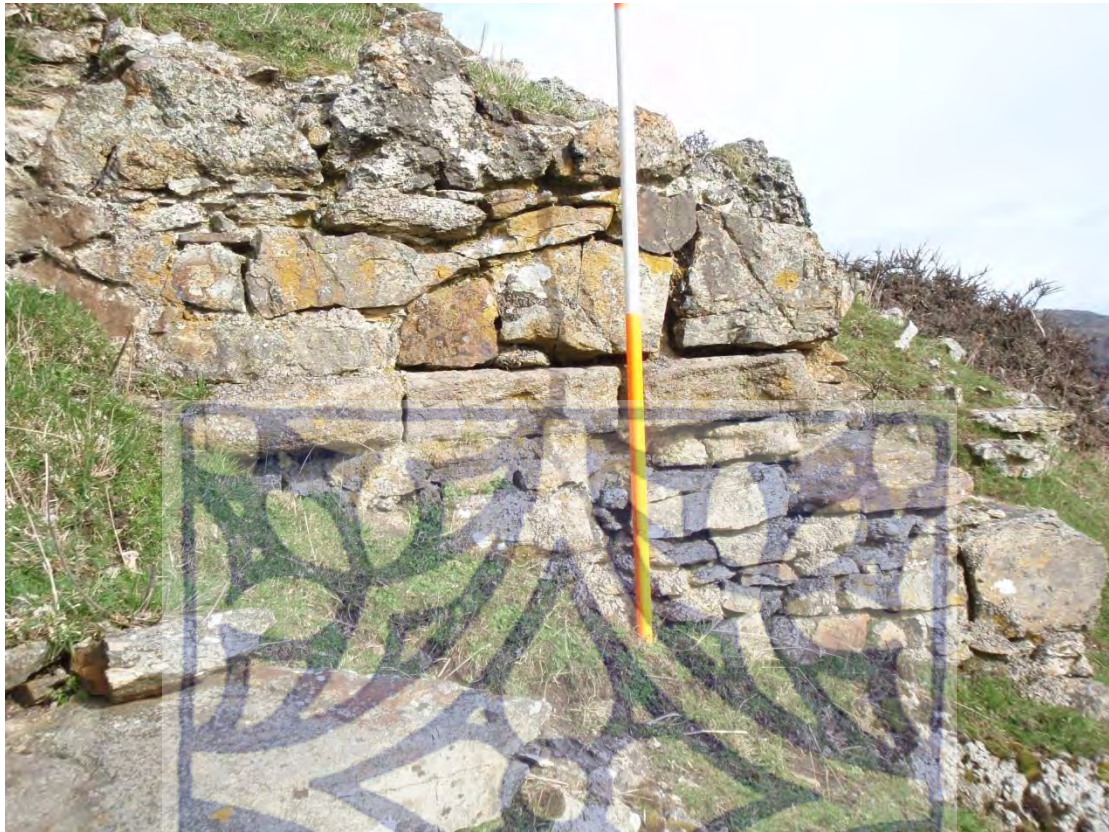
West Hill: South East Tower 10. Fragment of External Face with String Course.

and cut-out do not satisfactorily correspond. Further clearance by the contractors exposed a little more of the cordon and a substantial area of render on the external face of the tower. The relationship with two short lengths of wall to the west of 15 and lower down the slope of the tower remains unclear. They seem to relate to wall 15 descending the slope rather than the external stair projection mentioned by Alcock. The diameter of the tower compares favourably with that of round towers at Dolforwyn and Bere. Conserved September 2010.
Dwg. 7679 06. According to RCAHMW 1245-54, Alcock suggesting a date of c1250.

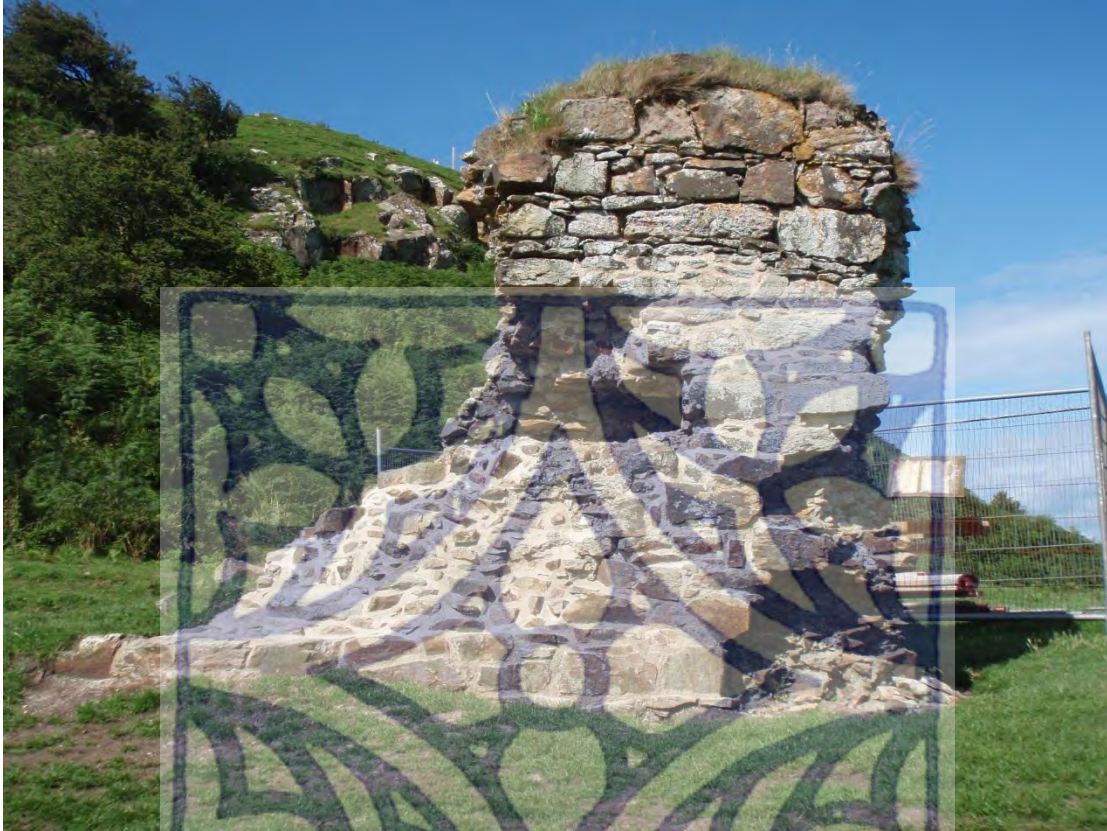
This is an isolated section of wall in line with the wide ditch and forwards of the bank forming the north defences of the bailey. It is 5m. long north to south, about 3.2m. high and 1.5m. thick, and represents part of the east wall of a tower, the modern track in to the bailey passing on its east side between the wall and ditch. A rectangular

Bailey: North Gate 'Pillar' 1 from East

hollow to the west of the wall suggests the footings, perhaps with an apsidal end, survive beneath the turf. The position of the tower is odd, since it appears to be built as a barbican across the line of the ditch and in front of the banks 24 and 29. A break through this bank for the modern track has no trace of strengthening to the opening. GAT describes it as a rectangular tower, the entrance was immediately east of it and that it is possible there was a timber tower on that side, although there seems to be no space for one, the distance to the ditch being less than 5m. The tower wall extends almost 7m. further to its south east corner, the south wall being about 8m. long internally. The form of the tower north of the 'pillar' is difficult to make out, its line appearing to be interrupted by a rounded hollow. It is in poor condition, a situation remedied by recent conservation, and there is a drawbar hole implying a doorway into the tower from the entrance. Conserved August-September 2010. Dwg. 7679 08 and 30. RCAM 1245-54, although Alcock suggests it should be attributed to Edward I.

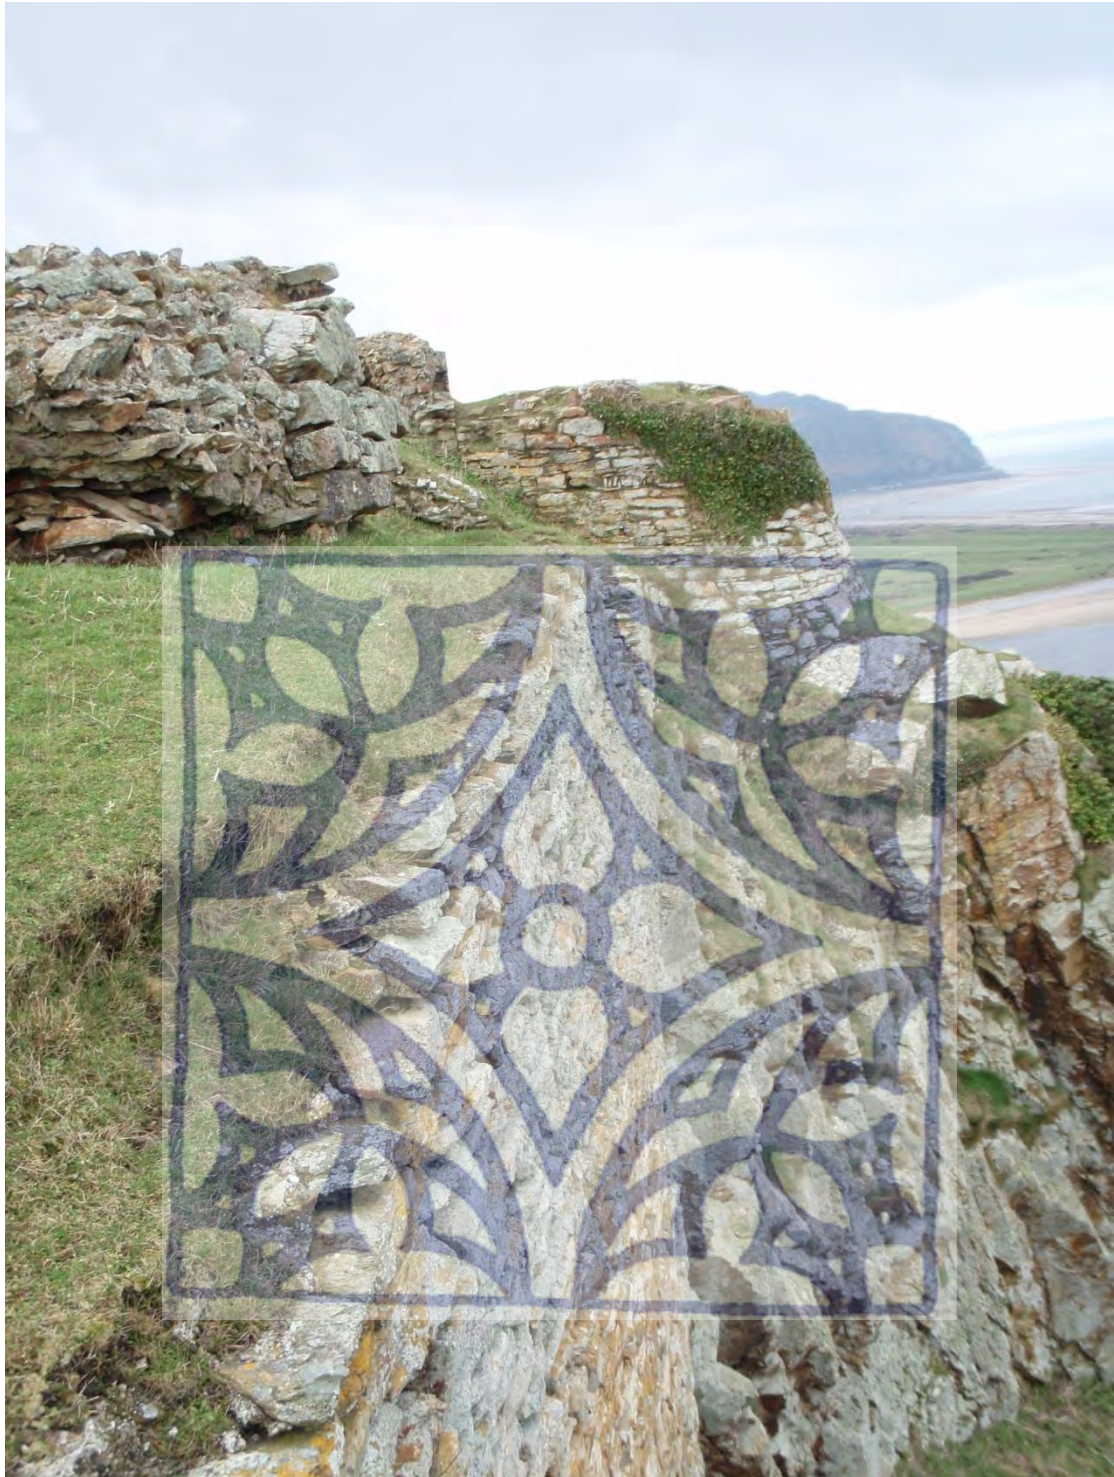
This is an impressive section of revetment wall connecting the rock outcrop 26, at the north end of the hill, with that surmounted by the tower 4 and closing off what must have been a ravine between the outcrops. It is 12m. long and 6.5m. high above a

turf 'berm' at its base with its original mortar, although it has lost its upper section above the present ground level. Its relationship with the isolated length of wall 3 is uncertain except that it is set 0.5m. forwards of it and, according to the depth of the putlog holes – between 0.8m. and 1.9m. deep – beneath it. This suggests that it predates wall 3, the RCAM giving a date of c1215 for the revetment wall and 1245-54 for the upper length, although Alcock proposes the opposite sequence. The round putlog holes are arranged horizontally in four lines between 0.65m. and 1.7m. apart, and between 1.0m. and 1.5m. vertically. The diameter of the holes is 0.07 and 0.11m. and almost all are at right angles both in the horizontal and vertical planes to the wall. Conserved August-September 2010. Dwg. 7679 28. RCAM c1215, Alcock 1260s.

West Hill: North Revetment Wall 2, Wall 3 top left and Tower 4 background

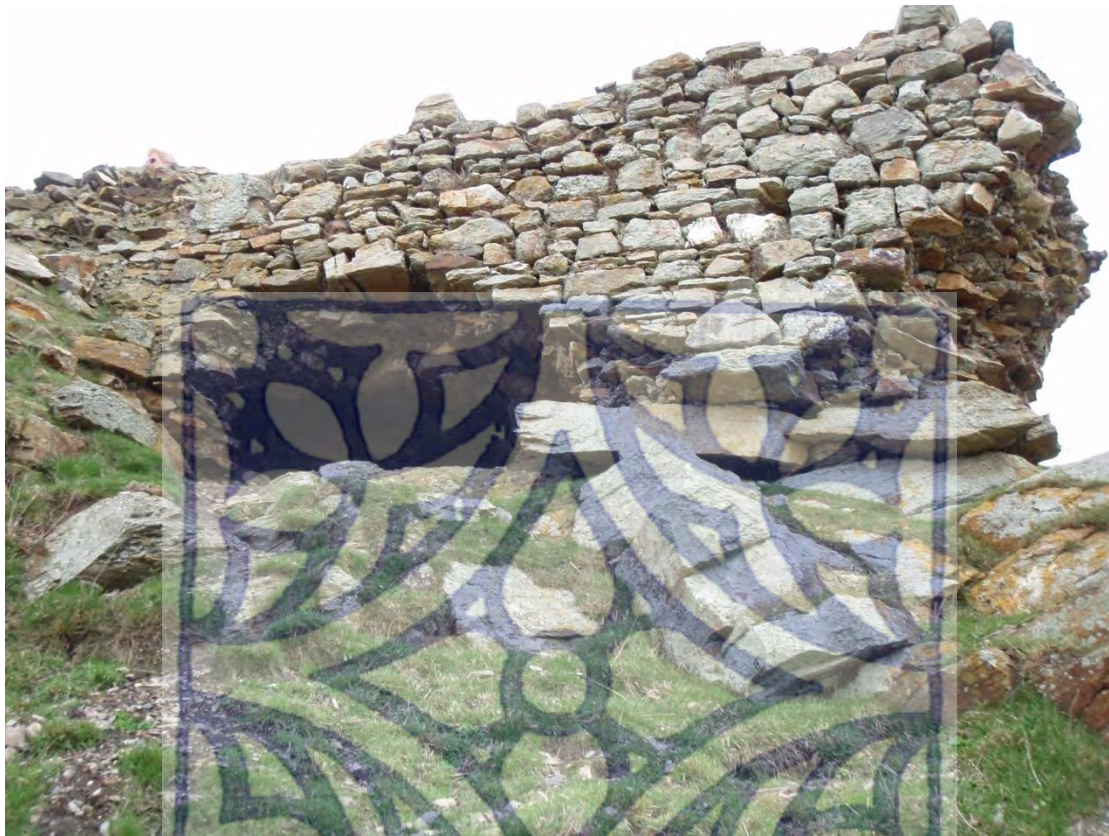
12m.long south west to north east and up to 1.7m.high internally, 2.5m.externally, and 1.5m.thick. There is an embrasure, possibly for a double garderobe, close to the angle with the west part of the curtain wall. The section to the east of this, next to the angle with Tower 4 is undermined and open from both its east and external sides with a horizontal shaft-like opening from the embrasure/garderobe. Is the hole a result of mining, exploited by a badger's sett?

A vertical joint 0.42m. high in the external face may indicate blocking of an arrow loop or some other such opening through the wall, perhaps when the west wall of the tower and what may be a buttress in the angle of curtain wall and tower were built. This seems to be confirmed by an inset in the internal face of the wall, the top of the wall core appearing to be secondary to the lower mass of the wall, with a distinct soil-line between them. This appears to be contradicted, however, by the stump of a side wall at almost a right angle to the curtain wall, which may have formed part of an end wall to a building across the angle of the curtain wall. It seems to be bonded to the curtain wall, but could not be traced further than about 0.4m.away and south east from the main wall, except that it appears to be continued by a scar in the grass slope and to be directed towards tumbled masonry. It was not possible to define its north east side, but the curtain wall is slightly wider than it is to the south west of this stub wall.

West Hill: North West Curtain Wall 5: 'Hole' and Garderobe? Breach

Contemporary with 6, to which it is bonded. RCAM 1245-54, but probably incorporating earlier c 1215 work. Conserved August 2010, the hole being filled with reclaimed rubble and mortar in order to support the masonry, but the horizontal shaft being left intact. Dwgs. 7679 01, 7679 28 and 7679 29. 1245-54.

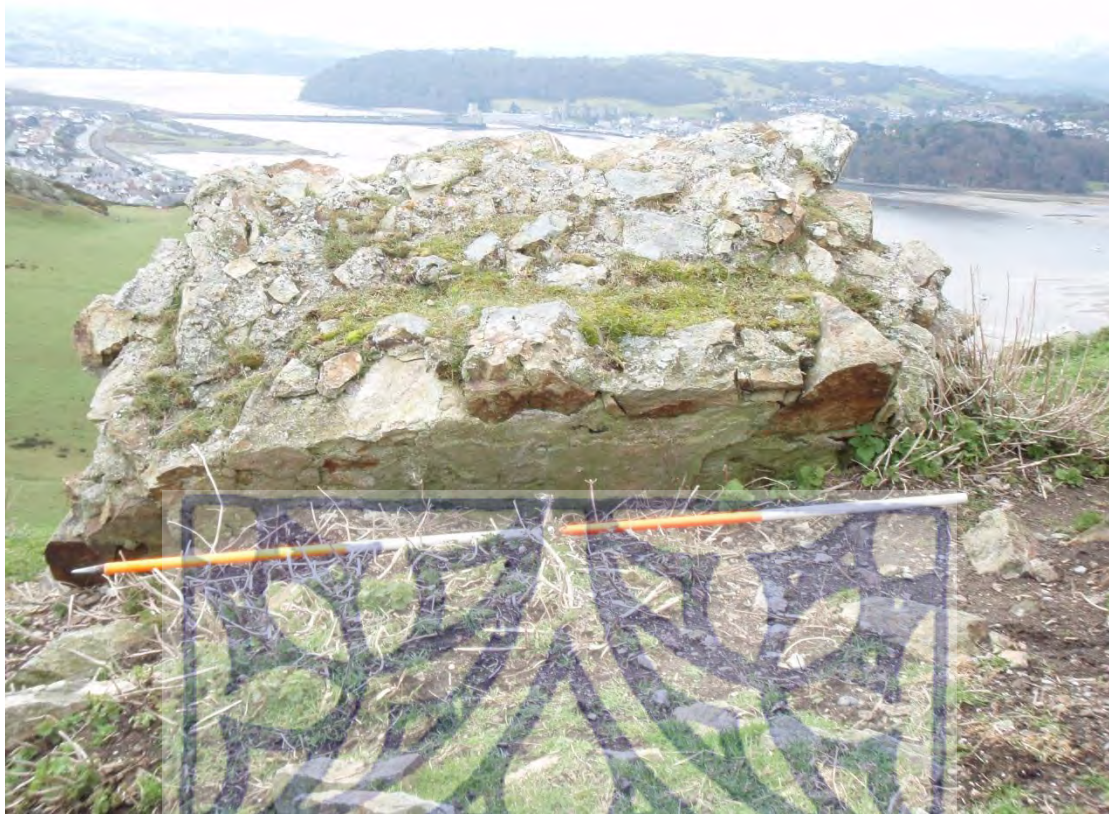
One of the fallen masses is plastered, confirming Alcock's observation of the inner walls of the hall, and part of both core work and short lengths of wall faces protrude from the turf. The west end may have been the site of a tower for the main gateway at the south west corner of the hilltop since it overlooks a 3m.wide gap and an oval bank close to the terminus of the Curtain Wall 6, but this may be debris from the fallen west wall. The modern track passes on the west side of the oval mound. Dwg. 7679 05 and 7679 06.
1245-54.

West Hill: 'King's Hall' 12 Fragment of Plastered Wall

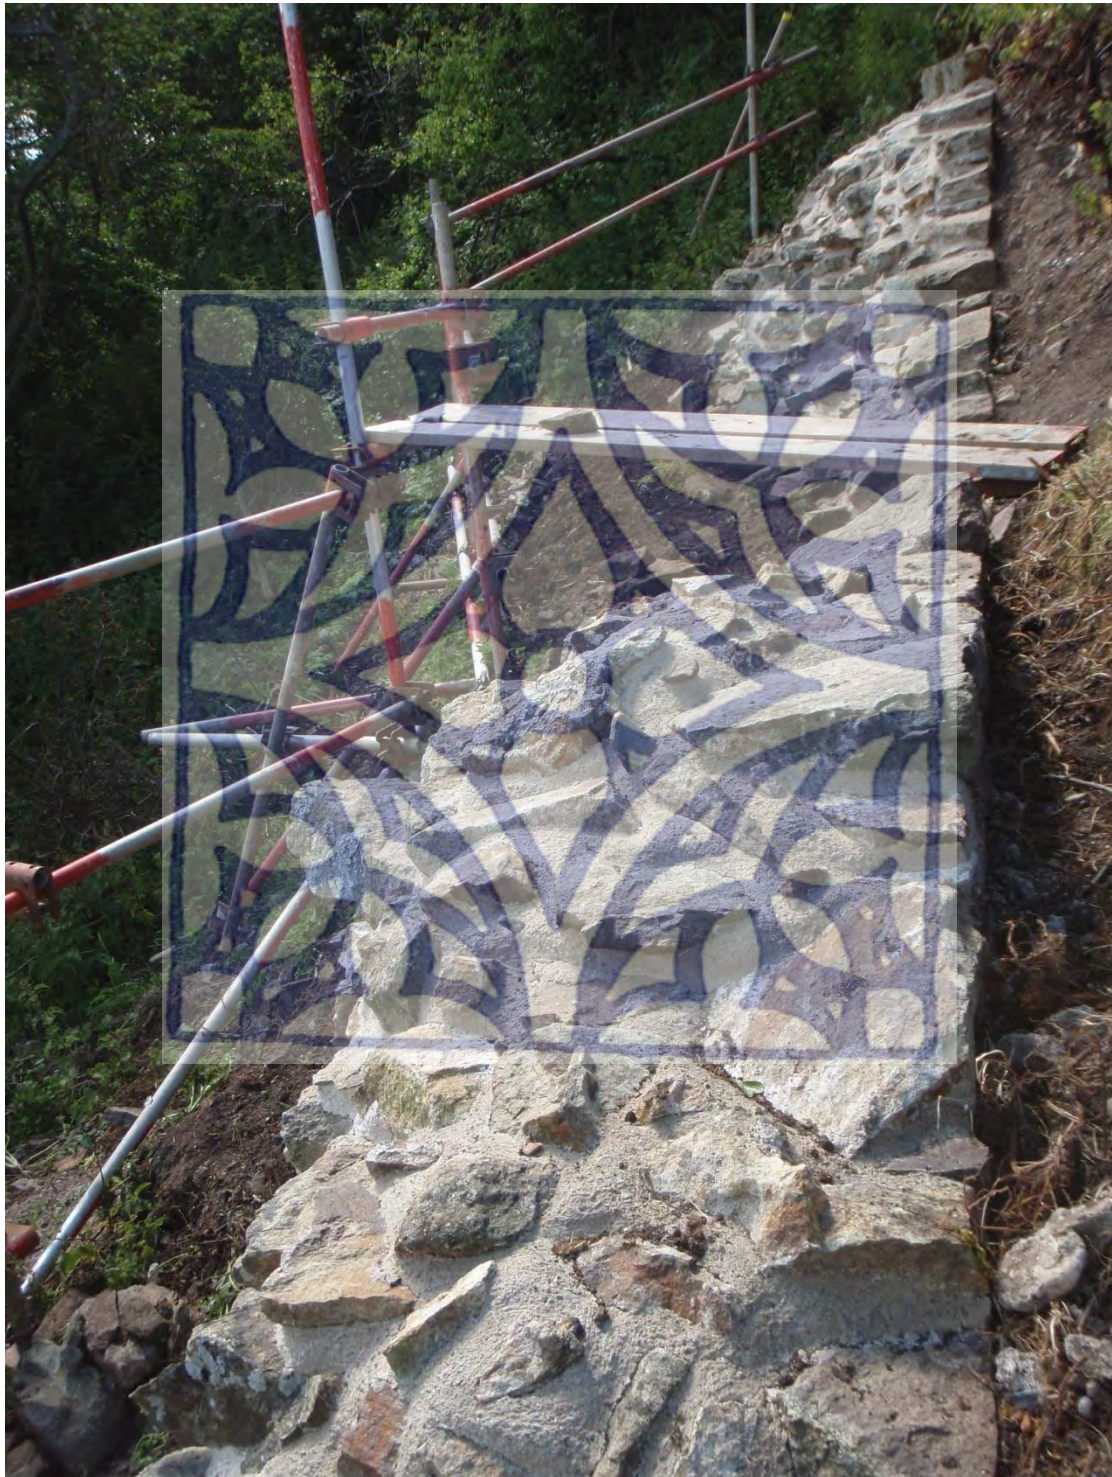
This is visible in two sections; firstly, as a 3m. length of wall 1.6m. wide abutting the east side of the tower 25 and secondly, as a 13m. length of what appeared, in 2010, to be almost entirely corework at the base of the hill about halfway to the South Gate. Between these points the curtain wall seems to have been demolished although footings may survive below the scree in the thicket of thorn trees. The shorter section attached to the bastion was not conserved; the more substantial, if apparently unstable, lower section of wall was conserved in May and June 2011. A combination of careful removal of tree stumps and clearance of encroaching spill and vegetation exposed far more of the wall than was anticipated. This included the top of the internal face and two short lengths of the external face at each end. This revealed a wall 1.6m. wide, although Alcock's excavations east of the South Gate suggested a wall 3m. thick. Removal of tree roots unearthed the strap handle of a jug SF5 at the east end of this length of curtain wall as well as two further pieces SF6 and several pieces of a hard, grey crystalline rock.

South Curtain Wall 16: Lower Section from East Conserved

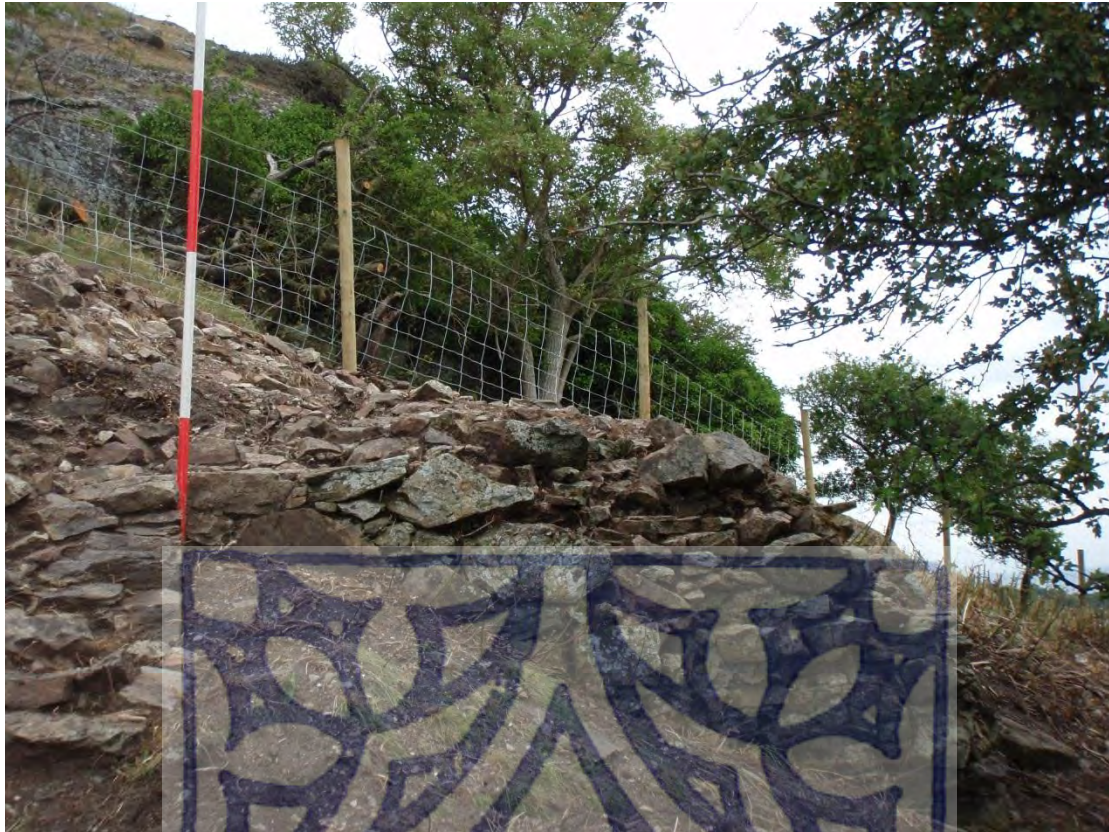
This is suggested by two curving projections against whose west and east sides the curtain walls 14 and 16 abut. Clearance of modern debris – the base of a bottle dating from after 1876 – has not defined the internal face of the tower on its west side, and the south arc may be entirely lost. Alcock describes it as a solid bastion, and it was roughly the same size as the North West Tower 4. It is 7.0m. west to east between the junctions with the respecting curtain walls, the east side appearing to align with the north-south wall 15. GAT do not mention this tower or show it on plans. The RCAM places the 'Site of Gate' at this point. Dwg. 7679 13 and 7679 39. 1245-54 or earlier?

West Hill: Tower 25 Left and Curtain Wall 16 Right from South
