PLAS BERW BARN, PENTRE BERW

NPRN 265407 SH46817187 PGW2*

Survey and Description August 2014

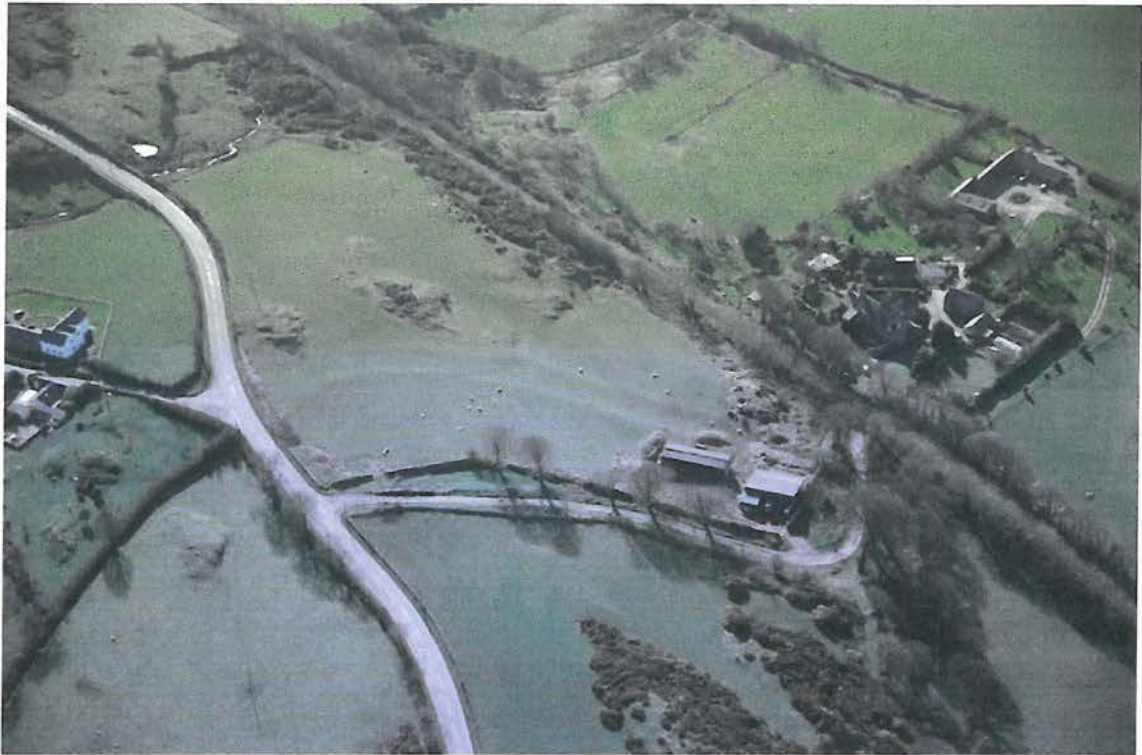
Fig. 2: Coflein AP 2005 0167 Cat.No. C839856. Plas Berw from the East. Photograph by Toby Driver 2005. Note the inturned curving entrance and hollow way in the centre which crosses Parc yr Hydd and the mid 19th. century railway embankment bisecting the park.

A RCAHMW air photograph taken by Toby Driver in 2005 (Fig.2) suggests that the earlier approach to Plas Berw was from the south east opposite the Nant-gwag junction on what is now the B4419 Pentre Berw to Newborough road and some distance south of the modern entrance. This feature can be traced on the ground as a widely curving and inturned entrance and hollow way with parallel banks cutting across the upper part of the deer park ('Parc yr Hydd') towards the modern sheds and the present track where it turns sharply to descend the hill to Plas Berw. This feature appears to be shown in the 1840 Ordnance Survey map (Fig.5) but not in the later 1887-88 map when the modern track was already in place and outside of the east wall of the deer park. Its earlier line is close to, but does not coincide exactly with the parish boundary between Llanidan and the detached part of Llanfihangel Ysgeifiog which crossed the field a little to the west. The relocation of the approach to Berw thus appears to have taken place after 1840, perhaps at the same time as the railway bisected the park. The earlier entrance and approach appear to be consistent with the medieval landscaping and building of the deer park, but there is no evidence from the maps or topography that the footpath from Pentre Berw to Plas Berw, which is terraced into the side of the valley and passes close to the barn, ever formed a formal drive.

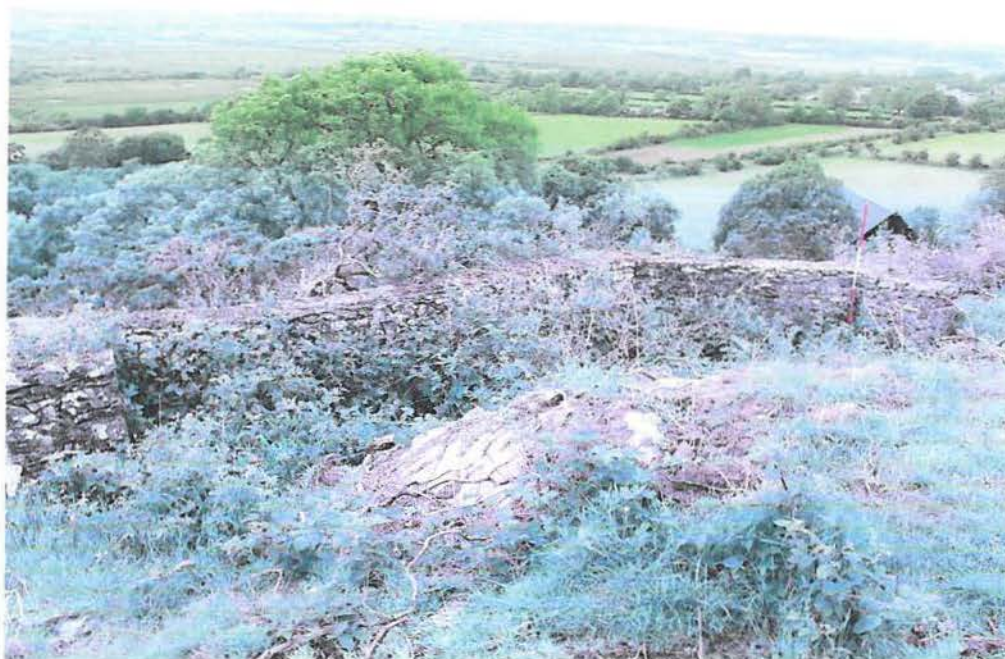
Photograph 3: SH4678171775 June 2014, Flechette to the south of and overlooking the barn.

The Register of Historic Parks and Gardens in Wales refer to reuse of the barn during the Second World War for military purposes, being partly reroofed at that time and altered inside with the addition of much concrete. The writer has been unable to find any other written evidence for the Second World War use of the building, but previously unrecorded features include two Second World War 'flechettes' in the field to the south of the barn (Appendix Photographs 3 and 4).

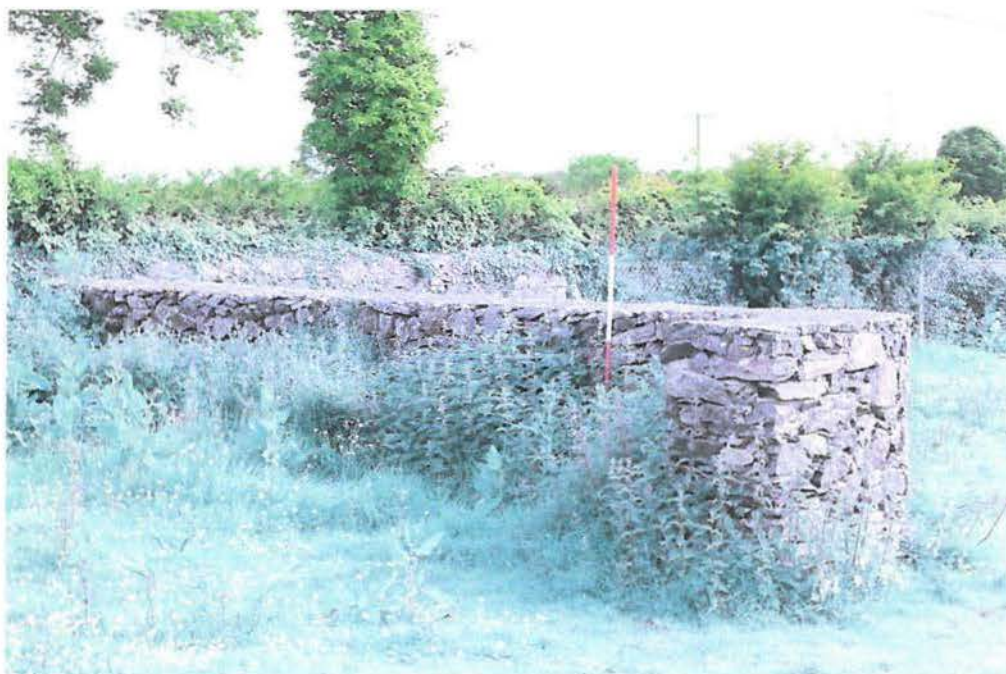
Photograph 4: SH4681971708 June 2014, Flechette next to the B4419 Pentre Berw to Newborough road.
