DITITION WAT	ERITAGE SURVEY MB.						
Α	BW Region	M+SW	J		PRN		-	204
	Waterway	M+B	. C		OS Sheet			
	BW Struc No	BR NO	强 53	5	NGR			
	Side	TOW OF	F ŒN	отн	Photo Neg N	0 15	14 + 5	
	BW Owned	Y	Ú/K	N	MMS/PMS			
В	County	GWEN	ıT		Alt Address	Joine	1 BRIDG	rE
	LA District	Mesuro	with -	Torface	-		•	
	Parish	·						
	Address	OR M	· 55	55 ,A	472 , US	sk ro	A D	···
С	Date Listed				SAM No	:		
	Grade	1	11*	: II	Protected Are	a NP	AONB (CA SSSI
	Serial No	:			Structures in Item	:		
D	Design Integ	A B	<u></u>	D	Context	VIL	URB I	SO GRO
	Setting	A B	С	D	Condition	Α	B)-(d	D D
	Group Value	Y	N			PV E	BUL RI	BRIDGE
	Listable	Y	N		Present Use	ŗ		
E	Building Type	PUBLIC	ROM) BRII	ogŧ		-	
	Date	1) 193	2	2)			3) 1	₹
	Designer(s)							
	Materials	BR	ST	EBR	<u></u>	IR	ME	WD
		Ti	SL	СТІ	CER	AS	ОТН	
	S Features/ Tech Merit							
	Date Inspected	25	10	95

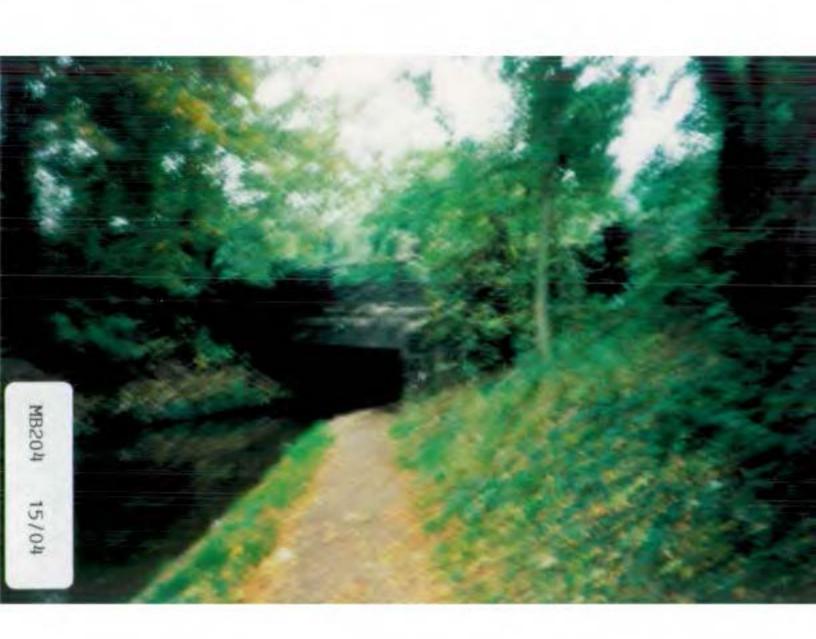
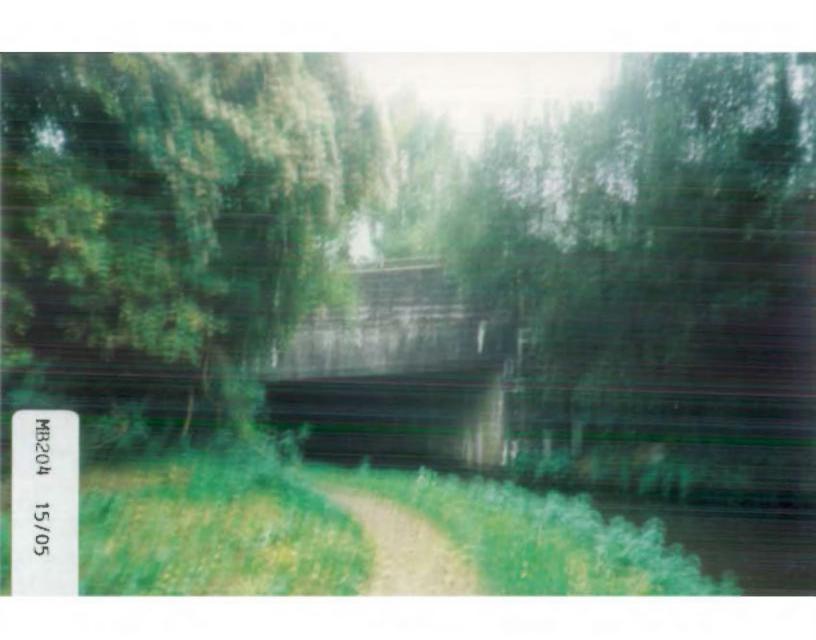
F	Site Note							
		Public road bridge, skew to the canal. Buil dressed with coursed rustic stone. Re-enfo	orced concrete road deck. Parallel					
		parapet and continuous wingwalls along road level, terminating in square piers with pyramidal capstones. The canal leaves the Brecon Beacons National Park to the south of this bridge, and is classified as a Remainder Waterway from this point.
