BRITISH WATERWAYS ARCHITECTURAL HERITAGE SURVEY

A	BW Region	M + SW	PRN	206
	Waterway	M + BC	OS Sheet	
	BW Struc No		NGR	
	Side	TOW OFF <u>CEN</u> OTH	Photo Neg No	14/35 - 36; 15/11
	BW Owned	<u>Y</u> U/K N	MMS/PMS	
B	County	GWENT	Alt Address	
	LA District	Torfaen		
	Parish			
	Address	PONTYMOILE AQUEDUCT		
C	Date Listed		SAM No	
	Grade	I II* II	Protected Area	NP AONB CA SSSI
	Serial No		Structures in Item	
D	Design Integ	A <u>B</u> - <u>C</u> D	Context	VIL <u>URB</u> ISO GRO
	Setting	A <u>B</u> C D	Condition	A <u>B</u> - <u>C</u> D
	Group Value	Y <u>N</u>	Present Use	AQUEDUCT
	Listable	Y ? N		
E	Building Type	AQUEDUCT		
	Date	1) 1812 2)		3) C19 + C20 REBUILDING
	Designer(s)	WILLIAM CROSSLEY		
	Materials	<u>BR</u> <u>ST</u> EBR <u>CO</u> IR ME WD		
		TI SL CTI CER AS OTH		
	S Features/ Tech Merit			
	Date Inspected	28 10 95

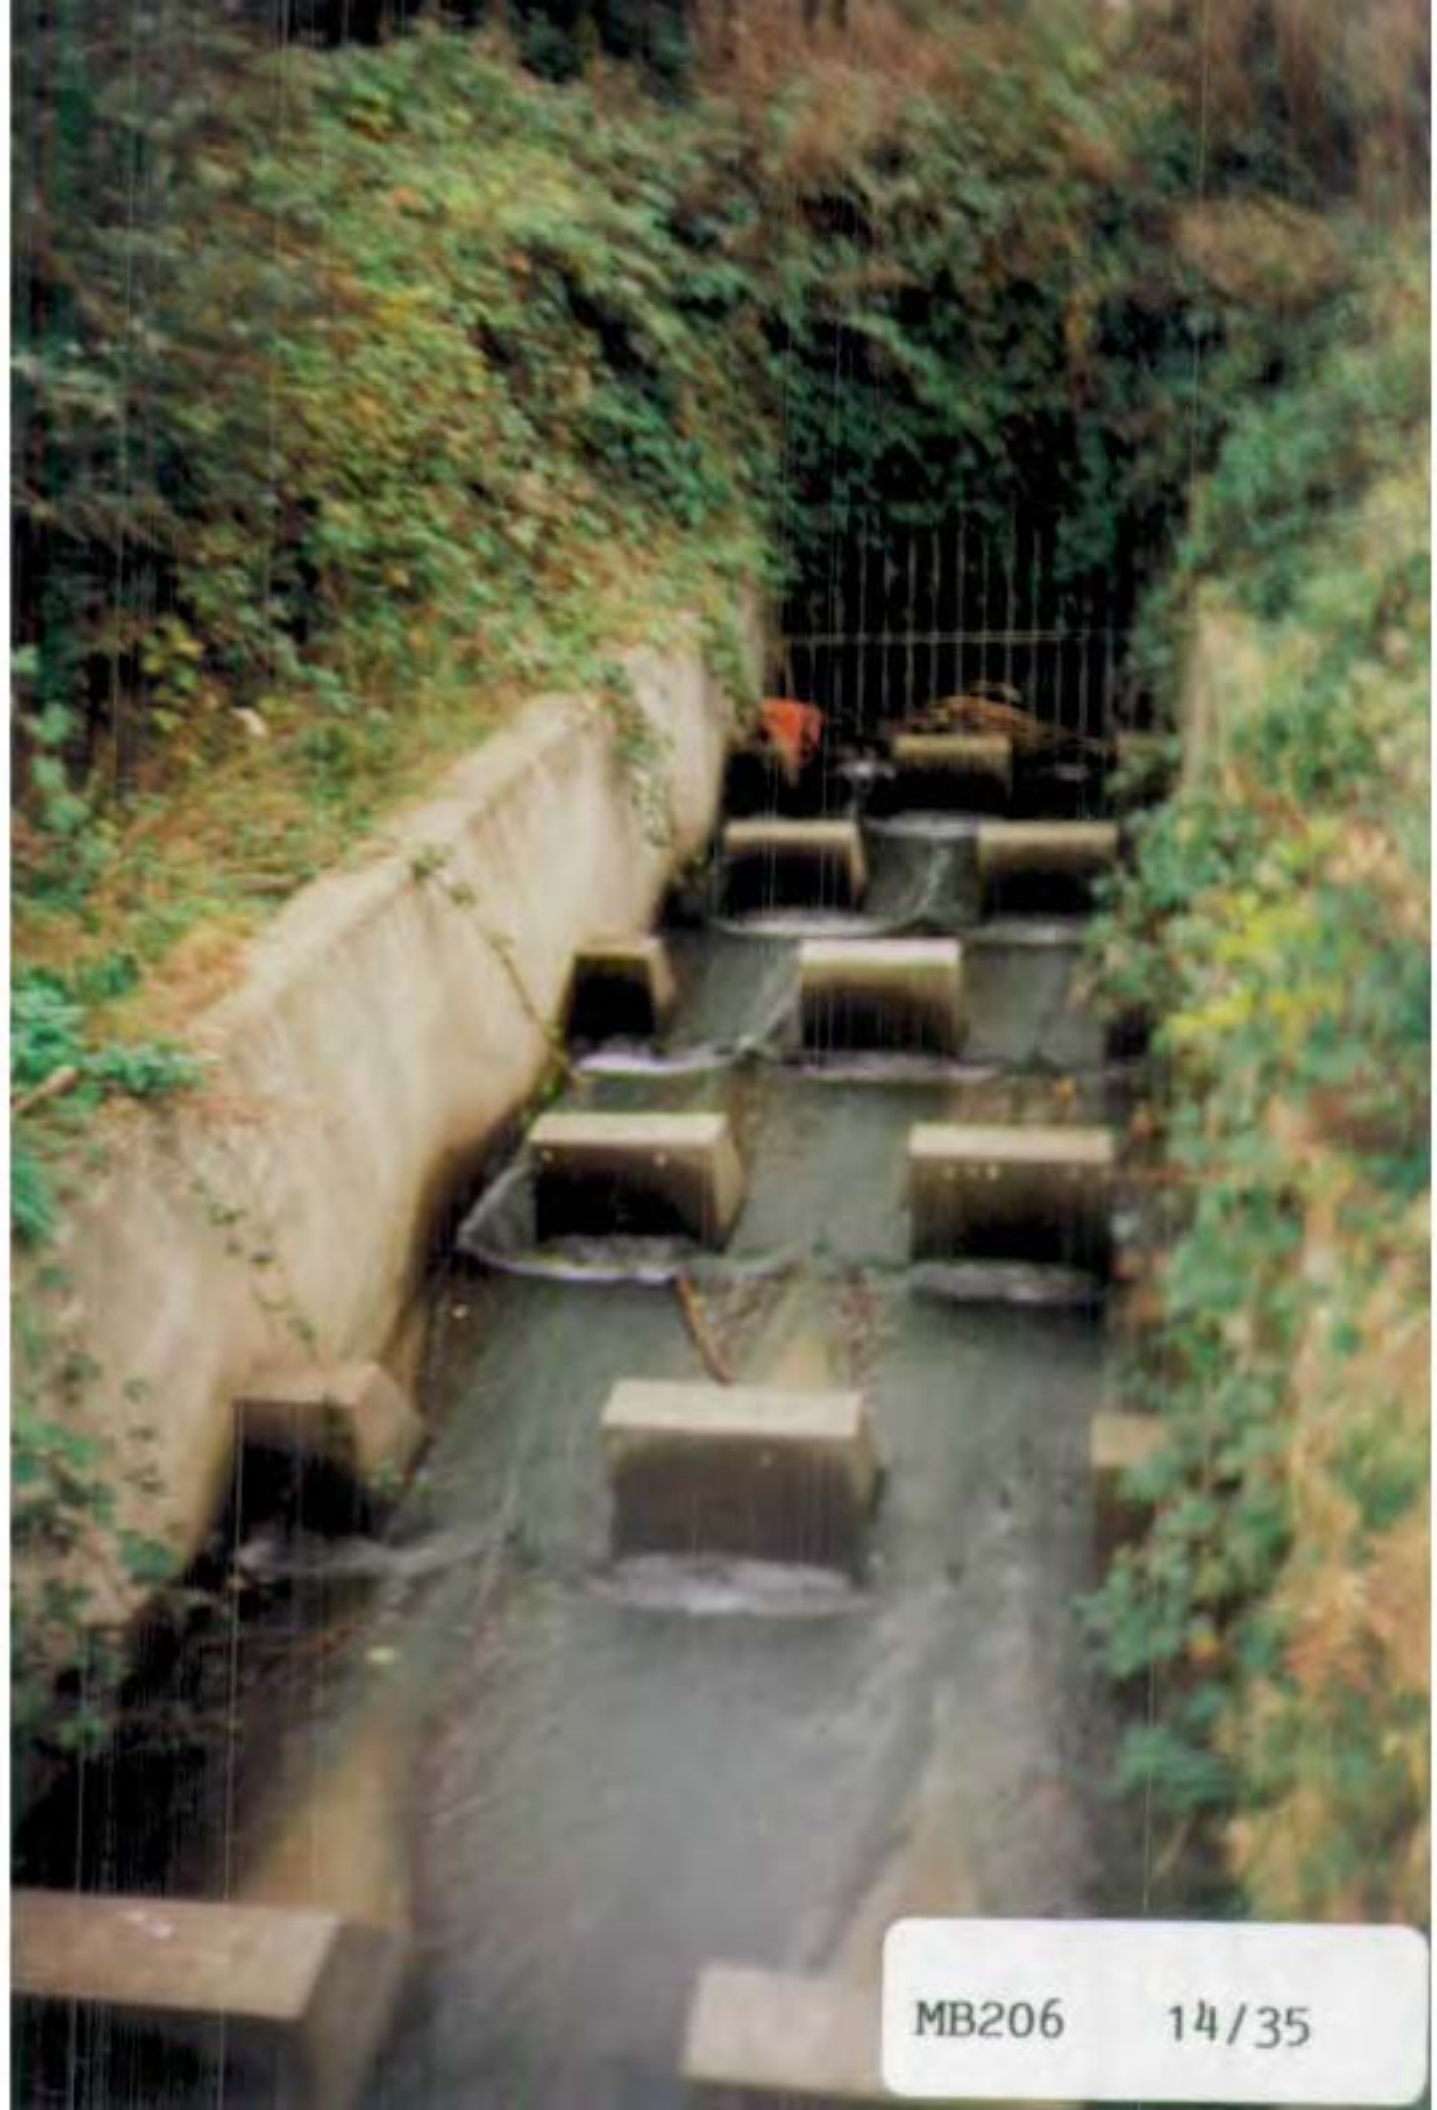
14/35

Aqueduct. c1812 with C19 and C20 renewal. Coursed rubble sandstone. Elliptical arch with dressed stone voussoirs and prominent keystones. Curved parapet wall to towpath, rebuilt and patched with cement. Flat stone copings, replaced with brick to the offside. North of the aqueduct is concrete overflow wier taking water from the canal for industrial purposes at nearby factory.
