## BRITISH WATERWAYS ARCHITECTURAL HERITAGE SURVEY

A	BW Region	M+SW	PRN	137
	Waterway	M+BC	OS Sheet	SO 2717 1367
	BW Struc No	BR. NO. 97	NGR	
	Side	TOW OFF <input checked="" type="radio"/> CEN OTH	Photo Neg No	11/12-14
	BW Owned	<input checked="" type="radio"/> Y <input type="radio"/> N/K N	MMS/PMS	
B	County	GWENT	Alt Address	GRIVILON YARD BR.
	LA District	Monmouth		
	Parish			
	Address	BR 97, TAKING B4246		
C	Date Listed		SAM No	
	Grade	I II* <input checked="" type="radio"/> II	Protected Area	<input checked="" type="radio"/> NP AONB CA SSSI
	Serial No	33/C/45(2)	Structures in Item	
D	Design Integ	A <input checked="" type="radio"/> B C D	Context	VIL URB ISO <input checked="" type="radio"/> GRO
	Setting	A <input checked="" type="radio"/> B C D	Condition	A <input checked="" type="radio"/> B C D
	Group Value	<input checked="" type="radio"/> Y N	Present Use	PUBLIC ROAD BRIDGE
	Listable	<input type="radio"/> Y <input checked="" type="radio"/> N		
E	Building Type	PUBLIC ROAD BRIDGE

Date	1) 1812 2)		3) WIDENED, REPAIRED (20
	Designer(s)	WILLIAM CROSSLEY (ENG.)		
	Materials	BR <input checked="" type="radio"/> ST EBR <input checked="" type="radio"/> CO IR ME WD		
		TI SL CTI CER AS OTH

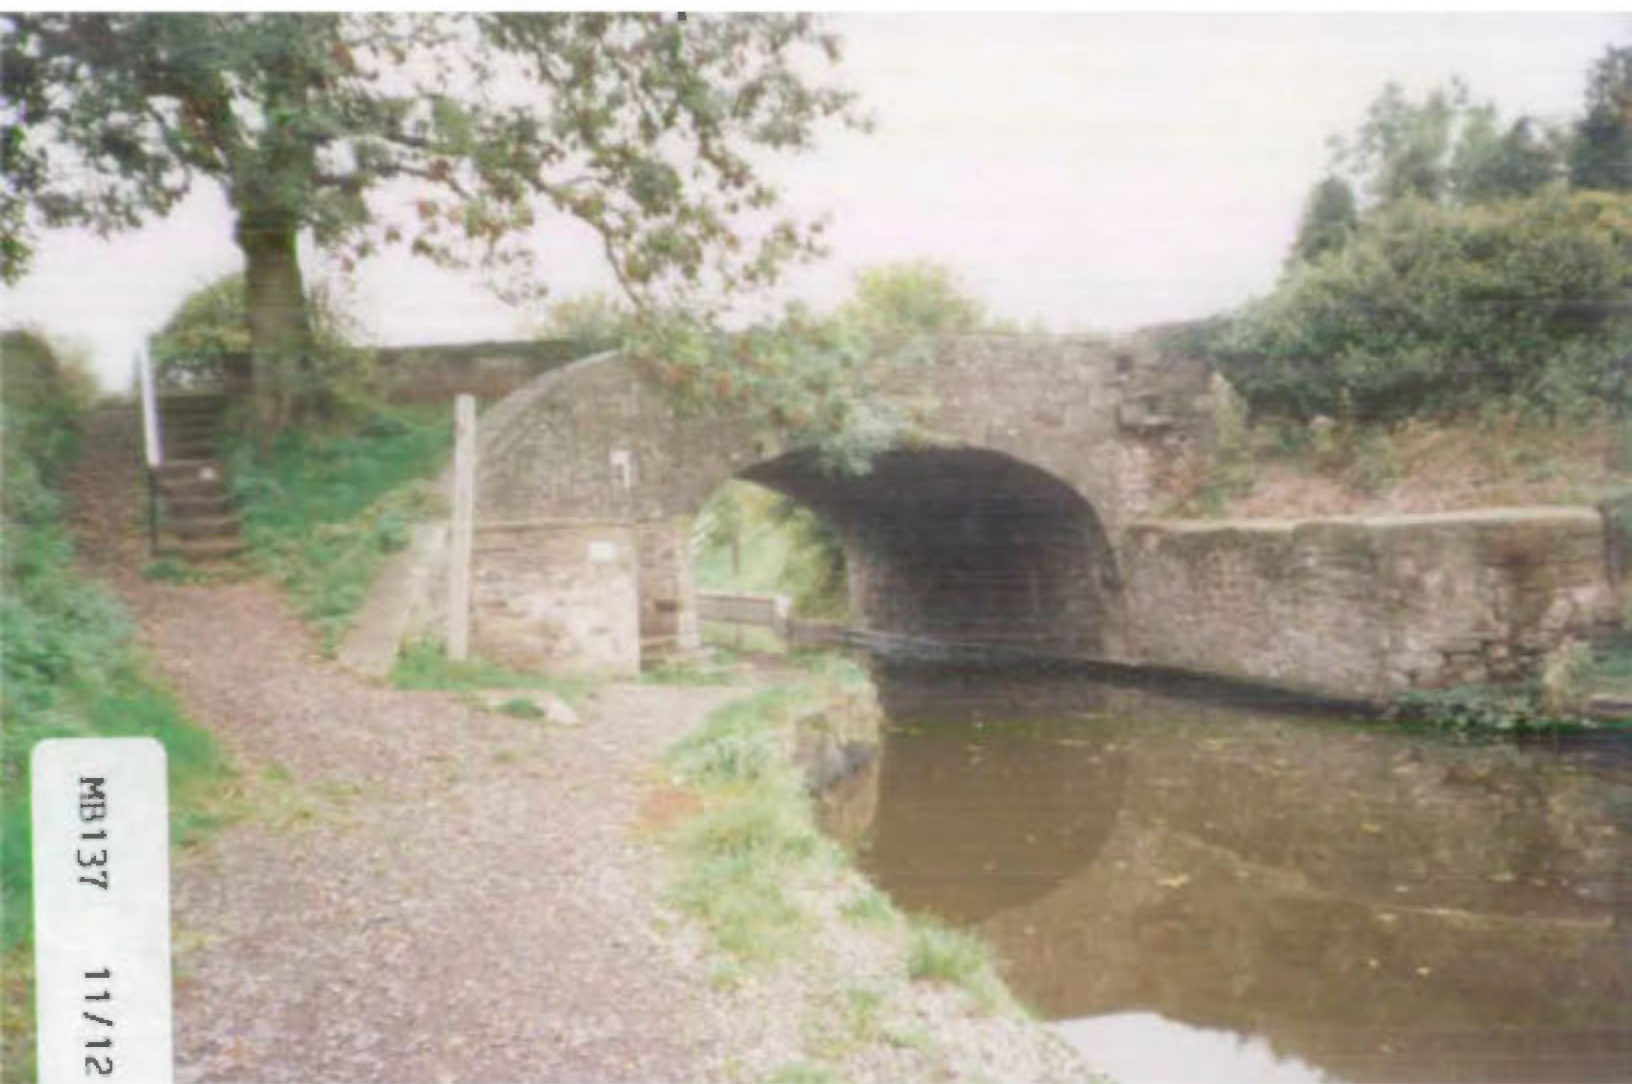
MB137 11/12

- Public road bridge. c1812, widened and repaired C20. William Crossley engineer. Coursed dressed rubble sandstone. Elliptical arch with stone voussoirs and flat stone copings, patched with concrete in places. Bridge soffit heavily jointed with mortar. Northern wingwall sweeps down to path on towside. Terminating piers to offside, patched with rubble stone. Reconstituted stone steps on towside up to road level.
