BRITISH WATERWAYS ARCHITECTURAL HERITAGE SURVEY

Address LENGTHMAN'S COTTAGE, GOUTRE WHARF

E Building Type LENGTHMAN'S COTTAGE

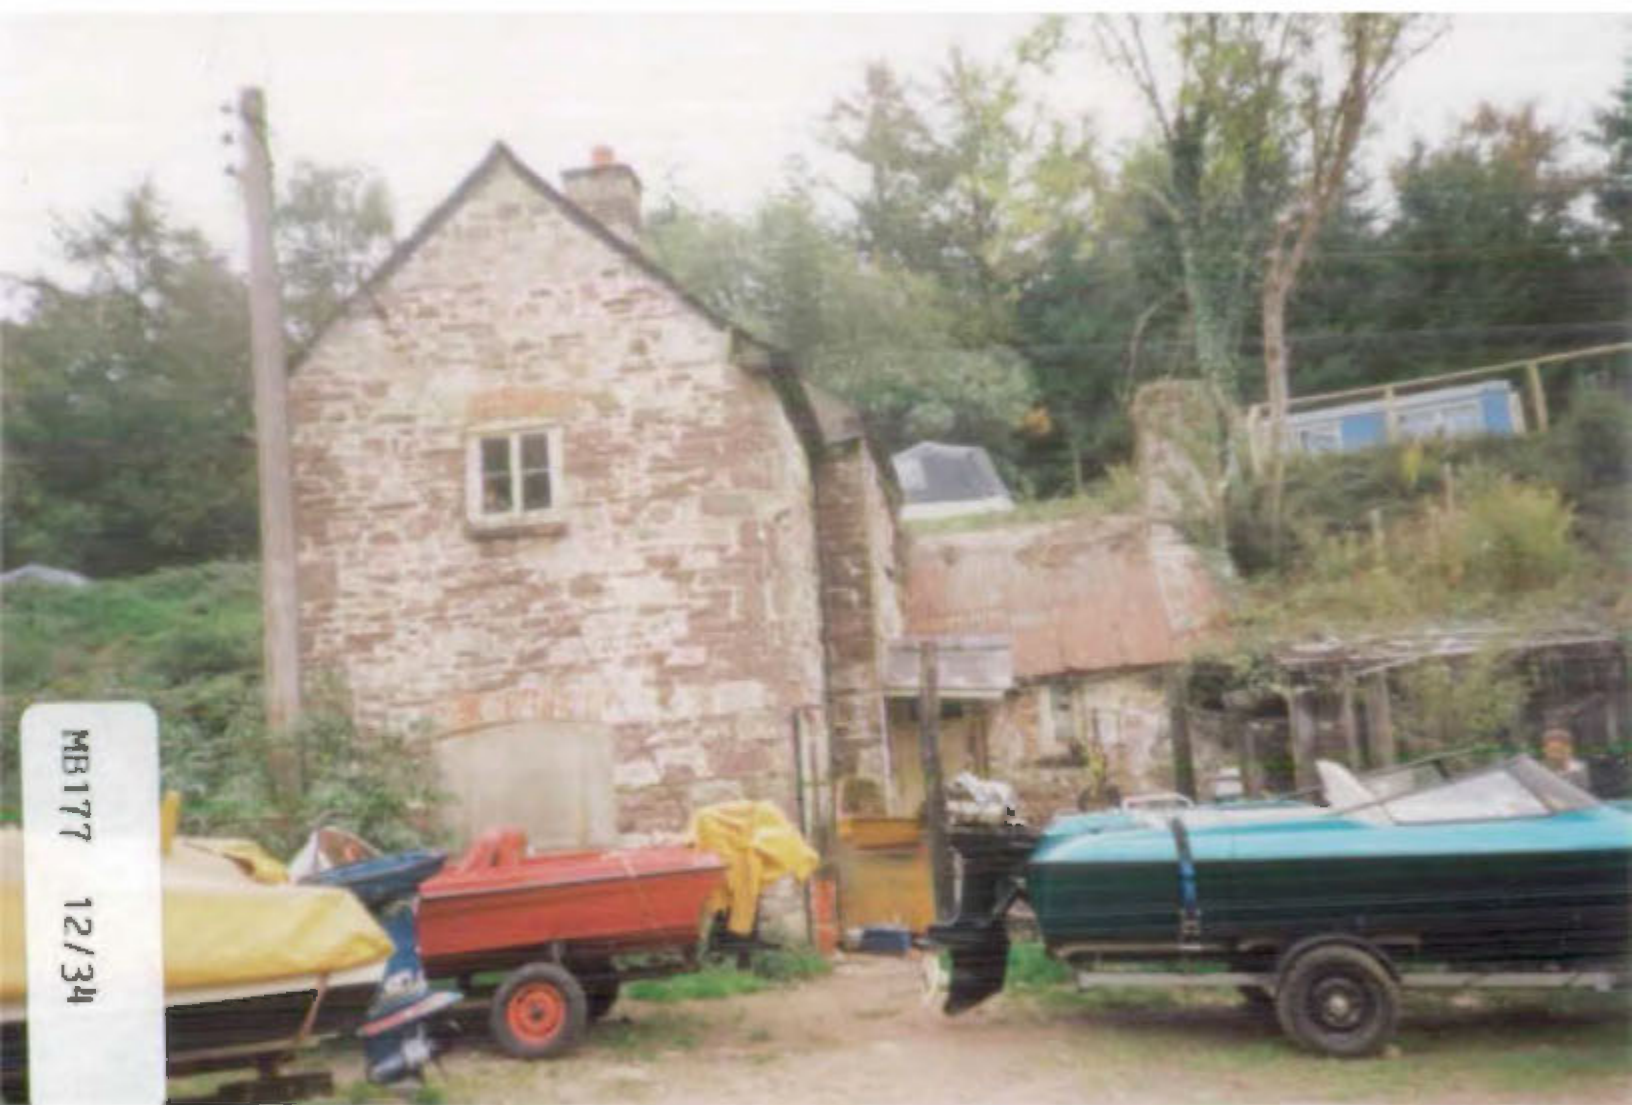
Lengthman's cottage. M-LC19. Coursed rubble sandstone. Pitched slate roofs with stone and brick gable chimneys to earlier section of cottage. Two storeys. Rectangular plan, elonged by later extension in same style. Single storey outshut at right angles to original block with stone chimney and corrugated iron roof. Irregularly spaced windows to both storeys. First floor windows still wooden casements with brick heads and stone sills. Ground floor windows replaced with MC20 top-opening casements. Gable end has larger brick headed entrance, now blocked, and first storey casement. Cottage now entered through outshut doorway. The house is uninhabited, and appears to be used for storage and workshop purposes.
