Moel Hiraddug Hillfort

REVISED ENTRY TO THE SCHEDULE OF MONUMENTS COMPILED AND MAINTAINED BY THE SECRETARY OF STATE FOR WALES UNDER SECTION 1 OF THE ANCIENT MONUMENTS AND ARCHAEOLOGICAL AREAS ACT 1979.

Name of Monument: Moel Hiraddug Hillfort

REASON FOR REVISION:

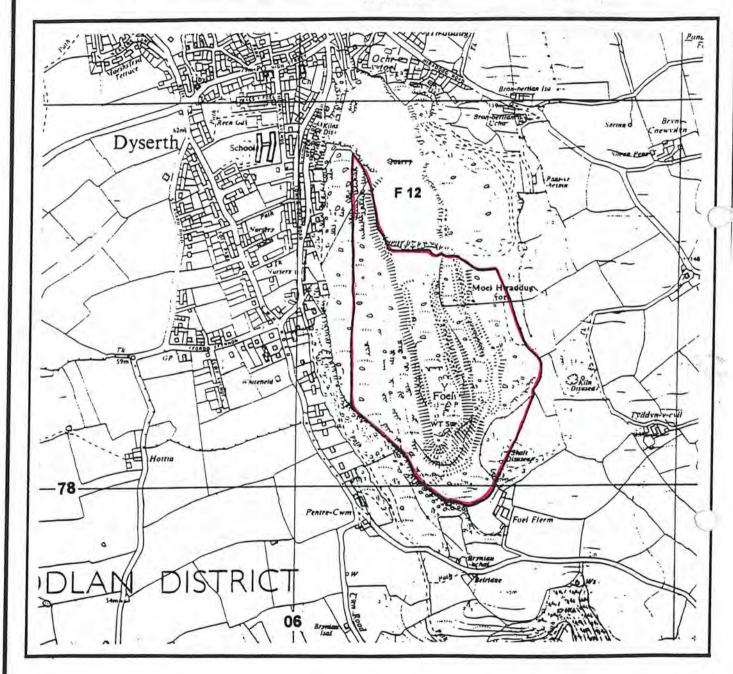
Extract from O.S. Sheet No.

The scheduled area has been reduced by bringing the northern boundary further south to the edge of the undisturbed site. This northern third of the site has been completely removed by quarrying,

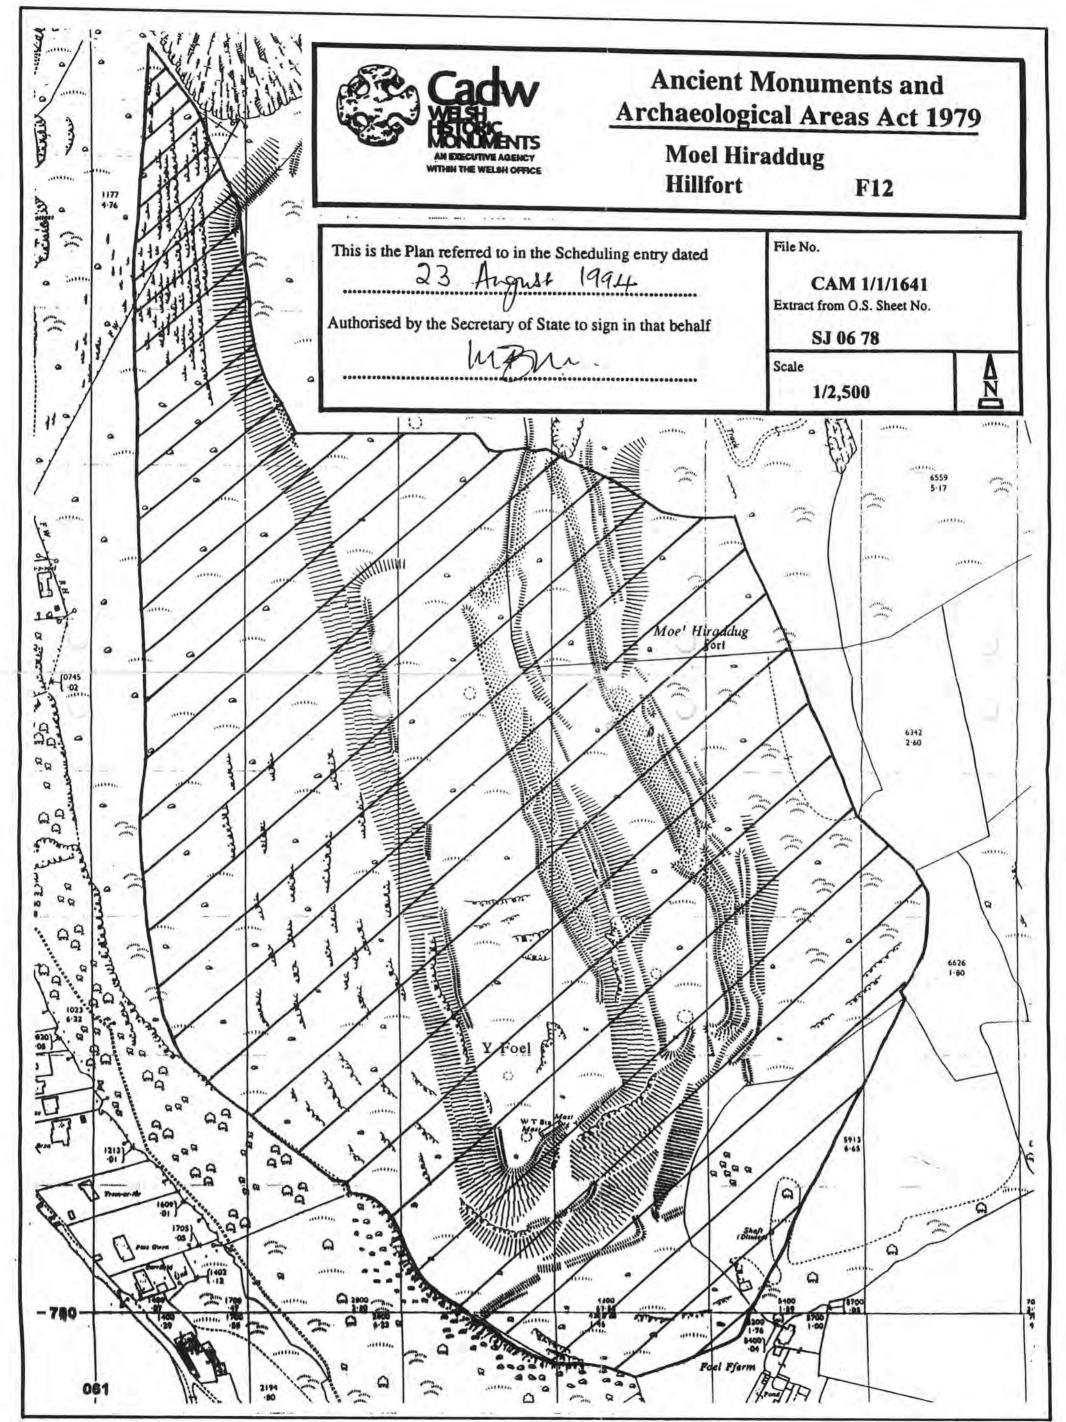
The scheduled area has been reduced by bringing the northern boundary further south to the edge of the undisturbed site. This northern third of the site has been completely removed by quarrying,

The site of the monument is shown on the attached map.
