*Welsh Water Elan Trust - E/09/3780*

Tir Gofal Historic Environment report - HE2

report prepared by CPAT for CCW

CPAT Project No 1153

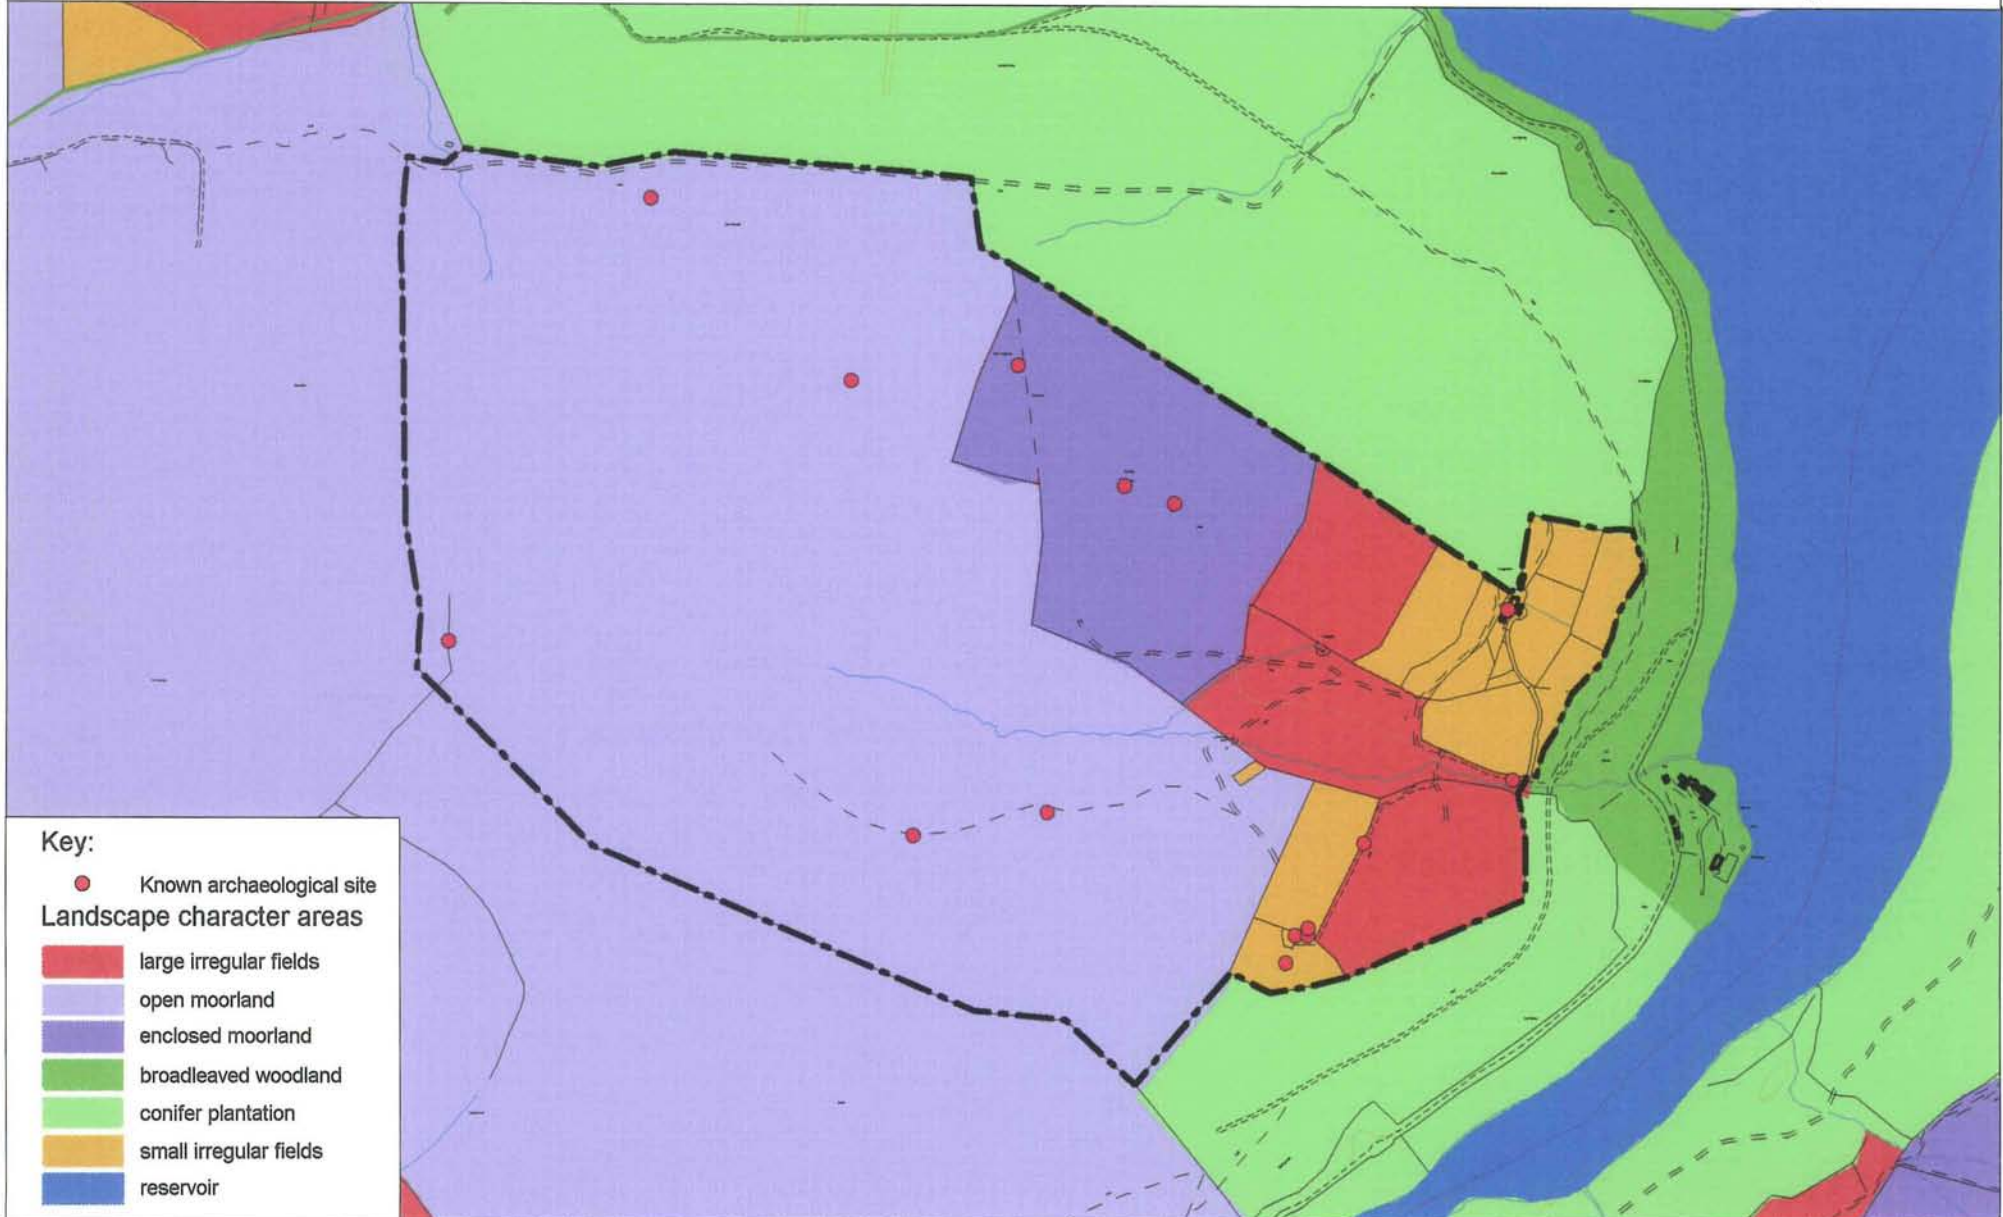
Tir Gofal applicant: Mr Baker, Welsh Water Elan Trust (Land at Pen-glan-einon).  
CPAT TG ref.: 36204 CCW TG ref.: E/09/3780

**Historic landscape character**

This application can be best described as an area of open moorland to the west with a small area of enclosed moorland to the north. To the east there are large and small irregular fields on the lower ground between and around the farmsteads of Pen-cae-haid and Pen-glan-einon and associated with them. Almost all of the boundaries are post and wire fences although some new hedges have recently been planted around the Pen-cae-haid farmstead. There are two much older field boundaries on the open moorland (pm65716 and pm67998), which could date to the post medieval period when areas of moorland were being enclosed. There is another short bank boundary close to Pen-glan-einon farmstead.

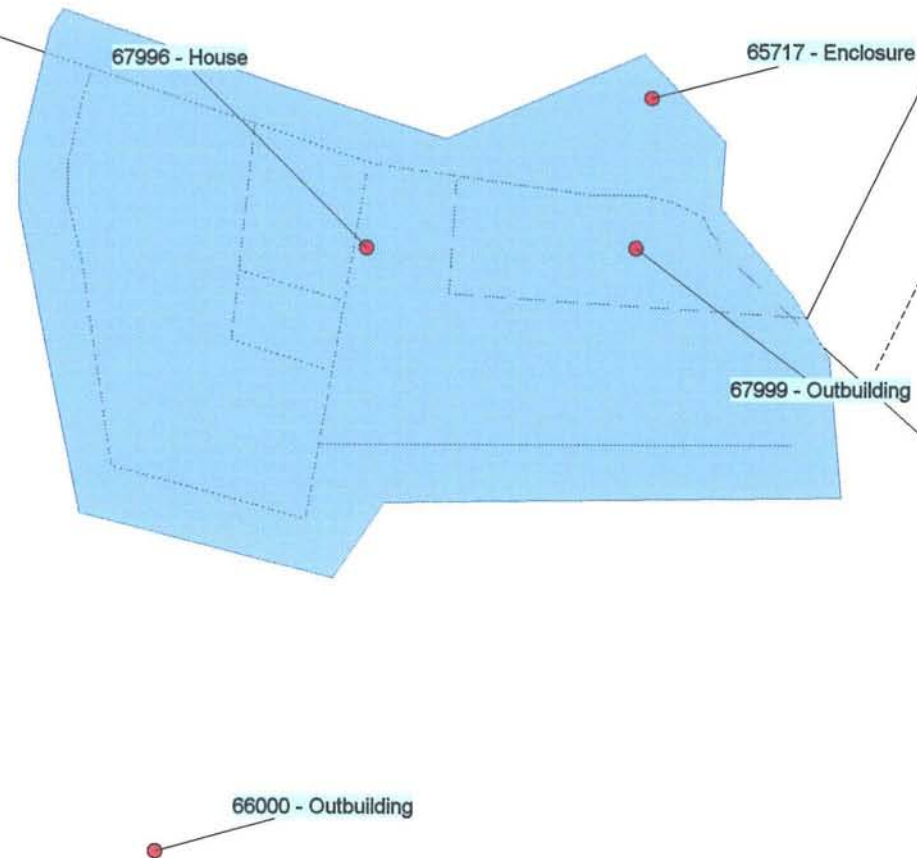
Tir Gofal applicant: Mr Baker, Welsh Water Elan Trust (Pen-glan-einon - Pen-cae-haid farmstead)  
CPAT TG ref.: 36204 CCW TG ref.: E/09/3780

Pen-cae-haid farmstead is composed of a house, an outbuilding with a toilet (prn67999), an enclosure (prn65717), and a track (prn65718) leading into the farmstead from the east. See individual PRNs for details.

A partly ruined rubble-stone gabled house. The southern room is still standing while the rest of the building is at ground level. The east-facing elevation has a door into the southern room, there is no evidence of an opening into the centre room, the southern part of the elevation is open. There is no evidence of openings in the north-facing gable which survives to a height of 0.4m. The west-facing elevation is 0.5m high to the north but remains at its original height to the south (1m), and has a doorway into the central room. The south-facing gable stands to its original height of 3m and has no evidence of openings.

The southern room is built into the northeast-facing hill slope and is about 2m wide (N-S) and 4m long. It has a slate covered two purlin and wall plate roof structure. The roof timbers are in good condition at present although about a third of the slates are missing. There are three stone steps to the south of the doorway on the outside of the house leading up the hill slope to the back of the house. There is no internal access from this room to the rest of the house.

67996: Pen-cae-haid farmstead - replace roof covering on the house to preserve the building in its present condition.

**MANAGEMENT:-****1. Maintain in present condition.****2. Maintain this building in a weatherproof condition.****3. Work should not be undertaken that would alter or affect the distinctive character or setting of these buildings.****4. The building should be maintained using traditional materials in keeping with the style of the original.****5. Do not remove any building stone or other material.****6. Maintain existing surrounding grass cover, which provides a substantial ground cover to protect any earthworks and/or buried archaeological features.****7. Control bracken, gorse and growth of woody plants, to prevent root damage to any archaeological deposits and upstanding features.***See individual PRNs for management recommendations.*

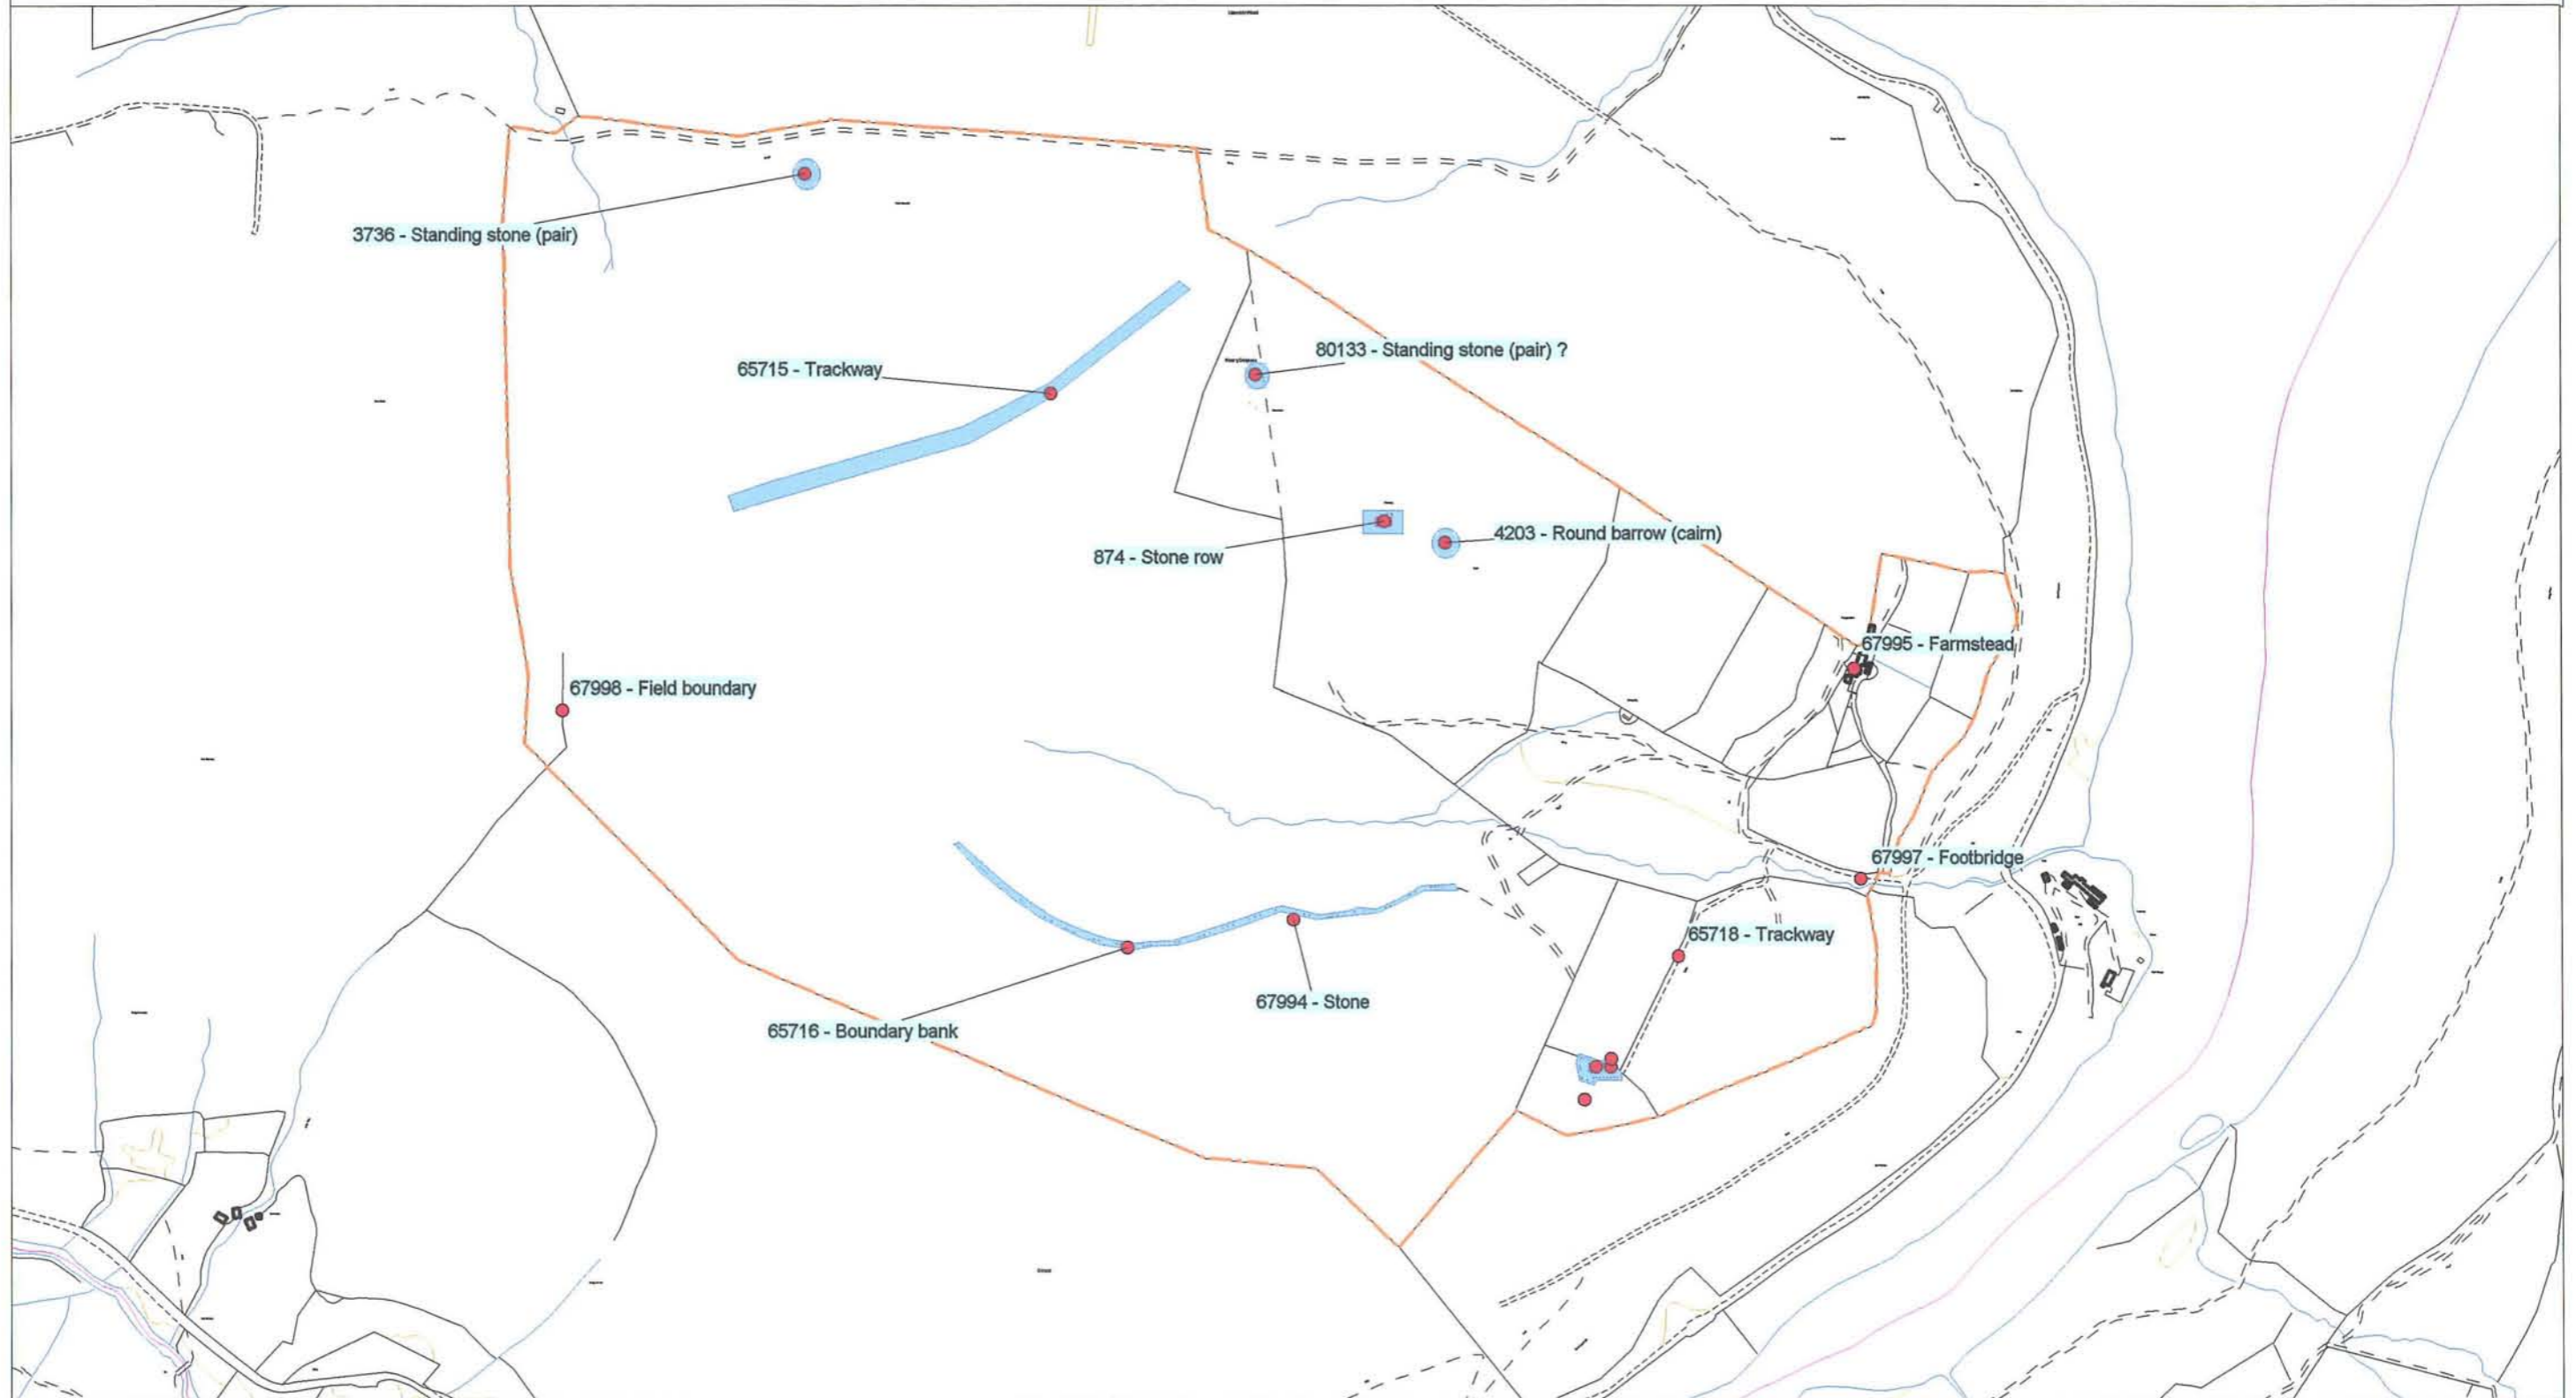
Tir Gofal applicant: Mr Baker, Welsh Water Elan Trust (Land at: Pen-glan-einon)  
CPAT TG ref.: 36204 CCW TG ref.: E/09/3780

The earliest features on this holding are the four Bronze Age monuments (2400-600BC): Rhos-y-gelynnen Stones (pm874), Cefn-llanerchi Stones (pm3736), Rhos-y-gelynnen Cairn (pm4203) and Pen-glan-einon standing stones (pm80133). Bronze Age cairns and standing stones are associated with funerary processes and the abundance of these features in this area shows that it was an important area.
