A SURVEY OF DEFENDED ENCLOSURES IN CEREDIGION, 2006: GAZETTEER OF ORDNANCE SURVEY GRID SQUARES SN14 AND SN15

RHIF YR ADRODDIAD / REPORT NO. 2006/20
RHIF Y PROSIECT / PROJECT RECORD NO. 54269

SITE GAZETTEER OF 10KM GRID SQUARES SN14 AND SN15

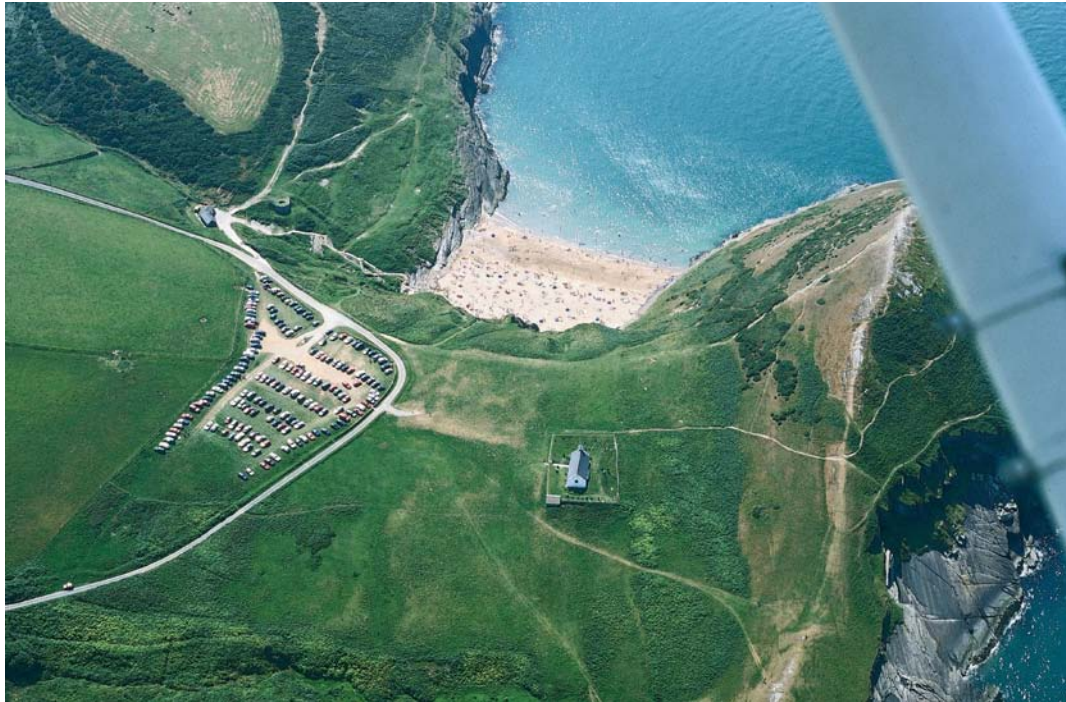
1041 Foel y Mwnt. Aerial photograph RCAHMW Crown Copyright © reference 2002-cs-1042

Foel y Mwnt is a rocky promontory that rises to over 60m above the sea. On the landward side it rises steeply from a saddle in which is located Mwnt Church and a National Trust car park. The main line of defences runs across this steep slope, about one-third of the way up. This defence consists of a low earth or earth and stone bank up to 1m high and 3m wide on the outside (east and downslope) of which are indications of a ditch. The overall impression is that the bank has eroded back into the ditch. A simple entrance marked by a gap in the bank and ditch lies along the northern section of this defence. The edge of what seems to be a natural terrace at the base of the steep slope has been artificially steepened to form a second, outer line of defence. This is not so clear as the main line, and its course at its northern end is unclear.

The main line of defence closes off approximately 6ha. On the landward side this is land is very steep with exposed bare rock. However, on the seaward side slopes are more gentle (although still steep) and grass covered. Here there are numerous hollows which may be house platforms. These slopes are very exposed to sea winds. The second line of defence at the foot of the slope enclosed an extra area of approximately 0.6ha.

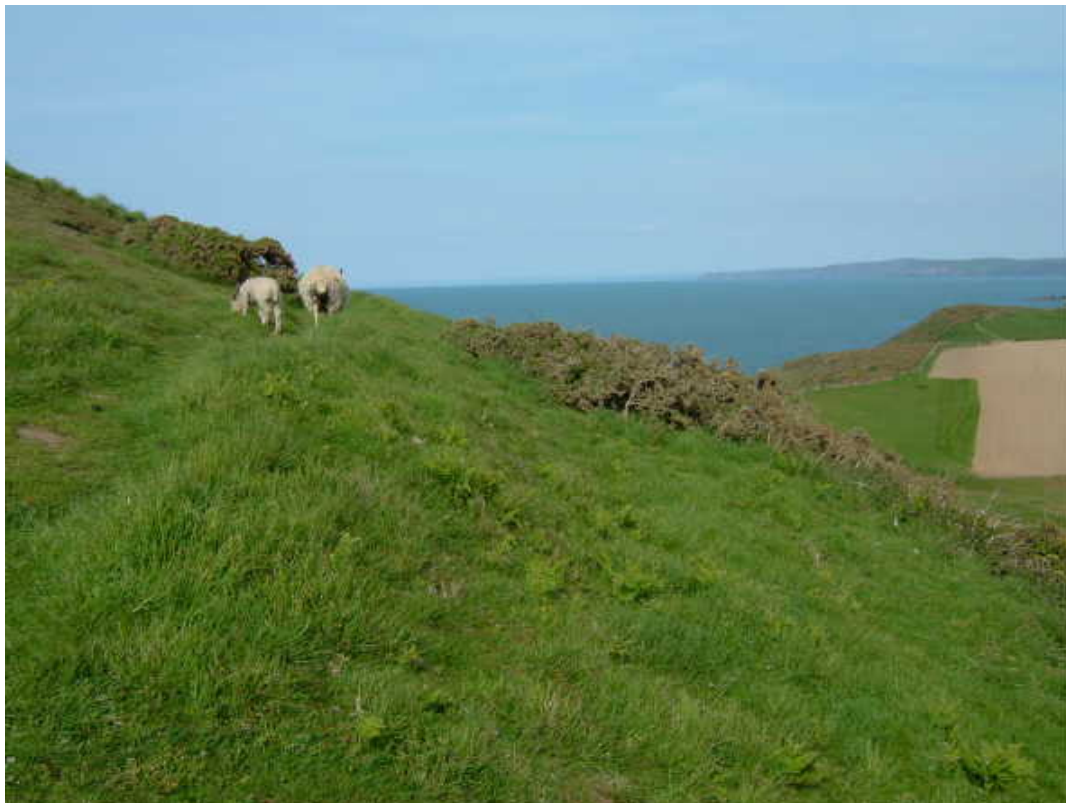
There seems to be very little coastal erosion occurring. However, a path leading up the steep landward facing slope is deeply rutted, particularly where it crosses the main defence. Here the bank is exposed revealing earth construction of stones of a possible revetment.

1041 Foel y Mwnt. Ground photograph looking along the line of the defensive bank.

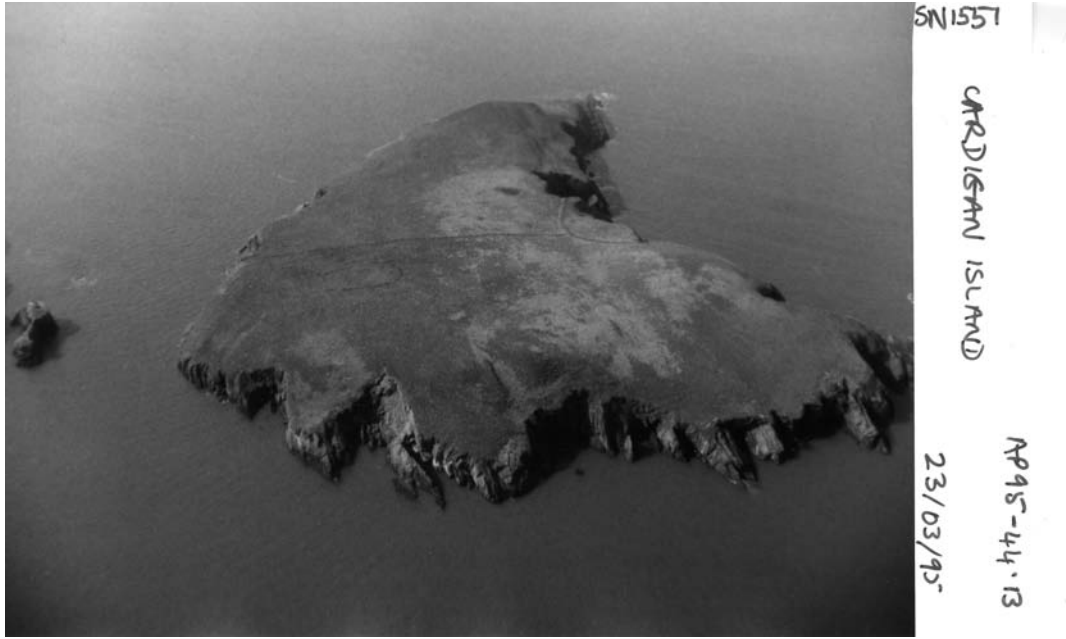
Aerial photograph Cambria Archaeology.

This is a sub-rectangular earthwork enclosure lying on a gentle southeast-facing slope on Cardigan Island at 30m above sea level. The enclosure is defined by a bank, which is nowhere more than 1m high and averages 3m wide, and external ditch, approximately 2.5m wide and 0.5m deep. There are several small gaps in the bank, but the only one sufficiently wide enough for an entrance is in the southeast corner. Within the enclosure against the bank are four circular platforms varying from 6m to 8m diameter - possible round-houses. In the centre of the enclosure a sub-rectangular mound 12m by 8m could mark the site of a rectangular stone building. The external ditch on the west side is interrupted by a rectangular annexe 12m by 7m.

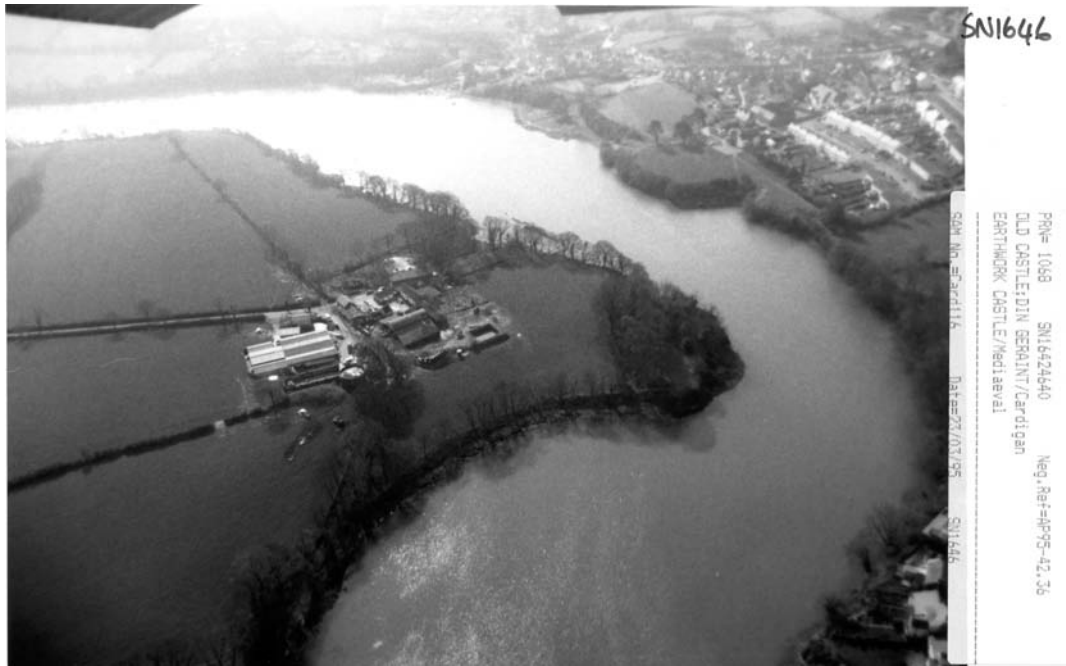
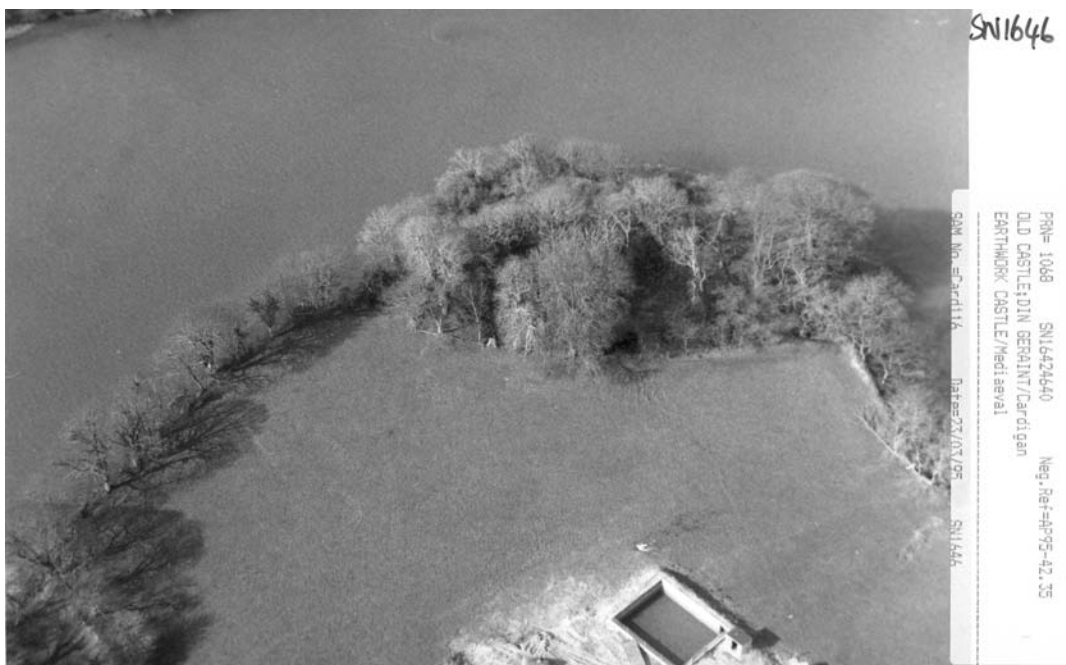
This site has long been associated Din Geriant, the first castle founded by the Anglo-Normans at Cardigan. However, it is possible the Din Geriant lies on the present Cardigan Castle site, and that this site - Old Castle - is an Iron Age promontory fort. Alternatively it could be an Iron Age site later reused as a medieval castle.

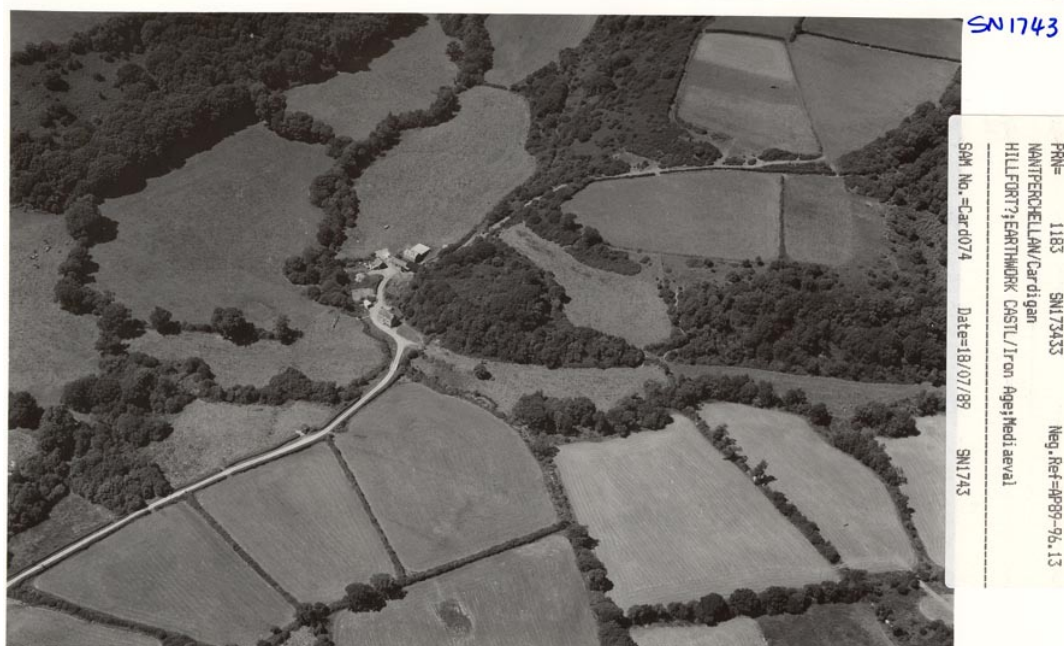
1183 Nantperchellan. Aerial photograph, Cambria Archaeology reference no. DAT89-95.13

Located on an inland promontory, Castell Nantperchellan is most likely to be an Iron Age fort, although medieval origin and/or use cannot be ruled out. It is located at 40m above sea level. To the west, south and east of the site land falls away steeply into a narrow valley. To the north the land rises steadily to a rounded summit some distance away. A bank and ditch cut off the easily accessible north and east sides. The bank rises up to 1.7m above the interior and over 5m above the base of the rock-cut ditch. A short length of outer (counterscarp), slighter bank lies on the north side. On the south and west a cliff naturally defends the fort. The site of the entrance is uncertain, but probably on the west side against the steep slope. The sloping interior is approximately rectangular, 55m by 40m. The site is covered with dense scrub

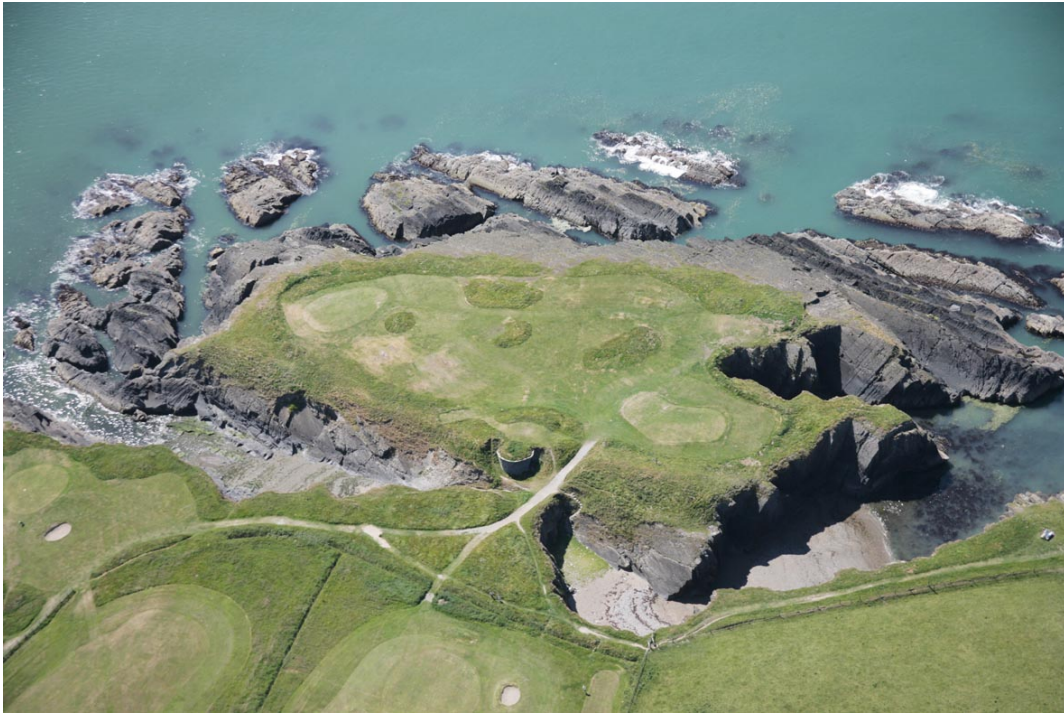
Aerial photograph RCAHMMW Crown Copyright © reference 2005-cs-1060

Craig y Gwbert is an Iron Age promontory fort superbly located on an isthmus on the eastern side of the mouth of the River Teifi. The isthmus is attached to the mainland by a narrow neck of land. The hard-rock sea cliffs are here only 10m high, but they form a virtually unassailable barrier to the fort around 95% of its circuit, thus only a short length of built defences were required. The fort entrance is approached via the narrow neck. The entrance is a simple gap through the defensive bank. Because of the fort's defensive location there is only a need for a bank for approximately 20m - 25m either side of the entrance. The bank is up to 2.5m wide and 15m wide. Natural ravines running up to the narrow natural neck have been artificially deepened and widened to create ditches in front of the bank adjacent to the entrance. There is a counterscarp bank up to 1m high on the outer lip of the ditches. The present interior of the fort is approximately 1.5ha, but it is unknown how much has been lost to the sea. The interior of the fort is fairly level.

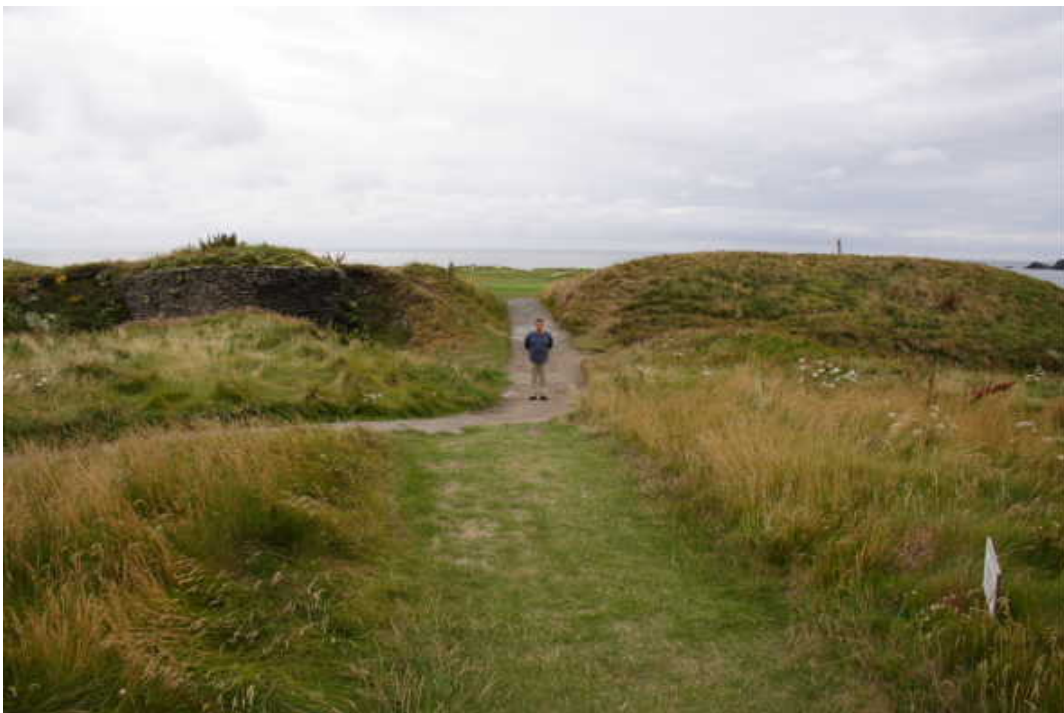
The fort is being affected by several different agencies. Firstly, the interior of the fort and immediately outside is now a golf course, part of the Cliff Hotel. There are greens, tees and bunkers within the fort, but construction of these does not seem to have involved large-scale groundworks, and therefore little damage to below ground archaeology has been caused. A path through the fort's entrance has been gravelled, stabilising this part of the site and preventing erosion through the passage of feet. Second, a limekiln was built into the defensive bank to the south of the entrance in the 19th century (PRN 7736). A small part of the defensive bank adjacent to this kiln is eroding, revealing earth and stone make-up. It is uncertain whether this is original Iron Age bank material or is associated with the limekiln. Third, sea spray has eroded a 10m - 20m band of topsoil along the cliff edge revealing archaeological features cut into bedrock. Pete Bewers has noted a four-post structure, round-house gullies and post-holes (some with their original fill), but in August 2005 only several post-holes were recognised.

Ground photograph showing defensive banks and entrance.

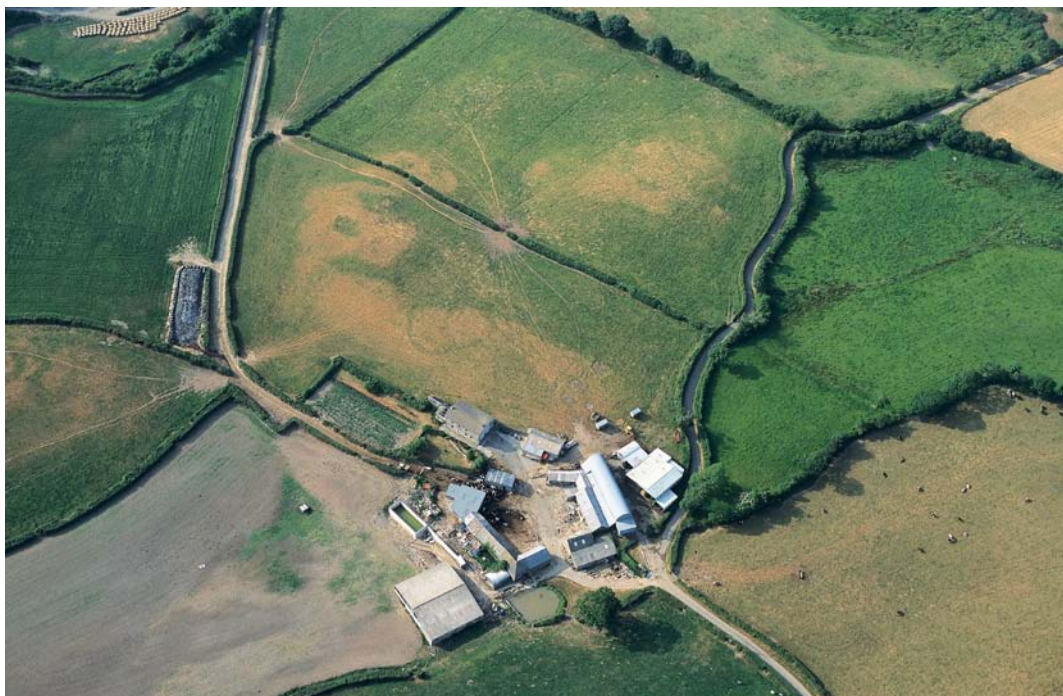
Aerial photograph RCAHMW Crown Copyright © reference 95-cs-1721

Glanllynan defended enclosure is a cropmark site with no earthwork or other surface evidence. It is located at approximately 70m above sea level on a small hillock or knoll, with the cropmark ditch encircling the summit area. To the north of the site the land is undulating, but to the southwest and southeast the land falls gently but steadily away giving wide ranging views. In 2005 the land was partly under improved pasture and partly under arable.

The cropmark ditch encloses a sub-circular area approximately 30m across. There is a southeast facing entrance and a hint of a slight outer ditch concentric to the main ditch on the northwest side.

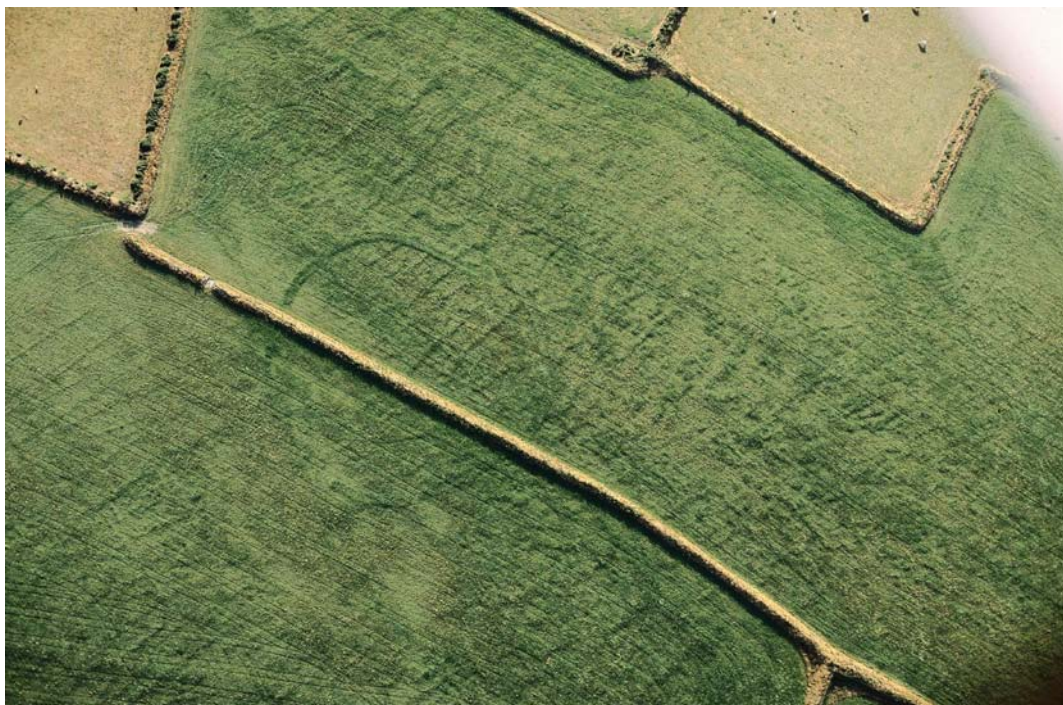
Aerial photograph RCAHMW Crown Copyright © reference 89-cs-742

This site is located just off the highest point of a flat hilltop at 150m above sea level. Wide-ranging views are obtained from the site in all directions except to the south - the direction of the highest point - with particularly good views over Cardigan Bay and Cardigan Island. Aerial photographs show a roughly circular cropmark ditched enclosure approximately 60m diameter internally, with possible opposing entrances to the west and east. On the ground the site is marked by a slight saucer-shaped depression approximately 20m across. A hedge-bank that ran through the centre of the site has been removed.

In 2005, a geophysical survey showed that the enclosure was sub-circular, rather than circular. On the west side the enclosure is interrupted or cut across by a more rectilinear ditch at the entrance. Other anomalies hint at a complex entrance on this side. A slighter ditch approaches the entrance from the northwest. A simple gap marks the entrance on the east side. There is a trace of a concentric ditch on the south side of the enclosure, closely set to the main ditch. A signal from the removed hedge-bank masks detail in the interior, nevertheless, anomalies indicate internal divisions, pits and possible structures. The site is under improved pasture.

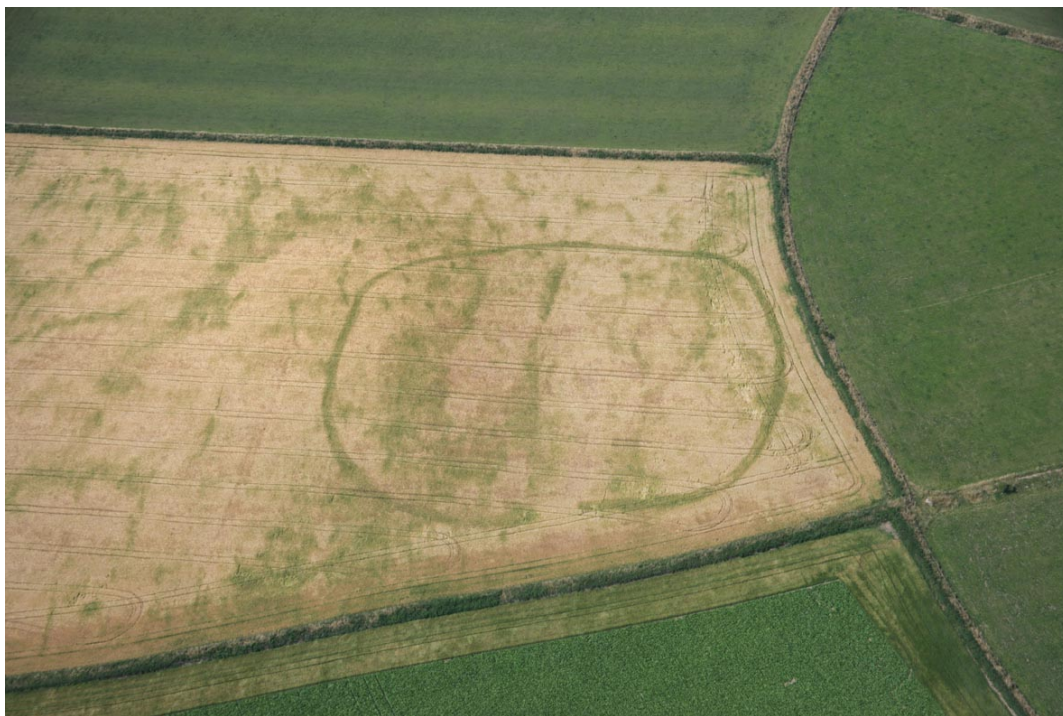
Aerial photograph RCAHMW Crown Copyright © reference 2005-cs-1586

Located at approximately 130m above sea level on a east-facing slope, this a cropmark site with no earthwork or other surface evidence. In 2005 it was under a barley crop. In 2004 it was under a root crop. Aerial photographs taken in 2005 show a cropmark ditch enclosing a sub-rectangular area measuring 110m north - south and 90m east - west.

An entrance lies on the centre of the north side. Here the ditch widens into expanded terminals. Aerial photographs taken in 1990 seem to show a rectangular cropmark in the centre of the photographs, but this is faint (as is the rest of the site on the 1990 photograph) and does not show on the very clear 2005 photograph.

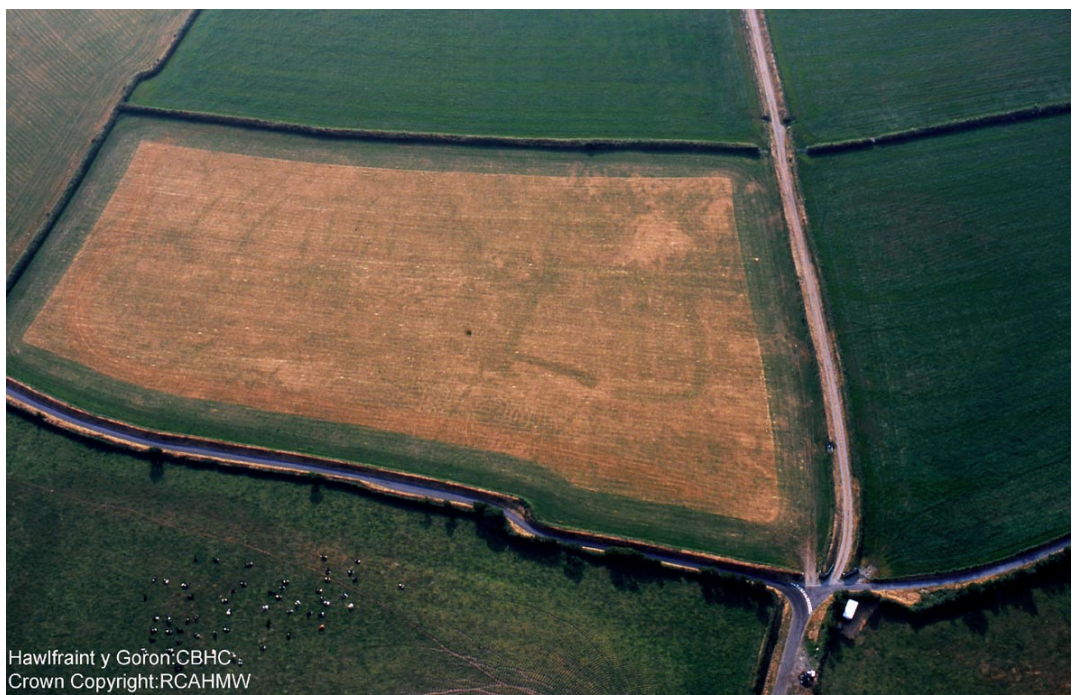
Aerial photograph RCAHMW Crown Copyright © reference 89-cs-659

A strongly marked, ditched, sharp-cornered trapezoid crop-marked enclosure measuring internally approximately 50m north to south and 47m east to west, 0.23 ha in area. The ditch is between 4m and 5.5m wide. A 5.4m wide entrance lies in the centre of the east side. There are no internal features visible, but a slight ditch runs east from the south terminal ditch, and a second, similar ditch runs approximately east - west immediately adjacent and parallel to the southern side of the enclosure. This ditch continues into the field to the west. Both these ditches seem to belong to field systems contemporaneous with the enclosure. The enclosure is located towards the foot of a southeast-facing slope at 120m almost at the watershed of a stream flowing to the north and one flowing southwest. Land within the enclosure slopes down 2.5m from west to east. The land is very well drained, with bedrock close to the surface.

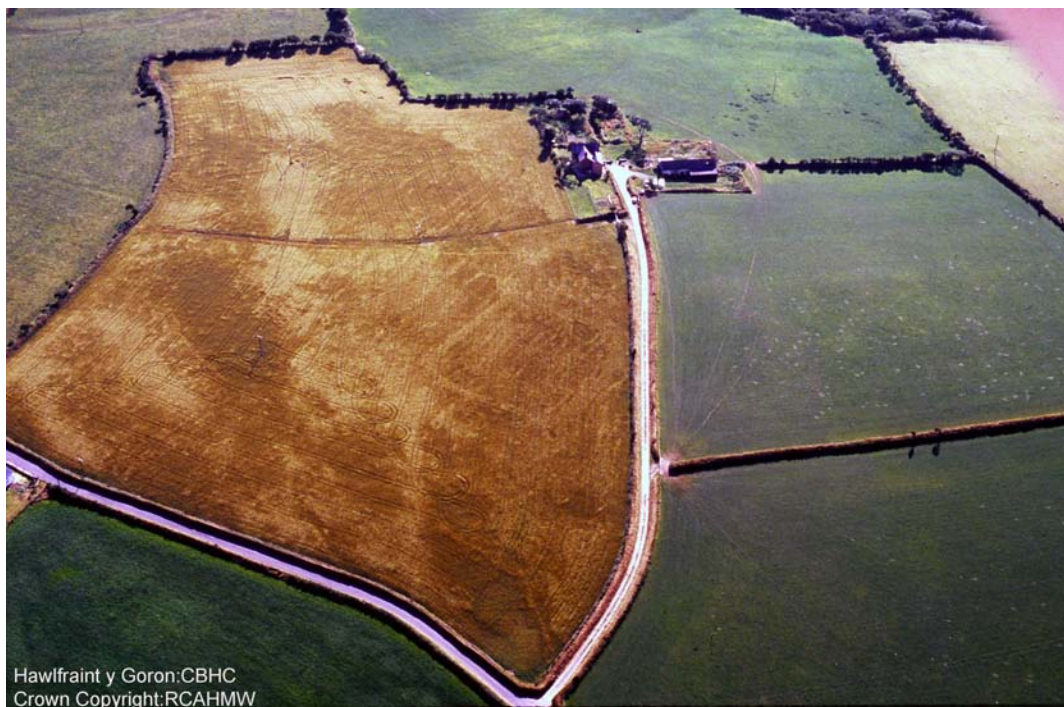
Aerial photograph RCAHMW Crown Copyright © reference 89-cs-649

Aerial photograph and geophysical survey - a well defined ditched enclosure, almost square, internally measuring approximately 44m east-southeast to west-northwest and 45m north-northeast to south-southwest, giving an internal area of 0.19 ha. The ditch is sharp-cornered with an average width between 3.2m and 4m, but up to 5.8m wide on the northern side. The single entrance through the ditch in the centre of the eastern side is 2.5m wide. There is no trace of a bank.

The enclosure lies at approximately 118m O.D., on land that gently slopes down from east to west, towards the head and on the east side of a small valley.

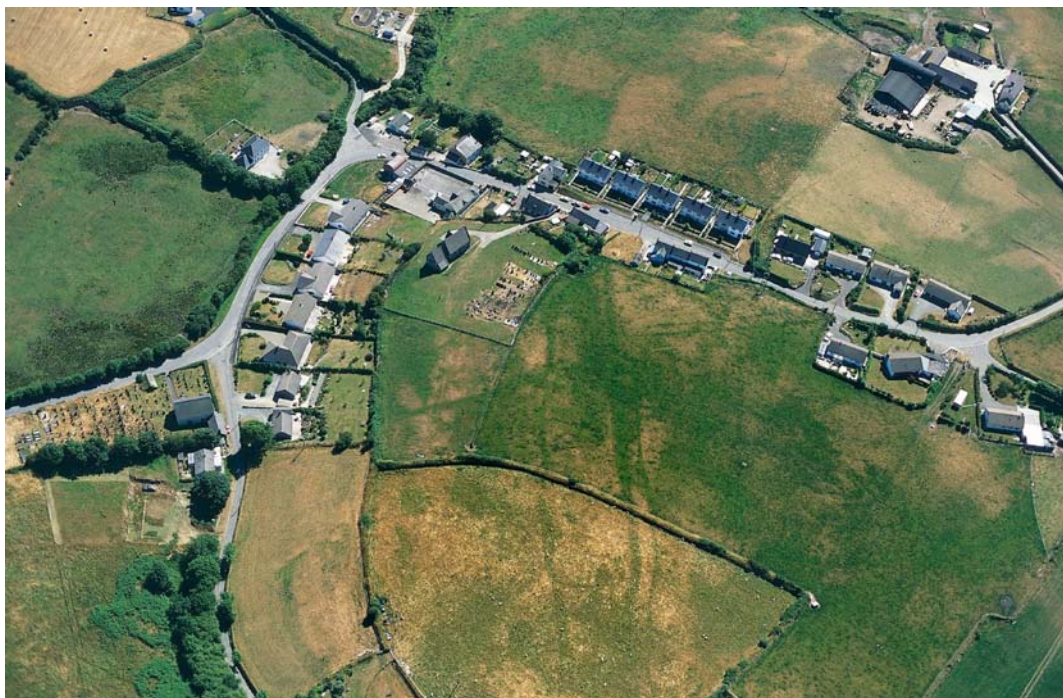
Aerial photograph RCAHMW Crown Copyright © reference 35723

Aerial photographs show what seem to be an enclosure and other cropmarks close to the parish church at Verwig. The enclosure shows as a cropmark ditch and is partial only, and is in an unusual location. Its northwest corner lies on level ground at approximately 100m, but immediately to the south and east of this corner the land falls away steeply into a shallow valley. It is on this steep slope that most of the enclosure is located.

Only the northern side of the enclosure survives; this measures 60m from east to west. If projected the current Verwig parish church would lie within in the enclosure. On level ground to the north a series of linear cropmarks may mark buried archaeological features, or they may be of geological origin. In 2005, the land outside the churchyard was under improved pasture.

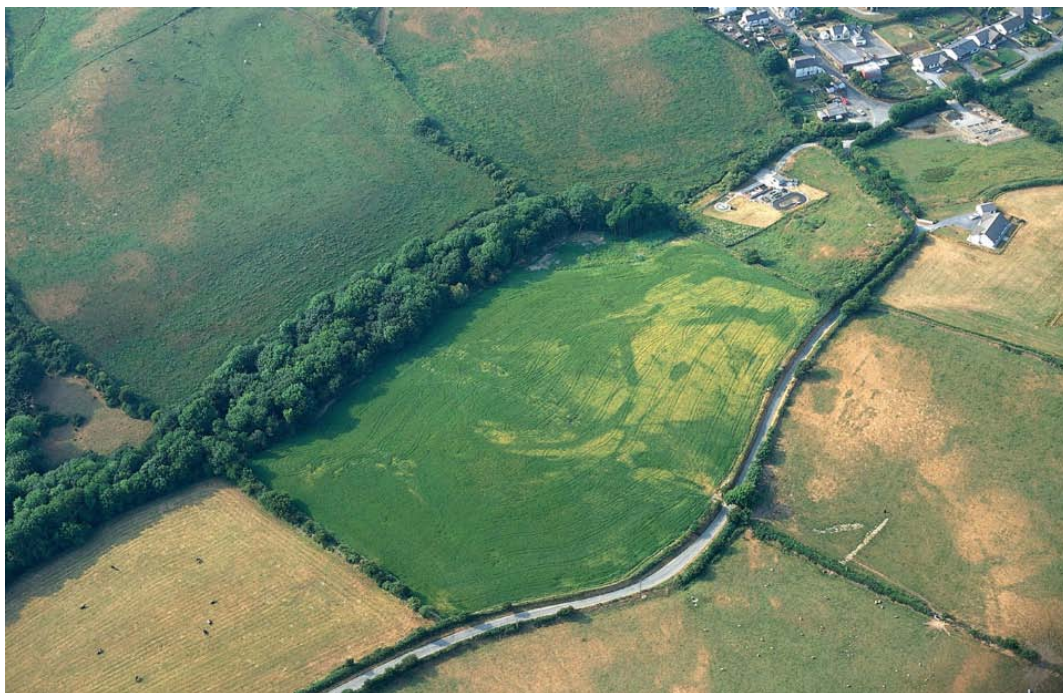
Aerial photograph RCAHMW Crown Copyright © reference 95-cs-1722.

This is a cropmark enclosure with no earthwork or other surface evidence. The site lies on a gentle west-facing slope, towards the head of a small valley, at approximately 90m above sea level. To the west the land falls away by 5m - 10m to a stream in the valley floor. The slope is undulating, and the southern side of the site occupies a small subsidiary valley or hollow a few metres deep. The site is overlooked from most sides. Aerial photographs show a curving arc of a cropmark ditch defining the eastern and southeastern sides of an enclosure, with a possible concentric ditch inside on the southeast side and splodges outside the ditch possible marking the site of pits. However, much of the field is marked by unresponsive vegetation which masks the site.

In 2005, a geophysical survey detected the curving line of ditch visible on aerial photographs with an entrance mid-way along its eastern side. The northern corner of this ditch turns a sharp right angle to the west, the southern corner is a gentle curve. Within the ditch a second (concentric) ditch springs from its northern side. This, too, has an entrance in its east side. Its south corner turns a sharp right angle to the west. This then is a bivallate enclosure, possibly of two phases, sub-rectangular in plan, approximately 60m by 60m. The site is under improved pasture.

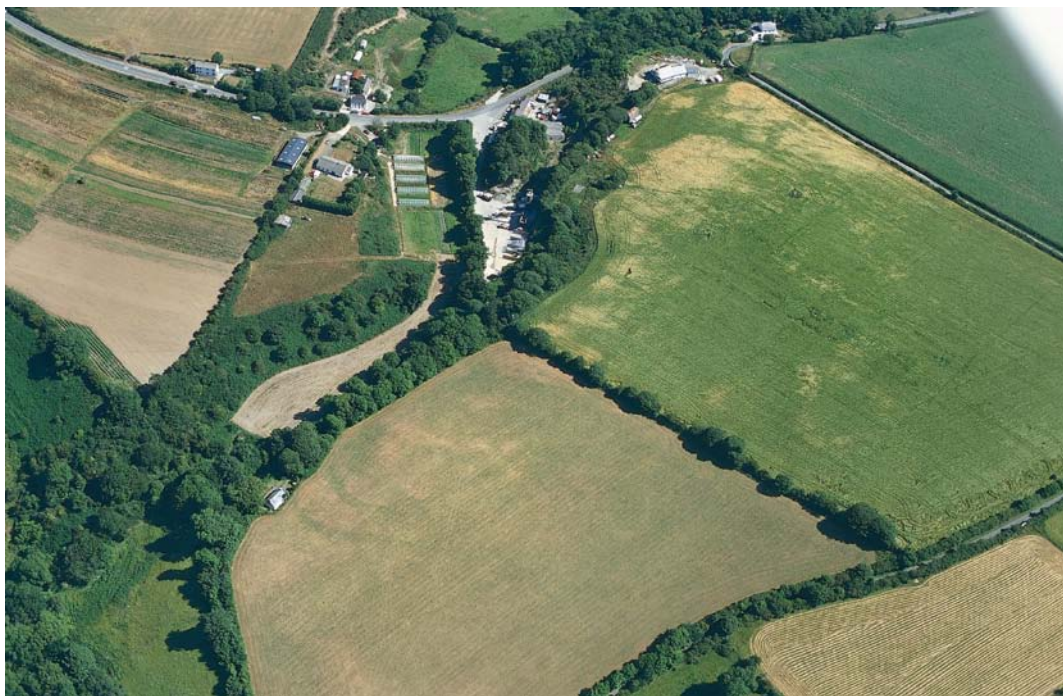
Aerial photograph RCAHMMW Crown Copyright © reference 96-cs-1428

In 2005 this site was seen only from public roads/footpaths. This is a defended enclosure recognised as a cropmark on aerial photographs but with earthworks surviving. It is sited on a hill slope at approximately 130m above sea level. To the east the land falls away steeply by c.10m into a shallow valley and to the north land falls away more gently. The land rises gently to the south and west. The enclosure is located to take advantage of the steep slope, incorporating it into the defensive circuit.

Aerial photographs show cropmark ditches of a bivallate, concentric, elliptical enclosure, with the inner enclosure measuring approximately 100m north - south and 60m east - west. The outer ditch lies approximately 20m outside the inner one. Both ditches are very well defined on the north and northeast sides, but gradually fading to the south. On the east side (in scrubby woodland), against the steep slope no ditches are visible on the photographs. Simple gaps through the ditches on the north side mark the entrance to the enclosure. Rather unusually the entrance faces down the slope.

On the ground the defences survive as earthworks, with both the ditches and banks visible. There is a high difference of approximately 1m between the bottom of the ditch and the top of the bank close to the entrance where earthwork survival is best. Away from the entrance the earthworks rapidly fade away. They are not visible on the east, west or south sides. In 2005, the site was under improved pasture.

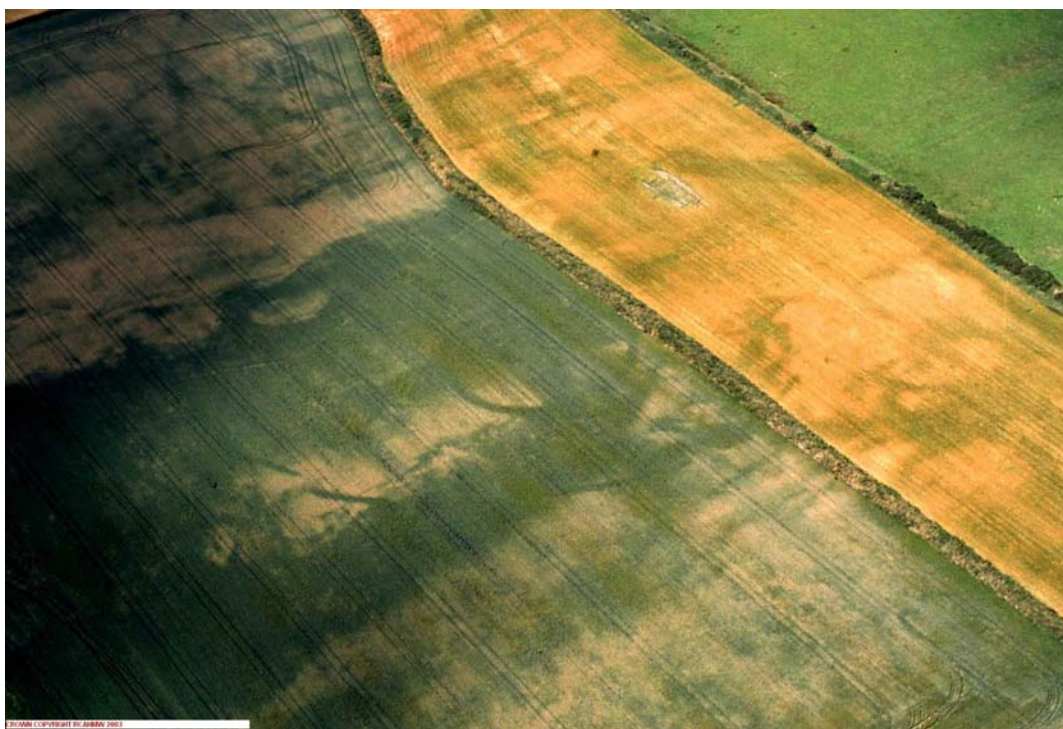
Aerial photograph RCAHMW Crown Copyright © reference 2003-cs-1458

Located at approximately 60m above sea level on a gentle northwest-facing coastal slope with views over Cardigan Island and the Irish Sea, Clos-y-Ynys defended enclosure is a cropmark site with no earthwork or other surface evidence. At the time of the site visit the land was under barley stubble.

Aerial photographs show a concentric ditched enclosure. The inner enclosure is circular approximately 40m in diameter. Owing to geological/crop conditions it is not a continuous cropmark. However, the entrance may lie on the southeast, up-slope, side. The cropmark of the outer ditch only shows on the south and west sides. It is concentric to the inner enclosure, c. 30m - 40m distant from it. It has a west-facing entrance.

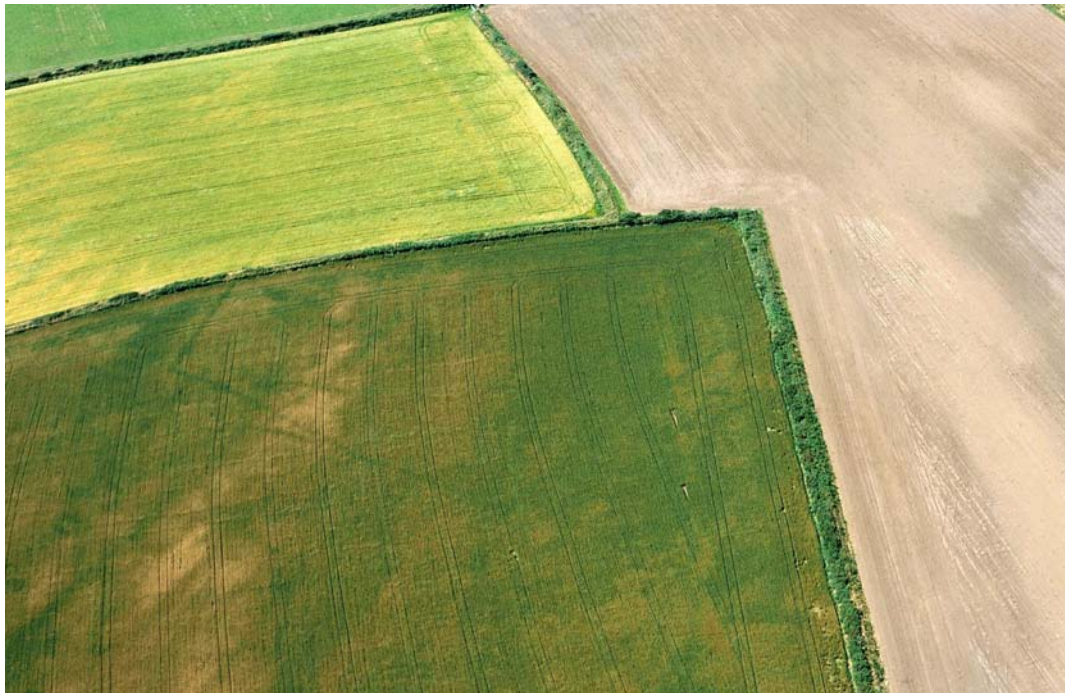
Aerial photograph RCAHMW Crown Copyright © reference 2003-cs-1585.

Enclosure - not a defended enclosure. Aerial photographs show what may be the ditch of a cropmark enclosure on a gentle south-facing slope at approximately 105m above sea level. Three sides of a polygonal enclosure are visible, measuring c. 70m - 80m across and underlying the present field system. No earthwork evidence of the enclosure survives. Given the size of the enclosure it is unlikely to be a settlement site, and is perhaps more likely to be a field system pre-dating the present fields.

In 2005, part of the enclosure was under improved pasture and part under arable (ploughed). Wind blown sand was evident in the ploughed fields.
