TWENTIETH CENTURY MILITARY SITES: AIRFIELDS – DISPERSED SITES AND DEFENCES

Final Report
A THREAT-RELATED ASSESSMENT 2013-2014
DAT 115A

DYFED ARCHAEOLOGICAL TRUST
RHIF YR ADRODDIAD / REPORT NO. 2012/70
RHIF Y PROSIECT / PROJECT RECORD NO. 103632
DAT 115A
Mawrth 2014
March 2014

Gan / By
Alice Pyper & Marion Page

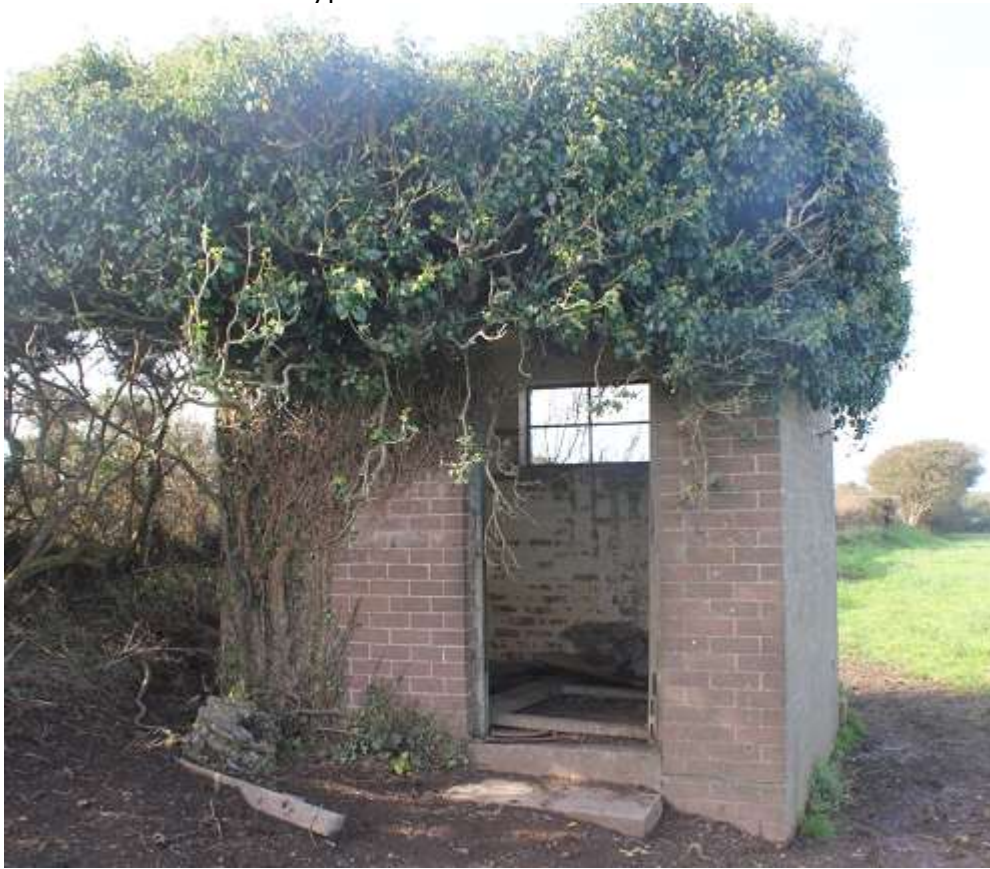
Figure 9: A small building located to the northeast of the airfield

A small building c 3m square, doorway in the southeast wall. Metal framed, six pane window high set and longitudinal in the northwest wall. Brick built, flat concrete roof with overhang all round. Blue painted four panelled door, broken with one panel missing. A Pyper 2013.

CONDITION DESCRIPTION Intact building, roof very overgrown with ivy. Window glassless and door broken. A Pyper 2014

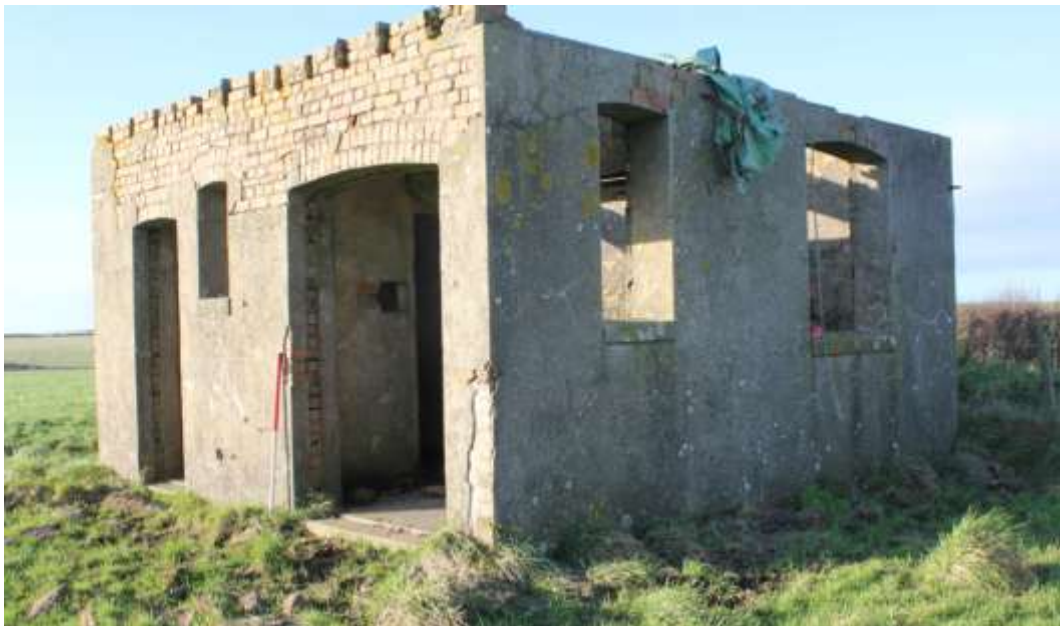
Figure 13: High Frequency Direction Finding building located to east of airfield.

CONDITION DESCRIPTION When visited in 2013 the building was roofless, and without windows and doors, but the walls still stood to roof level with roof timbers surviving. A Pyper 2013.

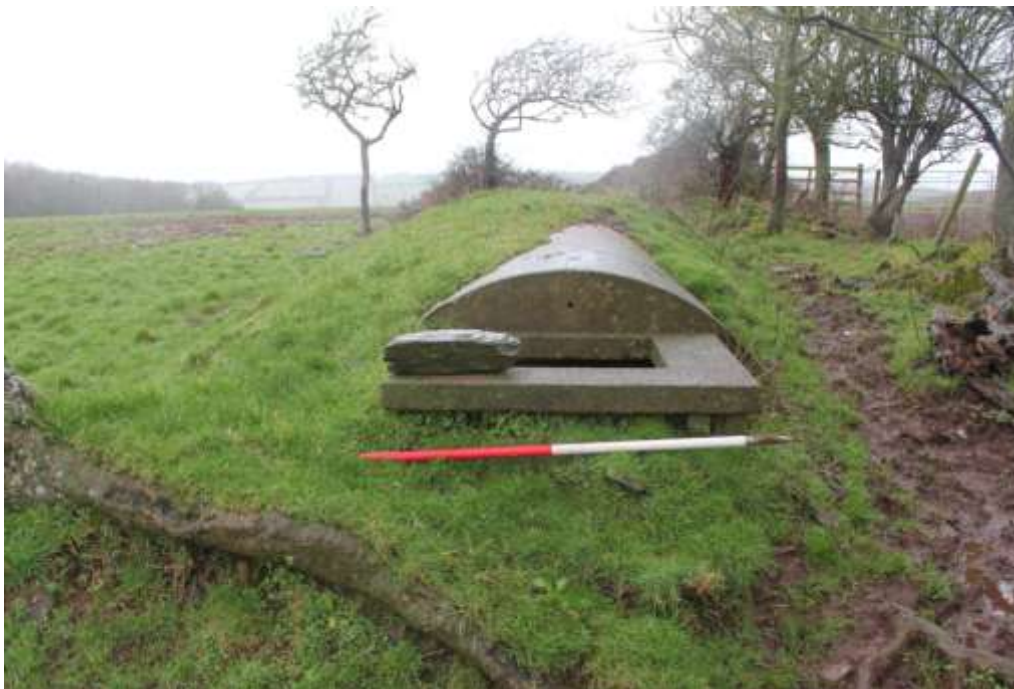
Figure 14: Air Raid Shelter now found on Hubberton Farm formerly Site No 5.

CONDITION DESCRIPTION In a stable condition near hedge line in farm, some bramble growing over north end. A Pyper 2013.

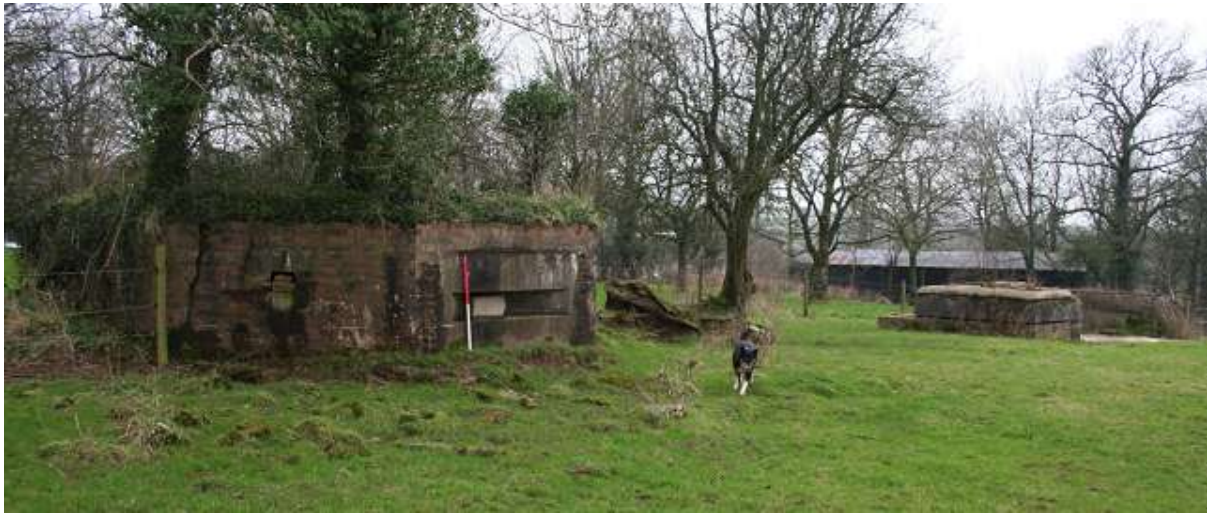
Figure 25: Battle Headquarters and nearby pillbox at Flemington Farm

CONDITION DESCRIPTION / Battle headquarters, still largely intact, part of the hand rails on the flight of steps missing, otherwise intact. Concrete cupola is showing signs of concrete failing, corner to NW has exploded and some of the concrete capping around the cupola disintegrating. Steps inaccessible due to dense bramble and scrub. A Pyper Jan 2014.

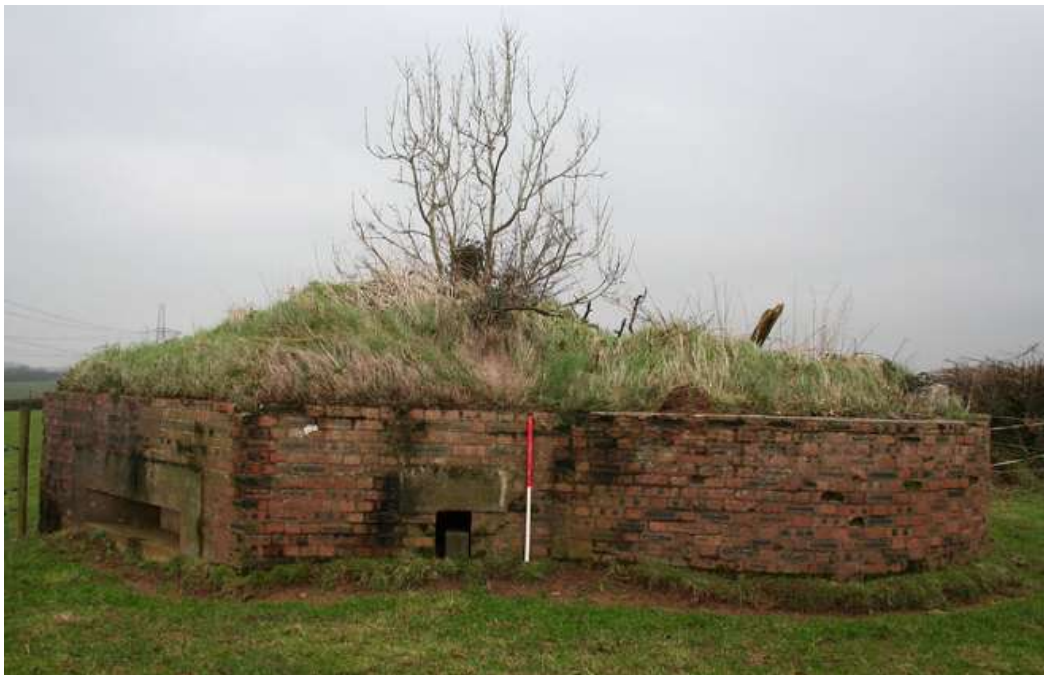
Figure 26: Pillbox to the east of the battle headquarters facing onto airfield

CONDITION DESCRIPTION / Pillbox situated at the junction of 3 hedges. Turf covered and sapling established on the roof of the structure. Otherwise in good condition. A Pyper 2014.

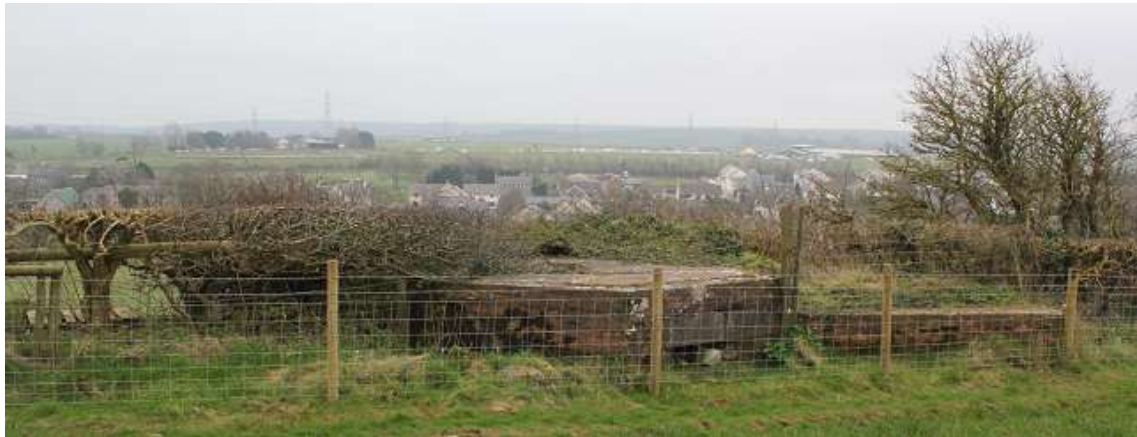
Figure 27: Pillbox overlooking airfield beyond

CONDITION DESCRIPTION / Intact pillbox, though very overgrown with brambles within hedge line. A Pyper 2014

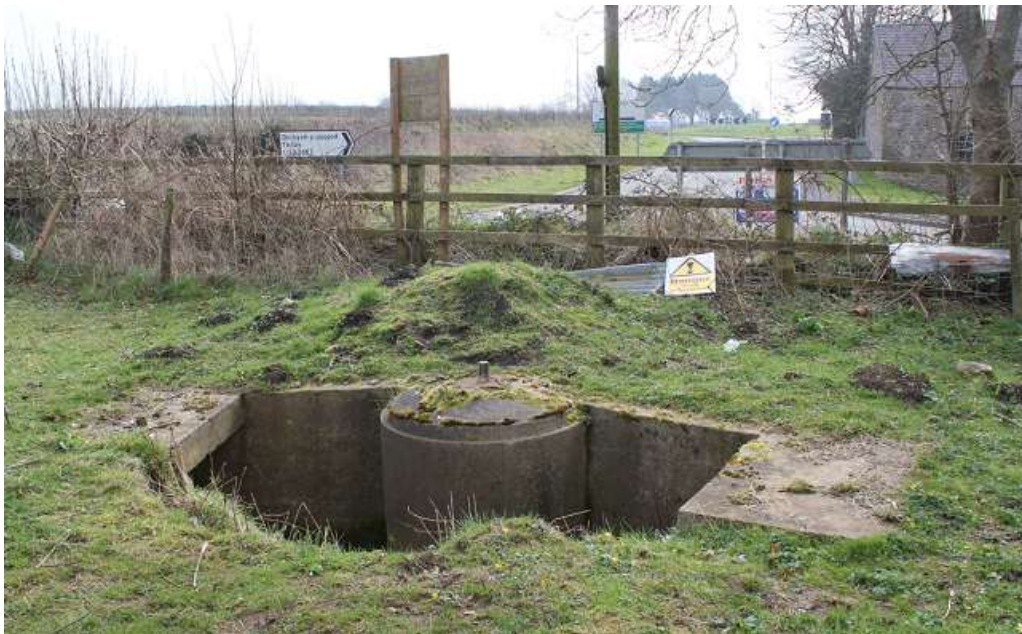
Figure 29: Spigot Mortar overlooking Sageston road junction

CONDITION DESCRIPTION Spigot mortar emplacement in excellent condition, having recently been dug out. Corrugated iron lines the circular part of the pit, this might be replaced when the emplacement was dug out. A Pyper 2014.

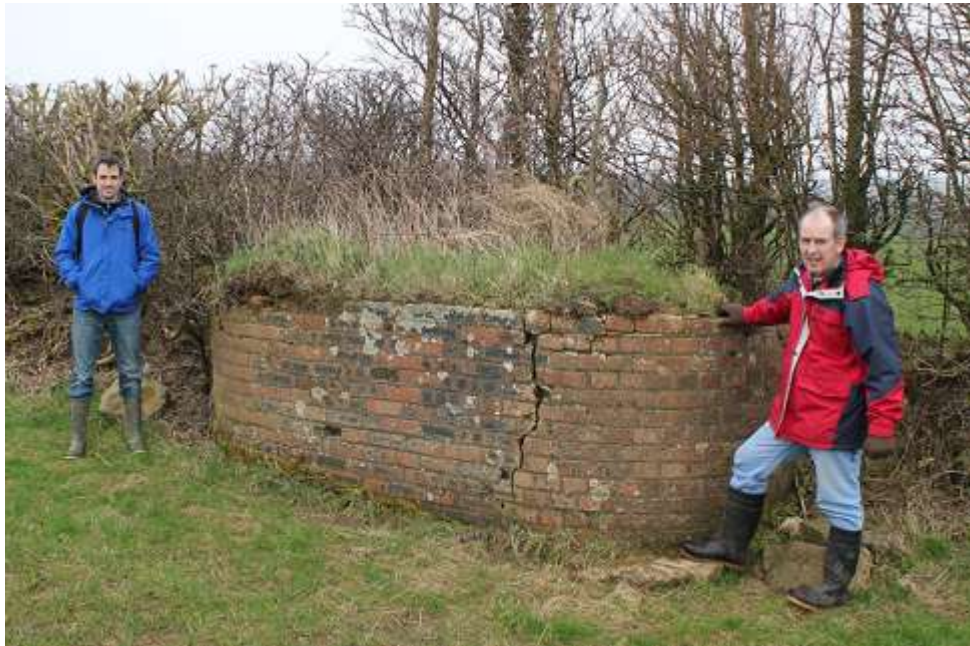
Figure 30: Motley stalk gun emplacement in the hedgeline to the north of RAF Carew Cheriton.

A light anti-aircraft gun emplacement, or motley stalk gun emplacement set into the hedge line running north between defences at PRN 26160 and PRN 105917. Consists of two precast concrete 'sewer pipes' set vertically side by side. The exposed edge on the west side has a brick built facade with wrapping around the curved ends. Earth has been backfilled between the pipes and brick facing with turf now covering. A Pyper 2014.

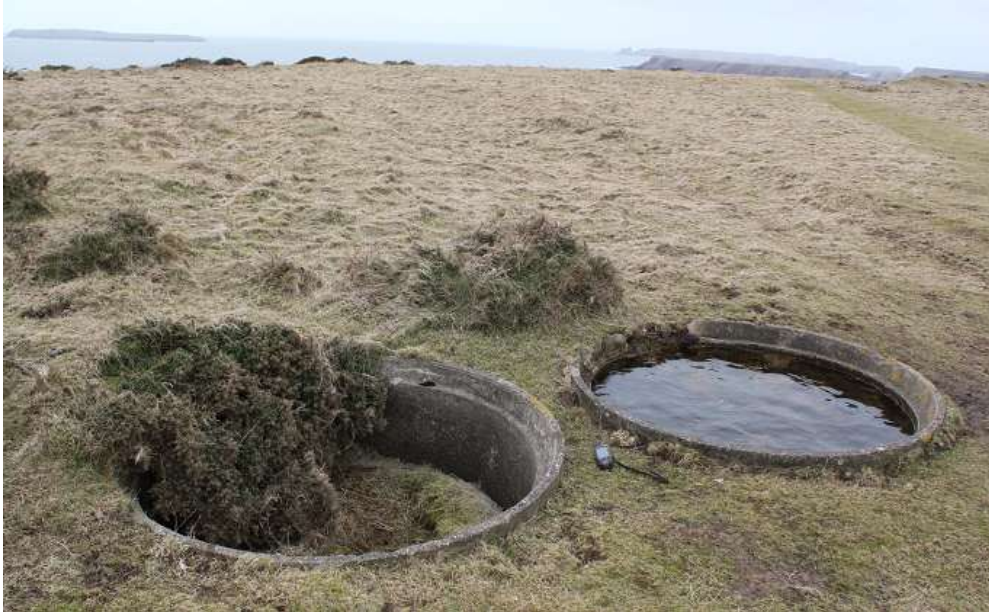
Figure 37: Motley stalk gun emplacement at the southwest corner of the airfield.

CONDITION DESCRIPTION / Two intact concrete rings side by side, sunk into the ground. intact when visited Feb 2014. A Pyper

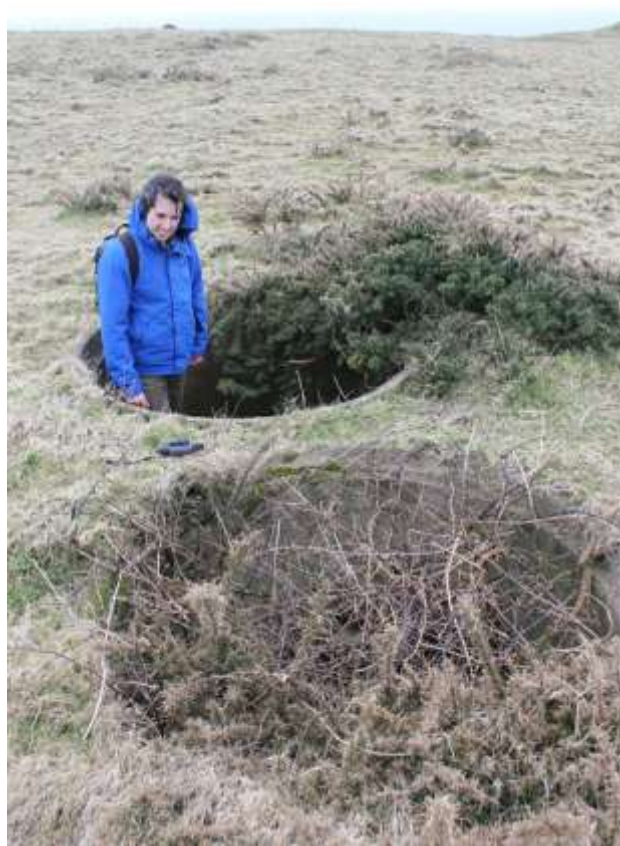
Figure 42: Second gun emplacement at the southwestern edge of airfield.

CONDITION DESCRIPTION Two intact concrete pipes sunk into the ground. Alice Pyper

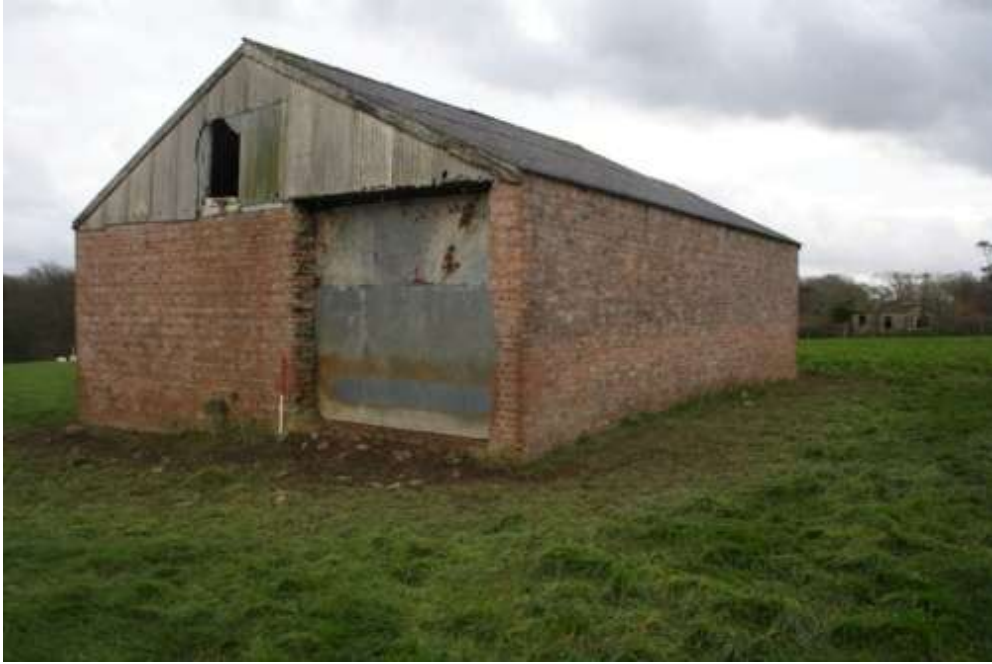
Figure 52: Inner beacon for the airfield at RAF Haverfordwest

Roof and walls appear intact. A Pyper 2012.

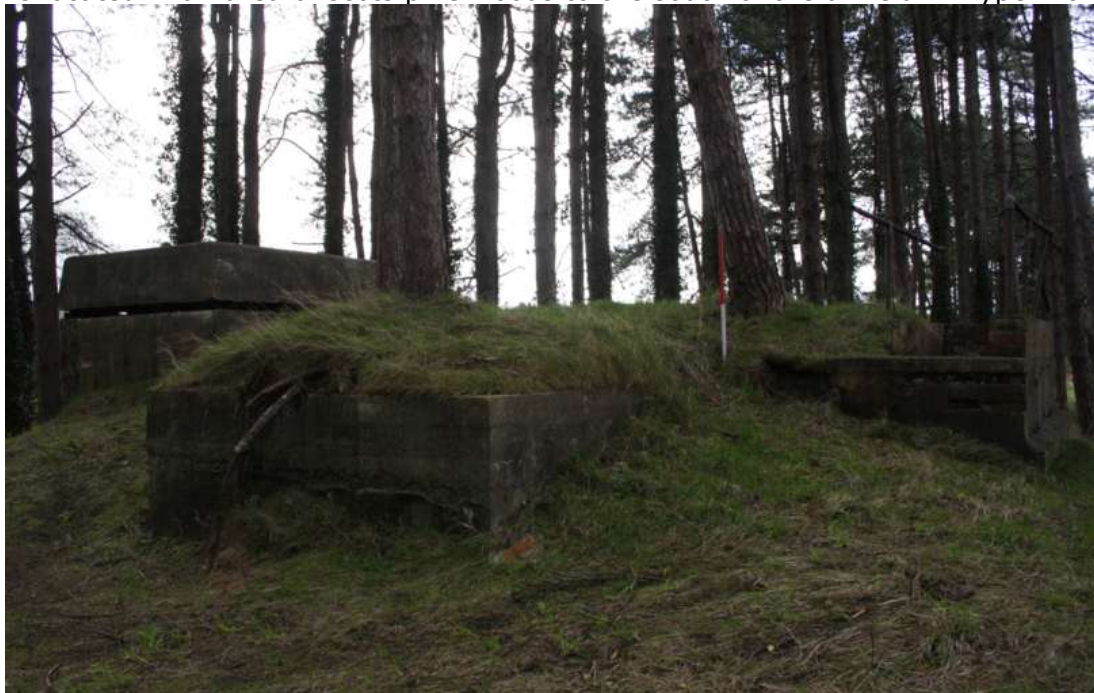
Figure 58: Pembrey battle headquarters

CONDITION DESCRIPTION Visited in 2012, the Battle Headquarters appears intact and is located in an area of scots pine woods to the south of the airfield. A Pyper 2012.

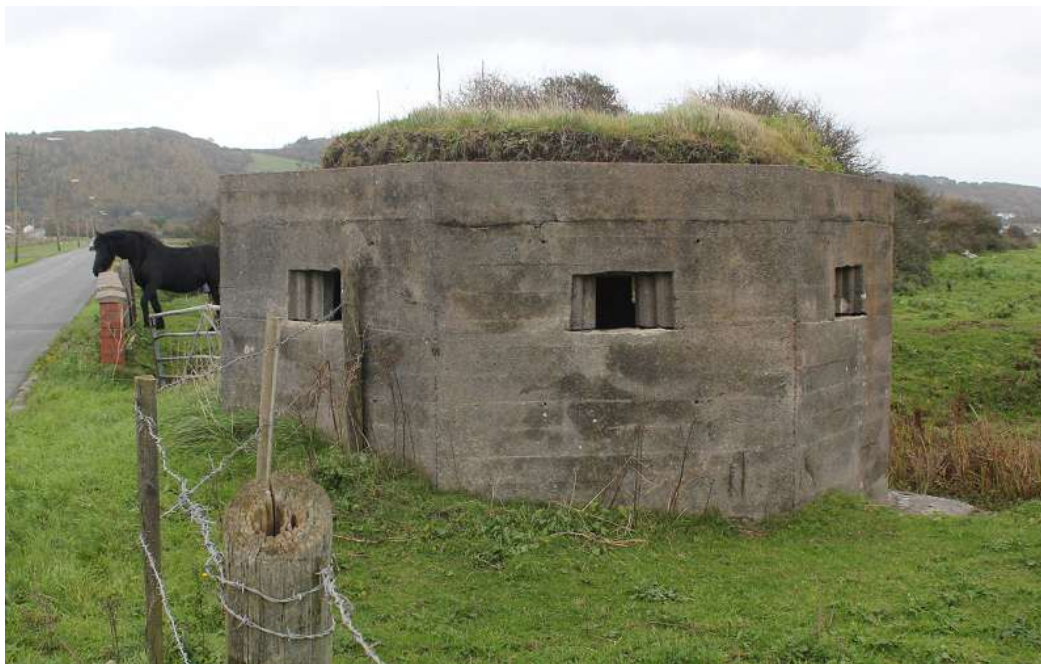
Figure 59: Pillbox to the east of the Factory road

CONDITION DESCRIPTION / Becoming slightly undermined on the northeast side by the Swan Pool drain. A Pyper 2014.

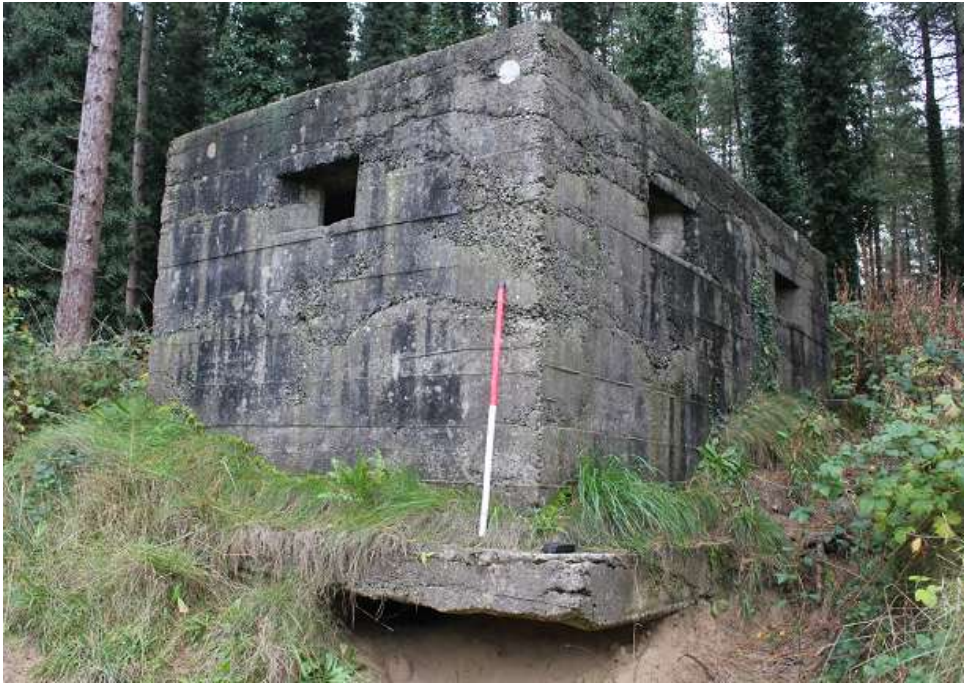
Figure 61: Pillbox overlooking Factory road at Pembrey

CONDITION DESCRIPTION / Intact pillbox though sand dune eroding underneath the northwest corner. A Pyper 2014.

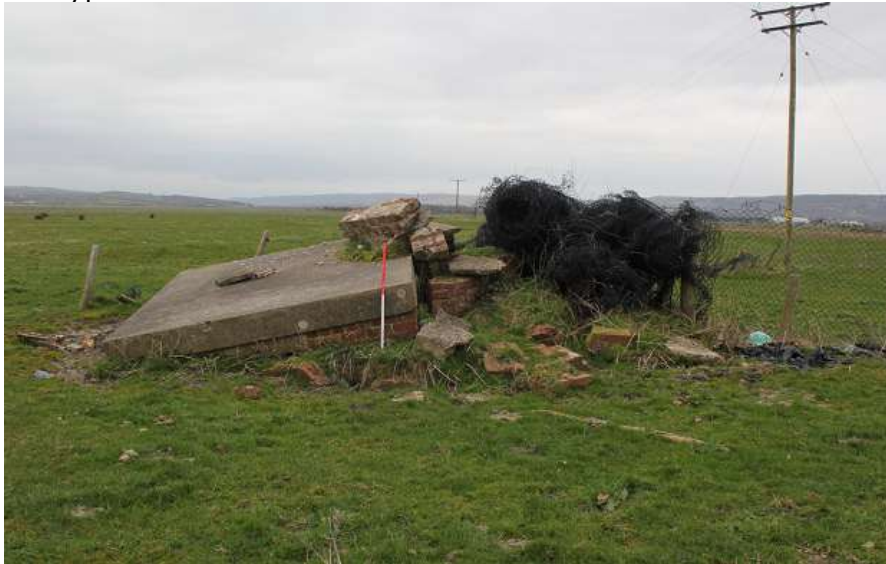
Figure 64: Remains of a pillbox at the southwest end of the sea wall

CONDITION DESCRIPTION / Although demolished (blown up?) at some point all the parts of the pillbox appear to survive where they fell, so it is possible to define the gun embrasures. A Pyper 2013.

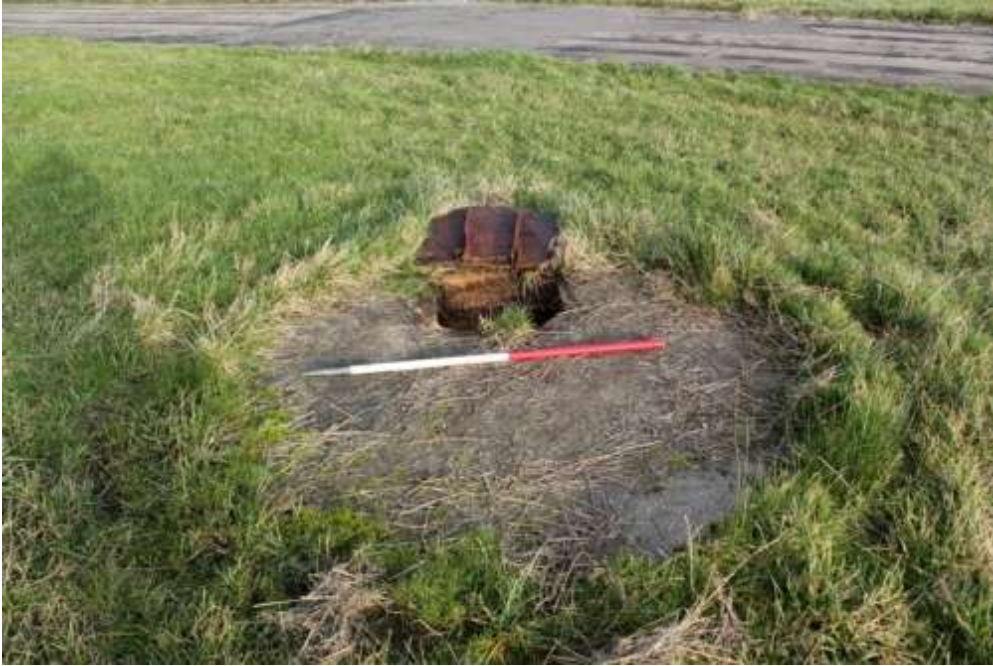
Figure 71: Pickett Hamilton fort at the north side of the airfield

Apparently intact, this Pickett Hamilton is one of two surviving examples which have been recorded at Pembrey airfield. This type of pillbox appears to be very rare in Wales. A Pyper 2012.

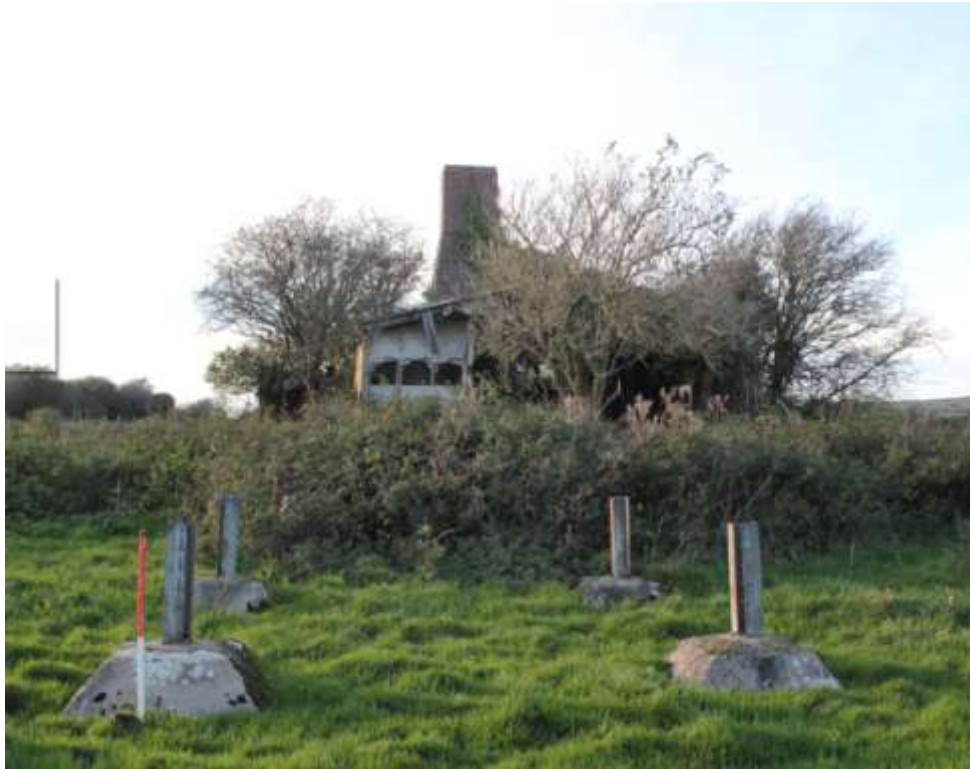
Figure 74: Radio station at RAF Pembrey, mast fixings in the foreground

CONDITION DESCRIPTION The timber building at the centre of the site is derelict and the timber walls collapsing. The blast wall is also fragmentary and vegetation is overgrowing it all. The air raid shelter survives to the west but is very overgrown. The mast bases survive well. A Pyper 2014

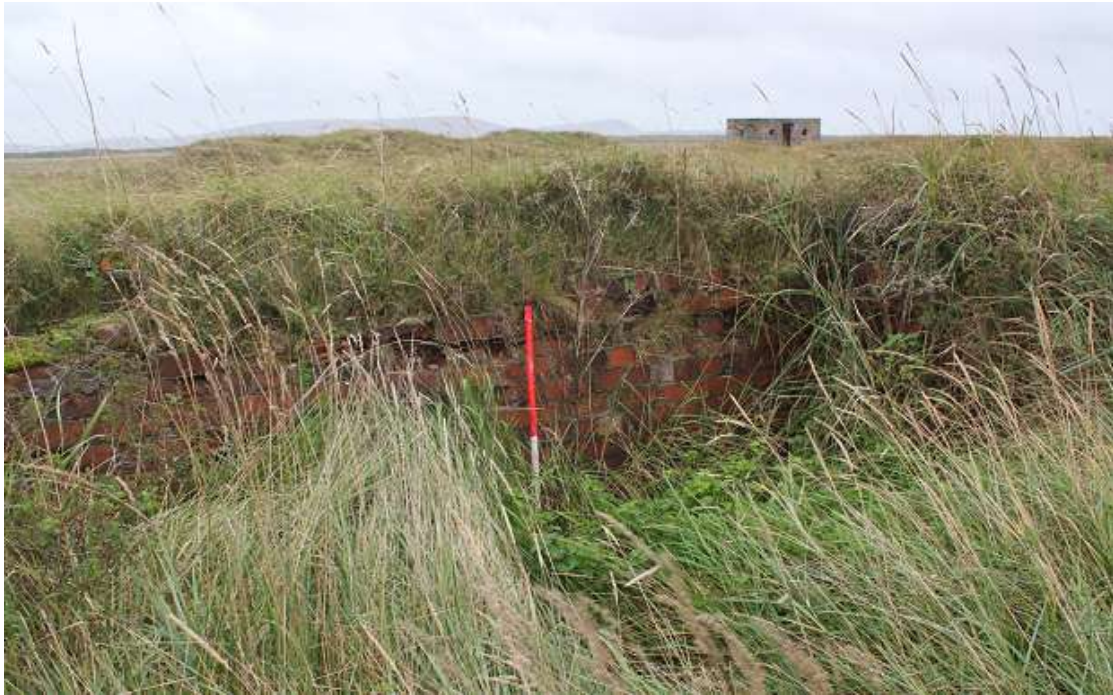
Figure 77: Weapons pit in the foreground and pillbox beyond

CONDITION DESCRIPTION Brick lined pit still identifiable though one side appears to have been moved or demolished. A Pyper.2014

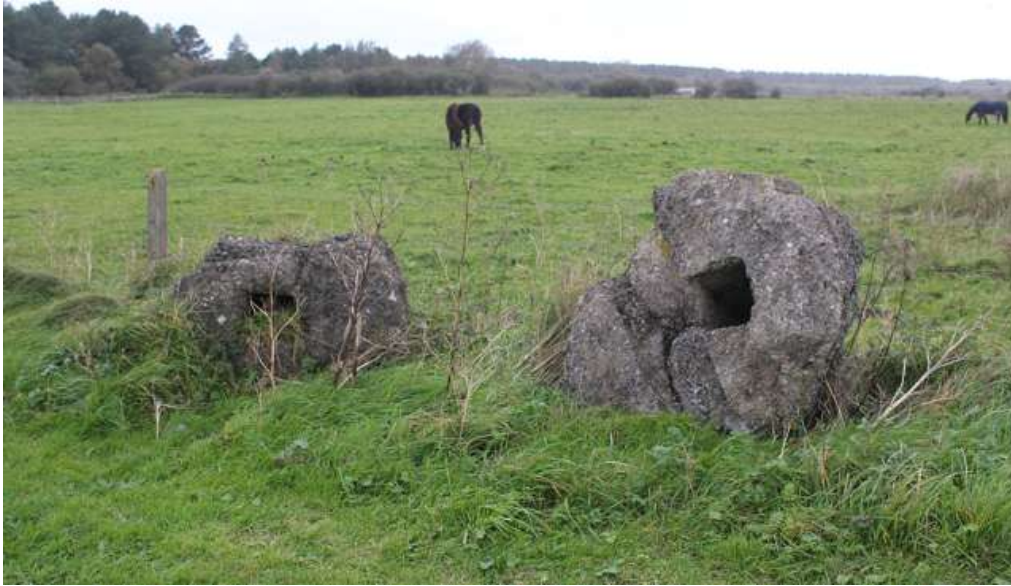
Figure 78: Remains of a dug out road block beside pillbox PRN 31365

CONDITION DESCRIPTION Two large lumps of concrete with square post sockets within them, removed from the road surface and lying on the roadside verge. One socket still in situ at the side of the road. A Pyper

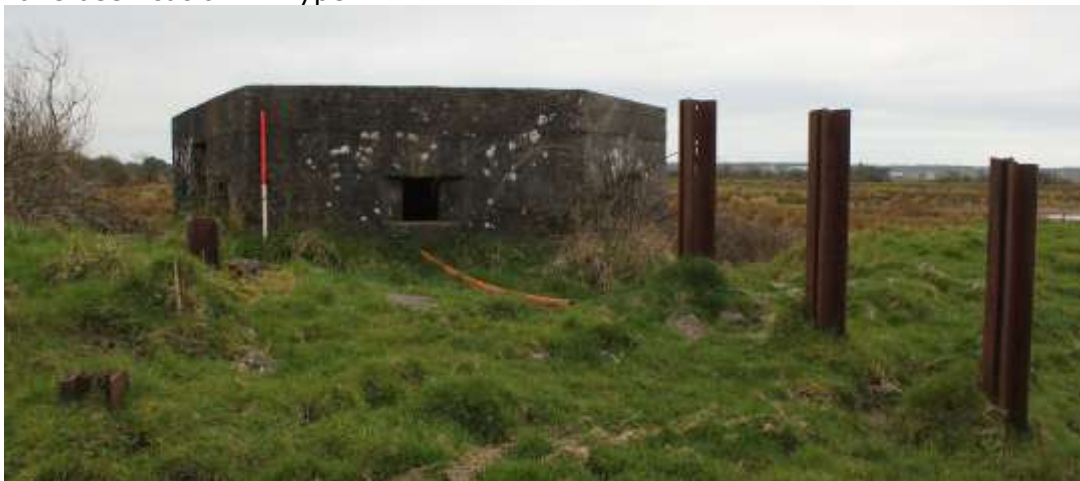
Figure 79: Anti- tank rails with pillbox

CONDITION DESCRIPTION Two parallel lines of anti-tank vertical rails, the eastern line have been cut off. A Pyper

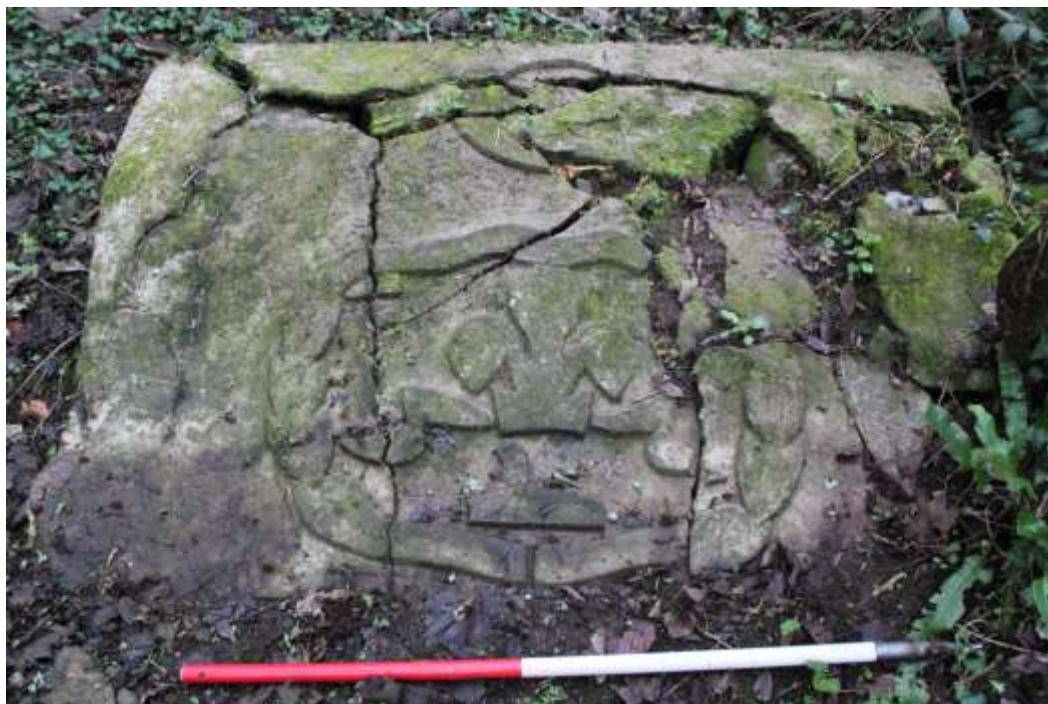
Figure 88: Commemorative plinth of the Manchester regiment

CONDITION DESCRIPTION concrete memorial cracked and broken. Lies within woodland and is quite overgrown. A. Pyper Jan 2013

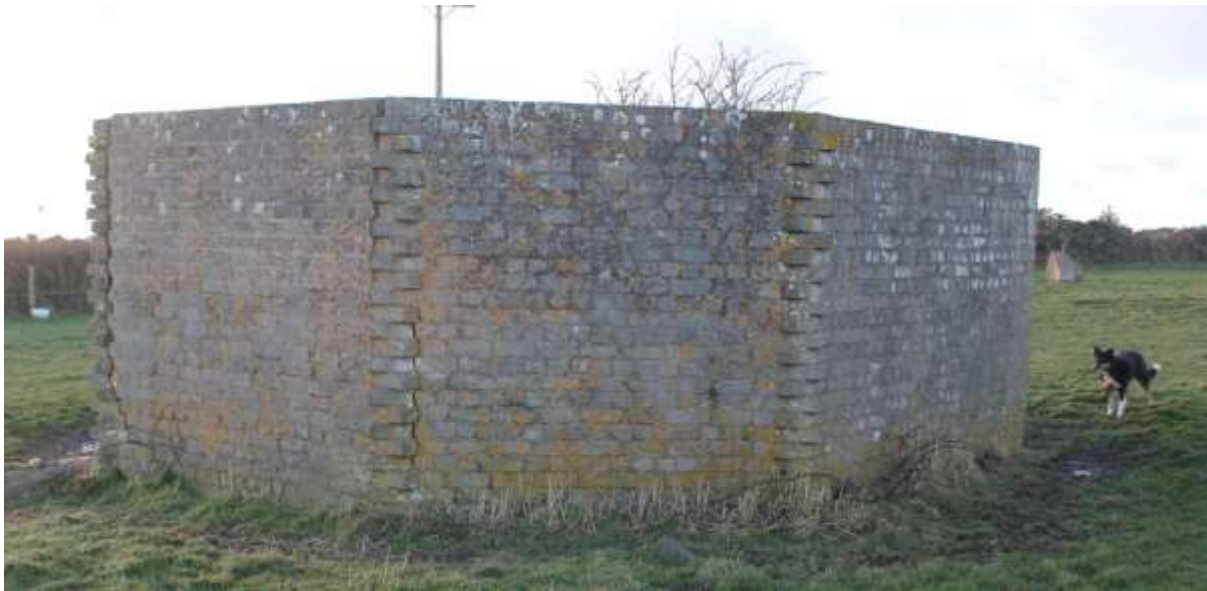
Figure 93: Octagonal wall formerly enclosing a HF/DF tower

CONDITION DESCRIPTION / Brick building intact to wall tops. Slightly overgrown with brambles inside. A Pyper 2013.

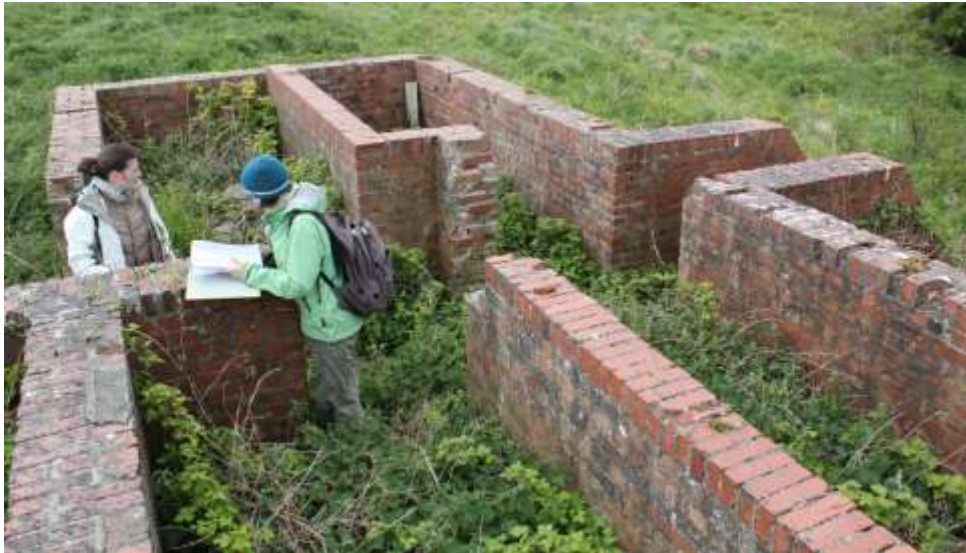
Figure 96: Blast shelter at the communal site

CONDITION DESCRIPTION / Tipping of concrete within feature. L Meek 2013

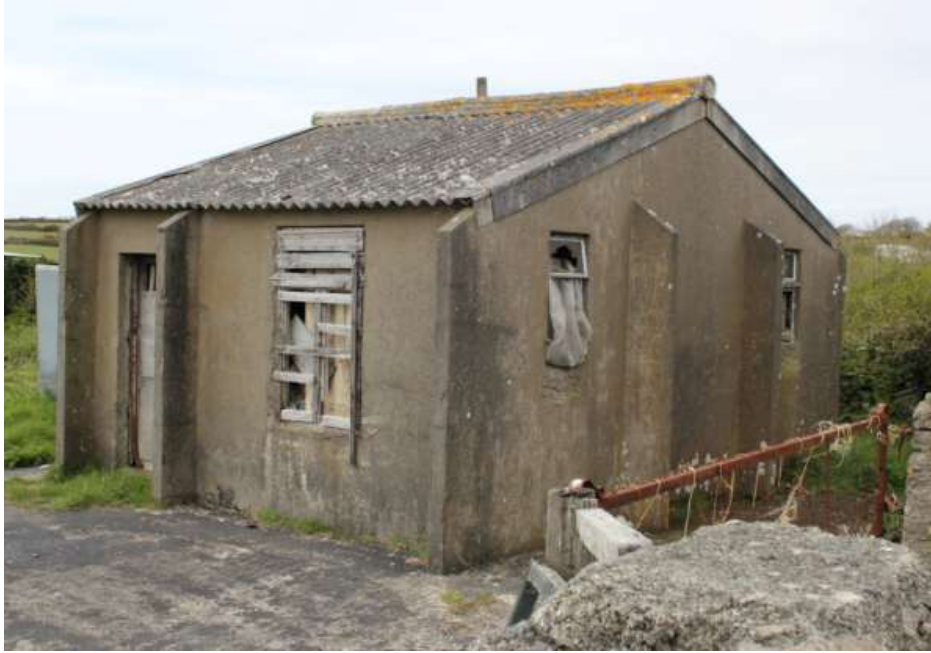
Figure 97: Remaining picket post

CONDITION DESCRIPTION / When visited in 2013; some windows and window frames still intact. Also remains of the door. L Meek 2013

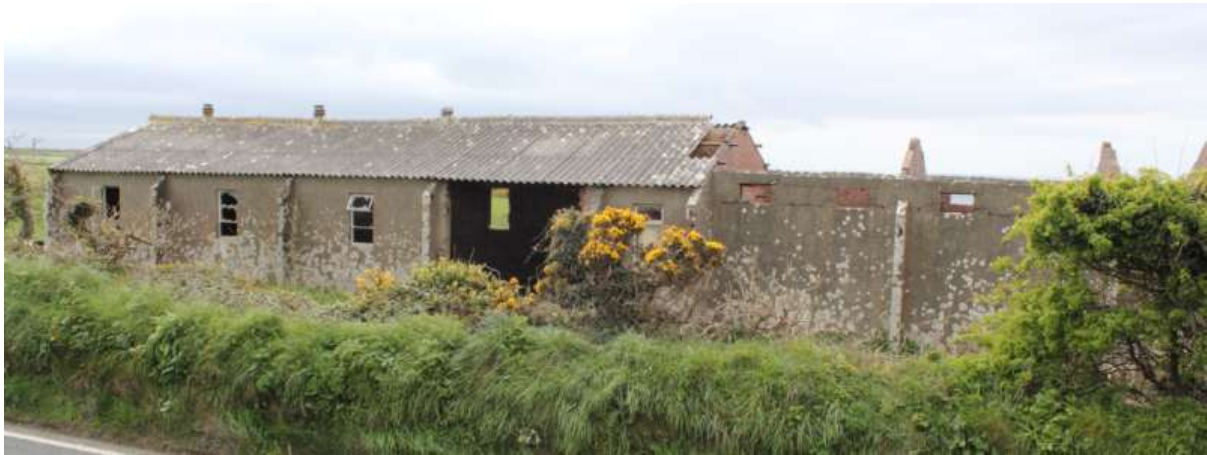
Figure 98: Partially roofless ablutions block

CONDITION DESCRIPTION / When visited in 2013; Some window frames and windows still intact. Roofless over the western end of the building. L Meek. 2013.

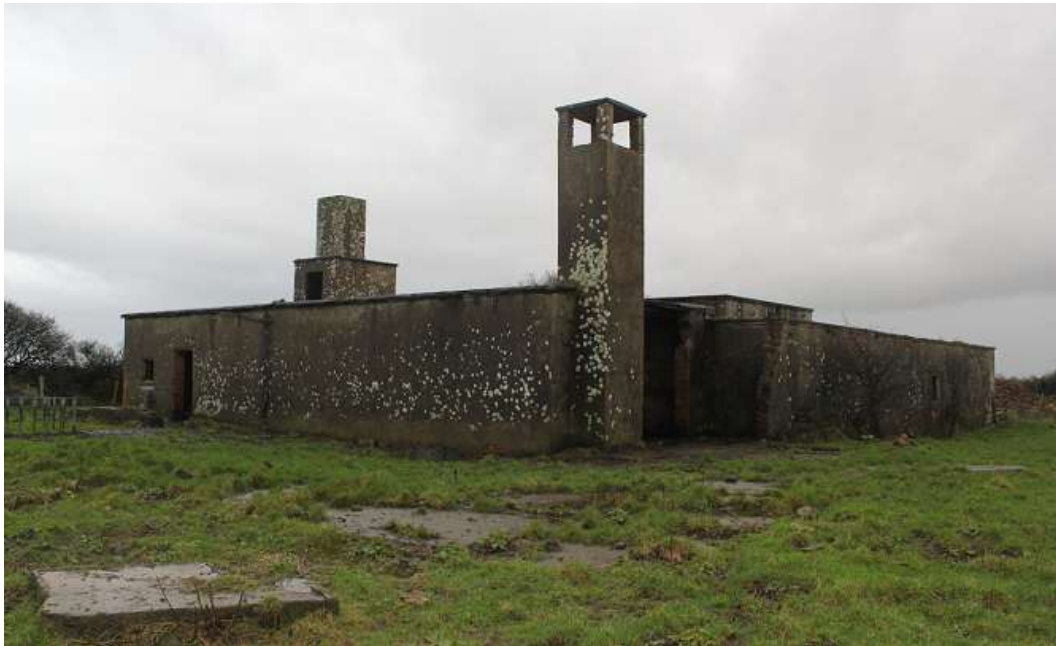
Figure 113: Derelict operations block

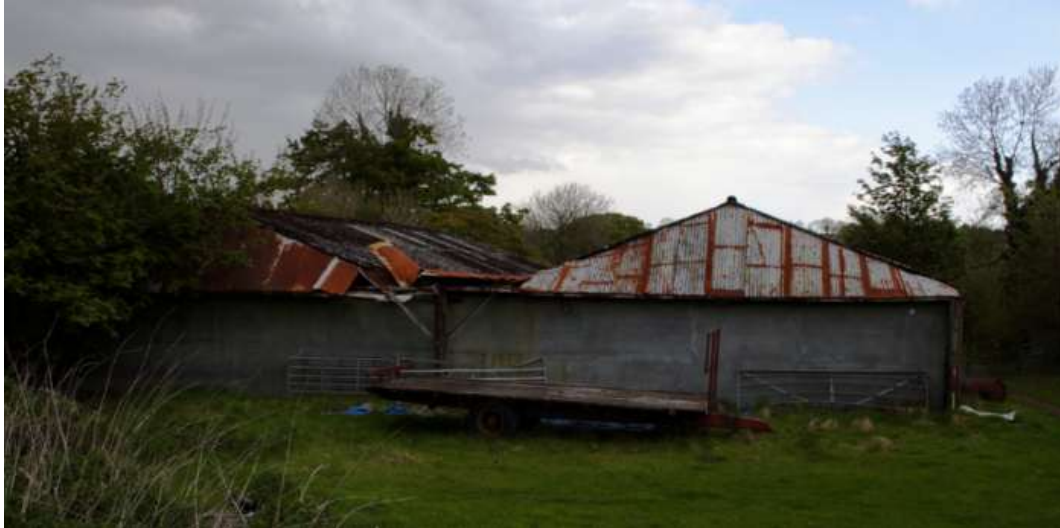
Figure 143: Only the concrete plinth from the beacon survives with a shed built over it
