CPAT Report No. 1937

# Dinas Brân Gatehouse, Llangollen

Excavation and Watching Brief

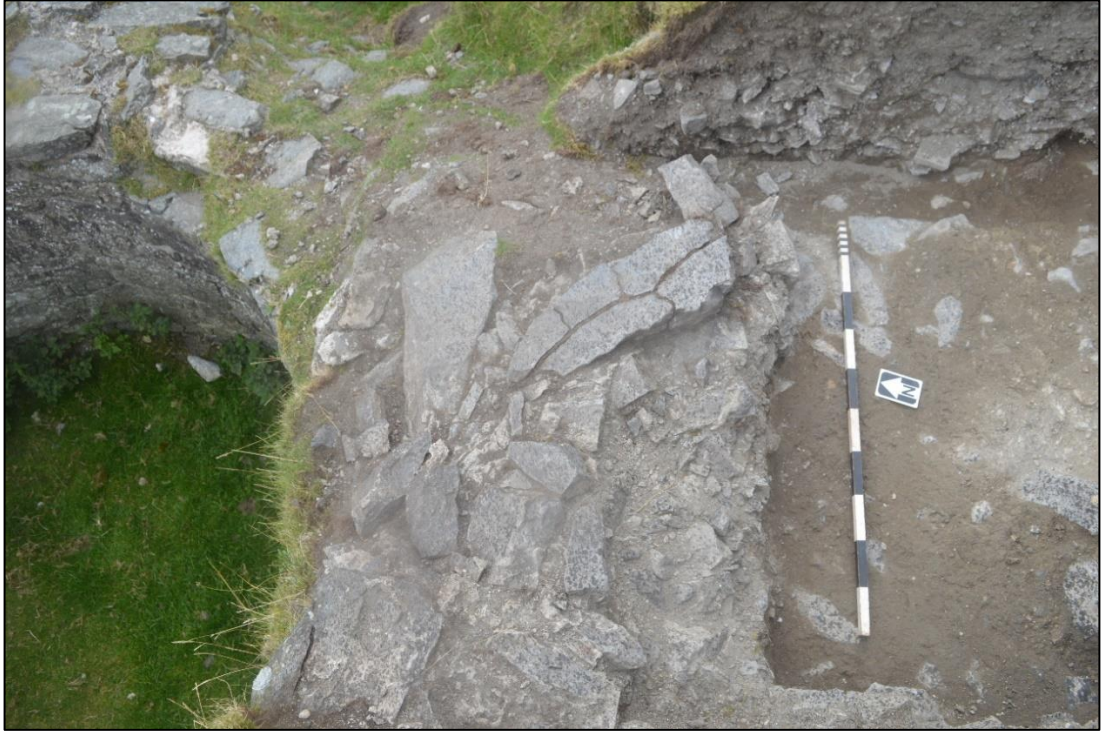
*Fig. 4 Remains of rubble core (014) within the northern gatehouse turret wall (013). Viewed from the west. Photo CPAT 4946-0090.*

- 2.8. Along the northern extent of the trench (Ai) the fragmented remains of the south wall (013) of the northern turret of the gatehouse were revealed (See Fig. 4-6). The wall, up to 1m wide and reduced to a height of 0.3m, was constructed with a rubble core of lime mortar and shale stone (014). There was no surviving trace of exterior dressed facing stones.

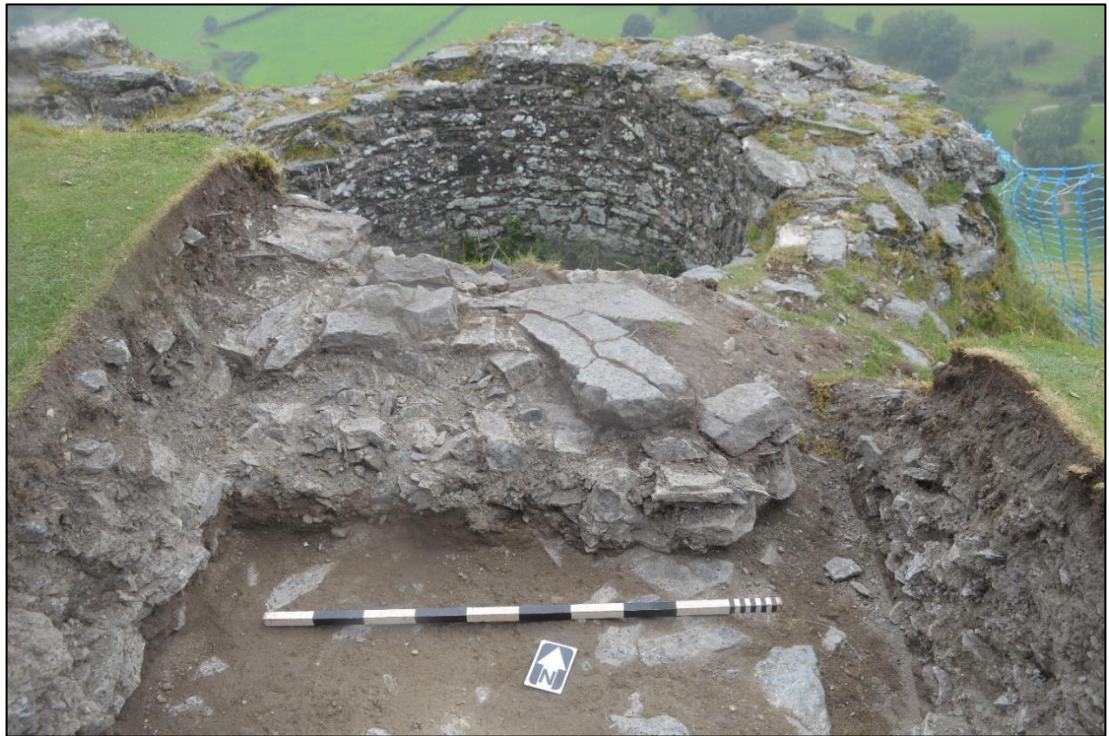
*Fig. 5 Remains of rubble core (014) within the northern gatehouse turret wall (013). Floor surface 005, in the foreground. Viewed from the south. Photo CPAT 4946-0089.*

- 2.7. The excavations at the eastern end of the excavations confirmed that the passageway was up to 2.6m wide. A firm trampled deposit (005) of large flat shale-stone bonded in a matrix of charcoal flecked silty clay, was revealed at a depth of 0.5m from the present ground surface. The surface is believed to be the first significant in-situ layer of medieval origin found at Dinas Brân. Two small sherds of pottery, an orange-glazed orange sandy-ware, were recovered from the floor surface. The fabric, with traces of rouletted decoration, is of 13<sup>th</sup> century origin.

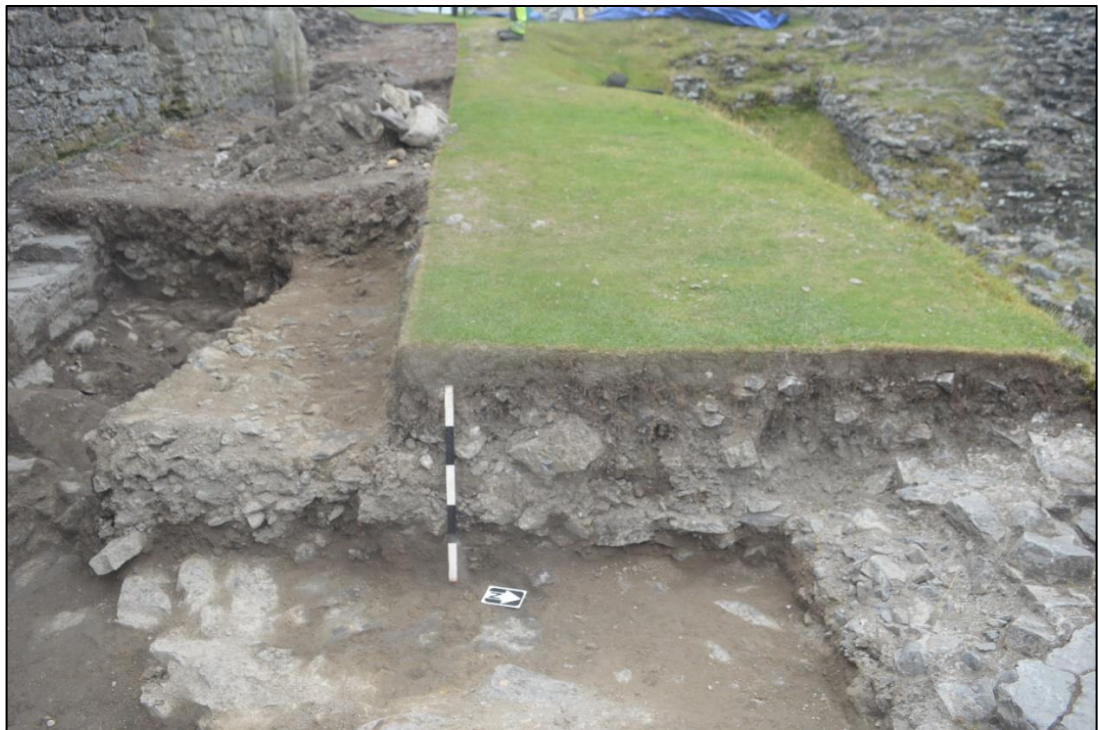
*Fig. 6 East facing section through the demolition rubble (003), gatehouse passageway. Photo CPAT 4946-0093.*

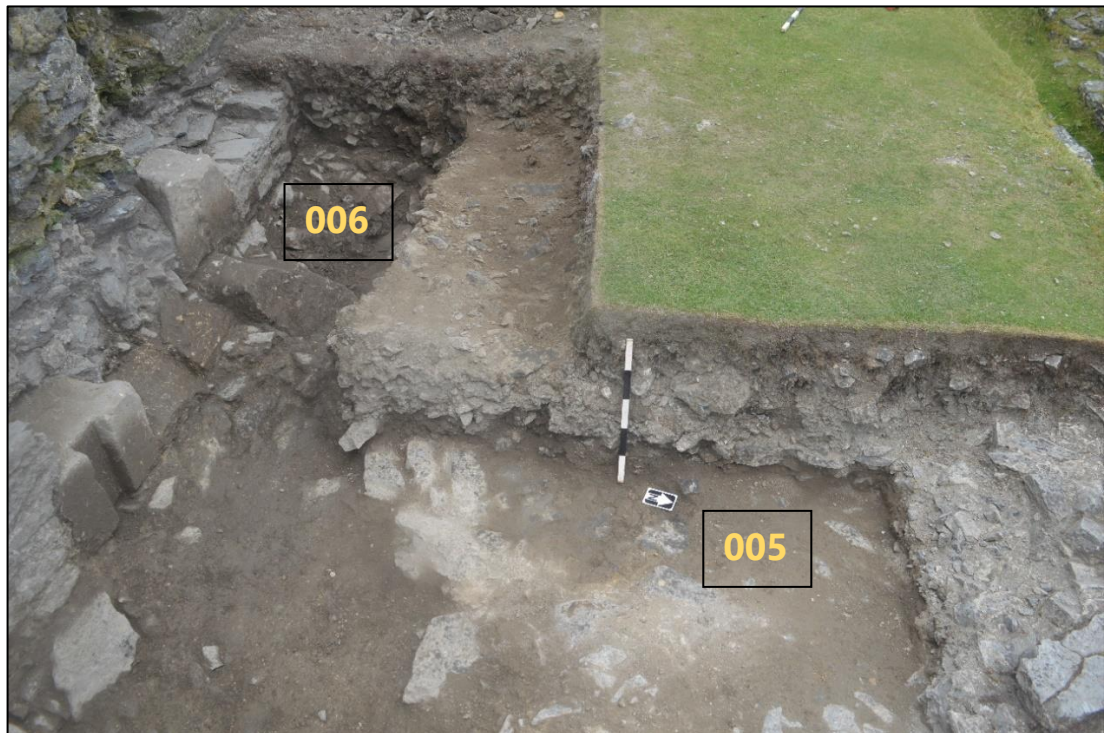
*Fig. 7 East facing section through the overlying demolition rubble (003), revealing medieval surfaces (005 and 006). Photo CPAT 4946-0091.*

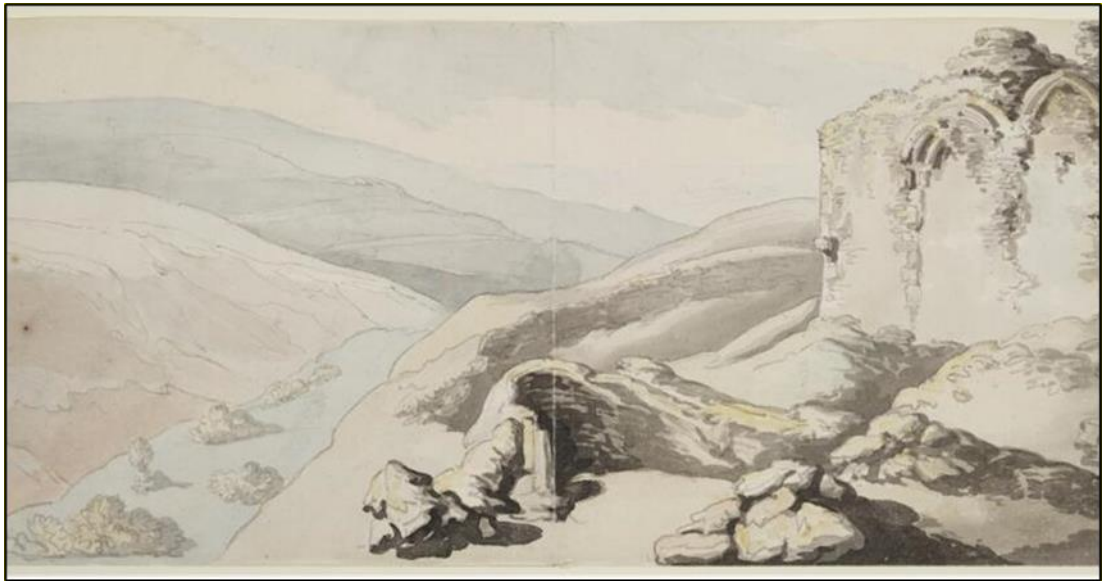
*Fig. 8 View of the gatehouse from the north-west, c. 1797. Engraving by Thomas Rowlandson*

- 2.10. As has been previously noted (section 1.4) the elevation of the southern turret passageway wall has been studied in detail (King 1974, RCAM 1913). The gatehouse passageway has been described as, at the entrance, consisting of a massive portal arch followed by the main gate, with door jambs and draw-bar holes and then an elaborately ornate vault consisting of three cross-vaulted bays. All that remains now of the latter is a large part of the third wall-shaft, with the whole dressed sandstone base in-situ. Evidence of the moulded wall ribs that supported the vaulted roof could still be seen on an engraving of the gatehouse by Thomas Rowlandson c.1797. (See Fig. 8).

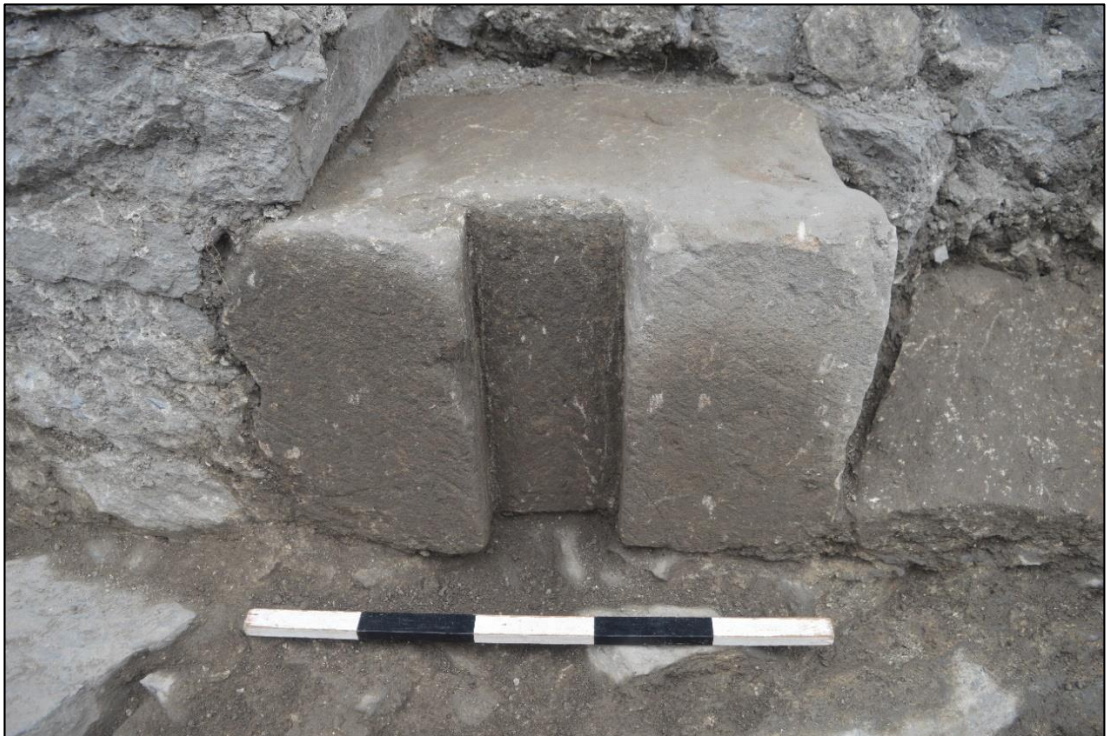
*Fig. 10 Portcullis slot (010), viewed from the north. Photo CPAT 4946-0077.*

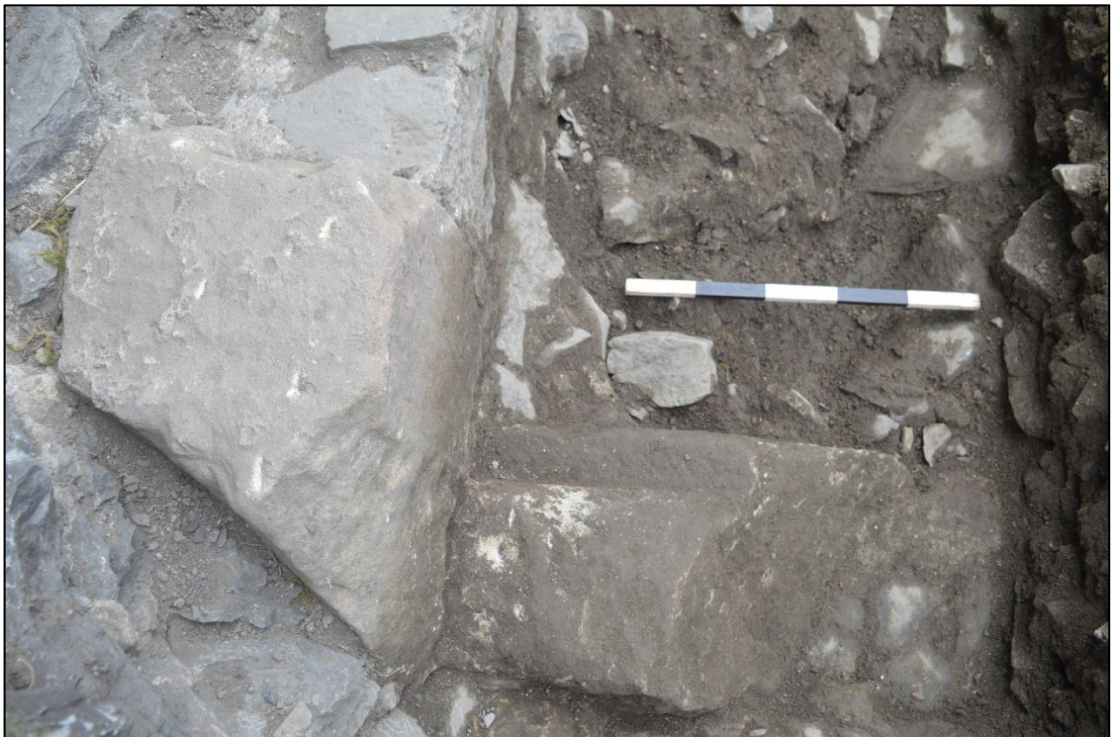
*Fig. 11 Door jamb (007) overlying medieval surface (006). Photo CPAT 4946-0078.*

- 2.13. At a point 0.9m west of the portcullis block (010) the remains of a door jamb (007) for the main gate were revealed (See Fig. 9 and 11). This was aligned just in front of the draw-bar hole (009), evident in the adjacent wall (011). The surviving medieval ground surface (006) to the west of the door jamb was recorded at a depth of 0.45m below the present ground surface (See Fig. 7).

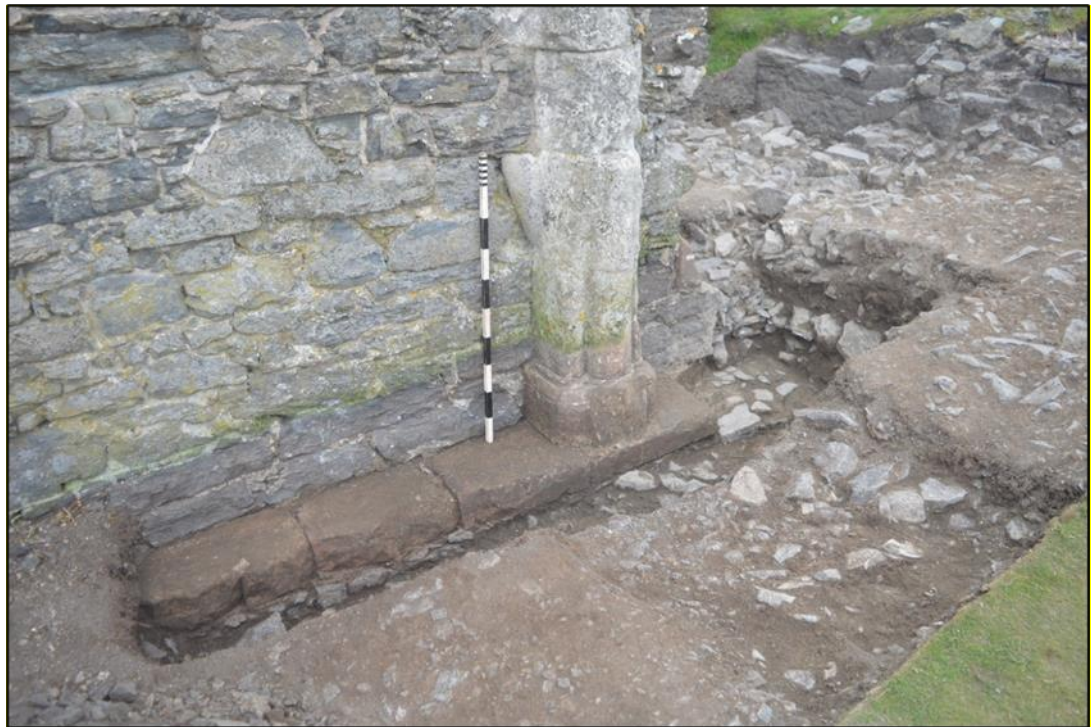
*Fig. 12 Dressed pillar base (017) and footings (018). Photo CPAT 4946-0096*

(008/018), survived in-situ. In addition, further evidence of the base of the third wall-shaft (17) was also recorded, located 5.8m west of the main gate door jamb (See Fig. 12-15).

- 2.15. The elaborately dressed sandstone pillar base (017) was well preserved, having not been exposed to the erosive natural elements. Whether or not the corresponding basal plinth survives in-situ on the northern turret is unknown. However, a sondage excavated outside the opening to the guardroom of the southern turret demonstrated that there is up to 0.75m of demolition rubble infilling the passageway between the two turrets at this point (See Fig. 17, Appendix 2 Fig. 22-23 Section E-F). Therefore, it is possible that not all the dressed masonry has been removed.

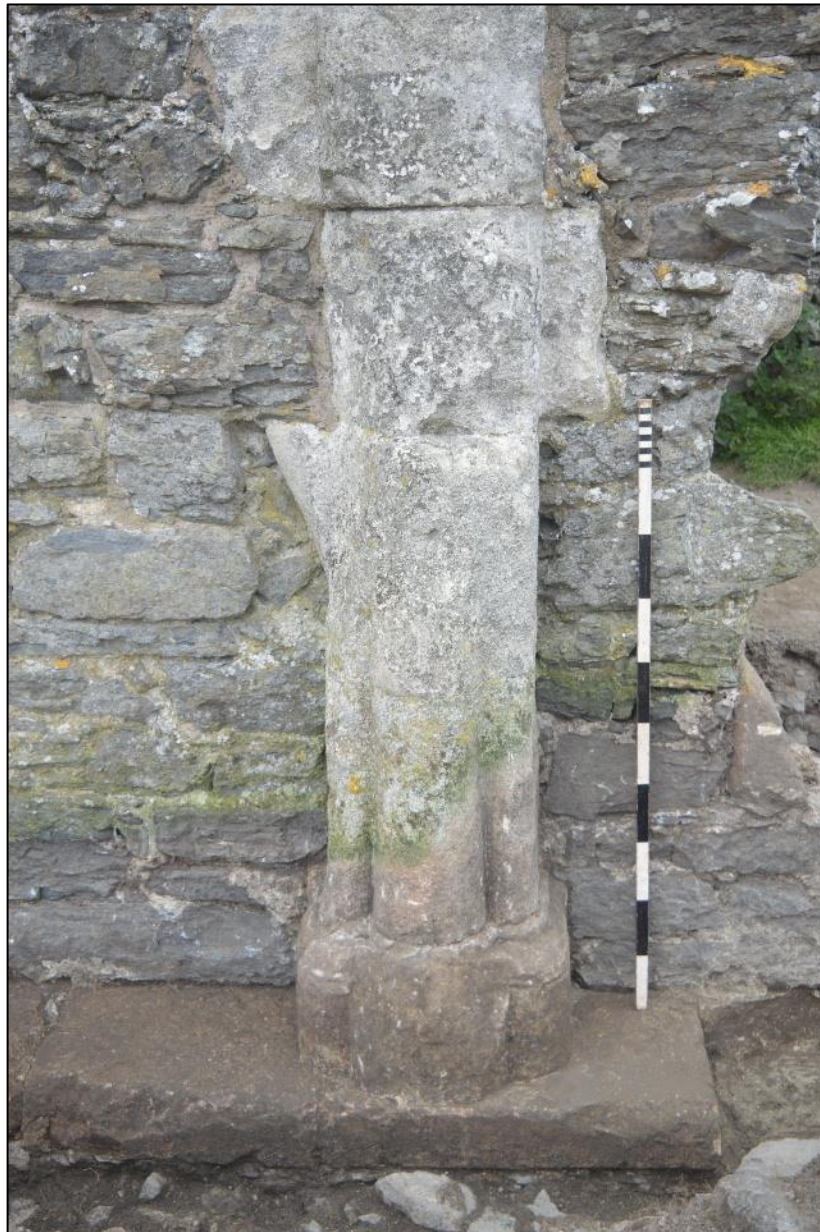
*Fig. 13 South turret wall. Base of dressed colonette/pillar (017), viewed from the north. Photo CPAT 4946-0100*

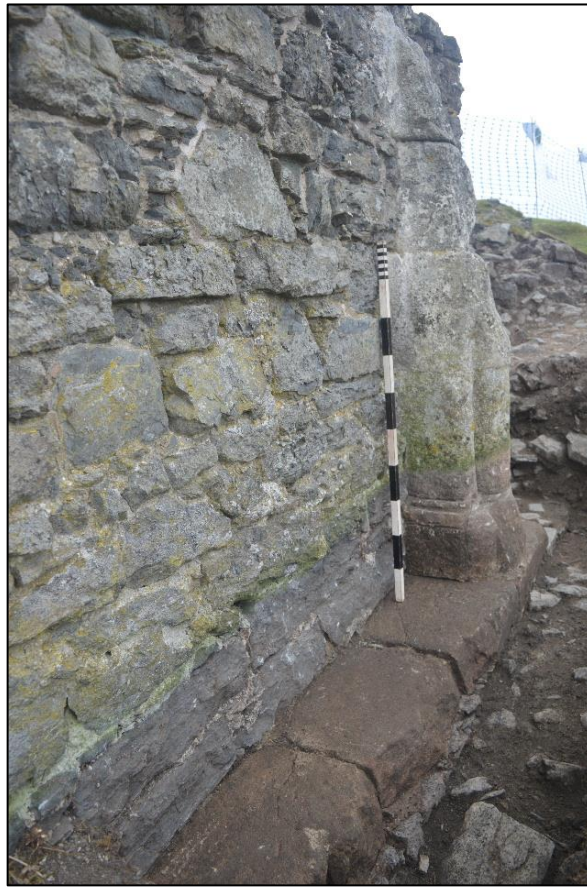
*Fig. 14 Pillar base (017) viewed in profile. Photo CPAT 4946-0098*

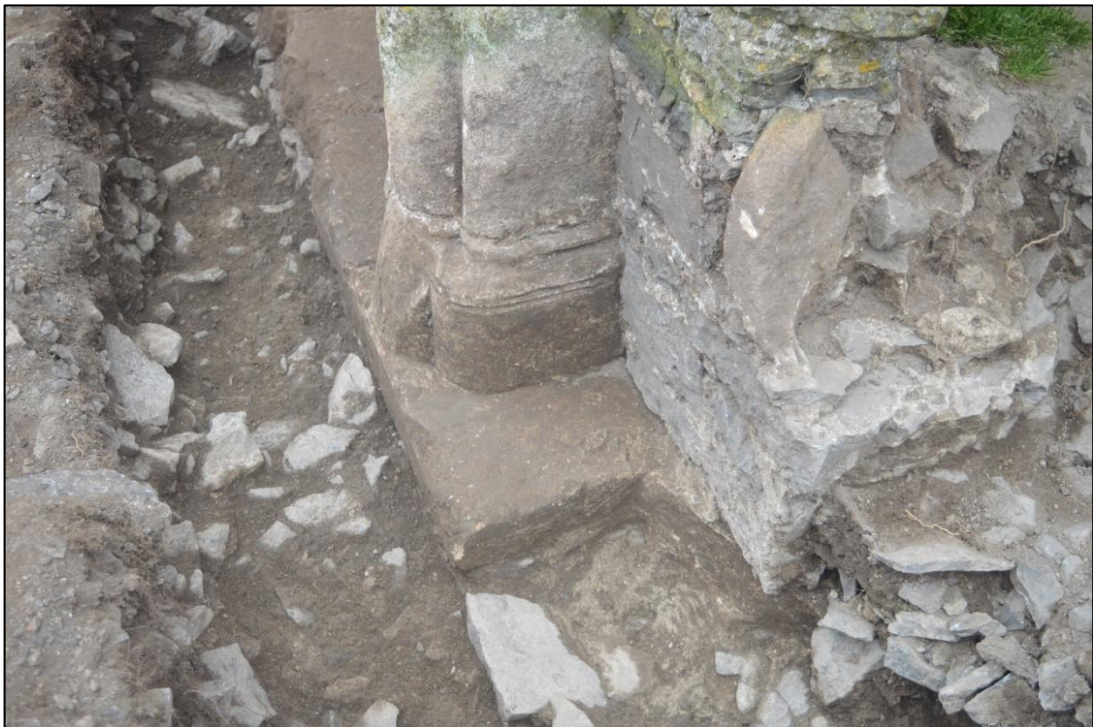
*Fig. 15 Detail of the carving on the pillar base (017), viewed from the west. Photo CPAT 4946-0108*

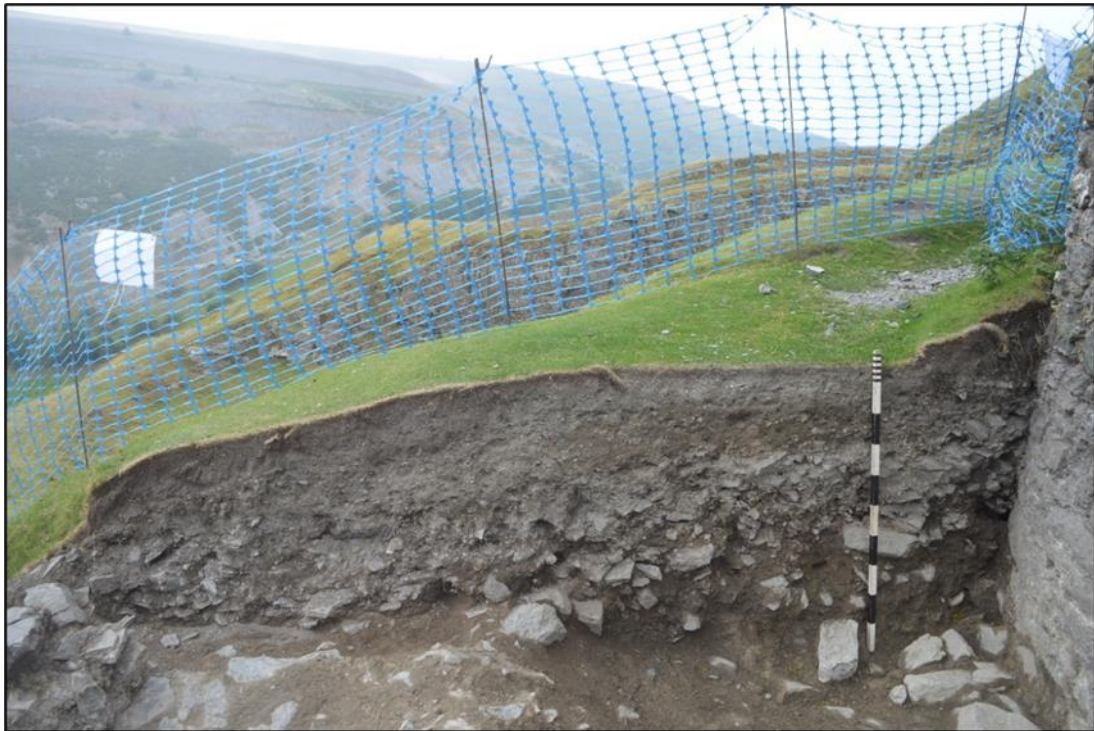
*Fig. 16 West facing section through post-medieval demolition and levelling material. Gatehouse passageway, eastern end. Photo CPAT 4946-0087*

- 2.16. As has been previously stated, the general overburden within the passageway consisted of at least three deposits (001-003) of deliberate backfilling material. The bulk deposit (003) consisted of shattered shale in a matrix of yellowish grey sandy silt, between 0.35-0.45m thick. This contained numerous fragments of bottle glass, white stoneware including ginger beer bottles, clay pipe stems and bowls, and animal bone (principally bird bones) all of which were of late 18<sup>th</sup>-19<sup>th</sup> century origin (Fig. 16).

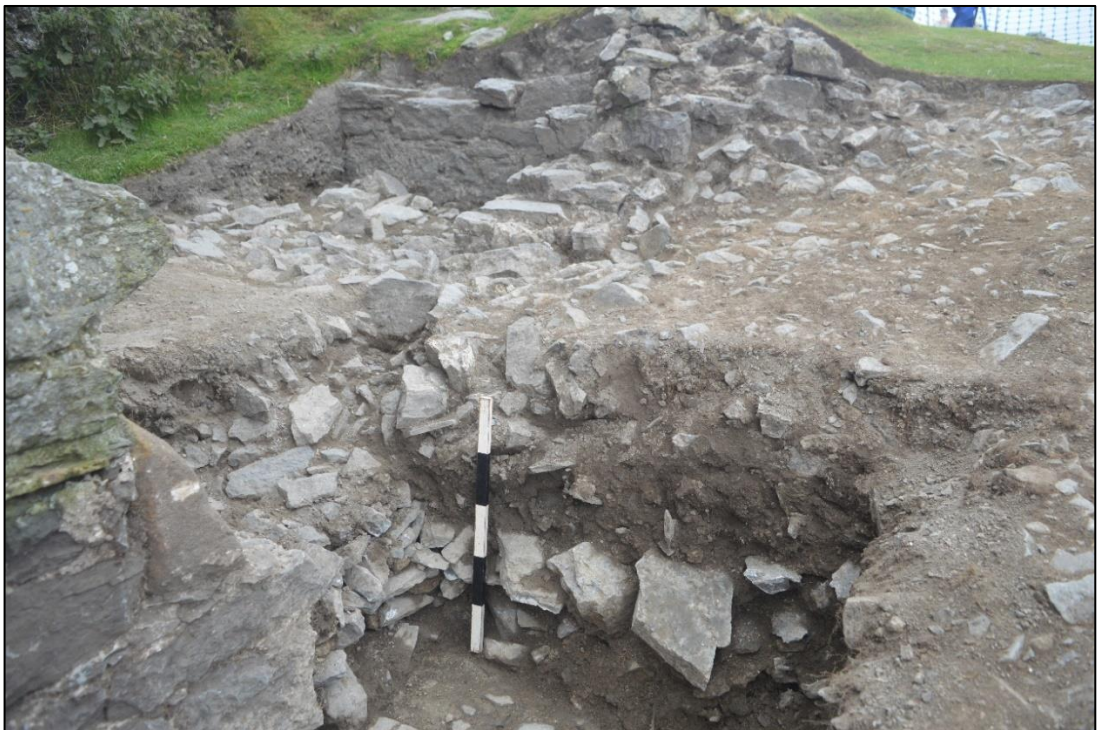
*Fig. 18 Possible location of entrance into the guardroom (020). North-east facing section through later demolition material. (003, 015-016). Photo CPAT 4946-0111*

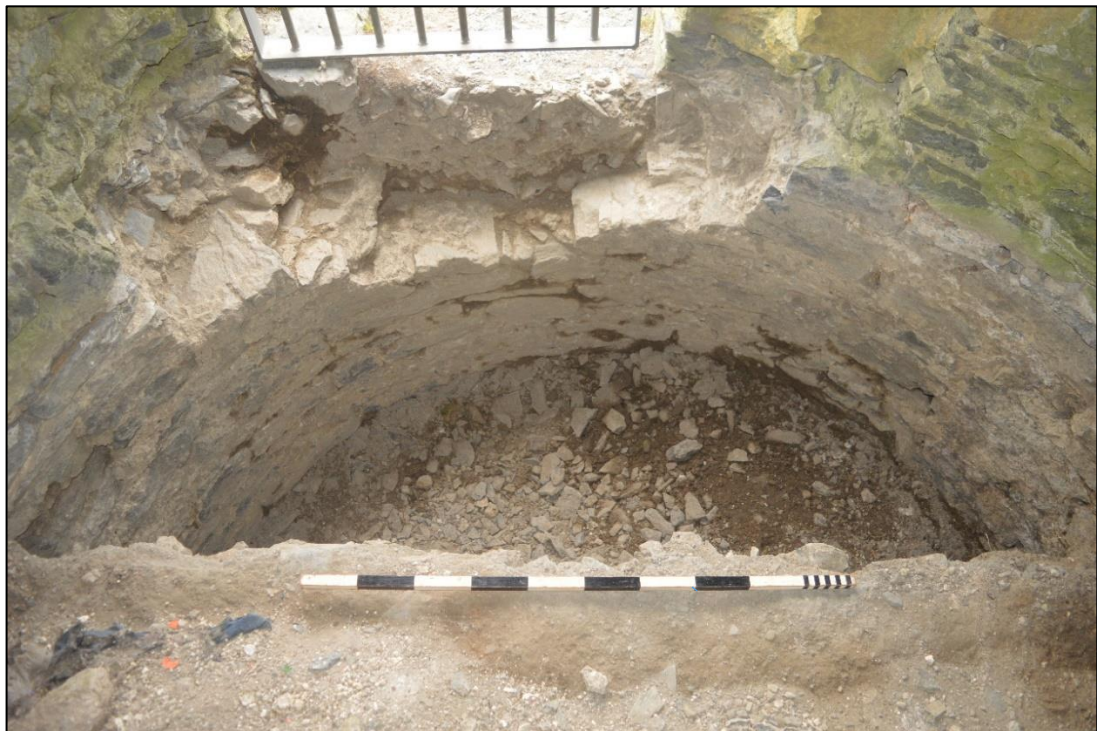
*Fig. 19 Test pit (2021 excavations) through 18<sup>th</sup> -19<sup>th</sup> century backfill, east end of south turret. Viewed from the west. Photo CPAT 4946-0057*

- 2.20. The backfilling deposits abutted the base of the east window and therefore we must assume this deliberate act was to allow the window embrasure to be converted into a 'ground floor' access into the turret. It was noted that within the newly exposed lower courses of the embrasure, all the dressed ashlar corner stones (quoins) had been removed in antiquity (See Fig. 19).

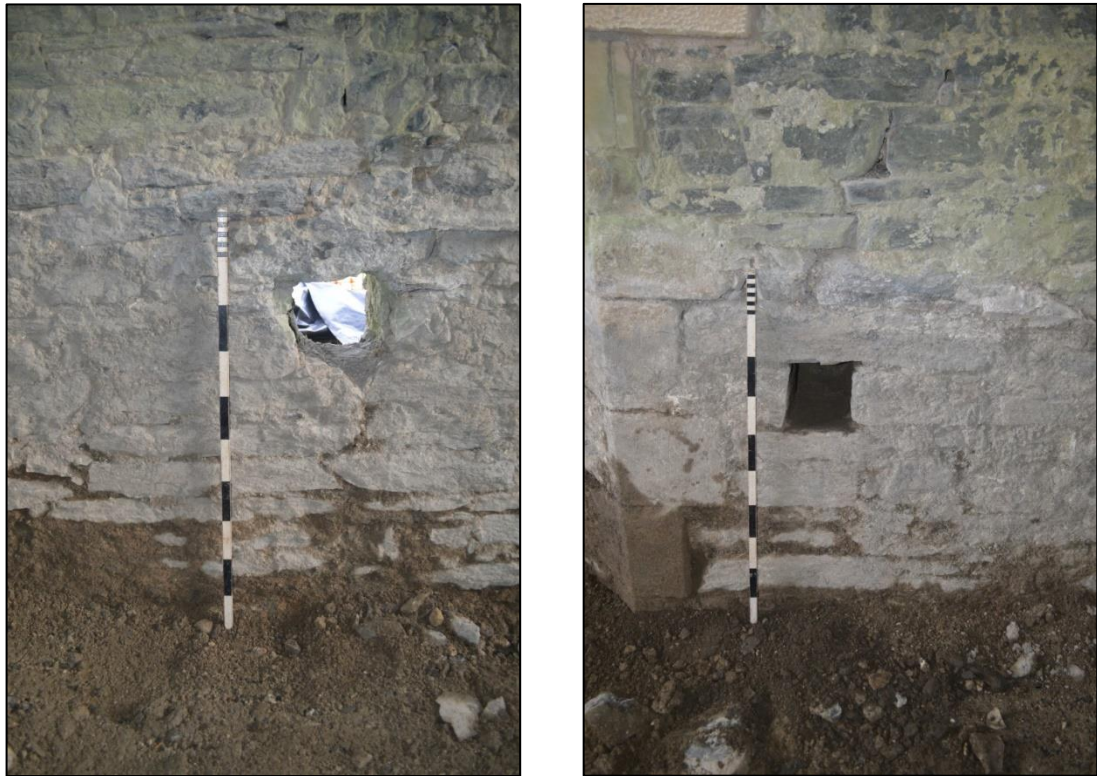
*Fig. 21 Draw-bar holes for bracing the gatehouse door, north wall and south wall, south turret. Photo CPAT 4946-0199, 4946-0188*

- 2.22. Two additional features were recorded during the watching brief (2022). As the backfill material was removed, a pair of draw-bar holes were revealed, one in each side wall of the turret (See Fig. 21). The hole in the northern wall was a continuation of the main gate passageway draw-bar hole (009). The hole was 0.24m<sup>2</sup> and 0.44m deep (although the outer face was truncated – the width of the wall is 0.6m). The hole in the opposite wall measured 0.19m<sup>2</sup> and 0.47m deep.
- 2.23. Given that the internal passageway of the south turret is 1.9m wide, this allows for a drawbar up to 3m long – enough to extend behind the main gate in the passageway, which is 2.6m wide.
