*Carno Windfarm, Trannon Moor, Powys*  
ARCHAEOLOGICAL GROUND SURVEY

CPAT Report No 315

N.W.Jones and W.G.Owen  
March 1999

Report for National Wind Power and Powys County Council

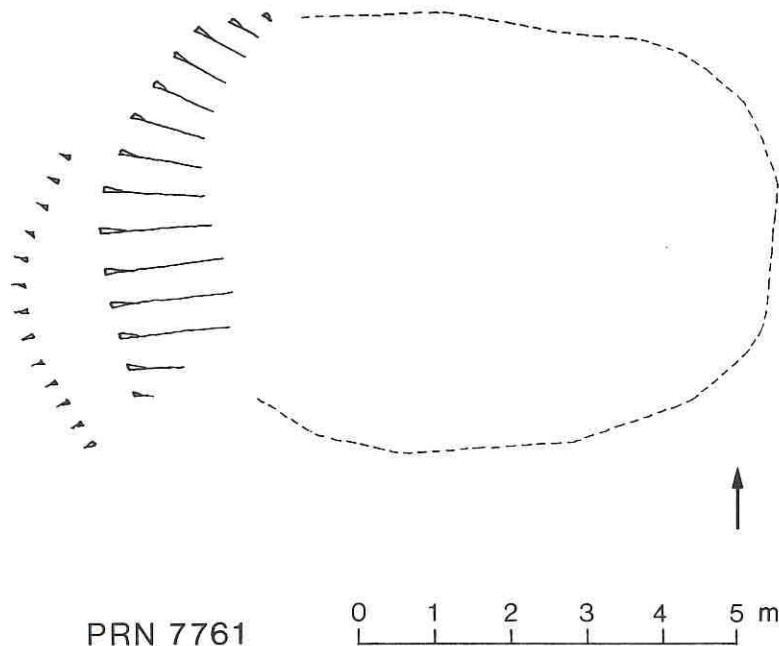
A level area measuring c. 7.5 x 6.0m and obscured by rushes, has a distinct bank on the upslope, western end. The bank is slightly curving, c. 5.0m in length and up to 0.4m high. It is possible that this represents the remains of a small hut platform, although it may also be related to adjacent peat cutting.

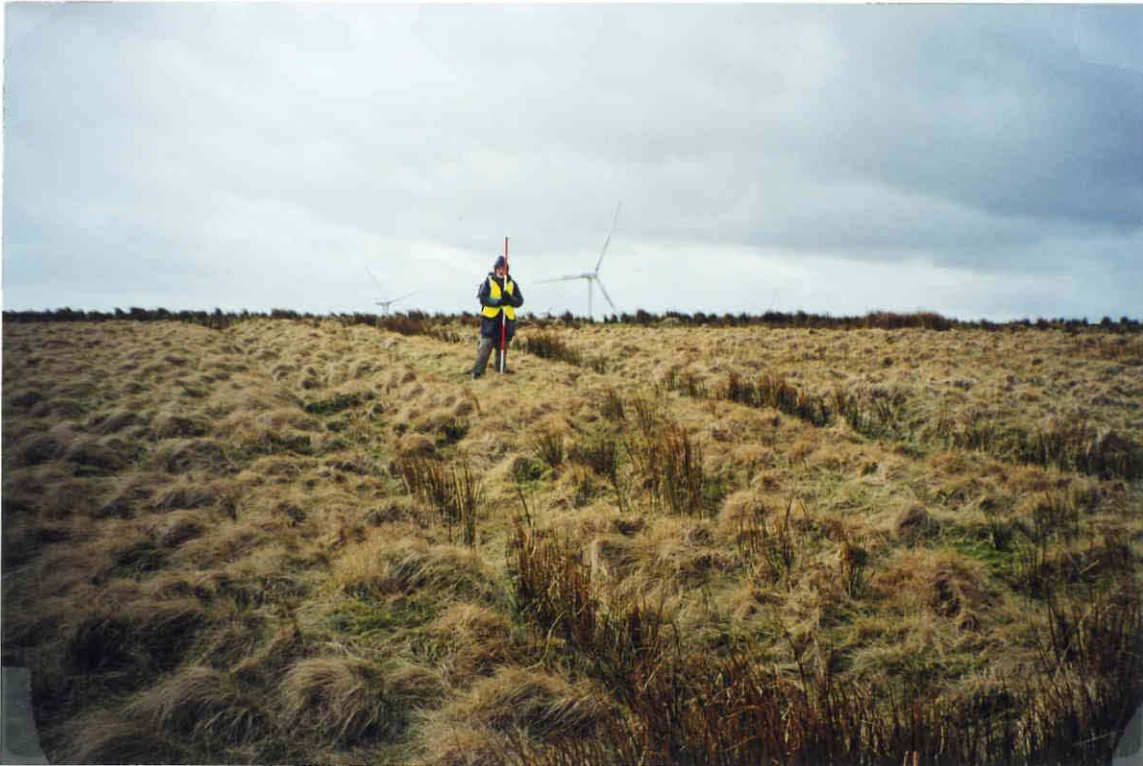
Plate 5 PRN 7755 Trannon Road from E. Photo CPAT 784.9

The road (plate 5) survives as an earthwork c. 1km in length, consisting of a cambered track, or agger, 3m wide with ditches on either side. It has been suggested by that the road is of Roman date, and probably linked the putative Roman fortlet at Penycrogbren above Dylife, with the fort at Caersws (Bebb *et al.* 1973; Hogg 1973).

Excavations across the road in two places in advance of the windfarm construction (Silvester 1995) revealed that it was constructed of redeposited stony loam with evidence for deliberate metalling surviving in places. Evidence of wheel ruts was revealed in one excavation. The excavation concluded that the road was of Roman date, as had been previously suggested.

The recent survey has provided an accurate plan of the surviving road, the results of which may cast some doubt regarding the assumed Roman dating. It is clear that the road undertakes an obvious dogleg at a point where it is crossed by a north-south boundary. Topographically, there is no reason for the road to make any such deviation in course, which may therefore suggest that the boundary was already in existence before the road was constructed. If this were so, it would be more likely to be post medieval in date, rather than Roman. However, conclusive evidence for dating could only be provided by further excavation.

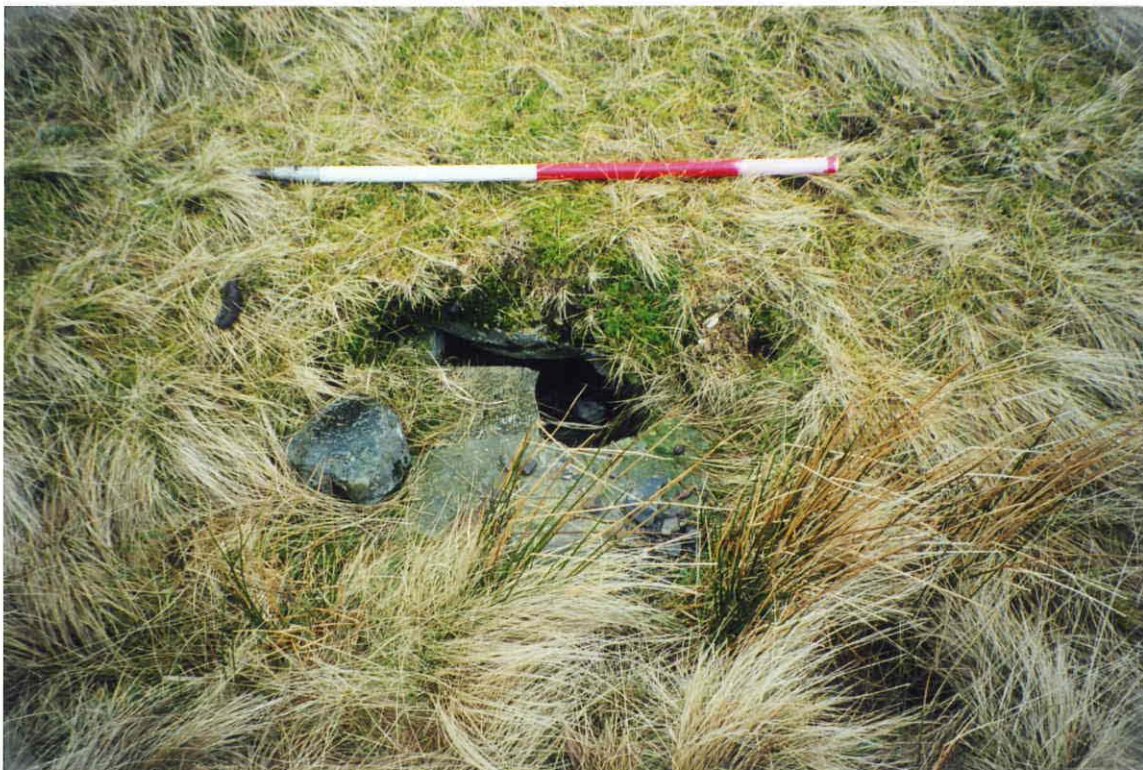
Plate 6 PRN 25662 Trannon Road Culvert 1 from S. Photo CPAT 784.10

Fairly well-preserved stone culvert (plate 6) with a capstone entrance at both ends and an earthwork gully to the north of the road.
