Tannery site, Machynlleth
Geophysical Survey Report (Radar)
Produced for Clwyd-Powys Archaeological Trust

MTR071

January 2008

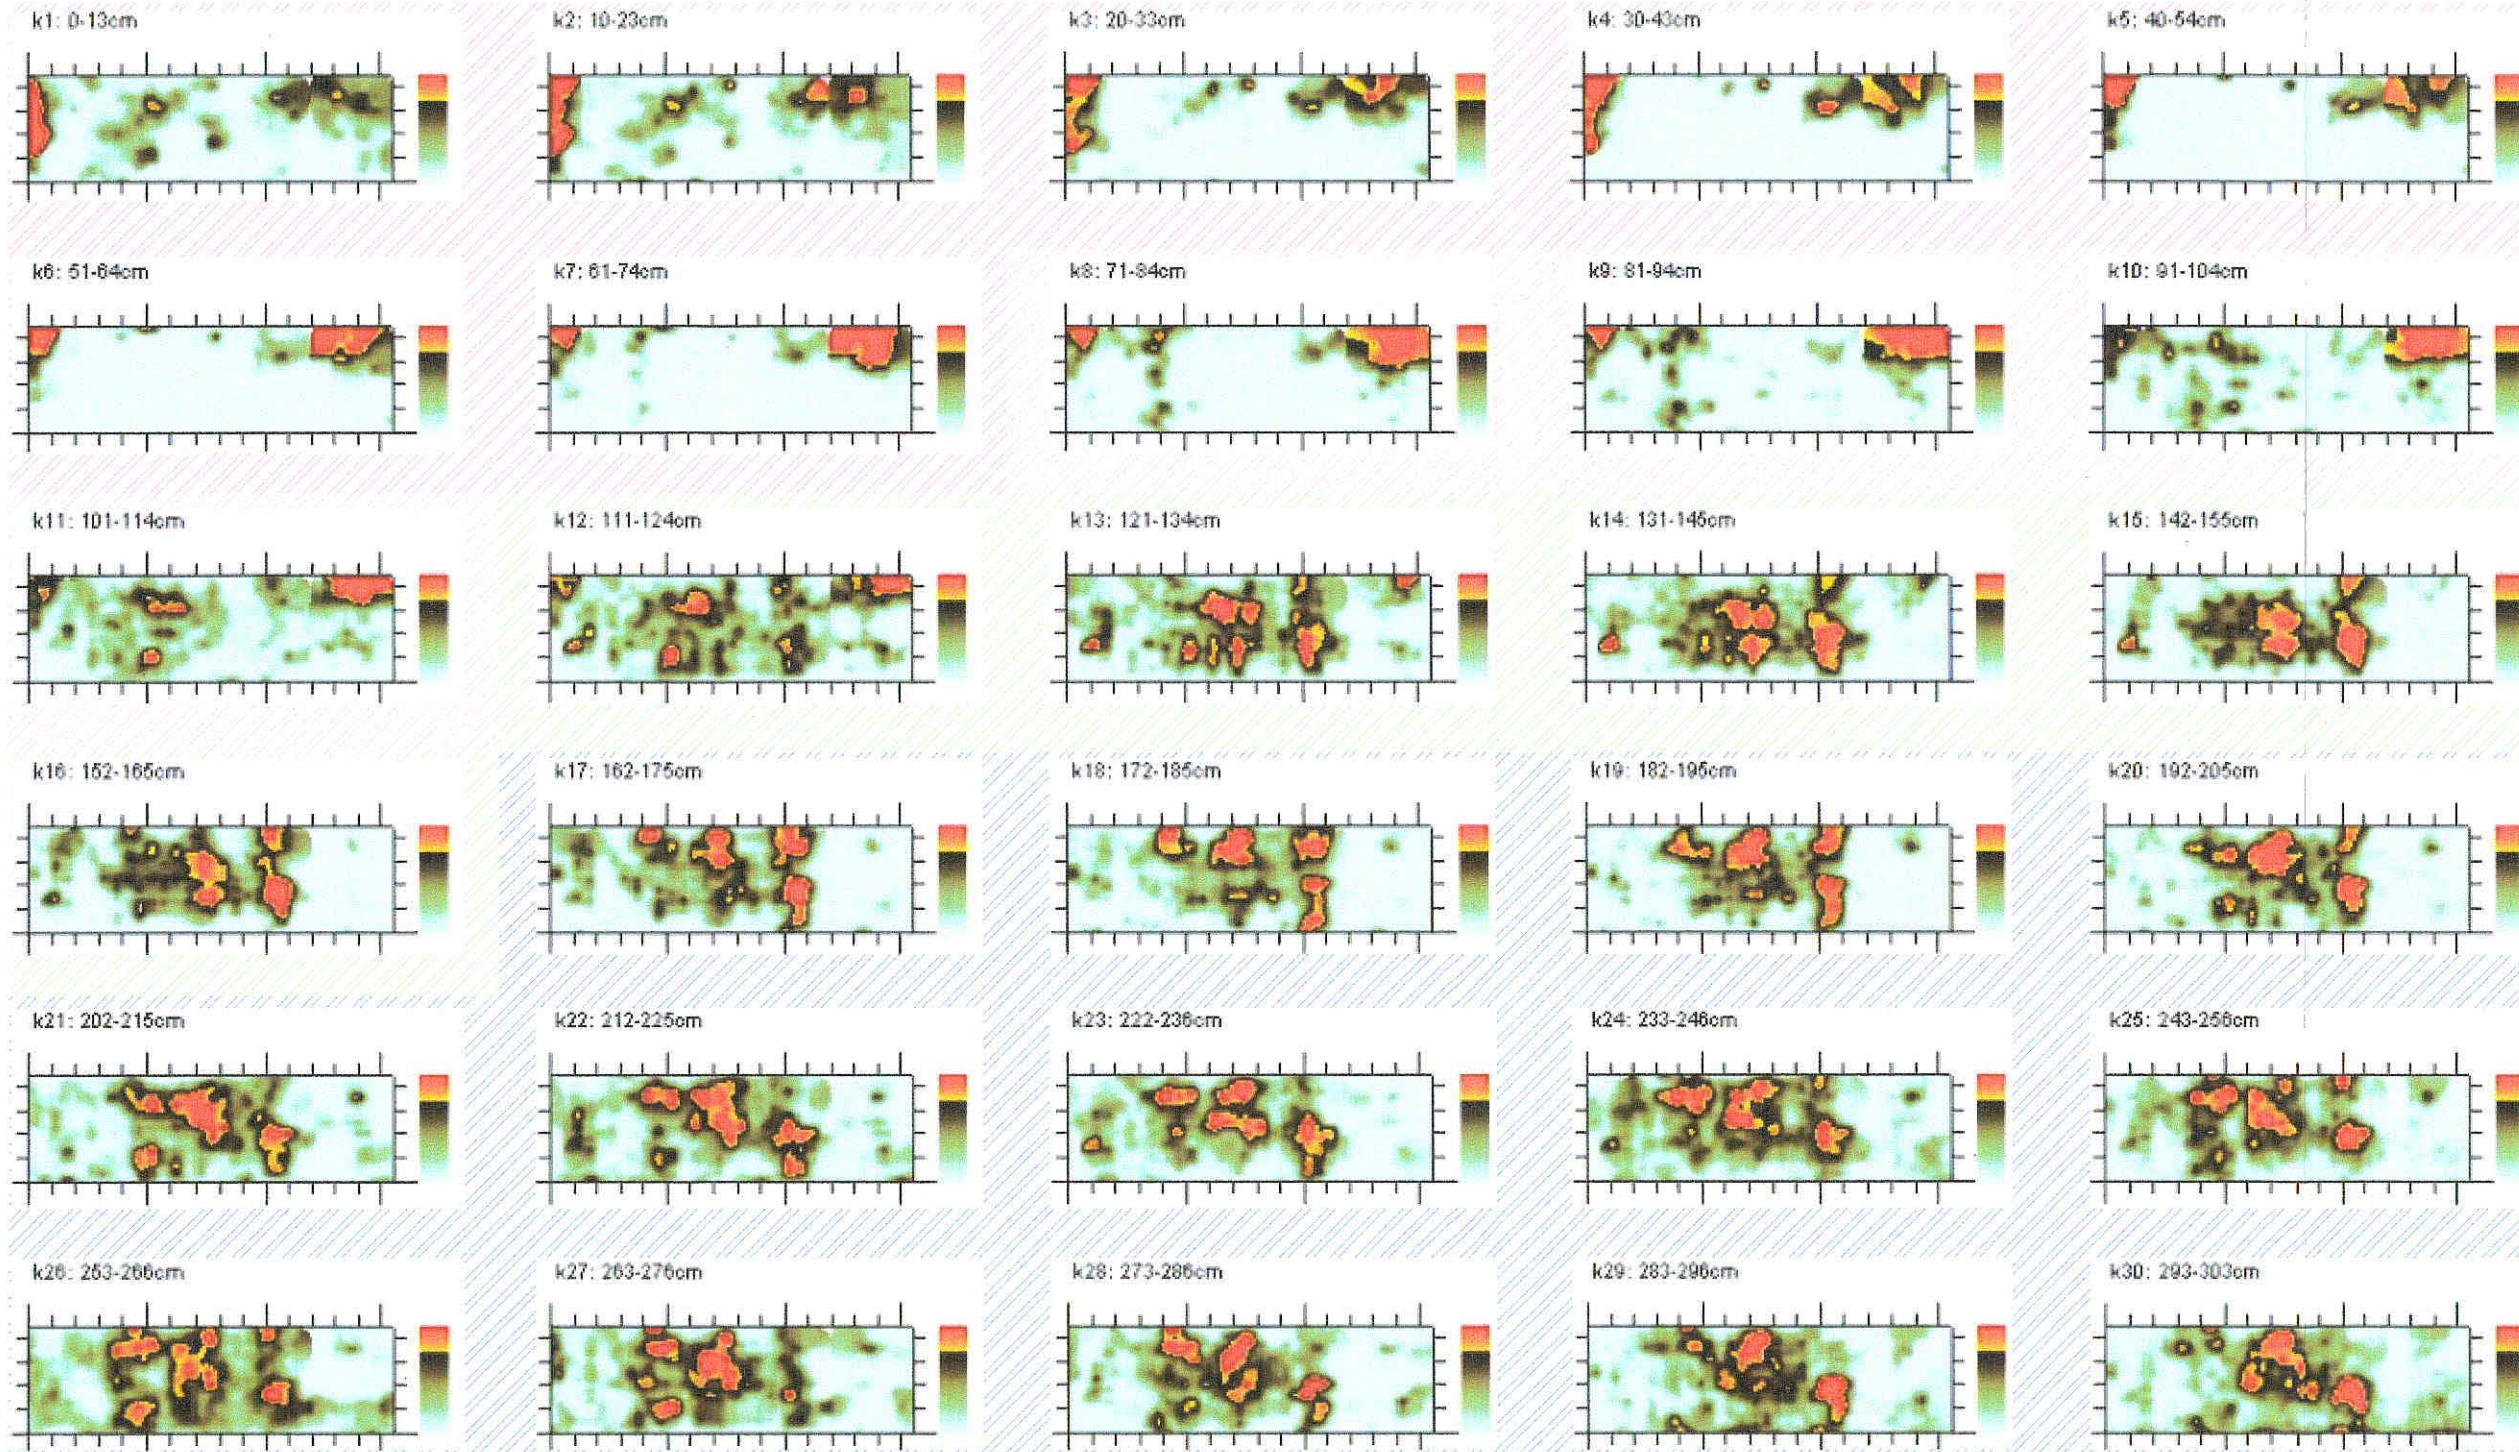
DWG 02

Horizontal Amplitude
Slices

Slice Sets

Coloured by basic context
post-tannery fill

base of post-tannery fill

on and into tannery floor

below tannery floor and into rock

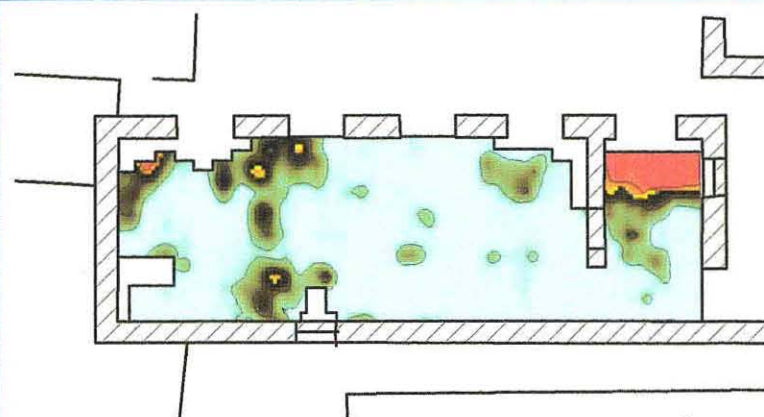
81 - 94 cm depth
above tannery floor

The shallowest slice is through the fill material supporting the concrete floor and as expected from observation of an exposed section it is a fairly uniform material with the odd larger inclusion or metal object apparent as variation from the pale blue colour representing low reflection intensity. Just to the left of the blocked doorway in the south wall can be seen a linear reflector that is most probably a thin dividing wall. It doesn't pass below the tannery floor so could represent an addition after disuse. The reflection in the northwest corner is spurious and seems to be a reflection from the underside of the stairs. In the eastern room a strong reflection near the north wall may represent a rubble fill or perhaps the upper surface of the bedrock.

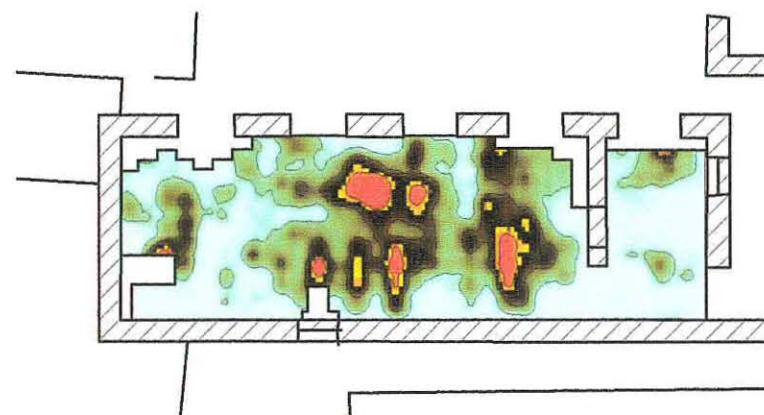
121 - 134 cm depth
at and just below tannery floor

By 120cm depth the radar has imaged through the tannery floor and is 'seeing' reflections off thin bar-like structures in the floor and the uppermost fills of the tanning pits which are just becoming visible as a disturbed area central within the building. The low response in the eastern room confirms that the rock in here is much higher and probably immediately beneath the tannery floor, itself similar to the existing level.

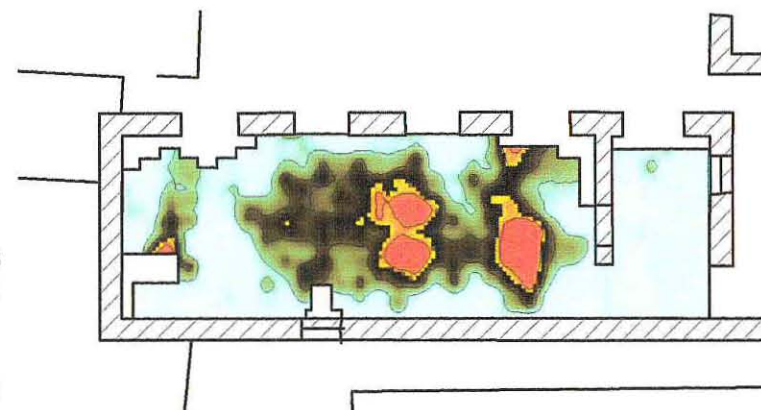
142 - 155 cm depth
below tannery floor

These pits become more visible with depth where they contrast strongly with the rock into which they are cut. Strength of radar reflection is a measure of inhomogeneity thus these fills are inhomogeneous, perhaps layers of different materials. The third and fourth slices show variations corresponding to six pits grouped with four central to the western room and a further pair between these and the eastern room. More clear images of the pits themselves are presented elsewhere in the report. It is notable how little space must have been available inside the room; there is no more than 1m between the southern doorway and the southwestern pit.

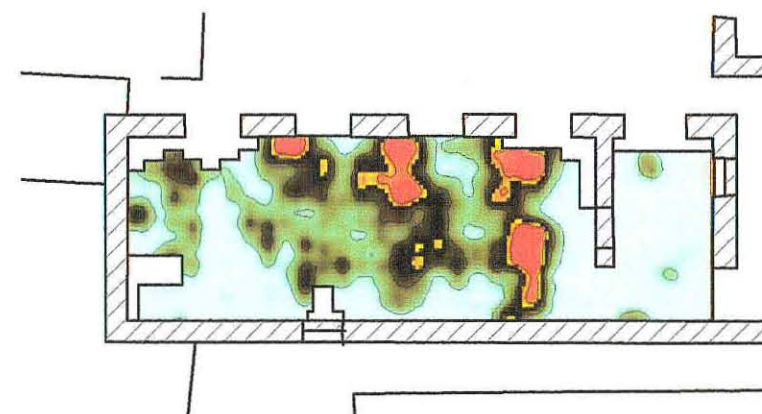
162 - 175 cm depth
below tannery floor

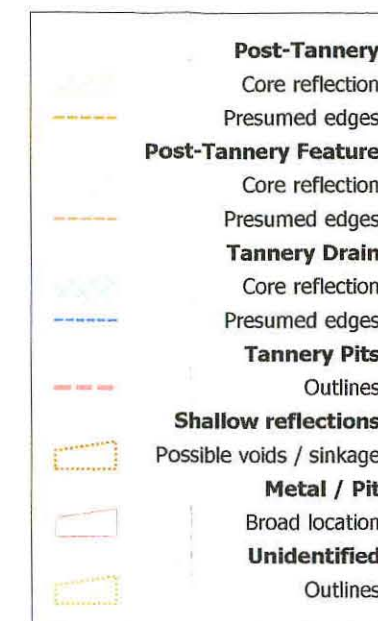
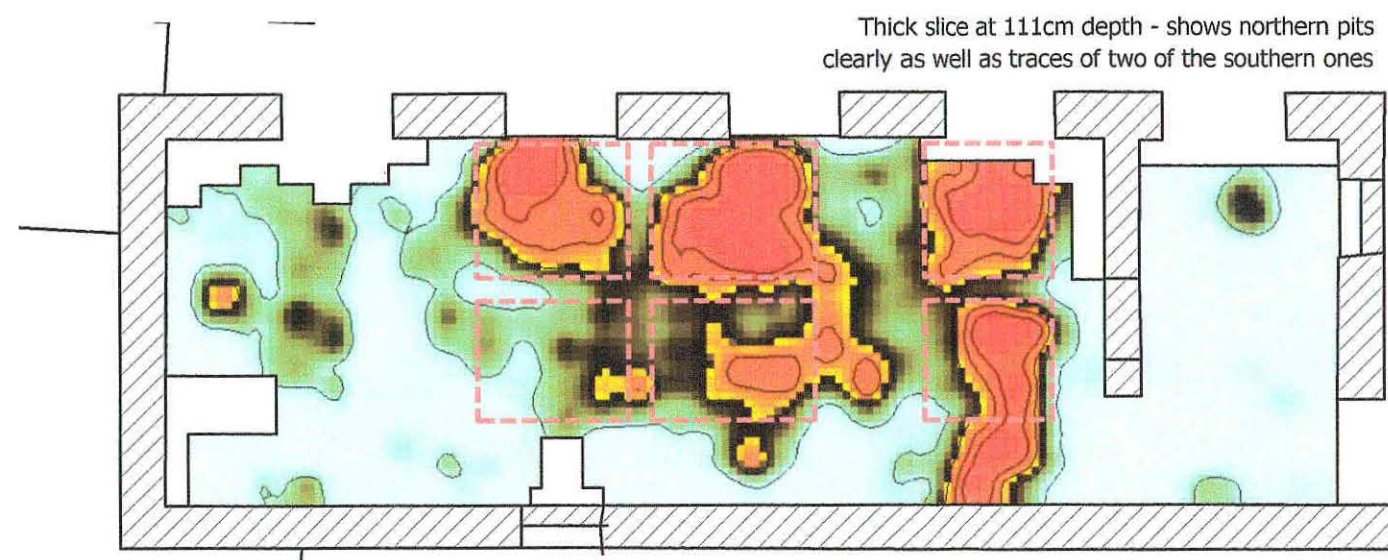
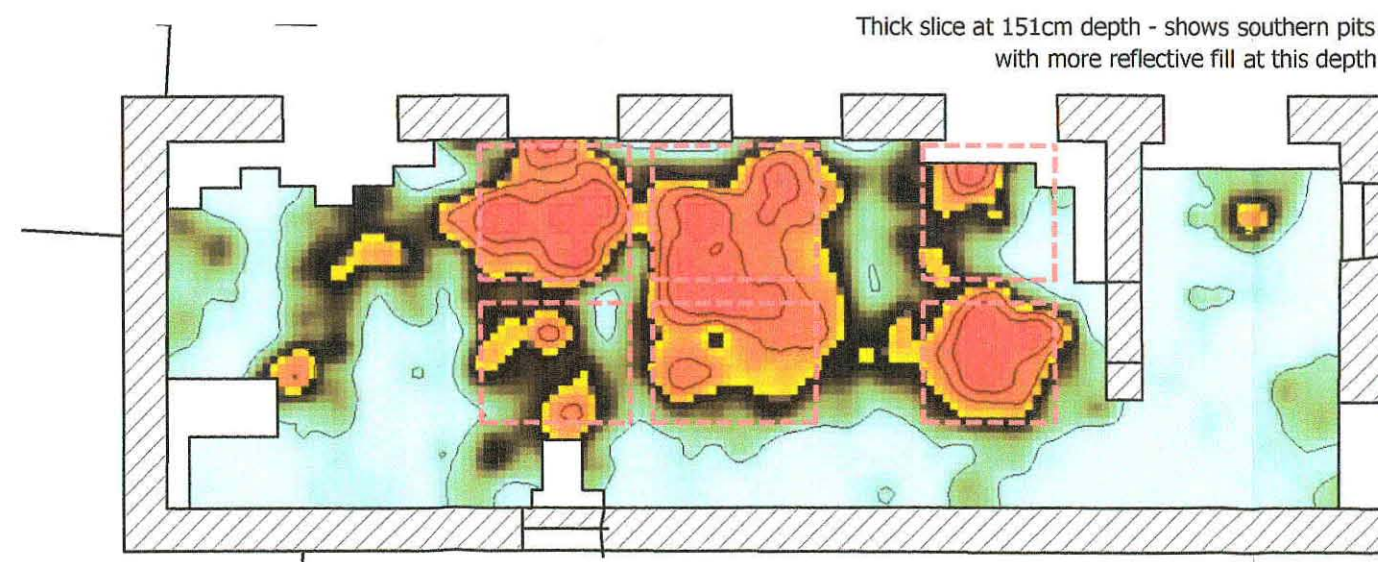
DWG 03

Selected Timeslices
