Historic Environment Feature Management Report

Site name: Corndon Hill building

UID: 105806

PRN 81298 Name Corndon Hill building
Period Medieval **Site Type** Building
NGR SO30459663

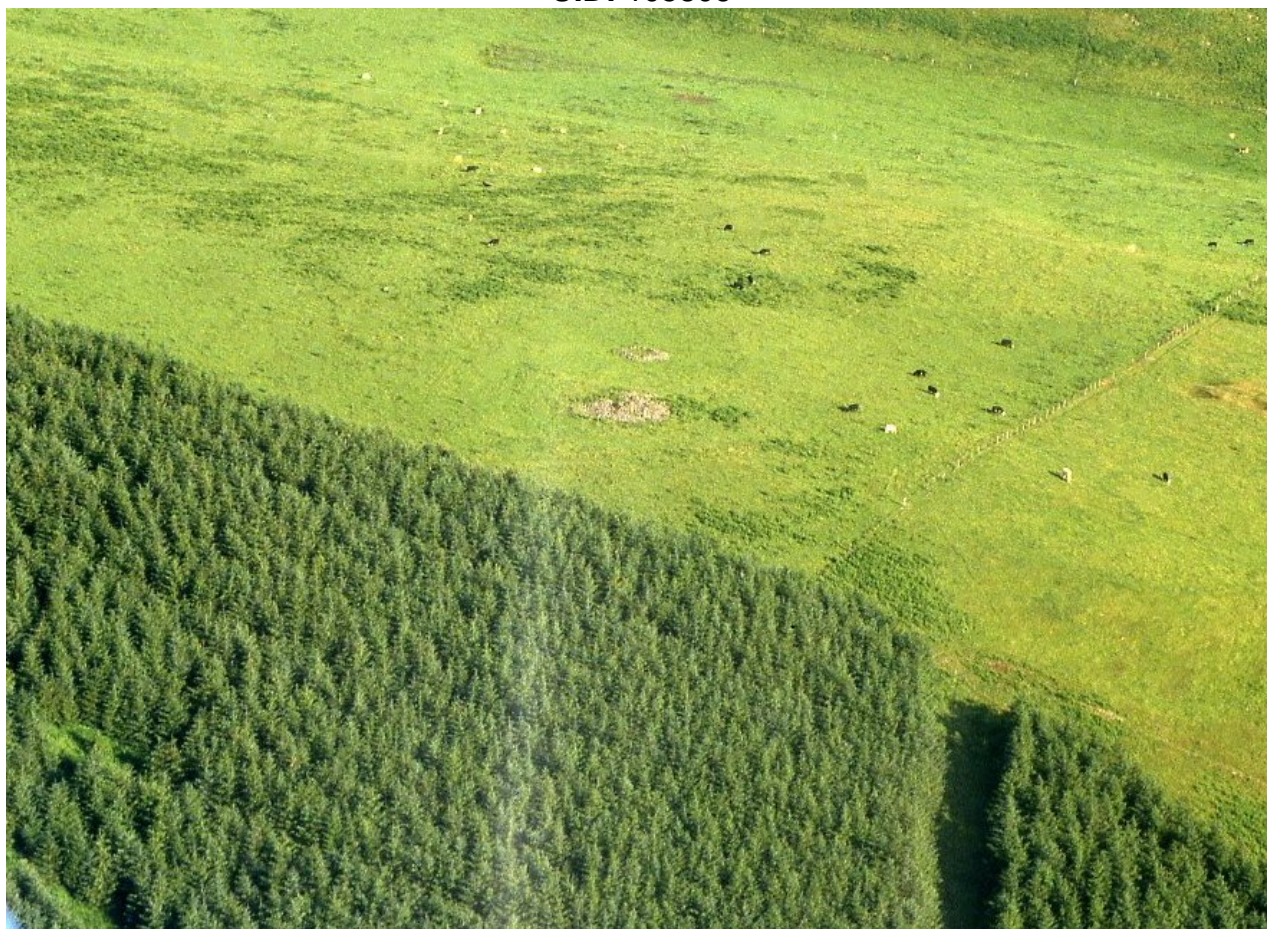
Photograph showing the Corndon Hill Barrow I in the foreground with the Corndon Hill building behind it.
Image 85-c-0167 © CPAT

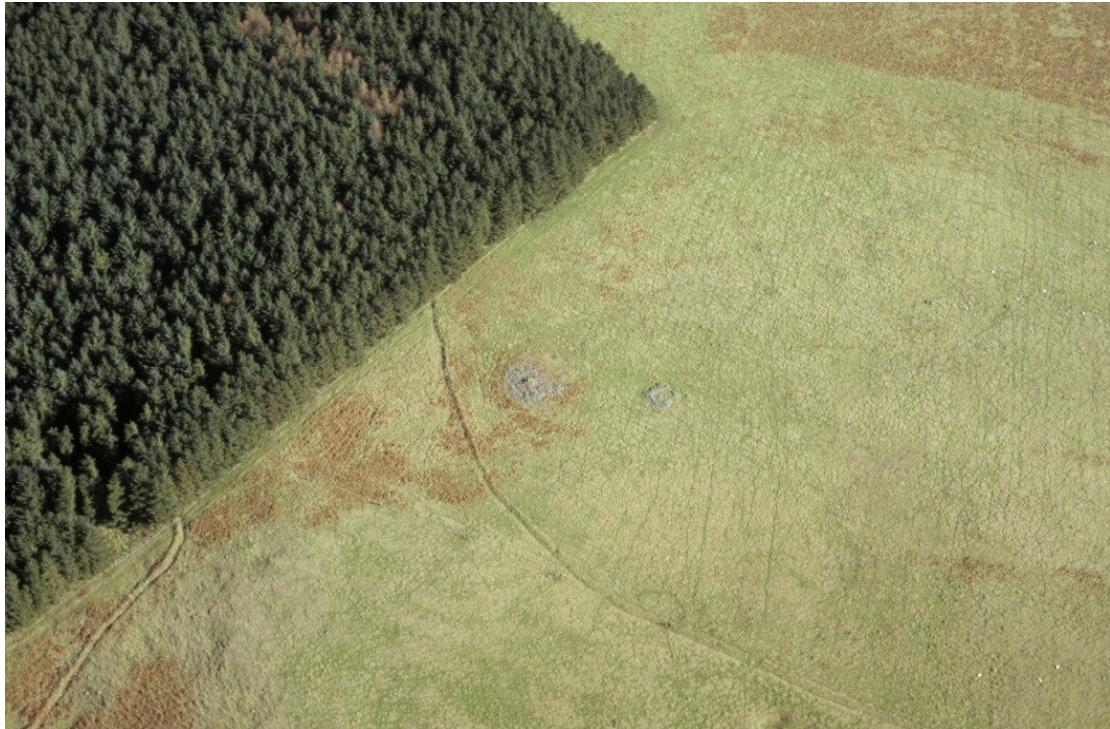
Foundations of a square building situated on level ground, around 20m SSE of Corndon Hill Barrow (PRN 215). Probably built of material removed from the barrow. Structure has roughly faced walls, both internally and externally, but no visible entrance (CPAT 2003).

Aerial photograph showing the Corndon Hill Barrow I (left) with the Corndon Hill building adjacent (right). Image 2004-cs-0080 © CPAT
