CPAT Report No 1249

Military Aircraft Crash Sites

SCHEDULING ENHANCEMENT PROGRAMME

R Hankinson and J Spencer

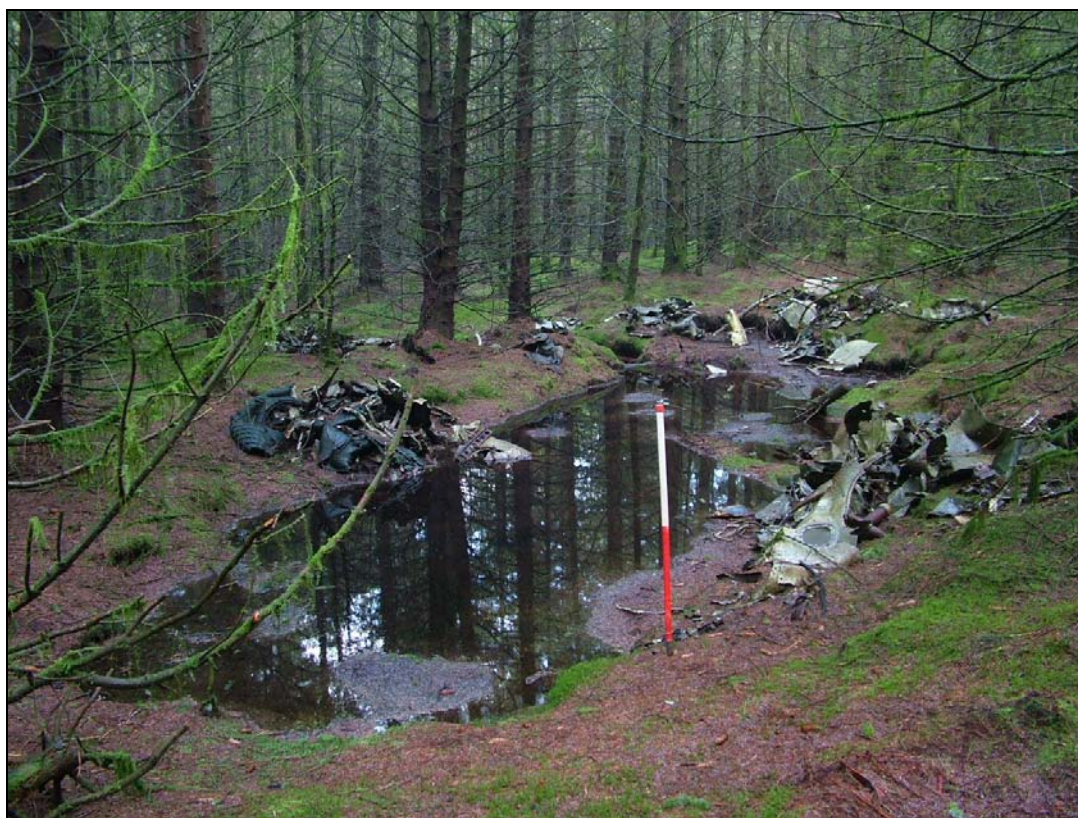
Fig. 2: The impact site and disturbed wreckage of Grumman Avenger FN821, in forestry near Llangynog, Powys (Photo CPAT 3732-0123)

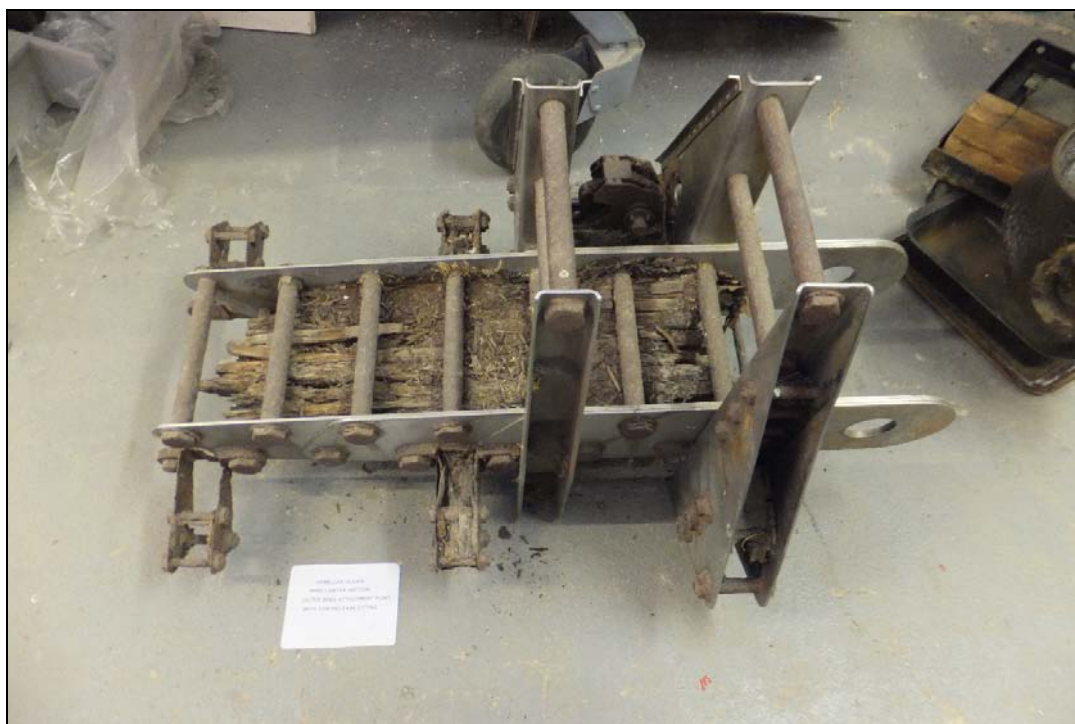
Fig. 3: Part of the wing centre section of Hamilcar HH922, including a tow release fitting, in the Wartime Aircraft Recovery Group Museum at Sleaf, Shropshire (Photo CPAT 3732-0110)

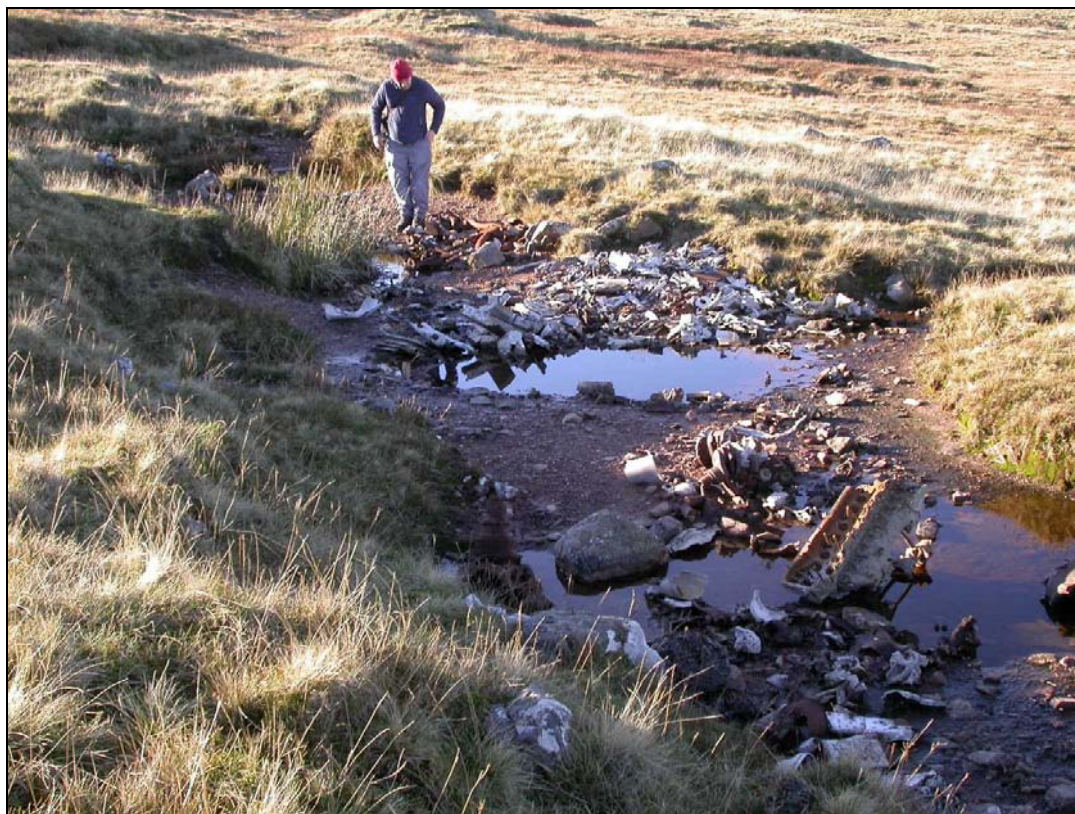
Fig. 6: Recording the high-energy crash site and debris of Avro Lancaster W4929 in the Black Mountain (Photo CPAT 3732-0026)
