RHAYADER CASTLE, RHAYADER (RD132)

Archaeological Watching Brief

Welsh Historic Monuments

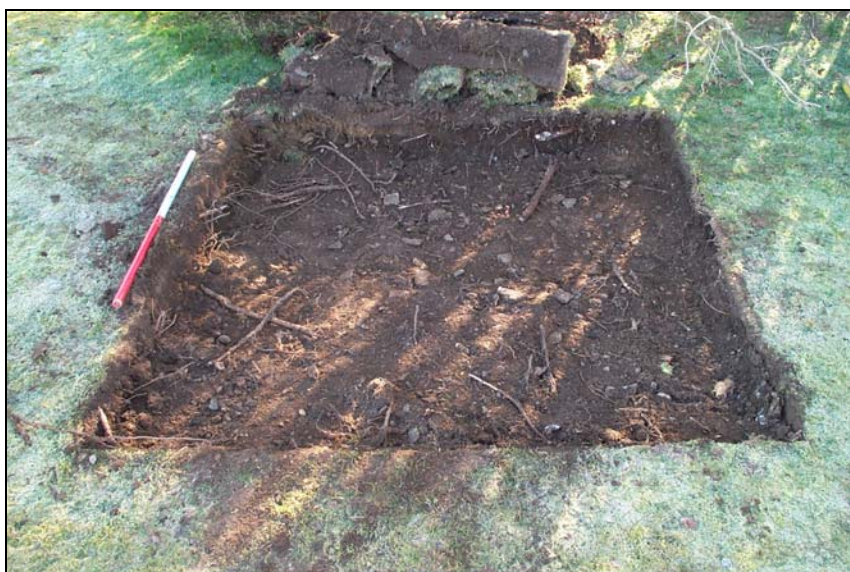
Photo 01: View of Trench 5 (scale 1m), looking SE

Trench 5 – was the northernmost trench of the two and was excavated to a maximum depth of 0.16m, which was deep enough to remove the topsoil 'A' horizon exposing the upper portion of the underlying deposit. The topsoil was a humic mid brown silty clay that contained occasional sherds of modern porcelain and pottery. Below the topsoil was a mid brown stoney deposit that appeared to have been redeposited. No datable material was recovered from this underlying deposit.

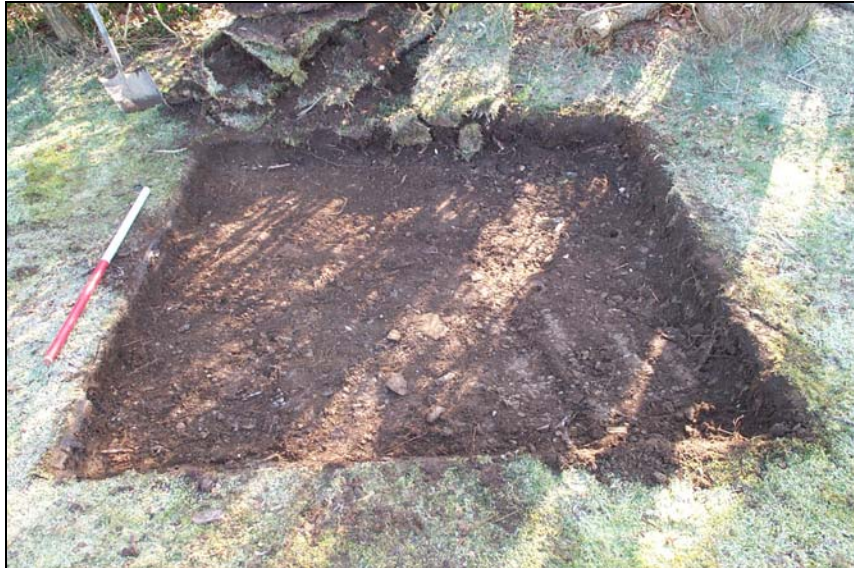
Photo 02: View of Trench 6 (scale 1m), looking SE

Trench 6 - was excavated to a depth of 0.13m, which was deep enough to remove most of the topsoil 'A' horizon exposing the upper portion of the underlying deposit. The sequence of deposits was the same as that exposed in trench 5 - The topsoil was a humic mid brown silty clay that contained occasional sherds of modern porcelain and pottery. Below the topsoil was a mid brown stoney deposit that appeared to have been redeposited. No datable material was recovered from this underlying deposit.

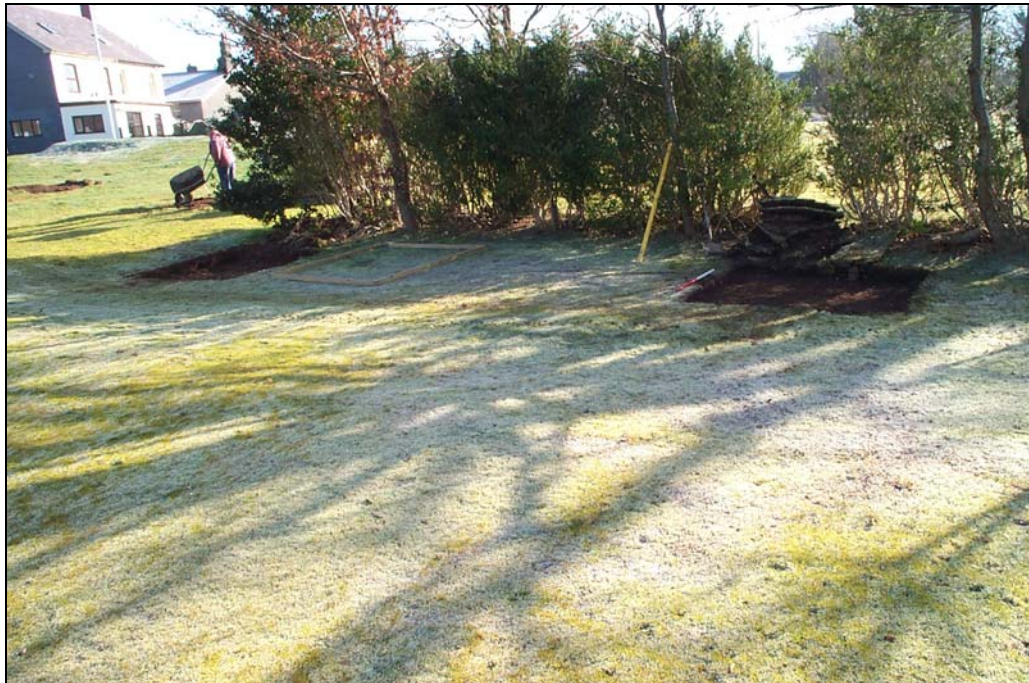
Photo 03: View of Trenches 5 & 6, looking NE

A watching brief was maintained throughout the course of the machine excavation works. The works involved the excavation of two square trenches (Trenches 5 & 6), both measuring 1.9 x 1.9m, that were located within the centre of the Castle on the west side of a small stand of trees.

The soil material excavated from Trenches 5 and 6 was used to backfill Trenches 2 and 3 that were still lying open following the suspension of works in August 2007.
