# PEMBROKE CASTLE CAFÉ PEMBROKESHIRE

## ARCHAEOLOGICAL WATCHING BRIEF

**RHIF YR ADRODDIAD / REPORT NO. 2008/98  
RHIF Y PROSIECT / PROJECT RECORD NO. 94316**

**PEMBROKE CASTLE CAFÉ,  
PEMBROKESHIRE:  
ARCHAEOLOGICAL WATCHING BRIEF**

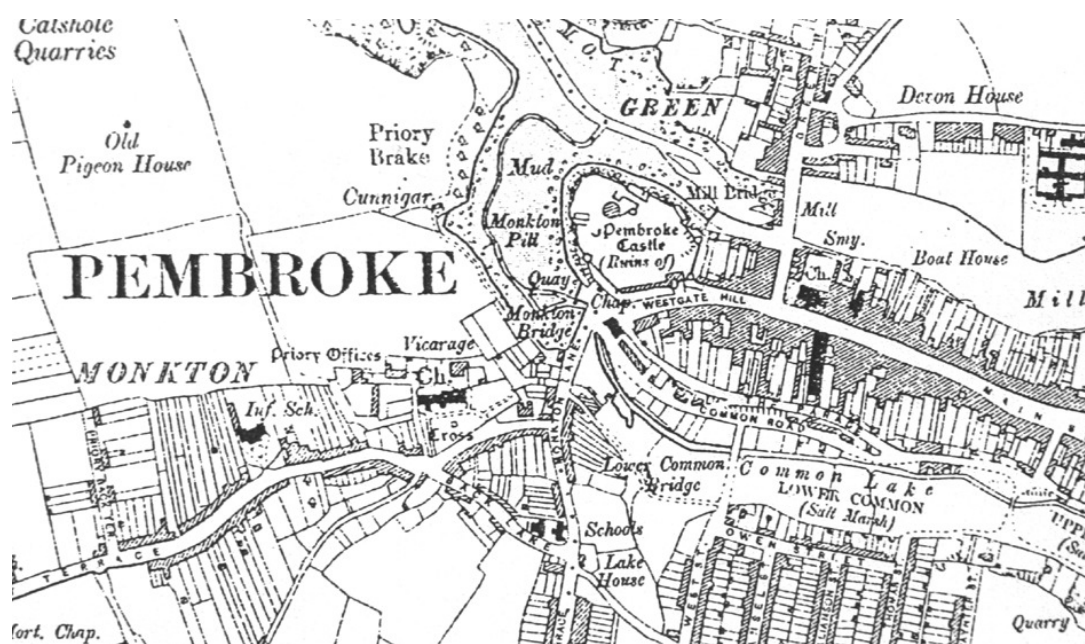
**Figure 2:** Extract from 1906 6" Ordnance Survey map of Pembroke.

Pembroke Castle is situated at the west end of a precipitous (c.20m above Ordnance Datum) Carboniferous Limestone ridge flanked by two, formerly tidal, creeks of the Milford Haven waterway (Figure 1). The castle occupies the most westerly part of the historic town of Pembroke (Figure 2) whose medieval town walls projected from two of its southeastern towers. A full description and discussion of the history and phasing of the castle by D. J. Cathcart King has been undertaken elsewhere (King 1978), and a brief outline is included below.

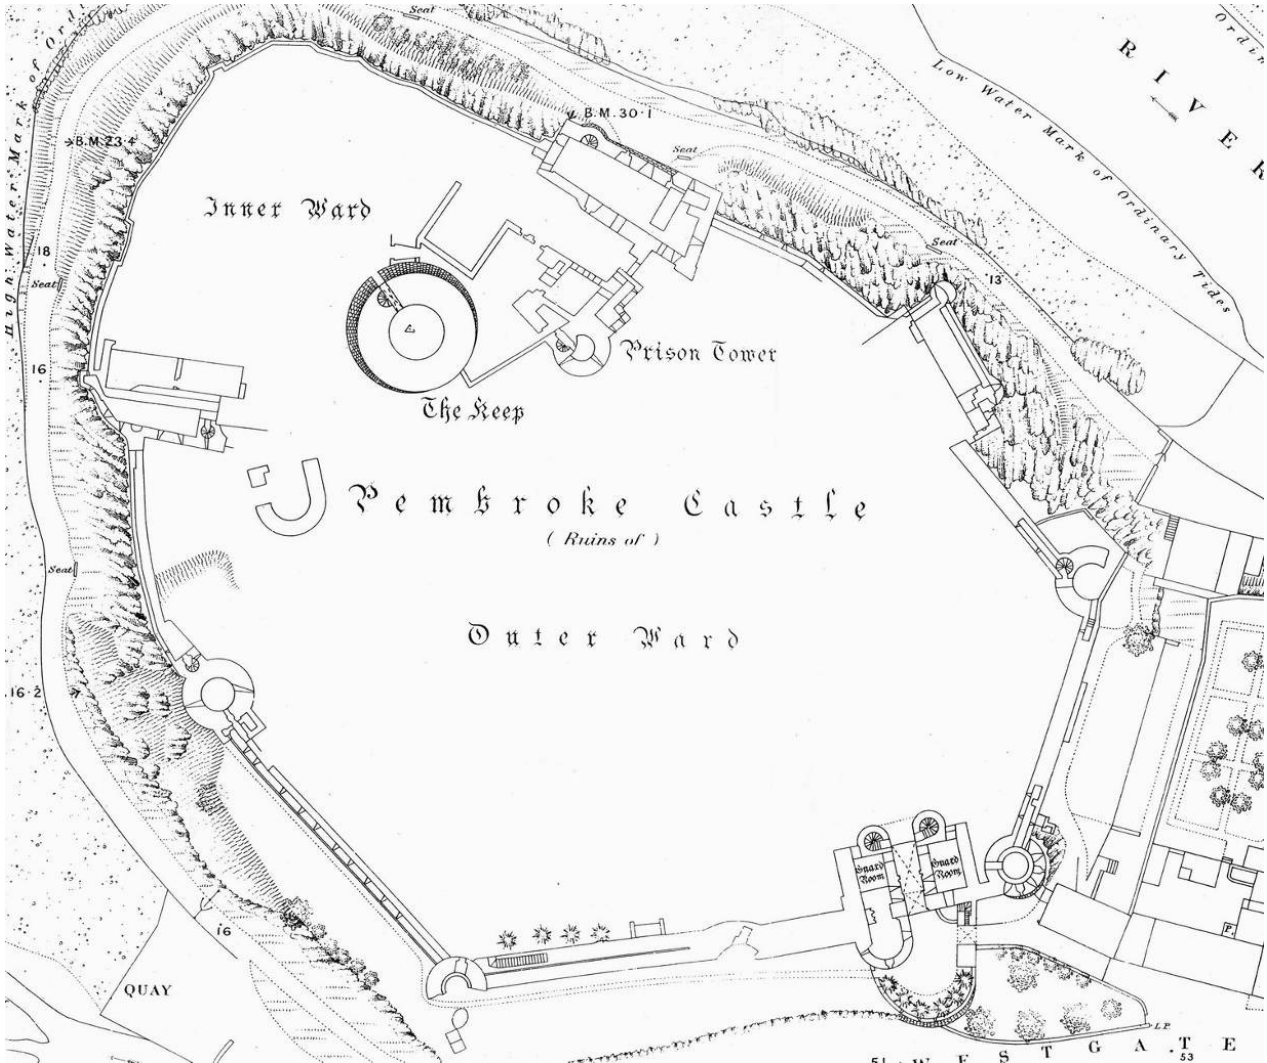
**Figure 4:** Extract from Ordnance Survey 1:500 Map, First Edition, 1861.

*In plan, the bastion in its present form reflects medieval arrangements and is shown in its unrestored form on the Ordnance Survey First Edition map of 1861 (Figs. 4 & 5). This map also shows the stump of a wall running parallel with the outer wall of the bastion but 8 metres to the southwest, as if to define a rectangular area within the bastion. Prints and photographs taken prior to restoration provide some further detail. The arrangements shown appear to be reflected in the present structure, but much of the inner faces of the turrets, the parapets, and the small rectangular open 'turret' that now forms the northwest corner of the bastion (see Figure 5) are missing. However, it is clear that the present corbel tables follow an earlier pattern. What is also clear is that it was always a substantial structure. Taken overall, the structural evidence suggests a date early in the 14<sup>th</sup> century, possibly under Aymer de Valence (1307-1324); succeeding Lords of Pembroke were largely absentee.*

In addition to the observations made above with regard to the Ordnance Survey First Edition map of 1861, the presence of a wall-face projecting southwest into the outer ward from the northwest turret of St. Anne's Bastion and a rectangular building abutting the northwest corner of the rectangular space within the bastion should be noted (see areas marked in red in Figure 5 below). Both of these features lay, or partly lay, within the area of the groundworks for the café extension but were not apparent as features above ground prior to the commencement of the excavations.

Structure 132 was shown to be abutting the footing of a southwest to northeast aligned wall (131) (Photo 8 and Figure 9). Wall 131 was 0.82m in width with a 2.5m length exposed, it was at least 0.4m in height at its northeastern end, however it had been badly damaged by service trenches along the rest of its revealed length. At its southwest end the concrete foundation slab for the retaining wall was left *in situ* (Photo 9), and this obscured the majority of the wall, although it was still discernible beneath. Wall 131 was constructed directly upon the underlying bedrock. It is considered likely that the wall represents a continuation of the northwest end wall of St Anne's Bastion, the alignment of which appears to be shown on the first edition 1:500 scale Ordnance Survey map of 1861 (Figures 4 & 5).

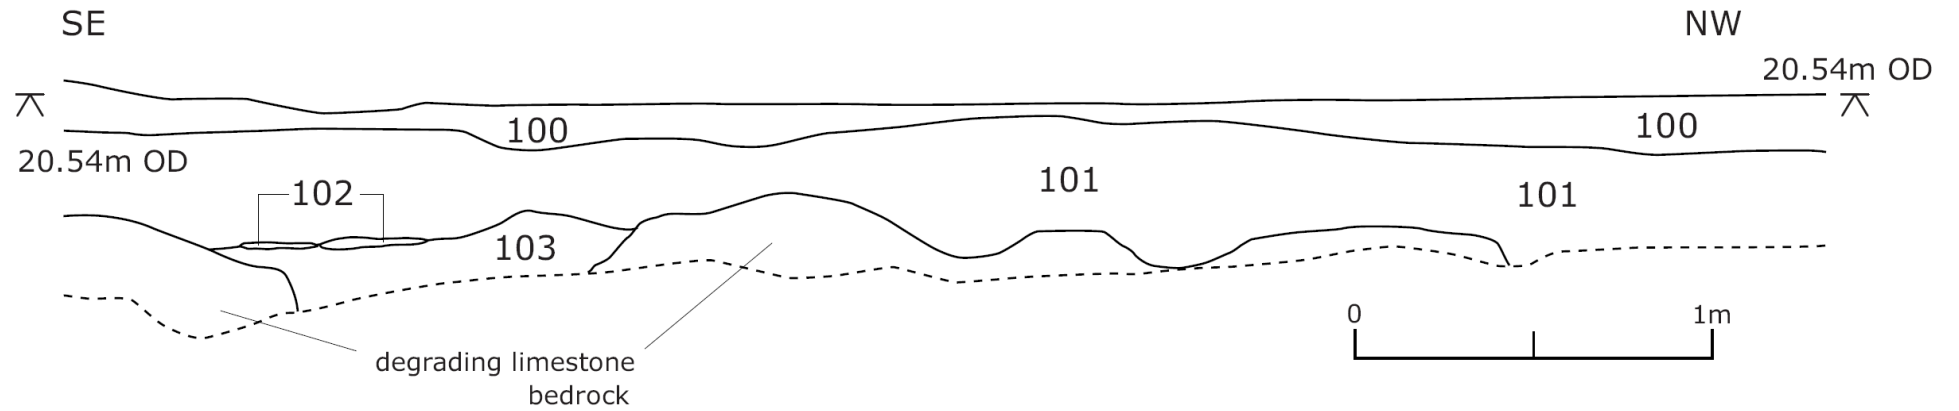
**Figure 7:** Representative section of the revealed outer ward deposits after removal of the retaining wall and steps at the south edge of the site.

Demolition and removal of a 21.4m length of the 0.6m wide by 0.45m high southwestern retaining wall (including the stone steps) exposed a vertical profile of the stratified deposits making up the northeastern edge of the outer ward. The topsoil (100) varied in depth to between 0.1m and 0.2m along the section and overlay a succession of deposits, of varying depths, containing high percentages of building demolition debris in the form of shattered shale and roofing slate fragments, small and medium sized angular limestone and mortar fragments (Contexts 101, 103, 110, 113, and 151 to 155 inclusive; Figures 7 & 8). These layers continued down to the natural subsoil (109), where it was present, or lay directly on the deeply fissured undulating natural limestone bedrock. At the southerly end of the exposed section the bedrock was encountered at only 0.3m (20.24m OD) below the ground surface compared with a depth of 0.8m at the northerly end (19.8m OD). The demolition layers probably represent landscaping layers deposited during levelling-up in the outer ward for the construction of a tennis court in the 1920s, or perhaps later landscaping.

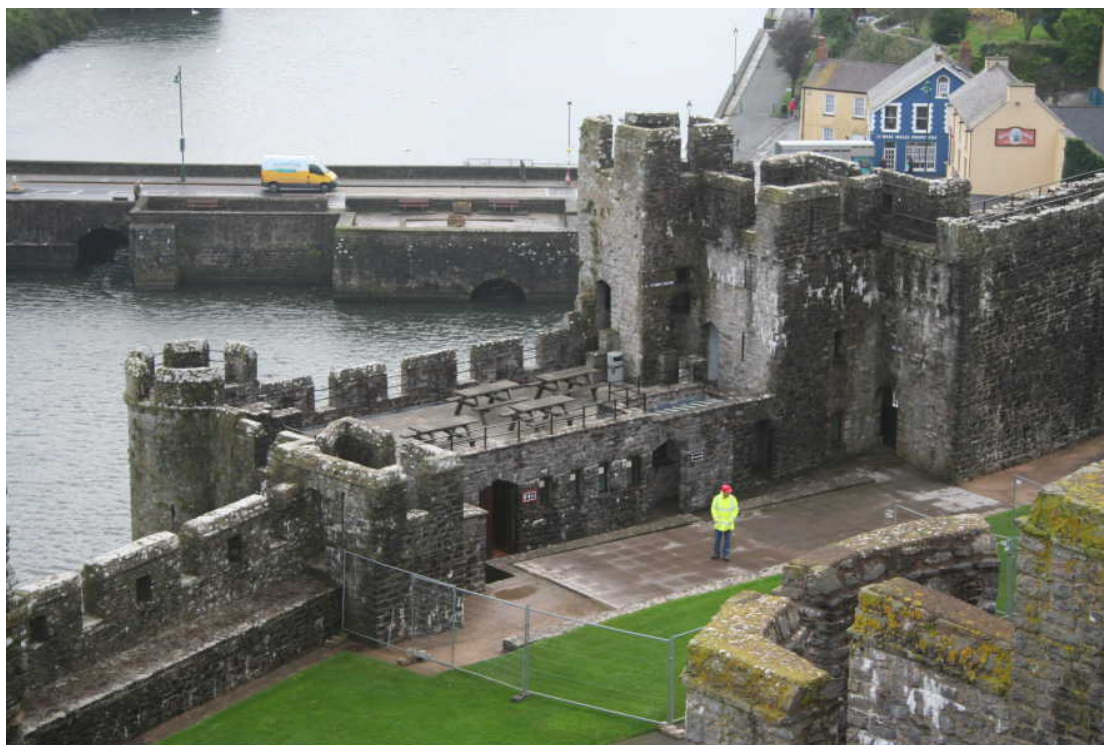
**Photo 1:** View of St. Anne's Bastion taken from the Keep, view east, prior to groundworks.

The new construction is located immediately adjacent to St. Anne's Bastion (Photo 1) which projects outwards from the northeast curtain wall of the castle. Pembroke Castle is a Scheduled Ancient Monument (SAM No. PE005) and therefore any building works undertaken within the scheduled area required the granting of Scheduled Monument Consent (SMC). Cadw granted SMC, by a letter dated 8<sup>th</sup> July 2008, which required that an archaeological watching brief and archaeological recording be carried out during the groundworks for the new building.

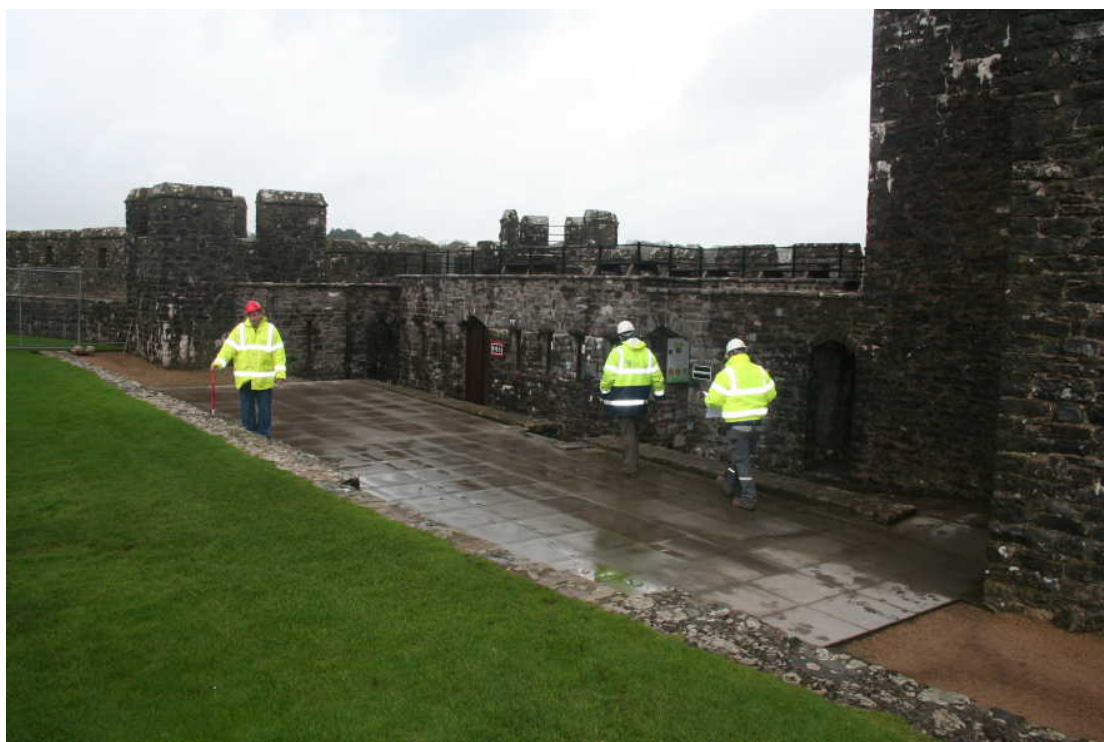
**Photo 2:** Oblique view of the two retaining walls and flagstone area in front of St. Anne's Bastion prior to groundworks. View north.

The groundworks were carried out using a 4.5 ton tracked excavator with a toothed bucket for the demolition of the two retaining walls and removal of the flagstones and paved area in front (to the southwest) of St. Anne's Bastion (Photo 2). A toothless grading bucket was used to remove all other deposits down to either the top of archaeological features and deposits or the natural limestone bedrock.

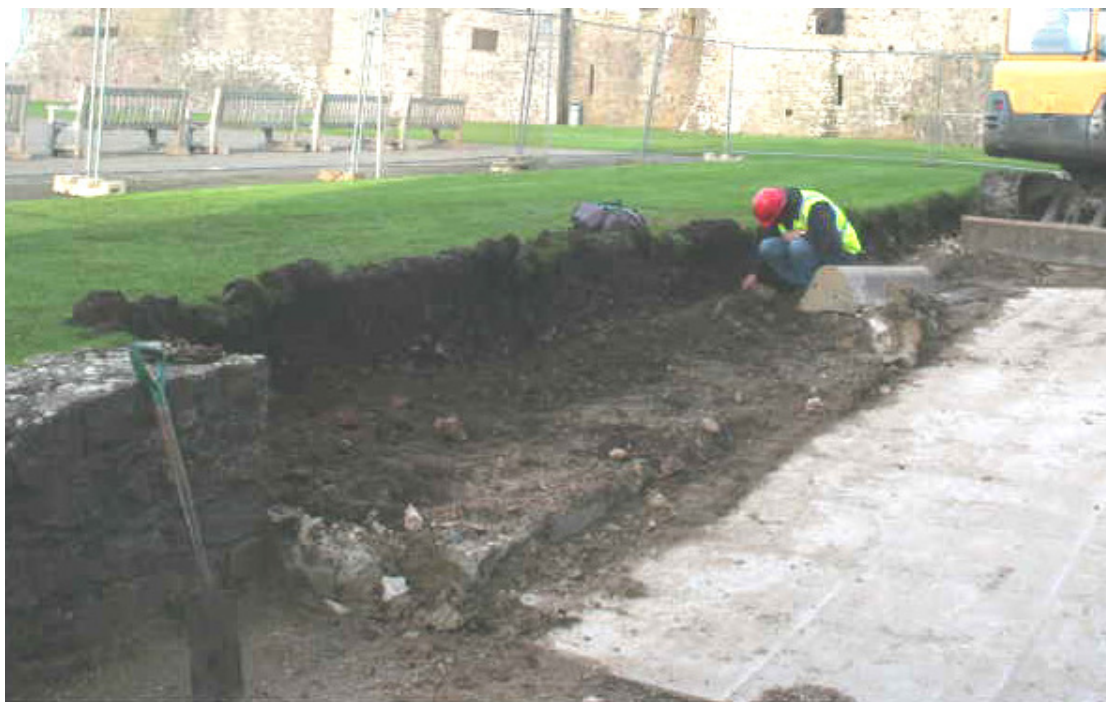
**Photo 3:** Outer ward deposits revealed after removal of retaining wall and steps  
View northwest.

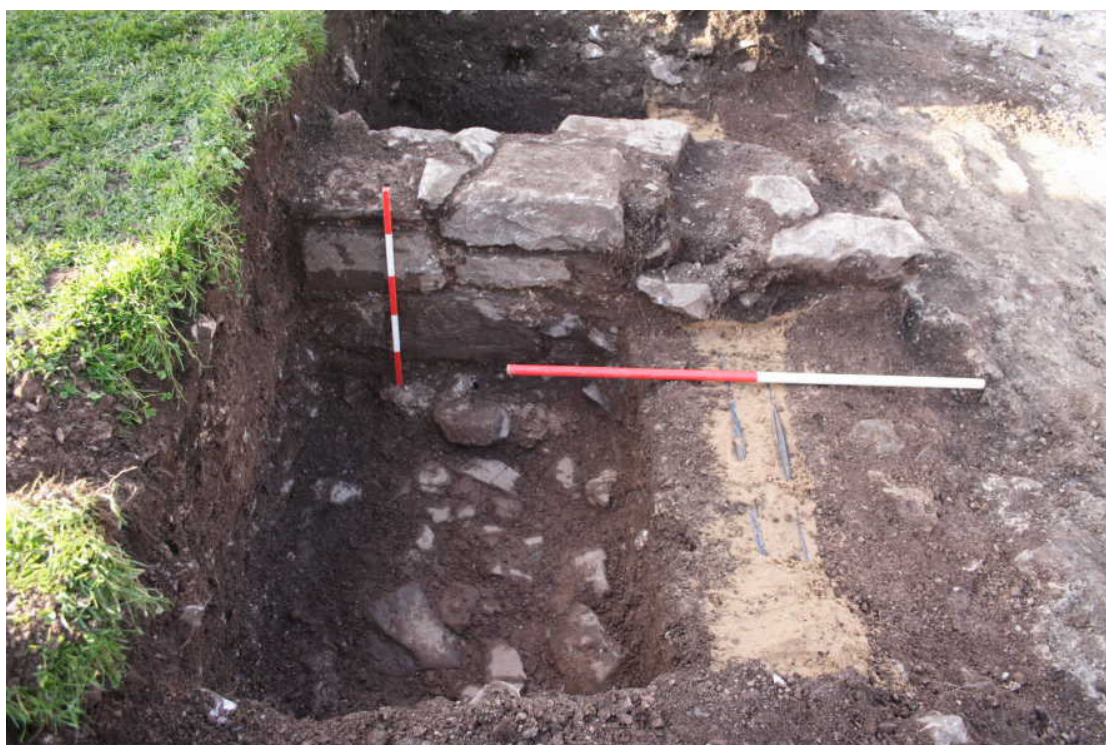
**Photo 4:** Wall 114 showing its SE face with possible metallised surface (120) in front of it, and modern service trench cutting its NE end. Prior to the removal of the retaining wall concrete foundation on the far right of the picture. Scales are 1m and 0.5m.

The butt end of a wall (114) was revealed in the north end of the section and this was further revealed by hand-excavating trenches to either side of it to the southeast and northwest. The wall (Figure 8 and Photo 4) lay some 0.2m below the present ground surface beneath a 0.1m depth of topsoil (100) and a 0.1m depth of the uppermost demolition layer (110). A modern electricity cable trench (117) was revealed cutting through the top of the wall to a depth of about 0.3m, some 0.4m from its eastern end. A 0.5m depth of homogeneous mid reddish brown friable silty clay soil (111) containing 20% small and medium size angular limestone fragments and frequent fragments of mortar lay against the southeast face of the wall. In section this layer continued to the southeast for about 0.9m before being apparently truncated and giving way to later demolition debris deposits (151) and (152). Layer 111 was seen to overlie and seal a c.0.12m deep compact dark brown silty clay deposit (120) containing 80% small angular fragments of limestone, which in turn directly overlay the natural bedrock. Layer 120 appeared to be a possible randomly laid metal surface.

The revealed wall (114) was aligned WSW-ENE, terminating at its eastern end. It was 0.66m high by 0.44m wide and continued westwards into the outer ward beyond the excavation trench for an unknown distance. It was lime mortar bonded and exhibited randomly coursed stonework on its northern face and larger coursed stonework facing on its southern side. This may suggest that it functioned as a revetment wall, or at least that it was only the southern side that was exposed. The top of the wall appeared to be even and flat (apart from the damage caused by the service trench) indicating that it may remain at its full height, but this is uncertain.

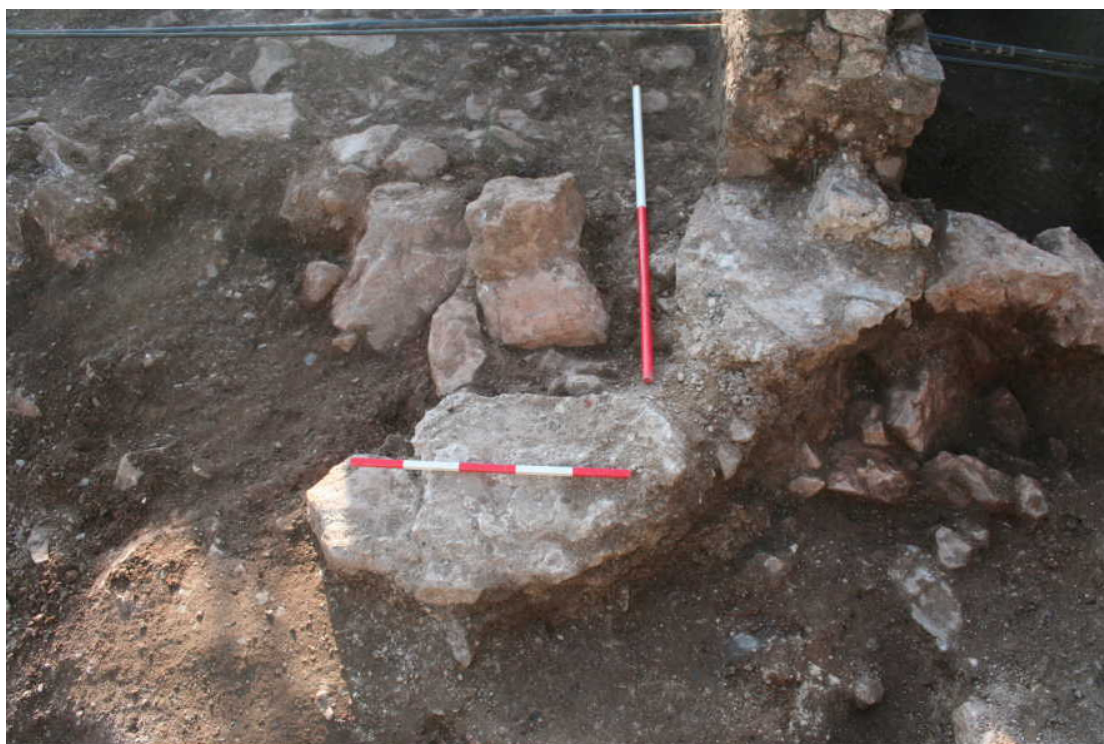
**Photo 5:** View of 136, centre of picture, looking west-southwest, scales 1m and 0.5m.

The demolished modern retaining wall had been built upon a 1.10m wide by 0.22m thick concrete slab foundation, which underlay it for its whole length. During the removal of this and the compacted modern gravel surface near the northern end of the site, a curvilinear single course of large and medium size mortar-bonded limestone blocks (136) was revealed mortared to the bedrock (Figure 9 and Photo 5). This feature was 1.2m long by 0.12m wide by 0.12m high and was abutted (a mortared abutment) by, or abutted, wall 114; the true relationship between 136 and 114 was unclear because the laying of the concrete foundation slab and construction of the modern retaining wall appeared to have compromised the fabric of 136, however, the presence of the butt joint suggests phased construction.

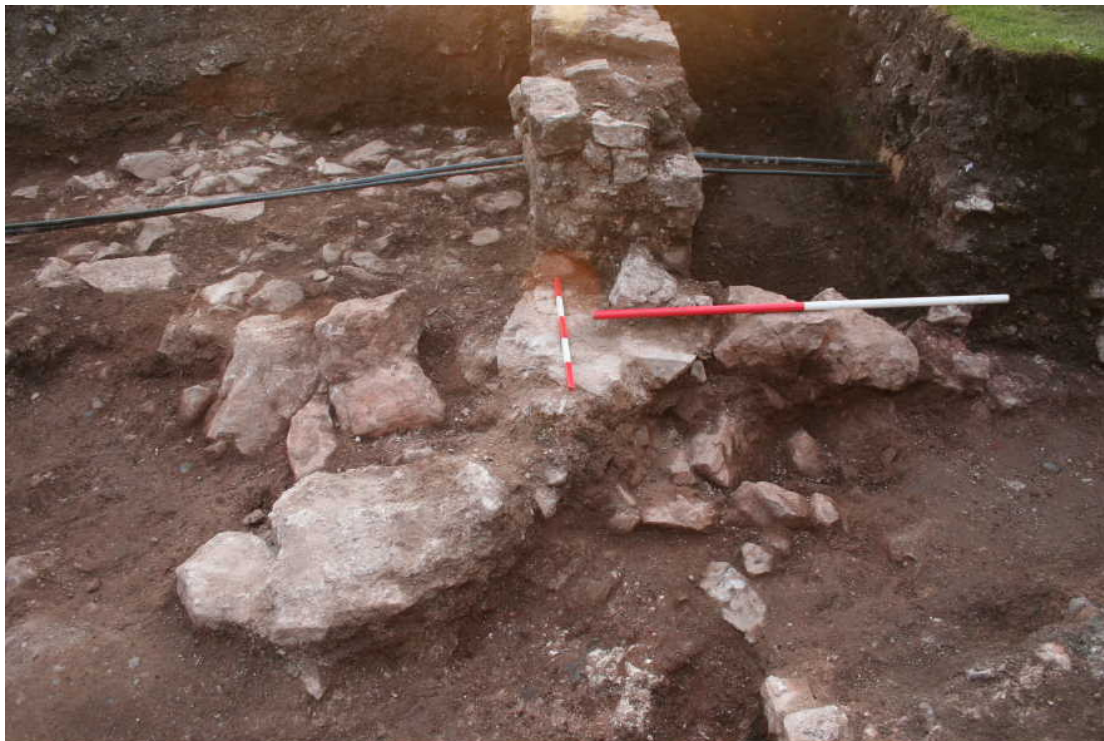
**Photo 6:** View of 136 and its relationship with 149/148 on right hand side of picture, looking west-southwest, scales 1m and 0.5m.

A northwest to southeast linear arrangement of mortared limestone blocks (contexts 148 & 149) was revealed abutting the northwestern end of 136 (Figure 9). Further removal of the concrete slab and overburden (comprising disturbed ground caused by service installation) revealed a circular mortared stone structure (132). Within its centre was a hollow of 0.9m diameter at its top and 0.6m diameter at its base. This steep sided hollow was lined with mortared masonry and slates. A large modern service trench, aligned NNW-SSE, cut through the centre of this feature. The lower fill removed from the base of the hollow within structure 132 contained compacted fill with a high percentage of mortar and occasional fragments of charcoal (context 142). There is possible evidence of the outer face of the structure in the form of a linear arrangement of mortar-bonded stone revealed to the southeast of the circular hollow (Photo 7 and Figure 9). On its south-westerly side the outer wall of the structure may be represented by the linear configuration of stones 149 and their possible extension 148, the alignment is good but any definitive relationship is lost due to the intrusion of modern service trenches.

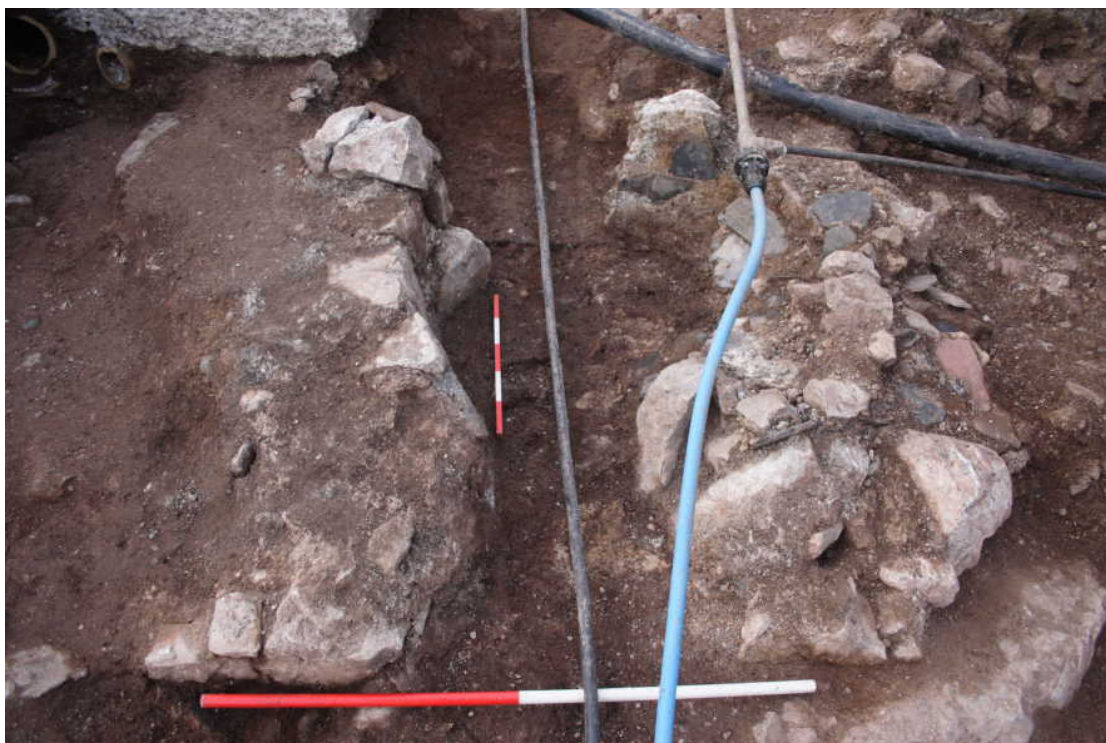
**Photo 7:** View of structure 132, its central circular hollow (0.5m scale), and the disturbance from modern services, looking north-west. The southern edge of the structure is indicated by the 1m scale.

The possible southeast face of structure 132 lay some 1.75m to the southeast of its abutment with wall 131, whilst the possible southwest face of the structure, represented by linear features 149 and 148, lay some 3.5m to the southwest of the linear configuration of loose stones noted within layer 133. Although the evidence is at best nebulous, due to the destruction caused by the intrusion of the modern service trenches, it is possible to conjecture that structure 132 was rectangular and measured 3.5m long by 1.75m wide with its northwest side abutting wall 131. An exact interpretation of the structure is not possible due to its damaged state, but it clearly represents a possible oven or kiln involved in some industrial or domestic process.

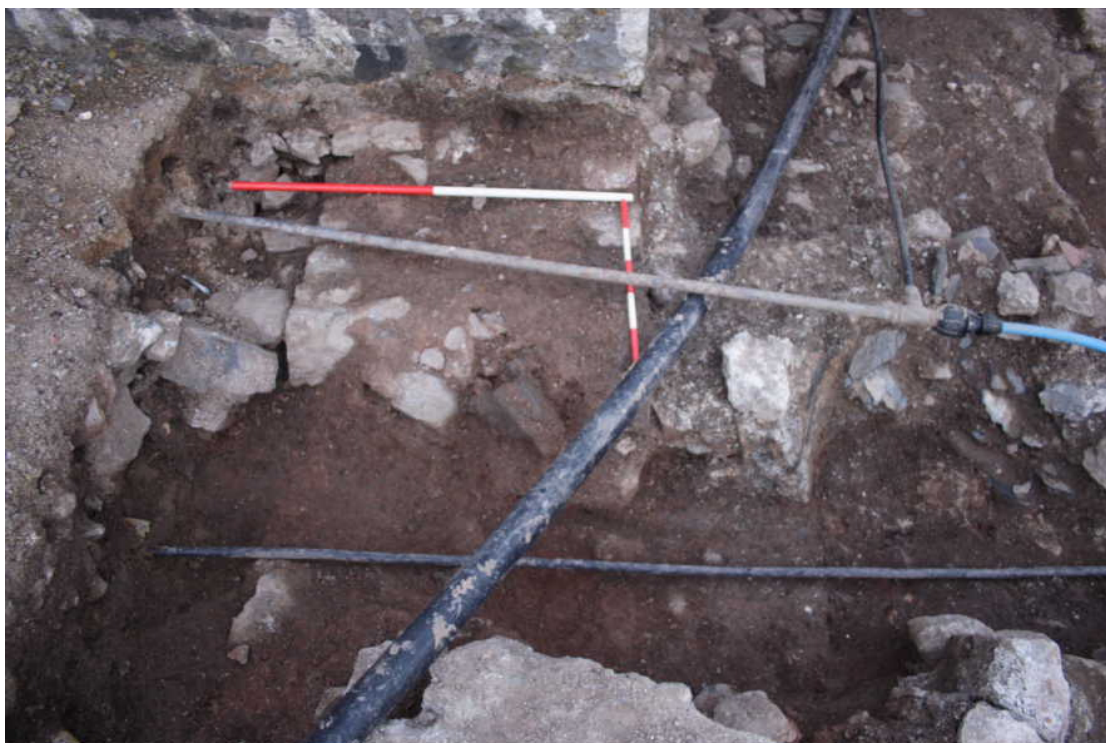
**Photo 8:** View of wall 131, looking northeast, showing abutment of structure 132 to right, and truncation from modern services, scales 1m and 0.5m.

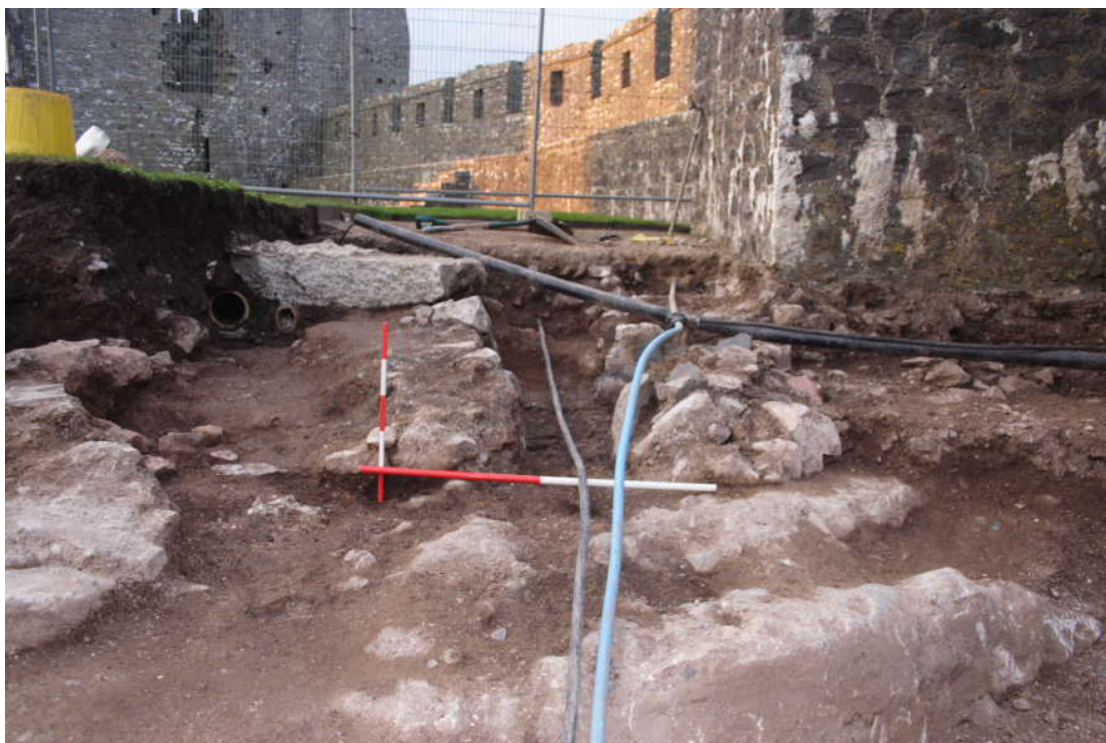
**Photo 9:** Overview of northern end of site showing the fall of the natural bedrock in the foreground, with structure (132) behind, remnant concrete slab for retaining wall to rear left and extensive truncation from modern services, scales 1m and 0.5m.

To the north of the previously flagged area in front of St Anne's Bastion, the natural bedrock was found to lie very close to the ground surface (this area was previously laid to gravel). Beneath the flagged area the natural topography sloped gently down from the southeastern end of the site before rising sharply immediately to the southwest of the staff toilet block (Photo 9). As previously noted during the archaeological evaluation undertaken in 2006 (Ludlow 2006), the majority of the formerly flagged surface was underlain by a number of 19<sup>th</sup> and 20<sup>th</sup> century levelling layers (contexts 106, 107, 108, 121, 122, 123, 128 & 129) (Photo 11). The make-up layers were sealed beneath a modern concrete slab (105) of 0.25m depth, which had been laid between the two retaining walls as a base for the former flagged surface. These make-up layers were presumably derived from imported material used to landscape this part of the site, as suggested in the 2006 evaluation report, to fill the hollow in the natural bedrock. Layer 130, which lay directly beneath the levelling layers on top of the bedrock, contained evidence of possible medieval activity, indicated by the presence of bone, mortar fragments and oyster shells.

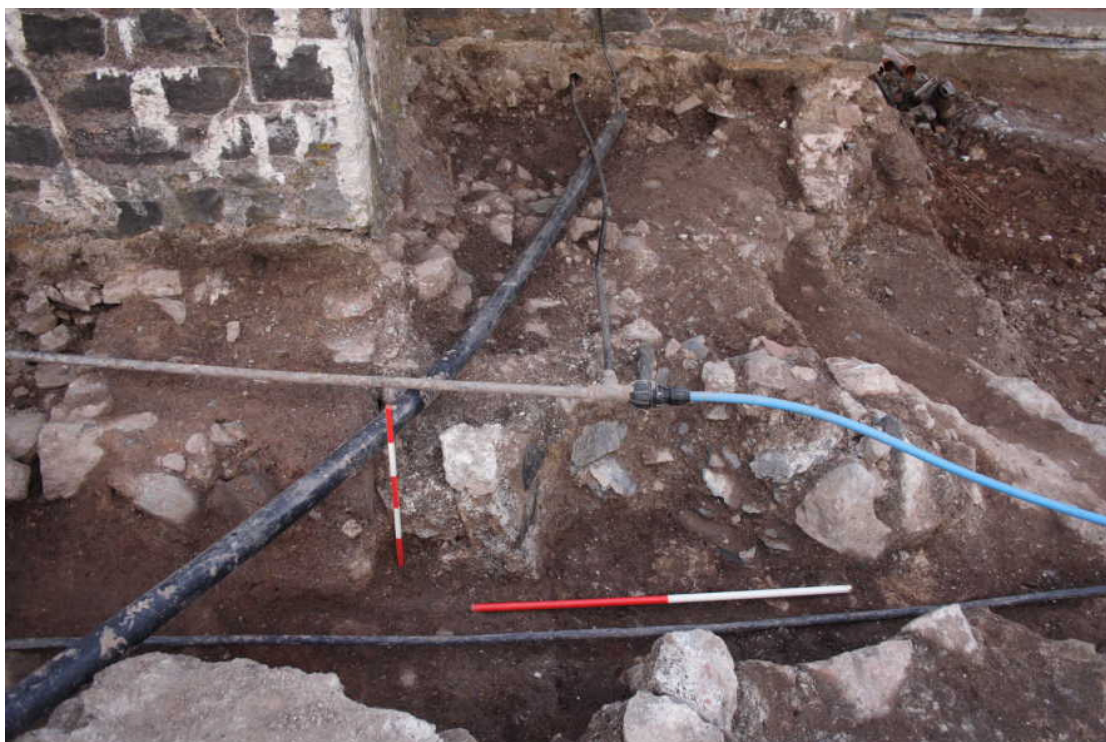
**Photo 10:** View northeast across structure 132, with wall 131 to the left, layer 133 in the upper part of the photo and truncation from modern services, scales 1m and 0.5m. Wall 104 lies in the upper right part of the photograph.

To the northeast of the stone structure 132, a layer of mixed material was excavated (context 133) (Photo 10). The layer contained a significant quantity of finds including an iron arrow head, medieval pottery (Saintonge green glazed sherd and Dyfed gravel tempered ware), medieval glazed ridge tile fragments, animal bones and oyster shells, a fragment of window lead, fragments of roofing slates with nail holes, a sherd of green glazed white stoneware and several sherds of North Devon gravel tempered ware pottery. A discrete NNW to SSE aligned linear spread of stone noted within this layer may have represented demolition rubble from the northeastern side of structure 132, perhaps defining the extent of the northeast side of the structure. The insertion of modern services to the staff toilet block had caused considerable disturbance to layer 133 and, in so doing, appears to have added to the destruction of the northeastern side of structure 132.

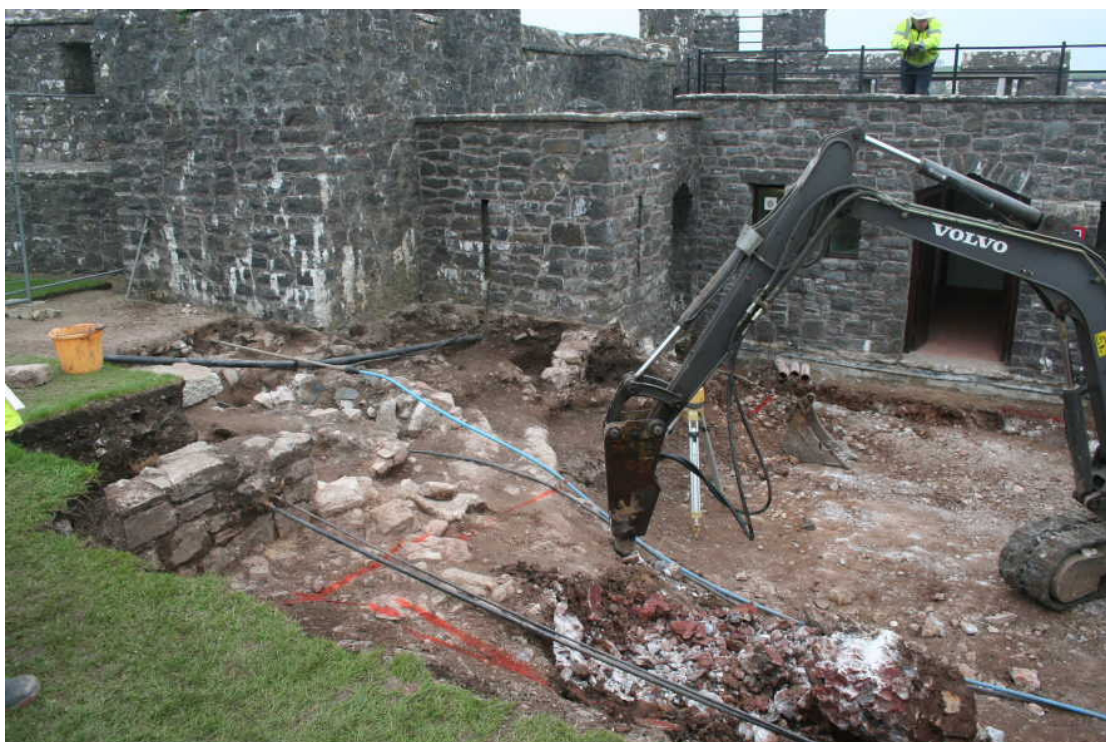
**Photo 12:** Machine excavation of bedrock to form the footprint of the new café, with red spray-paint line showing agreed limits of groundworks to preserve archaeological remains.

Following discussions between CADW: Welsh Historic Monuments and Pembroke Design Ltd it was agreed to modify the design of the café to enable preservation of all the revealed structures *in-situ*. All loose masonry on the structures was consolidated using a sympathetic mortar mix<sup>4</sup>, voids in the structures were filled with a loose limestone gravel<sup>5</sup> to prevent further movement and then covered with a geo-textile<sup>6</sup> prior to their reburial (Photos 13 and 14). This work was undertaken in the presence of an archaeologist at the behest of Cadw as part of the archaeological watching brief.

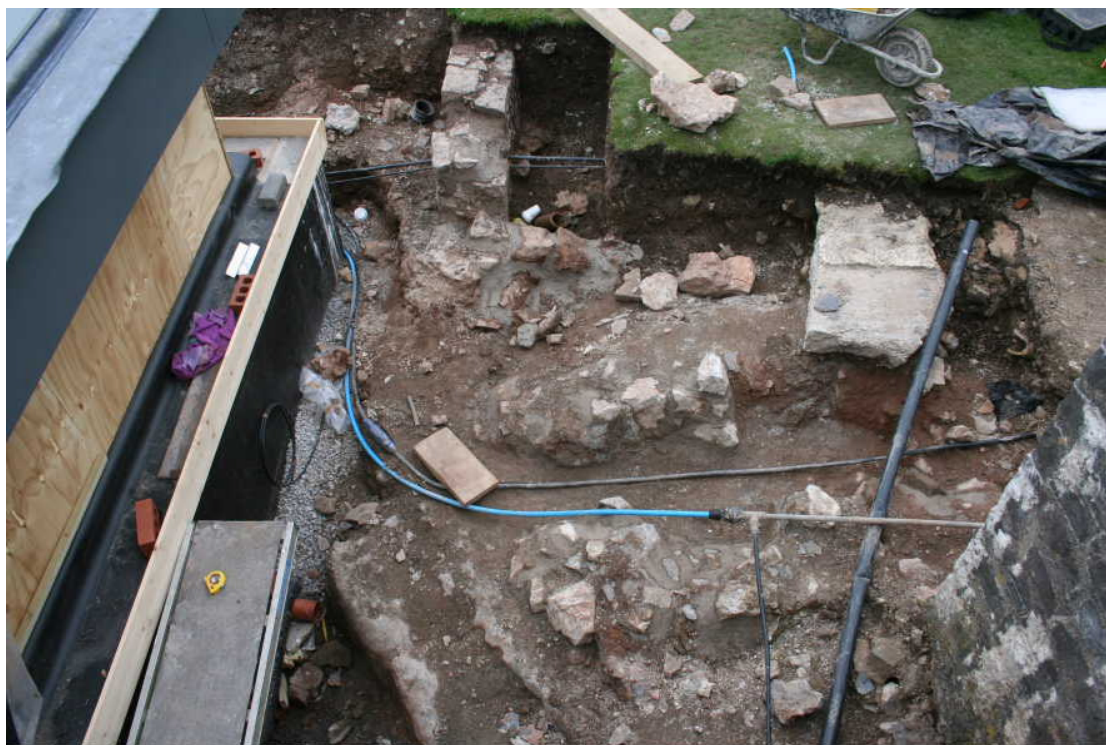
**Photo 13:** Revealed structures as they looked after consolidation, immediately prior to their reburial in February 2009.

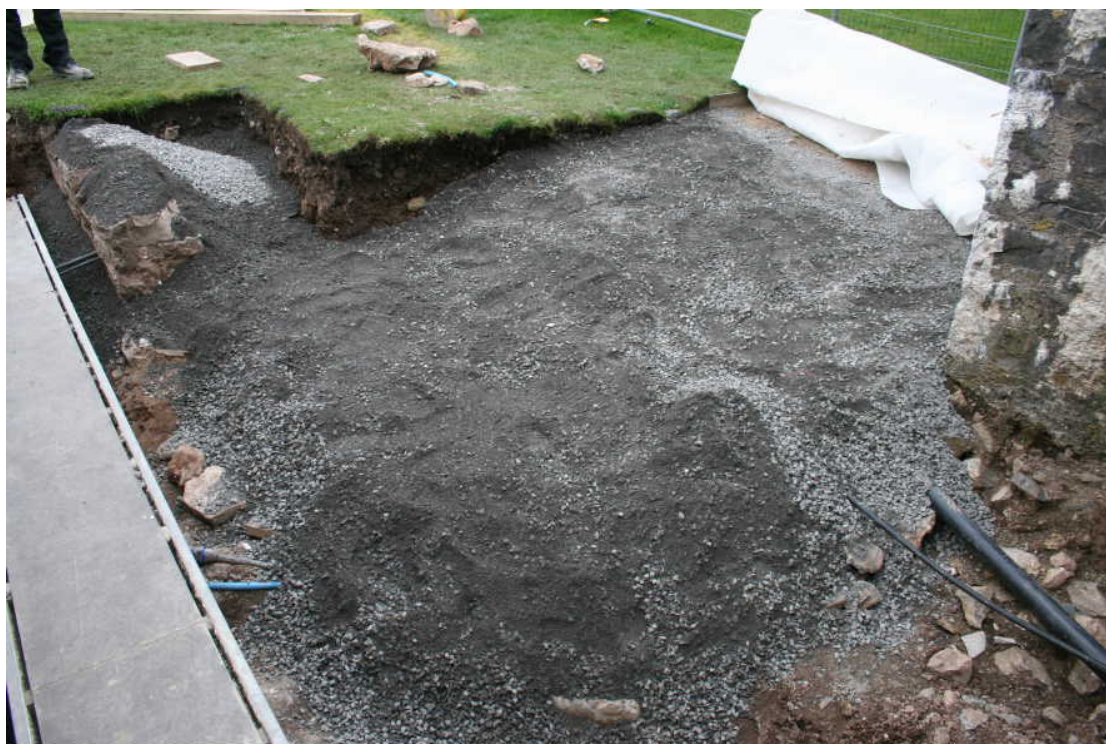
**Photo 14:** The graded limestone (8mm to dust) laid over the revealed archaeological features prior to being covered by a geotextile membrane (top right).

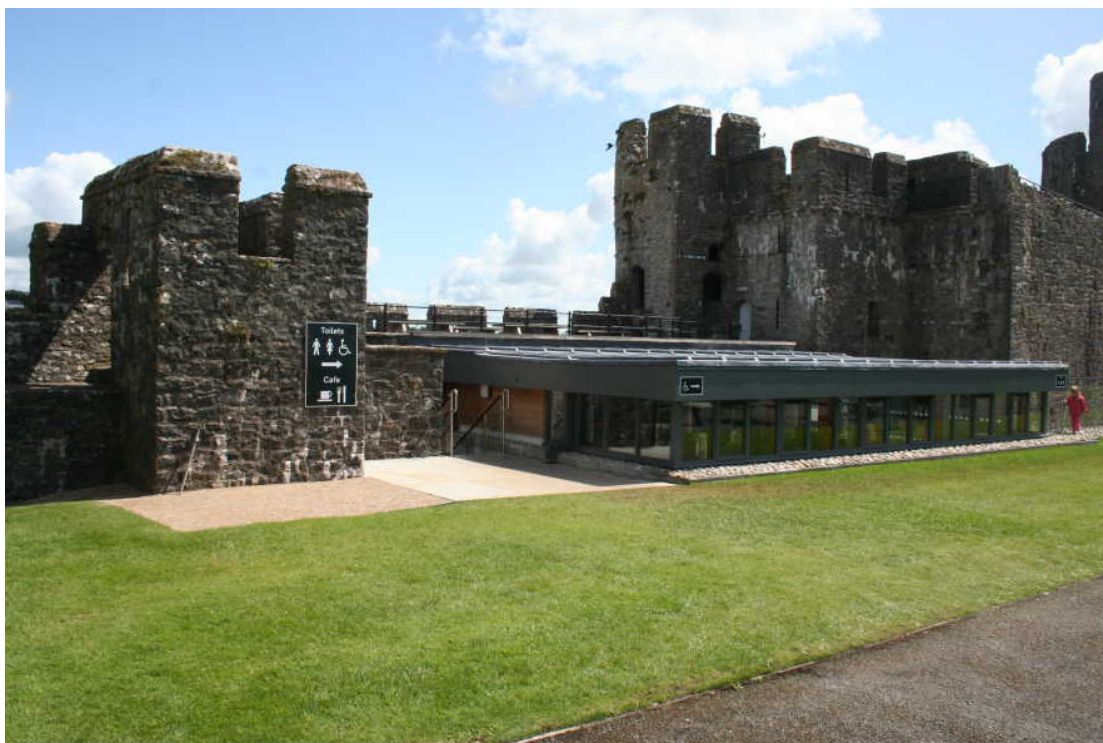
**Photo 15:** A view of the new café after completion, looking southeast.
