EXCAVATIONS AT THE COKE OVENS, TONDU IRONWORKS, BRIDGEND

RHIF YR ADRODDIAD / REPORT NO. 2007/37

EXCAVATIONS AT THE COKE OVENS, TONDU IRONWORKS BRIDGEND 2007

Duncan Schlee

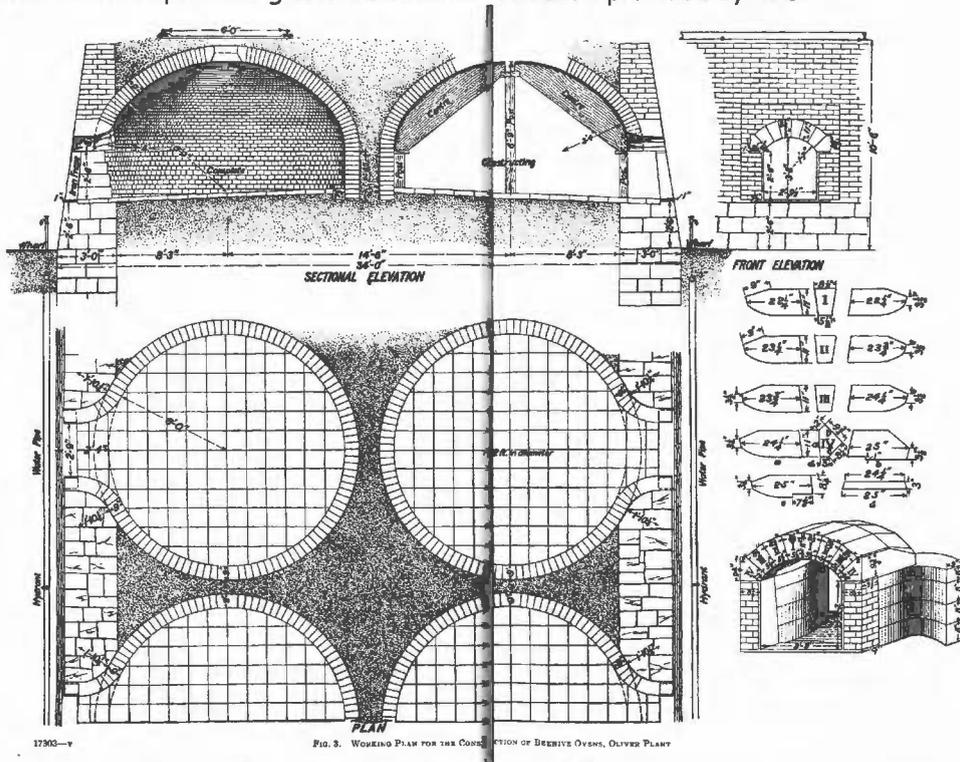
Plan and cross-section and front elevation of part of a double bank of common beehive ovens. Note provision of water standpipes for supplying hosepipes (not shown) for quenching the charge during emptying (from *Coke – A Treatise on the manufacture of Coke and Other Prepared Fuels and the Saving of By-Products*, Fulton J, Scranton PA., 1906)

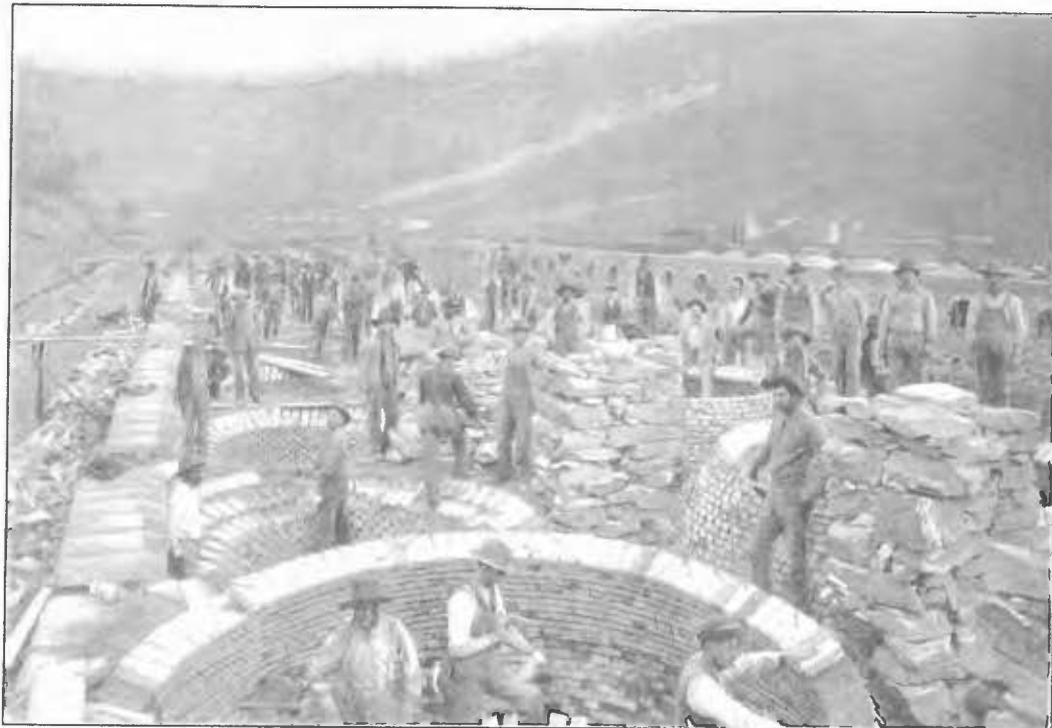
FIG. 9. CONSTRUCTION OF BEEHIVE OVENS

A double bank of common beehive ovens under construction, c.1900 ovens (from *Coke – A Treatise on the manufacture of Coke and Other Prepared Fuels and the Saving of By-Products*, Fulton J, Scranton PA. 1906)

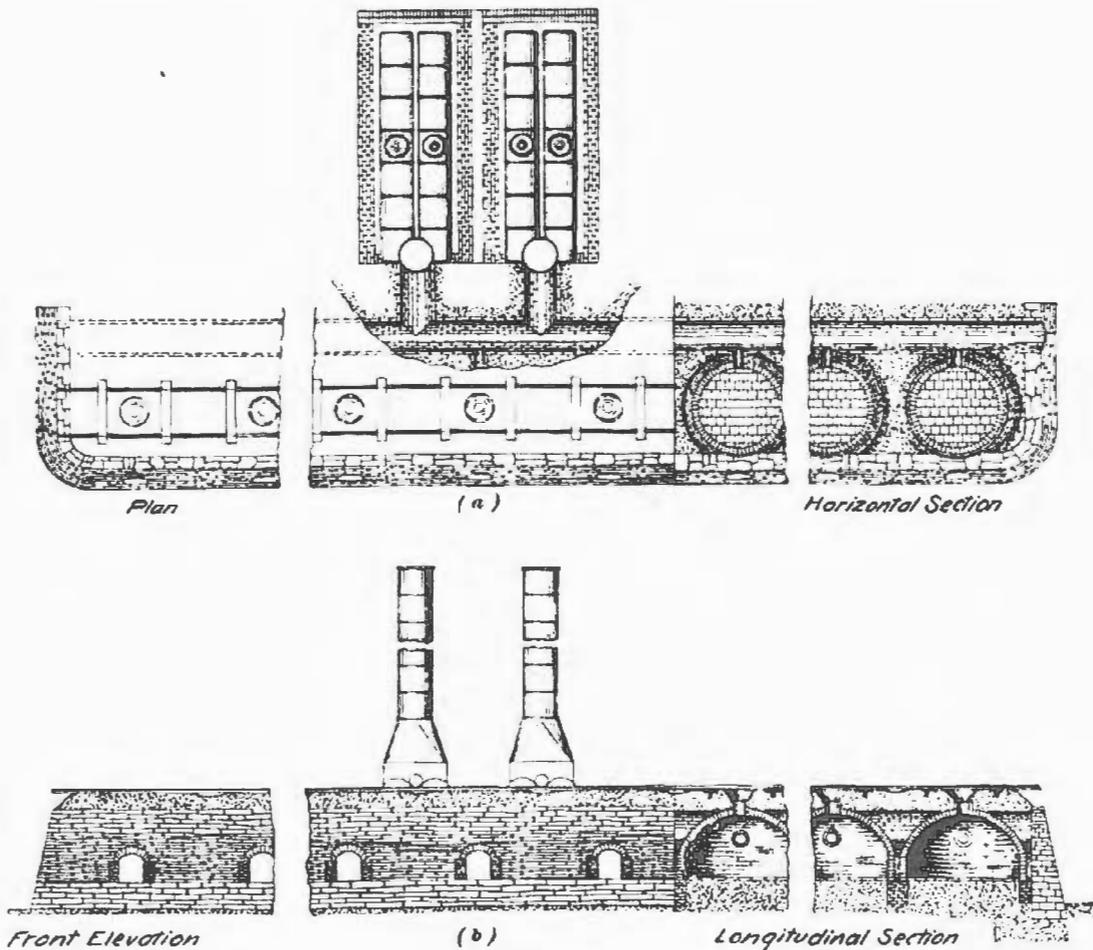
(a) Top View and Horizontal Section. (b) Front Elevation and Longitudinal Section
 FIG. 15. OVENS AT PRATI MINES, ALABAMA USING GASES FOR STEAMING PURPOSES

Single oven bank with vaulted flue feeding exhaust gasses to two pairs of boilers located at right angles to rear (from *Coke – A Treatise on the manufacture of Coke and Other Prepared Fuels and the Saving of By-Products*, Fulton J, Scranton PA., 1906)

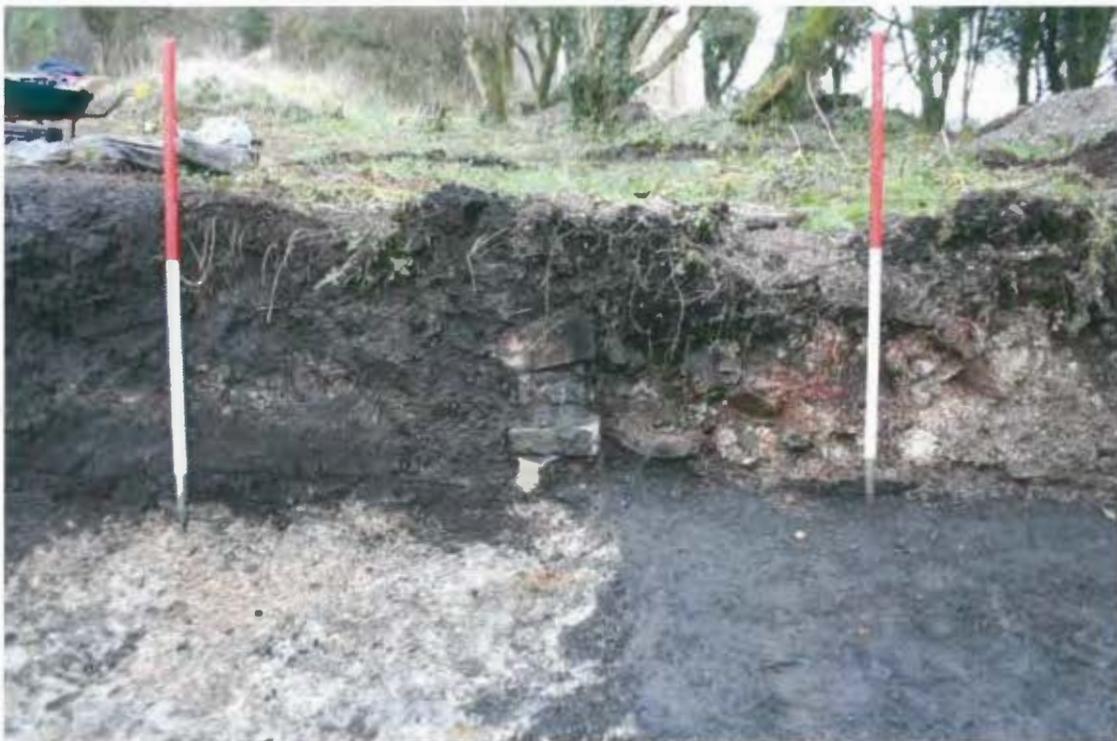
Photo 6: Trench 1A. Low brick wall (in section) separating the 'apron' (right) and 'platform' (left) working areas, looking west

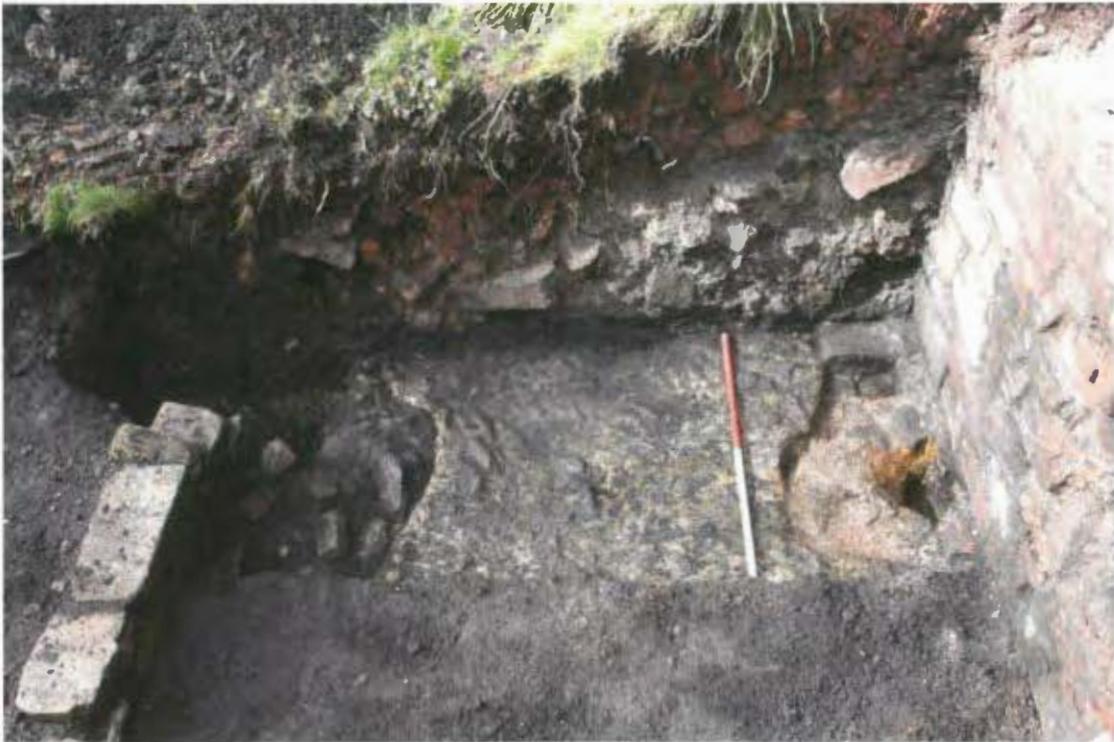
Photo 11: Trench 2C looking west showing features cut into 'apron' surface

associated with the coking operations were observed in any of the 'apron' areas, except in Trench 2C where two features of uncertain purpose were cut into the clay and sealed by the coke laminations. It is therefore uncertain whether the raised platforms and 'apron' working areas represent a later phase of working that has removed or masked an earlier working surface.

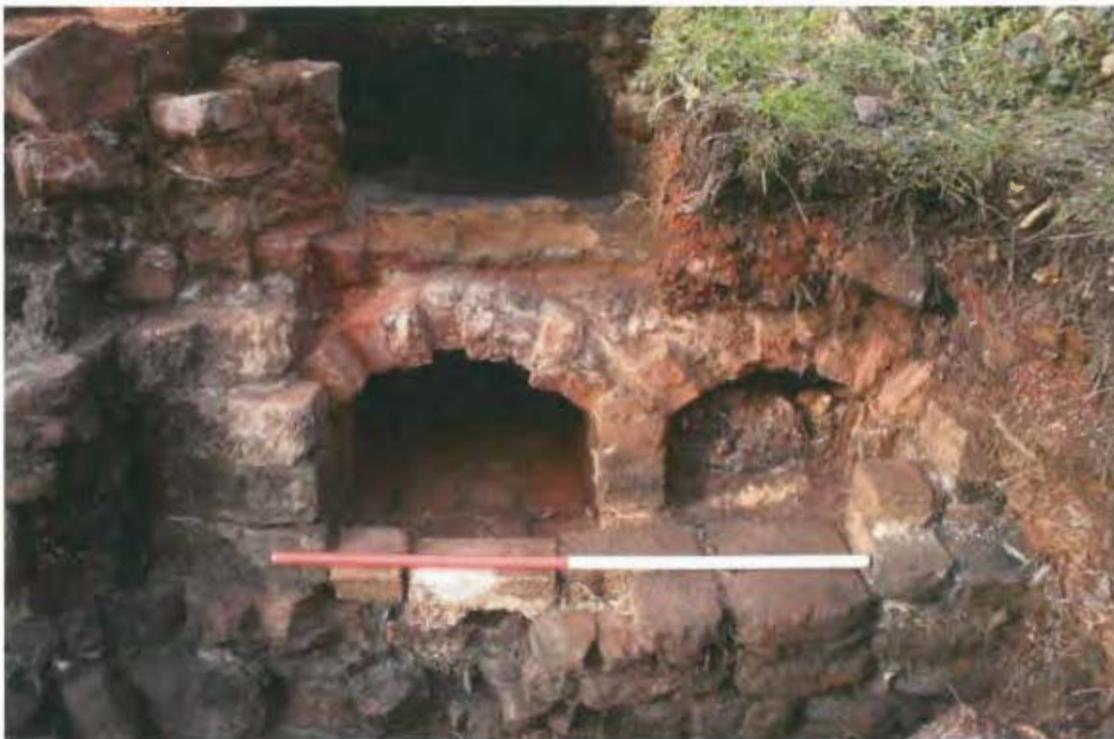
Photo 12: Trench 2C. Entrances to sole flues of southern coke oven

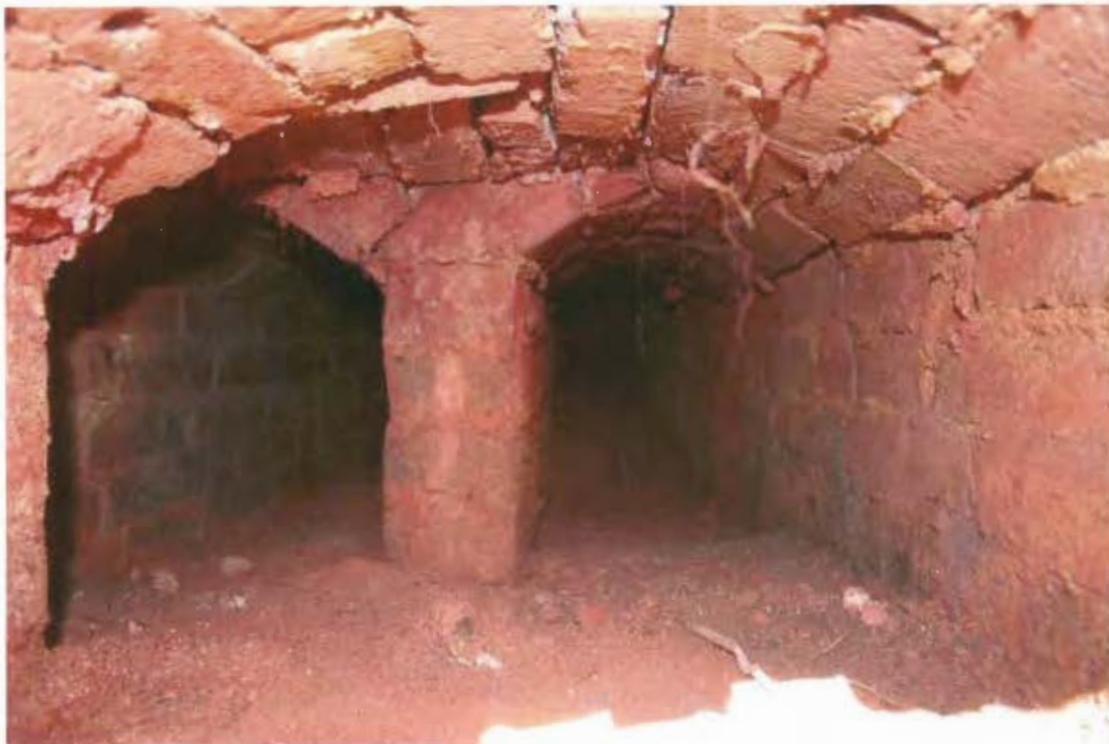
Photo 13: Trench 2C. Detail of flue structure beneath coke oven

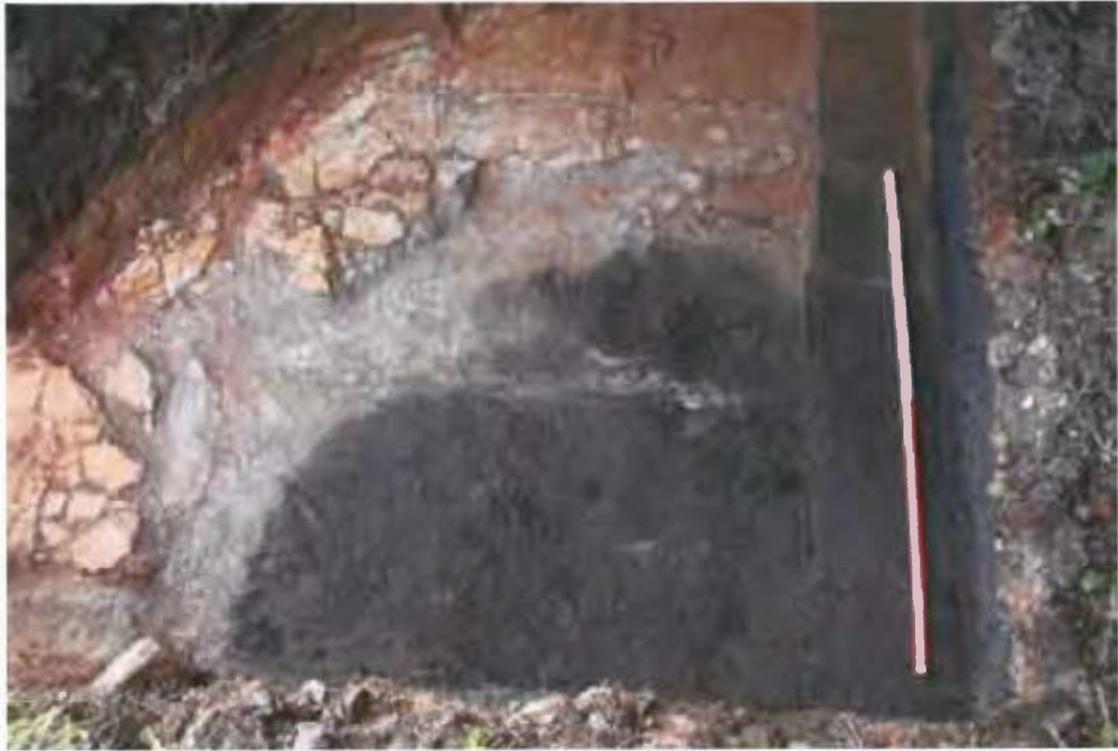
Photo 15: Trench 2C. Burning pattern and missing oven floor tiles etc.

In the excavated portion, the southern half of the oven floor bricks (207) had been removed (fig. 14, photo. 14). The evidence of burning where the bricks had been, perhaps suggests that the bricks were removed during the practical use of the oven, possibly as a result of heat damage. It would appear from the burning pattern, damage to the sub-floor mortar bed, and the apparent deposit of spent fuel and coke in the base of the oven, that the oven was used subsequently, without replacing the floor bricks (see photos 14 and 15).

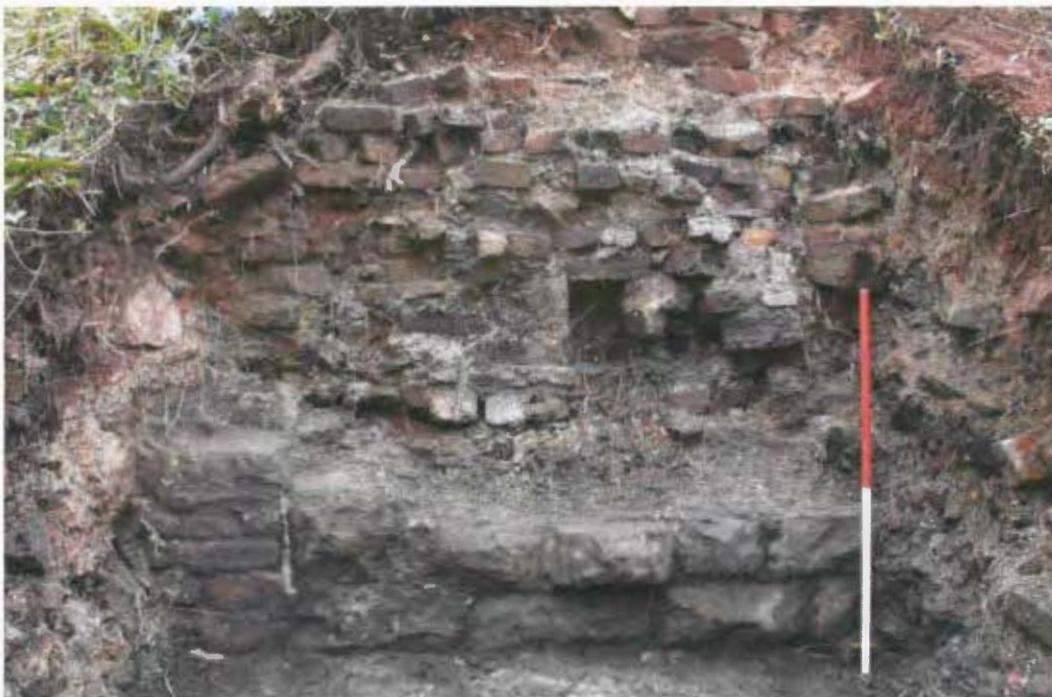
Photo 20: Trench 2A. Detail of robbed north wall of battery looking south

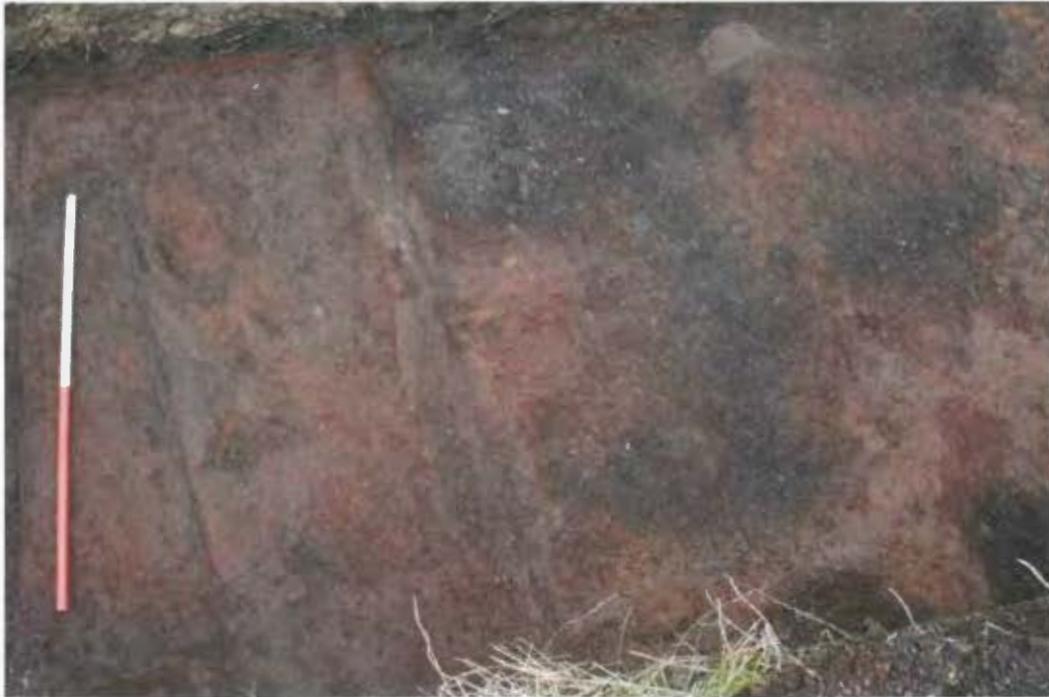
Photo 31: Trench 6B. Remnants of rails and iron plate impressions, looking north

No evidence of a formal constructed working surface was apparent. The most significant would appear to be that associated with the iron plates and possible rails (664) found at a depth of 0.80m below ground level. Generally there appeared to have been a gradual accumulation and compaction of spreads of oven waste. The culverts appeared to have been cut into their associated layers rather than constructed previously, apparently post-dating an initial deposit of oven waste? (665).

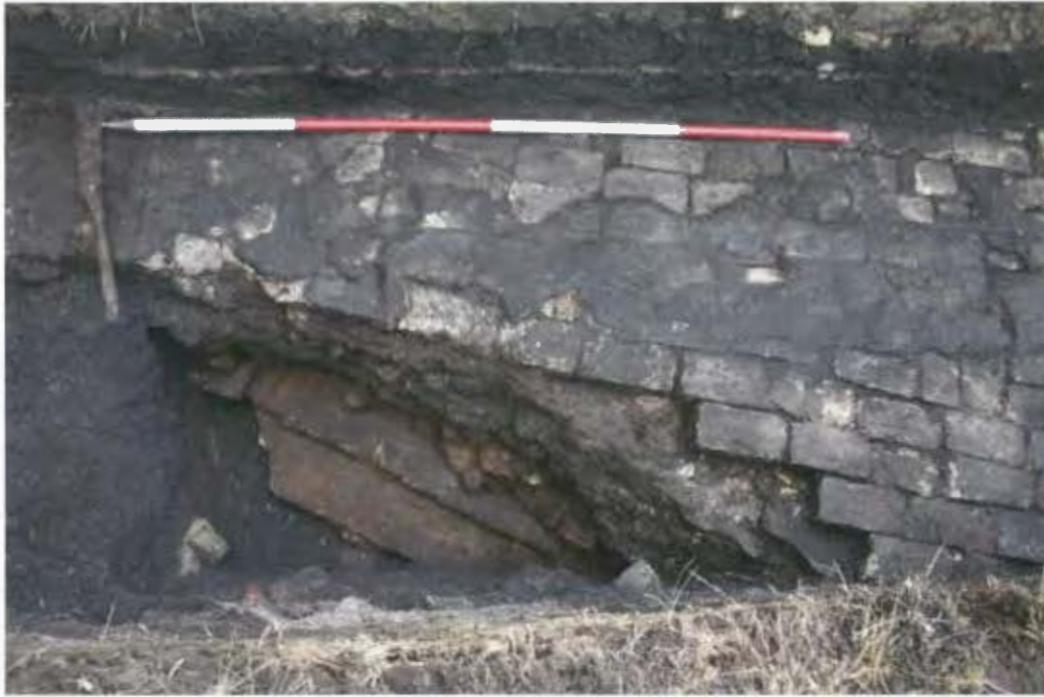
Photo 35: Trench 5B looking east. Truncated floor with underlying culvert

Floor 573 was also truncated along the western edge of the trench by cut 560, and backfilled with clean, crushed, un-burnt coke (558). Removal of the fill revealed the edge of a flue or culvert (561) running beneath the floor in an SW-NE direction i.e. at an angle to the alignment of the building (see photos 35 and 36) at A.O.D. 76.12m. The overlying deposit 559 was presumably backfill of a construction cut for the culvert (as well as the bedding for brick surface 573). Brickwork 571 may be a vestige of masonry footings marking the north extent of the boiler house (see photos 36 and 37). A small portion of culvert at the northern end of the trench (570) was a continuation of culvert 669 from Trench 6B. Deposits 557 and 554 are thought to be secondary backfill deposits of cut 560.

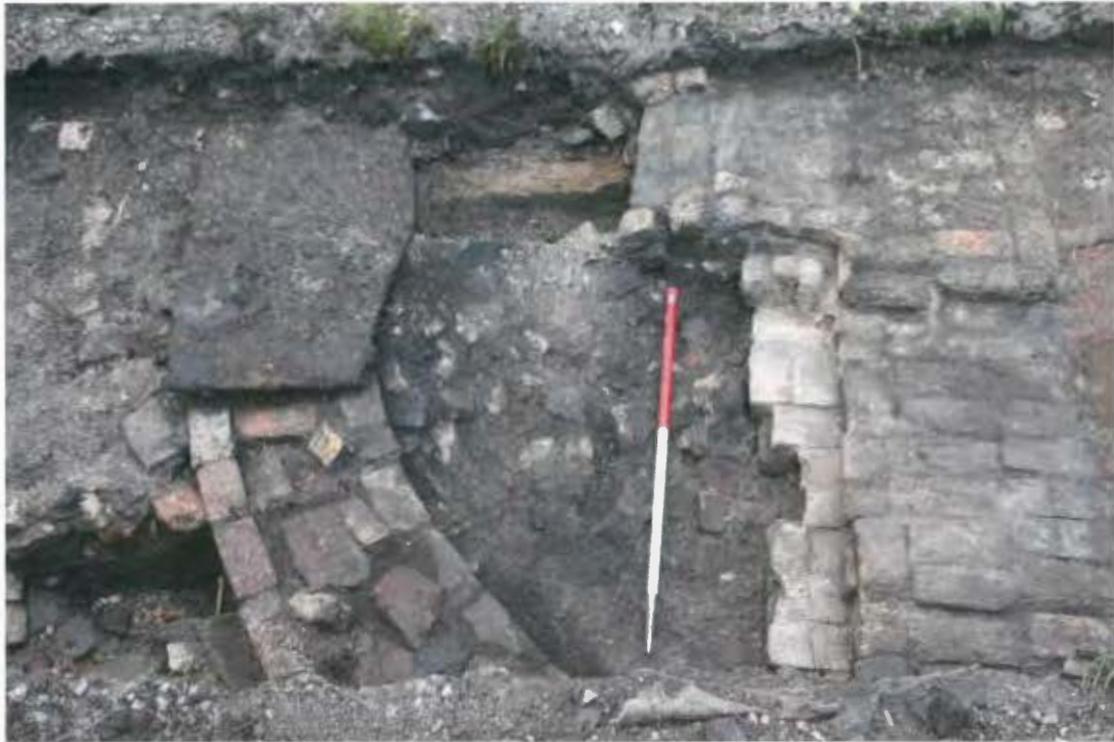
Photo 43: Trench 5A looking south, showing culvert (left) and wall footing (right) presumed to represent the west wall of the former boiler house. Note possible vestige of floor (at red end of scale and in section)

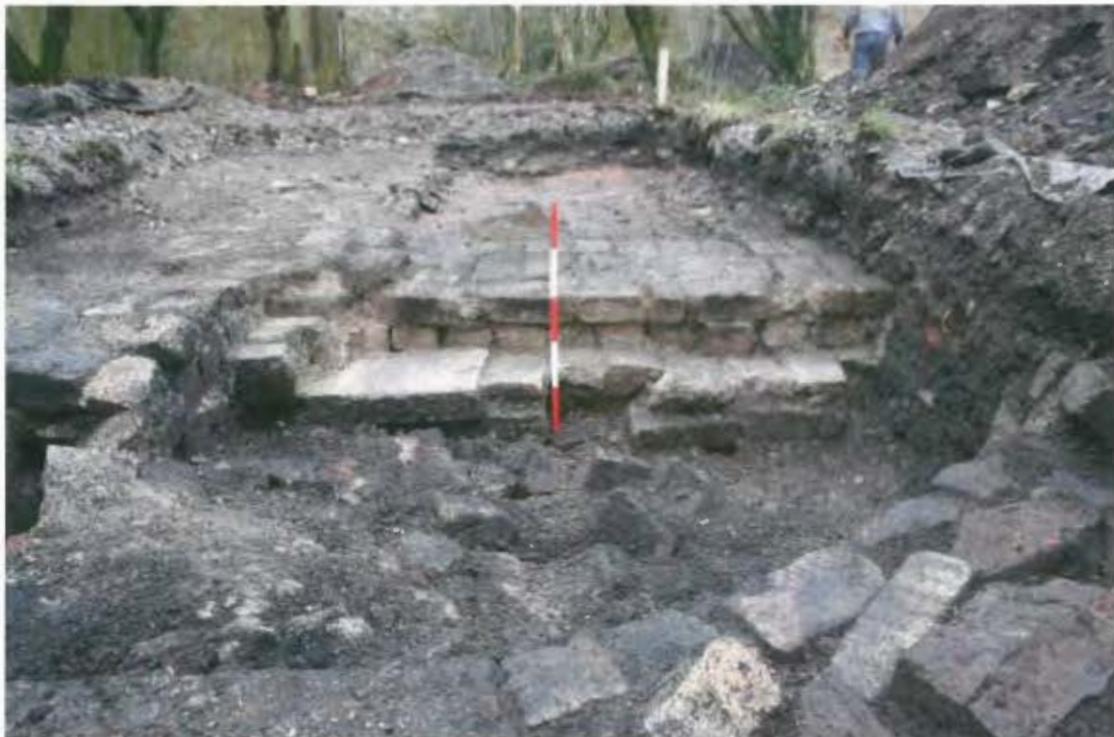
Photo 44: Trench 5A looking west, showing wall footing presumed to represent the west wall of the former boiler house. Note possible vestige of floor to left

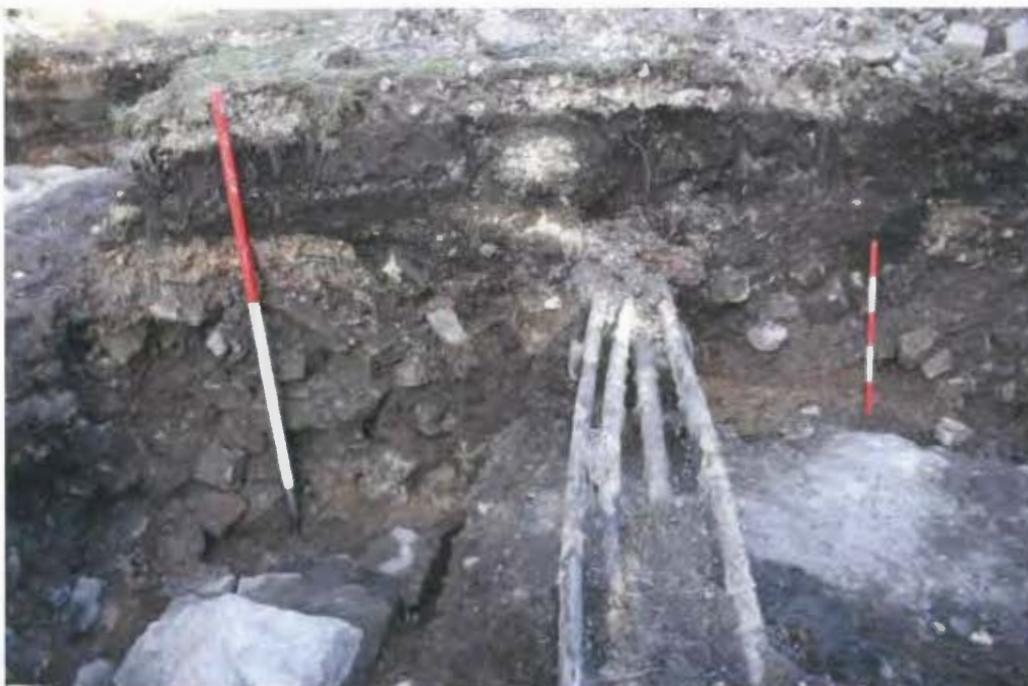
Photo 46: Trench 6A north end, looking east with wall 602 and floor 601

The main structural features noted in the trench were a portion of a substantial mortar surface (601) revealed 0.35m below ground level (top of surface at A.O.D. 76.18m), that appeared to run up to the remnants of a robbed out wall 602 (see fig. 20 and photos 45 and 46) constructed from randomly coursed, roughly dressed stone bonded with a very dark grey mortar. The wall survives to a width of 0.50m but may be truncated on its north side. The surface consisted of a 0.2m thick bed of compact crushed brick capped with a 0.05m thick hard grey mortar screed. Surface 601 appears to have been truncated to the east by a later phase represented by 603 and 605. This may also have removed evidence of a possible southern continuation of structure 517 from Trench 5A.

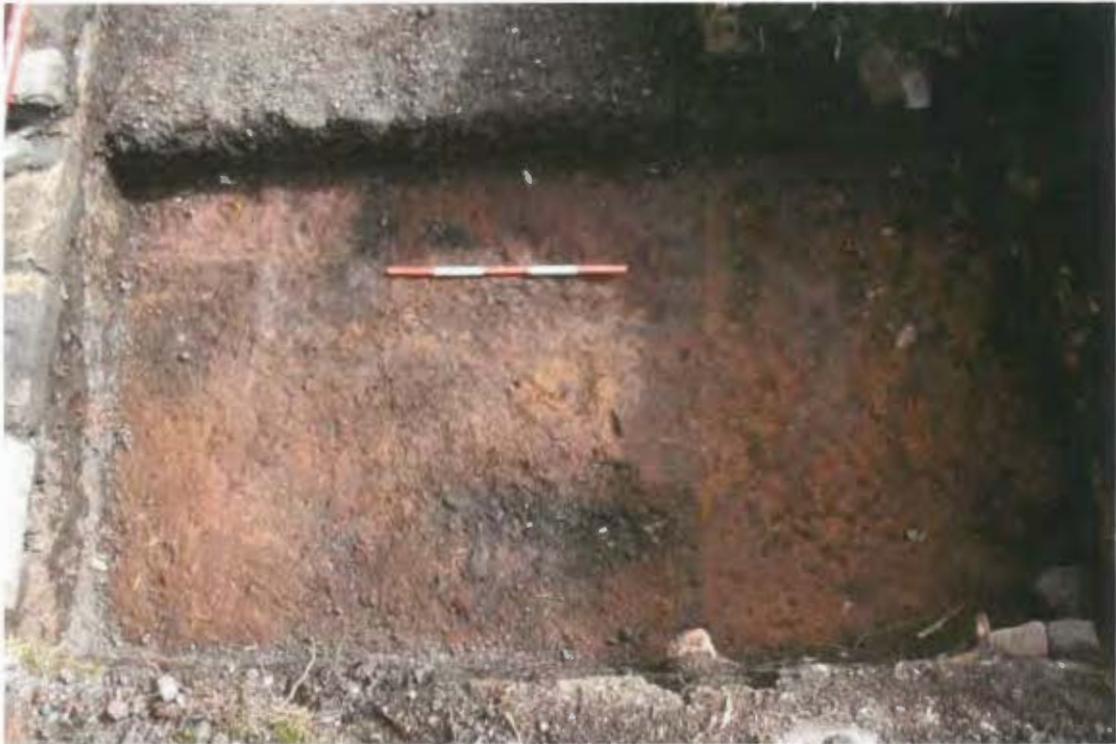
Photo 51: Trench 6C looking north, showing iron plate impressions

Deposits 805, 806 and 807 were removed down to 0.40m below ground level, where a flat and even horizon of compact ferrous-stained clay 809, in which impressions indicating the former presence of probable iron plates were discernable (see photo. 51) (top of 809 at A.O.D. 76.76m). These presumably formed a working surface during the latter phase of the ironworks. The retaining wall of the embankment also appeared to be constructed from this level, with no evidence of a foundation cut, or lower courses of masonry foundations discernable. It is possible, however, that 809 sealed earlier deposits.

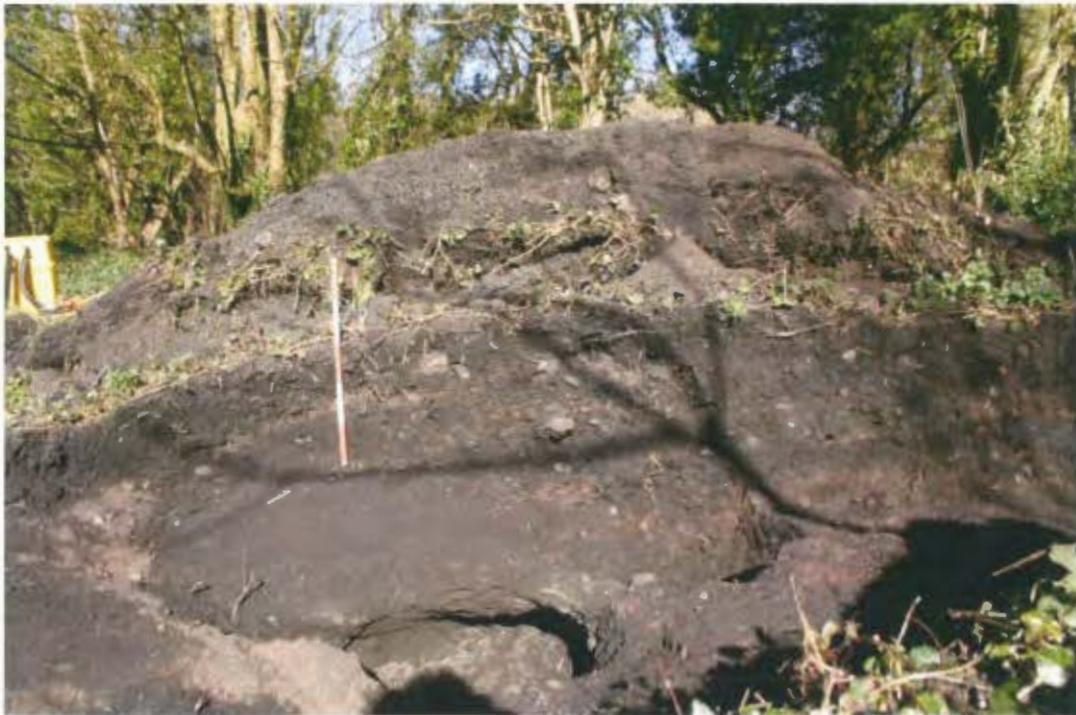
Photo 52: Trench 4A looking west, showing badger disturbance

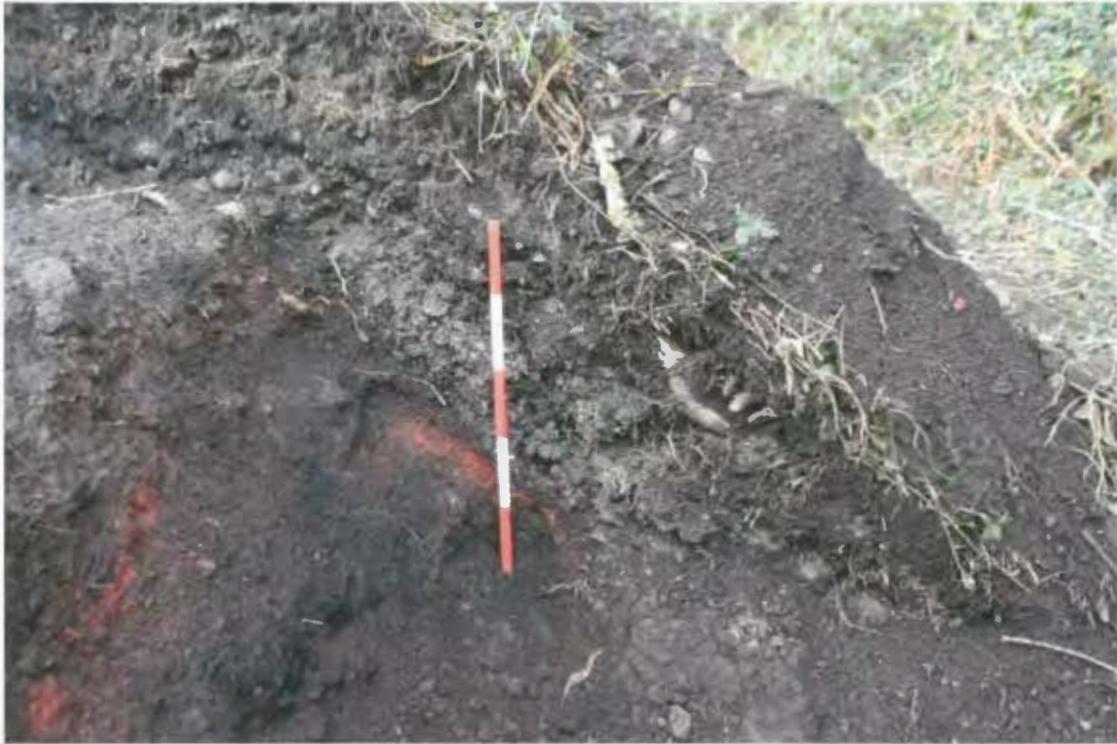
Photo 53: Trench 4A looking west, showing north side of embankment

Trench 4A was located on the top of the embankment (at A.O.D. 84.20m). Overburden deposits of loose dark grey oven waste(?) material 413, were removed to expose the impressions of wooden rail sleepers 405 (0.25 x 2.40m), set into a substantial deposit of compacted oven waste(?) material 407. Evidence of only one set of tracks was identified. Excavation was extended northwards to attempt to locate further rail tracks shown on maps and to clarify any surviving features on the north side of the embankment. No evidence of further tracks or northern retaining wall was revealed, although evidence of badger digging was noted (photo. 52). Compact structural deposits of oven waste(?) similar to those encountered on the south side of the embankment, but with more evidence of oxidization (reddening) were revealed (see photo. 53).
